## Toe structures management manual

Project: SC070056/R

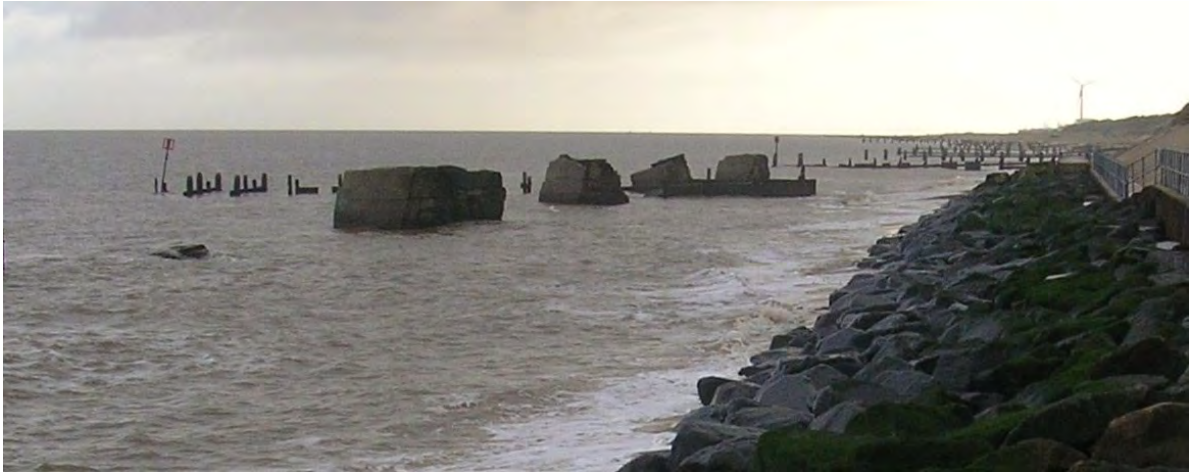
In 1870 the Colman family had concrete and timber coastal defences built to protect their property between the middle and the southern end of Corton. Relics from these early defences are still evident today (Figure C2.2).

**Figure C2.2** Detached concrete relics of 1870 Colman coast defences

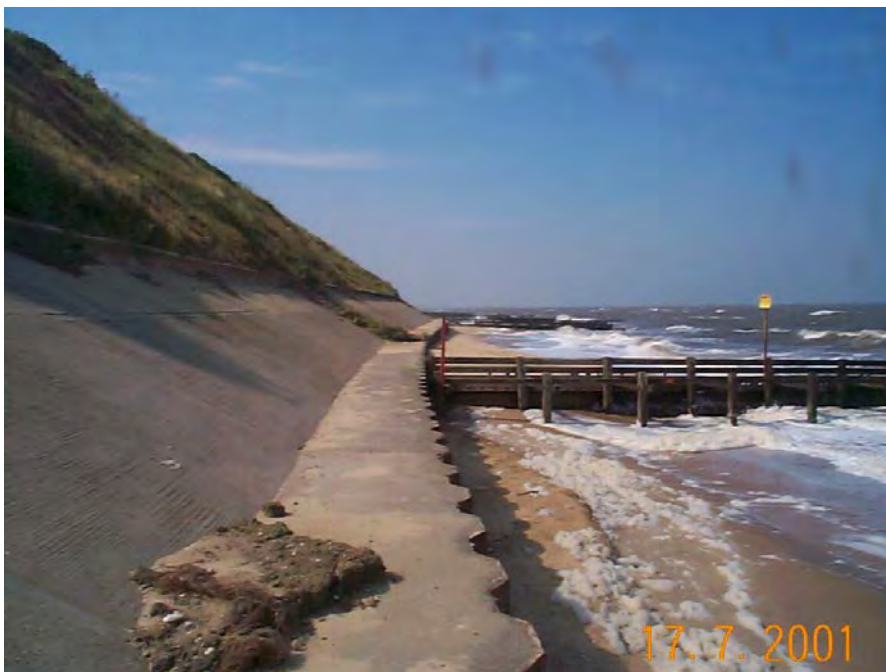
The seawall built prior to the works described in this paper originated from 1960 and 1967 and consisted of a steel sheet piled toe behind which was a mass concrete berm and a raked concrete slab covering the lower cliff face (Figure C2.3). In addition to the new seawall, timber framed/steel sheet faced groynes were installed along the frontage.

**Figure C2.3** Typical 1960–1967 toe and revetment structure (note date of photograph)

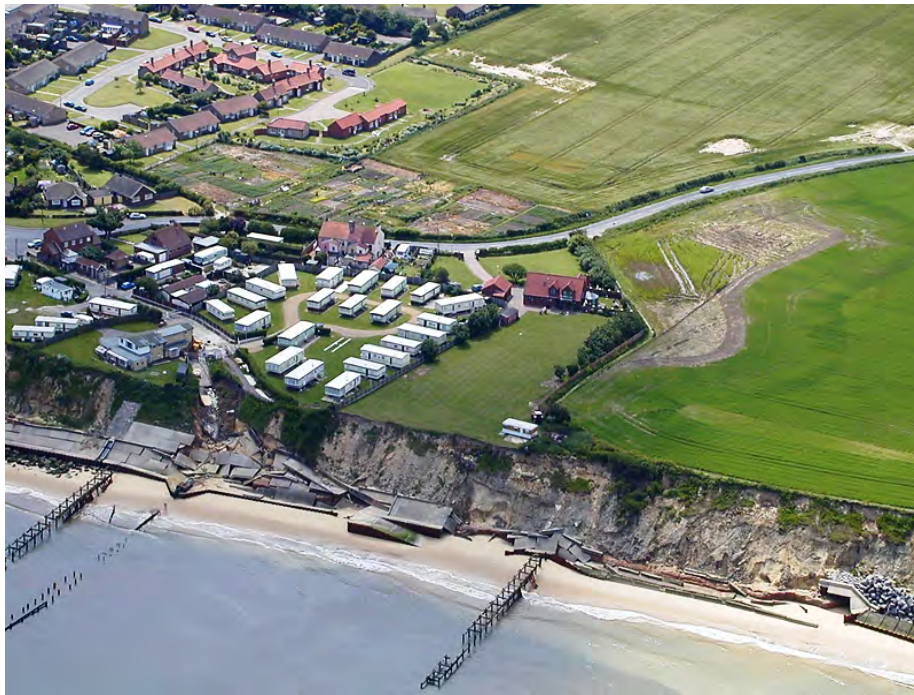
Uncertainties as to the form and scale of the long-term solution led to a decision to carry out immediate holding measures, thus giving the necessary time to properly consider and implement more major reconstruction work. The holding measures, carried in the autumn 2000, consisted of a double layer of 3–6 tonne rock placed along the failed defence line. In spite of these measures, further collapses occurred at other

**Figure C2.4** Failure of the seawall in winter 2000–2001

Figure C2.7 shows two design cross-sections through the revetment. The upper section shows the cross-section of the new defence where the original construction was totally destroyed (see Figure C2.4); the lower section shows the typical section to the south of this where, partly for cost reasons, the original cliff apron slab survived and was incorporated into the section.

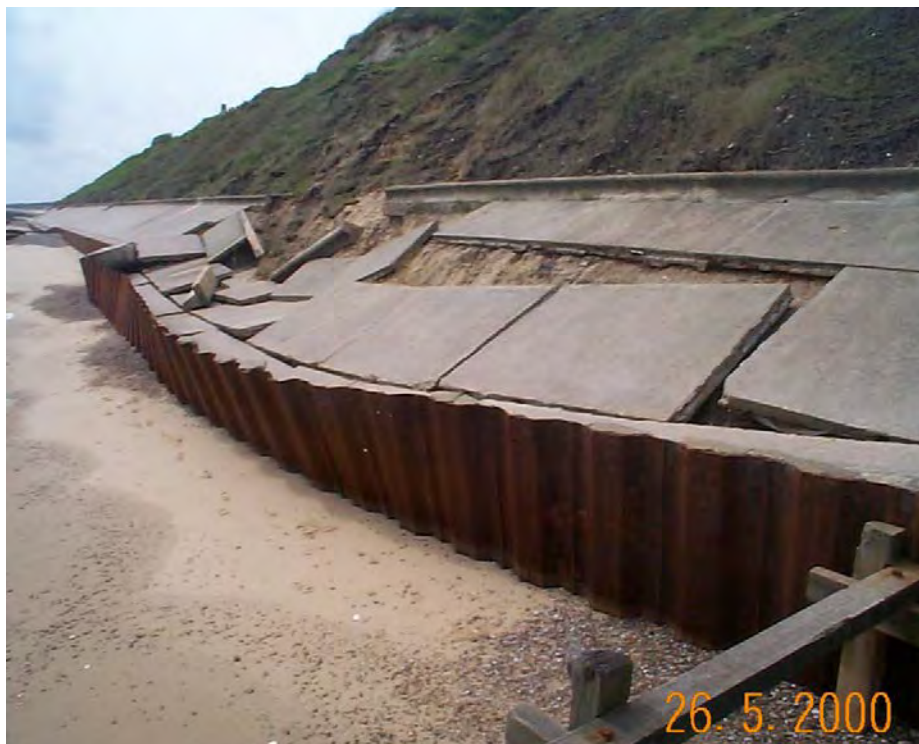
In 1986, 50 metres of the 1960s seawall failed due to undermining. By this time, the groyne field was also in poor condition due to abrasion of the steel piles. The failed section of seawall was rebuilt together with two groyne; otherwise only routine maintenance was applied. However, the shoreline continued to retreat and further collapses of the seawall occurred in November 1999 and April 2000 (Figure C2.4). It appears that the beach level dropped below the toe of the sheet piles but that the metal ties restrained them close to the top, resulting in the piles kicking out at the toe (Figure C2.5). Where scour penetrated behind the piles, the whole structure collapsed with the concrete berm articulating over the piling.

**Figure C2.5** Rotation of the toe piling (photograph taken after the 1999 failure)

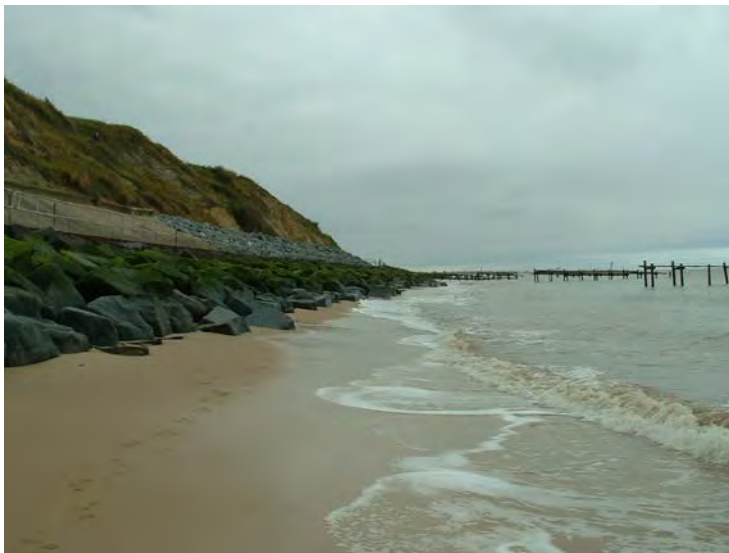
The completed scheme is shown in Figure C2.11.

**Figure C2.11**                      **Finished works**

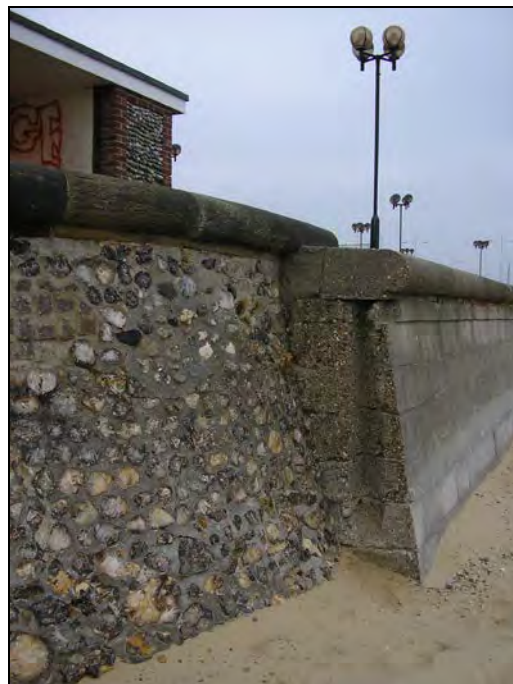
There were two types of seawall in the area of concern (Figure C3.3):

- a concrete wall (90 m northern half) dating from 1922 (actually an encasement of the original old flint wall);
- an old flint wall (110 m, southern half) dating from c.1880, with a concrete core of variable quality, faced with grouted flint cobbles.

**Figure C3.3** Old Flint Wall and concrete wall

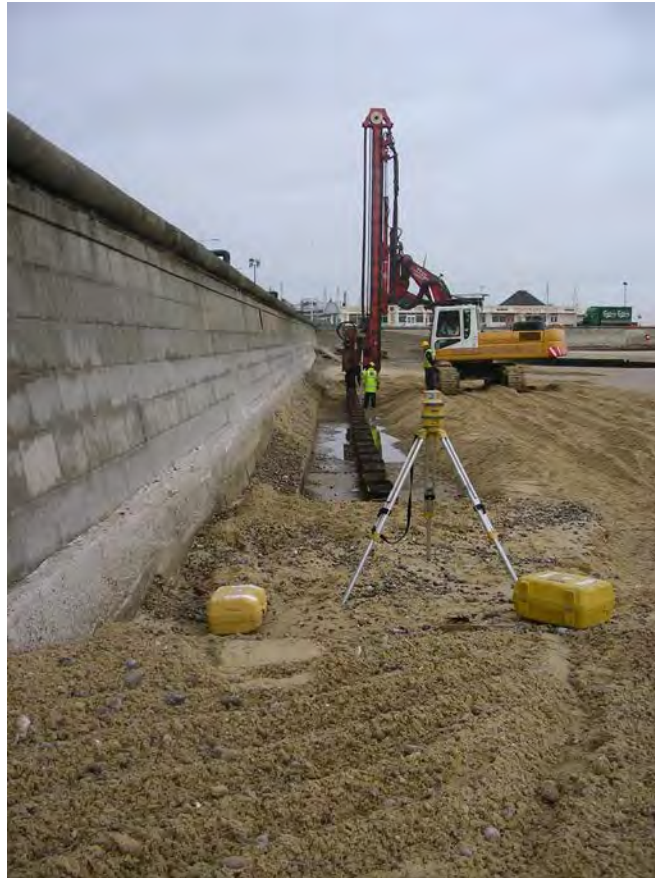
**Figure C3.6** Toe piling being installed (at concrete wall section)

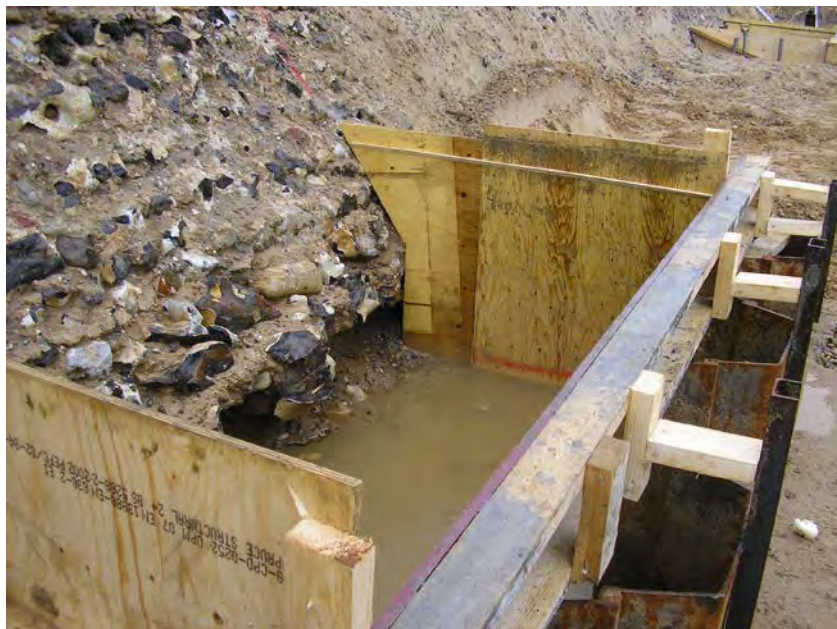
**Figure C3.7** Shuttering for concrete thrust block (apron) – old flint wall section (note water ingress and exposure of the toe of the existing wall)

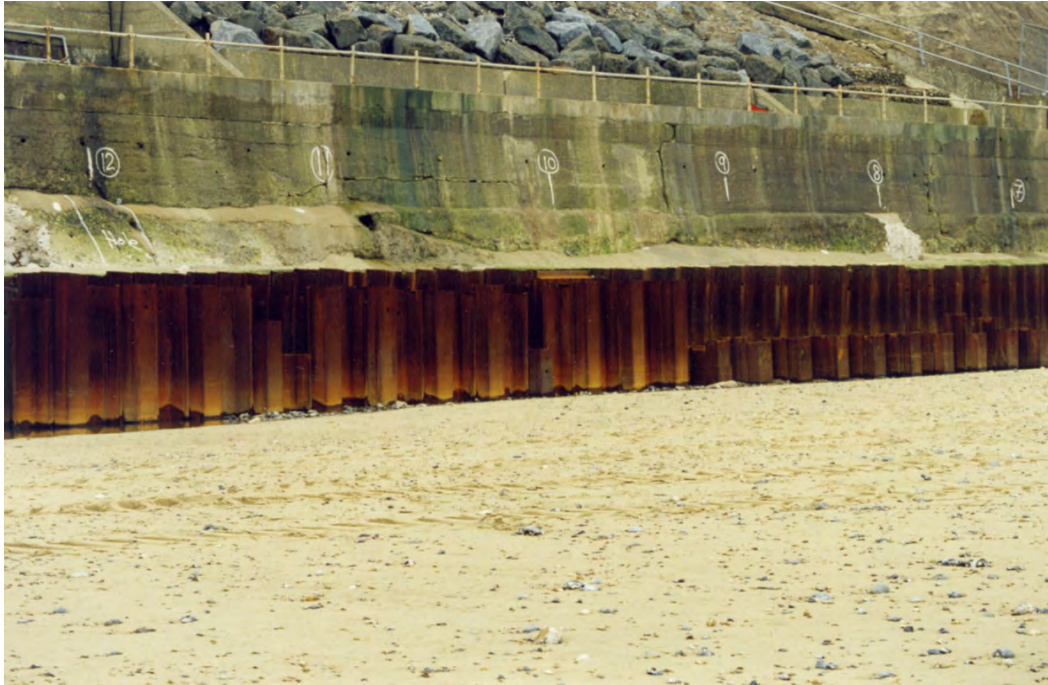
Prior to construction of the present structure, the coastal defence consisted of a sheet pile toe behind which there was a lower concrete apron, concrete retaining walls and a higher concrete apron, all containing the coastal cliff to a height of about 25 mODN. The old sheet piles were badly corroded and there were holes in some of the pile pans. The whole structure was believed to date from c.1908. Figure C5.3 shows part of the wall that did not fail.

**Figure C5.3**                      **The original wall**

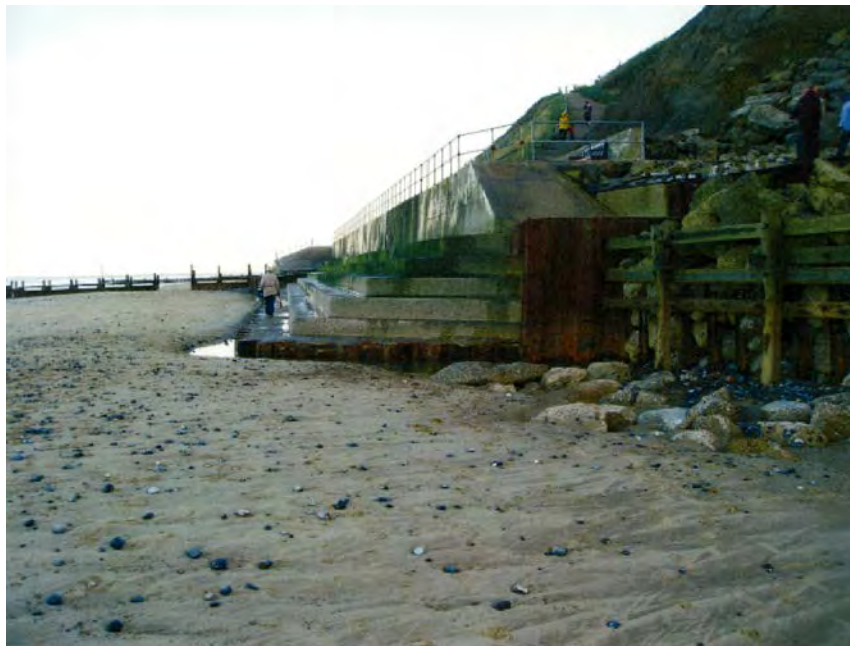
**Figure C5.5**

**End detail**

The front edges of the steps have become rounded (being sharp edged when cast). In retrospect, it would have been better to allow for corner chamfers in the shuttering.

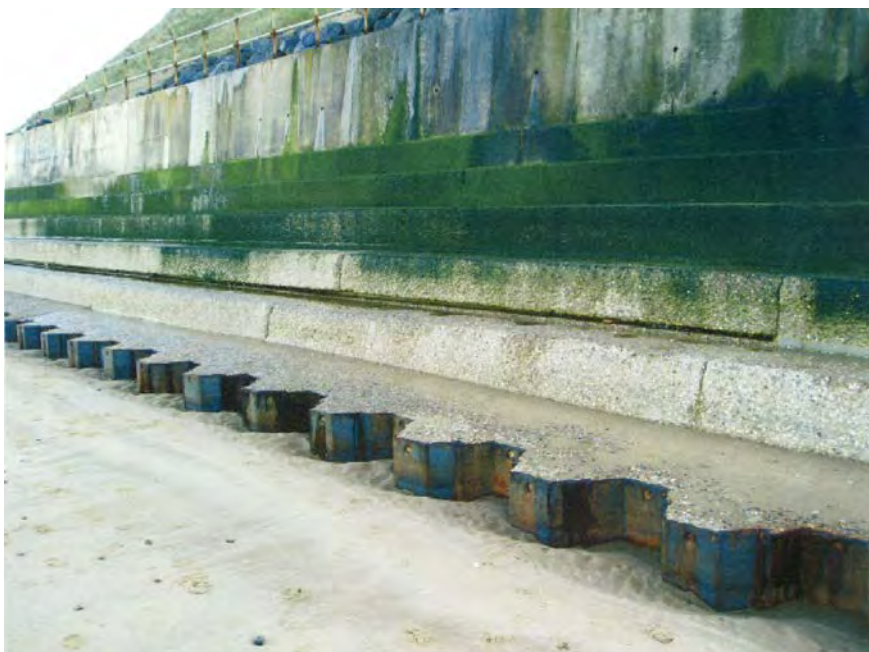
**Figure C5.6**

**Finished toe and wall**

The scheme provides amenity benefits and has been successful. The use of pre-cast concrete provided a quick economic solution in this case. Better attention to the detailing of the steps (edges) in future should be noted.

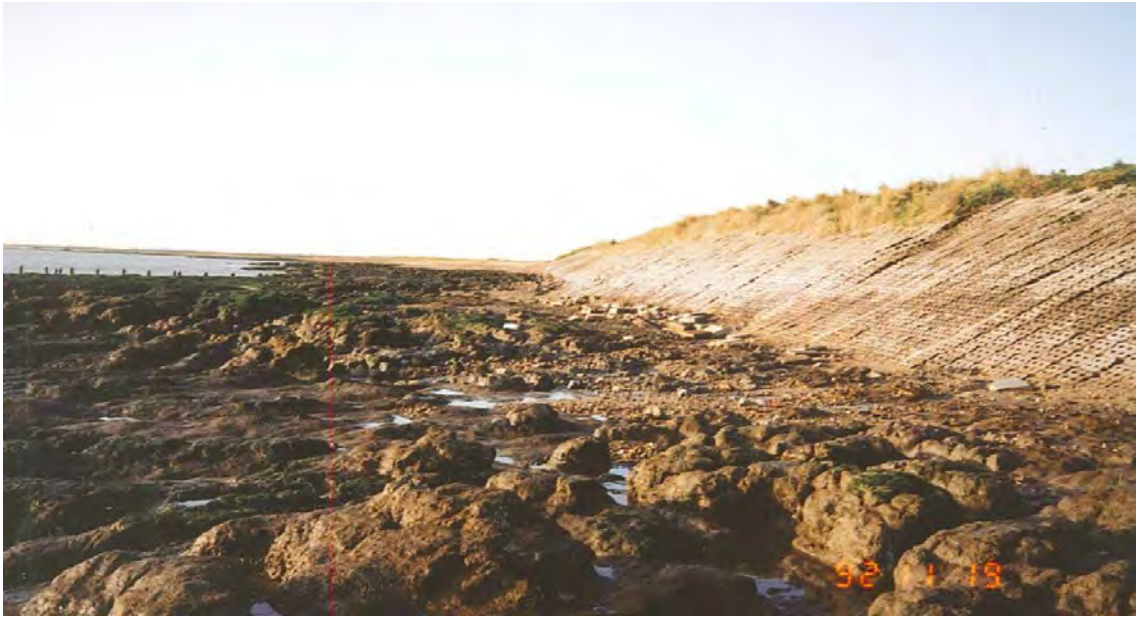
**Figure C6.2** Flexible armoured revetment (earlier defence structure)

Earlier attempts were made to arrest erosion of the spoil site by placing interlocking mattresses on the embankment (Figure C6.2). However, these were inadequate for the given exposure and were soon destroyed by storm wave action (Figure C6.3). An alternative low-cost revetment was sought.

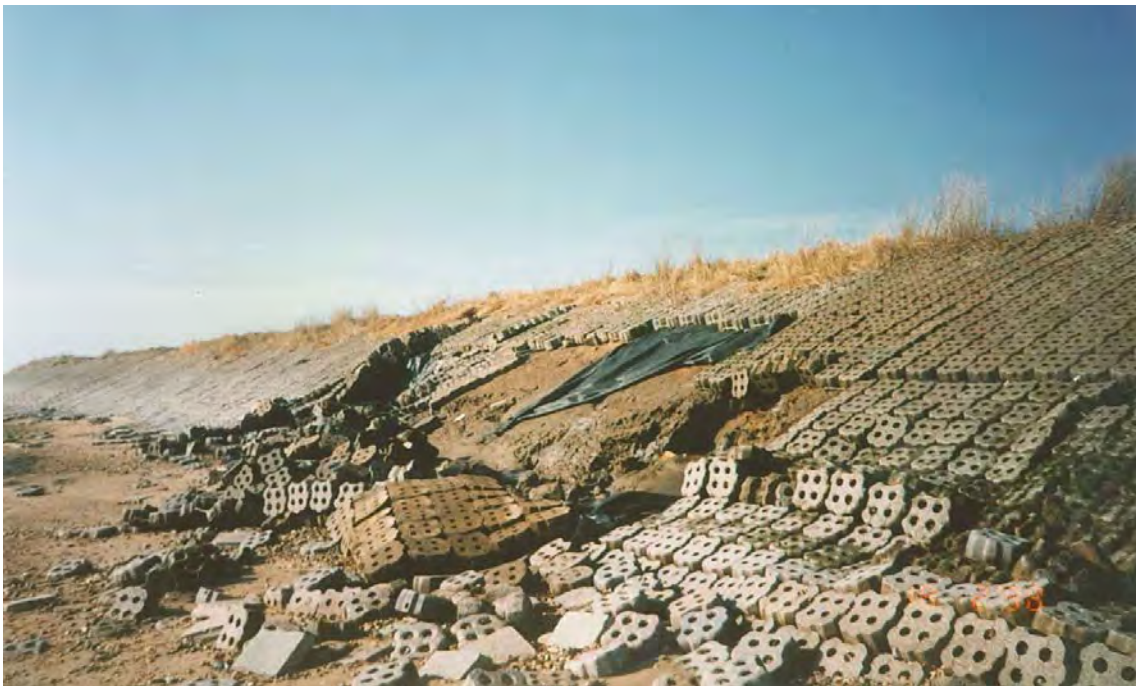
**Figure C6.3** Failed flexible armoured revetment

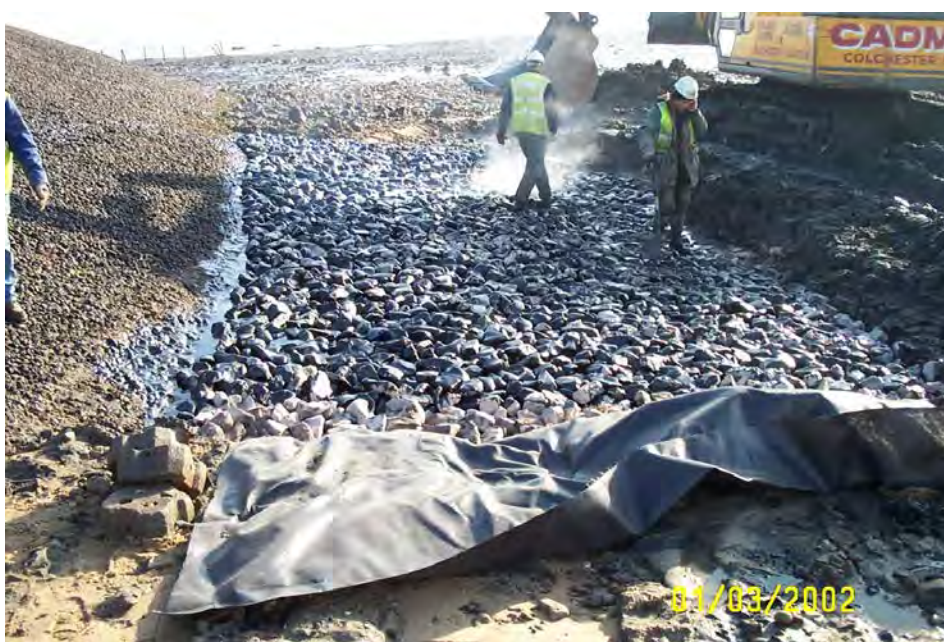
**Figure C6.7**                      **Toe construction**

Beach excavation and toe construction were undertaken using plant on the foreshore. Plant operated from the crest of the embankment for placing asphaltic materials on the revetment. Construction of the works was straightforward except for some damage to the top landscaped area due to plant movement; see Figures C6.6 and C6.7.

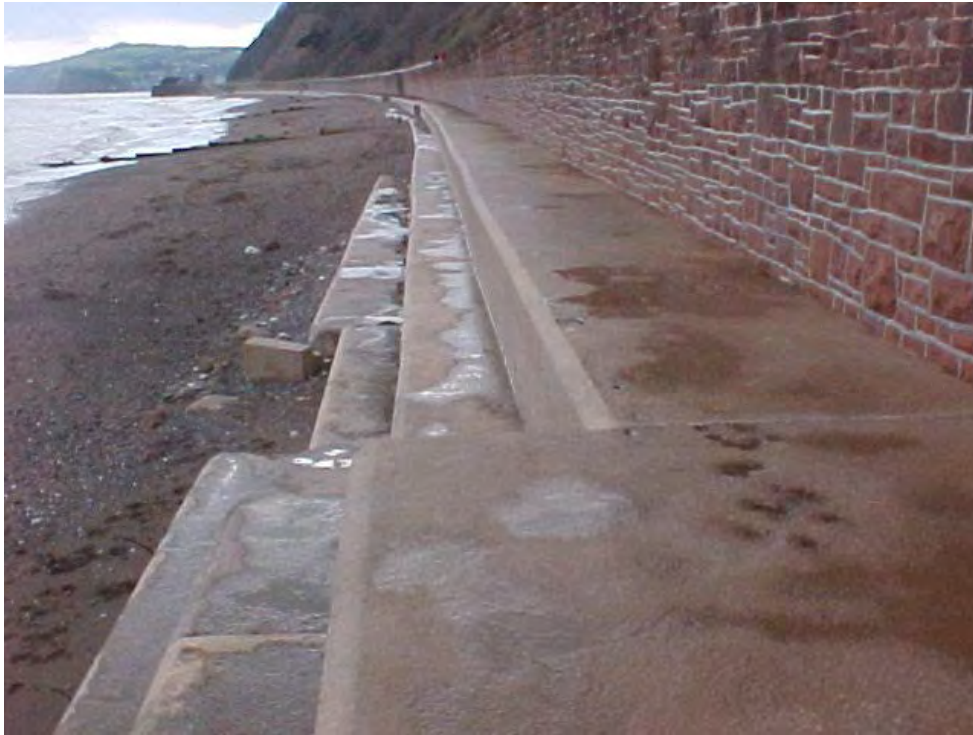
**Figure C7.4** Full foundation strengthening, Smugglers Cove to Sprey Point

Locally, provision in the detailed design was made to extend existing steps to the beach downward, to provide ramped sections where necessary, to negotiate features, and to make provision for watercourse outlets. Figures C7.4 and C7.5 show the full foundation arrangement at Smugglers Cove and Rockstone respectively. Figure C7.6 shows partial foundation strengthening.

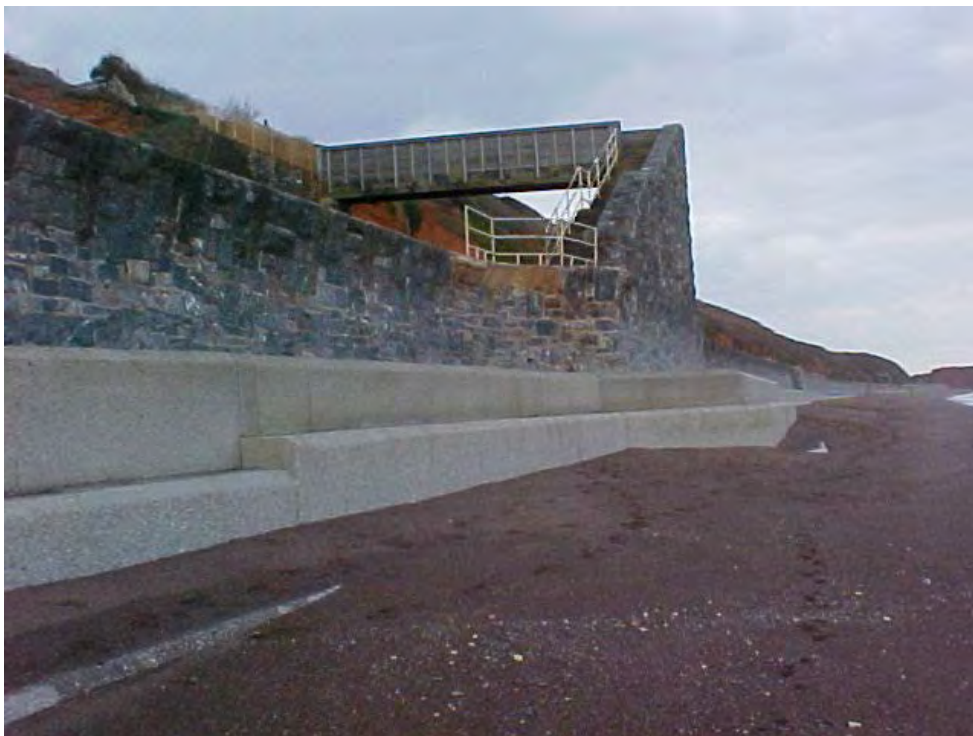
**Figure C7.5** Full foundation strengthening – Rockstone footbridge

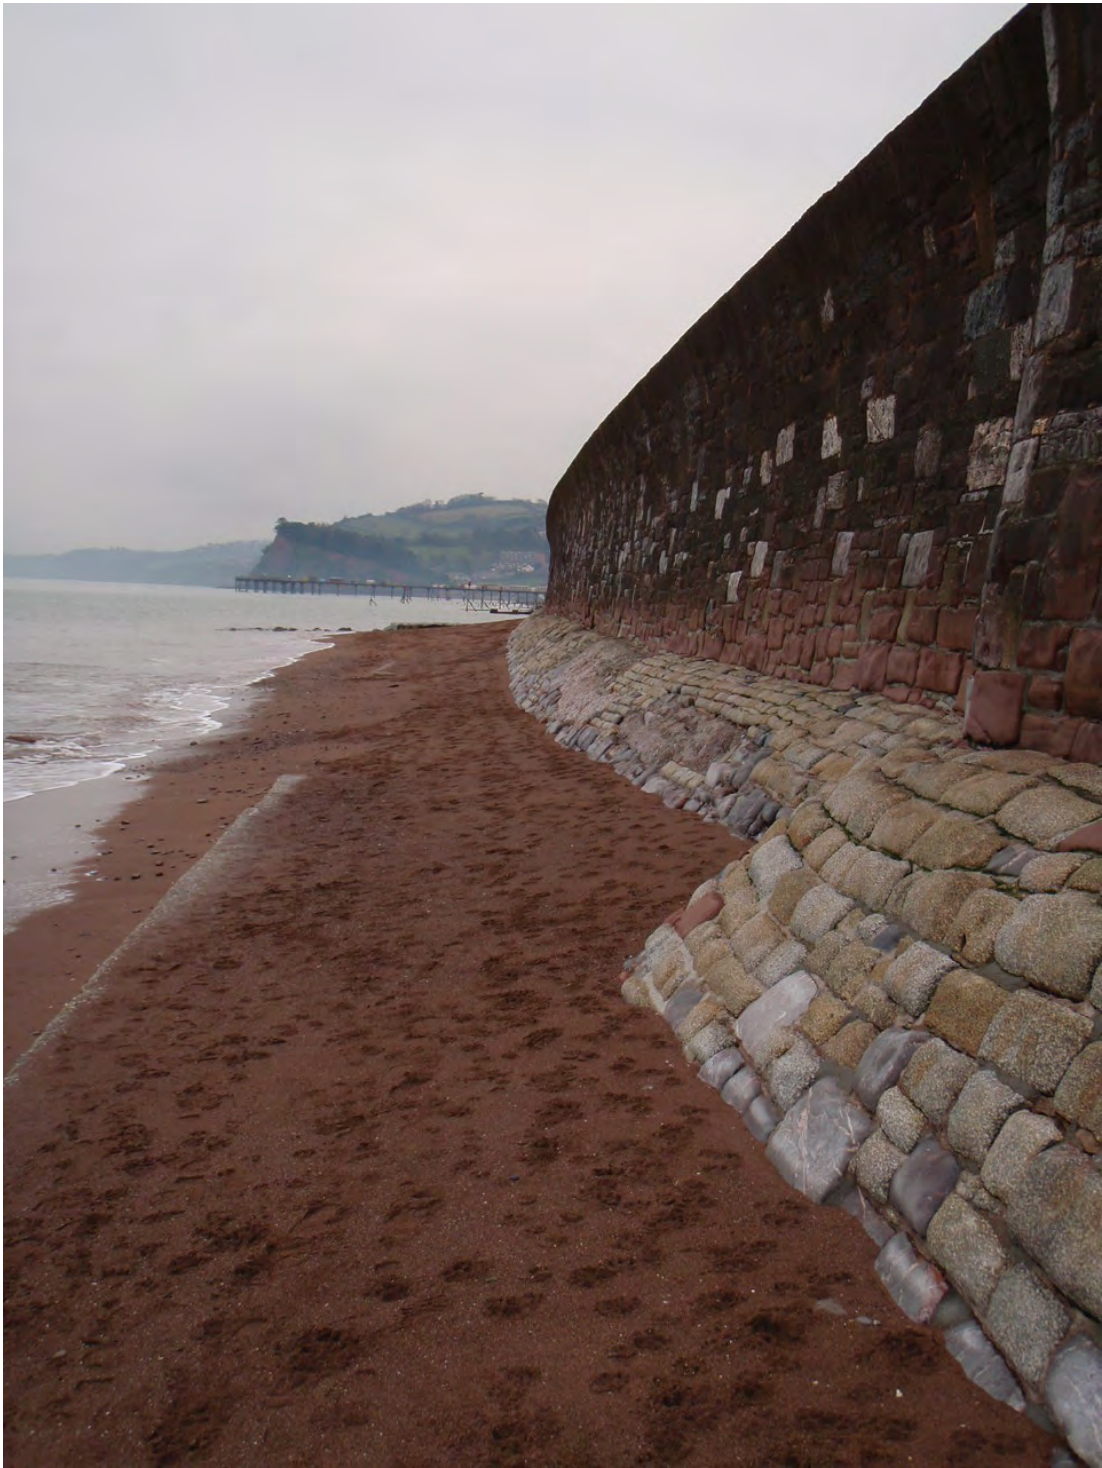
**Figure C7.6** Partial foundation strengthening – Sprey Point to Teignmouth (note only outer edge of single step visible at the time photo was taken)

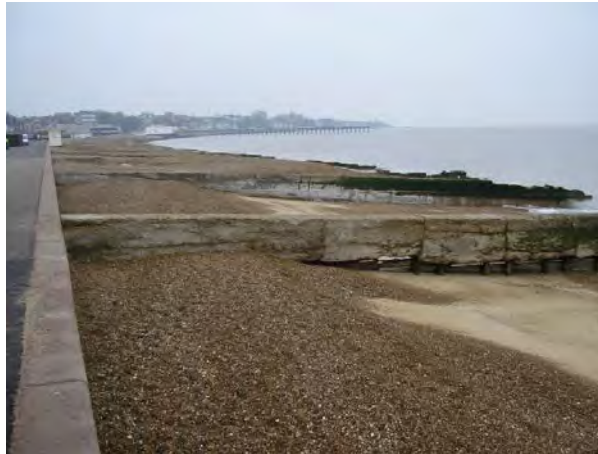
**Figure C8.2 Seawall and groynes at the SCDC frontage, 2005**

The earlier coastal defences consisted of a mass concrete seawall and promenade, constructed in 1903. The seawall was fronted by a mixed shingle–sand beach, with timber groynes encased in concrete, spaced at approximately 30 m centres (Figure C8.2). The beach was in a poor condition, sediment loss having been accelerated by wave reflection from the exposed vertical wall. Severe overtopping occurred regularly, damaging the promenade and causing localised flooding.

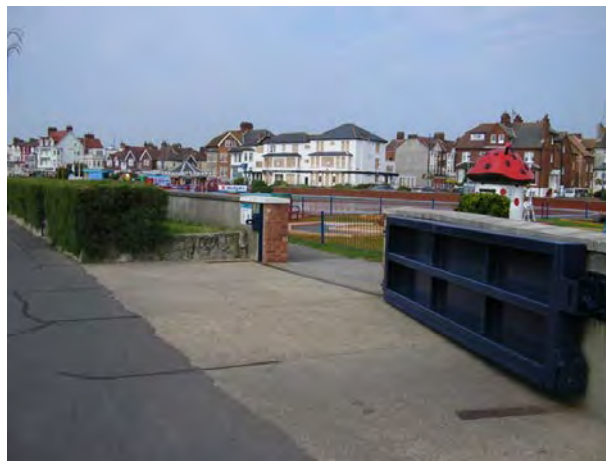
**Figure C8.3 Floodwall and gate**

Approximately 20 m landward of the promenade, there is a 1983 floodwall of a sheet piled construction; this is clad in concrete with facing bricks (Figure C8.3). This floodwall was in good condition in 2006 and provided a standard of protection of 1 in 200 years. However, its performance as a flood defence depended on the closure of floodgates and, in any case, was conditioned by the frontline seawall which was calculated to have a standard of protection of less than 1 in 1 year based on critical overtopping for damage. Furthermore, the seawall was at imminent risk of collapse due to undermining. It was estimated that following failure of this seawall, failure of the crucial floodwall would occur within five years.

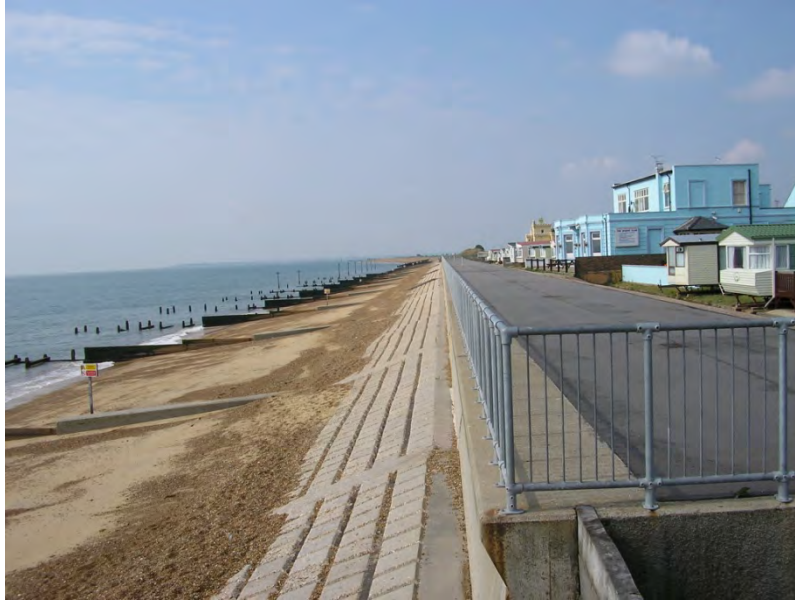
**Figure C8.4 Environment Agency seawall and flood defence, 2005**

- the Manor Terrace (northern) section of the wall was constructed in 1981 and has a concrete block revetment (Figure C8.4);
- the Landguard Common (southern) section of the wall was constructed in 1985 and has a stepped concrete apron.

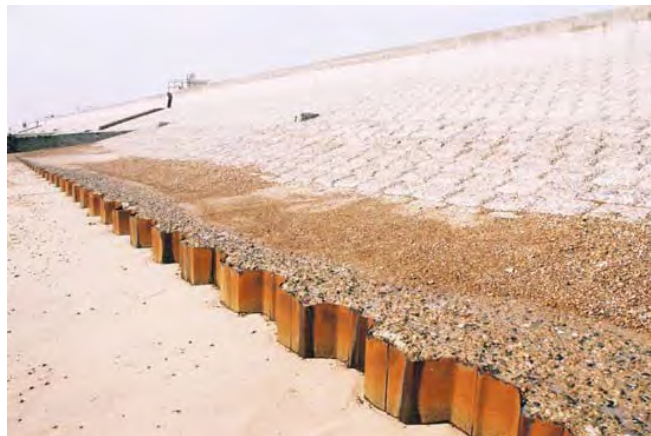
**Figure C8.5 Exposed toe piling at Environment Agency frontage, 2003**

Failure of some groynes in 2003 on the Environment Agency frontage resulted in a rapid fall in beach levels (Figure C8.5), requiring urgent repair works to the groynes and blockwork.

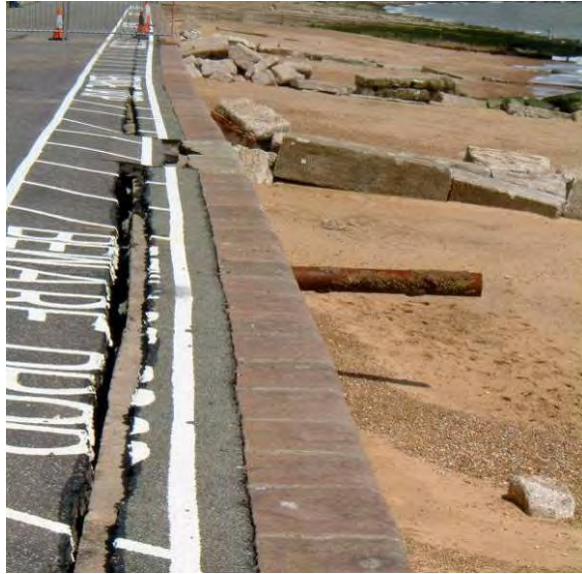
**Figure C8.6**                      **Rotating seawall, 2006**

Again, due to very low beach levels, the SCDC section of the frontage was undermined in May 2006 resulting in collapse of 150 m of the seawall (Figure C8.6). SCDC undertook emergency works in response to the damage, costing around £900,000 in total (Figure C8.7). Had action not been taken, the loose backfill behind the seawall would have washed away leading to rapid retreat, thus putting the floodwall at risk and indeed the low lying land behind. This temporary restoration was replaced with a permanent structural repair as part of the later main works.

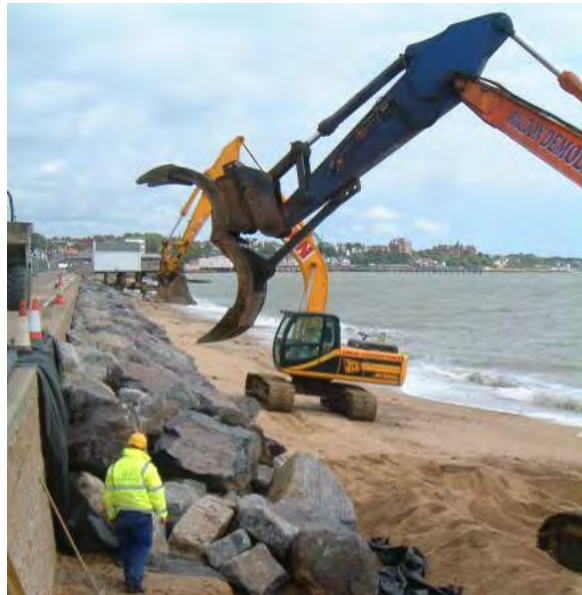
**Figure C8.7**                      **Emergency repairs to the seawall, 2007**

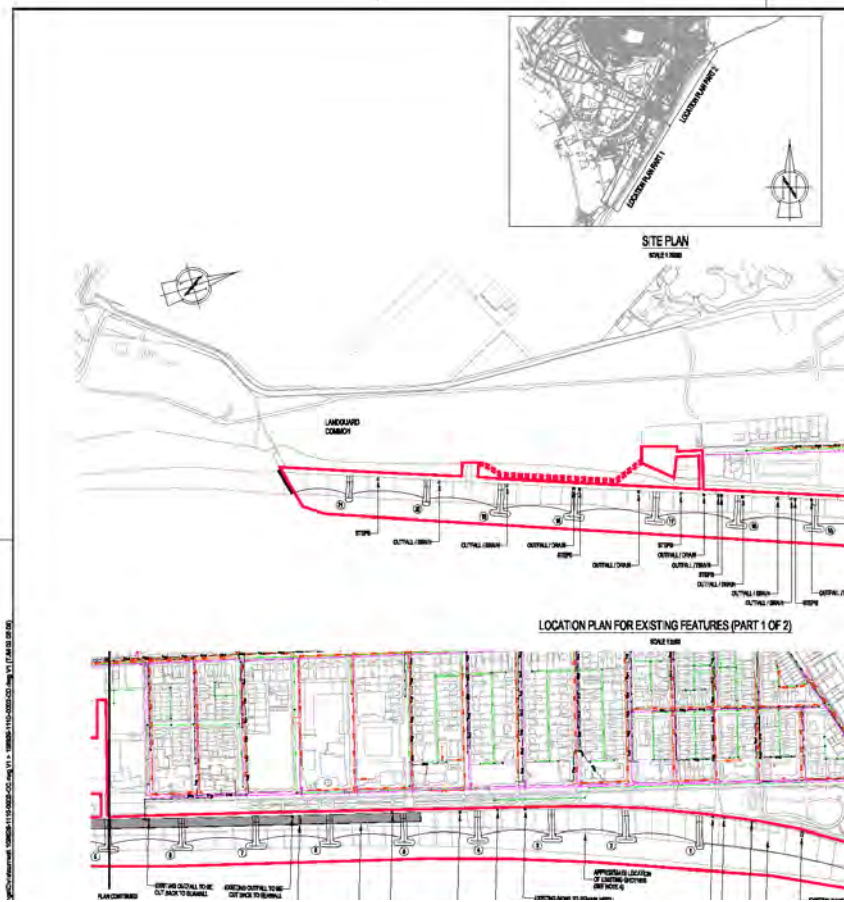
Figure C8.9

Extract from detailed design drawings – layout

Figures C8.9, C8.10 and C8.11 show extracts from the detailed designs drawings of the layout and groyne structures. Figure C8.12 shows a design cross-section for the permanent repair over the 150 m failed seawall.

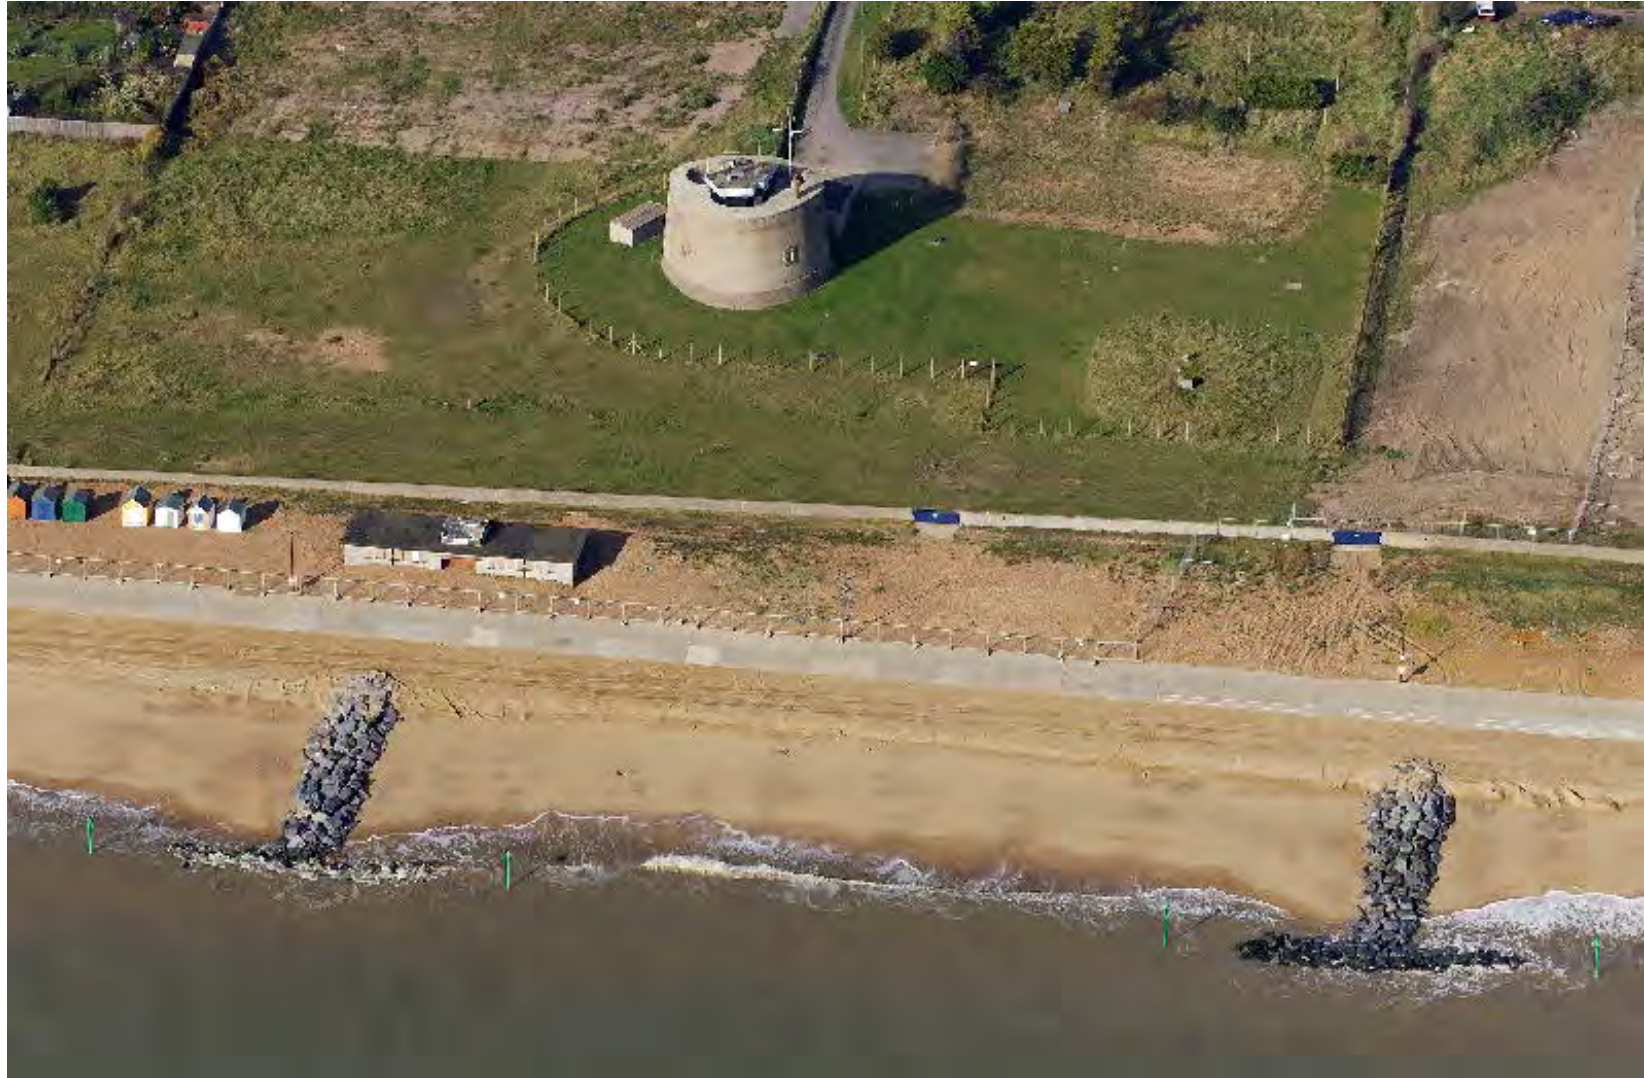
**Figure C8.13**

**Southern Felixstowe – the completed scheme**

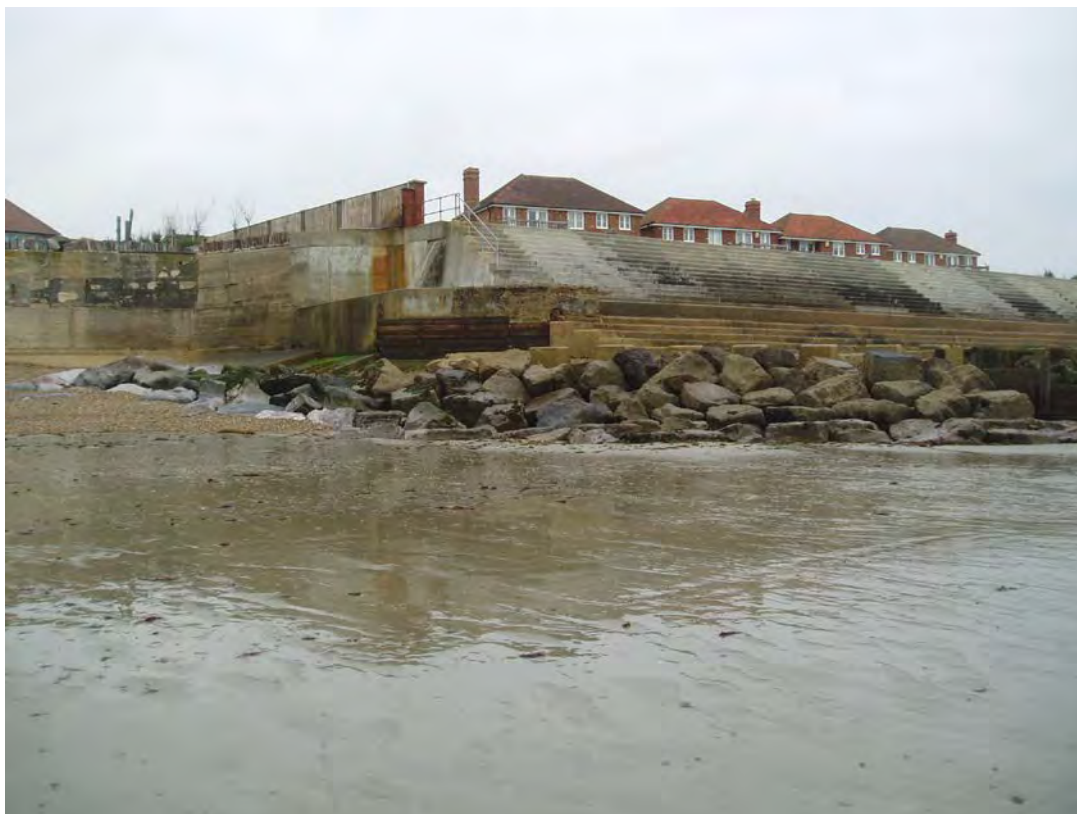
**Figure C9.4 The completed armour revetment**

Careful placing of the boulders together with protection provided by the Dragon's Teeth meant there was no damage to the existing concrete steps or apron.

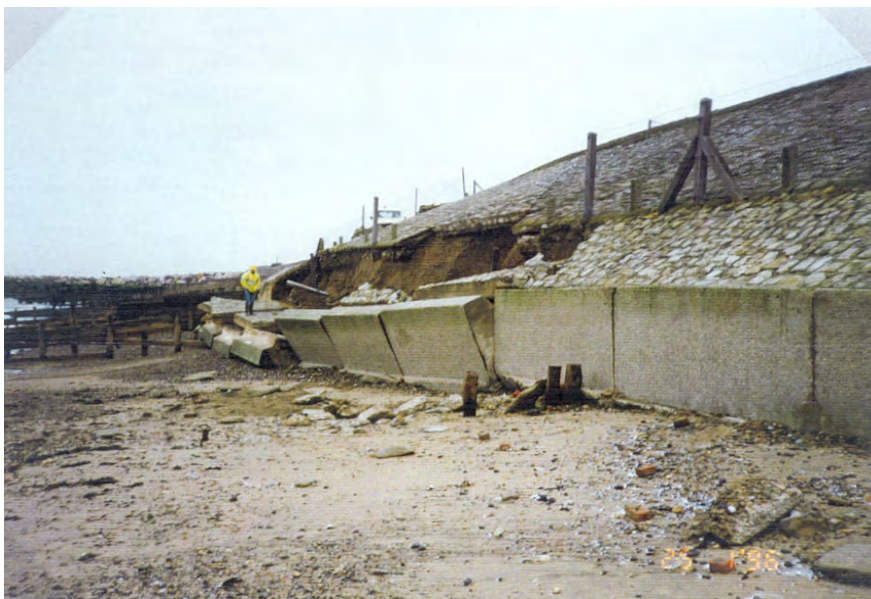
A storm with an estimated return period of 10 years occurred in February 1996, resulting in substantial destruction of the old wall. About half the Ragstone blocks came off the revetment. It appeared that the large toe blocks had just turned over rather than being undermined. An estimated 4 m of erosion occurred within four days as the mixed fill became exposed to subsequent wave action (Figure C10.3).

**Figure C10.3 Failure damage, 1996**

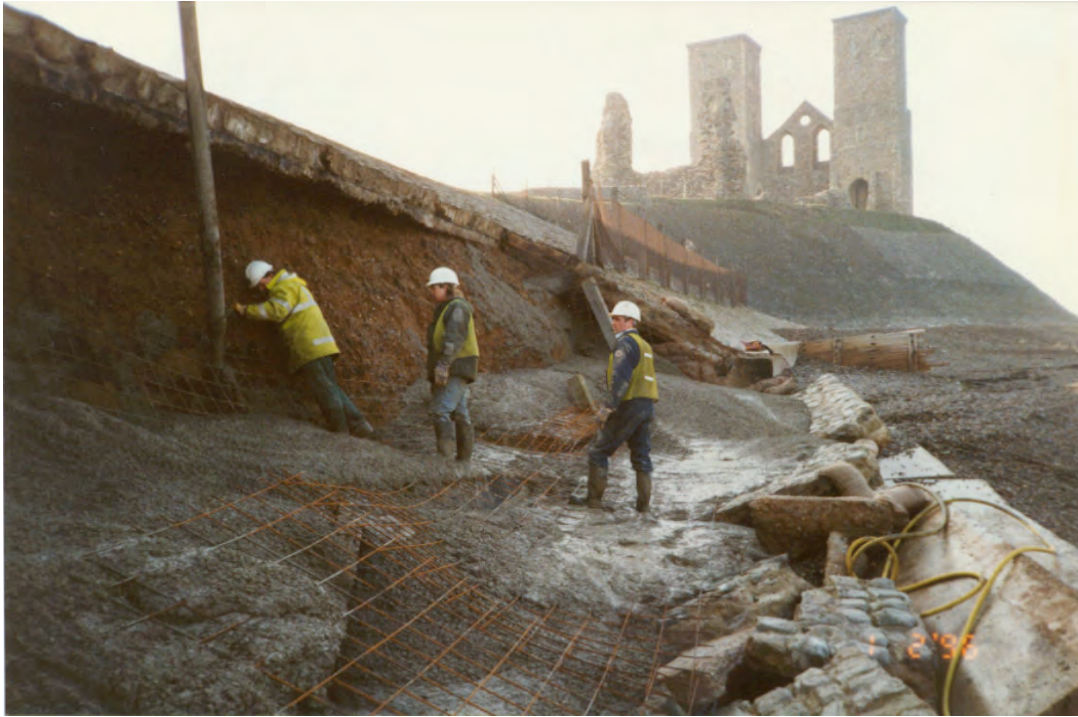
An immediate fix was needed to prevent further retreat, which might have put the archaeology at risk. This was achieved by backfilling the remaining toe blocks using pumped concrete and then carefully shoring up the exposed face (Figure C10.4). These emergency works were carried out in February 1996 and consisted of about 100 m<sup>3</sup> of mass concrete to the failed toe and 90 m<sup>2</sup> of sprayed concrete with mesh reinforcement to the exposed slope face. The cost of emergency repairs was about £27,000 in 1996. Further works to the slopes were again necessary in May 1996 with further concrete infilling (costing about £10,000). These emergency works then remained intact until the permanent works commenced in August 1998.

**Figure C10.4**                      **Emergency repair works, 1996**

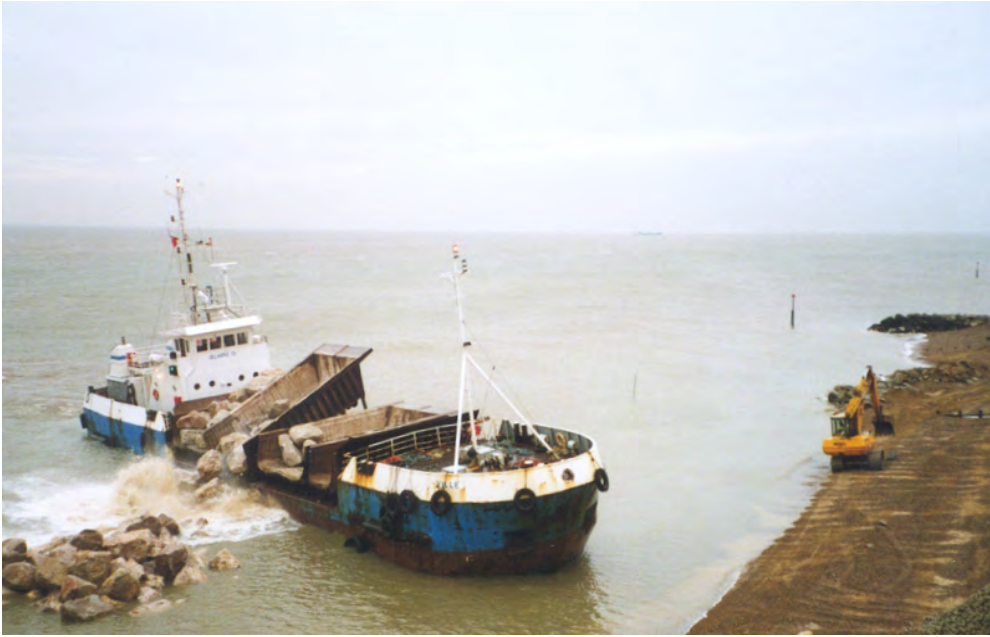
**Figure C10.6      Rock delivery**

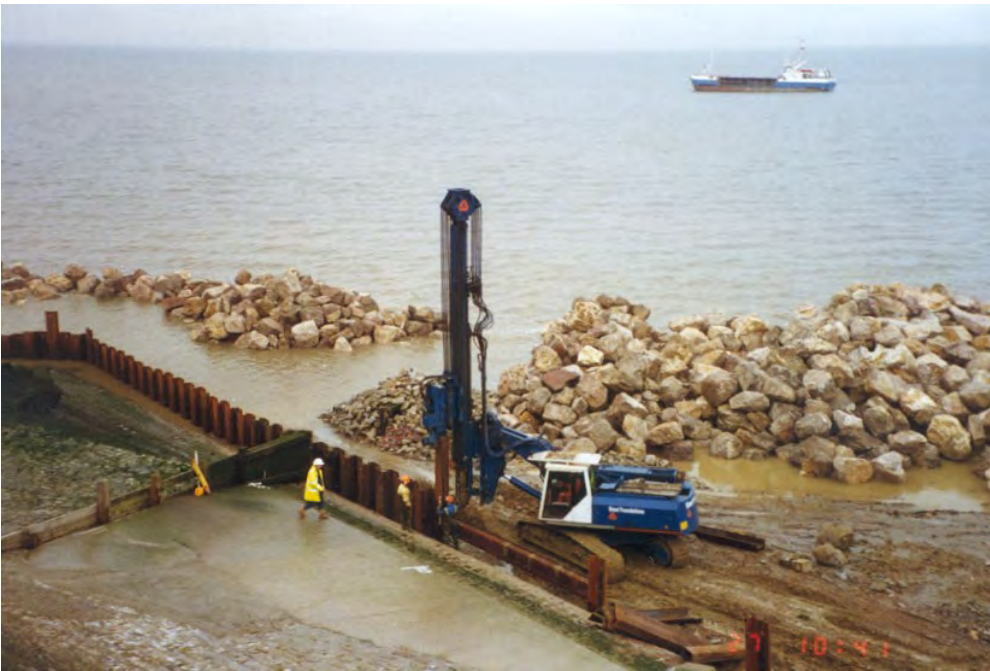
**Figure C10.7      Pile driving**

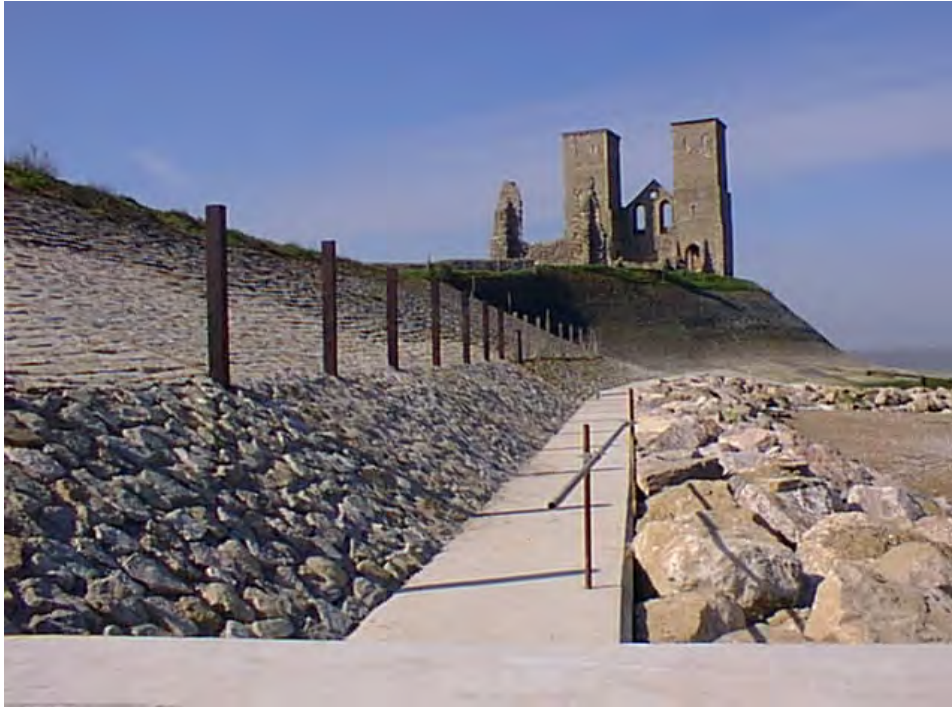
**Figure C10.8**      **Final construction**
