## Toe structures management manual

Project: SC070056/R

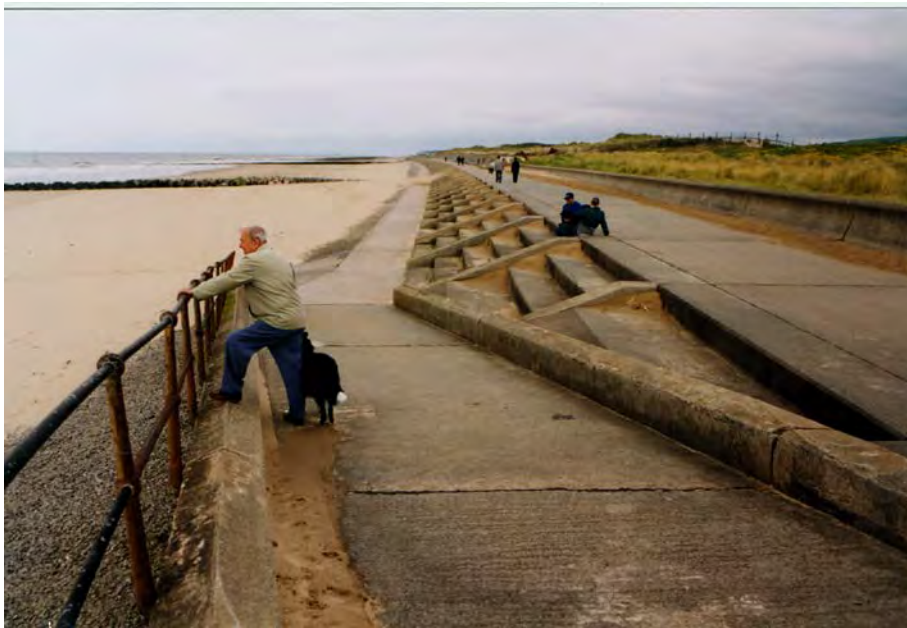
The increased height and width of the upper foreshore has resulted in the disappearance of the ridge and runnel features from in front of the seawall. The high foreshore levels have also removed the problems of wave overtopping. Figure C11.2 shows the swash limit along the line of the new sloping revetment. There is some sand build up above the revetment and on the seawall steps. The amenity value of the promenade, at the crest of the wall, has also been greatly improved.

**Figure C11.2 Sloping asphalt apron and rock groynes in front of steeped concrete seawall**

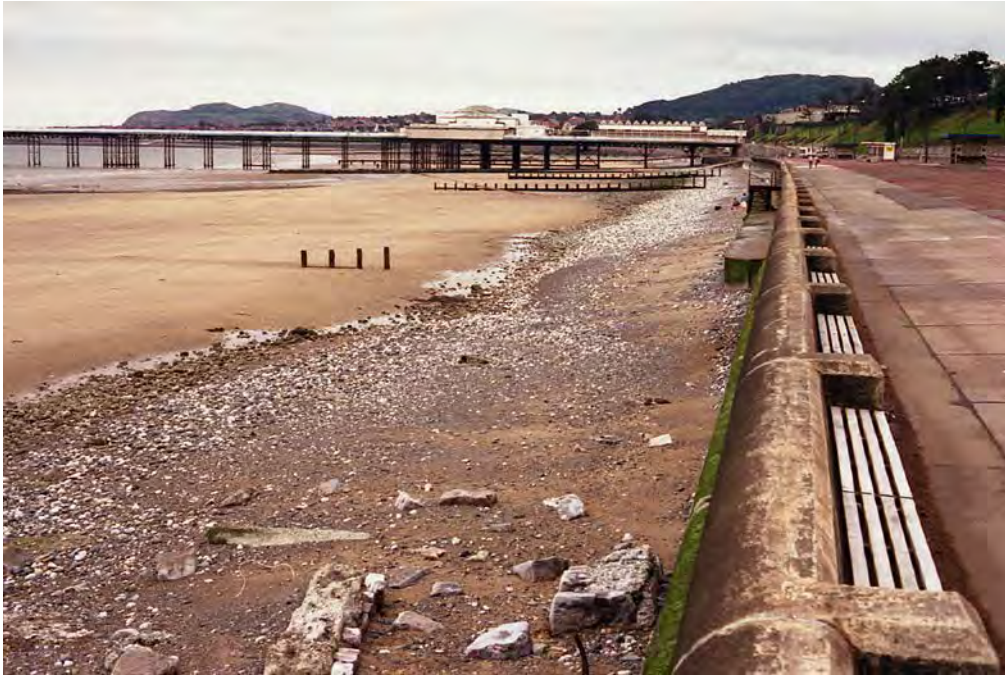
The construction of sea defences at Colwyn Bay dates back to the late 19th century. The masonry seawall has, over the years, suffered considerable damage, requiring extensive repairs and reconstruction. In the 1970s there was a groyned upper beach of shingle, with an almost continuous sand cover over the flatter, lower part of the beach. Subsequently the groyne system fell into disrepair, allowing beach levels at the wall toe to fall. Thus, by the 1980s the shingle beach had largely disappeared from the wall toe, causing foundation problems (Figure C12.2). In addition, the falling sand levels had exposed the underlying pebbles over much of the lower foreshore.

**Figure C12.2** Beach lowering in front of vertical seawall, Colwyn Bay

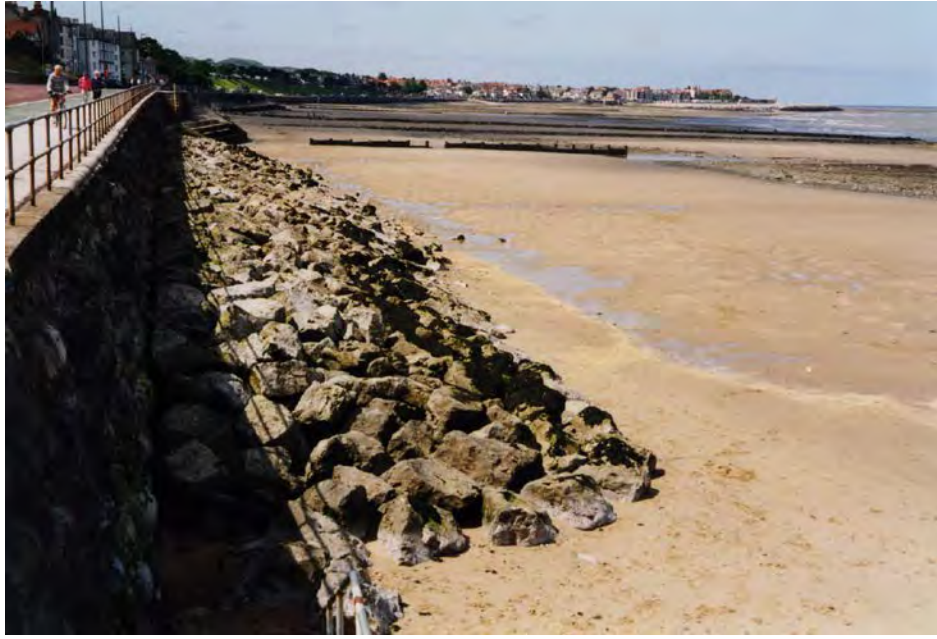
**Figure C12.3**

This scheme is a good example of how relatively modest defences can be used effectively to improve beach levels. The photograph in Figure C12.3, which was taken in 2002, shows the sand build up at the foot of the seawall. The long rock groynes can (just) be seen in the background, while a redundant timber groyne can be seen in the middle distance.

**Rock berm in front of vertical seawall, 2002**

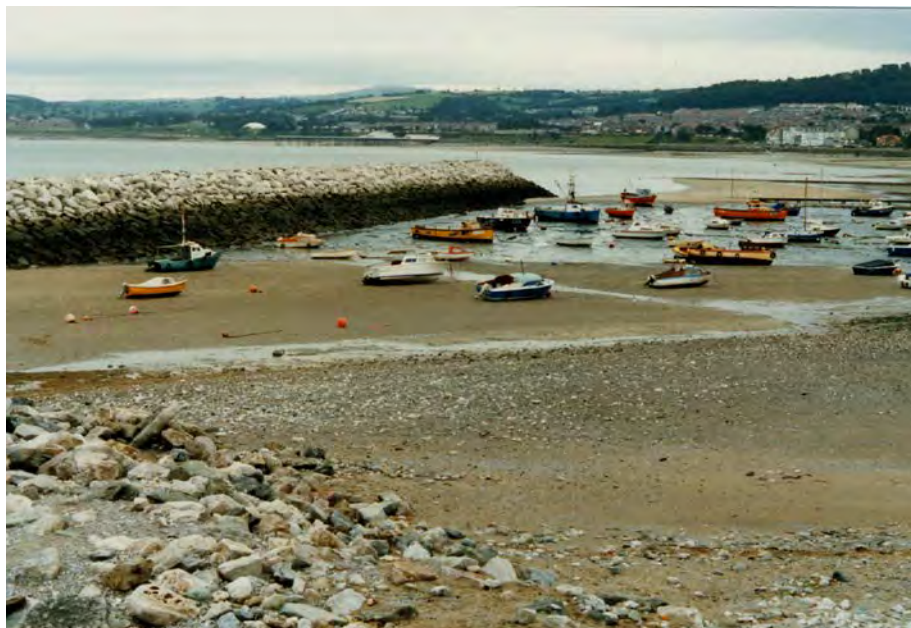
The breakwater has eliminated the problems of wave overtopping that were becoming increasingly more serious to the south of Rhos Point. The sheltered conditions in the lee of the breakwater have allowed small boats to anchor there (Figure C13.2). This has been possible because the breakwater is sited some distance away from the wall, but not so far offshore that its sheltering effect would be significantly reduced. The low groyne has been overtopped by beach material and shingle and sand have tended to collect in the lee of the breakwater, further reducing any potential risk of wave overtopping (Figure C13.3).

**Figure C13.2 View to the east showing usage by small boats**

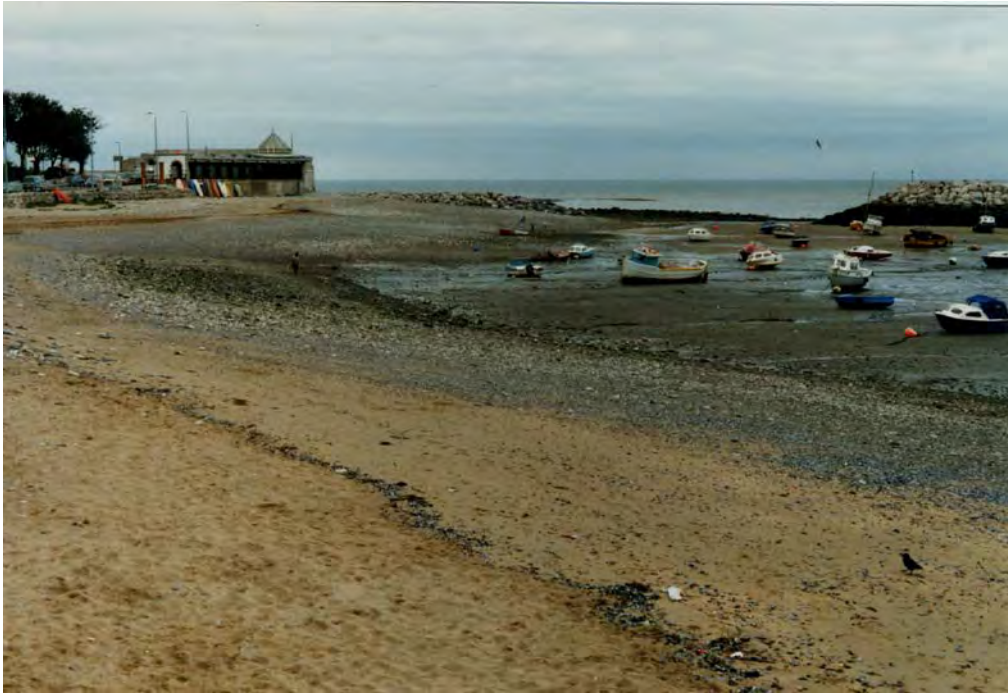
**Figure C13.3**      **View to the west showing beach recharge**

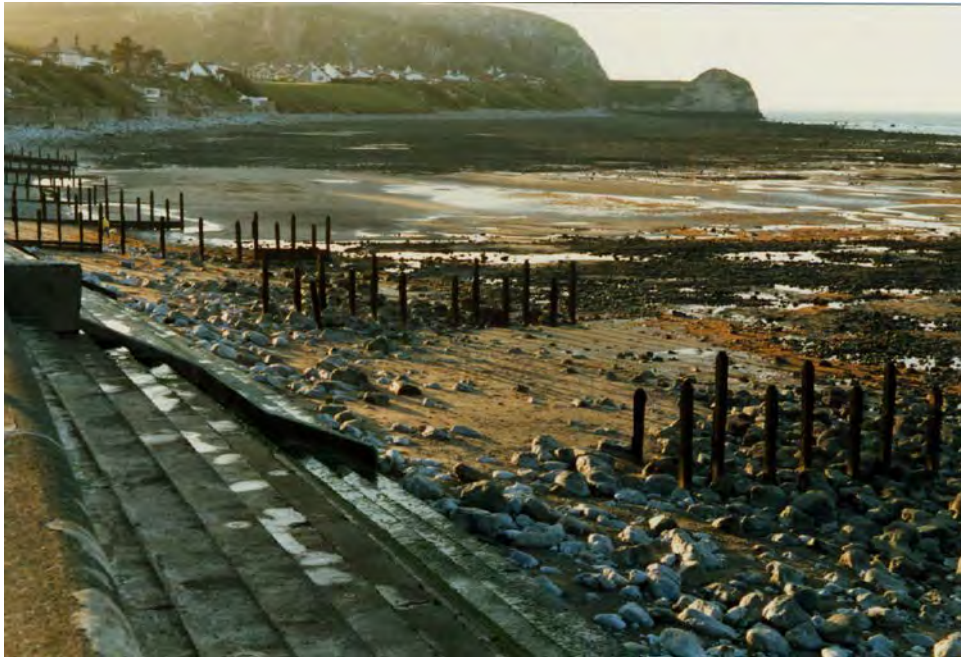
**Figure C14.2** Lowered beach exposing shore platform

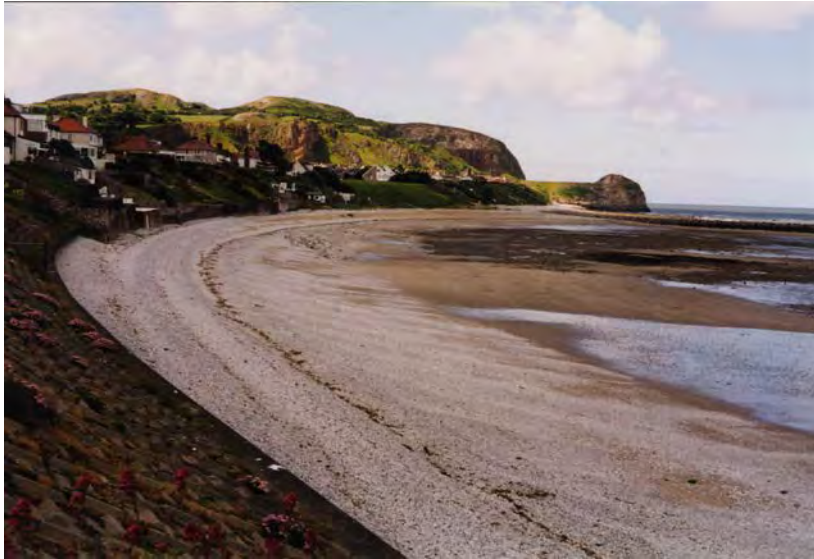
The beach was graded from sand in the west to an (artificial) cobble beach formed of quarried rock in the east. Movement of the material has caused a mixing of sediments to occur with mixed sand and shingle tending to stay in the (sheltered) western corner of the bay (Figure C14.3).

**Figure C14.3 View of beach recharge in western part of Penrhyn Bay**

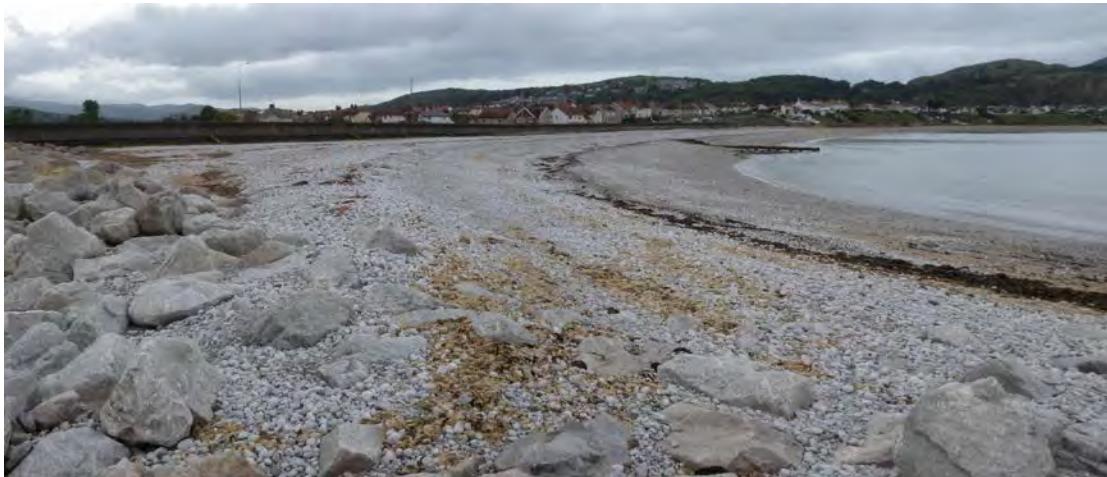
Further east, material from the centre of the embayment tends to be moved towards the easterly groyne where it can overtop the root of the groyne structure (Figure C14.4). Regular recycling of material back towards the centre of the bay (once or twice a year) is carried out in order to maintain Standards of Protection.

**Figure C14.4 View from easterly groyne (CEUK)**

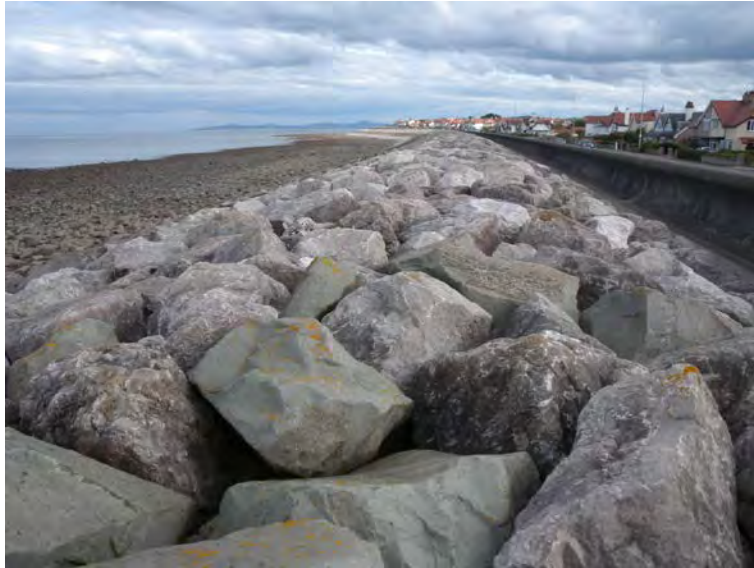
Further to the east beach levels remain low but reasonably stable and devoid of fines (Figure C14.5).

**Figure C14.5**            **View along rock revetment protected frontage to east  
(CEUK)**

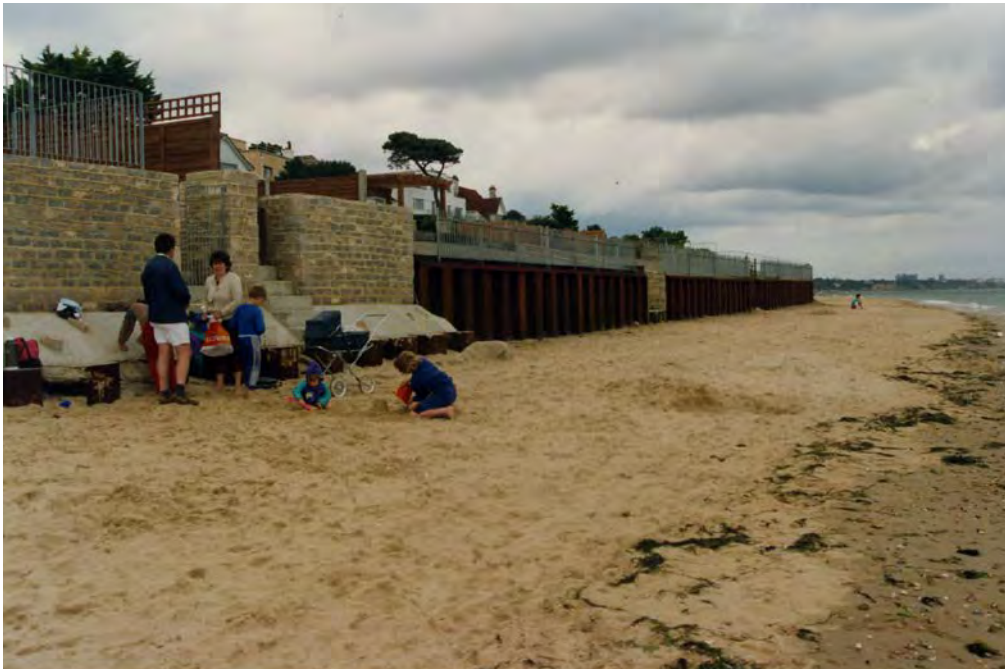
The sand beaches along the Sandbanks peninsula were originally protected by a system of crib type rock groynes. Historic charts show that these maintained high beach levels over much of the frontage. However, these groynes fell into disrepair, being removed in 1991 for health and safety reasons. Beach lowering was noted subsequently, becoming most serious at the western end of the frontage, where a seawall surrounds the head of the peninsula (Figure C15.1). The offshore transport of sand, due to waves being reflected from the wall and its subsequent removal by the fast tidal currents, caused concerns that the wall would become undermined.

**Figure C15.1** Vertical wall and low beach near Haven Hotel, Sandbanks, c.1998

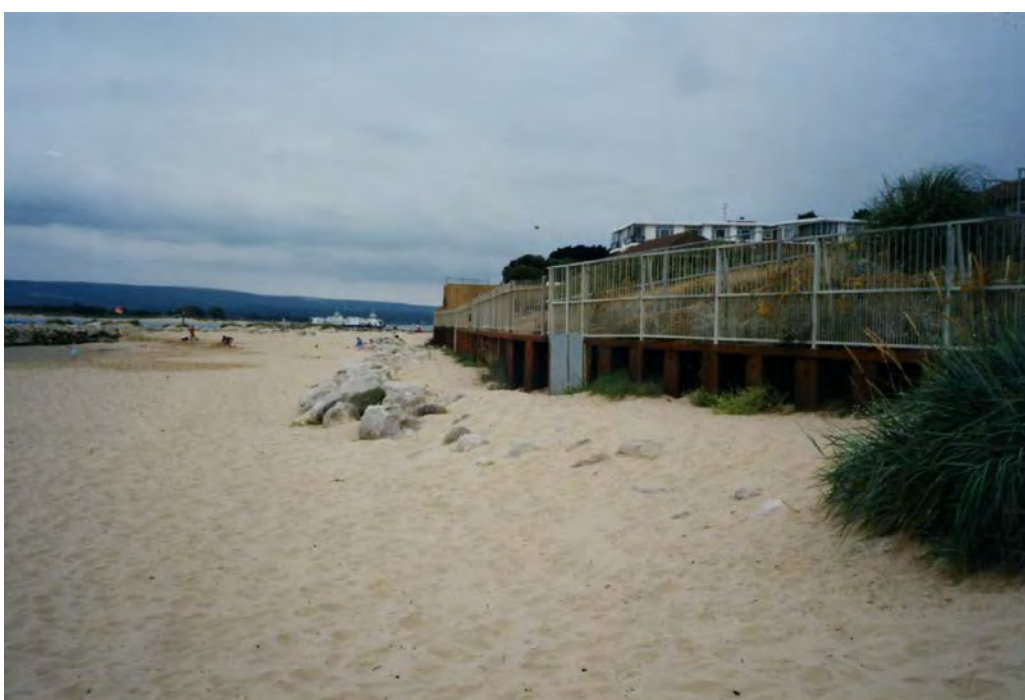
The scheme was constructed in 1995–1996. Overall, this was a great success with the earlier beach erosion being reversed and sand dunes forming where there were previously low beach levels (Figure C15.2).

**Figure C15.2 Widened beach after installation of sill and rock groynes, 2002**

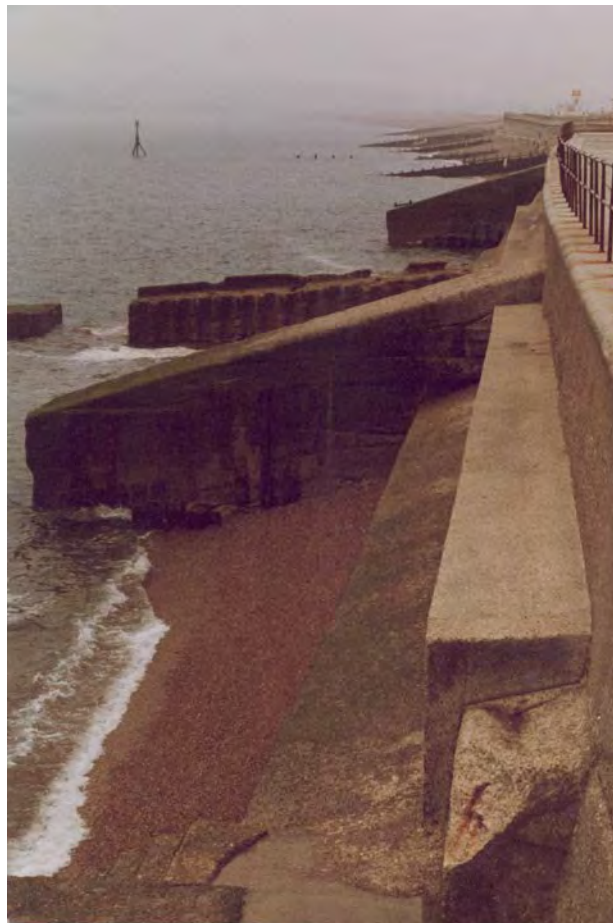
The subsequent development of the port of Newhaven has included the construction of training walls to prevent the littoral from blocking up the new entrance. Successive extensions of the western training wall were necessary as the beach to the west of the entrance accreted. This meant that the shingle beach at Seaford has received a dwindling supply of shingle. This has caused beach levels in front of the seawall to fall at an increasing rate during the last century. By 1980, the beach in the eastern half of the frontage had fallen to such an extent that it was providing very little support to the old mass concrete seawall; this wall was originally a secondary defence behind a then substantial shingle ridge. In places, erosion had exposed the underlying chalk platform, allowing waves up to 6 m high to reach the wall without breaking. In 1981 parts of the wall had become badly damaged and in 1985 undermining had caused local collapse of the promenade. Figure C16.1 shows the situation around 1982.

Low beach levels and damaged concrete seawall, c.1982

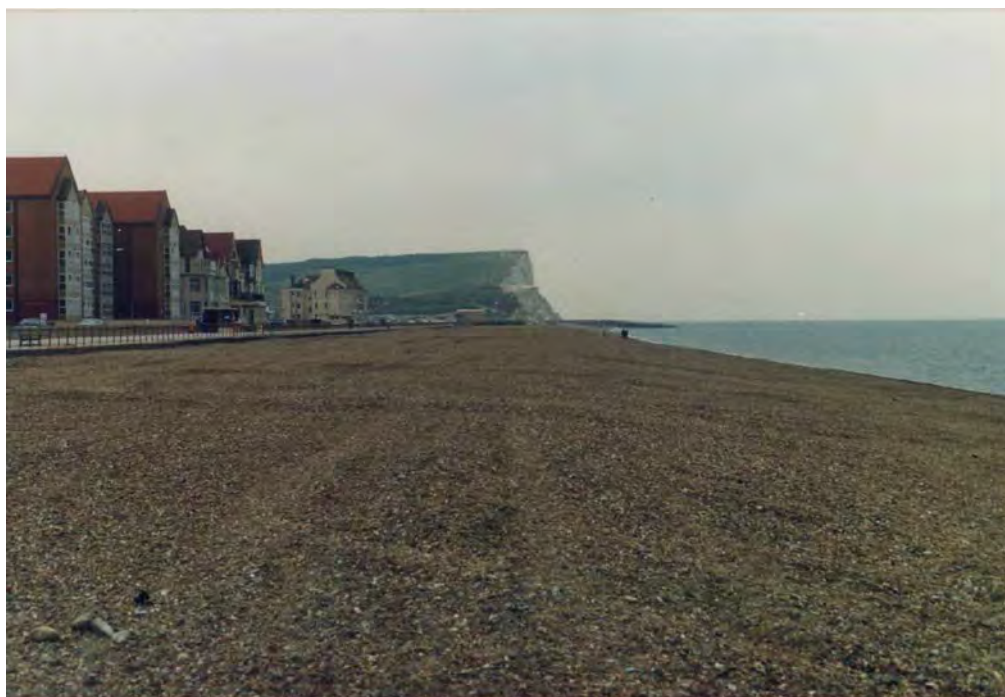
In 1987 the central and eastern end of Seaford was nourished with 1.5 million m<sup>3</sup> of shingle won from offshore (Figure C16.2). The material was won by using a trailer-suction dredger, extracting the material from an existing licence area on the Owers Bank, south of Selsey Bill. The material was spread over a 2.5 km frontage. The western frontage was left untouched, as the beach there was already wide.

Figure C16.2 Beach after renourishment

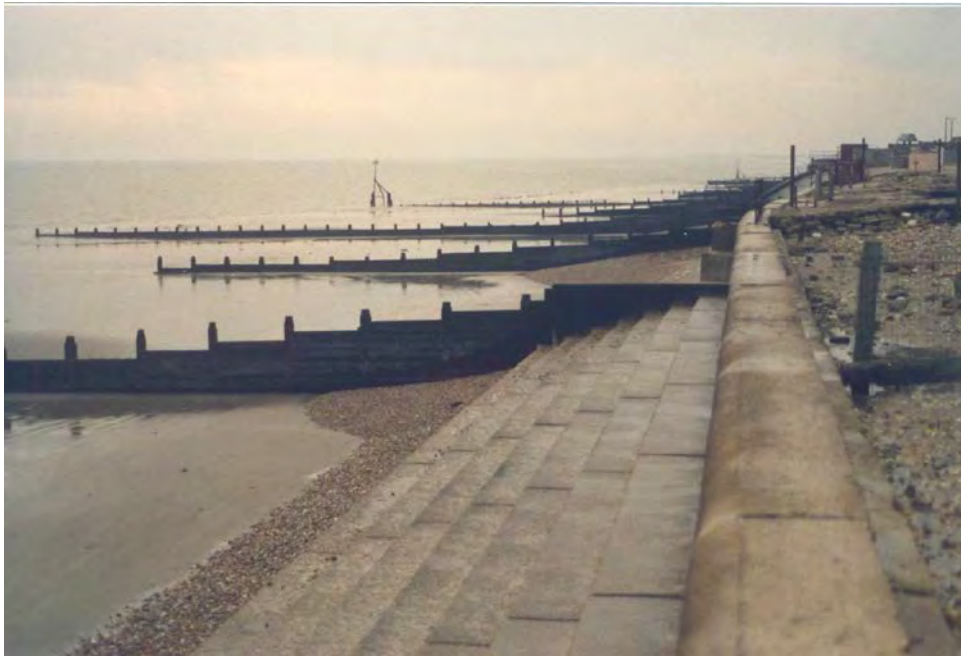
Sea defences were begun in the 1950s. With an onshore supply near the Bill, the beaches did not deteriorate as rapidly as might have been expected in view of the earlier very rapid rates of retreat. By the late 1980s, however, the walls had deteriorated through continuous wave action and falling beach levels. Figure C17.1 shows the situation in 1988.

**Figure C17.1** Low beach levels in front of stepped concrete wall, 1988

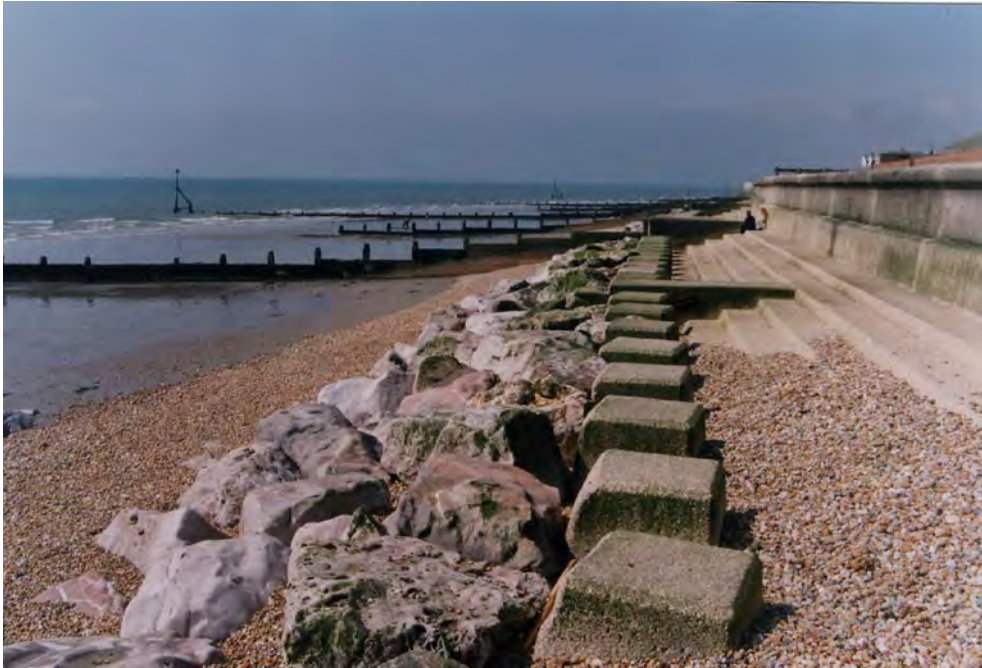
**Figure C17.2 Toe berm of rock and concrete armour units, 1994**

In 1992 a major scheme was initiated along much of the Selsey frontage. At Selsey West Beach, the seawall was reconstructed at strategic locations where heavy overtopping could not be tolerated. In other areas the wall was strengthened. In places the wall was extended by the addition of concrete armour units and a rock berm, as shown in Figure C17.2. In addition, some shingle was added to the upper beach, to help fill the groyne compartments.

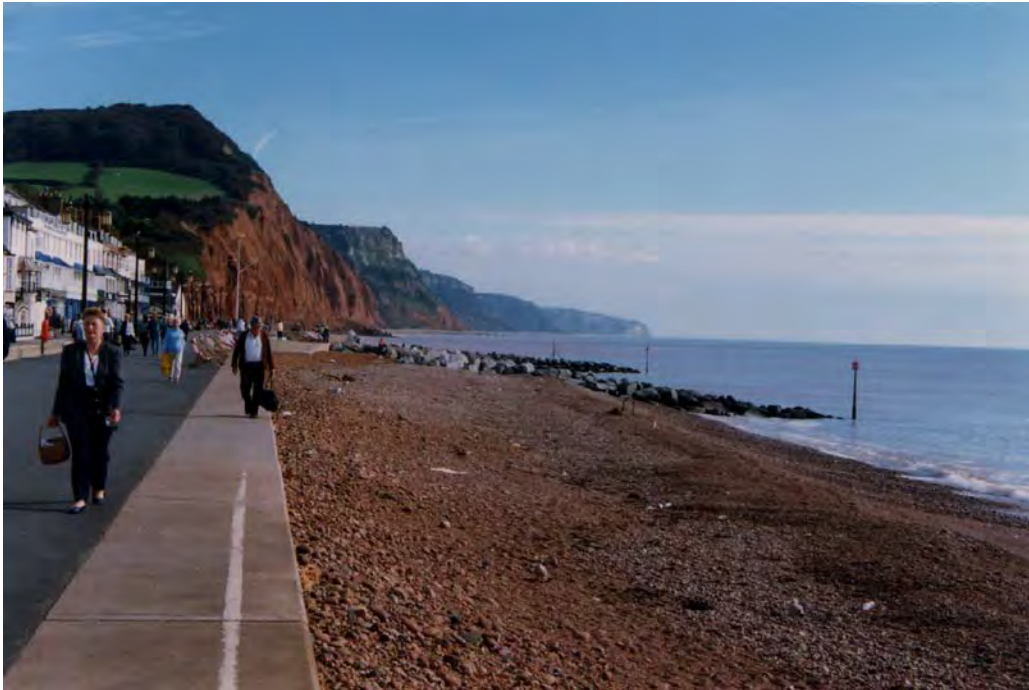
**Figure C18.2**

**Rock groynes and beach recharge, eastern end of promenade**

Figure C18.2 shows the eastern end of the nourished frontage. The improvement in beach width has not only effectively reduced the former problems of beach lowering but has also provided a more attractive beach. In addition, the offset breakwaters are also not visually intrusive, being below the horizon at promenade level.

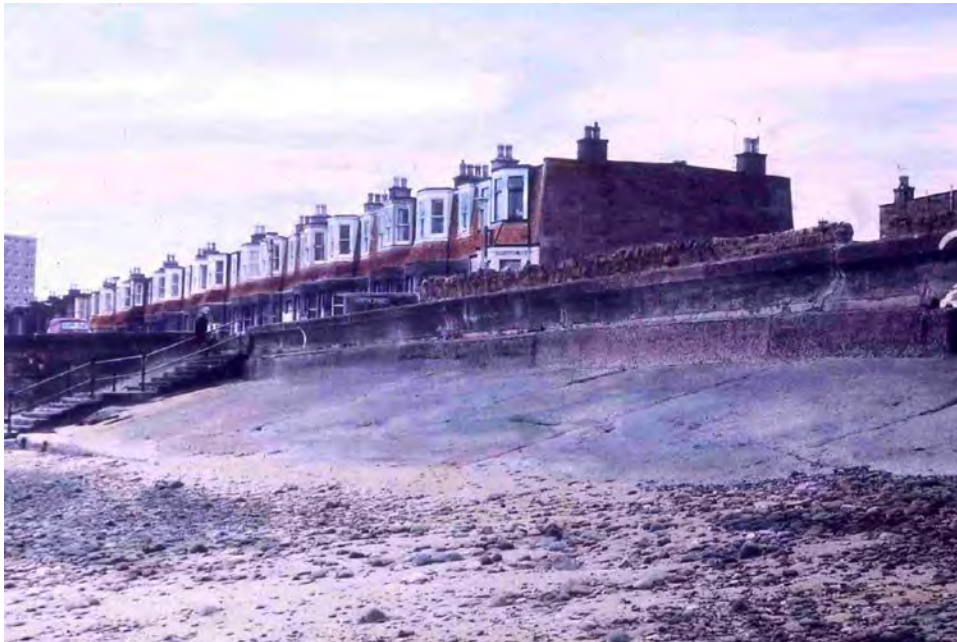
Figure C19.1

Portobello Beach, c.1970

The justification for many beach nourishment schemes in the UK has been that the cost of nourishment is considerably less than the cost of reinstating existing hard defences. One of the first schemes to be justified on this basis was carried out at Portobello Beach, Edinburgh. This beach is situated on the western side of Edinburgh and faces directly into the mouth of the Firth of Forth. It became denuded as a result of sand abstraction for the glass industry, which began in the 19th century and continued up to the 1930s. The promenade seawall at Portobello dates back to 1860. By the late 1950s the lowered beach meant that the wall was under continuous wave attack, with resulting frequent serious overtopping (Figure C19.1). By this time the beach had flattened and the median sand grain size was 0.2 mm.

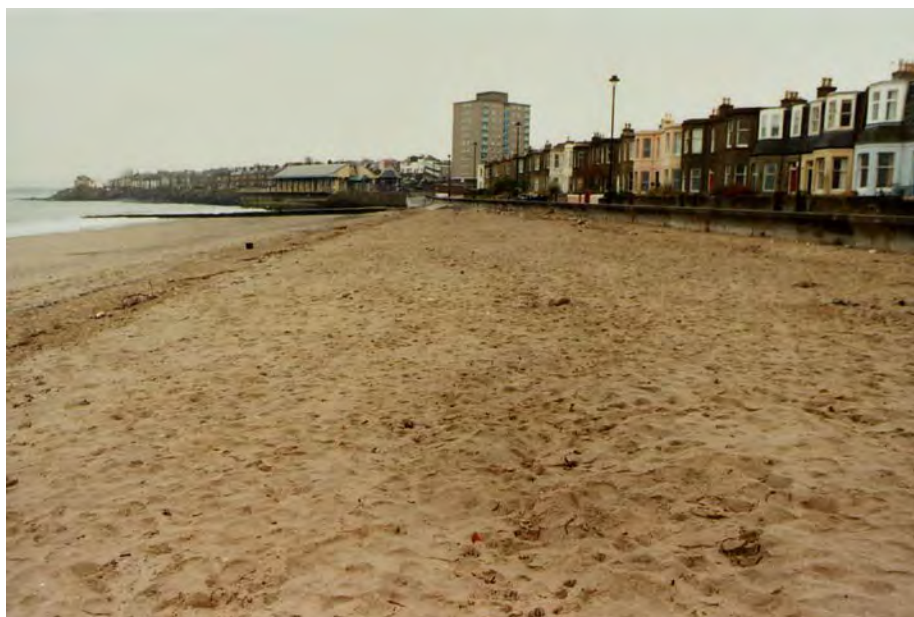
**Figure C19.2** Post-nourishment view at Portobello

Some 180,000 m<sup>3</sup> of coarse sand was extracted from a borrow area by bucket dredger, transported by barge and pumped over a 1.6 km frontage to a foreshore gradient of 1 in 20. The material was placed over a depleted beach whose gradient had fallen as a result of beach lowering to about 1 in 42. The nourished beach was held in place by a

number of timber groynes, with an (easily adjustable) gabion-type groyne at the eastern (updrift) end of the frontage (Figure C19.2).
