Testing the erosion resistance of
vegetated floodbanks

Science project SC030228/SR2

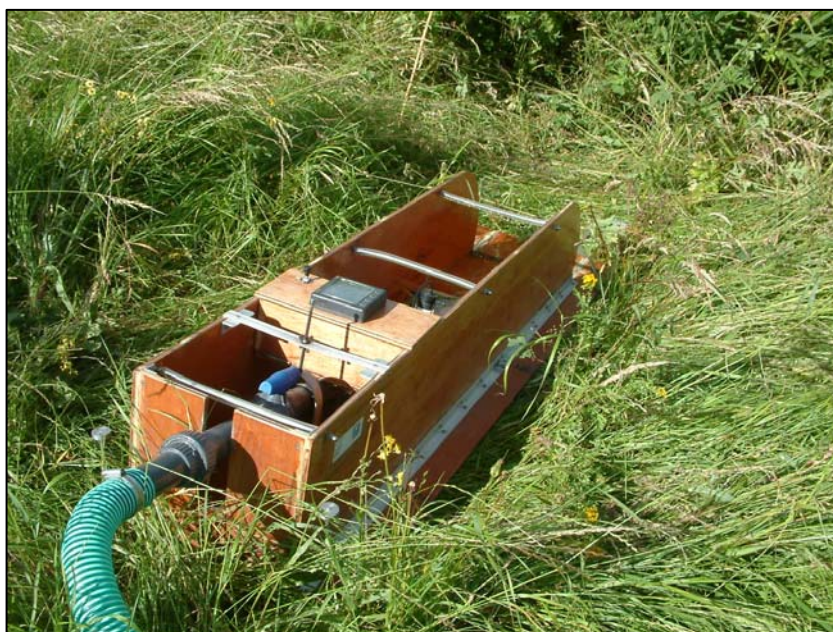
Figure 1.1 Erosion measurement device (EMD) used to test the erodibility of test areas on the floodbanks.

To fill this gap, the Environment Agency asked L A B Coastal to develop and test a portable erosion measurement device (EMD) that could be used to test the erosion resistance of vegetated grass banks by the principle of subjecting small test areas to running water to determine the point at which significant soil erosion occurs. The device used is pictured in Figure 1.1.

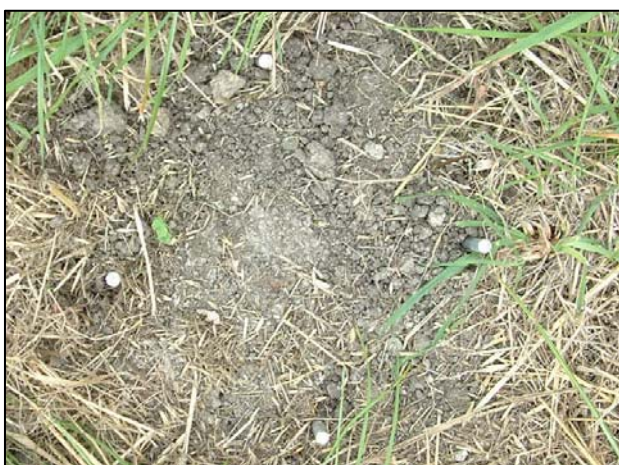
Figure 2.1 Test area marked out by the four marker pins which provide reference points for the recording of the profiles before and after the test.

The third variation in test procedures was the replacement of the planned quadrat with the use of four aluminium pins (each 150 mm long and 6 mm in diameter pointed at one end and flat on top) to locate the test area and to act as reference points for the determination of the profile of the soil surface (Figure 2.1).

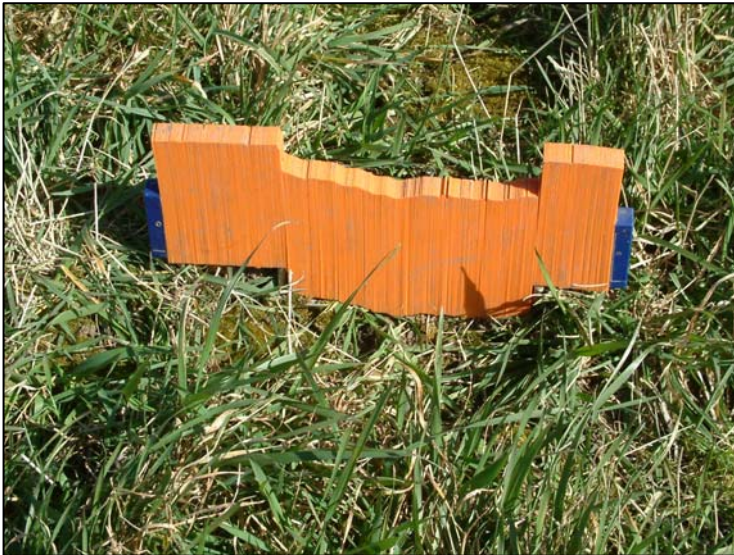
Figure 2.2 'Vitrex' plastic profile gauge used to record the profiles of each erosion plot before and after the test.

The profiler used was a 300-mm plastic profile gauge manufactured by Vitrex Ltd (Figure 2.2). This enabled the surface profiles of each test site to be determined at 1.5 mm intervals horizontally and drawn on a record sheet before and after running each erosion test.

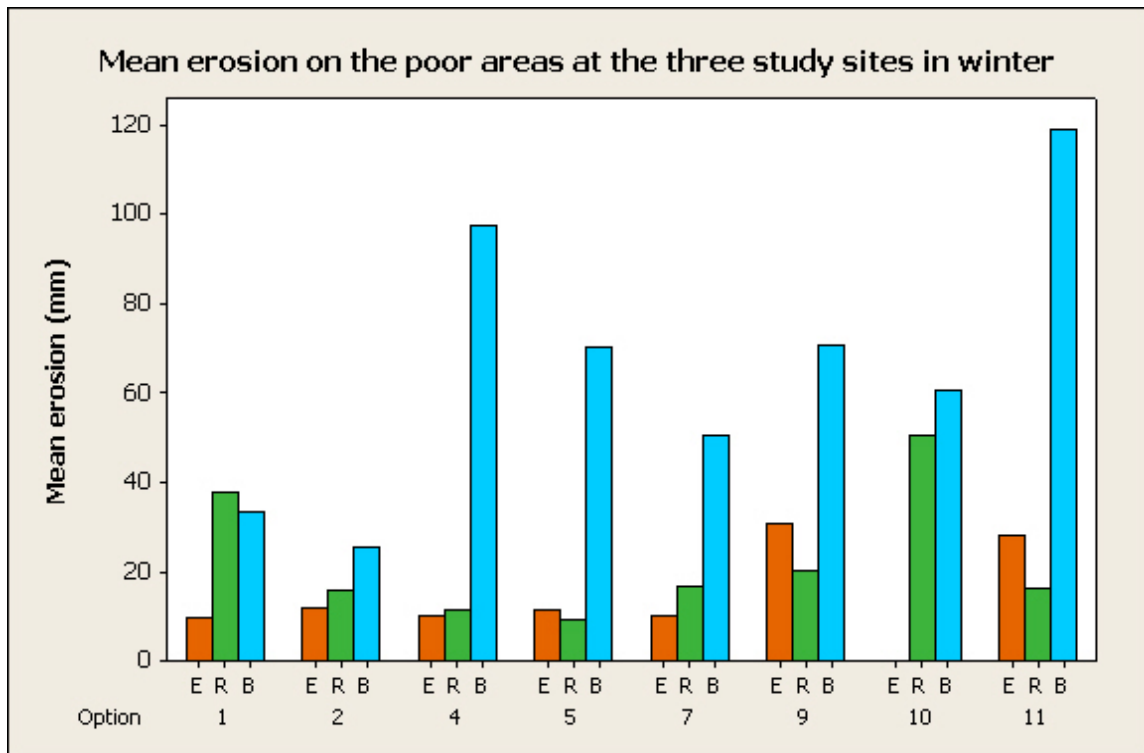
Figure 4.1 Mean erosion in poor areas at the three study sites in winter (E = Ely, R = Reach, B= Billingborough).

In the plots assessed as being poor, less erosion was generally experienced during the winter months than the summer (Figures 4.1 and 4.2).

in the poor plots during the winter (Figure 4.1). The former was the untreated control. Treatment Option 2 at Billingborough was where there was a slippage of the lower bank during testing and the site had to be abandoned (see Section 3.3); it was also much affected by small mammal burrows.

The greatest erosion in poor areas was seen in Treatment Option 11 during the winter (Figure 4.1) but, at least in some plots, there was rather more erosion during the summer months (Figure 4.2).

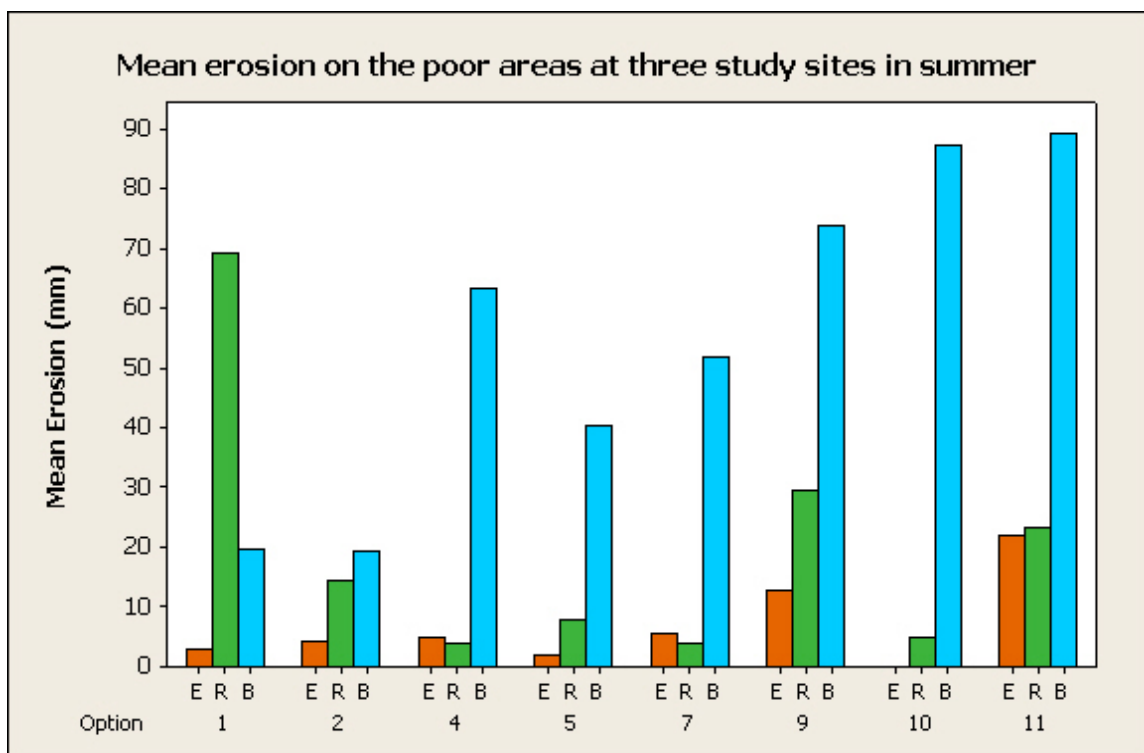
Figure 4.2 Mean erosion in poor areas at the three study sites in summer (E= Ely, R= Reach, B= Billingborough).

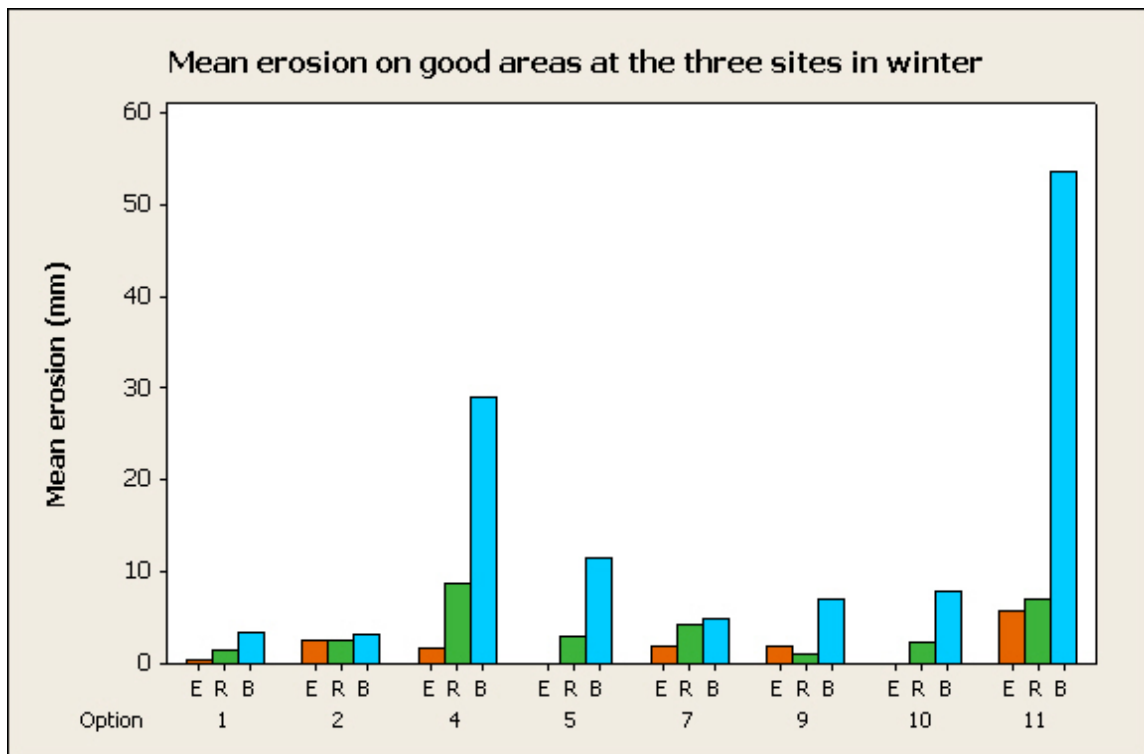
Figure 4.3 Mean erosion in good areas at the three study sites in winter (E = Ely, R = Reach, B = Billingborough).

In the plots assessed as being good, there was much less erosion than might have been expected, although Billingborough still showed significant erosion in Treatment Options 4 and 11 in the winter (Figure 4.3) and in Treatment Options 4, 7, 10, and 11 in the summer (Figure 4.4). Erosion was much less at the other sites and with the other treatment options. At both Ely Ouse and Reach Lode, none of the treatment options differed significantly from the control (Treatment Option 11).

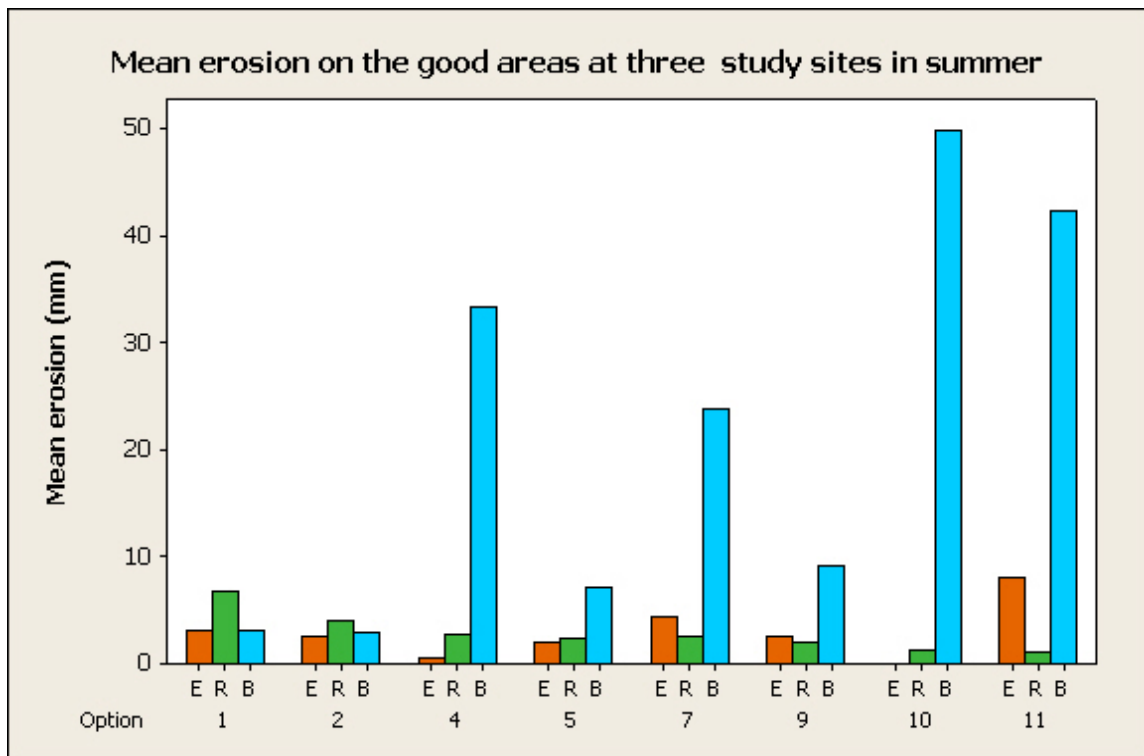
Figure 4.4 Mean erosion in good areas at the three study sites in summer (E= Ely, R = Reach, B = Billingborough).

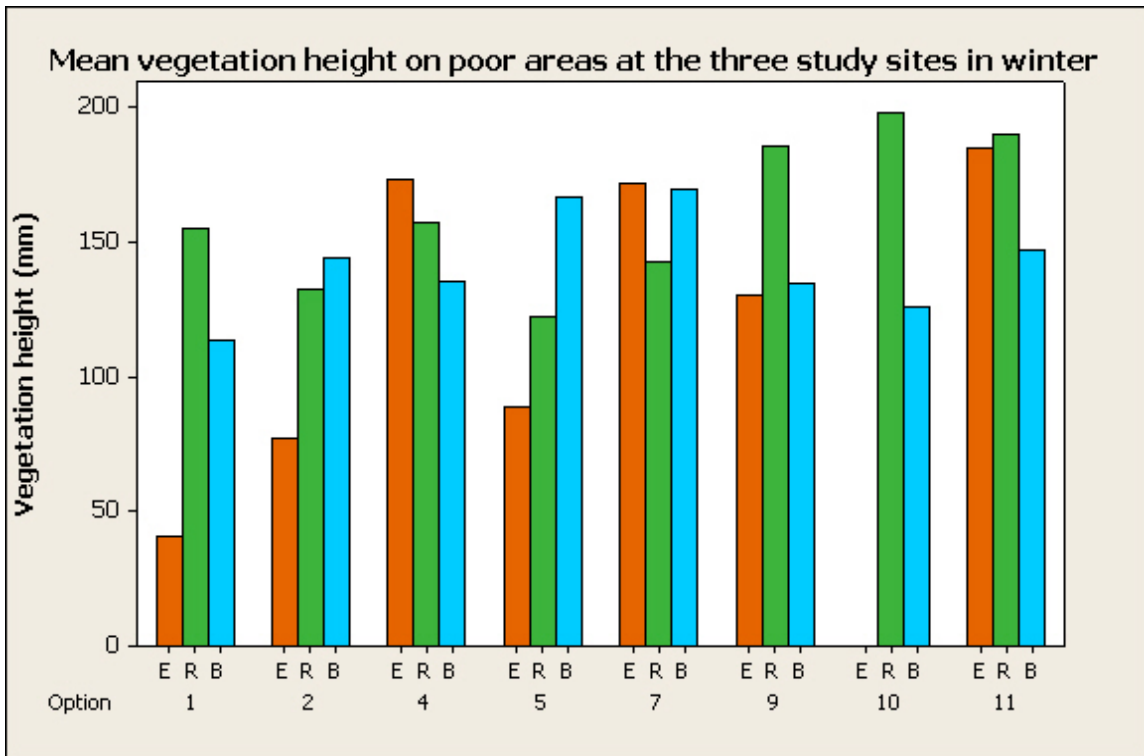
Figure 4.5 Mean vegetation height on poor areas at the three study sites in winter (E = Ely, R = Reach, B = Billingborough).

The mean vegetation height around the poor plots was very much lower during the winter than the summer, with only limited regrowth in the treatment options cut in September (Figures 4.5 and 4.6).

Nevertheless the winter vegetation height was significantly lower than the control (Treatment Option 11) in Treatment Options 1, 2, 5, and 7 at Ely and Treatment Options 2, 4, 5 and 7 at Reach Lode. At Billingborough, none of the treatment options were significantly lower than the control (Figure 4.5).

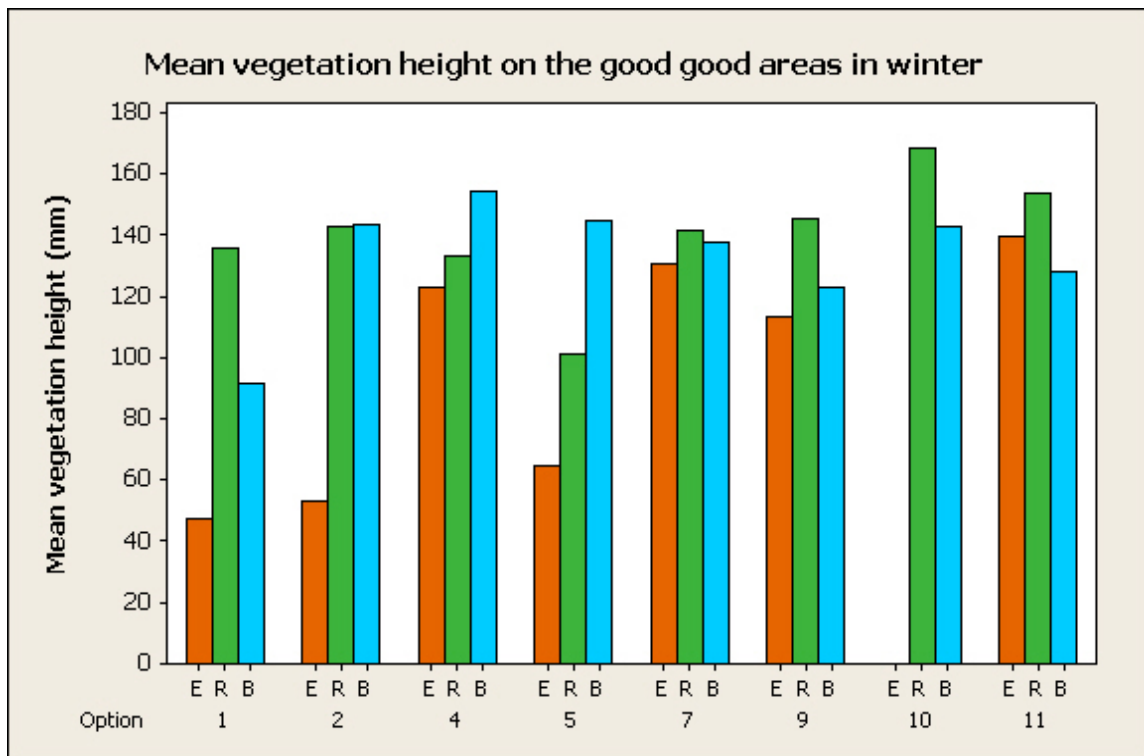
Figure 4.8 Mean vegetation height in good areas at the three study sites in winter (E = Ely, R = Reach, B = Billingborough).

The vegetation heights around the good plots were all much reduced during the winter months (Figure 4.8). At Ely Ouse, Treatment Options 1, 2, 5 and 9 were significantly lower than the control. At Reach Lode, only Treatment Option 5 was significantly lower while, at Billingborough, only Treatment Option 1 was significantly lower than the control.

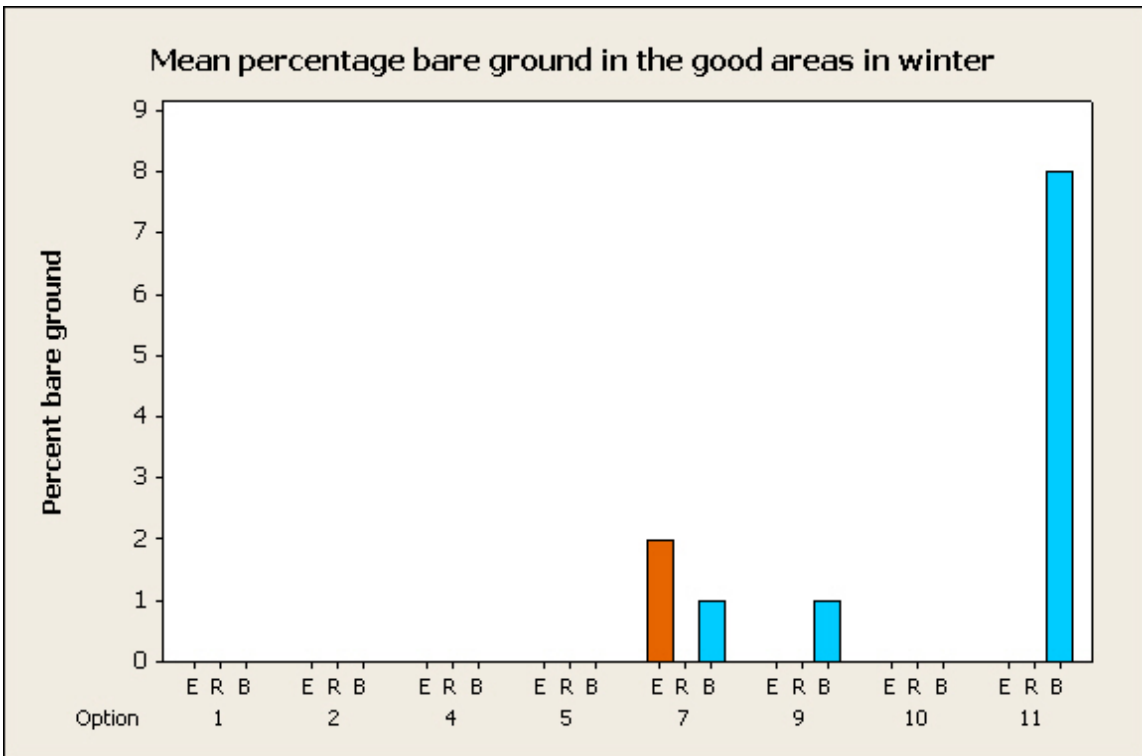
Figure 4.9 Mean percentage bare ground in good areas at the three study sites in winter (E = Ely, R = Reach, B = Billingham).

In the plots assessed as good, there was little bare ground in the winter and what there was, was mostly at Billingborough (Figure 4.9).

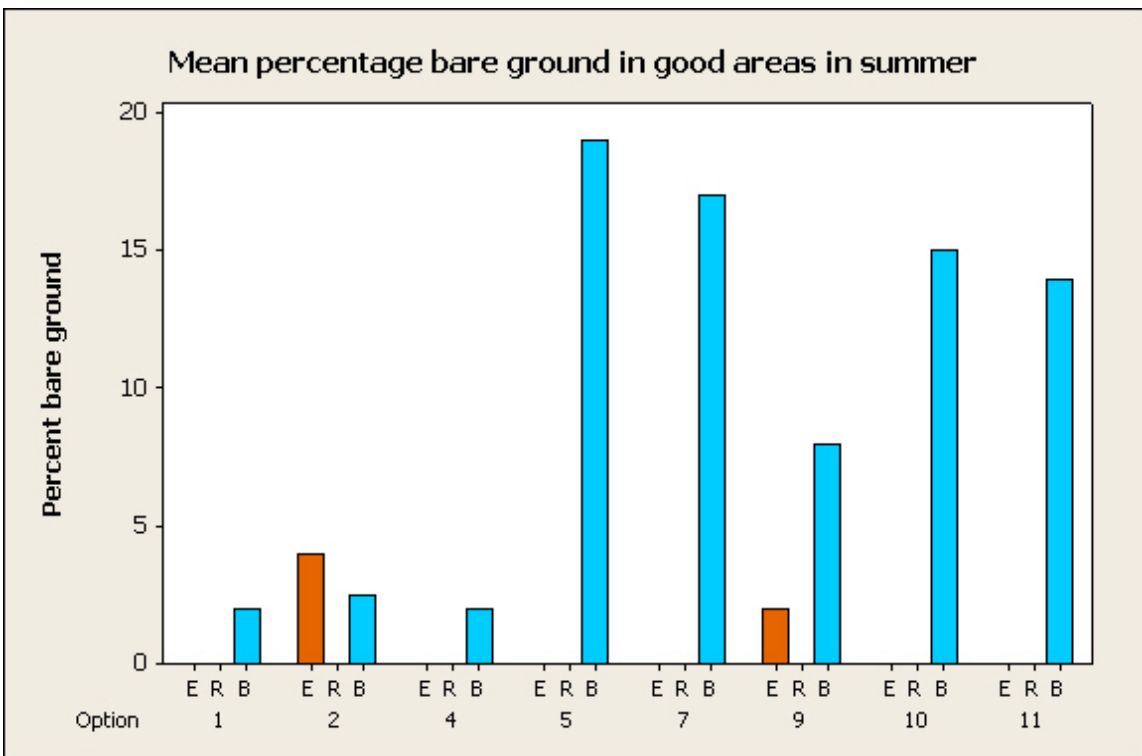
Figure 4.10 Mean percentage bare ground in good areas at the three study sites in summer (E = Ely, R = Reach, B = Billingham).

In the summer, however, there was some bare ground at all the plots at Billingborough with the least at Treatment Options 1, 2, and 4 (Figure 4.10).

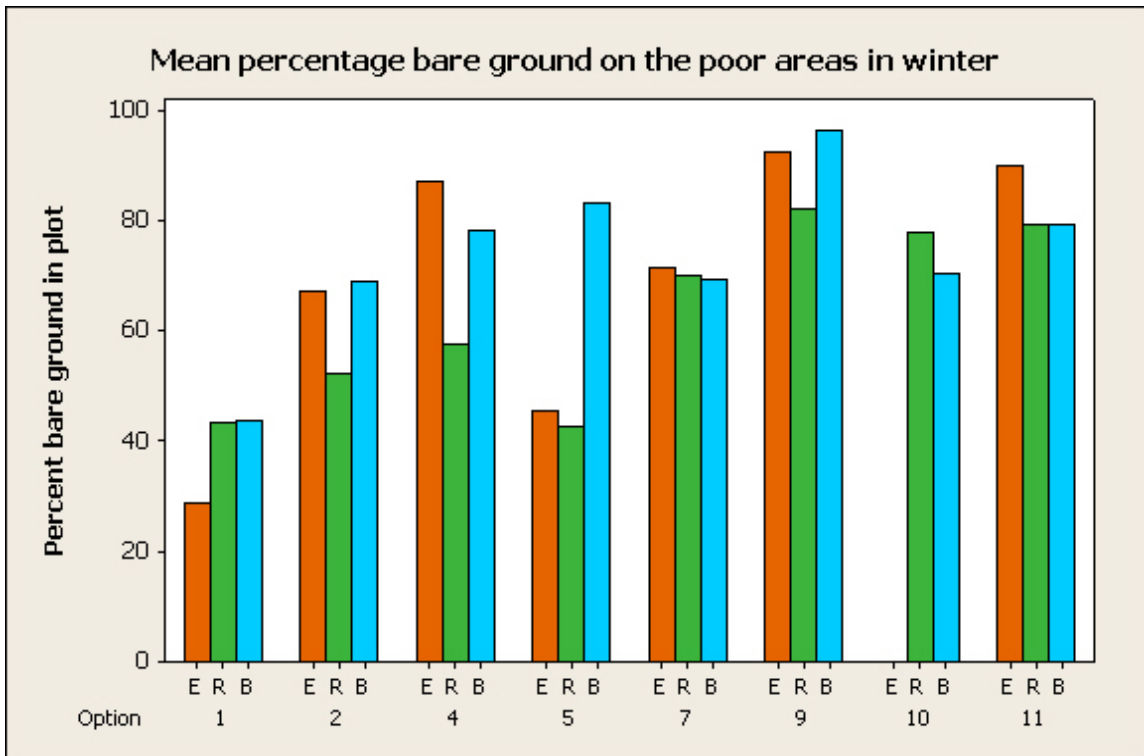
Figure 4.11 Mean percentage bare ground in poor areas at the three study sites in winter (E = Ely, R = Reach, B = Billingham).

In the plots assessed as poor there was extensive bare ground in both summer and winter (Figures 4.11 and 4.12).

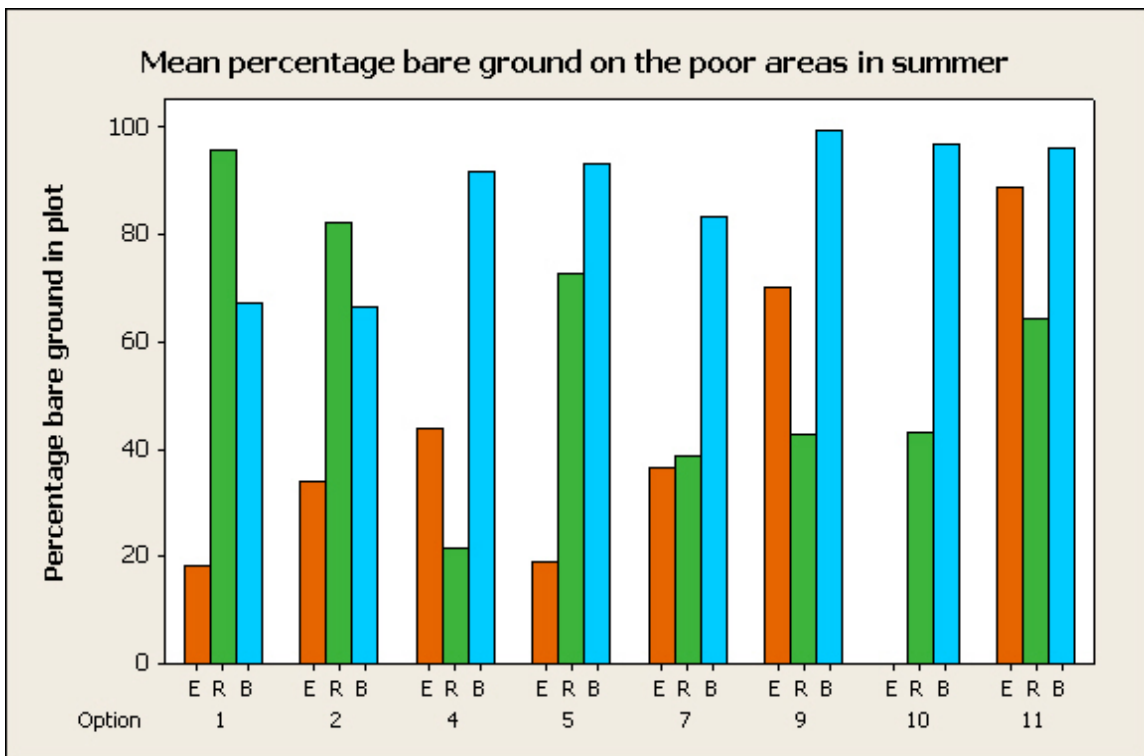
Figure 4.12 Mean percentage bare ground in poor areas at the three study sites in summer (E = Ely, R = Reach, B = Billingham).

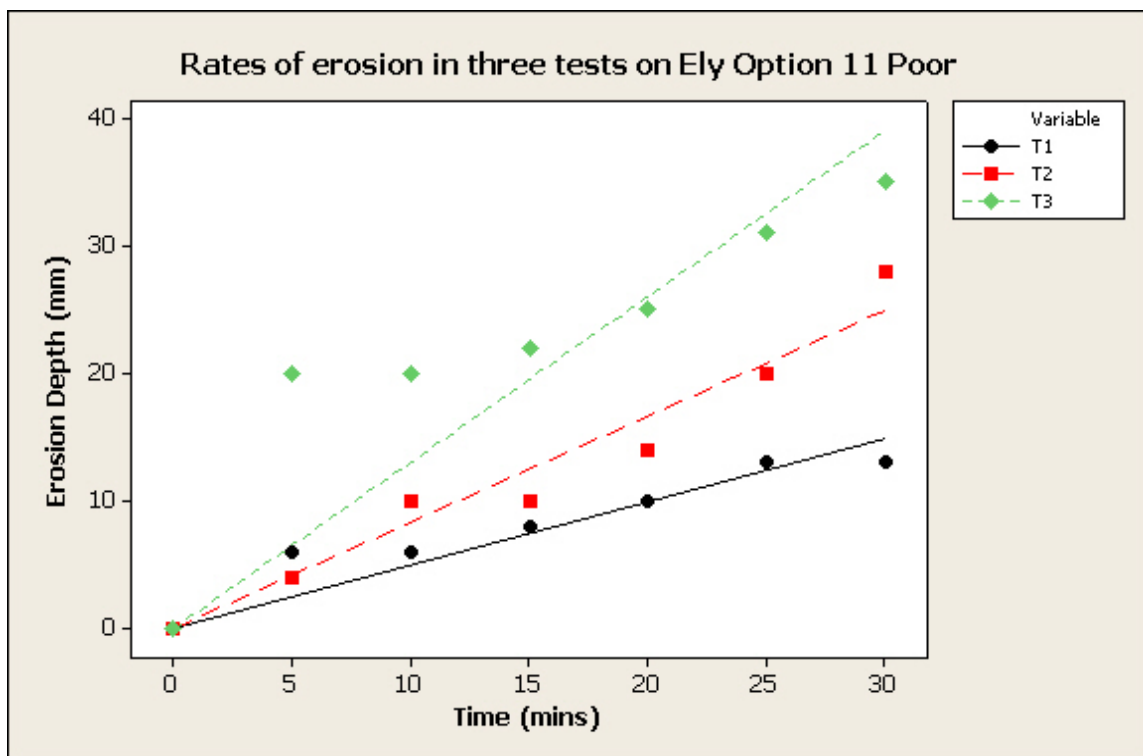
Figure 4.13 Rate of erosion of three test plots at Ely Ouse.

This raised the interesting question as to how much more erosion would there had been if the test had been allowed to run the full 30 minutes. Accordingly in one plot at Ely Ouse, estimates of the depth of erosion were made every five minutes for the duration of the 30-minute run of the test. The results showed that, although there was considerable variation in the rates of erosion during the course of a test, there was a degree of linearity in the rate of erosion (Figure 4.13).

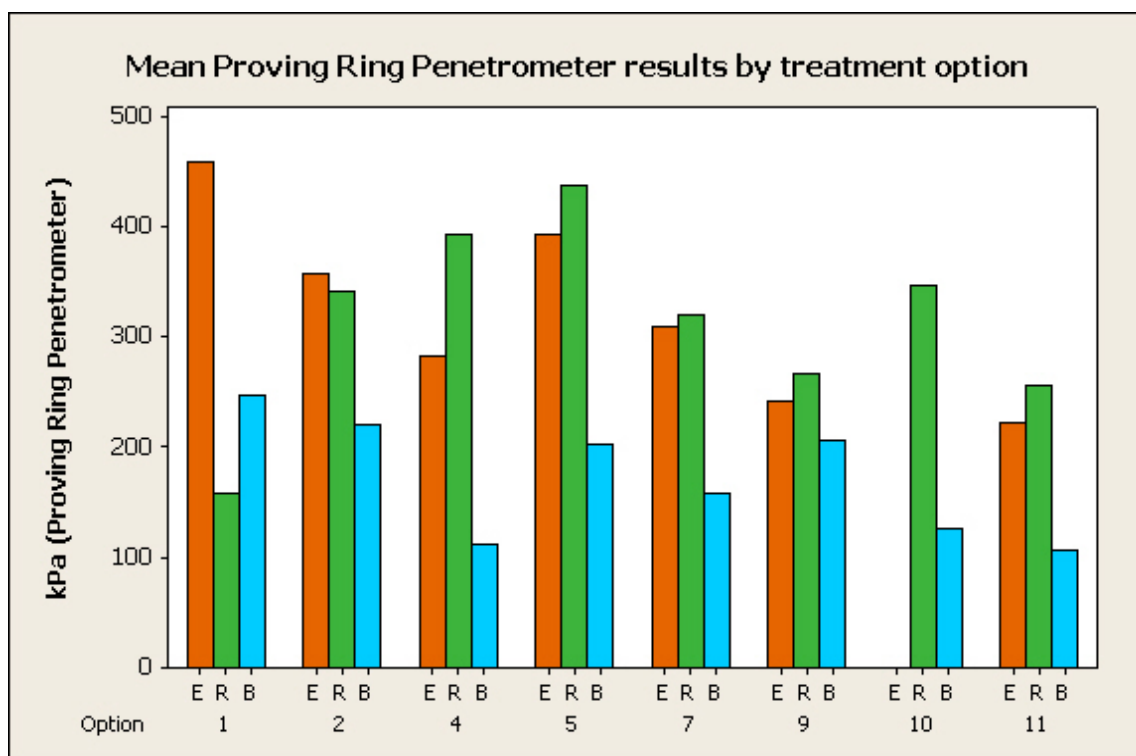
Figure 5.1 Soil strengths in the different treatment options as measured by proving ring penetrometer at the three study sites (E = Ely, R = Reach, B = Billingborough).

Examining the data for the whole treatment option (i.e. not distinguishing between the 'poor' and 'good' plant cover areas), soils at Billingborough were generally significantly ($p < 0.05$) weaker than at either of the other two sites across almost all treatment options (Figures 5.1–5.3).

At Billingborough, the situation was much more confused with the proving ring penetrometer showing Treatment Options 1, 2, 5 and 9 as having the strongest soils, but with Treatment Option 9 particularly strong when assessed with the pocket penetrometer and the shear vane and significantly stronger than almost all other treatment options. Treatment Options 4 and 11 recorded the weakest soils with all instruments.

At Reach Lode, the pattern was somewhat different with Treatment Options 4 and 5 significantly the strongest and Treatment Options 1, 9 and 11 the weakest, with Treatment Options 2, 7 and 10 somewhere in between.
