ACCIDENT

Aircraft Type and Registration:	Ikarus C42 FB100 Bravo, G-OSPH	
No & Type of Engines:	1 Rotax 912ULS piston engine	
Year of Manufacture:	2012 (Serial no: 1205-7202)	
Date & Time (UTC):	1 December 2020 at 1330 hrs	
Location:	Chilbolton Airfield, Stockbridge, Hampshire	
Type of Flight:	Private	
Persons on Board:	Crew - 1	Passengers - 1
Injuries:	Crew - None	Passengers - None
Nature of Damage:	Landing gear collapsed	
Commander's Licence:	National Private Pilot's Licence	
Commander's Age:	42 years	
Commander's Flying Experience:	127 hours (of which 60 were on type) Last 90 days - 23 hours Last 28 days - 7 hours	
Information Source:	Aircraft Accident Report Form submitted by the pilot and further enquiries made by the AAIB

Synopsis

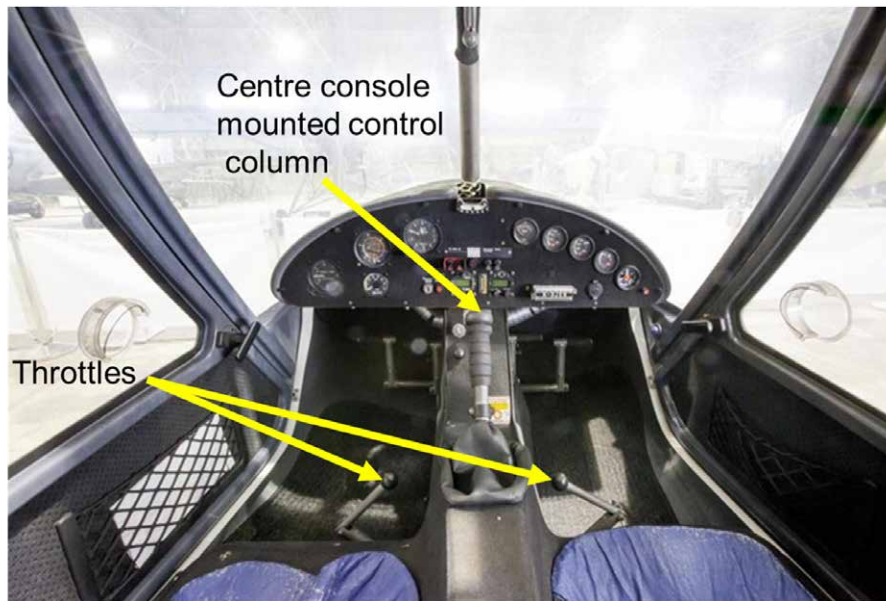
Figure 1

The Ikarus C42 primary flight control consists of a control column mounted on a centre console between the pilot seats. There are two throttle levers pivoted on the cockpit floor directly in front of the seats between the pilot's legs.

Example Ikarus C42 cockpit layout (Image © National Museums Scotland)
