## **Construction noise and vibration Monthly Report – January 2021**

### **Buckinghamshire**

This Noise and Vibration Monitoring Report fulfils HS2 Limited's commitment detailed in the Environmental Minimum Requirements (EMRs), Annex 1, Code of Construction Practice, to present the results of noise monitoring carried out within Buckinghamshire (BS) during the month of January 2021.

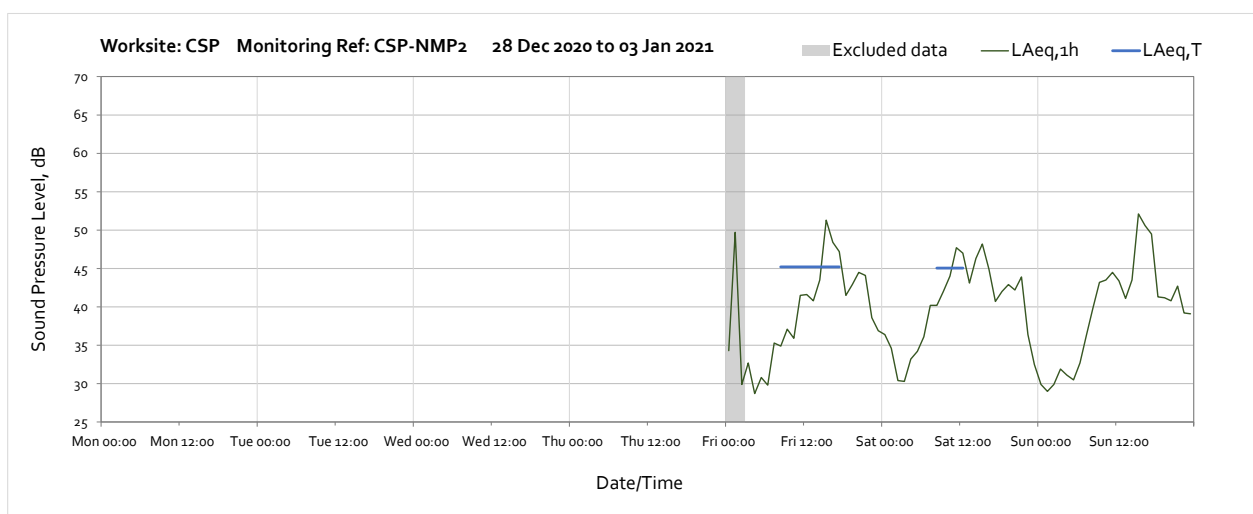
## Worksite: CSP – Monitoring Ref: CSP-NMP2

Note: High noise levels on the early hours of the 1st January were due to New Year's Eve celebrations and have been excluded to calculate values in Table 3.
