Construction noise and vibration Monthly Report – January 2021

London Borough of Camden

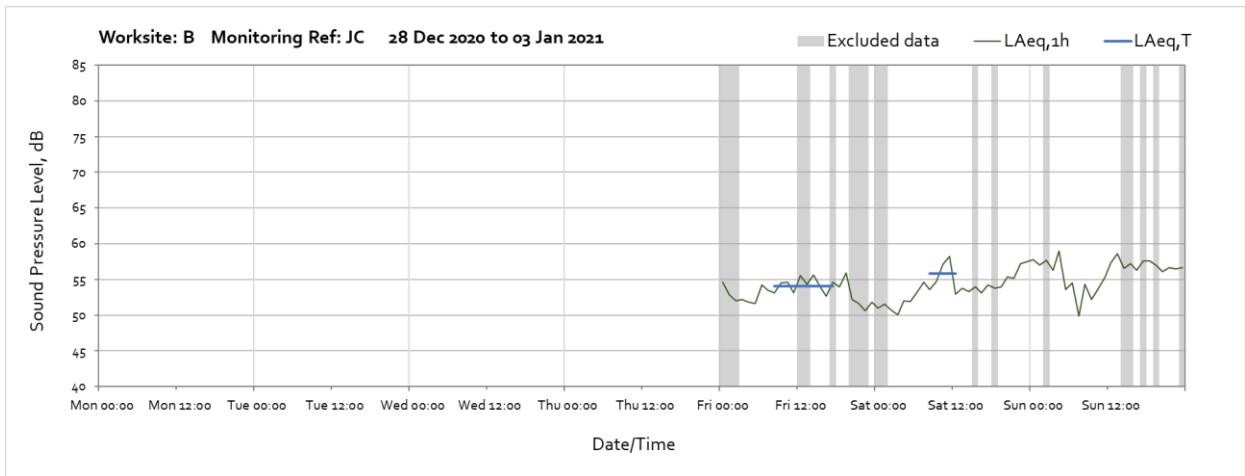
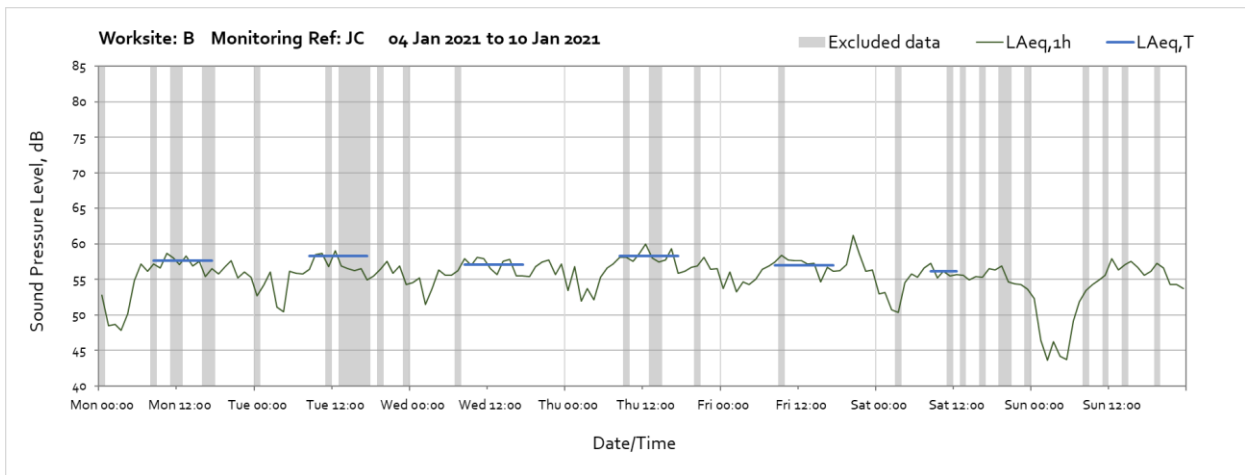
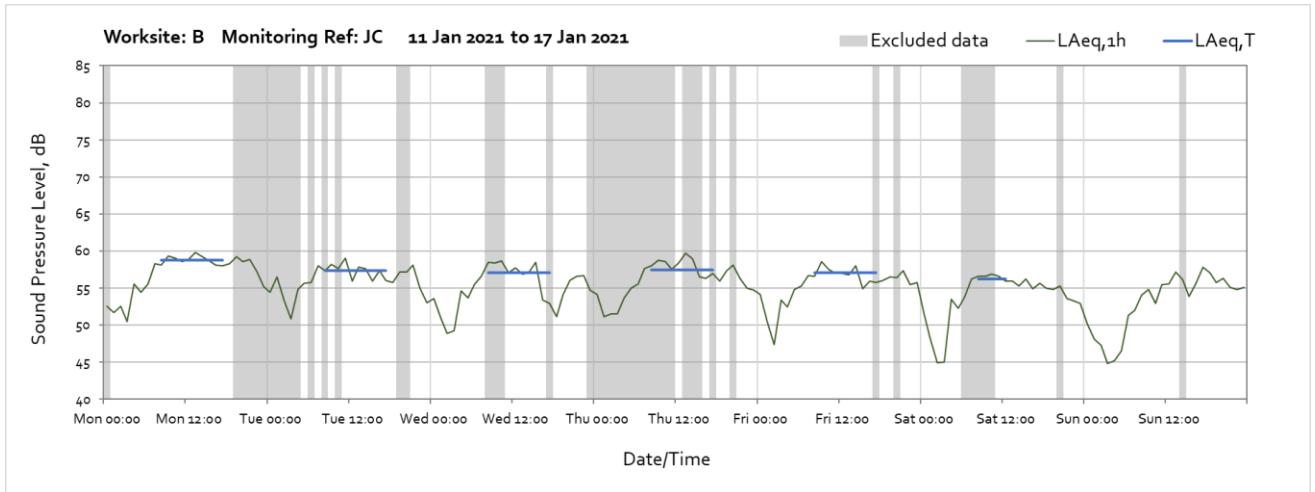
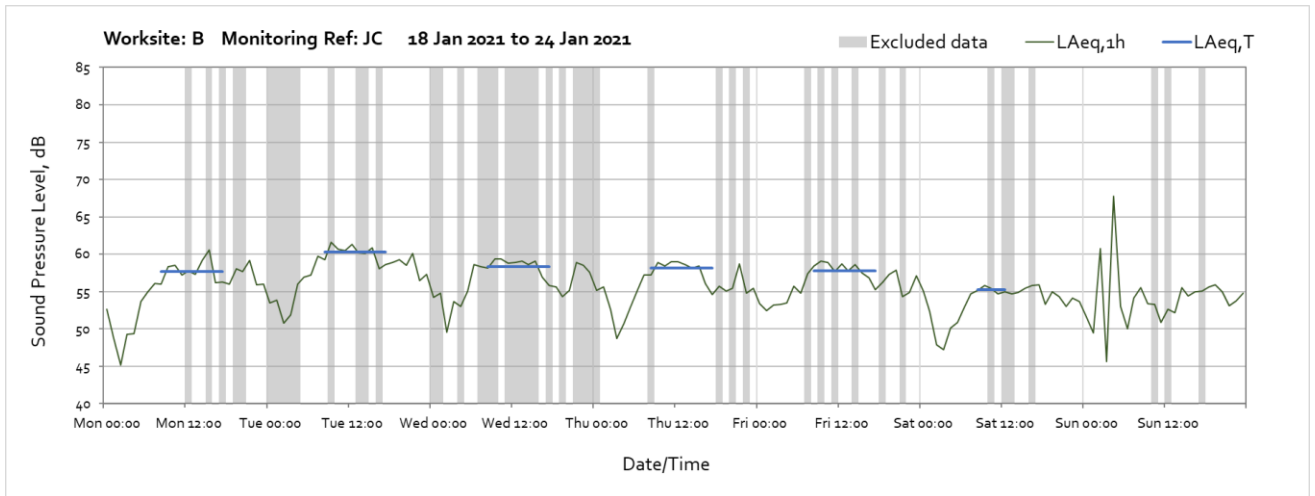
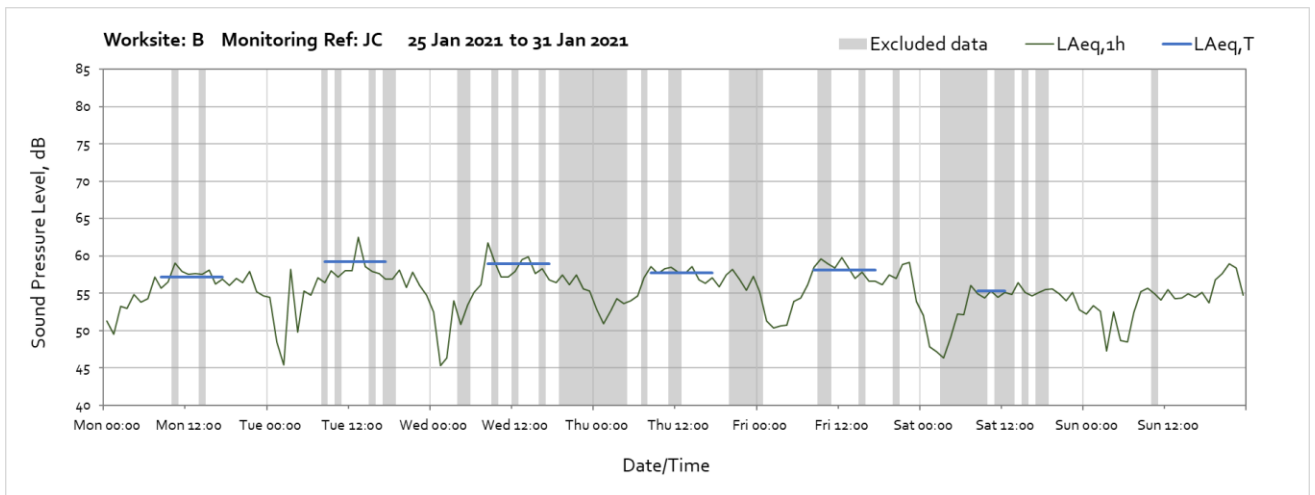
Worksite: B – Monitoring Ref: JC

The following graphs show the hourly measured ambient noise level $L_{Aeq,1h}$ and, where relevant, the averaged noise level $L_{Aeq,T}$ values, where the time period T is as specified in Table 1 of HS2 Information Paper E23. Periods with adversely weather affected noise levels are greyed out and have been excluded from the calculation of the $L_{Aeq,T}$ values in Table 3 of the main report.

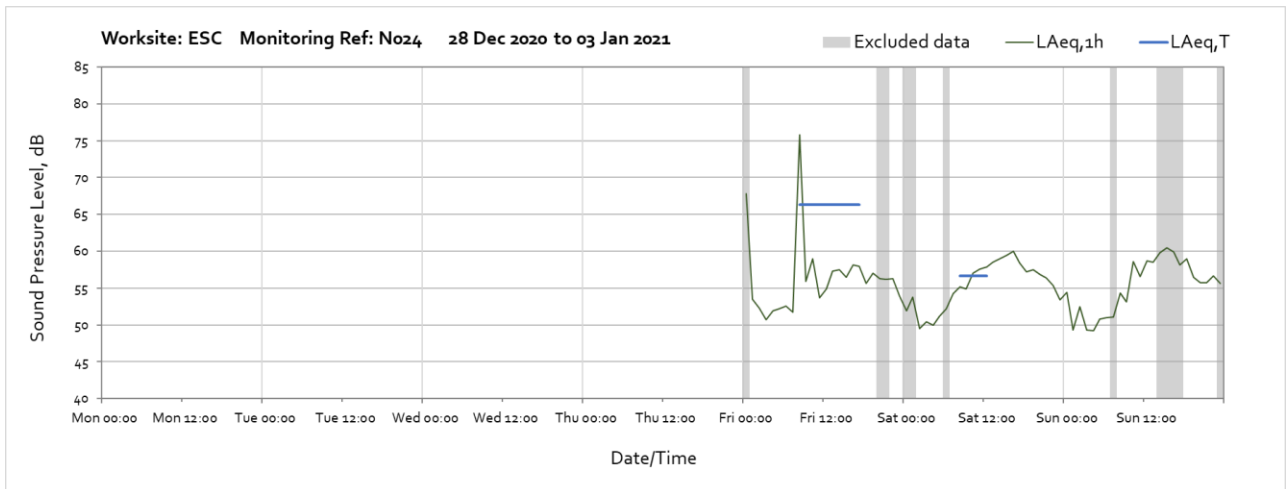
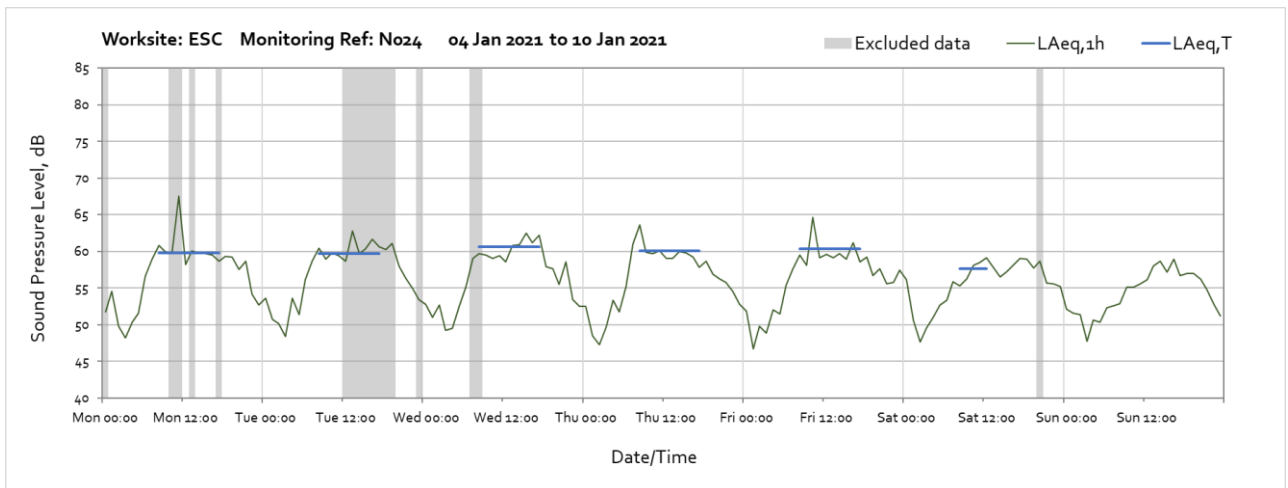
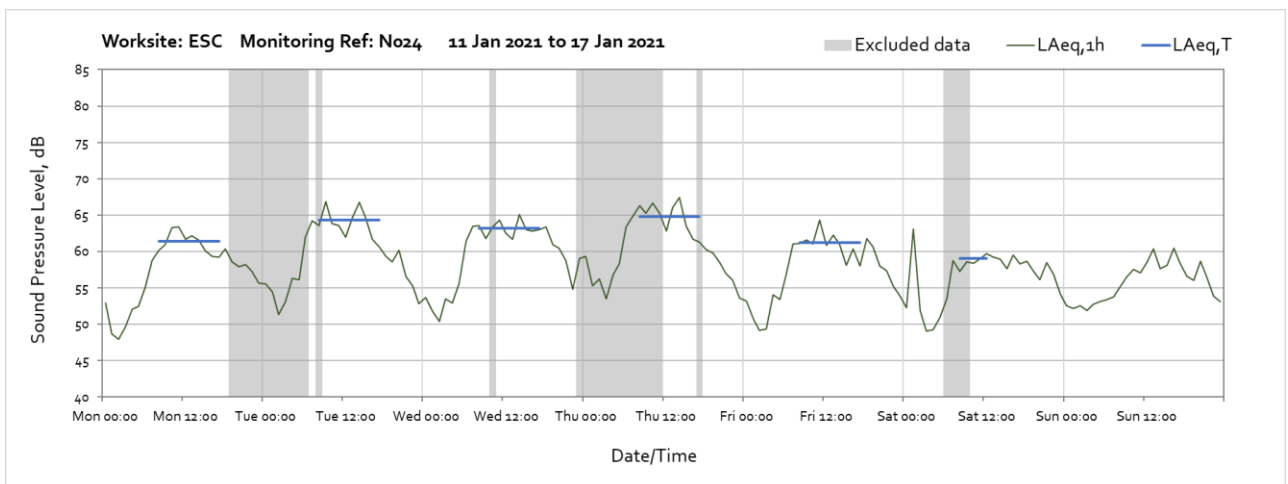
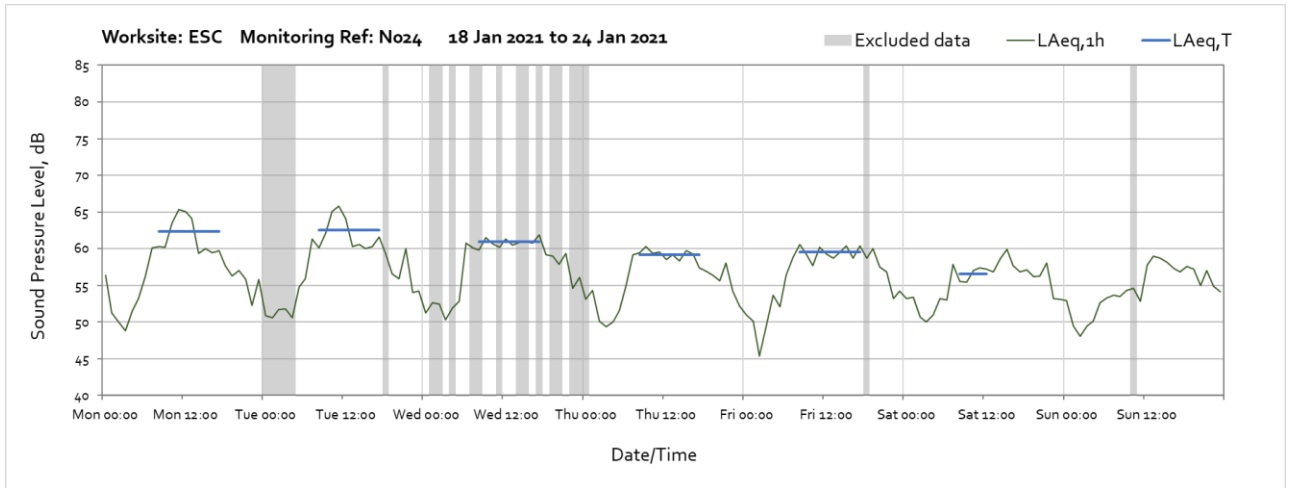
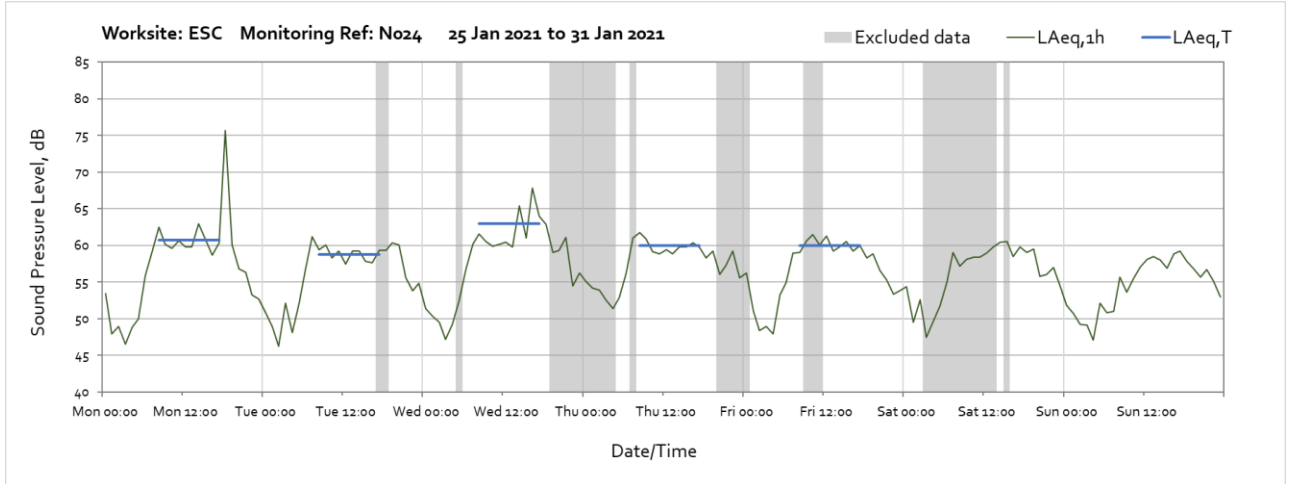
Worksite: ESC – Monitoring Ref: N024

Note: High noise levels on the early hours of the 1st January were due to New Year's Eve celebrations and have been excluded to calculate values in Table 3.

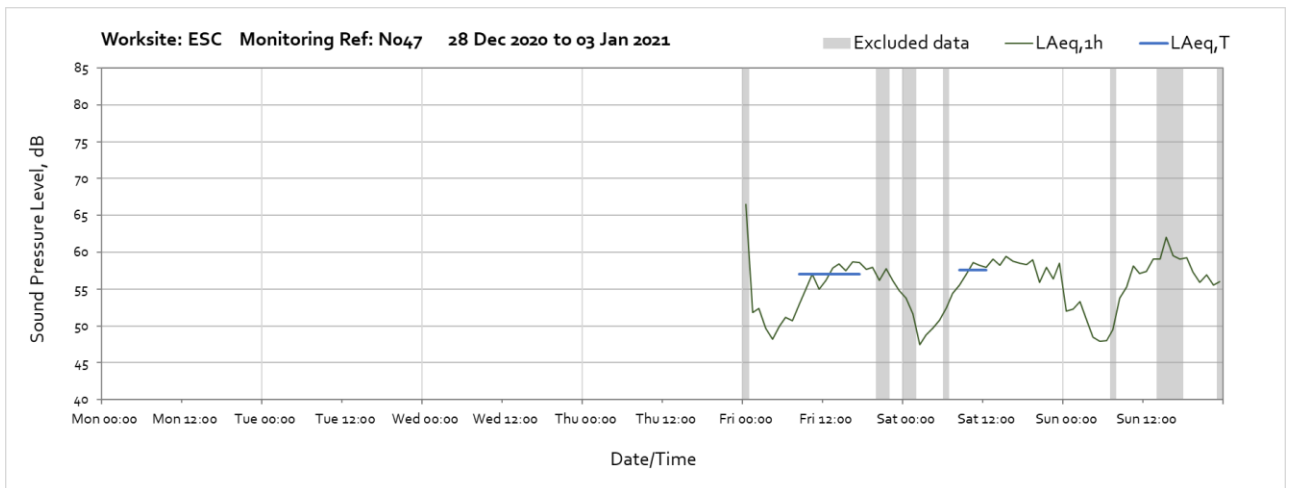
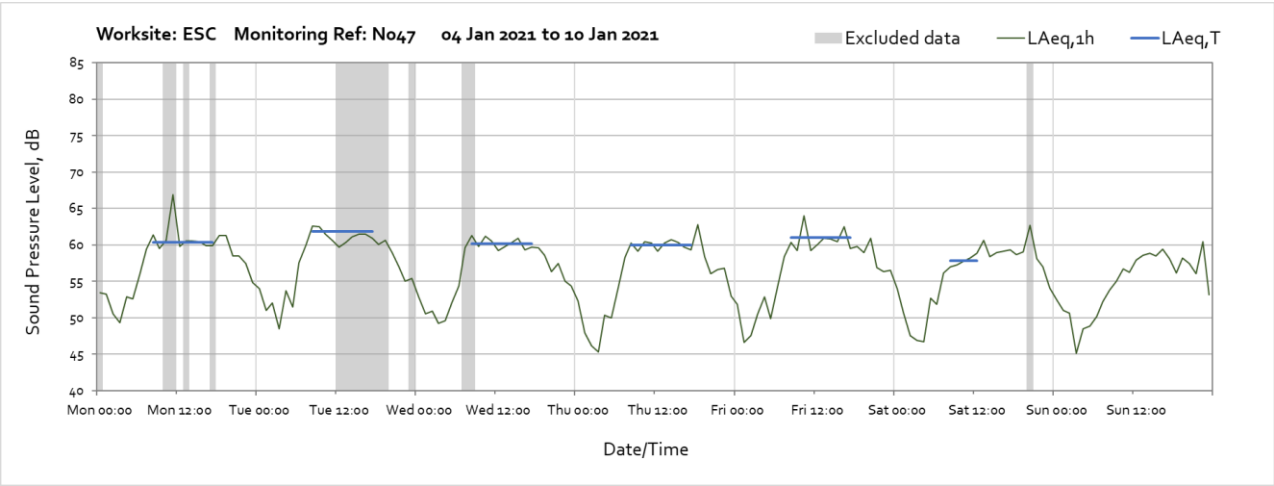
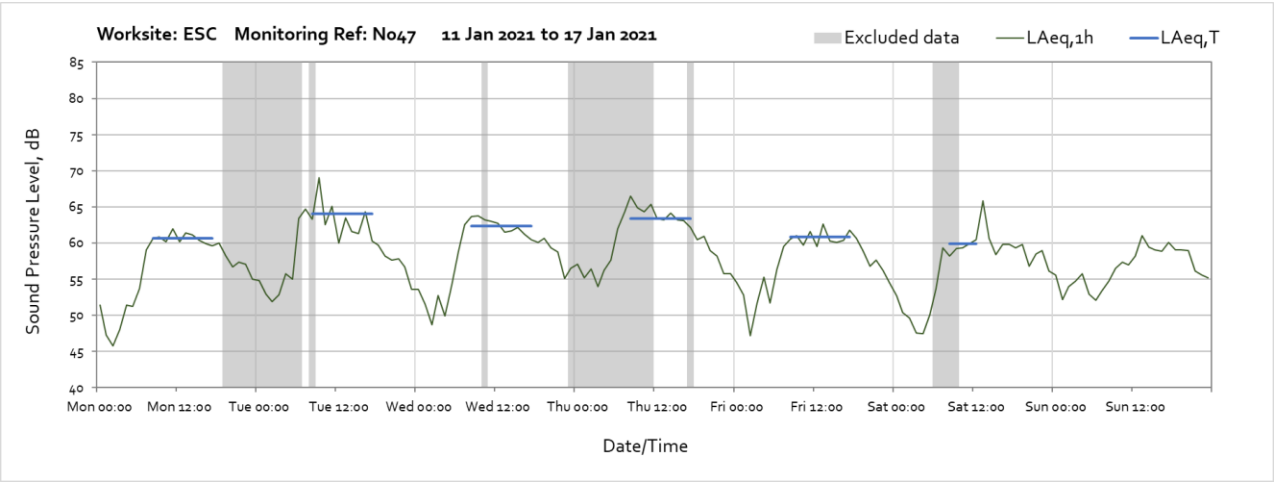
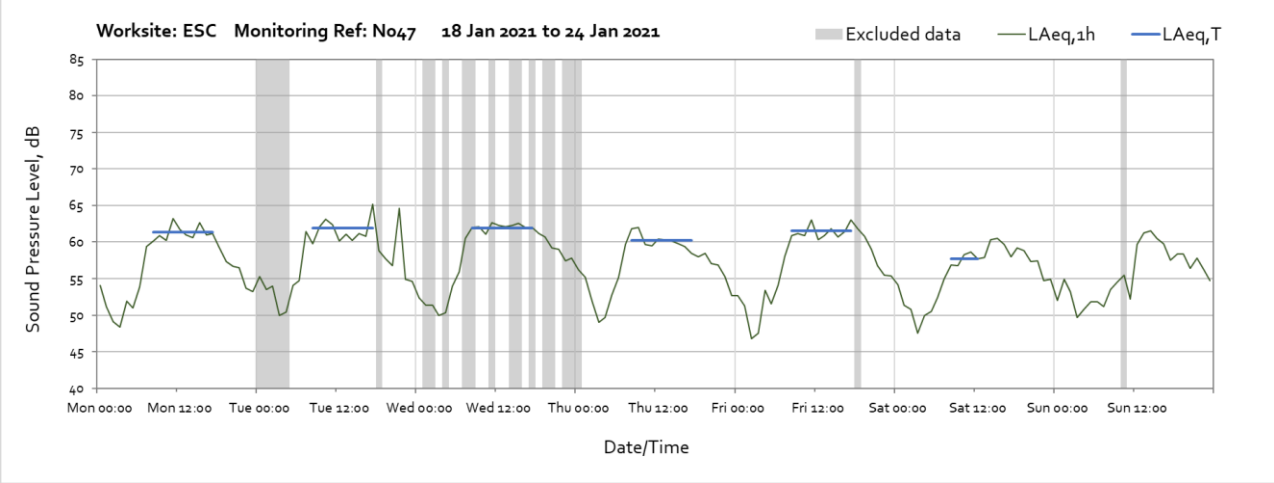
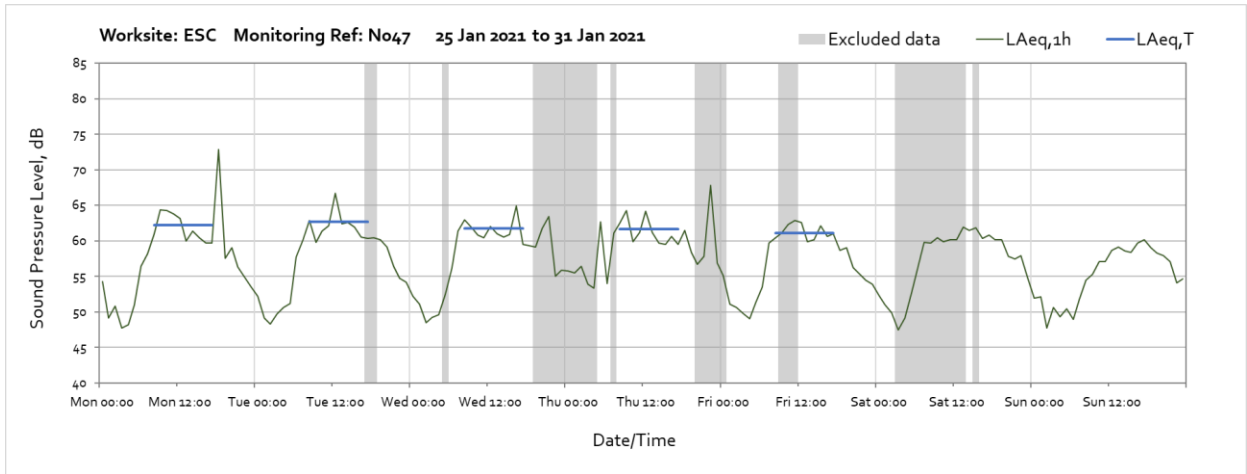
Worksite: ESC – Monitoring Ref: N047

Note: High noise levels on the early hours of the 1st January were due to New Year's Eve celebrations and have been excluded to calculate values in Table 3.

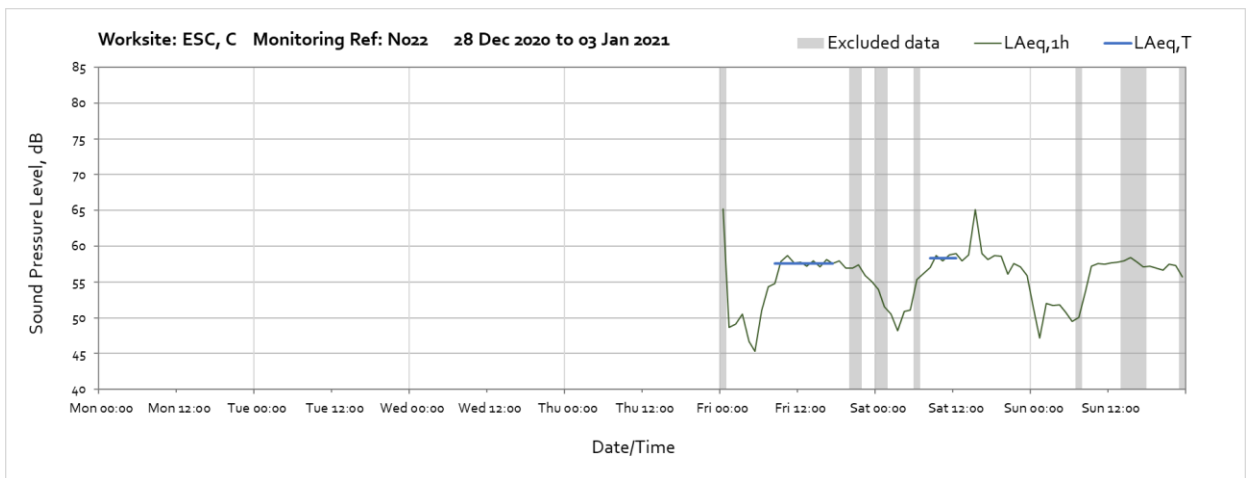
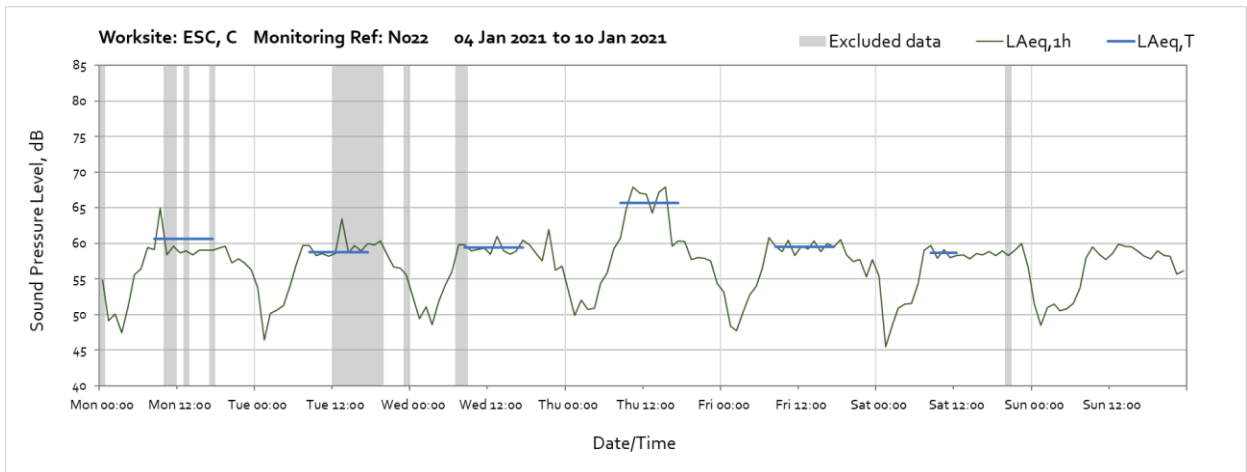
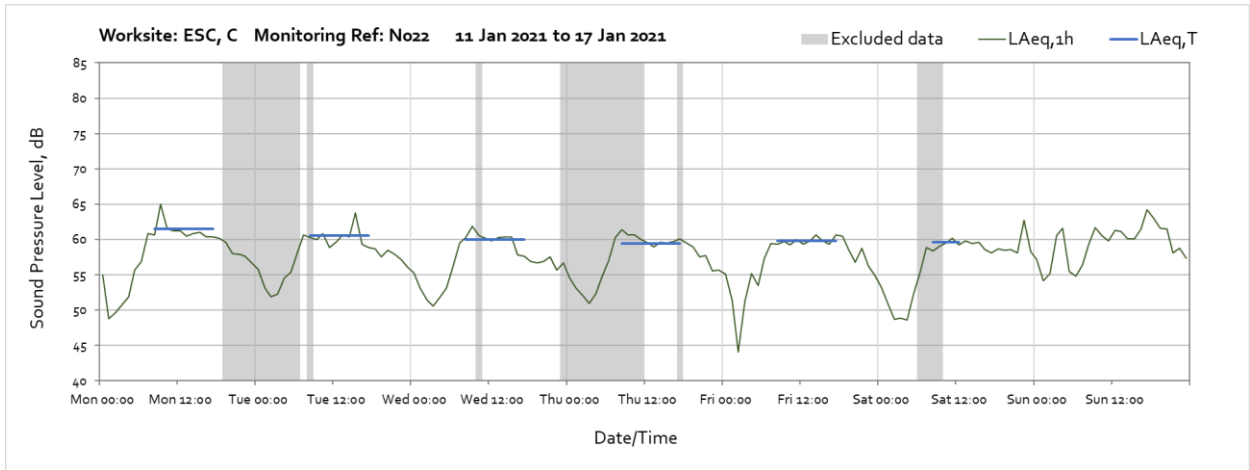
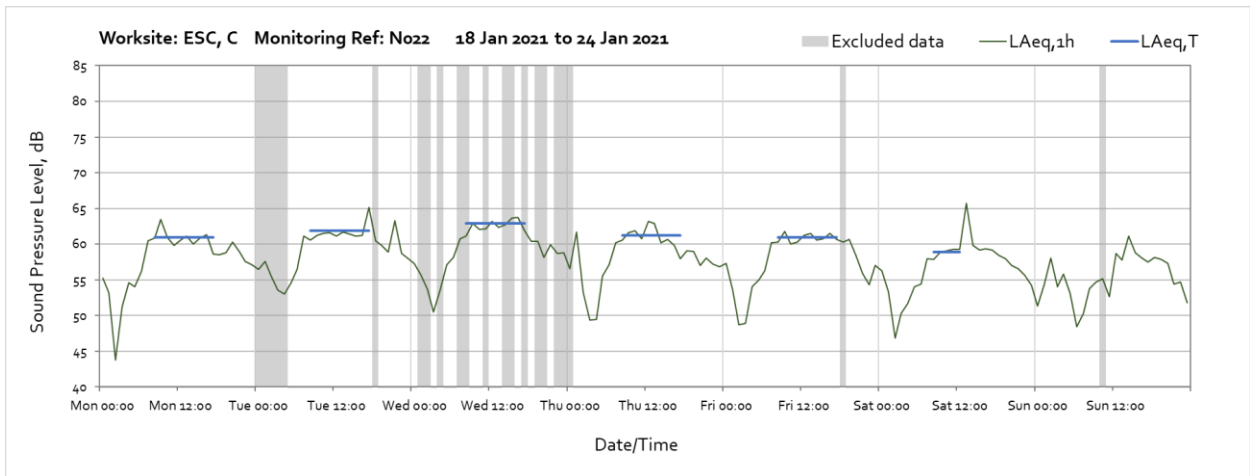
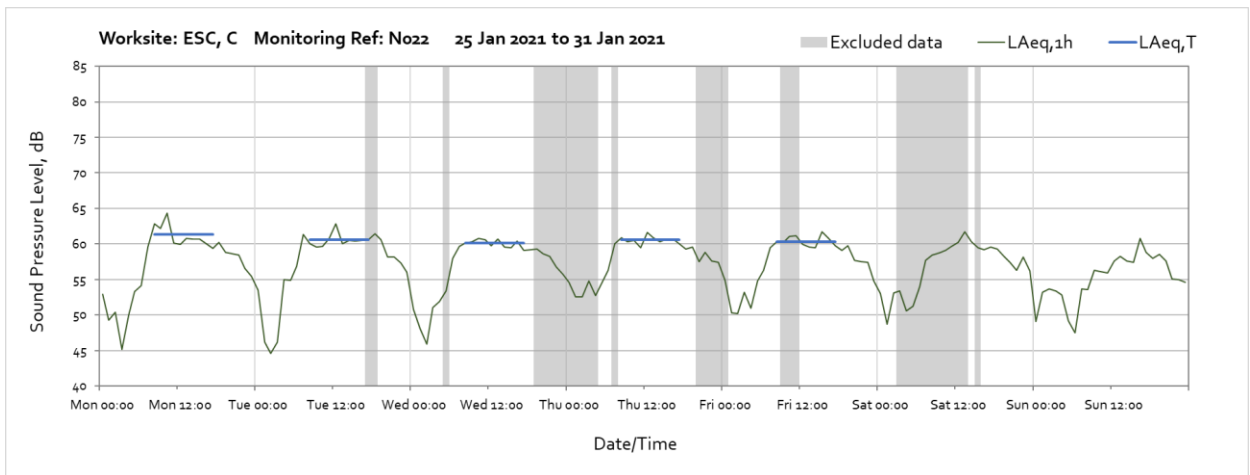
Worksite: ESC-C – Monitoring Ref: N022

Note: High noise levels on the early hours of the 1st January were due to New Year's Eve celebrations and have been excluded to calculate values in Table 3.

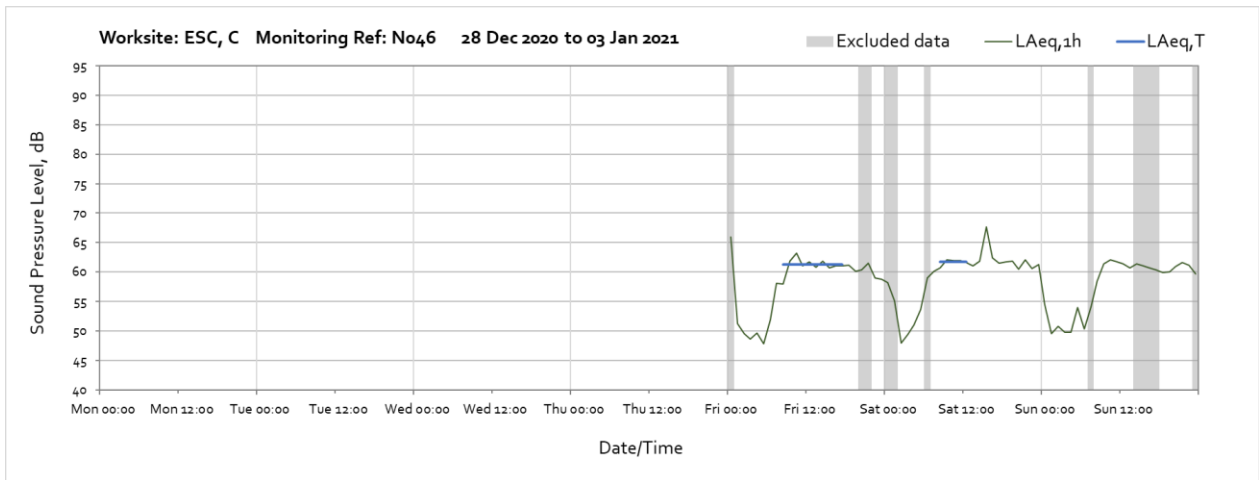
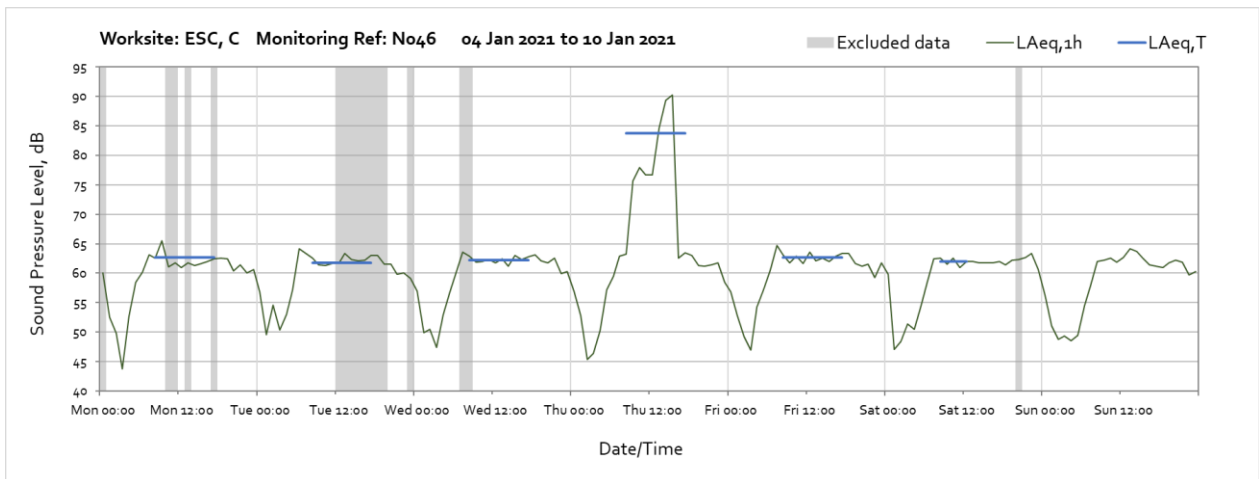
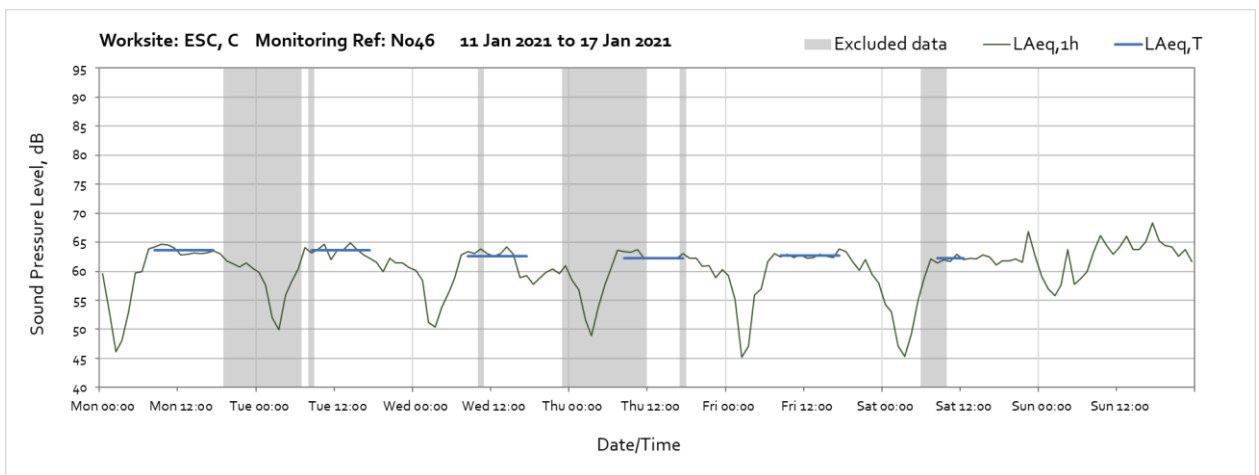
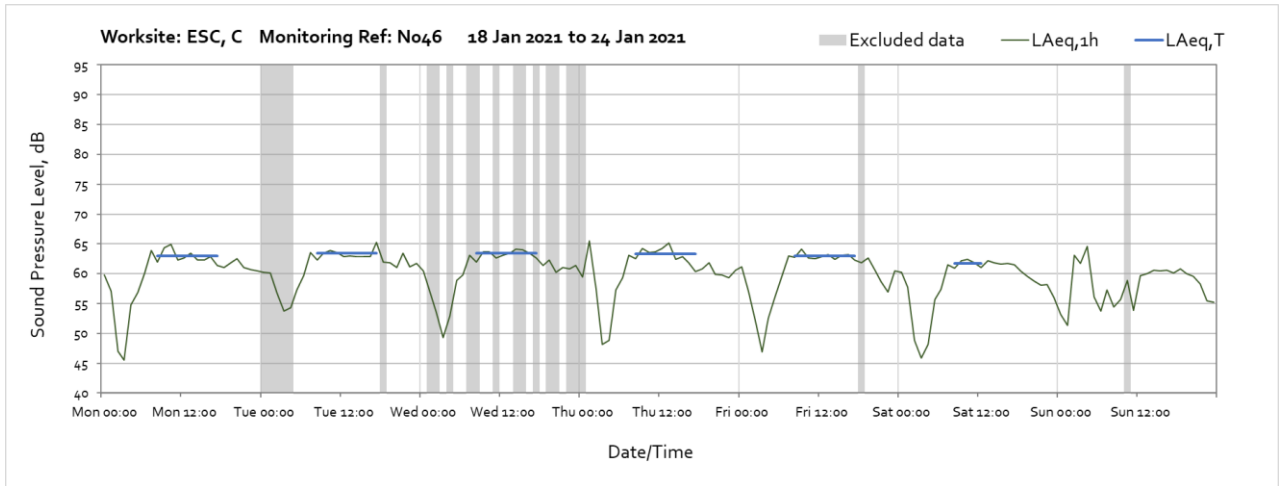
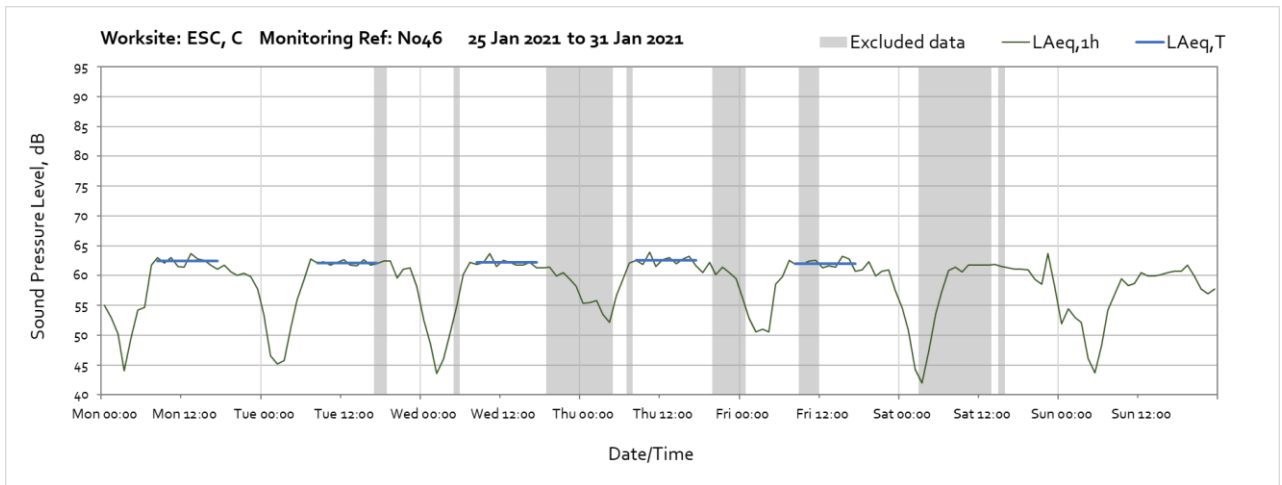
Worksite: ESC-C – Monitoring Ref: N046

Note: High noise levels on the early hours of the 1st January were due to New Year's Eve celebrations and have been excluded to calculate values in Table 3.

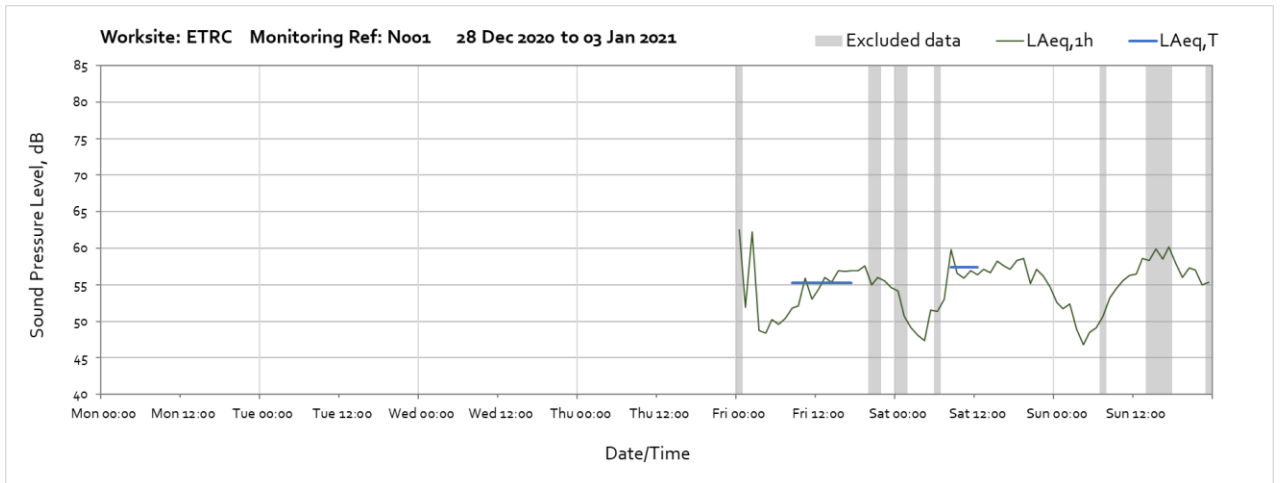
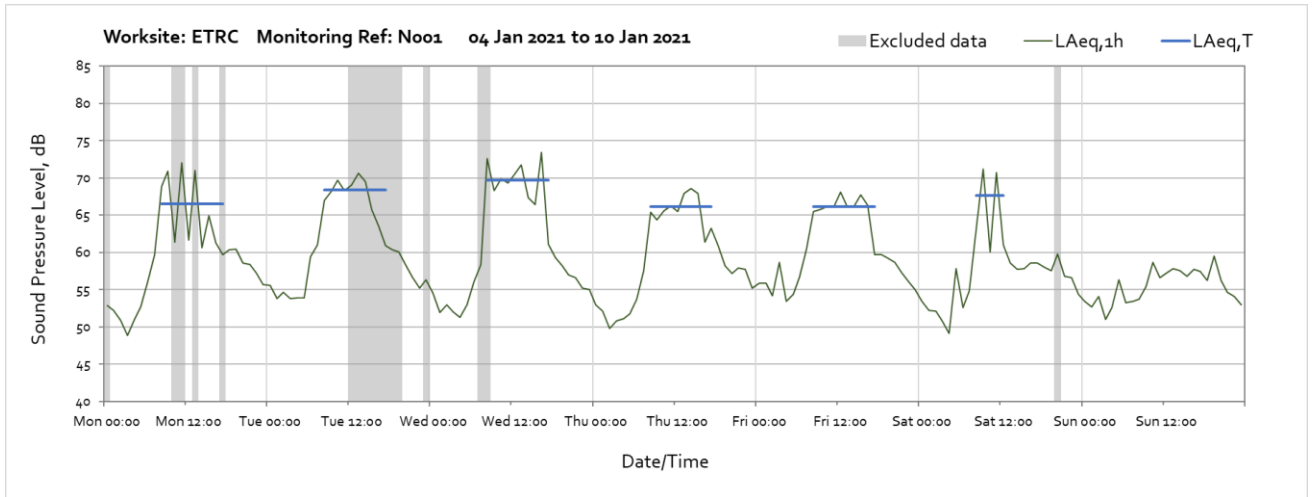
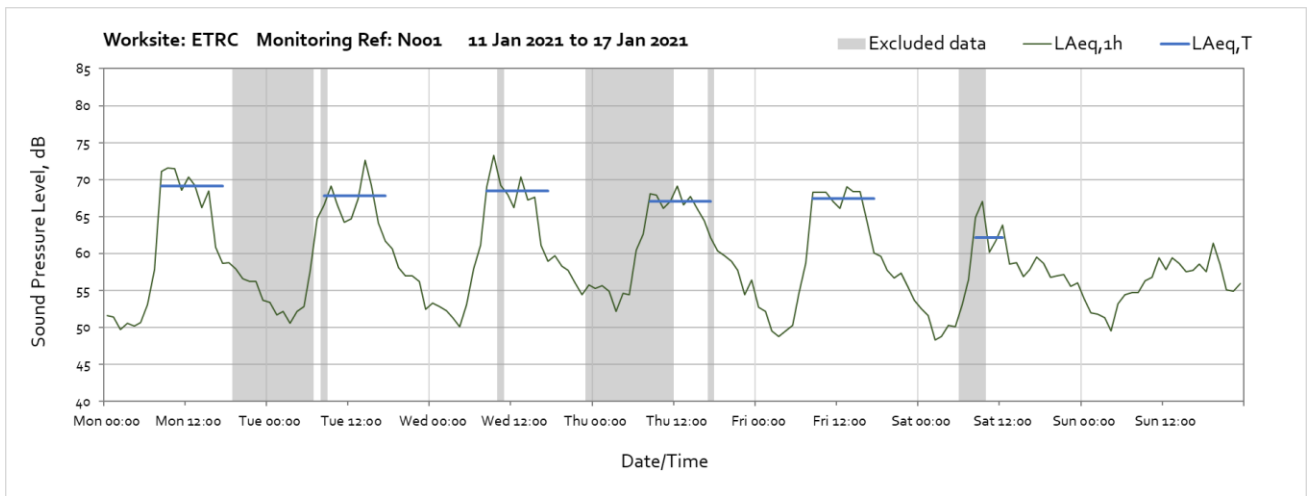
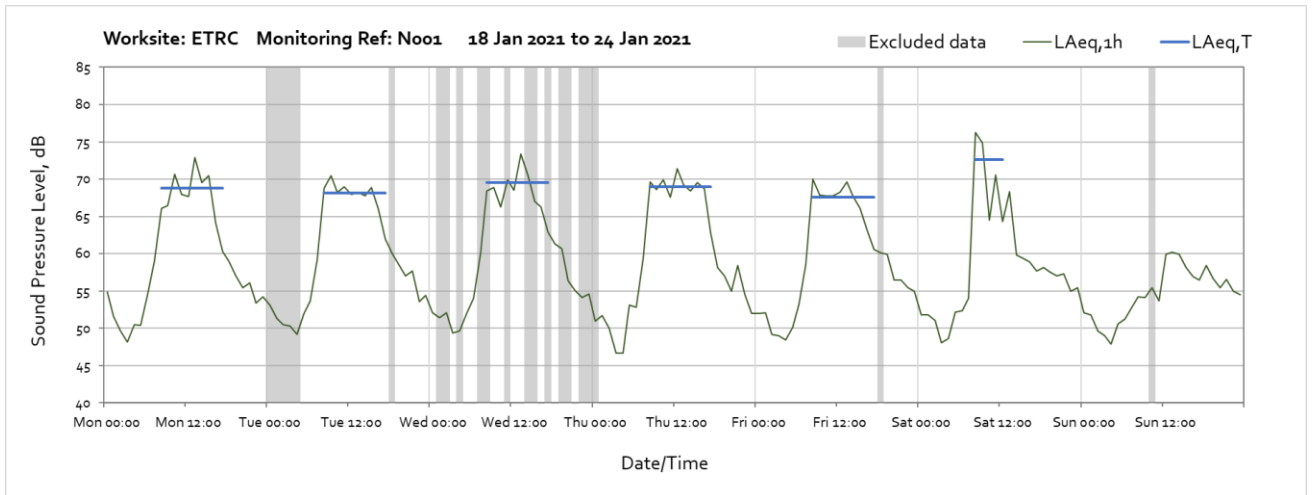
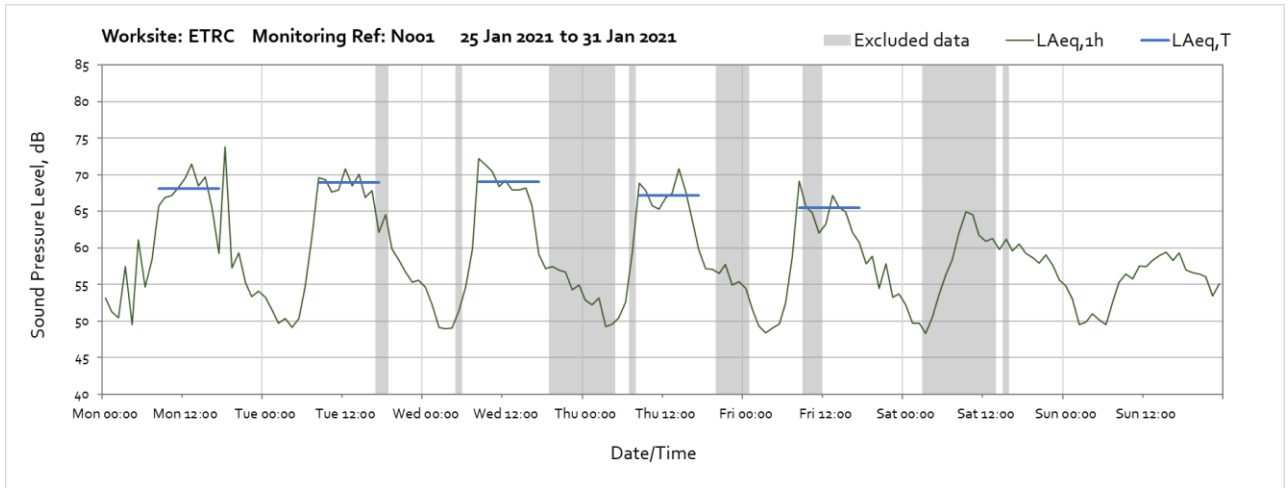
Worksite: ETRC – Monitoring Ref: N001

Note: High noise levels on the early hours of the 1st January were due to New Year’s Eve celebrations and have been excluded to calculate values in Table 3.

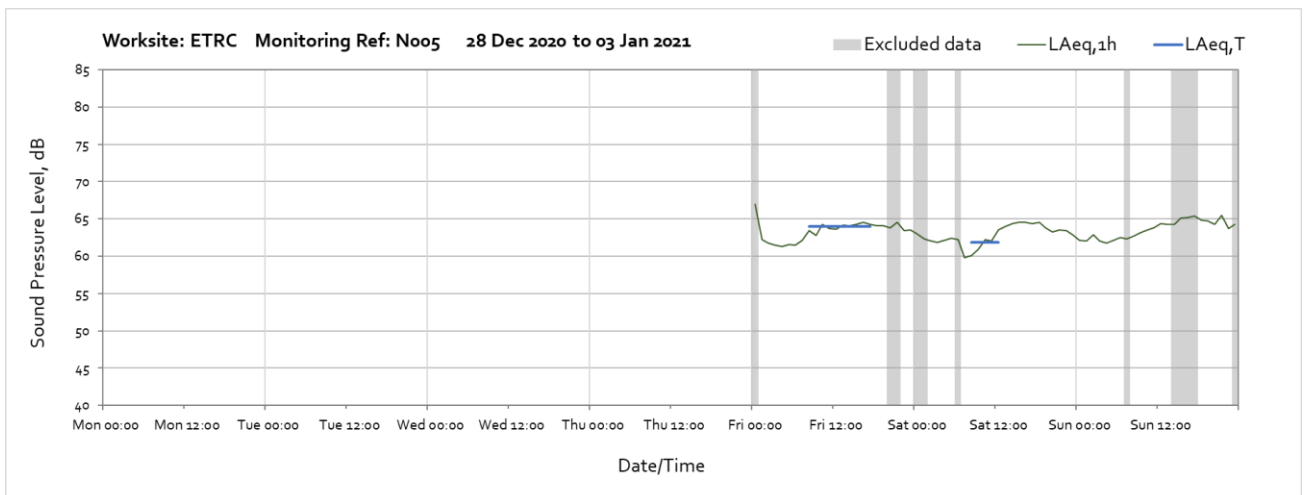
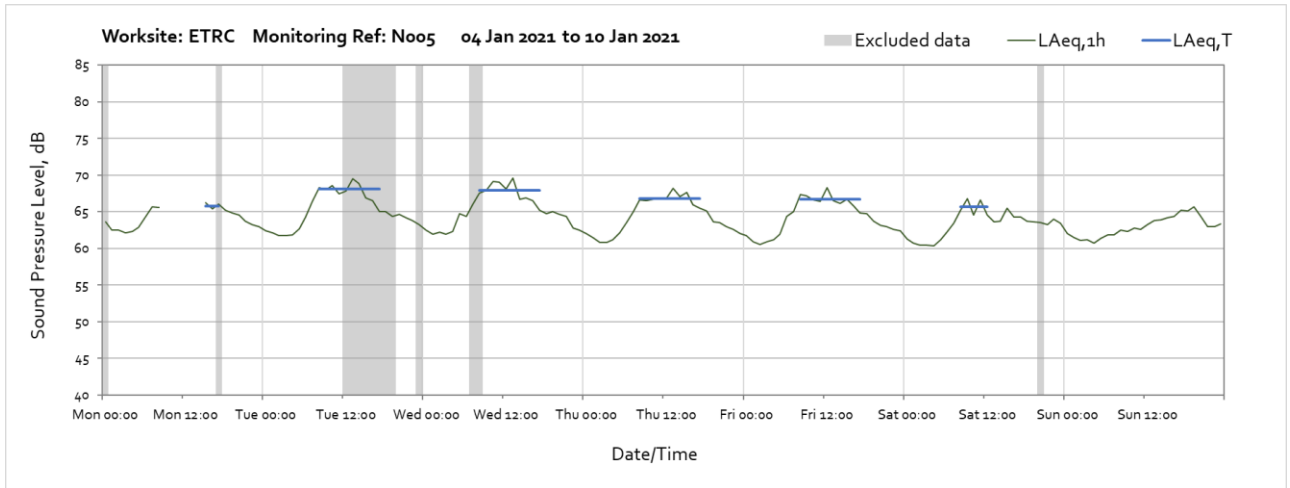
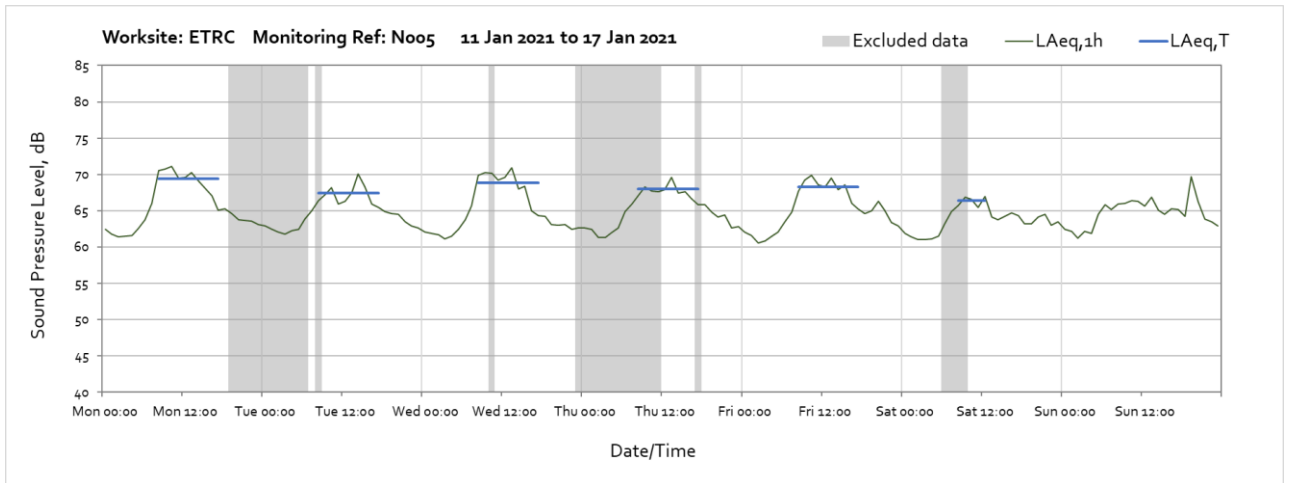
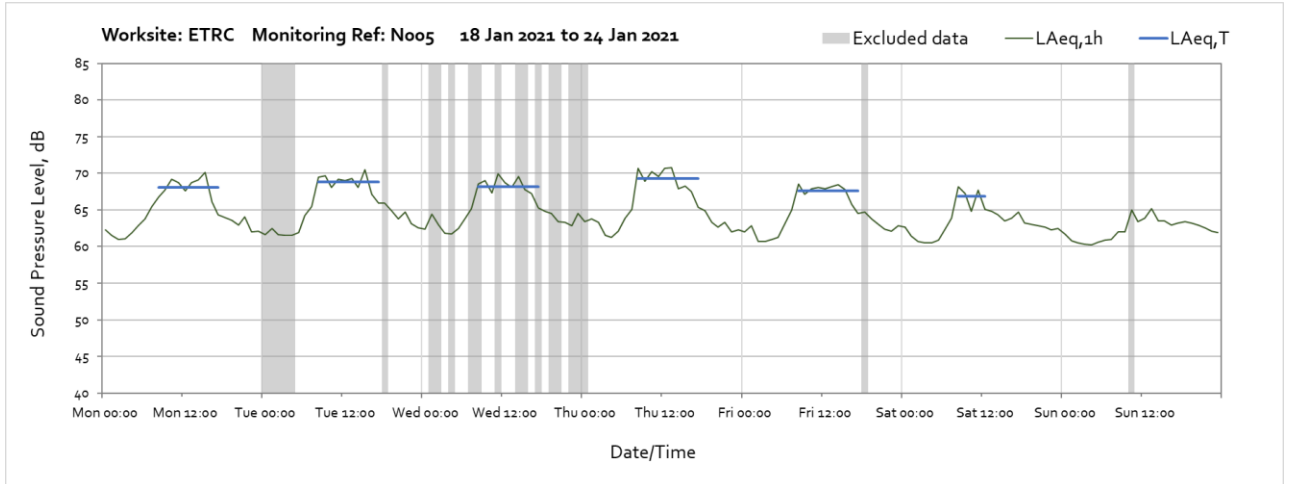
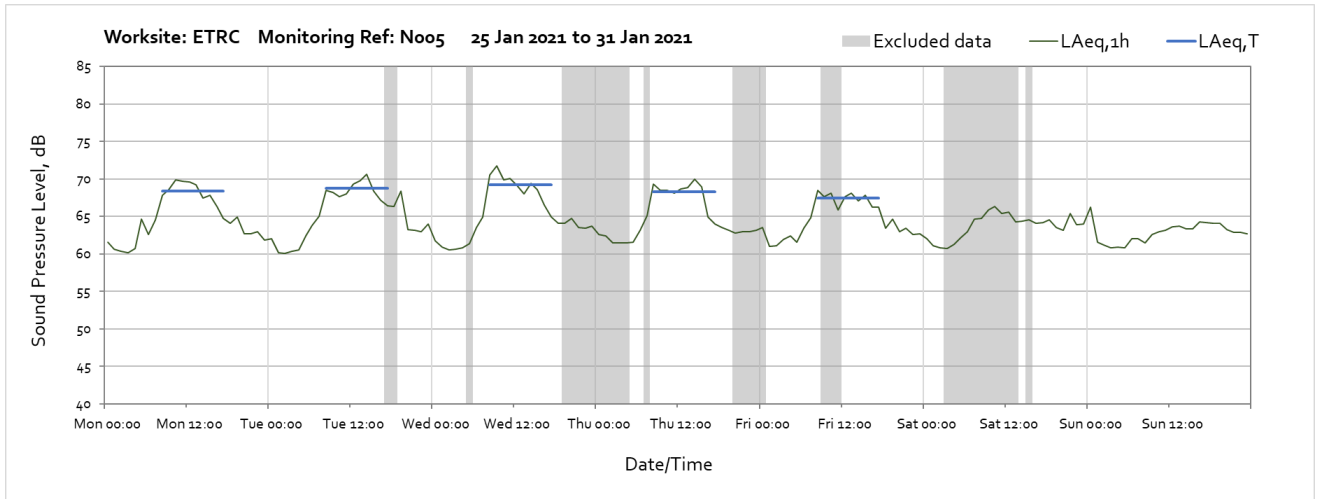
Worksite: ETRC – Monitoring Ref: N005

Note: Missing data from 09:00 until 15:00 on Monday 4th January was due to loss of power at the monitoring station caused by a loss of site power and depleted monitoring station battery. The battery depleted as access to the site and monitor was limited of the Christmas period. The site team were requested to check the remaining battery power at the start of each shift.

2.1.3 Appendix C presents graphs of the noise and vibration monitoring data over the month for each of the measurement locations. Noise data presented consists of the hourly L_{Aeq} values and, where relevant, the $L_{Aeq,T}$ values (where the time period T has been taken to be the averaging period as specified in Table 1 of HS2 Information Paper E23). Vibration data presented consist of hourly PPV values. The full data set for the monitoring equipment can be found at the following location: <https://data.gov.uk/dataset/24542ae7-dd44-444f-b259-871c4cc43b5e/environmental-monitoring-data>.
