Construction noise and vibration Monthly Report – January 2021

London Borough of Camden

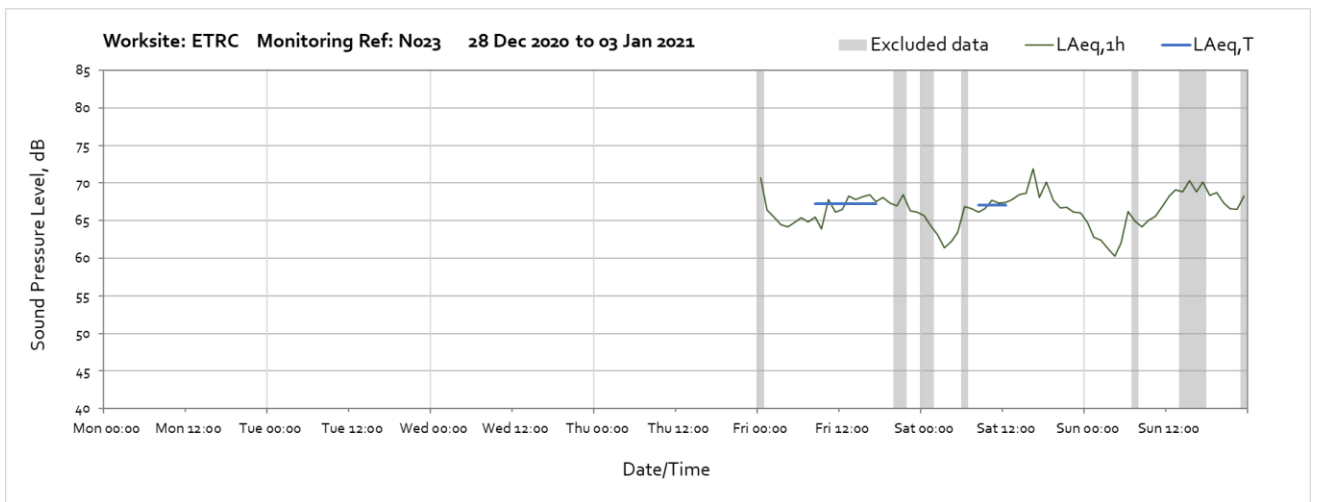
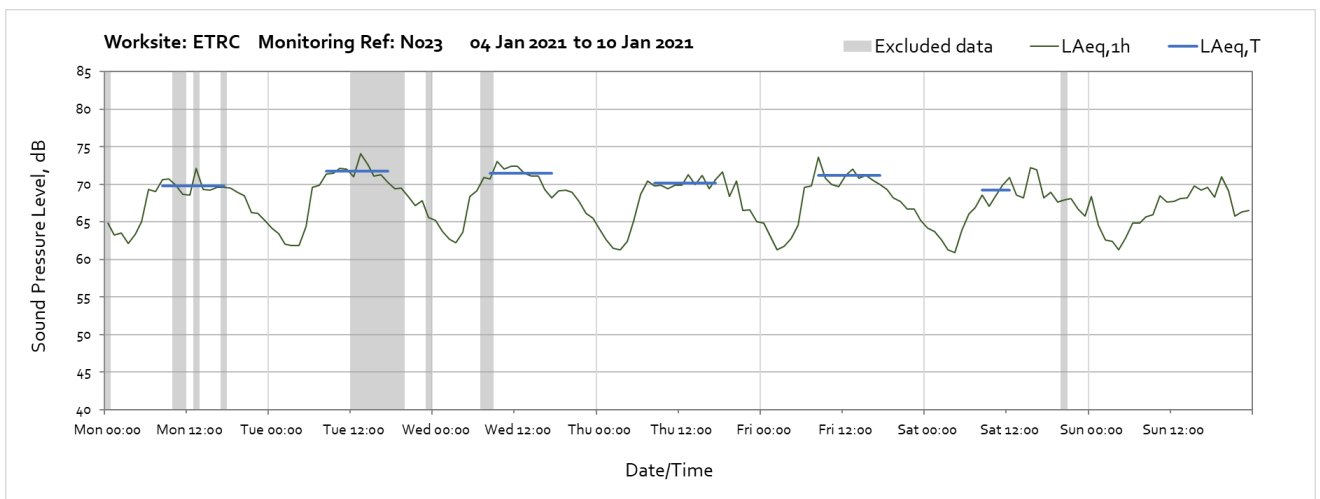
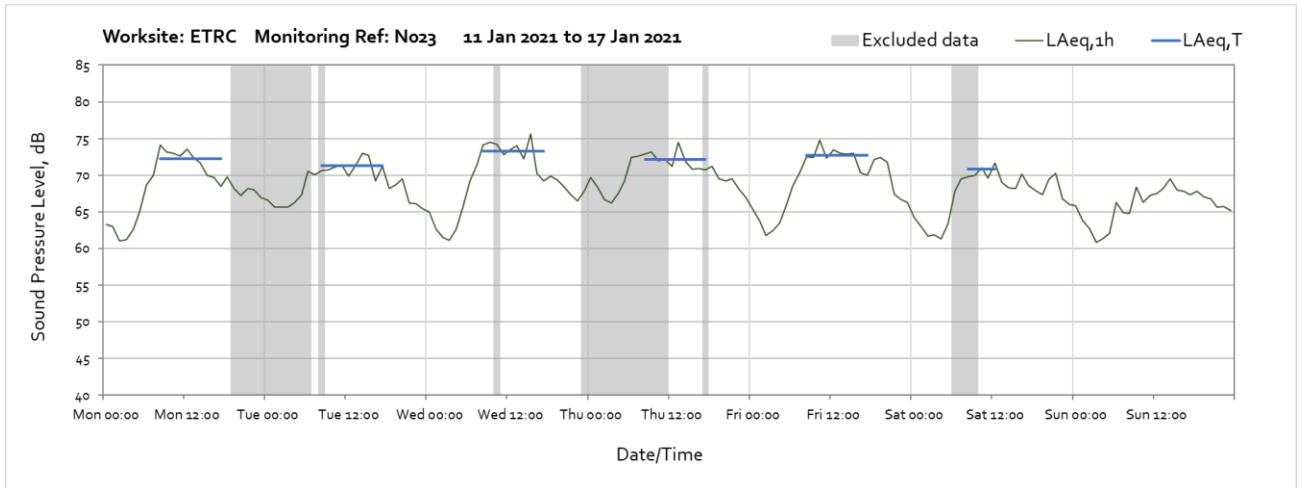
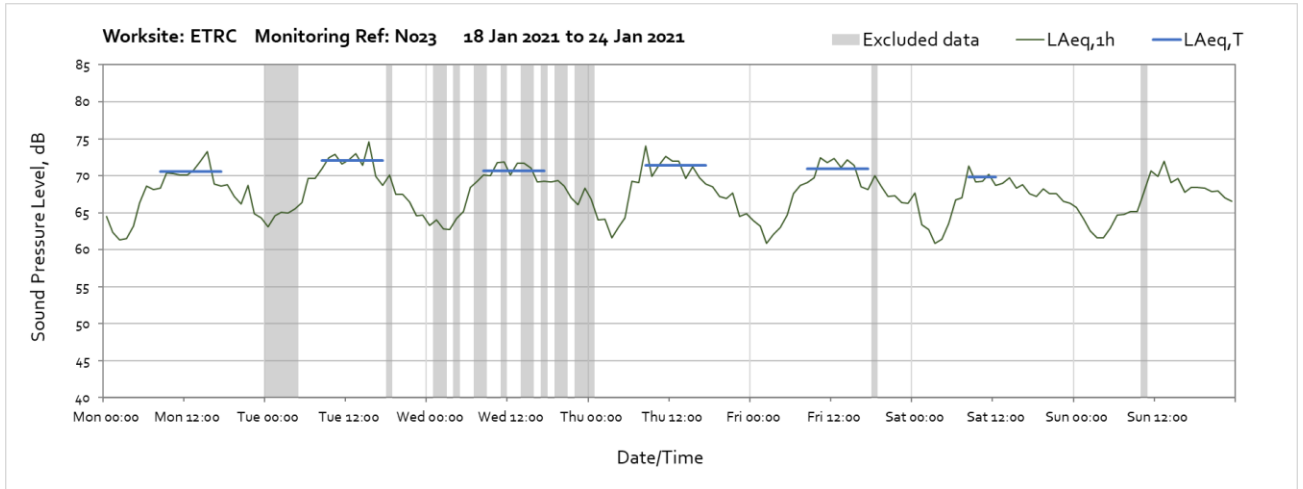
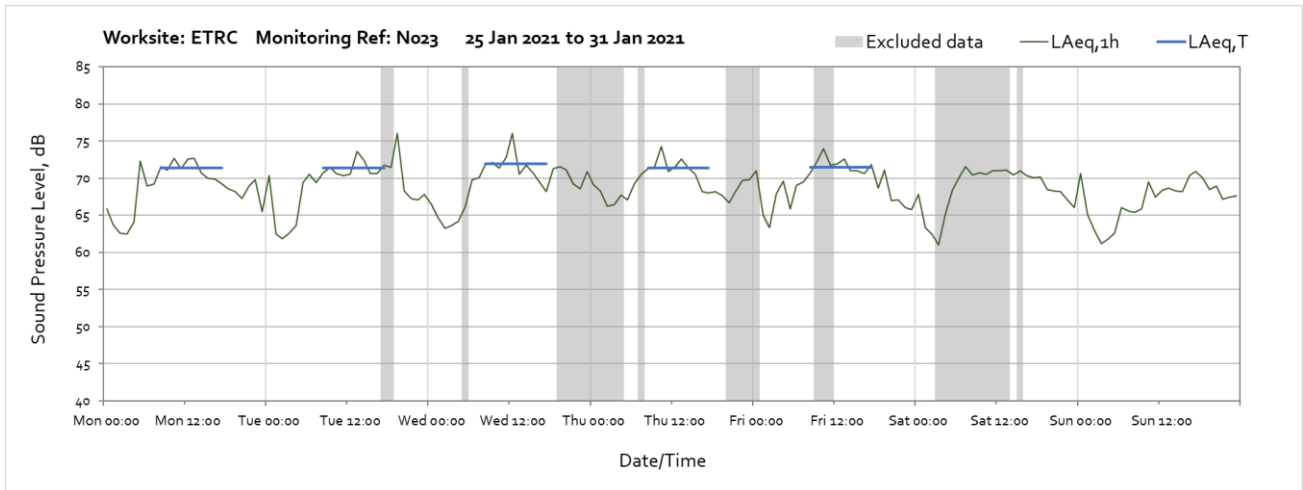
Worksite: ETRC – Monitoring Ref: N023

Note: High noise levels on the early hours of the 1st January were due to New Year's Eve celebrations and have been excluded to calculate values in Table 3.

2.1.3 Appendix C presents graphs of the noise and vibration monitoring data over the month for each of the measurement locations. Noise data presented consists of the hourly L_{Aeq} values and, where relevant, the $L_{Aeq,T}$ values (where the time period T has been taken to be the averaging period as specified in Table 1 of HS2 Information Paper E23). Vibration data presented consist of hourly PPV values. The full data set for the monitoring equipment can be found at the following location: <https://data.gov.uk/dataset/24542ae7-dd44-444f-b259-871c4cc43b5e/environmental-monitoring-data>.

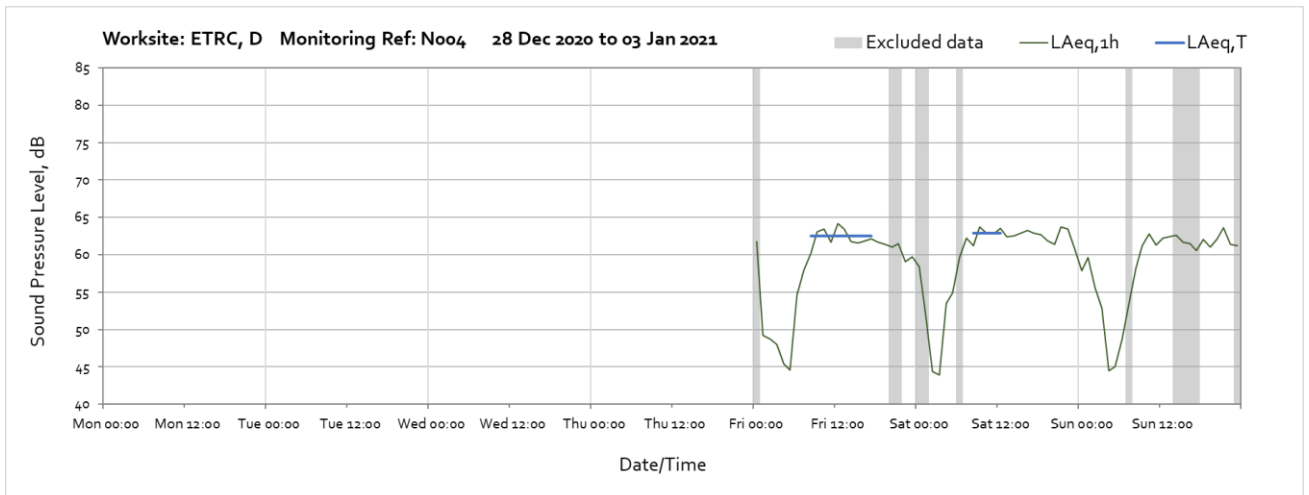
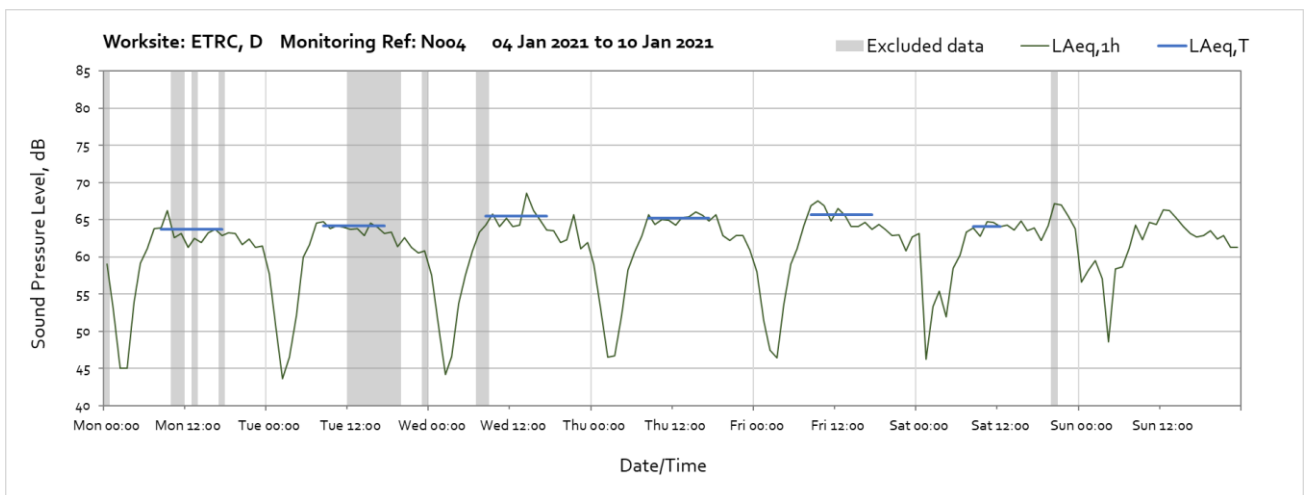
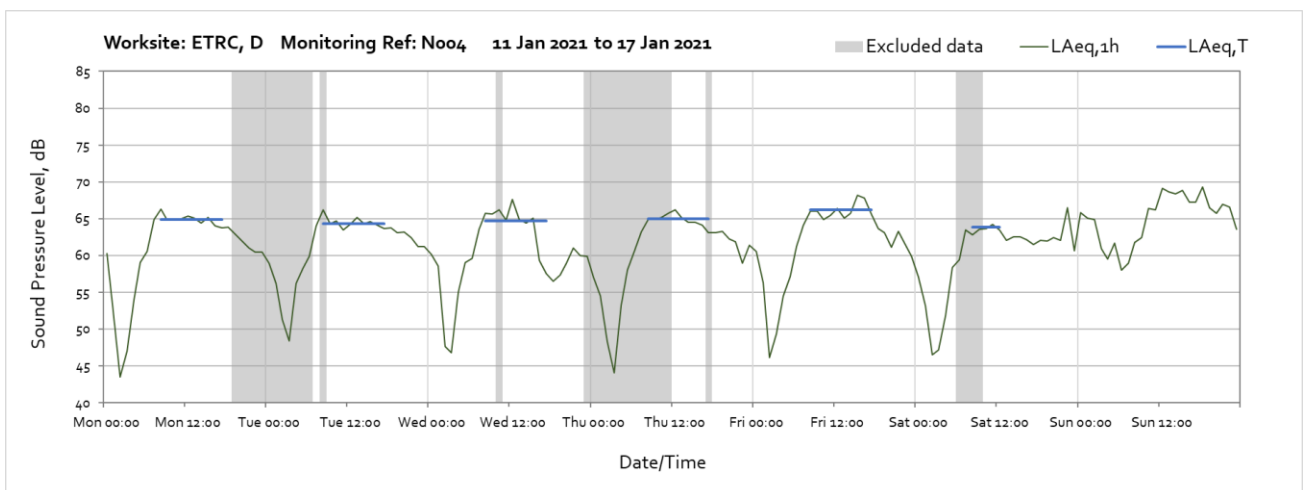
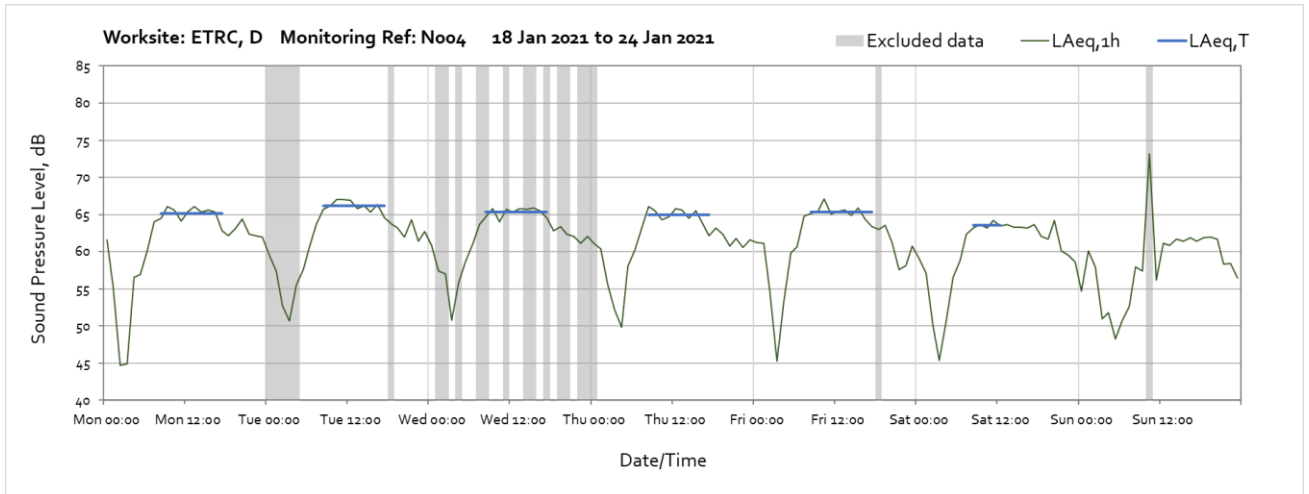
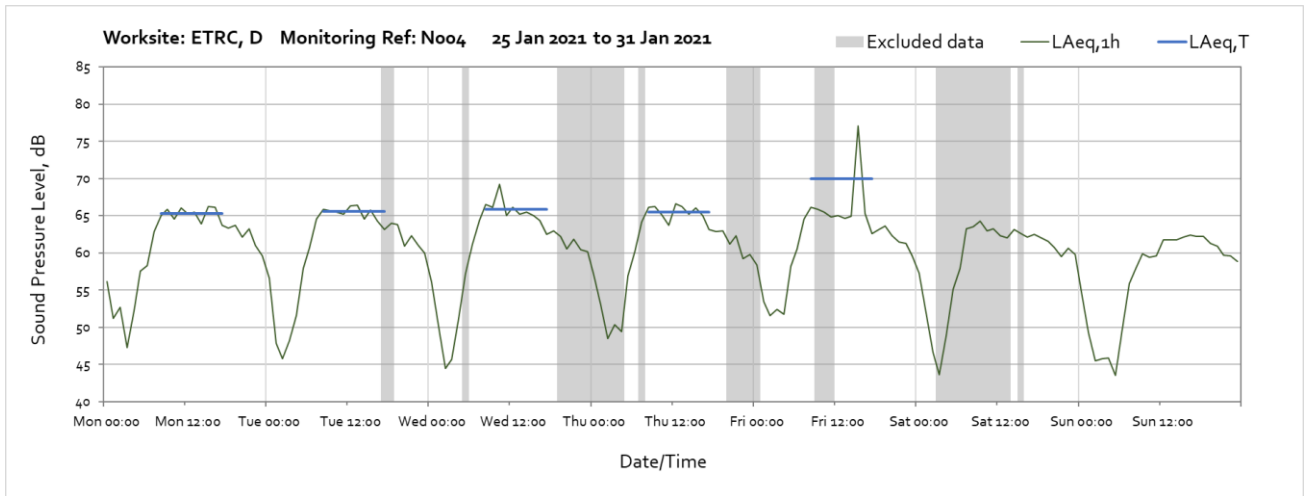
Worksite: ETRC-D – Monitoring Ref: N004

Note: High noise levels on the early hours of the 1st January were due to New Year's Eve celebrations and have been excluded to calculate values in Table 3.

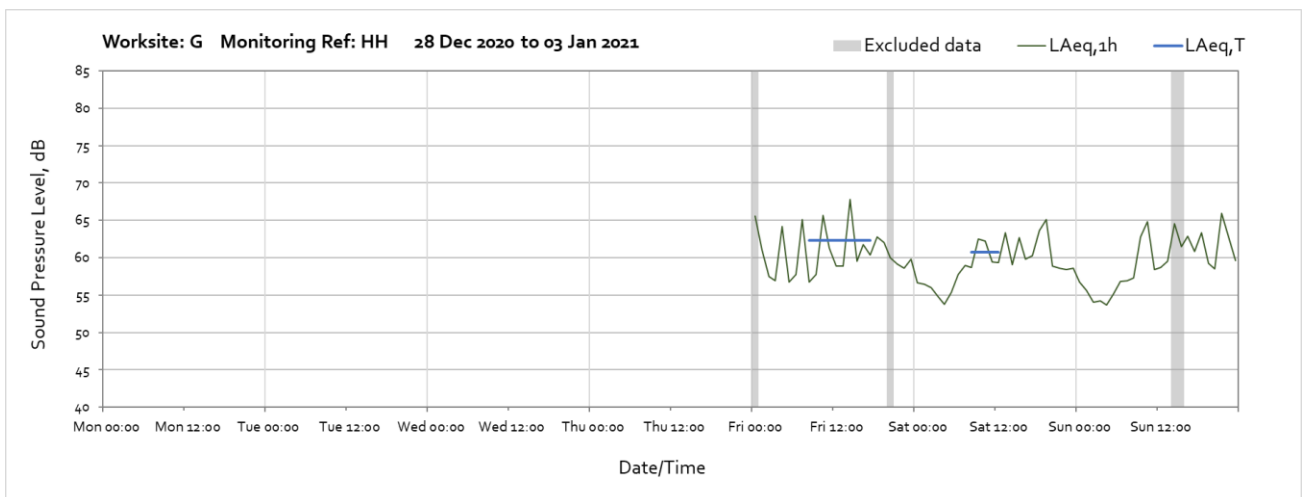
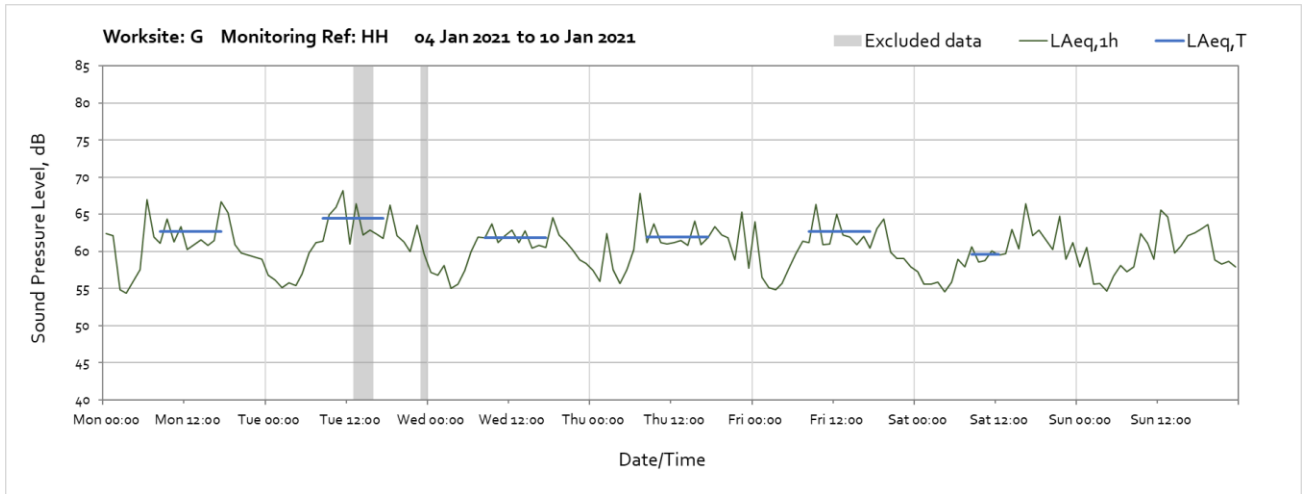
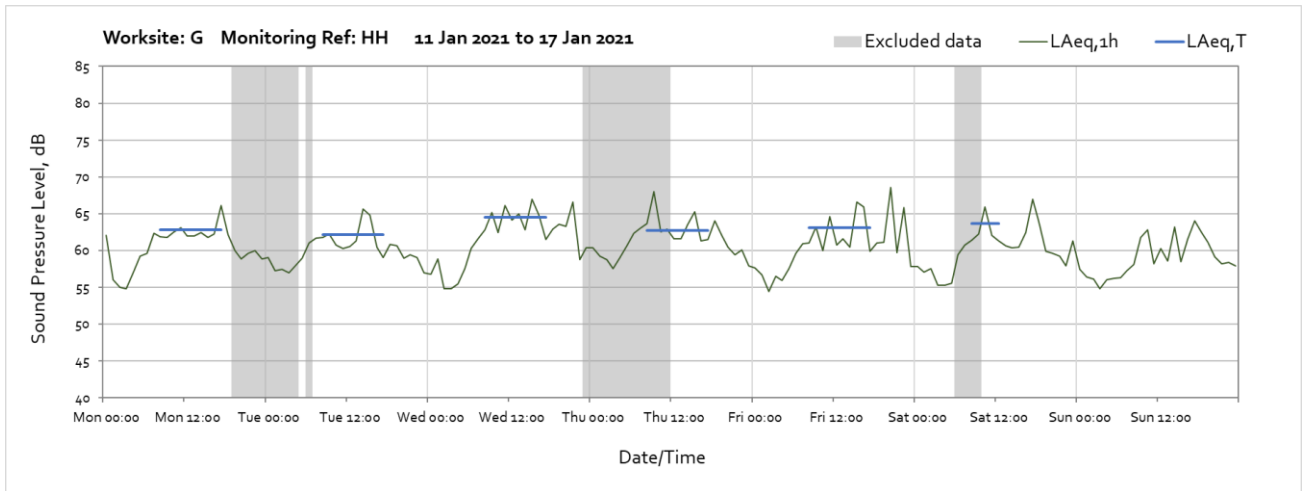
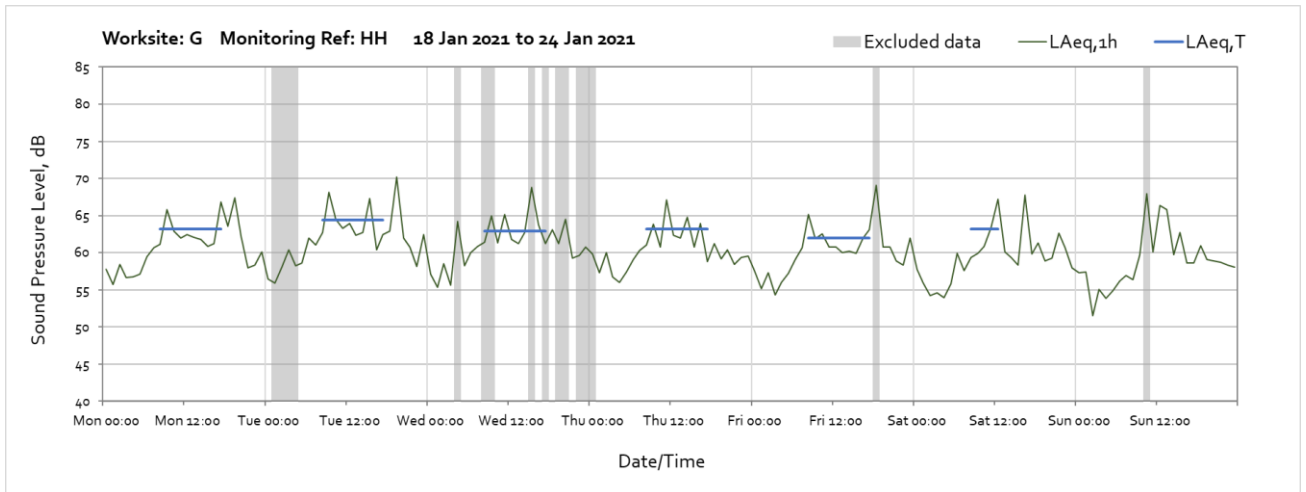
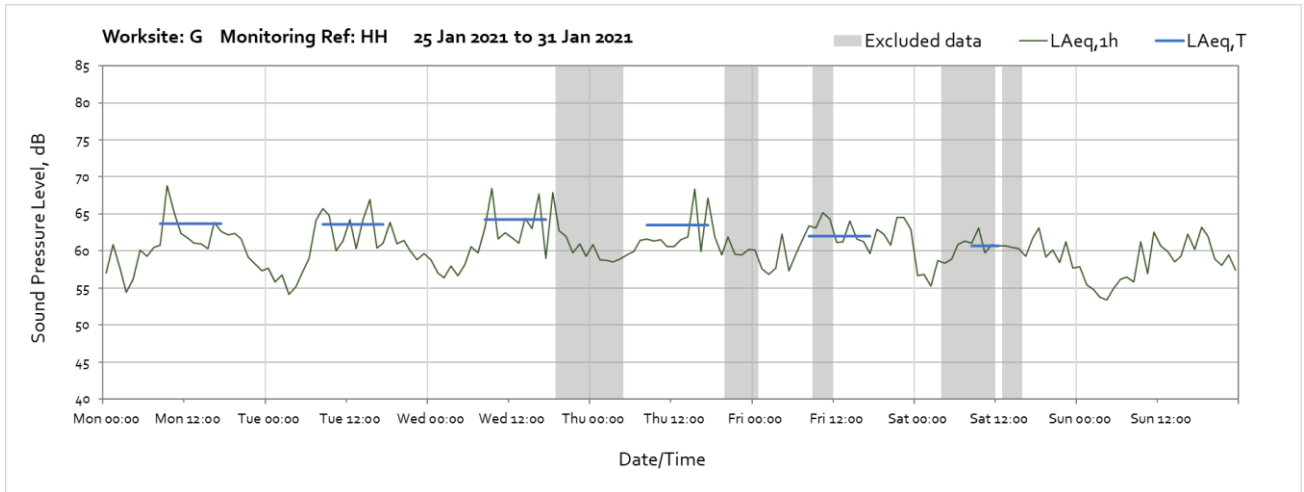
Worksite: G – Monitoring Ref: HH

Note: High noise levels on the early hours of the 1st January were due to New Year's Eve celebrations and have been excluded to calculate values in Table 3.

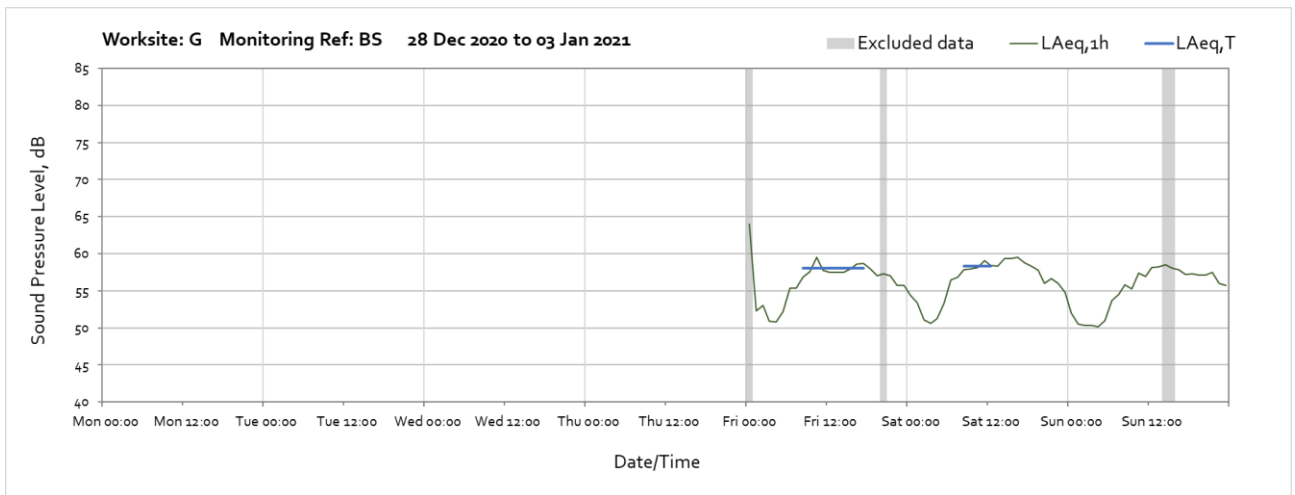
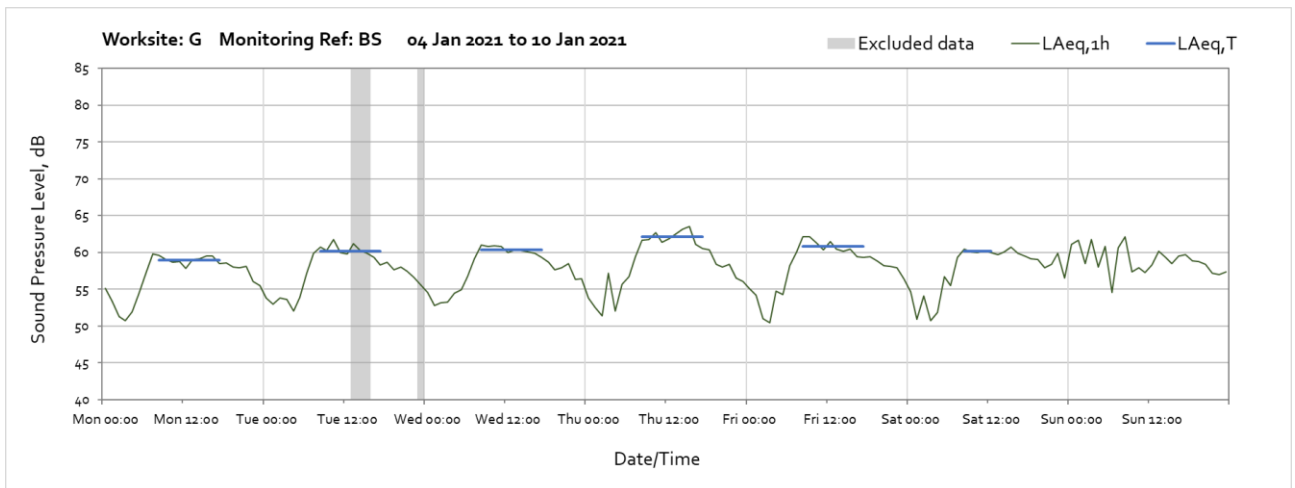
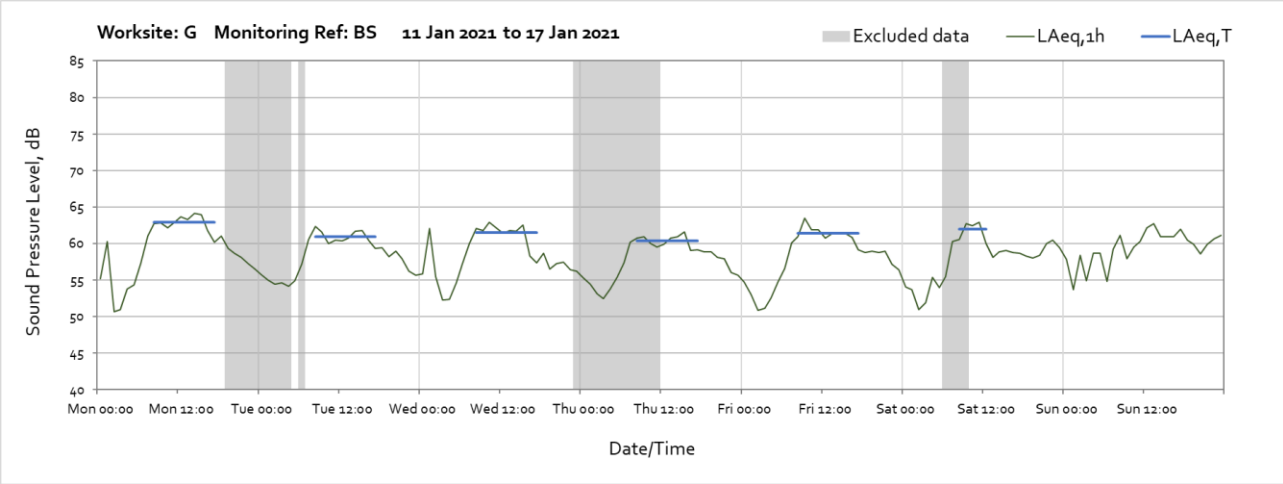
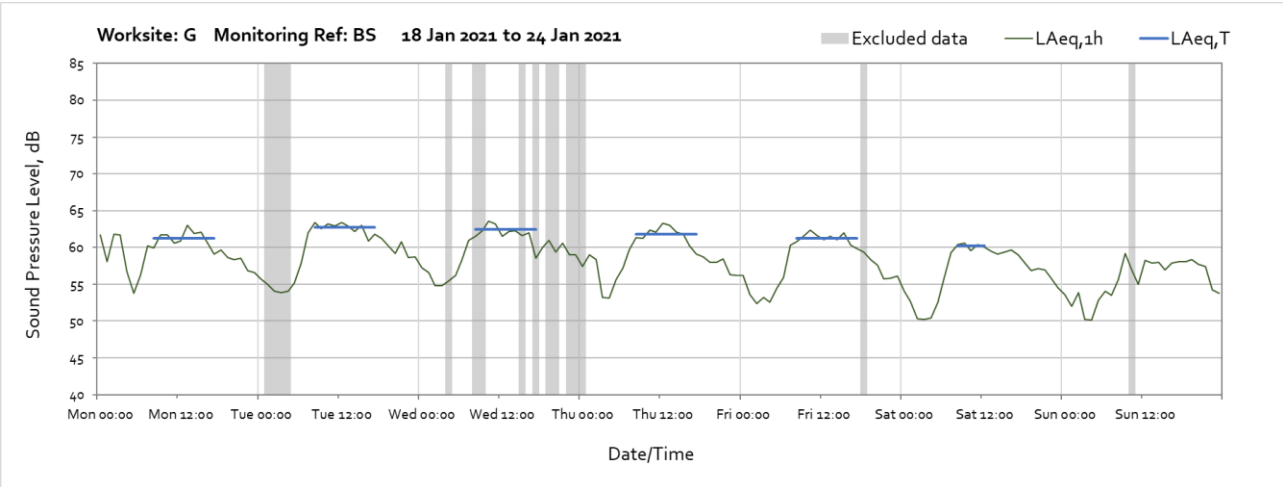
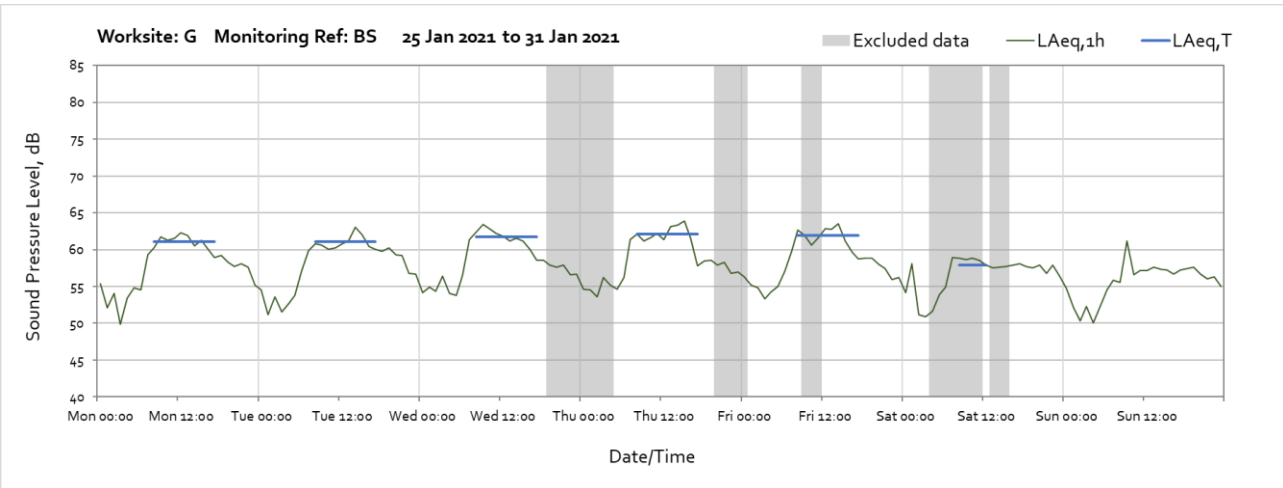
Worksite: G – Monitoring Ref: BS

Note: High noise levels on the early hours of the 1st January were due to New Year's Eve celebrations and have been excluded to calculate values in Table 3.

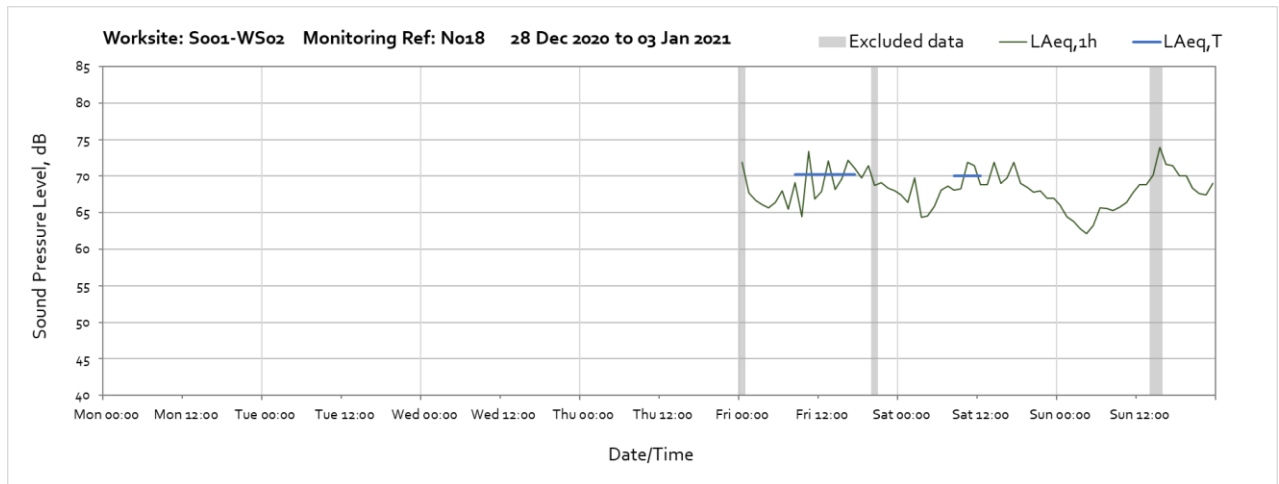
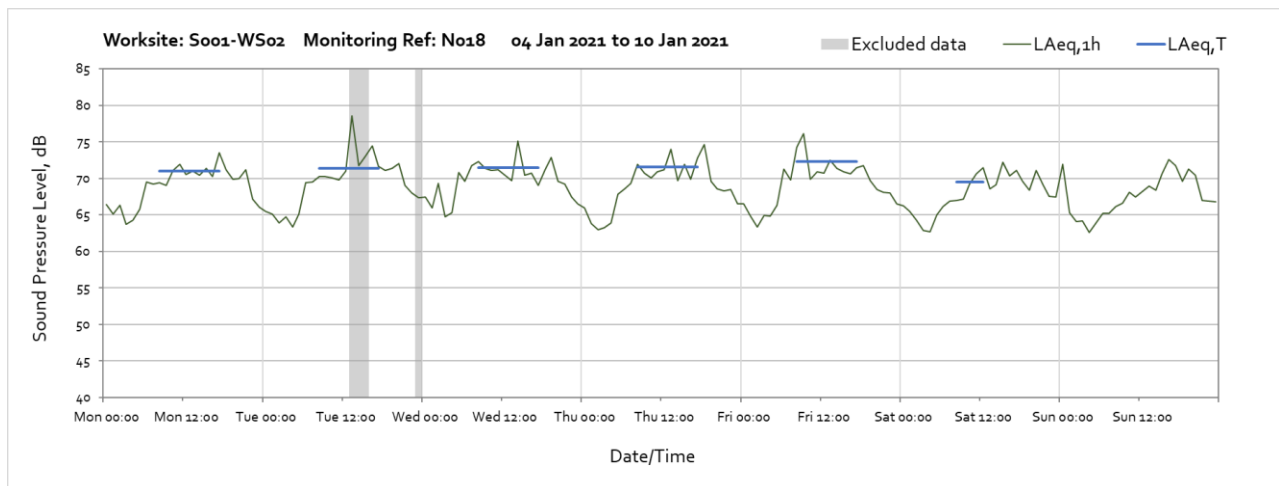
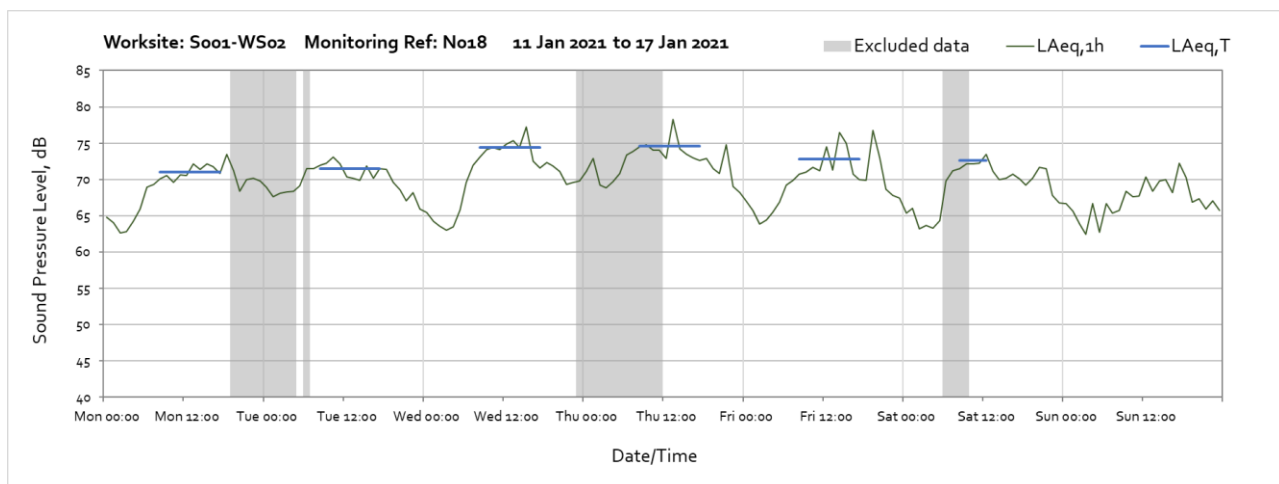
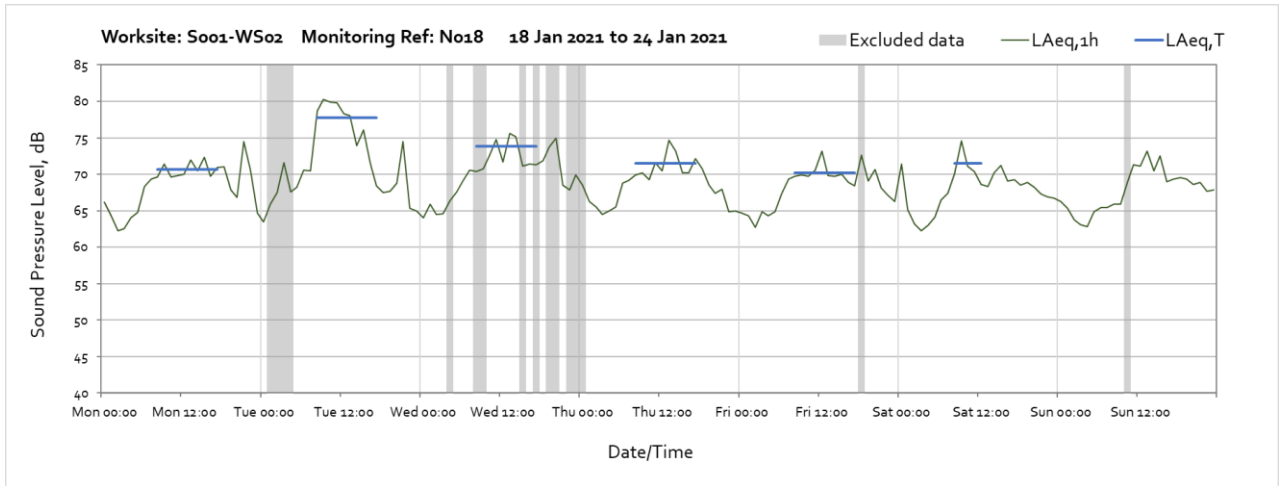
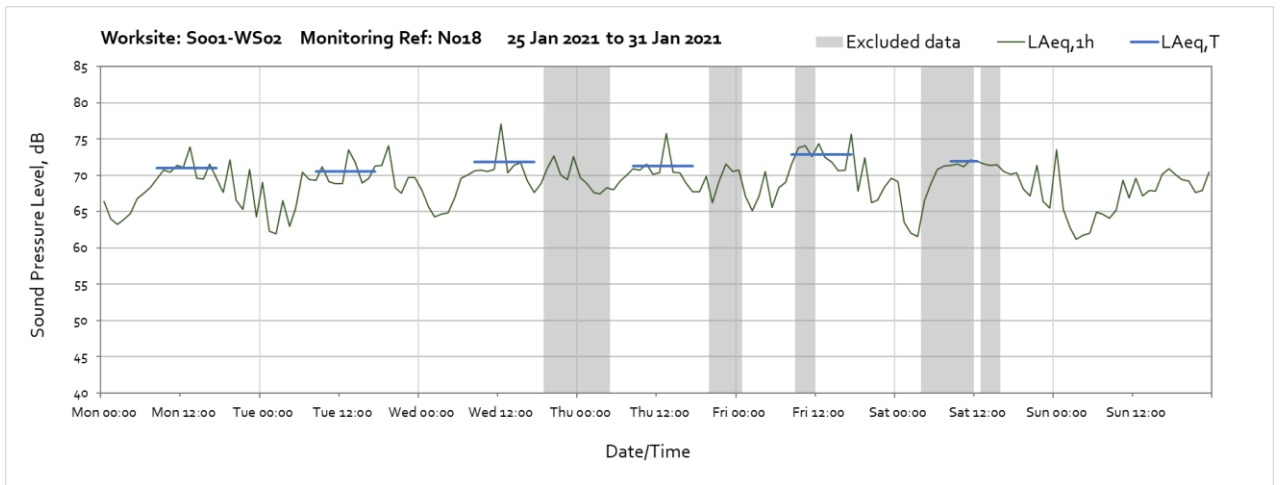
Worksite: S001-WS02 – Monitoring Ref: N018

Note: High noise levels on the early hours of the 1st January were due to New Year's Eve celebrations and have been excluded to calculate values in Table 3.

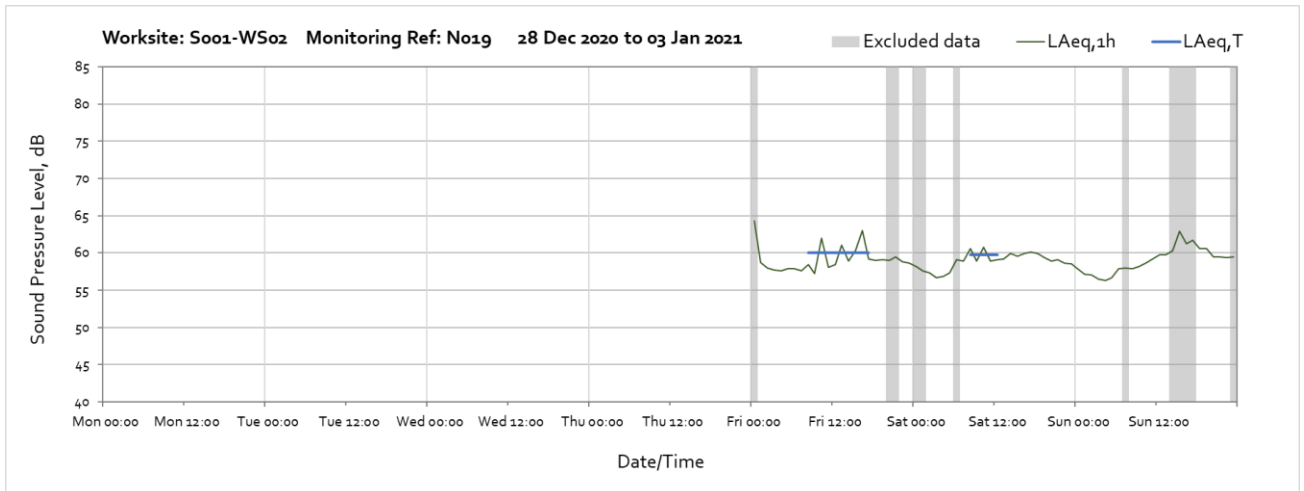
Worksite: S001-WS02 – Monitoring Ref: N019

Note: High noise levels on the early hours of the 1st January were due to New Year's Eve celebrations and have been excluded to calculate values in Table 3.

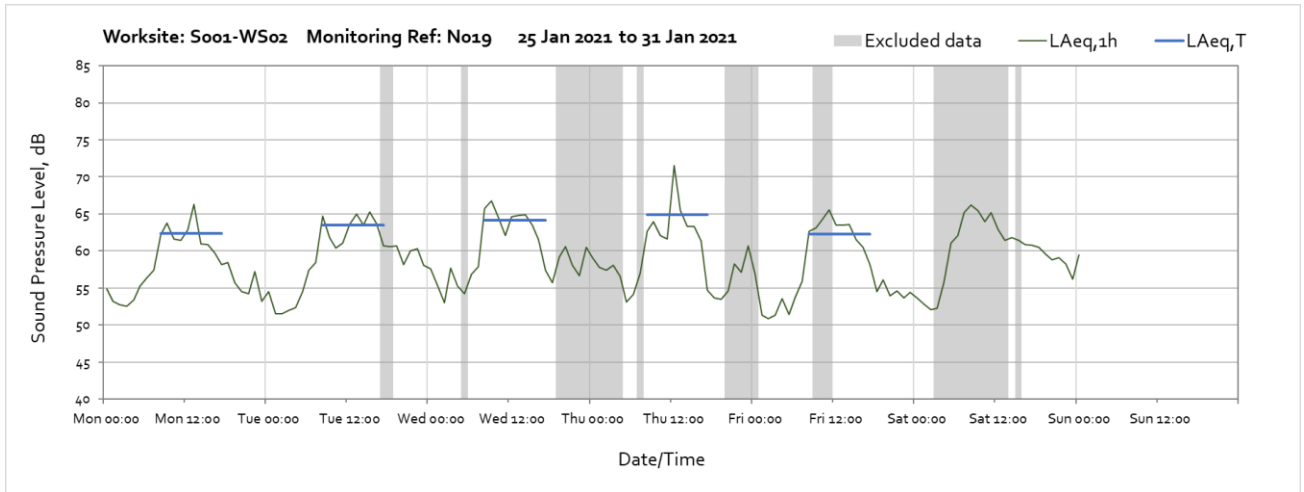
Note: Missing data from 00:00 on Sunday 31st January until the end of the month was due to loss of power to the lighting column which powers the monitoring station. The lighting column provider was contacted on the 29th January when the monitoring station battery charge was noted as reducing. The provider was asked to give notification to any potential interruptions in good time.

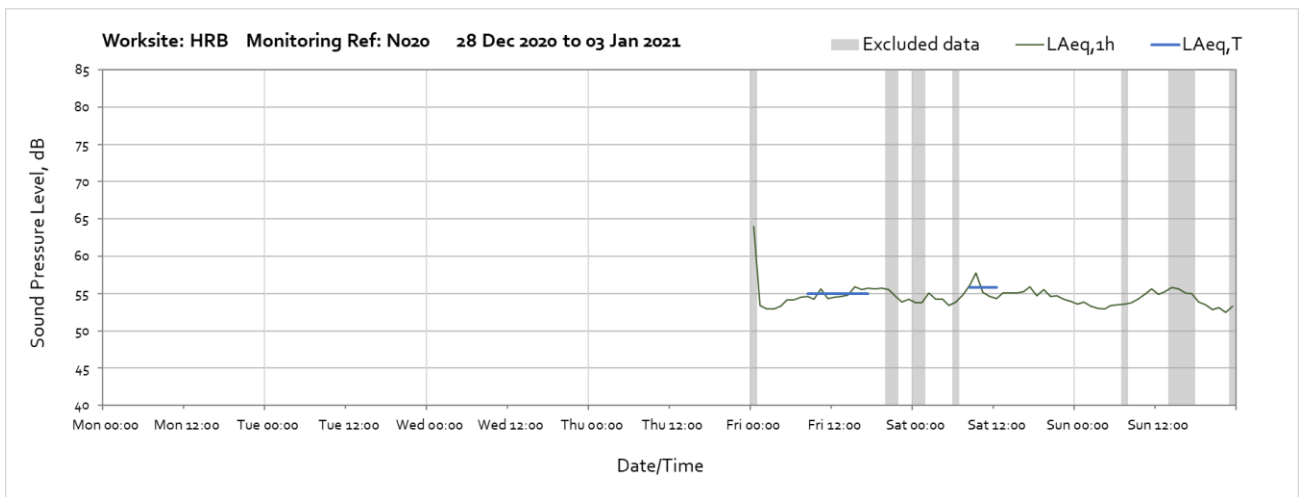
Worksite: HRB – Monitoring Ref: N020

Note: High noise levels on the early hours of the 1st January were due to New Year’s Eve celebrations and have been excluded to calculate values in Table 3.

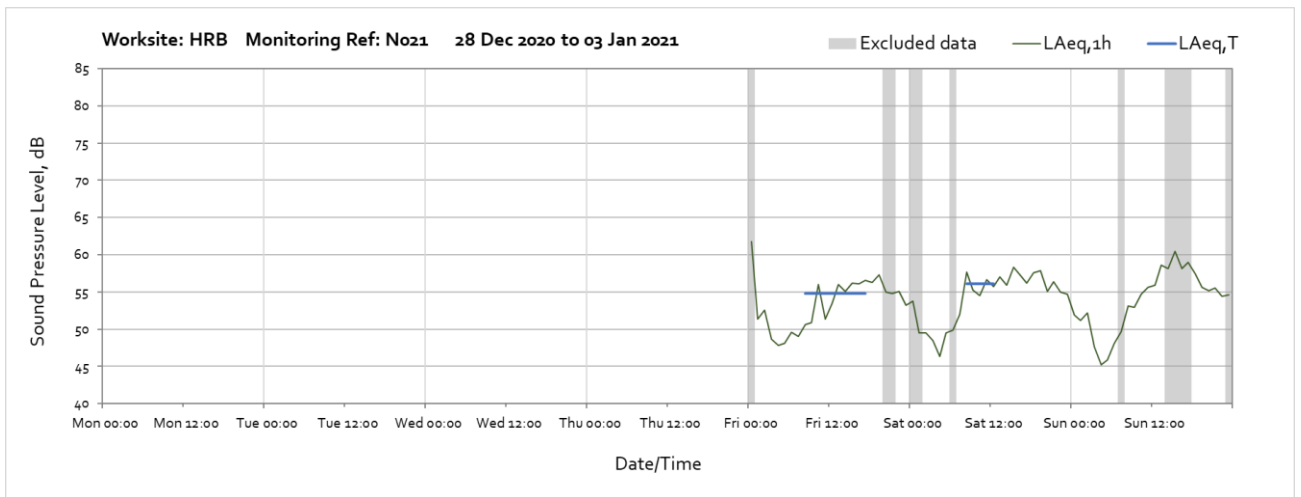
Worksite: HRB – Monitoring Ref: N021

Note: High noise levels on the early hours of the 1st January were due to New Year's Eve celebrations and have been excluded to calculate values in Table 3.

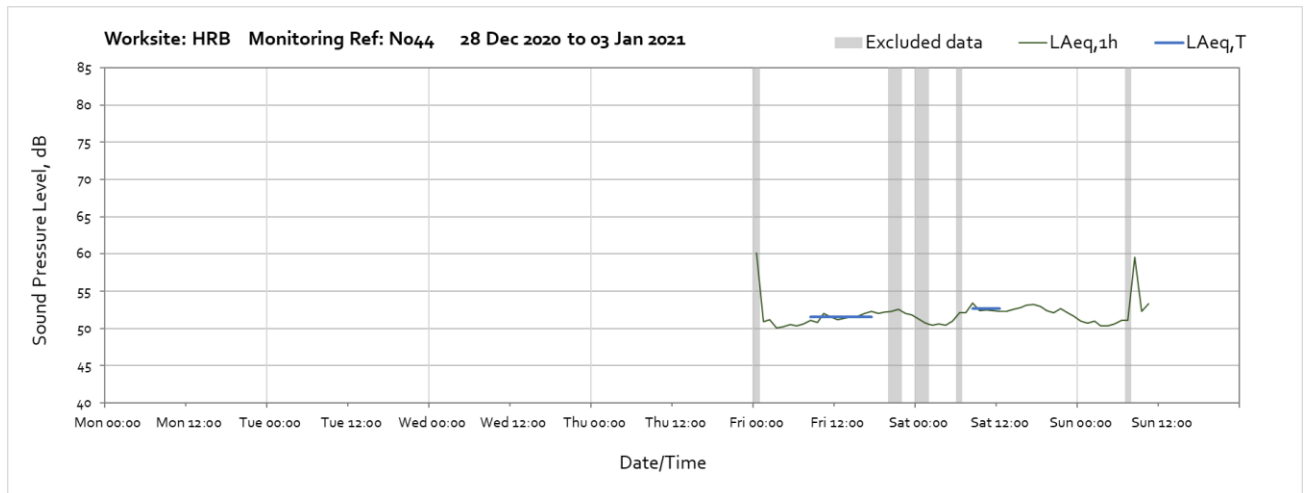
Worksite: HRB – Monitoring Ref: N044

Note: High noise levels on the early hours of the 1st January were due to New Year's Eve celebrations and have been excluded to calculate values in Table 3. Missing data between 11:00 on Sunday 3rd until 10:00 on Tuesday 5th January was due to loss of power at the monitoring station caused by a loss of site power and depleted monitoring station battery. The battery depleted as access to the site and monitor was limited of the Christmas period. The site team were requested to check the remaining battery power at the start of each shift.

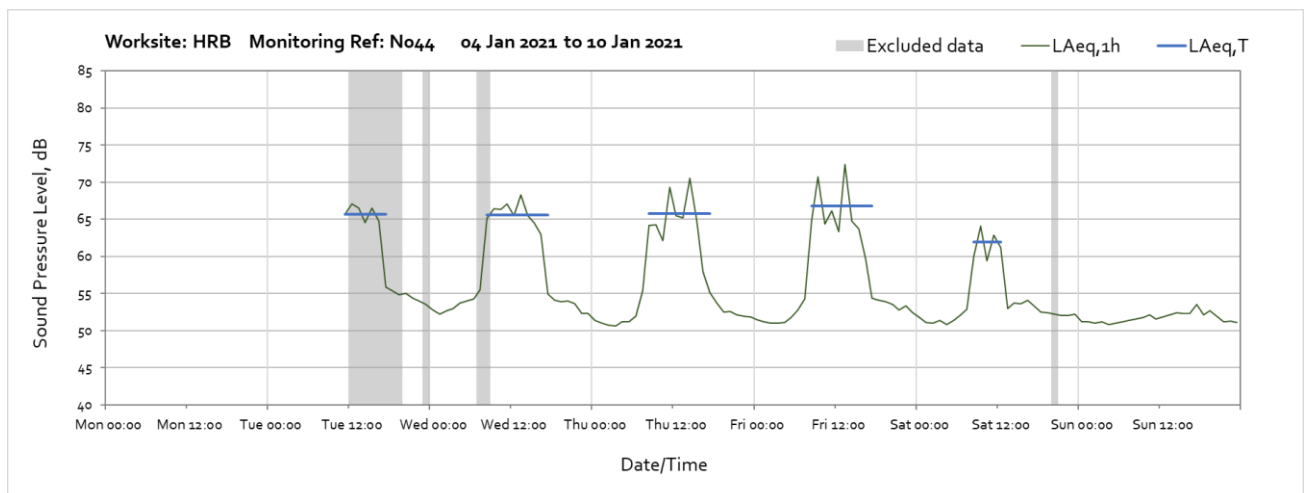
Note: Missing data between 11:00 on Sunday 3rd until 10:00 on Tuesday 5th January was due to loss of power at the monitoring station caused by a loss of site power and depleted monitoring station battery. The battery depleted as access to the site and monitor was limited of the Christmas period. The site team were requested to check the remaining battery power at the start of each shift.

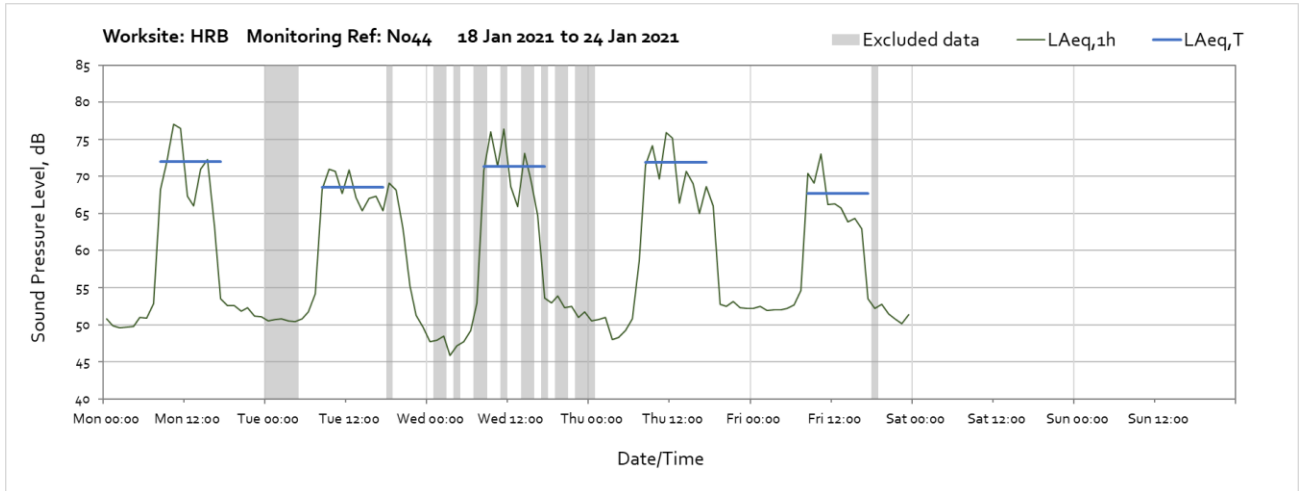
Note: Missing data from 00:00 on Saturday 23rd January until 11:00 on Friday 29th January was due to a system fault with the monitoring station. The monitoring station was replaced.

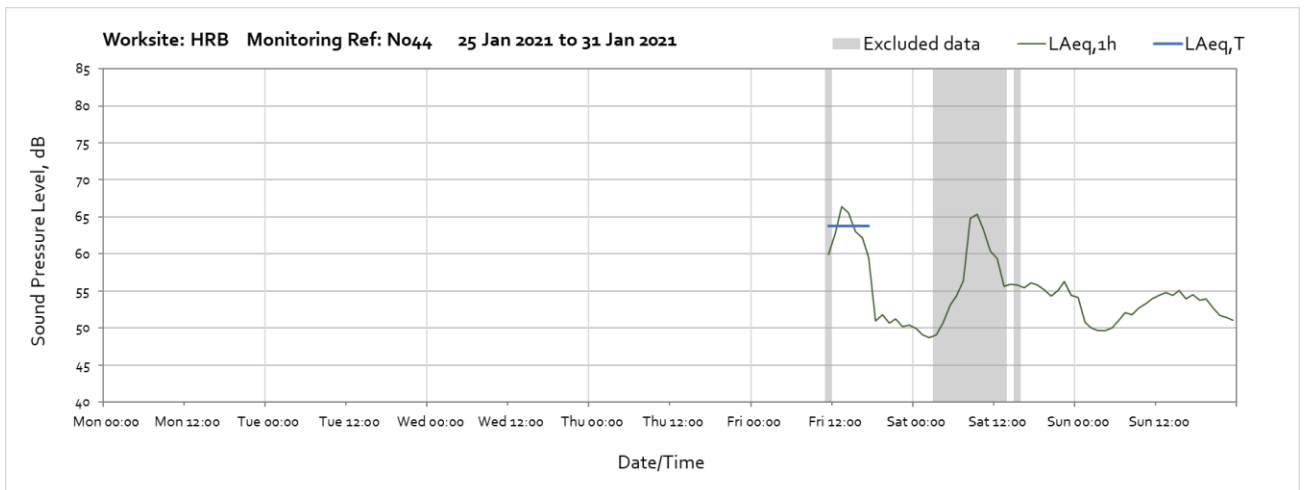
Note: Missing data from 00:00 on Saturday 23rd January until 11:00 on Friday 29th January was due to a system fault with the monitoring station. The monitoring station was replaced.

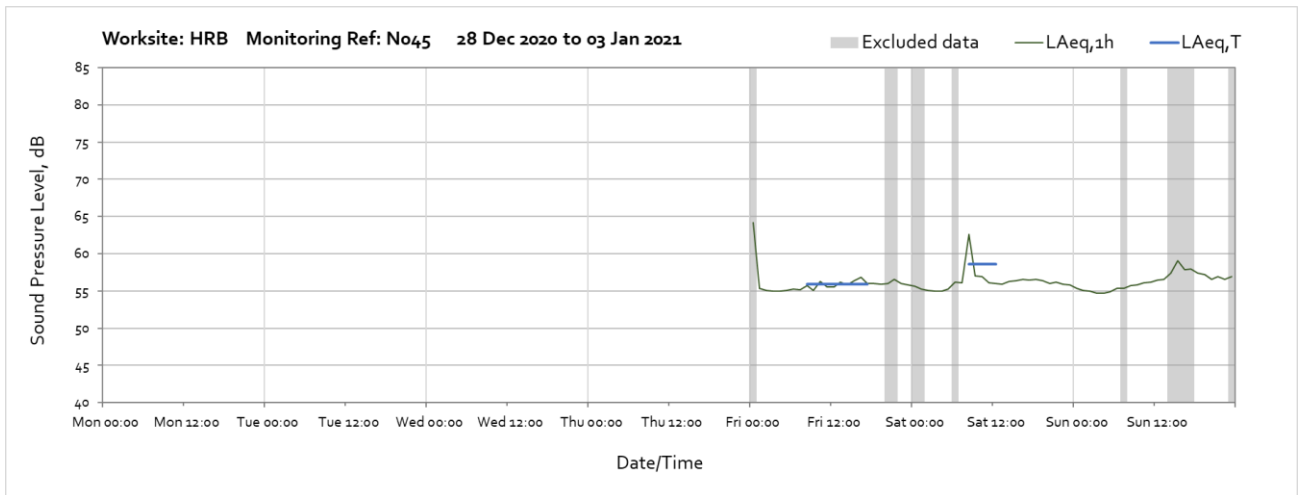
Worksite: HRB – Monitoring Ref: N045

Note: High noise levels on the early hours of the 1st January were due to New Year's Eve celebrations and have been excluded to calculate values in Table 3.
