Construction noise and vibration Monthly Report – January 2021

London Borough of Camden

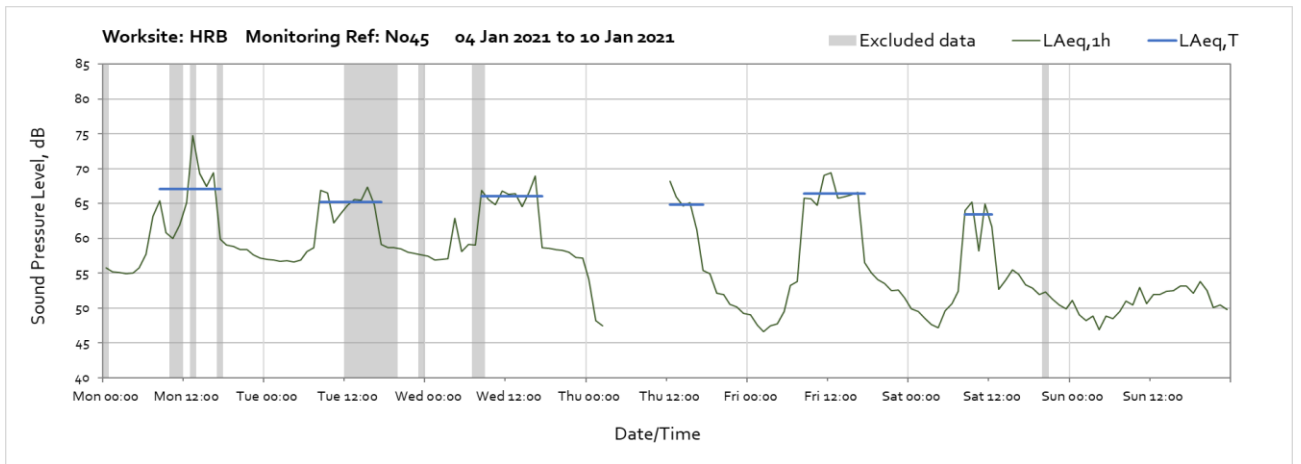
Note: Missing data between 03:00 until 12:00 on Thursday 7th January was due to loss of power at the monitoring station whilst the site generator hydrogen cylinder was replaced.

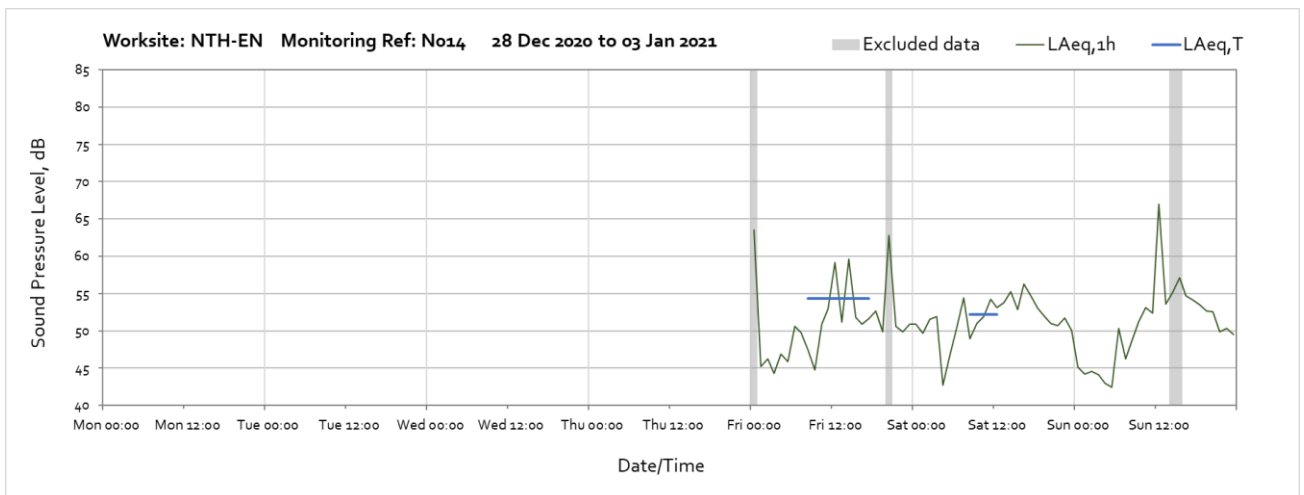
Worksite: NTH-EN – Monitoring Ref: N014

Note: High noise levels on the early hours of the 1st January were due to New Year's Eve celebrations and have been excluded to calculate values in Table 3.

2.1.3 Appendix C presents graphs of the noise and vibration monitoring data over the month for each of the measurement locations. Noise data presented consists of the hourly L_{Aeq} values and, where relevant, the $L_{Aeq,T}$ values (where the time period T has been taken to be the averaging period as specified in Table 1 of HS2 Information Paper E23). Vibration data presented consist of hourly PPV values. The full data set for the monitoring equipment can be found at the following location: <https://data.gov.uk/dataset/24542ae7-dd44-444f-b259-871c4cc43b5e/environmental-monitoring-data>.

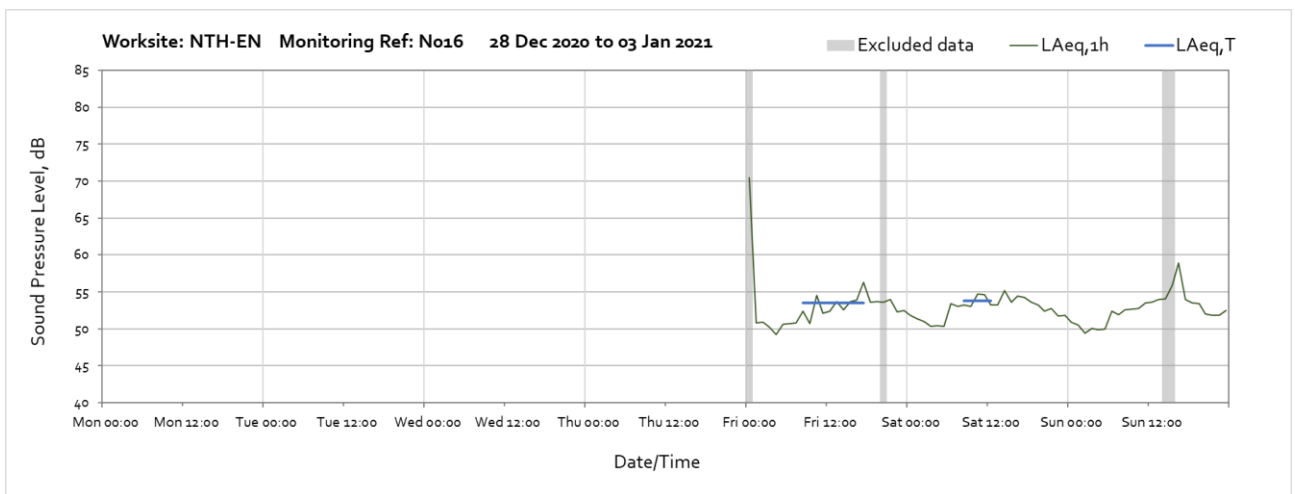
Worksite: NTH-EN – Monitoring Ref: N016

Note: High noise levels on the early hours of the 1st January were due to New Year’s Eve celebrations and have been excluded to calculate values in Table 3.

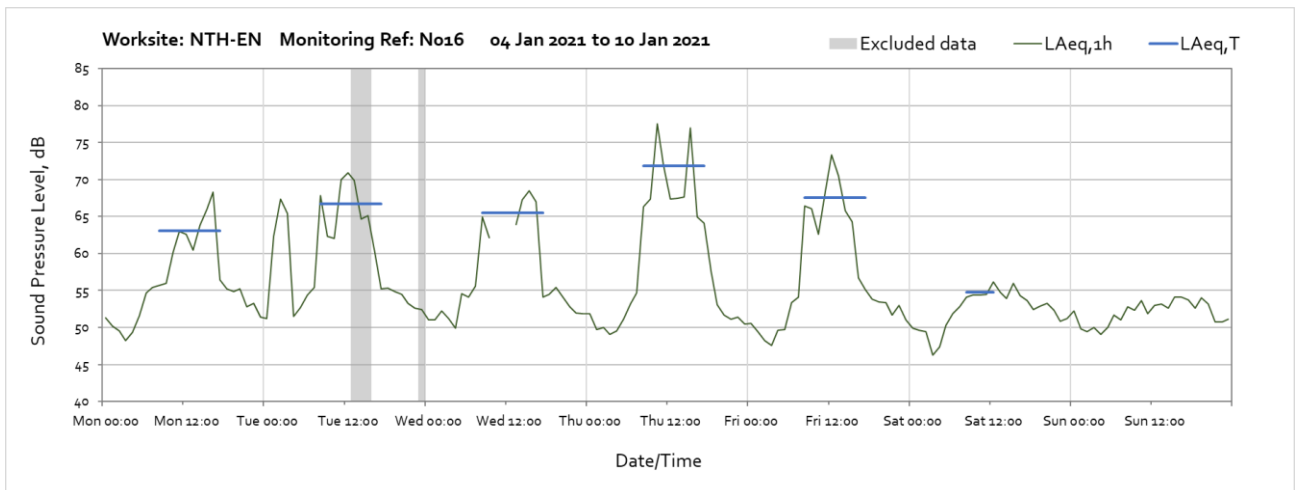
Note: Missing data from 10:00 until 13:00 on Wednesday 6th January was due to a software error within the monitoring station.

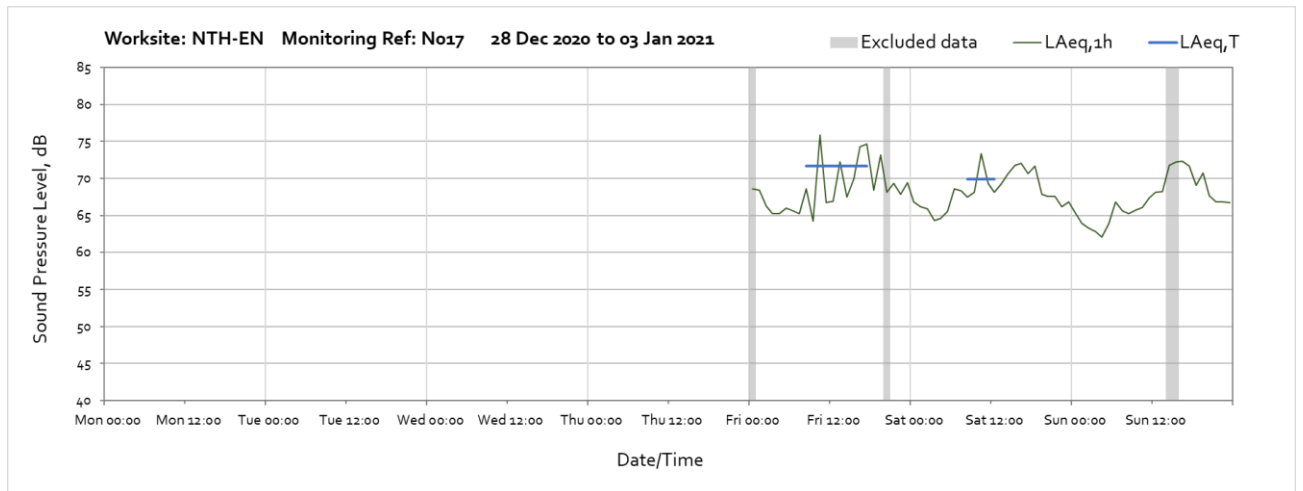
Worksite: NTH-EN – Monitoring Ref: N017

Note: High noise levels on the early hours of the 1st January were due to New Year's Eve celebrations and have been excluded to calculate values in Table 3.

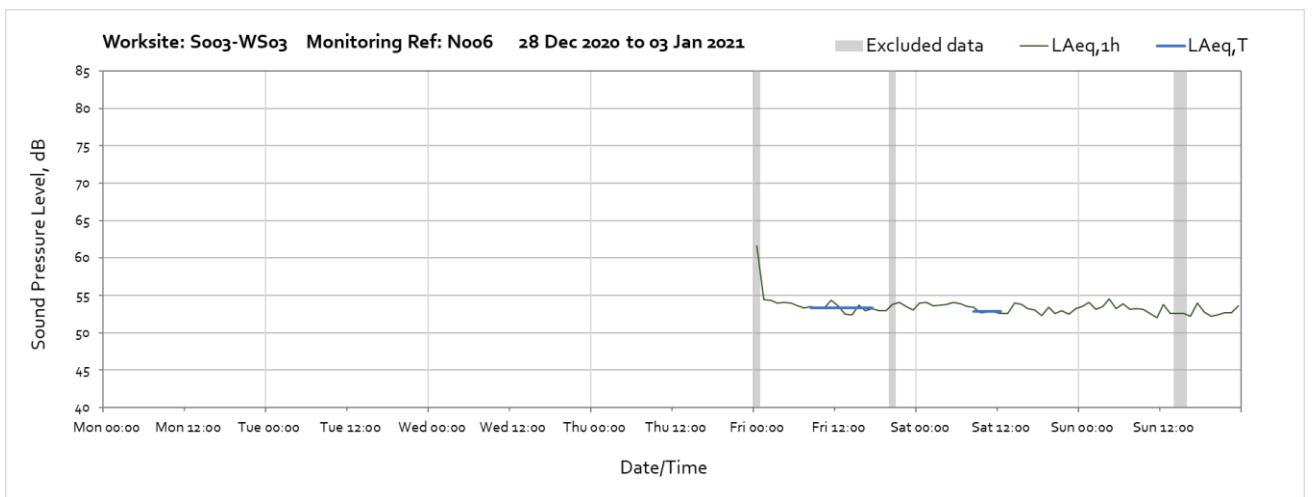
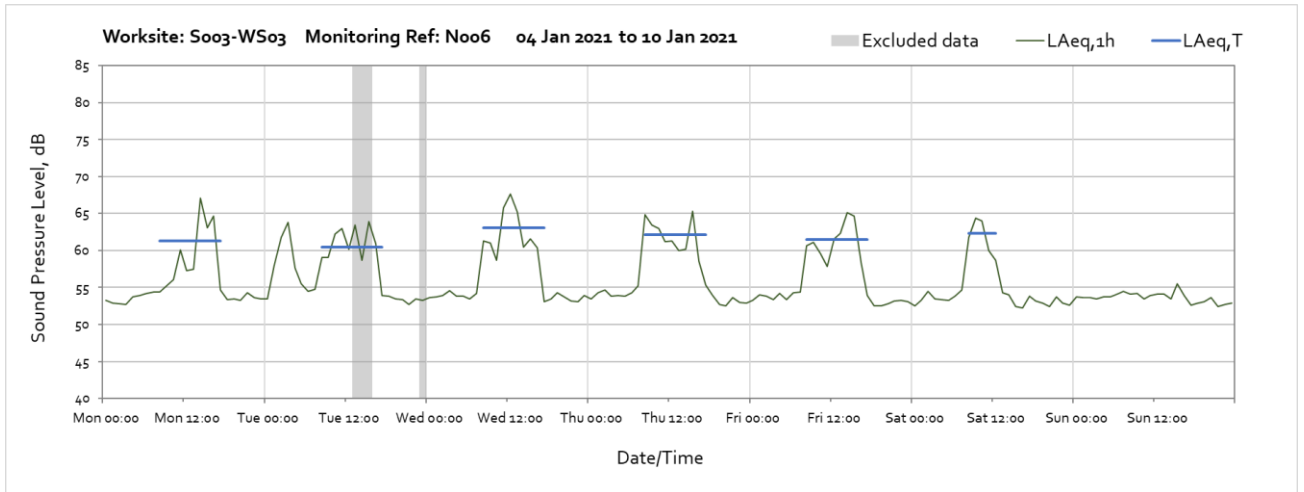
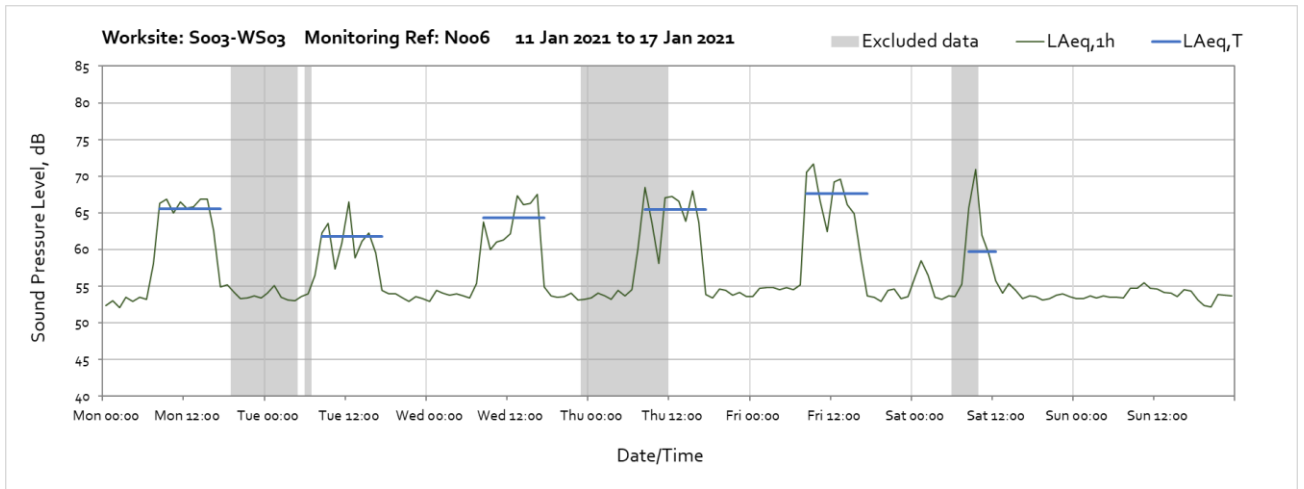
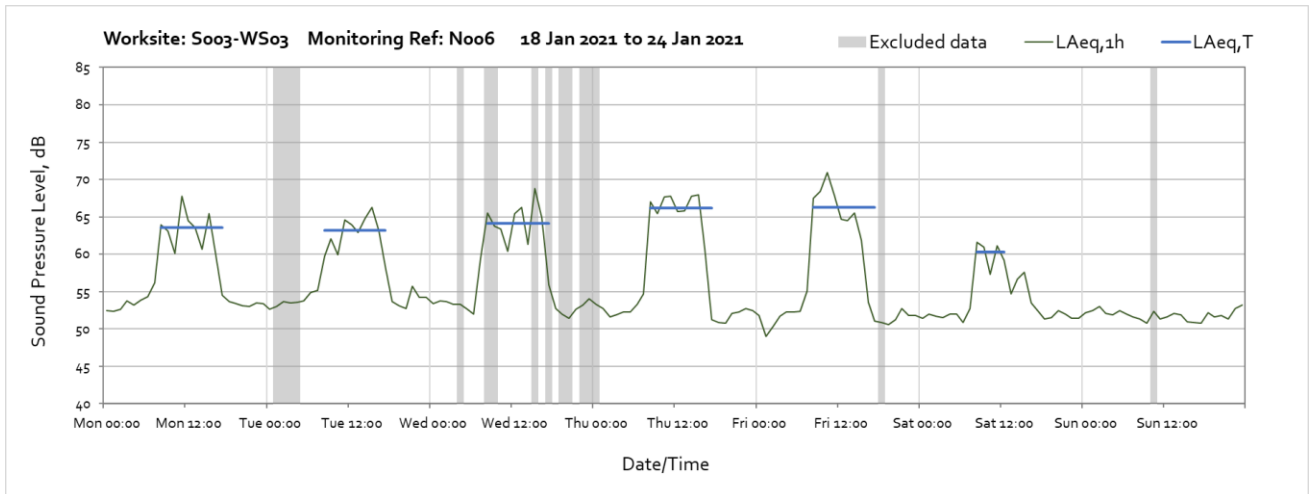
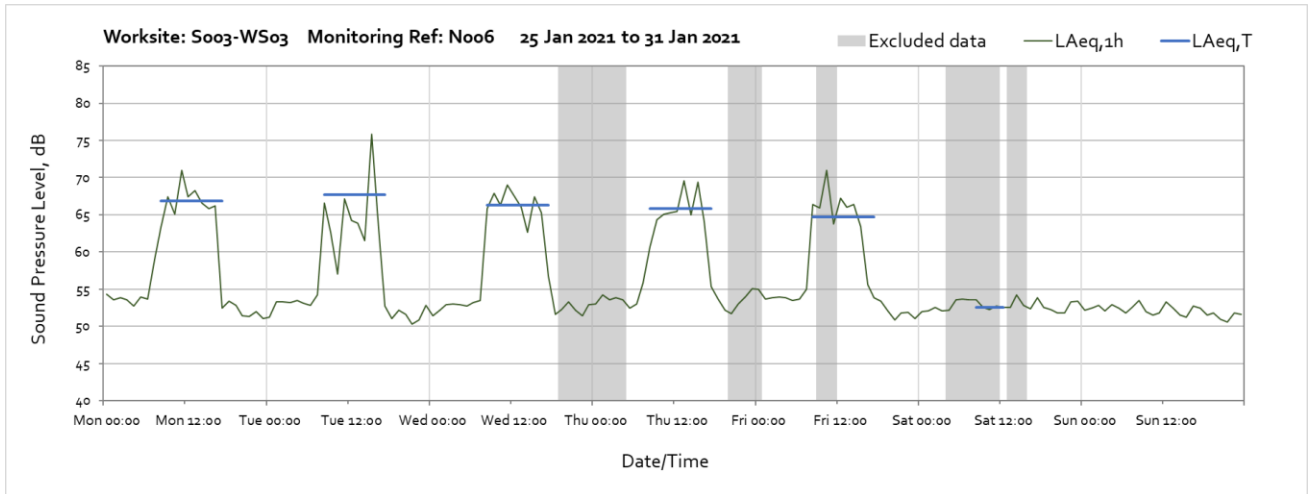
Worksite: S003-WS03 – Monitoring Ref: N006

Note: High noise levels on the early hours of the 1st January were due to New Year's Eve celebrations and have been excluded to calculate values in Table 3.

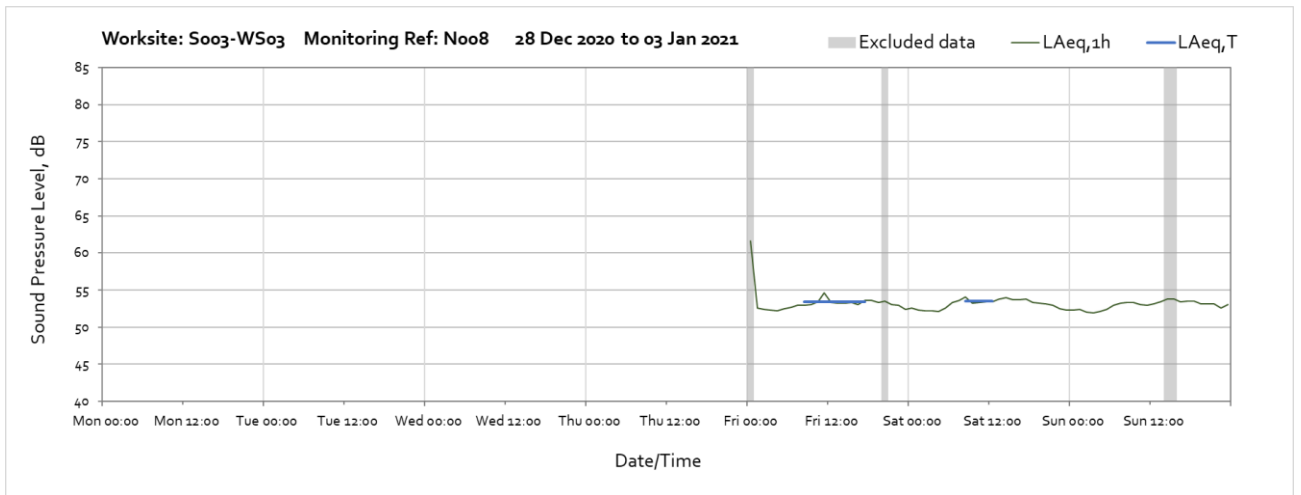
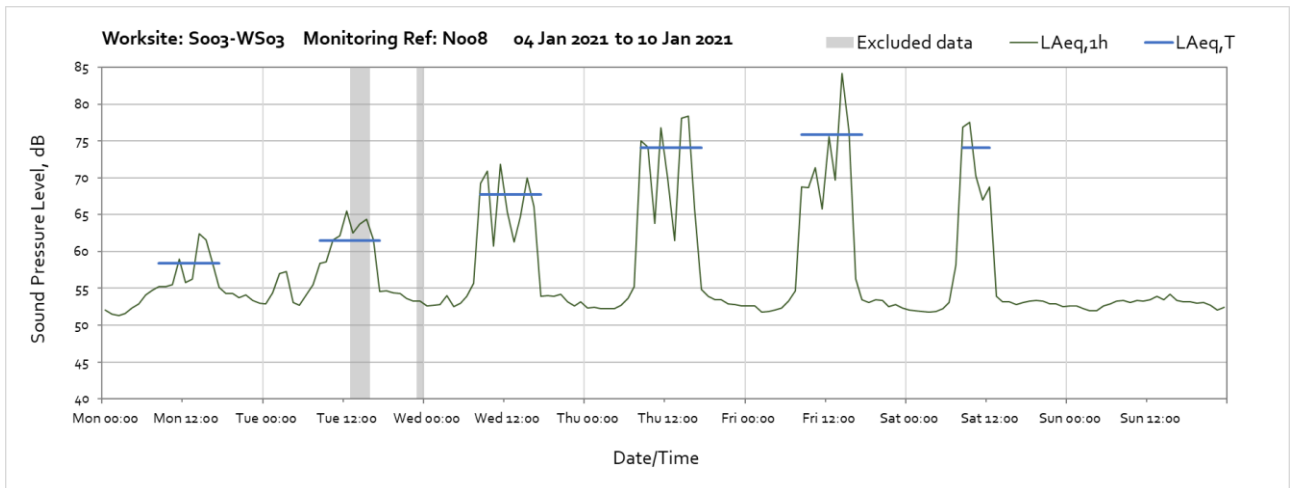
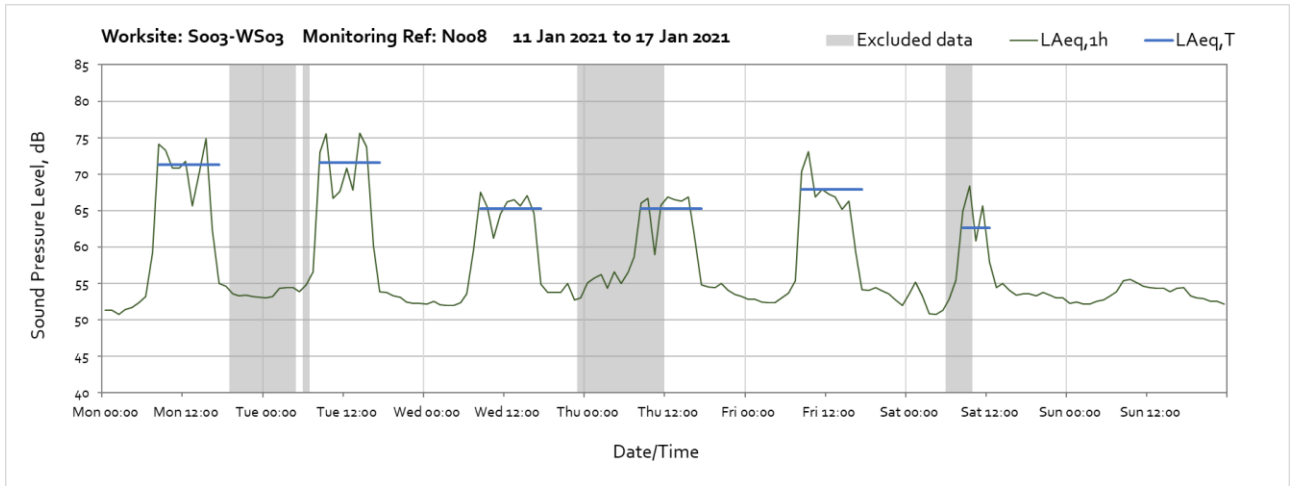
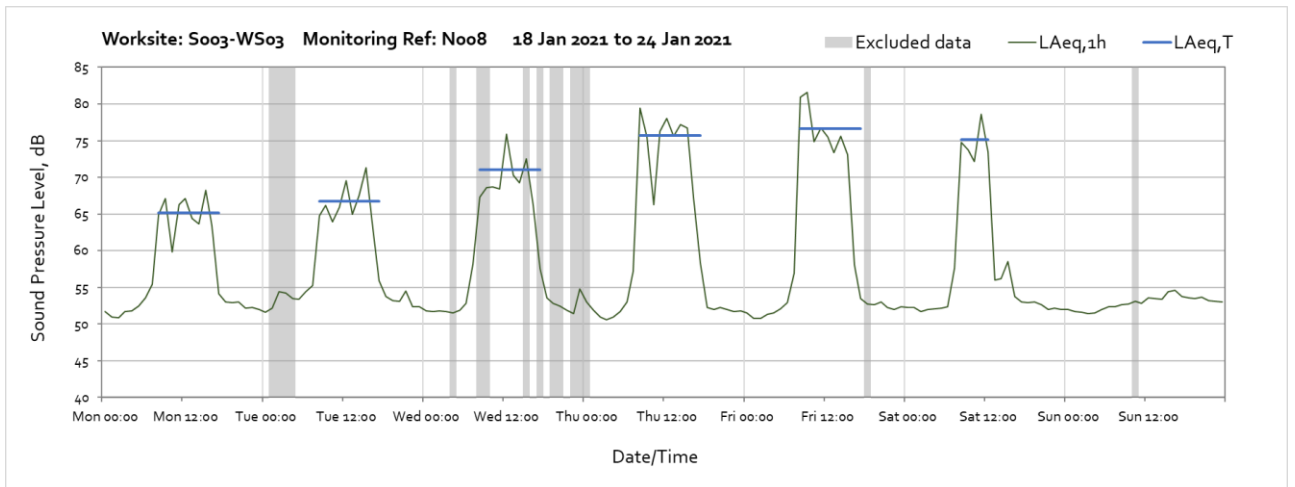
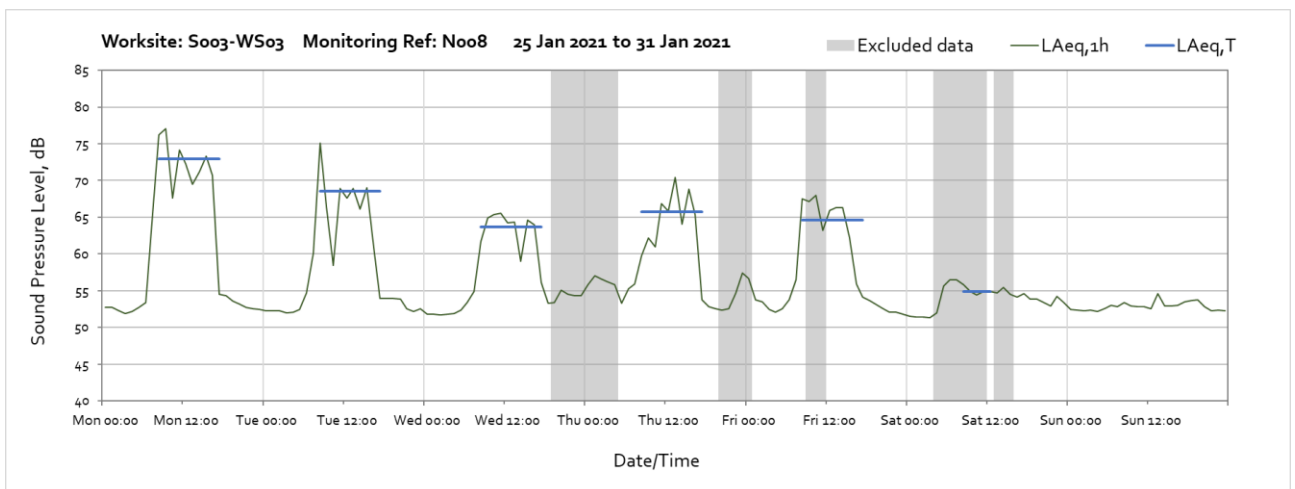
Worksite: S003-WS03 – Monitoring Ref: N008

Note: High noise levels on the early hours of the 1st January were due to New Year’s Eve celebrations and have been excluded to calculate values in Table 3.

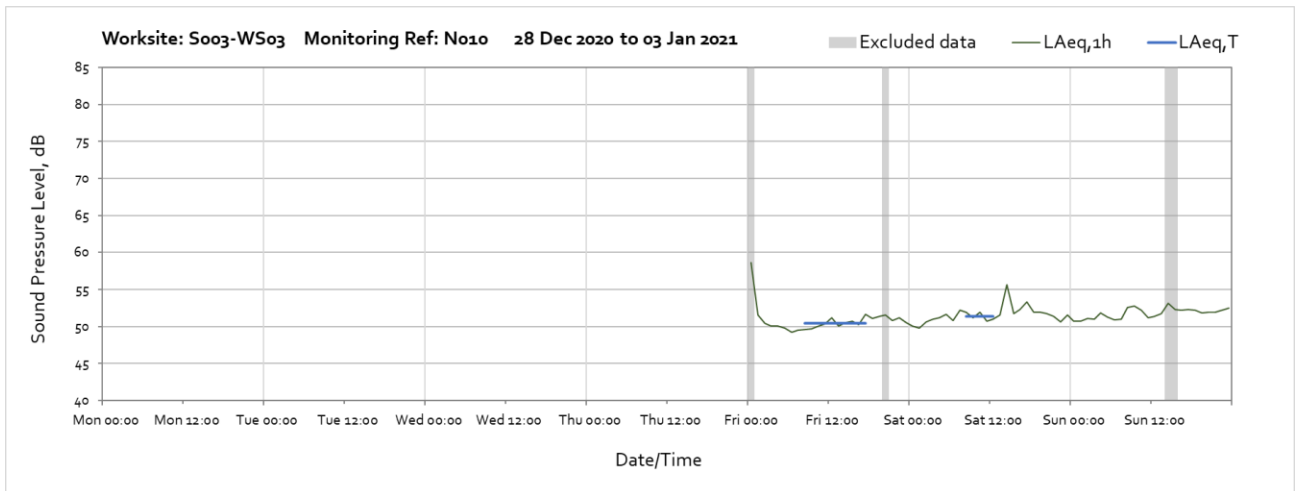
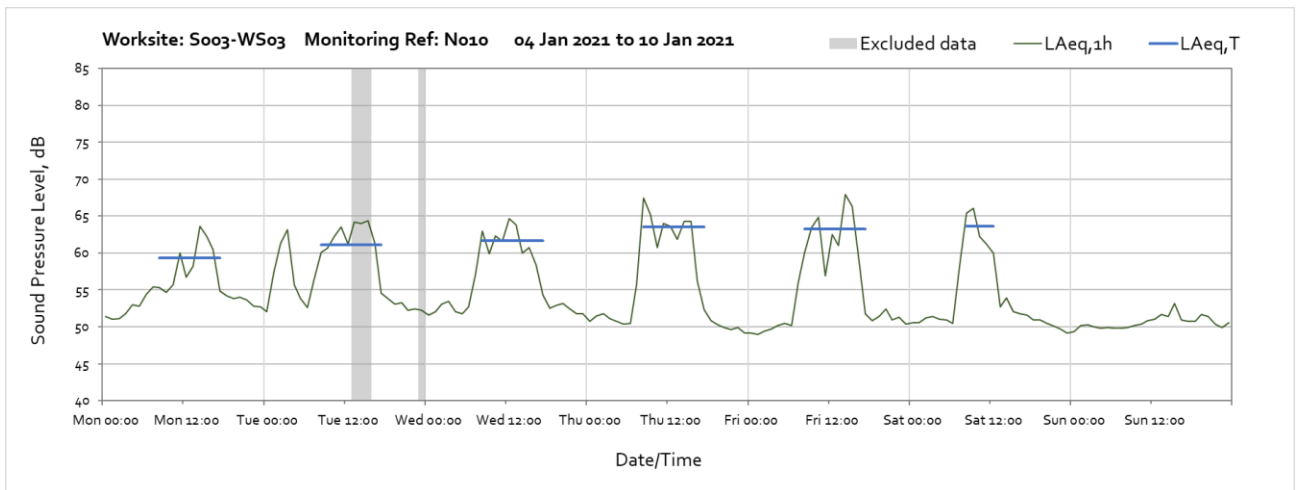
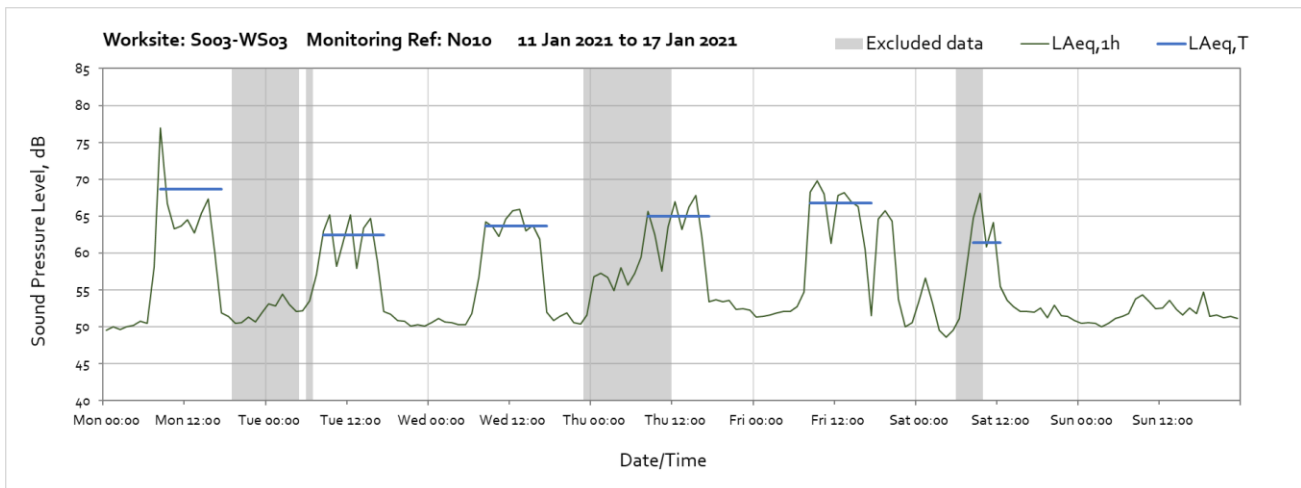
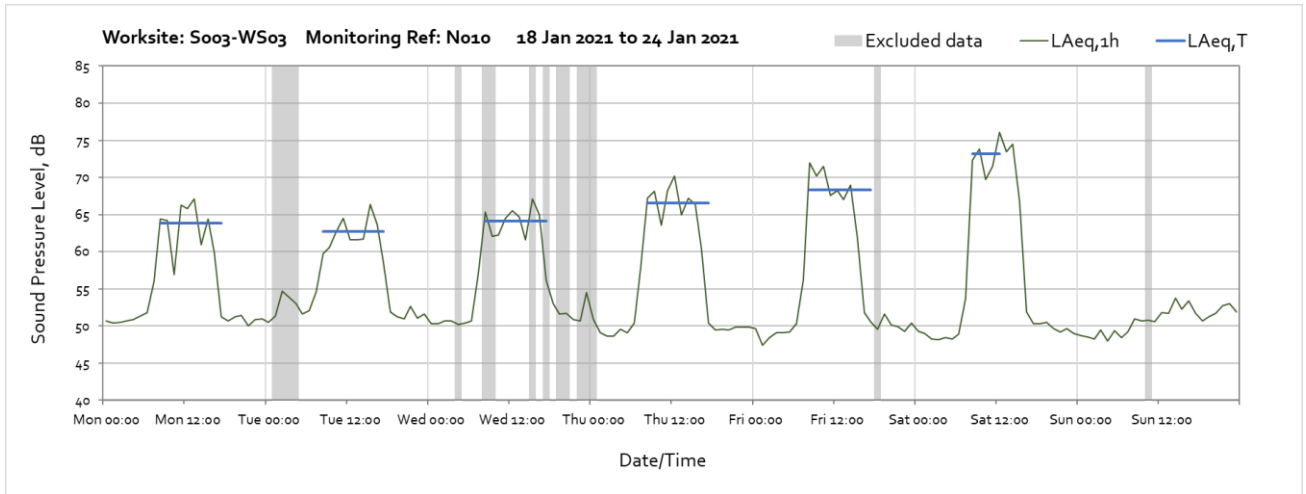
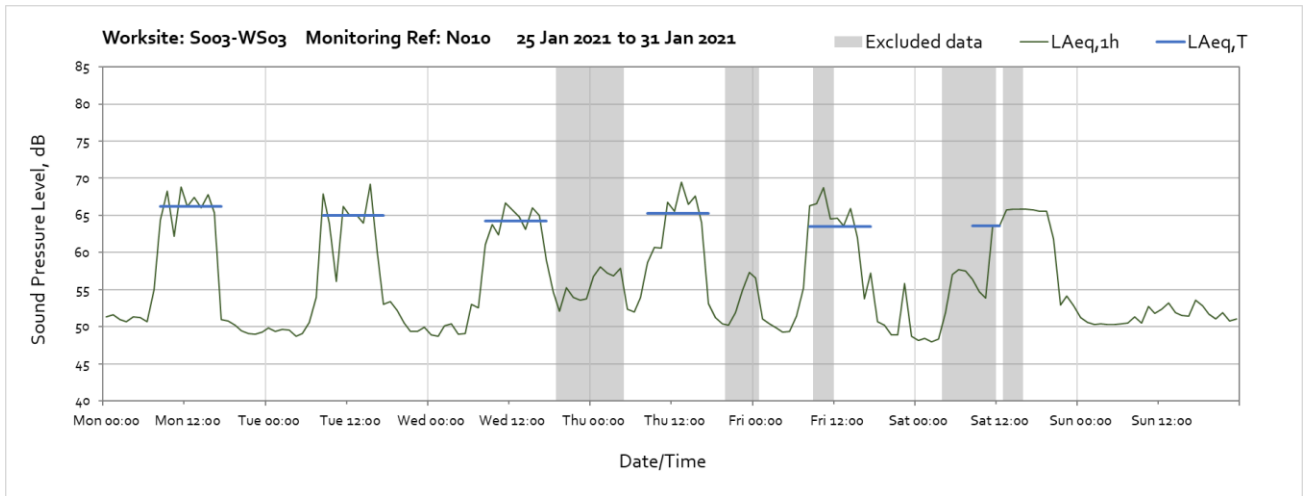
Worksite: S003-WS03 – Monitoring Ref: N010

Note: High noise levels on the early hours of the 1st January were due to New Year's Eve celebrations and have been excluded to calculate values in Table 3.

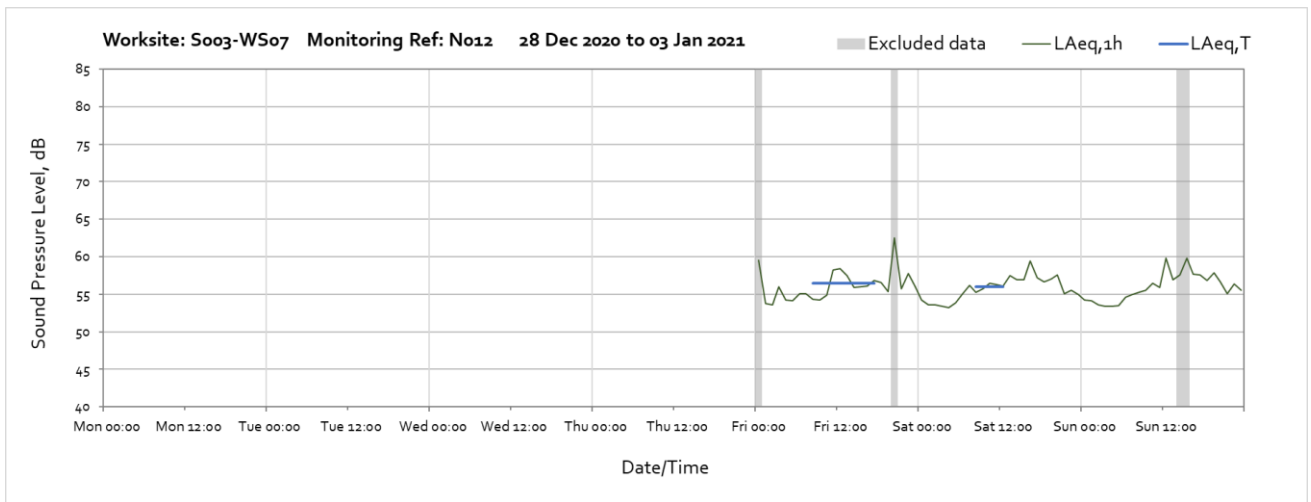
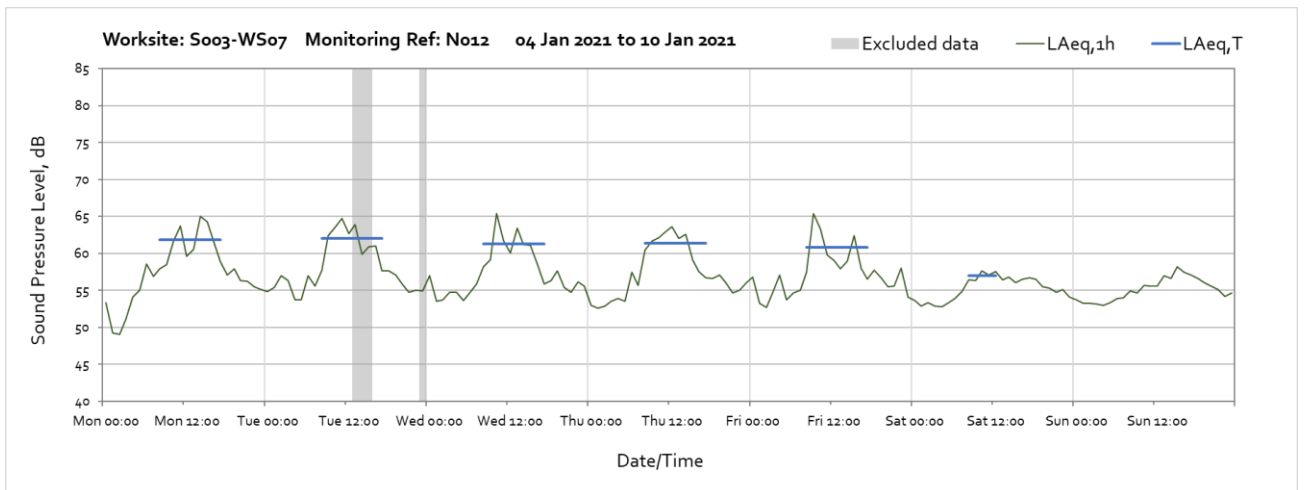
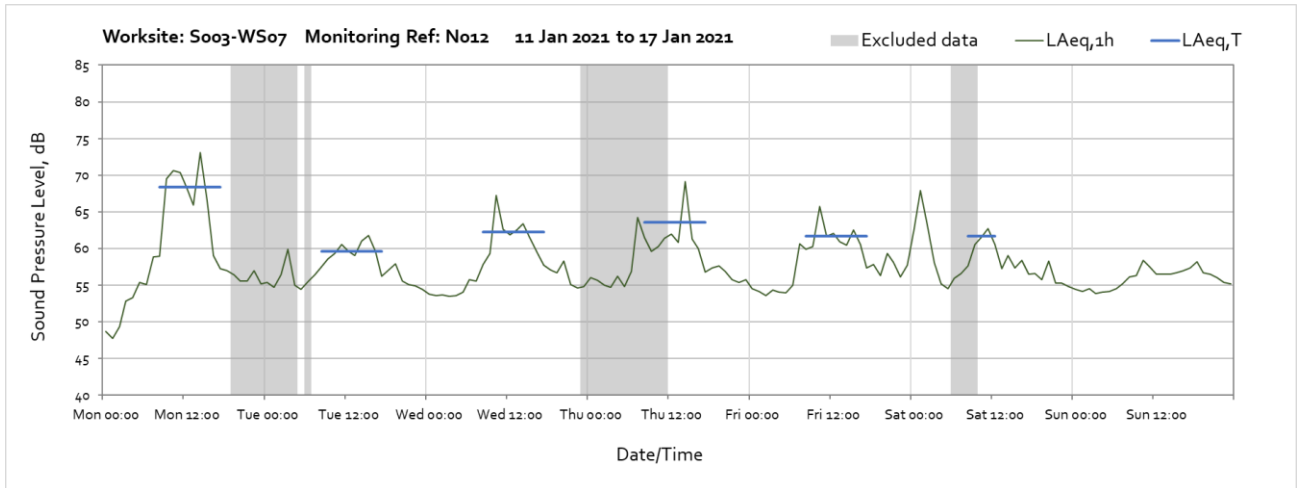
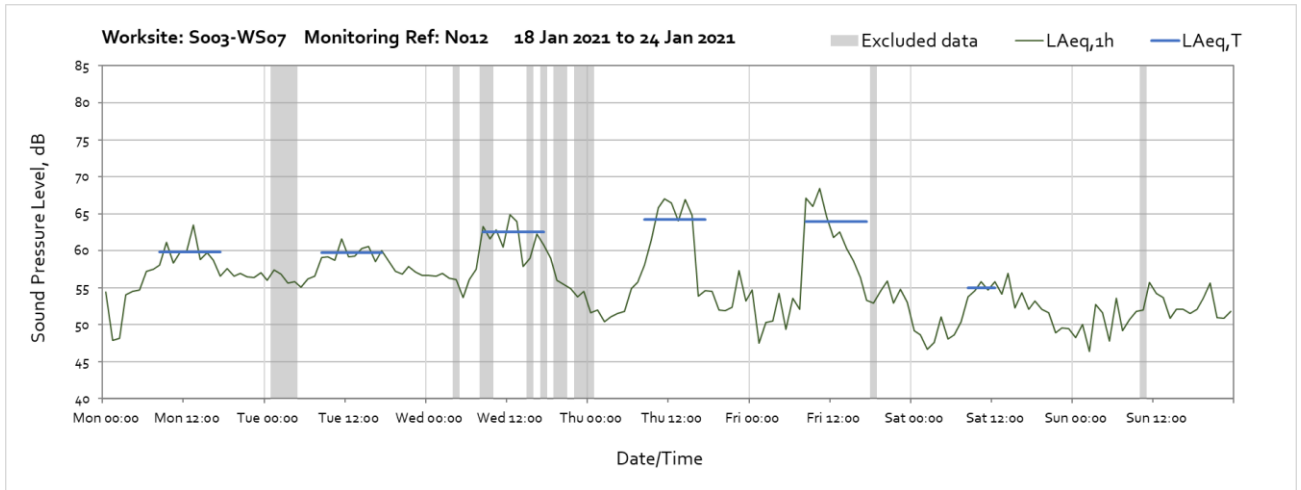
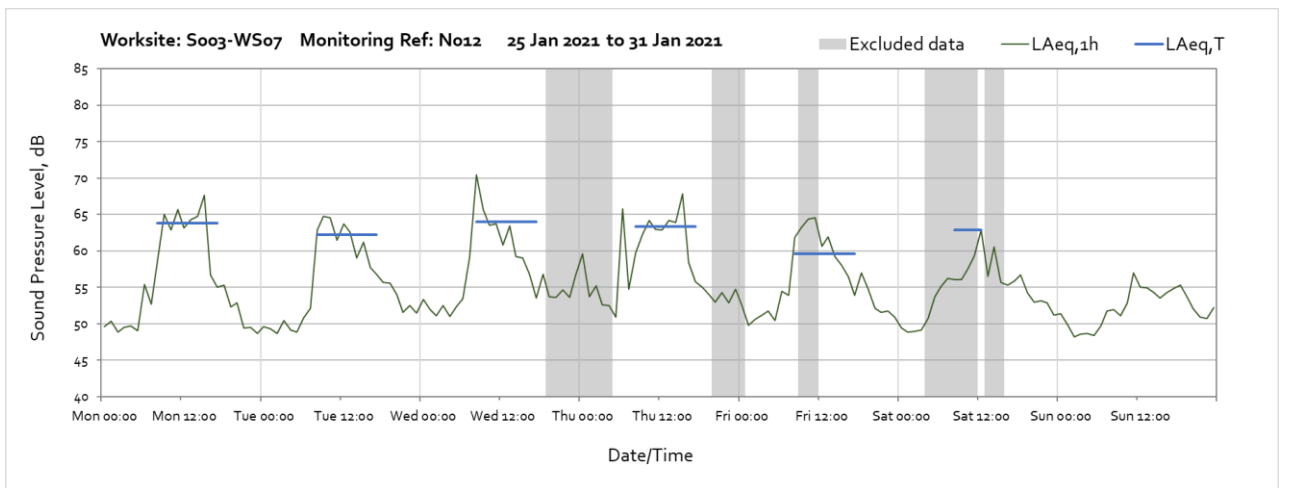
Worksite: S003-WS07 – Monitoring Ref: N012

Note: High noise levels on the early hours of the 1st January were due to New Year's Eve celebrations and have been excluded to calculate values in Table 3.

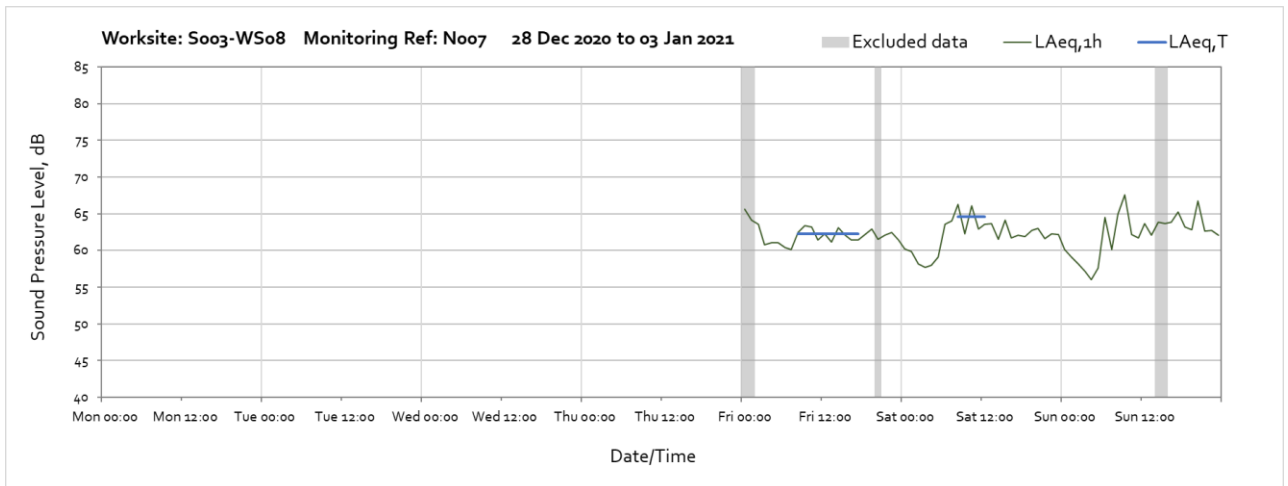
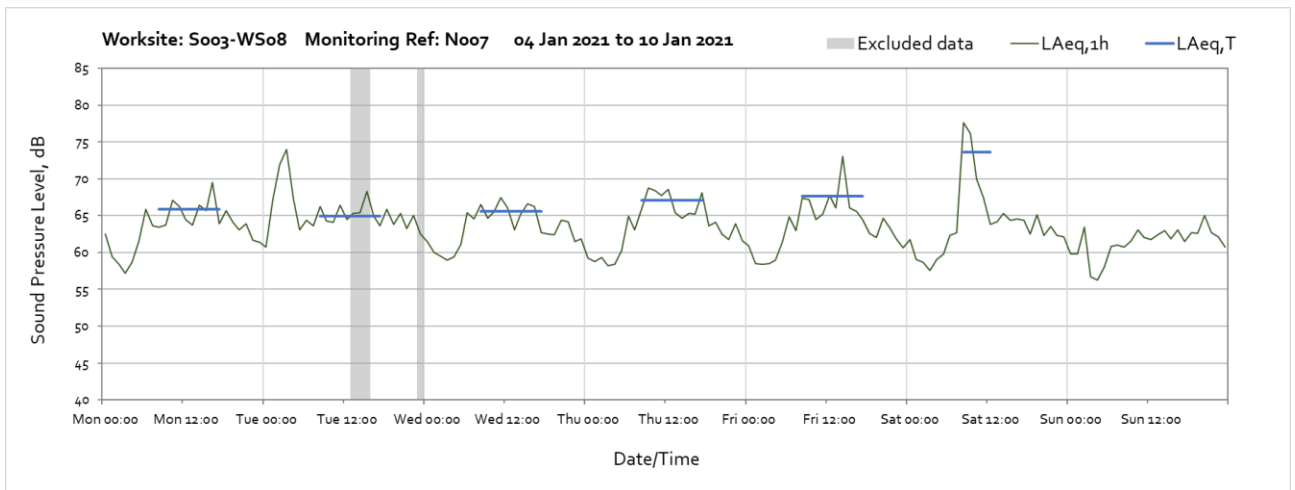
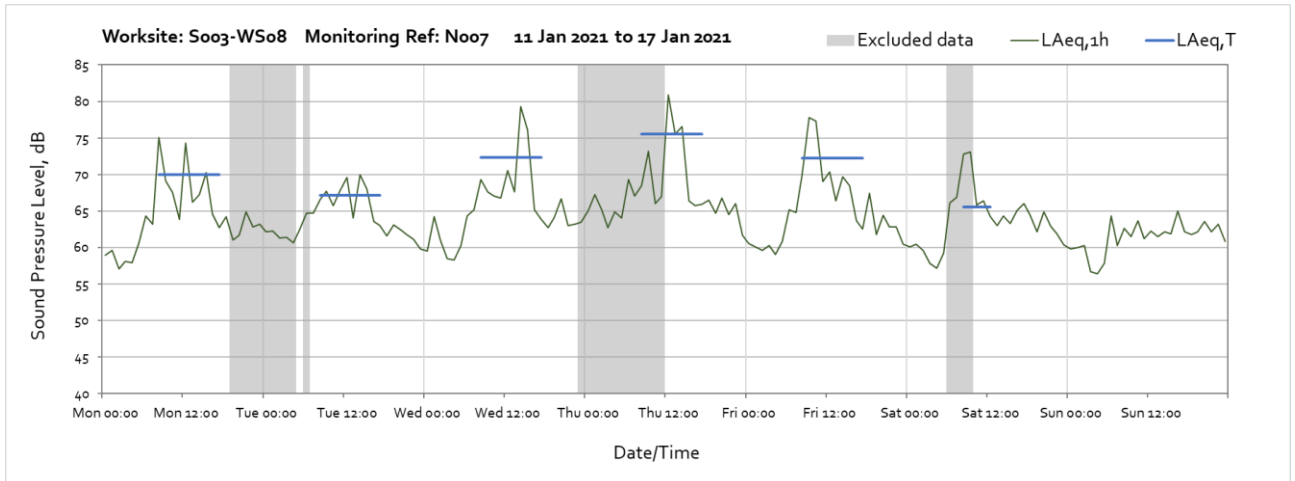
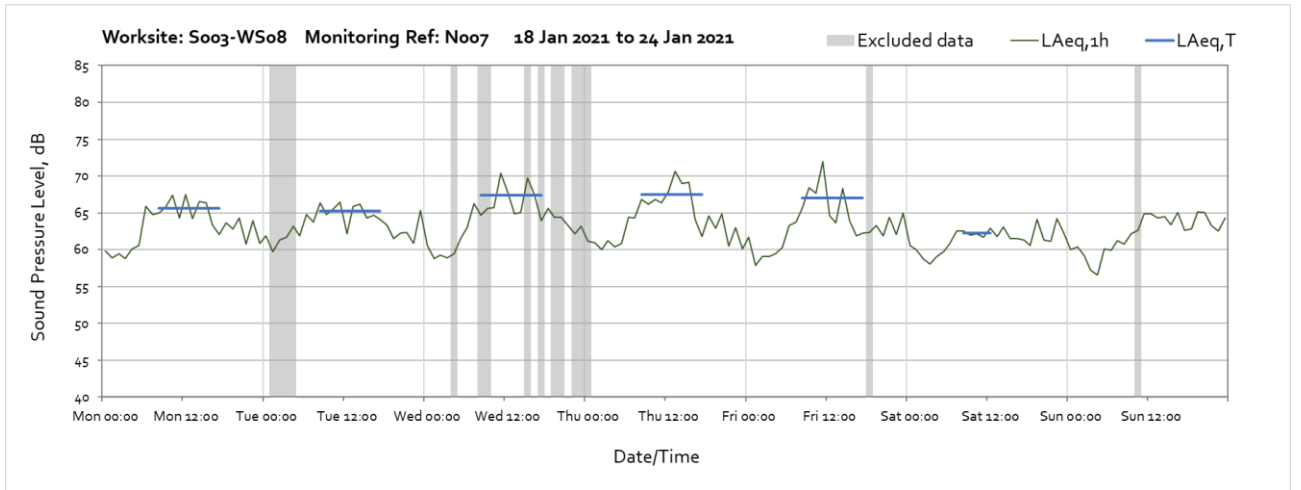
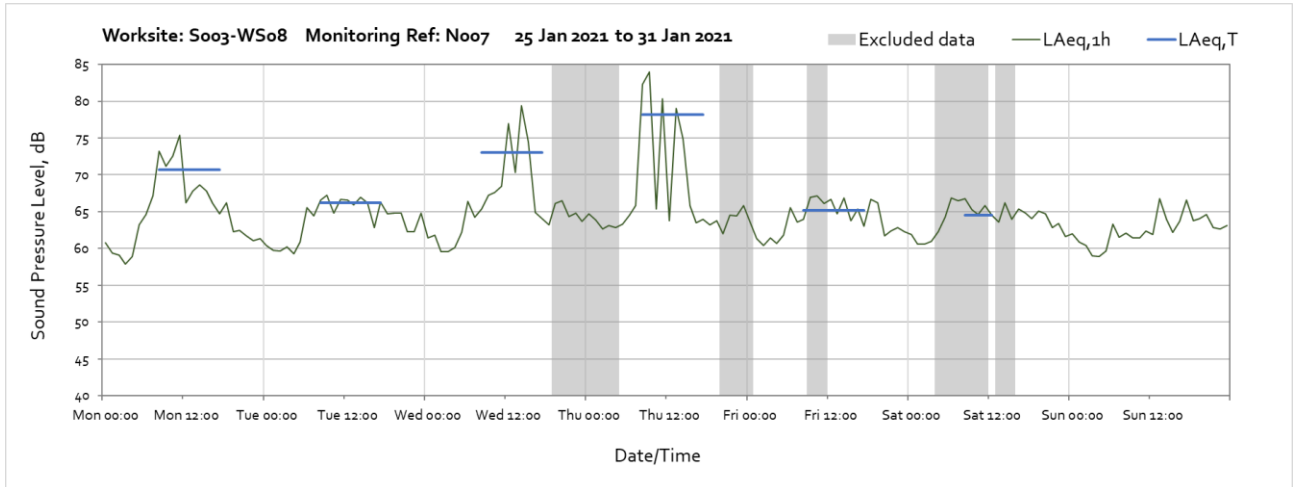
Worksite: S003-WS08 – Monitoring Ref: N007

Note: High noise levels on the early hours of the 1st January were due to New Year's Eve celebrations and have been excluded to calculate values in Table 3.

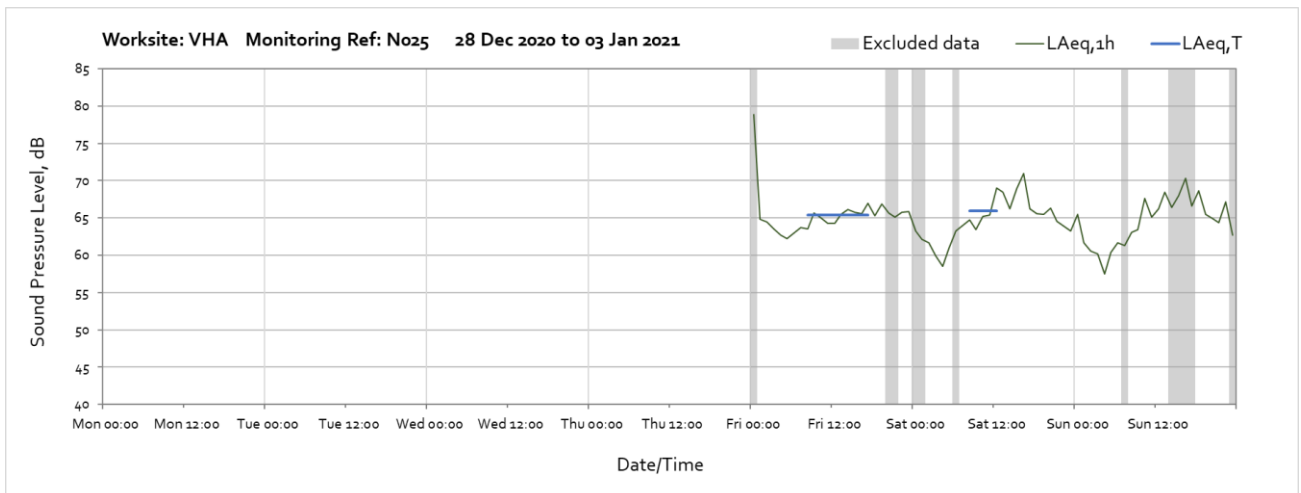
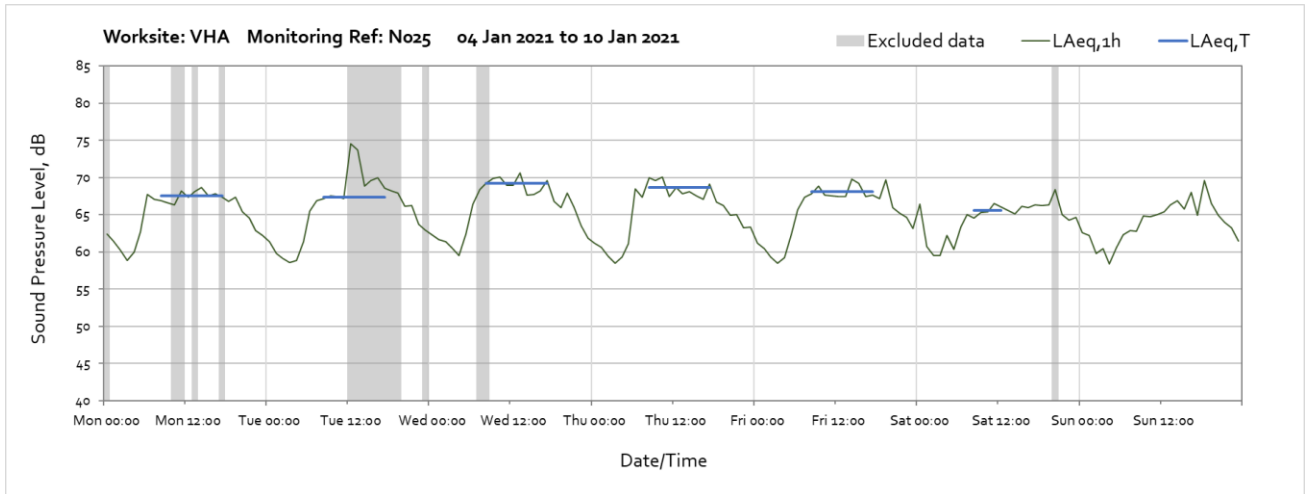
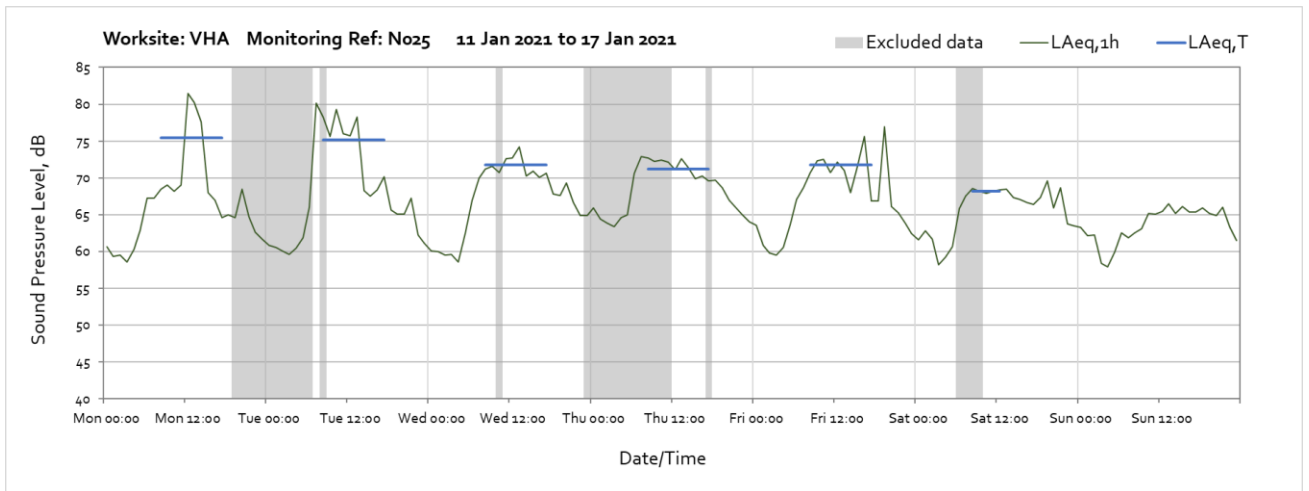
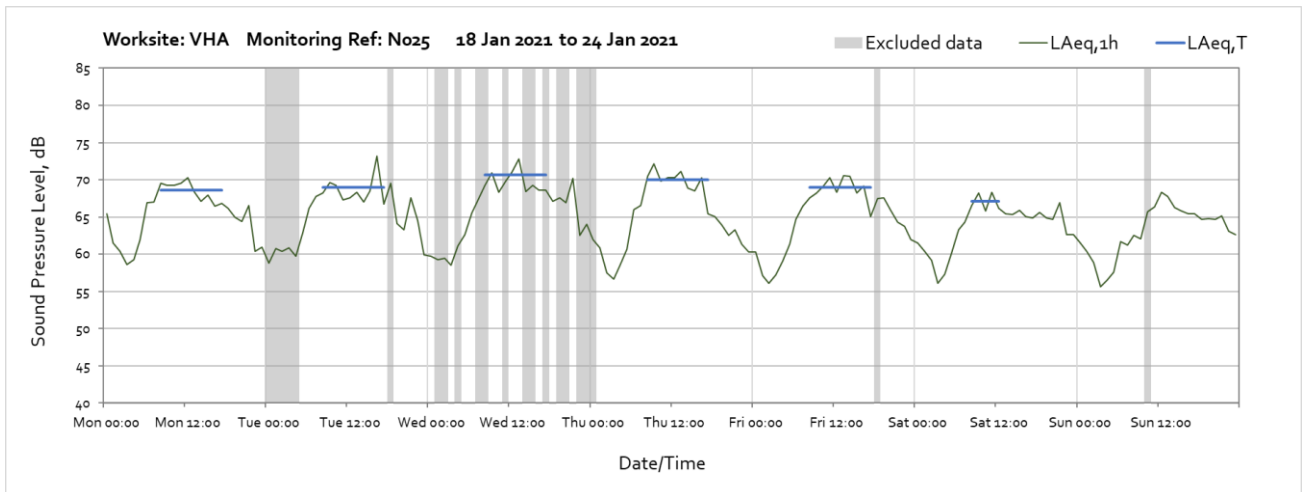
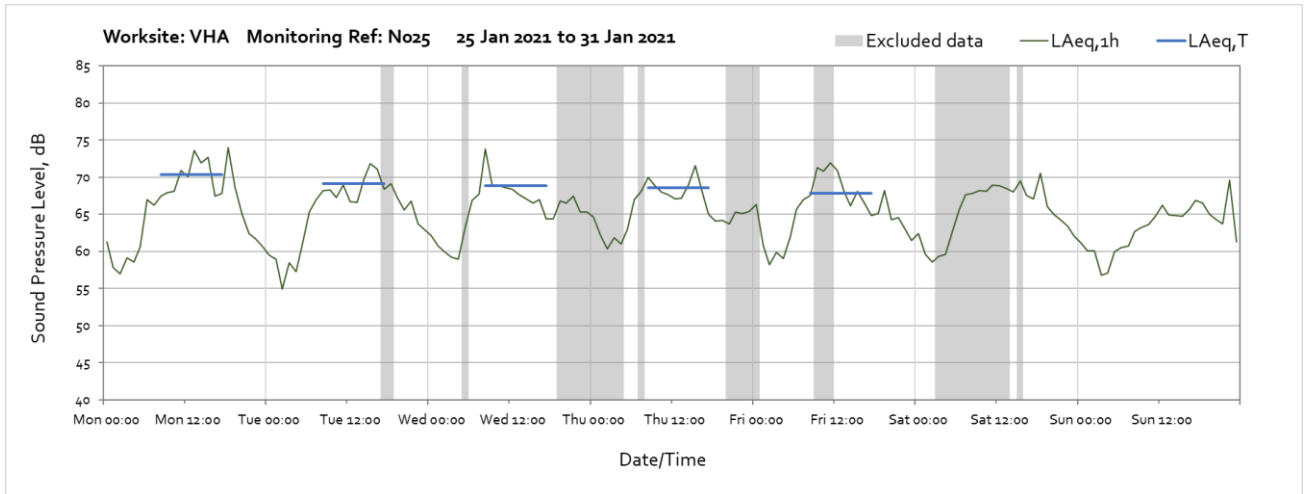
Vehicle Holding Area (VHA) – Monitoring Ref: N025

Note: High noise levels on the early hours of the 1st January were due to New Year's Eve celebrations and have been excluded to calculate values in Table 3.
