Construction noise and vibration Monthly Report – January 2021

London Borough of Camden

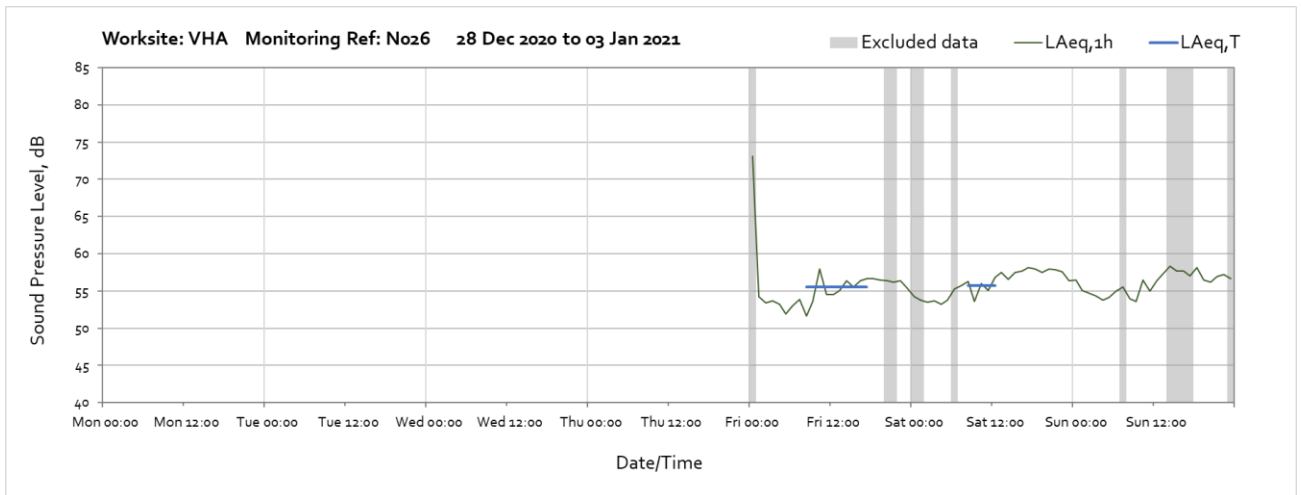
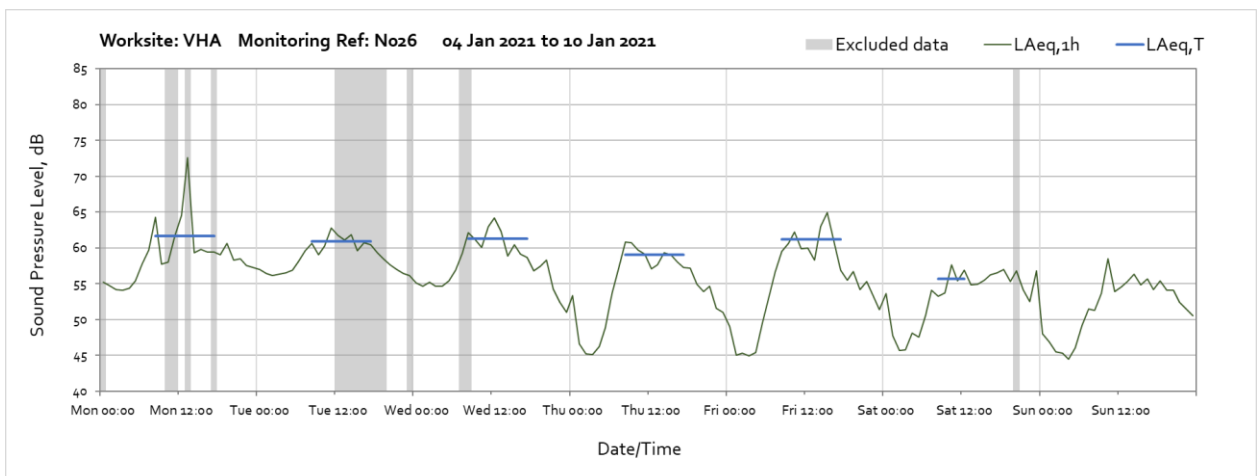
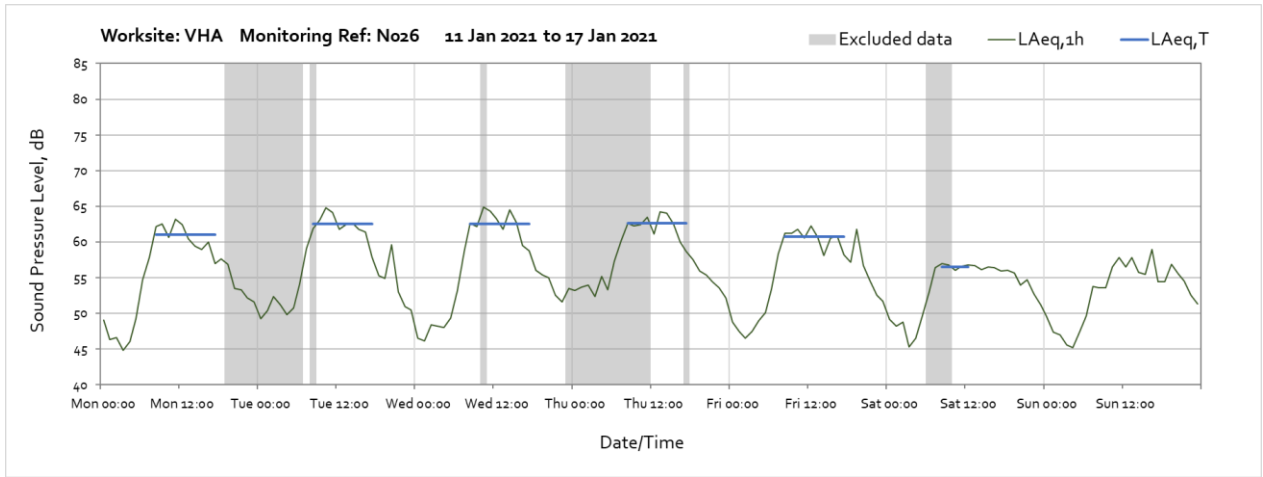
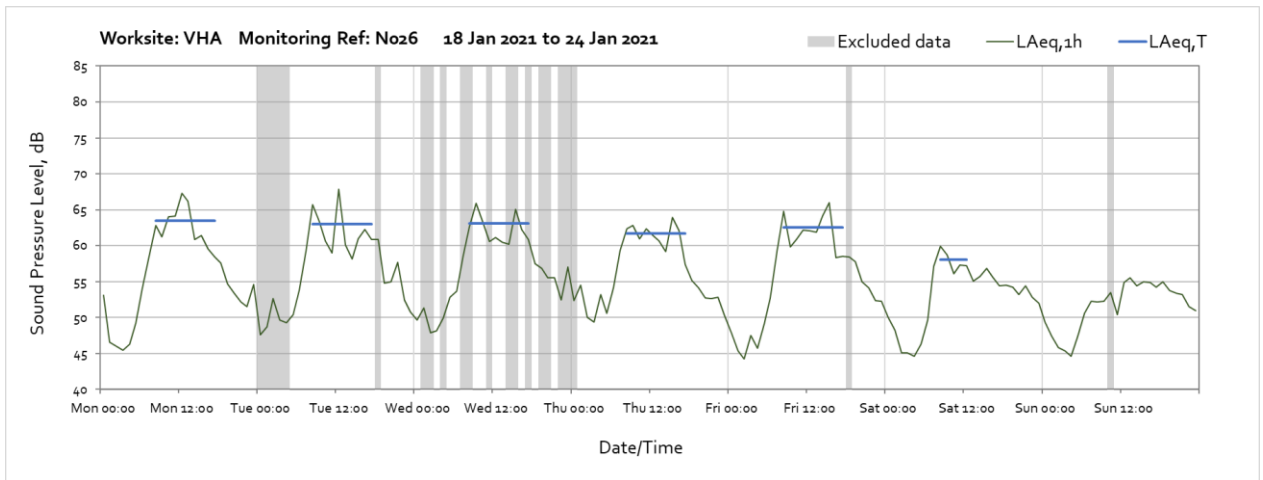
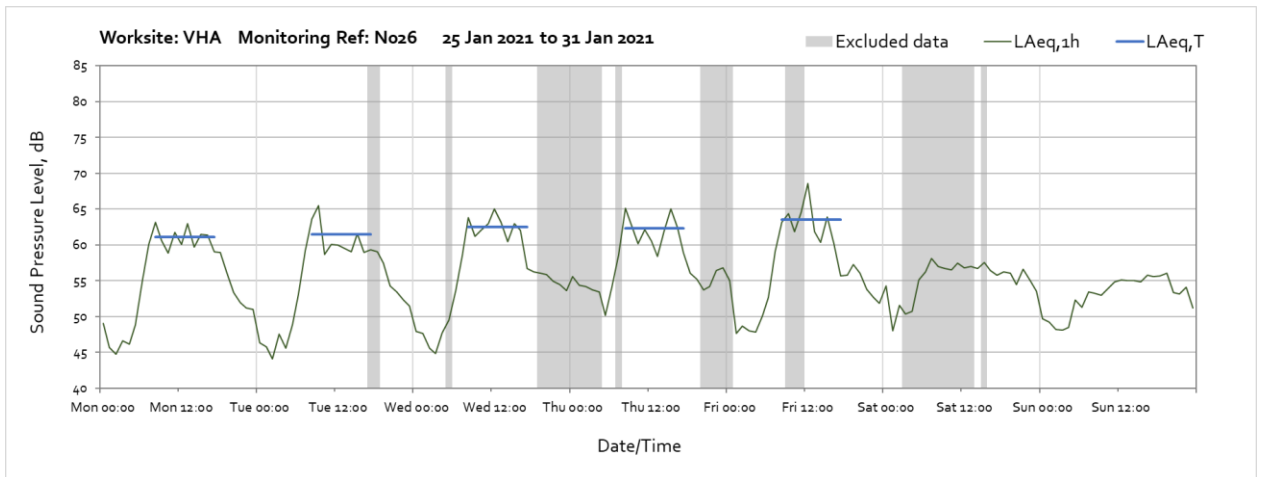
Vehicle Holding Area (VHA) – Monitoring Ref: N026

Note: High noise levels on the early hours of the 1st January were due to New Year’s Eve celebrations and have been excluded to calculate values in Table 3.

2.1.3 Appendix C presents graphs of the noise and vibration monitoring data over the month for each of the measurement locations. Noise data presented consists of the hourly L_{Aeq} values and, where relevant, the $L_{Aeq,T}$ values (where the time period T has been taken to be the averaging period as specified in Table 1 of HS2 Information Paper E23). Vibration data presented consist of hourly PPV values. The full data set for the monitoring equipment can be found at the following location: <https://data.gov.uk/dataset/24542ae7-dd44-444f-b259-871c4cc43b5e/environmental-monitoring-data>.

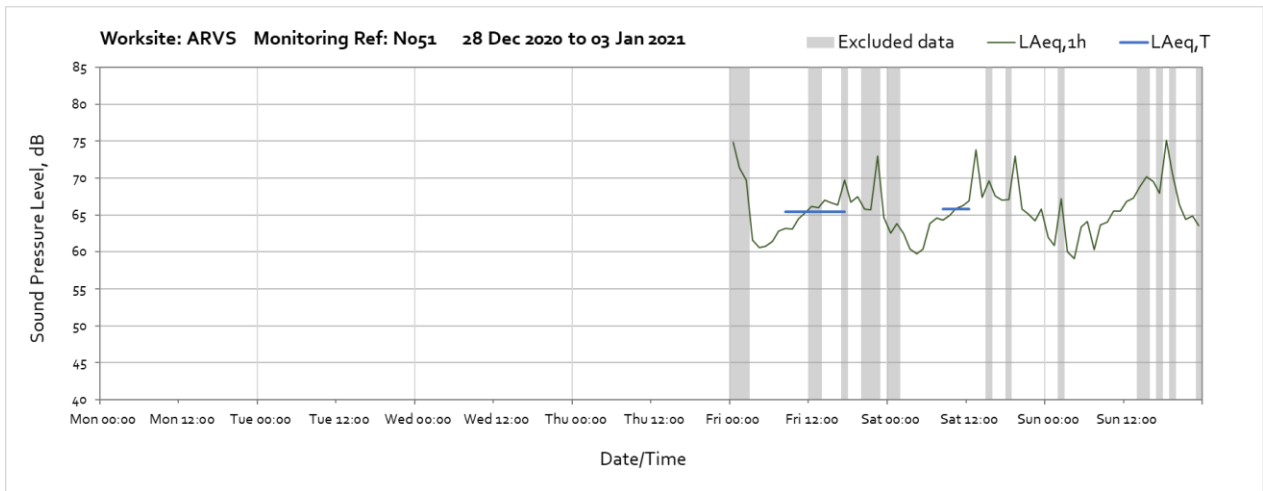
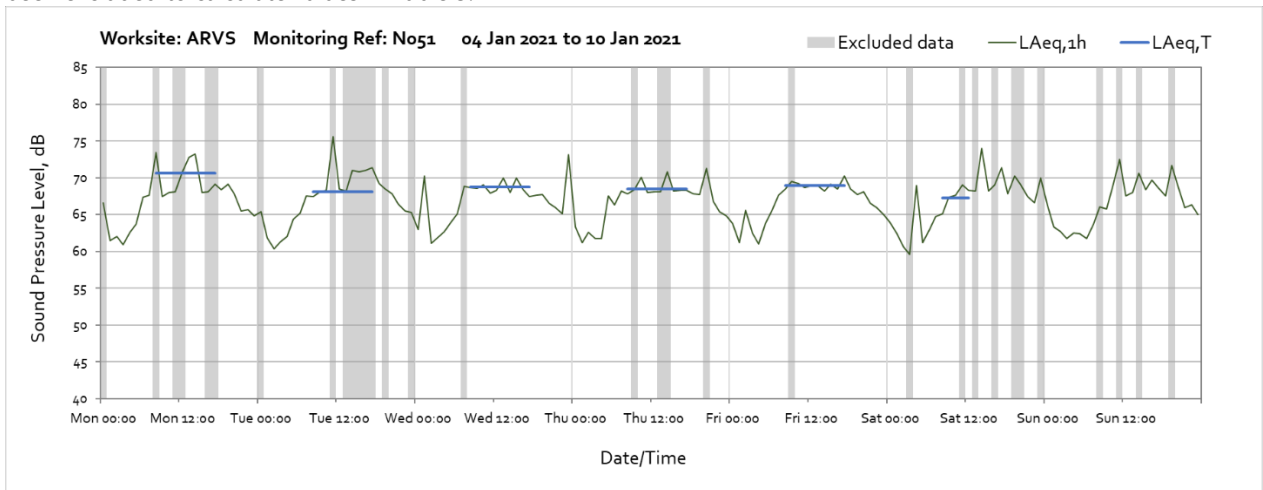
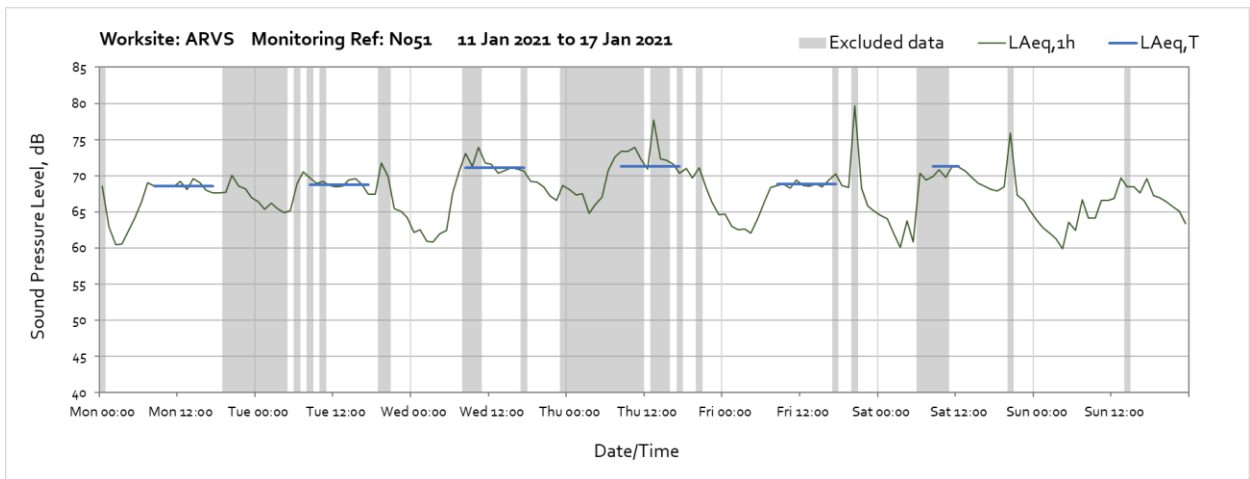
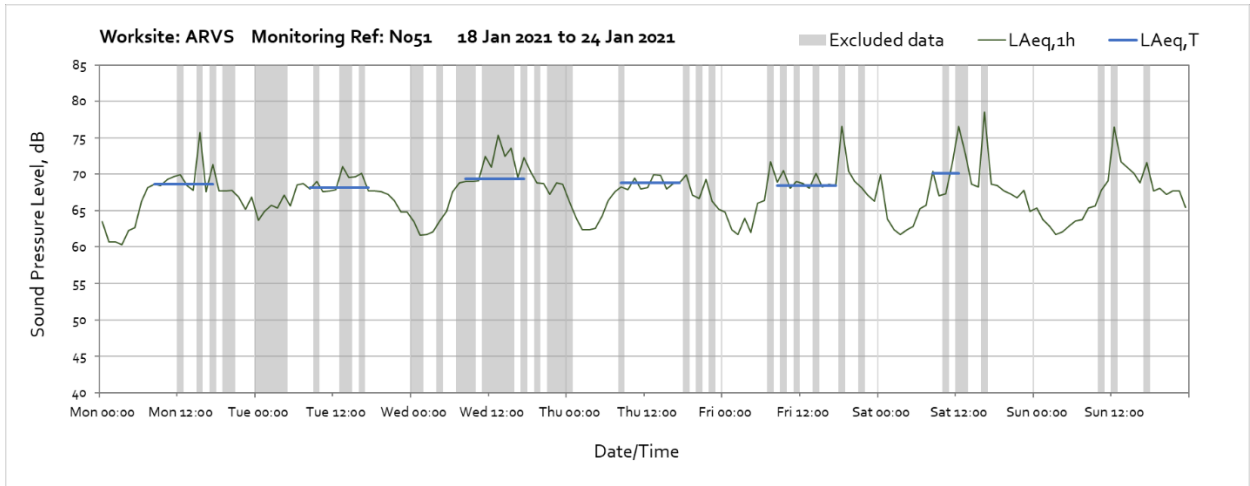
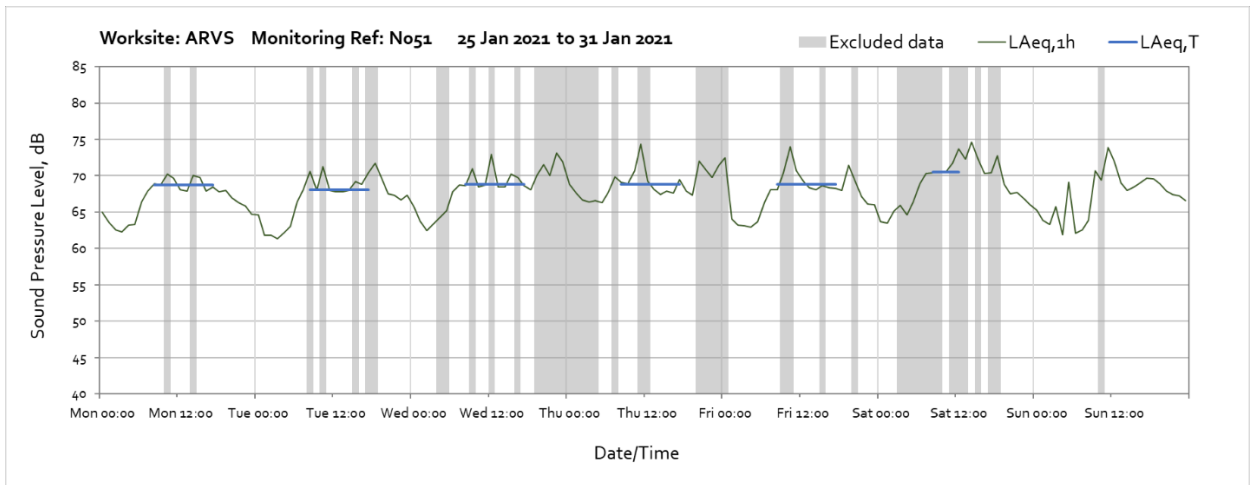
Adelaide Road Ventilation Shaft (ARVS) – Monitoring Ref: N051

Note: High noise levels on the early hours of the 1st January were due to New Year's Eve celebrations and have been excluded to calculate values in Table 3.

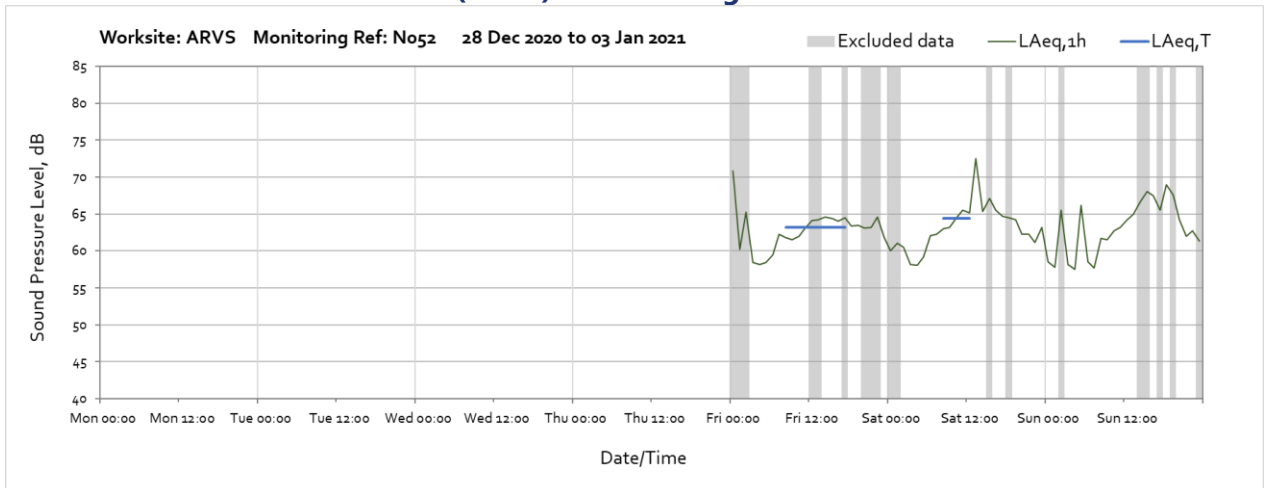
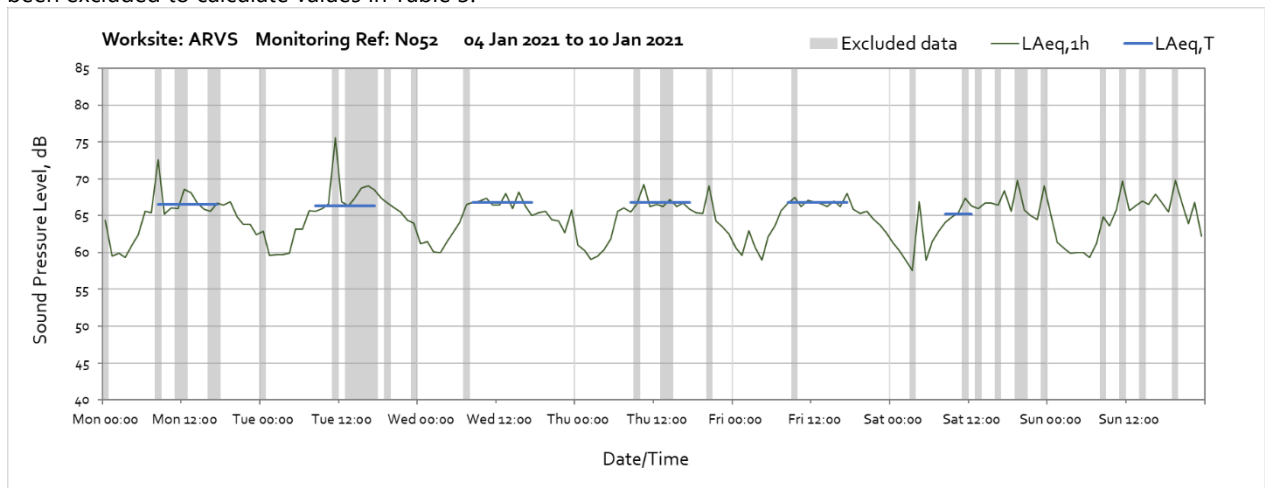
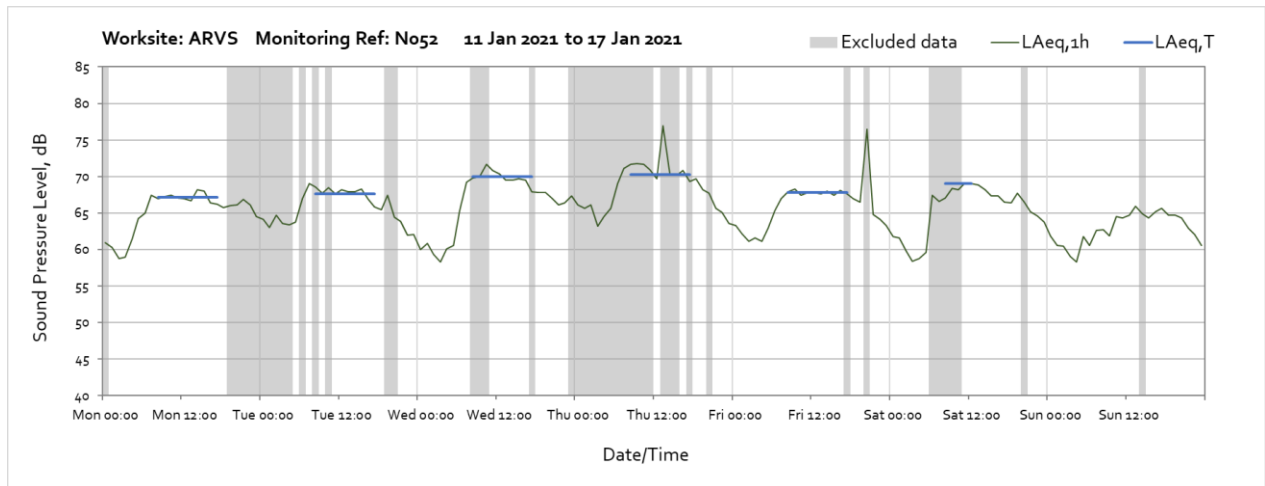
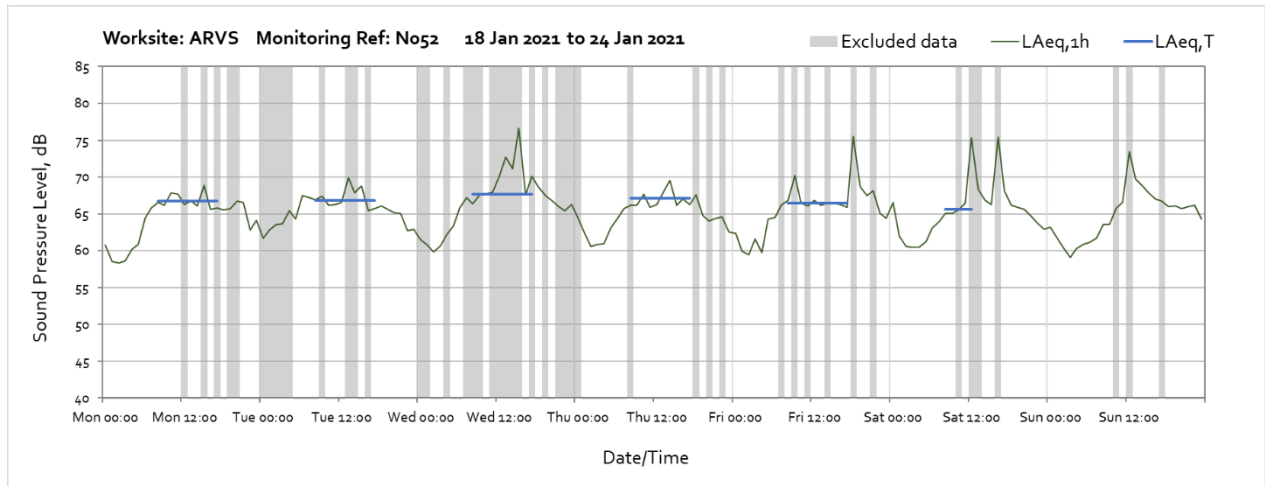
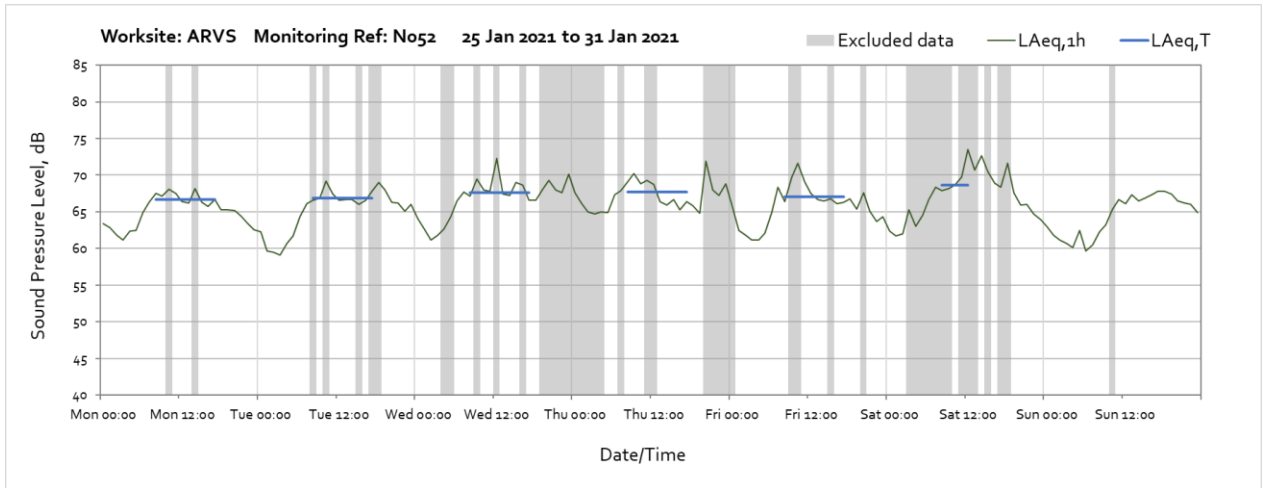
Adelaide Road Ventilation Shaft (ARVS) – Monitoring Ref: N052

Note: High noise levels on the early hours of the 1st January were due to New Year's Eve celebrations and have been excluded to calculate values in Table 3.

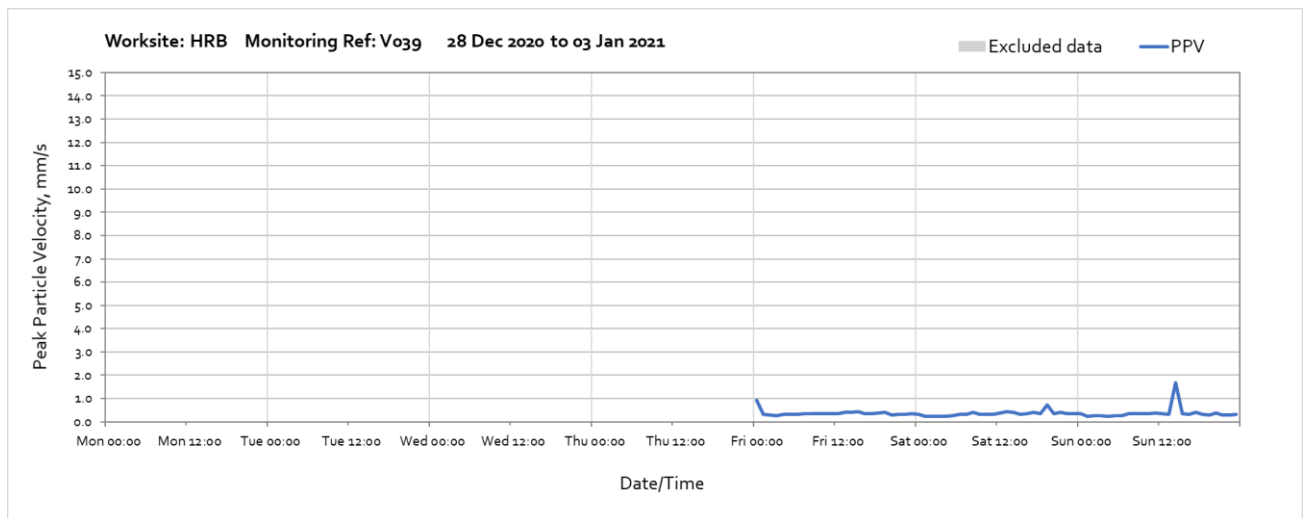
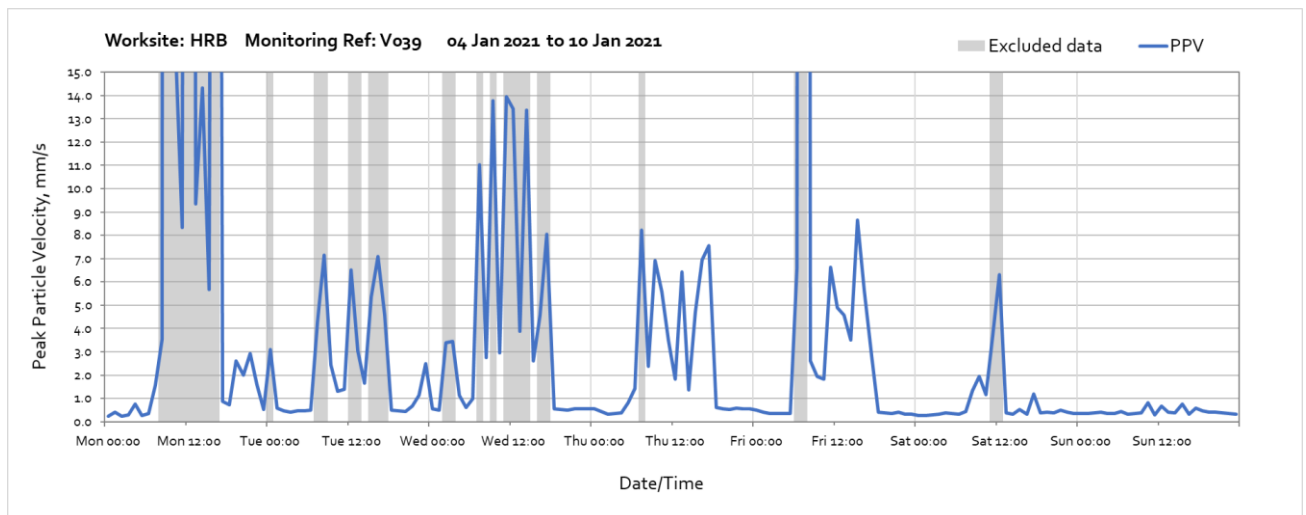
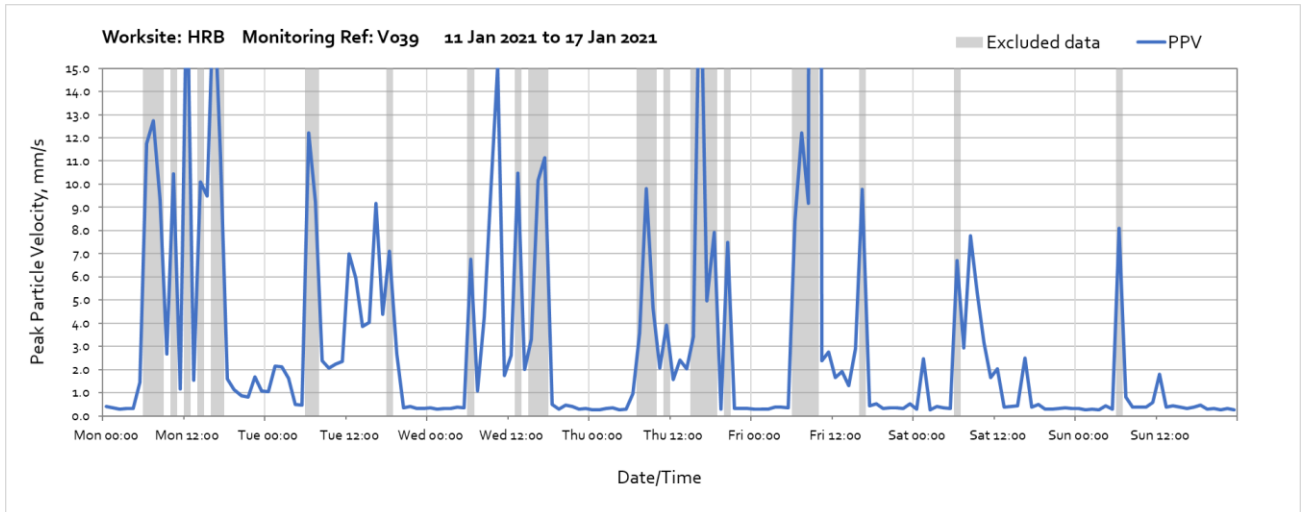
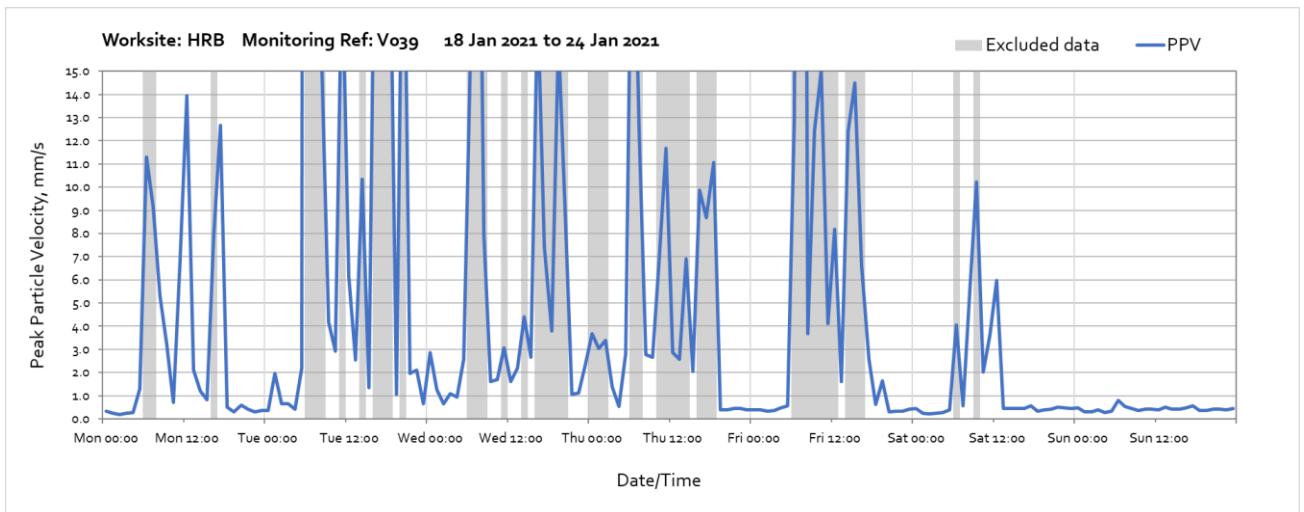
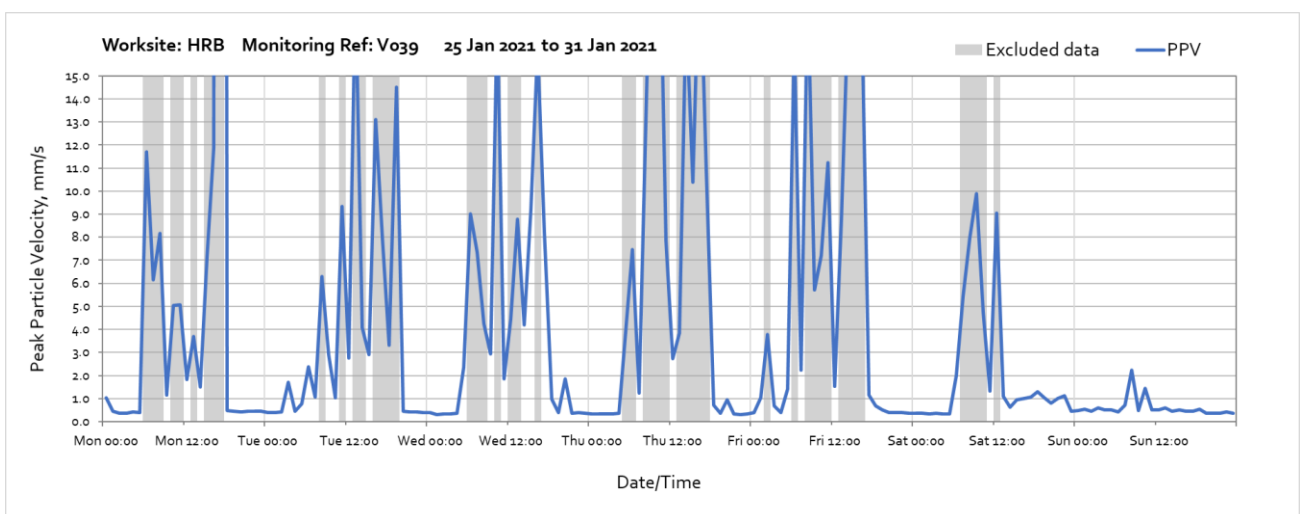
Worksite: HRB – Monitoring Ref: V039

The following graphs show the hourly measured peak particle velocity PPV recorded during the monitoring period. The graphs show the resultant PPV due to vibration components on three orthogonal axis x, y and z. Where high values of PPV were caused by local interference with the vibration monitor, which are not representative of HS2 construction works, these values have been greyed out in the following charts and have been excluded to calculate values in Table 4 of the main report.

Note: High vibration levels measured throughout the week were due to local disturbance of the vibration monitor and are not representative of HS2 vibration levels at the nearest receptor.

* High vibration levels were caused by works in close proximity to the monitor. The highest vibration level measured at a distance representative of the receptor was 7.74mm/s (Y-Axis).

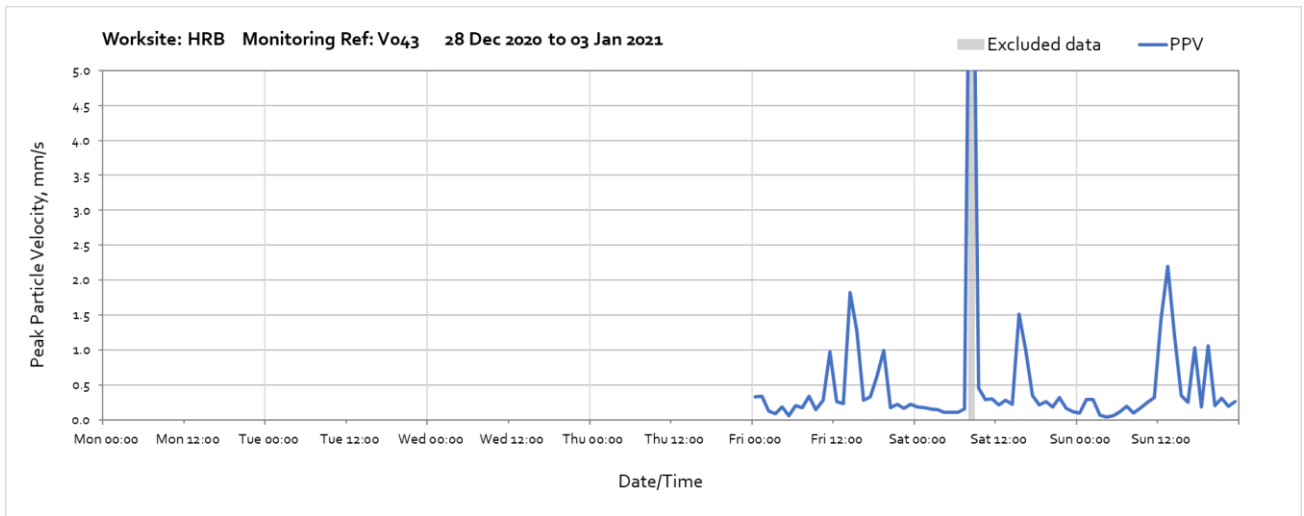
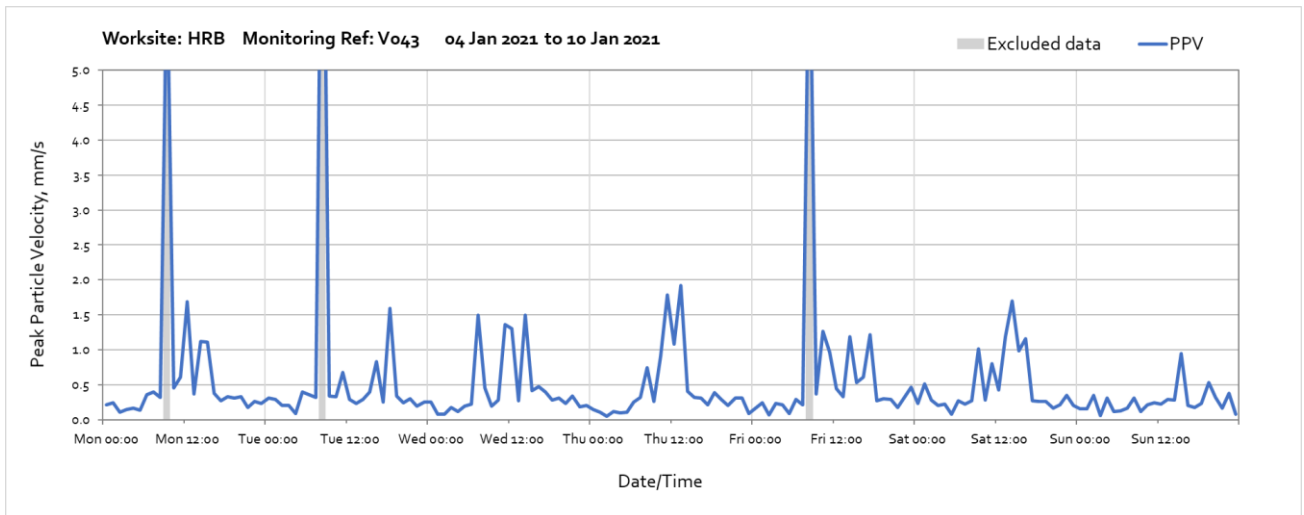
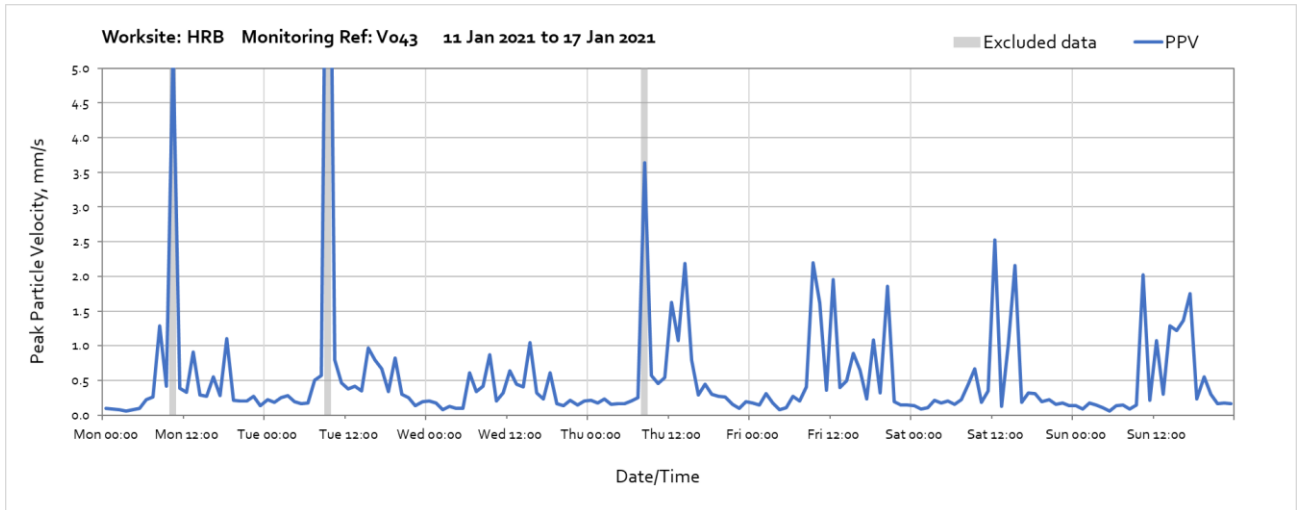
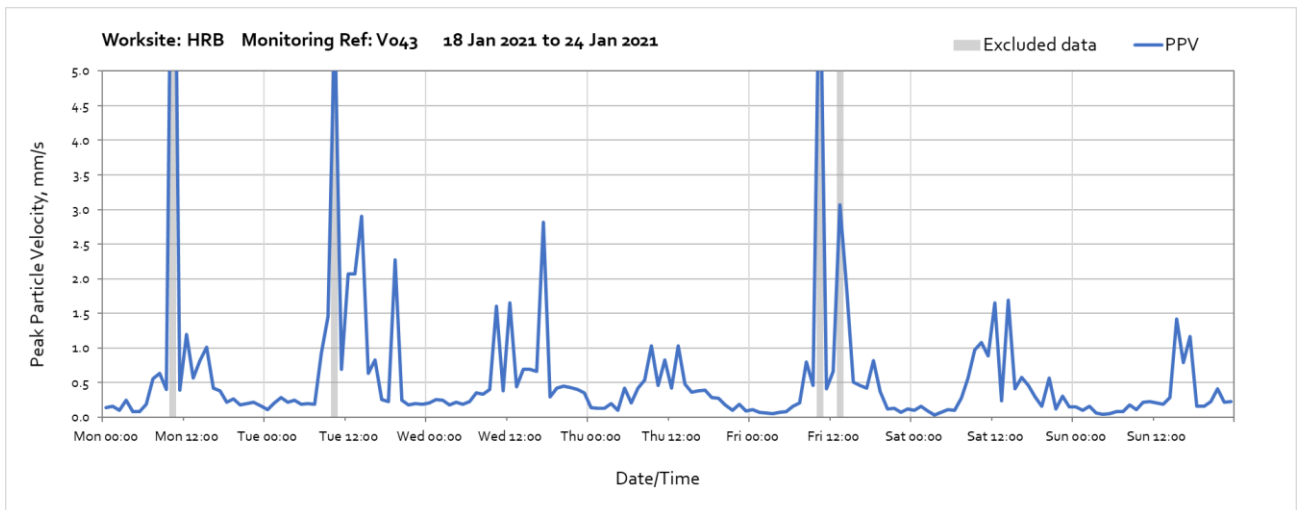
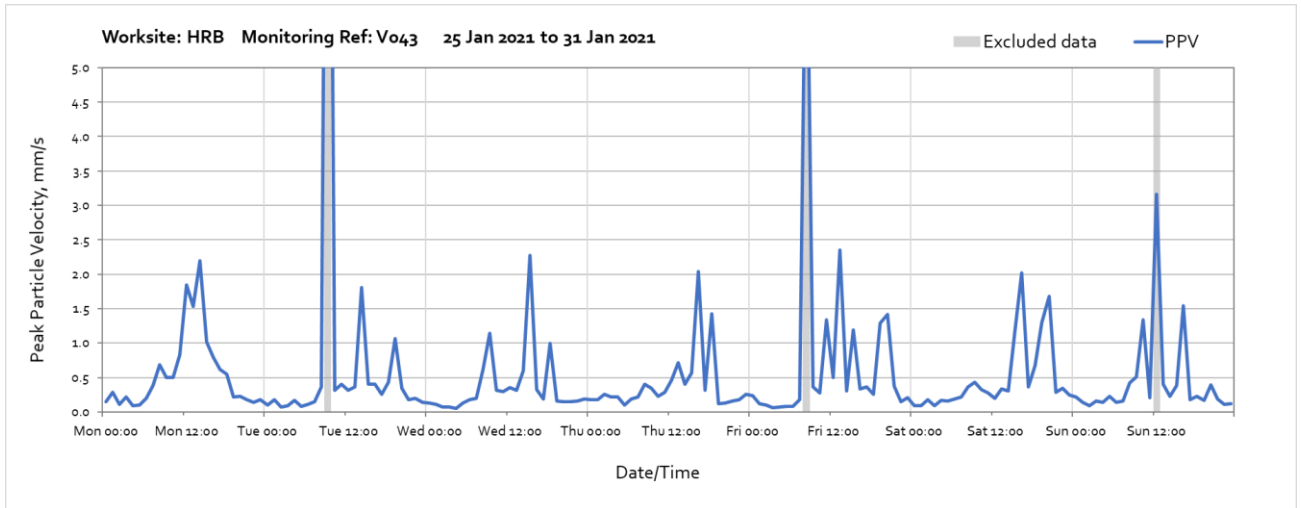
Worksite: HRB – Monitoring Ref: V043

Note: High vibration levels measured at 08:00 on Saturday 2nd January were due to use of the nearby residential bin store and are not representative of HS2 vibration levels.

Note: High vibration levels measured throughout the week were due to the use of the nearby residential bin store and are not representative of HS2 vibration levels.

Note: High vibration levels measured throughout the week were due to the use of the nearby residential bin store and local interference of the monitor and are not representative of HS2 vibration levels.
