Air Quality and Dust Monitoring Monthly Report – February 2021 **Buckinghamshire** Council

A report prepared by EWCs and MWCCs on behalf of HS2 Ltd.

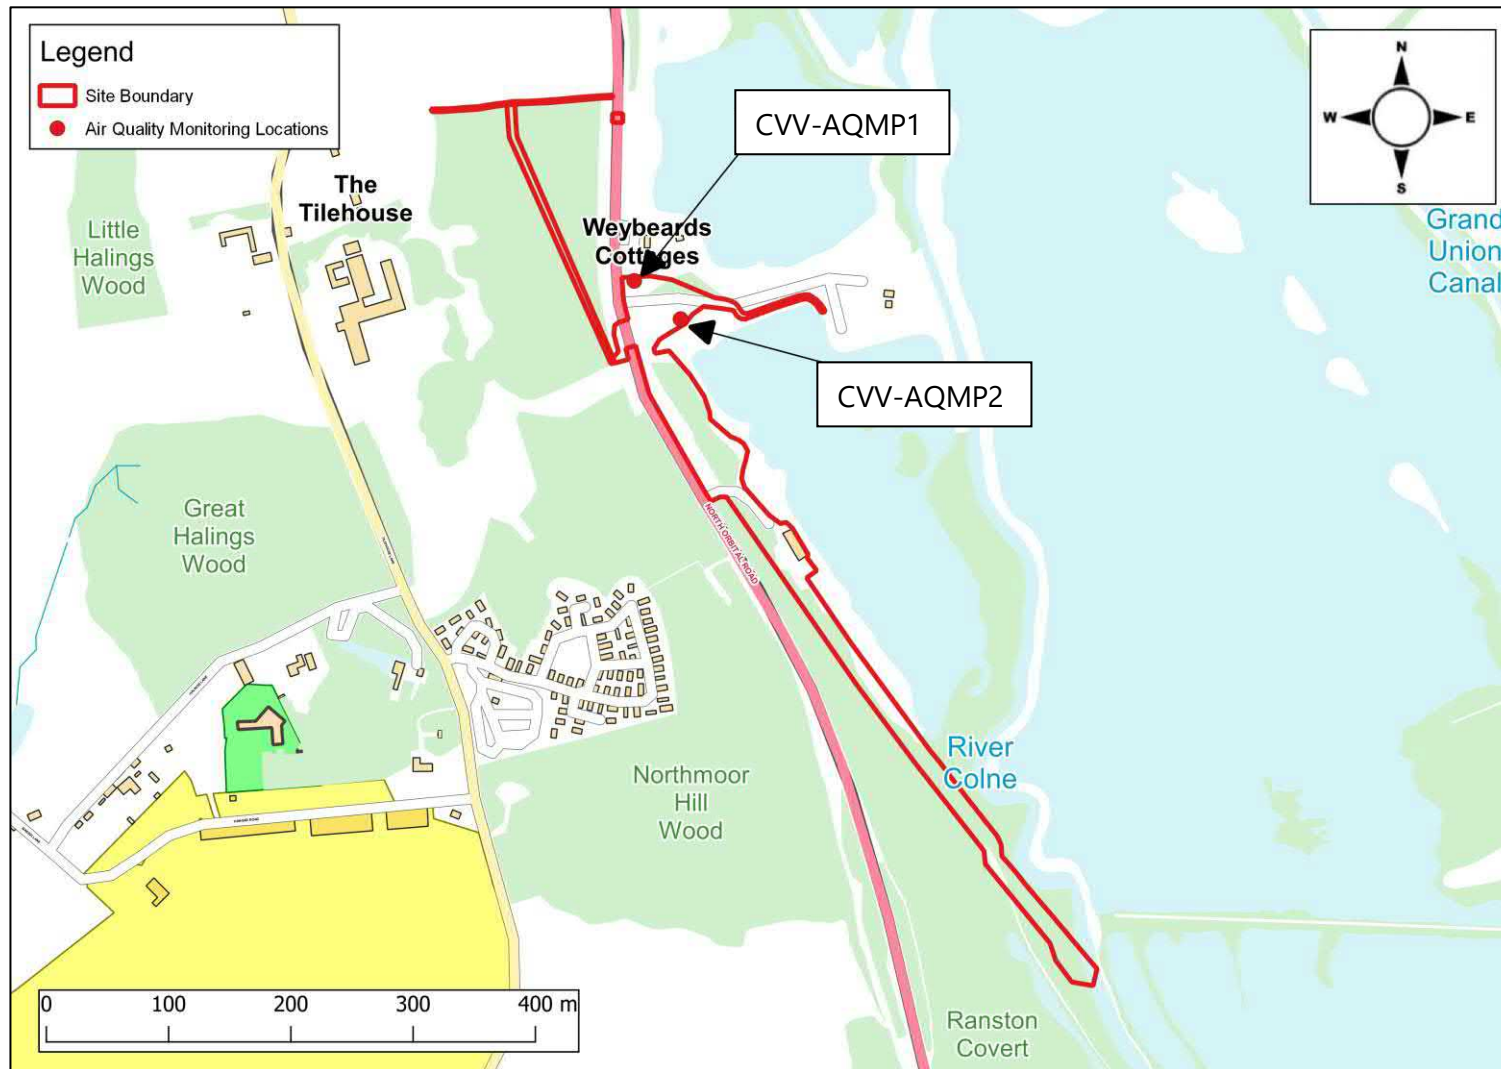
Figure 1: Buckinghamshire Council Worksite and Monitoring locations during February 2021 – Colne Valley Viaduct LTP1

- 1.1.4 The current phase commenced within BC during January 2020 and is expected to be completed by the end of September 2021. The current worksites at Colne Valley Viaduct (CVV) LTP1, Chalfont St Peter Vent Shaft, Amersham Vent Shaft, Lower Bottom House Farm Lane and DC2J Haul Road and Compound site are presented in Appendix A, Figures 1 to 5. Activities for each worksite during February 2021 included:

| Monitoring site ID | Coordinates (X,Y) | Location description | Dust risk rating for site | Monitoring site active during period | Change to site since previous period report | Mean 1-hour PM ₁₀ concentration (µg/m ³) | Minimum 1-hour PM ₁₀ concentration (µg/m ³) | Maximum 1-hour PM ₁₀ concentration (µg/m ³) | Number of 1-hour periods exceeding trigger level of 190 µg/m ³ | Data capture (%) |
|---|---|---|---|---|---|---|--|--|---|---|
| CVV-AQMP1 | 503602, 189832 | On the north boundary of LTP1 | M | Yes | Yes | 9.9 | 1.0 | 37.0 | 0 | 98 |
| CVV-AQMP2 | 503654, 189795 | On the south boundary of LTP1 | M | Yes | Yes | 10.4 | 1.0 | 39.0 | 0 | 63 |

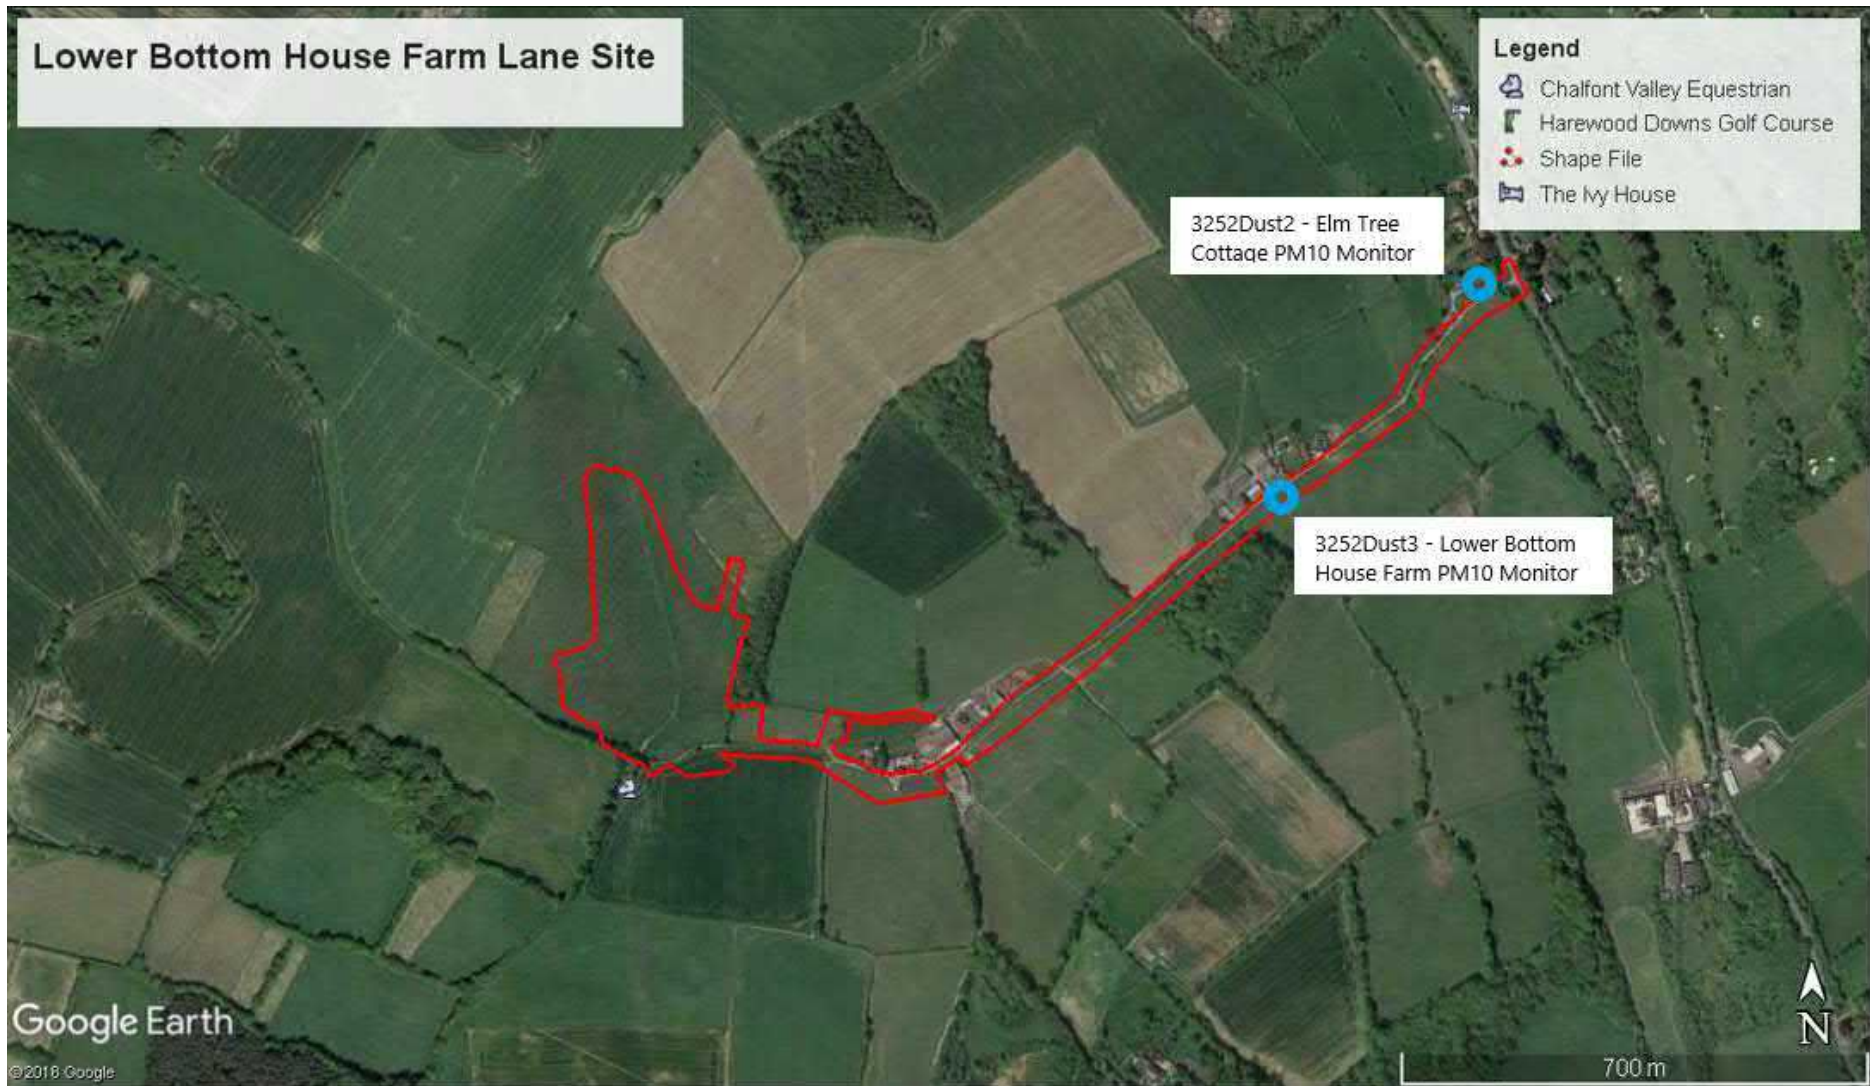
Figure 4: Worksite and Monitoring Locations during February 2021 – Lower Bottom House Farm Lane

| Monitoring site ID | Coordinates (X,Y) | Location description | Dust risk rating for site | Monitoring site active during period | Change to site since previous period report | Mean 1-hour PM ₁₀ concentration (µg/m ³) | Minimum 1-hour PM ₁₀ concentration (µg/m ³) | Maximum 1-hour PM ₁₀ concentration (µg/m ³) | Number of 1-hour periods exceeding trigger level of 190 µg/m ³ | Data capture (%) |
|---|---|---|---|---|---|---|--|--|---|---|
| 3252Dust2 | 498390, 195434 | On the boundary with Elm Tree Cottage, Bottom House Farm Lane | M | Yes | No | 13.6 | 0.7 | 301.3 | 1 | 100 |
| 3252Dust3 | 498100, 195145 | On the site boundary opposite Lower Bottom House Farm | M | Yes | No | 9.4 | 0.7 | 63.4 | 0 | 100 |

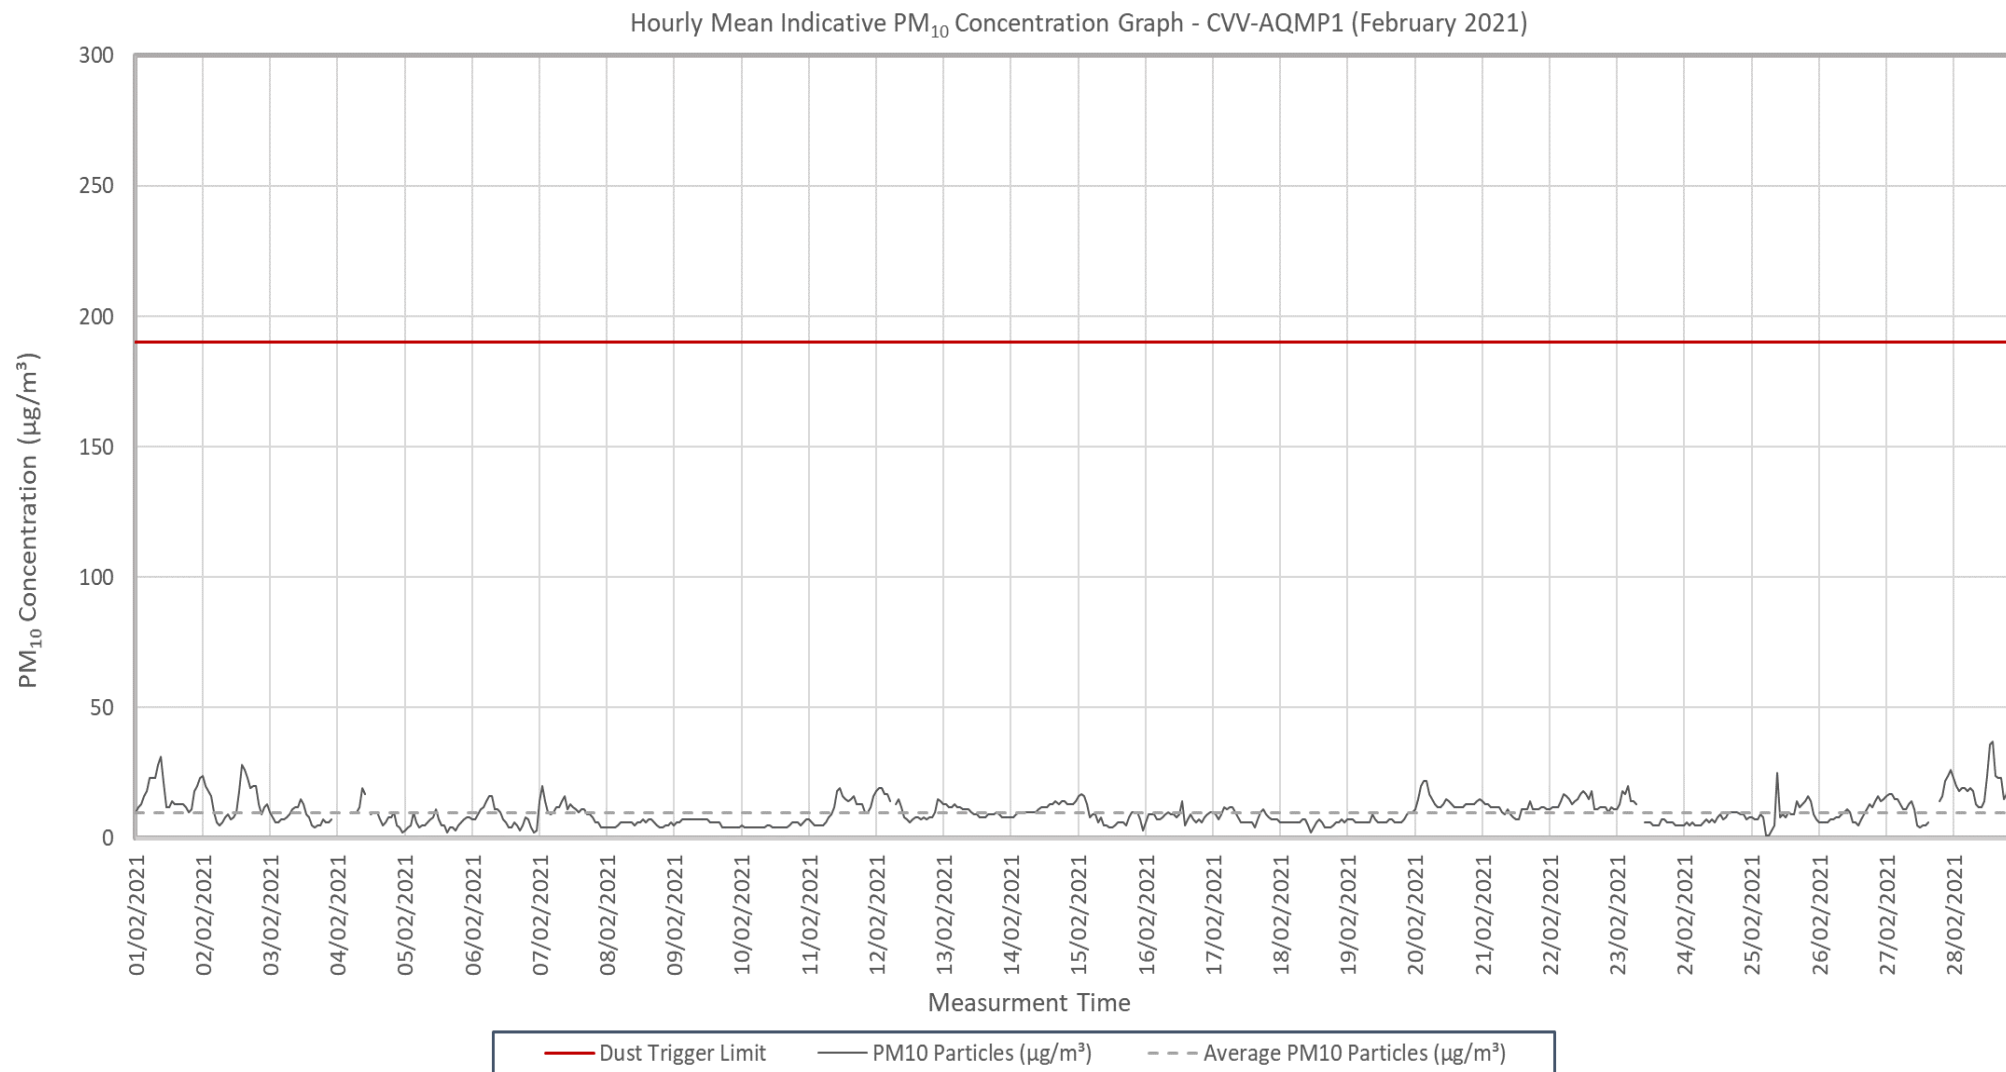
Figure 6: Continuous dust 1-hour mean indicative PM₁₀ concentration for CVV-AQMP1 for February 2021

- 1.1.6 Dust monitoring locations and results for February 2021 are presented in Appendix B, Table 1, together with a line chart of monthly data from each dust monitor presented in Figures 6 to 15. All continuous dust monitoring is undertaken using indicative monitors. Despite being Environment Agency (MCERTS) certified, indicative monitors carry a higher level of uncertainty than reference monitors, and therefore cannot be strictly compared with Air Quality Standards for human health and the environment. The purpose of the monitoring undertaken is to ensure the effectiveness of the on-site mitigation.

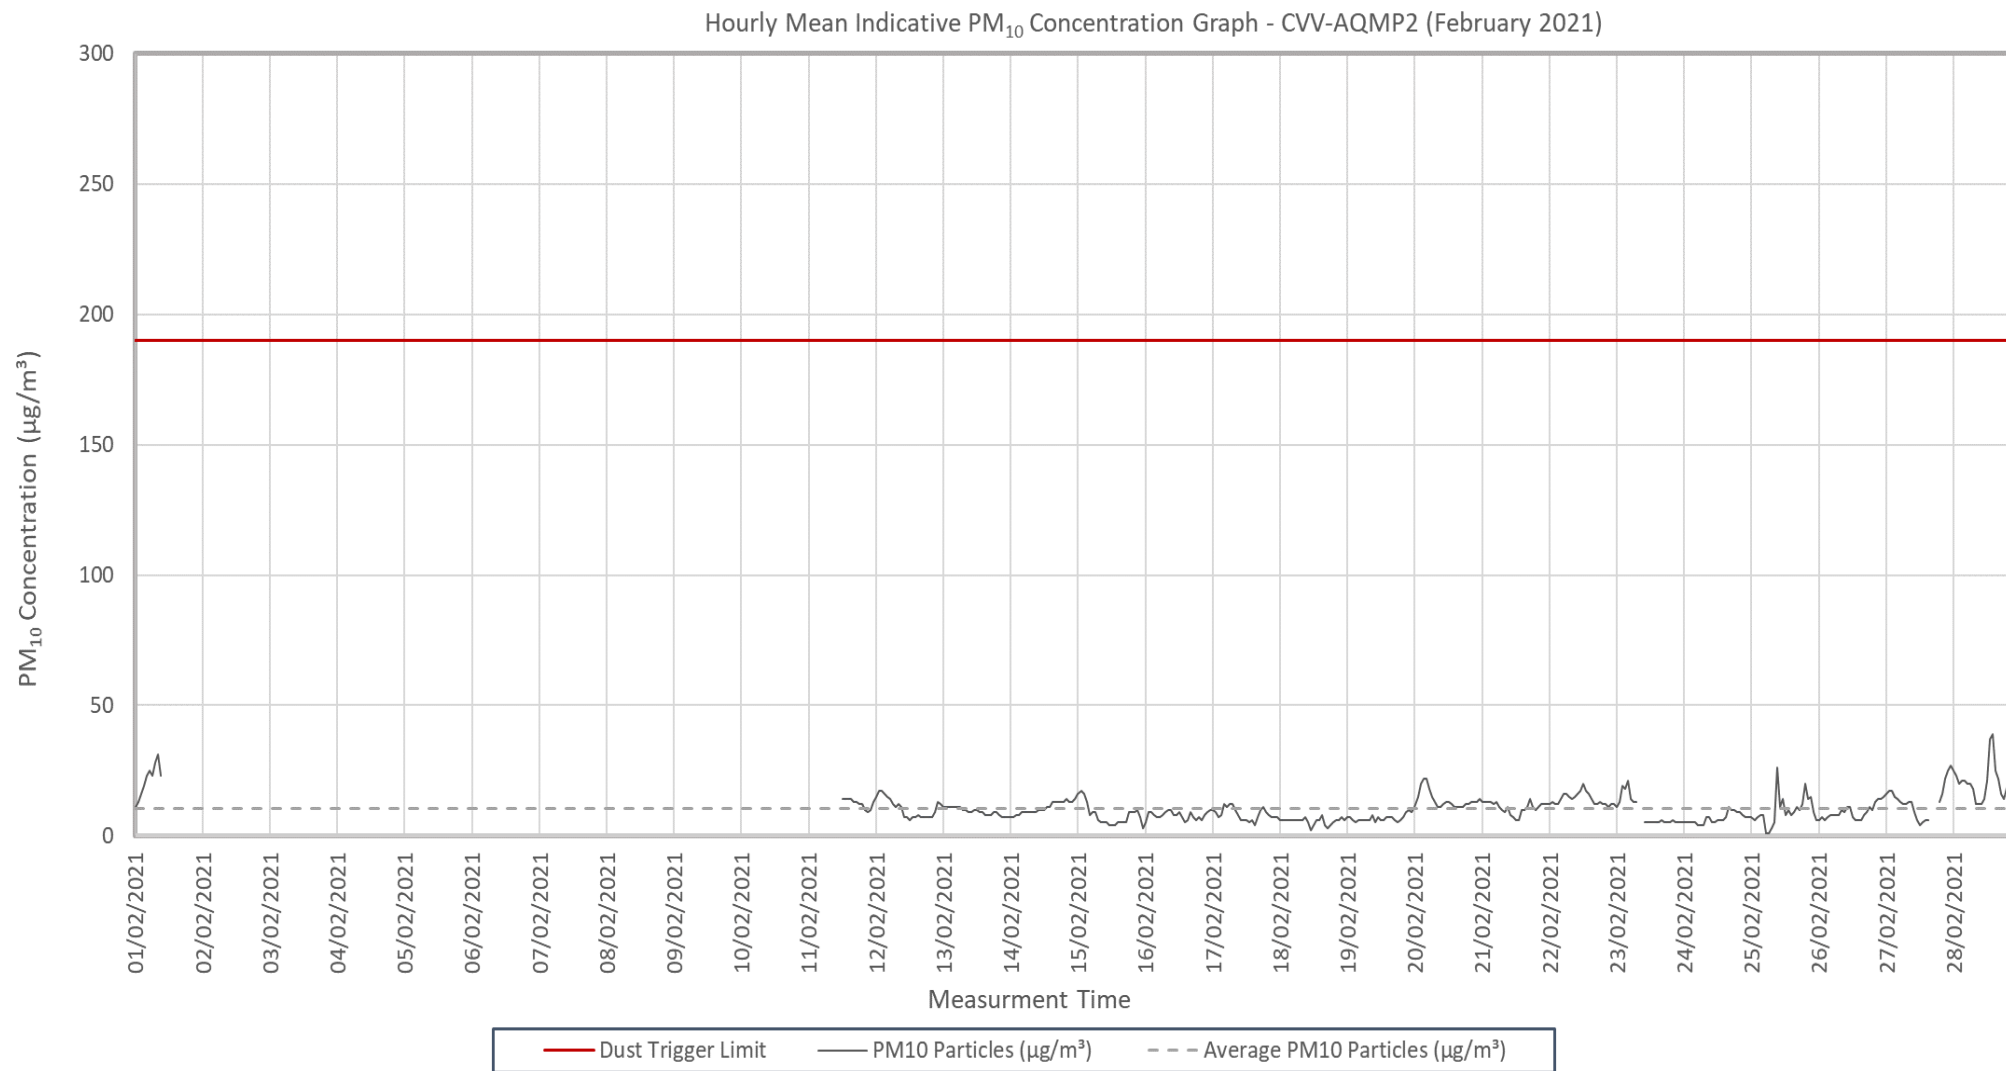
Figure 7: Continuous dust 1-hour mean indicative PM₁₀ concentration for CVV-AQMP2 for February 2021

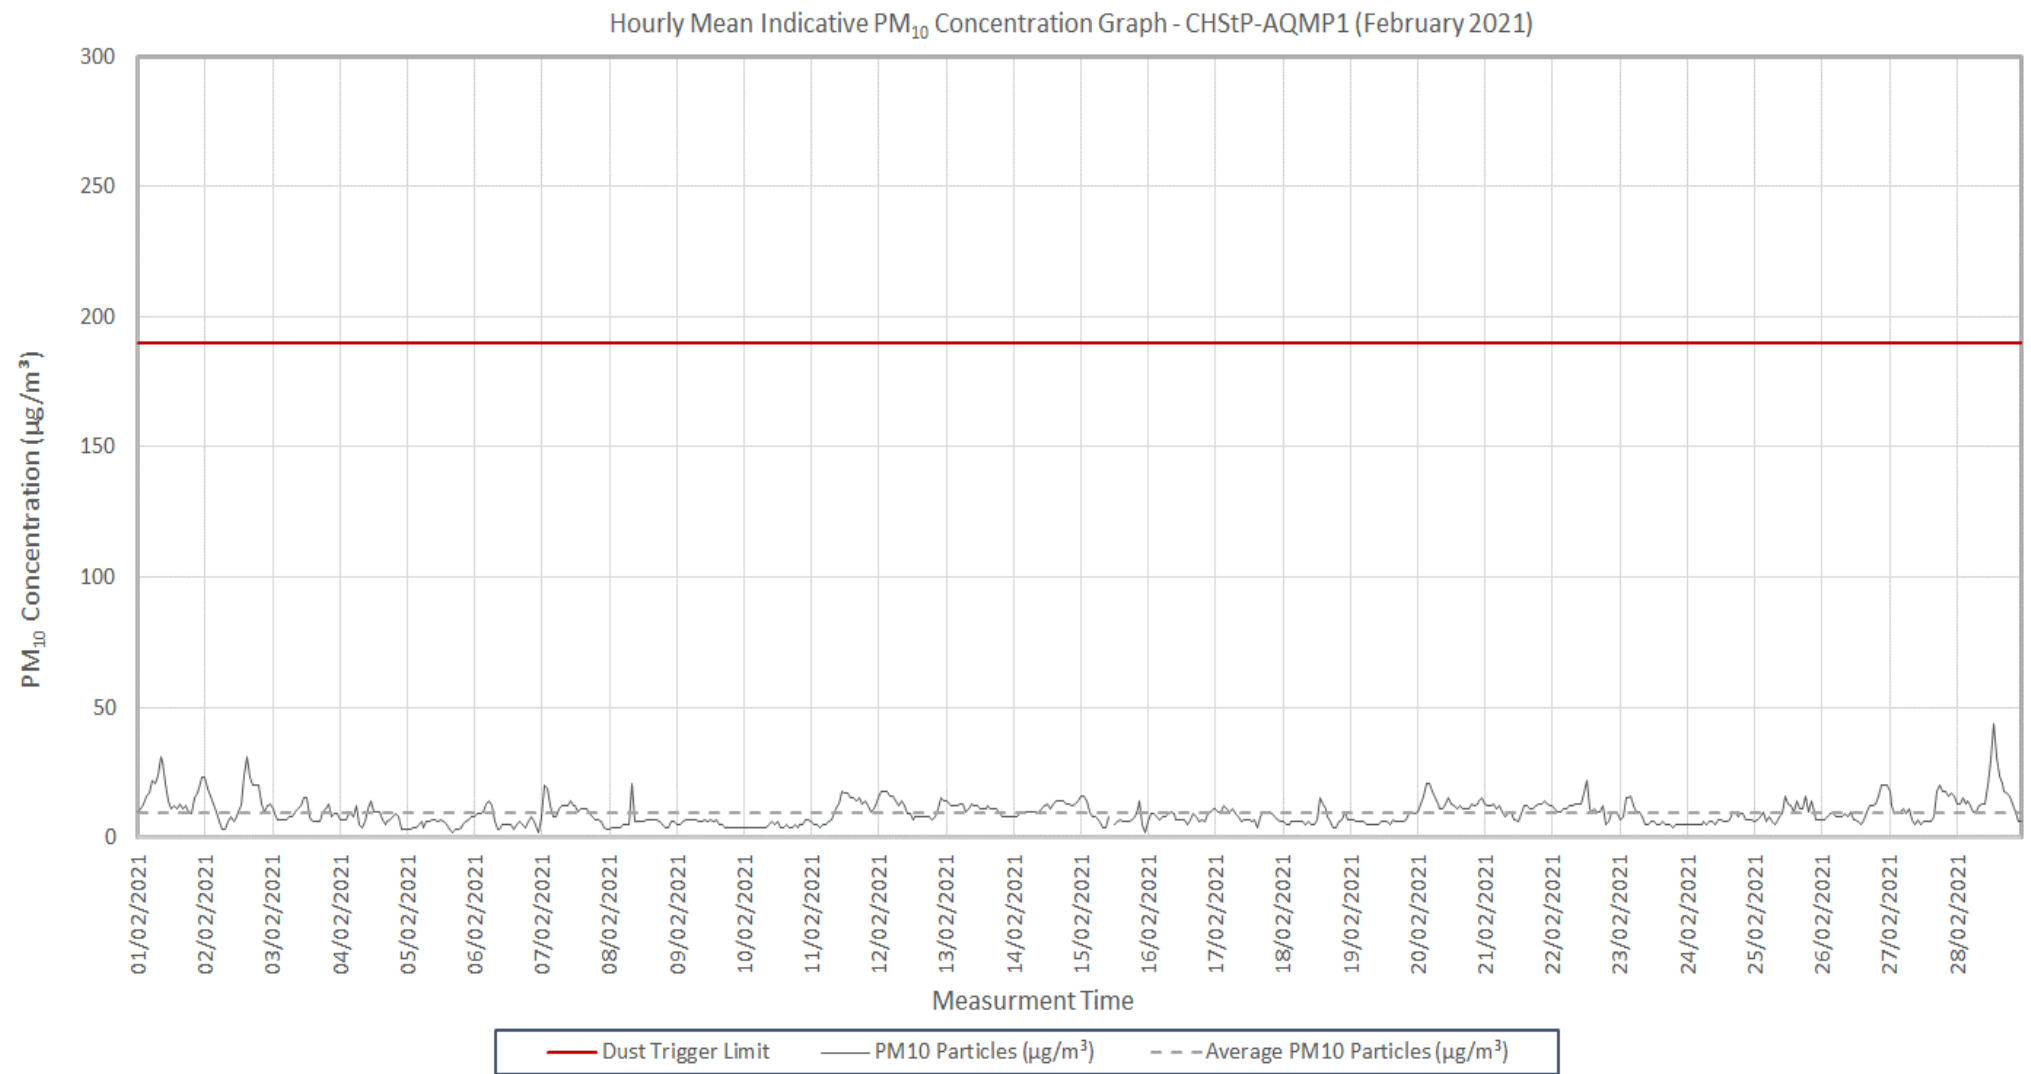
Figure 8: Continuous dust 1-hour mean indicative PM₁₀ concentration for CHStP-AQMP1 for February 2021

| Monitoring site ID | Coordinates (X,Y) | Location description | Dust risk rating for site | Monitoring site active during period | Change to site since previous period report | Mean 1-hour PM ₁₀ concentration (µg/m ³) | Minimum 1-hour PM ₁₀ concentration (µg/m ³) | Maximum 1-hour PM ₁₀ concentration (µg/m ³) | Number of 1-hour periods exceeding trigger level of 190 µg/m ³ | Data capture (%) |
|---|---|---|---|---|---|---|--|--|---|---|
| CHStP-AQMP1 | 500114, 193104 | On the eastern boundary of the site with Chesham Lane | M | Yes | Yes | 9.5 | 2.0 | 44.0 | 0 | 99.9 |

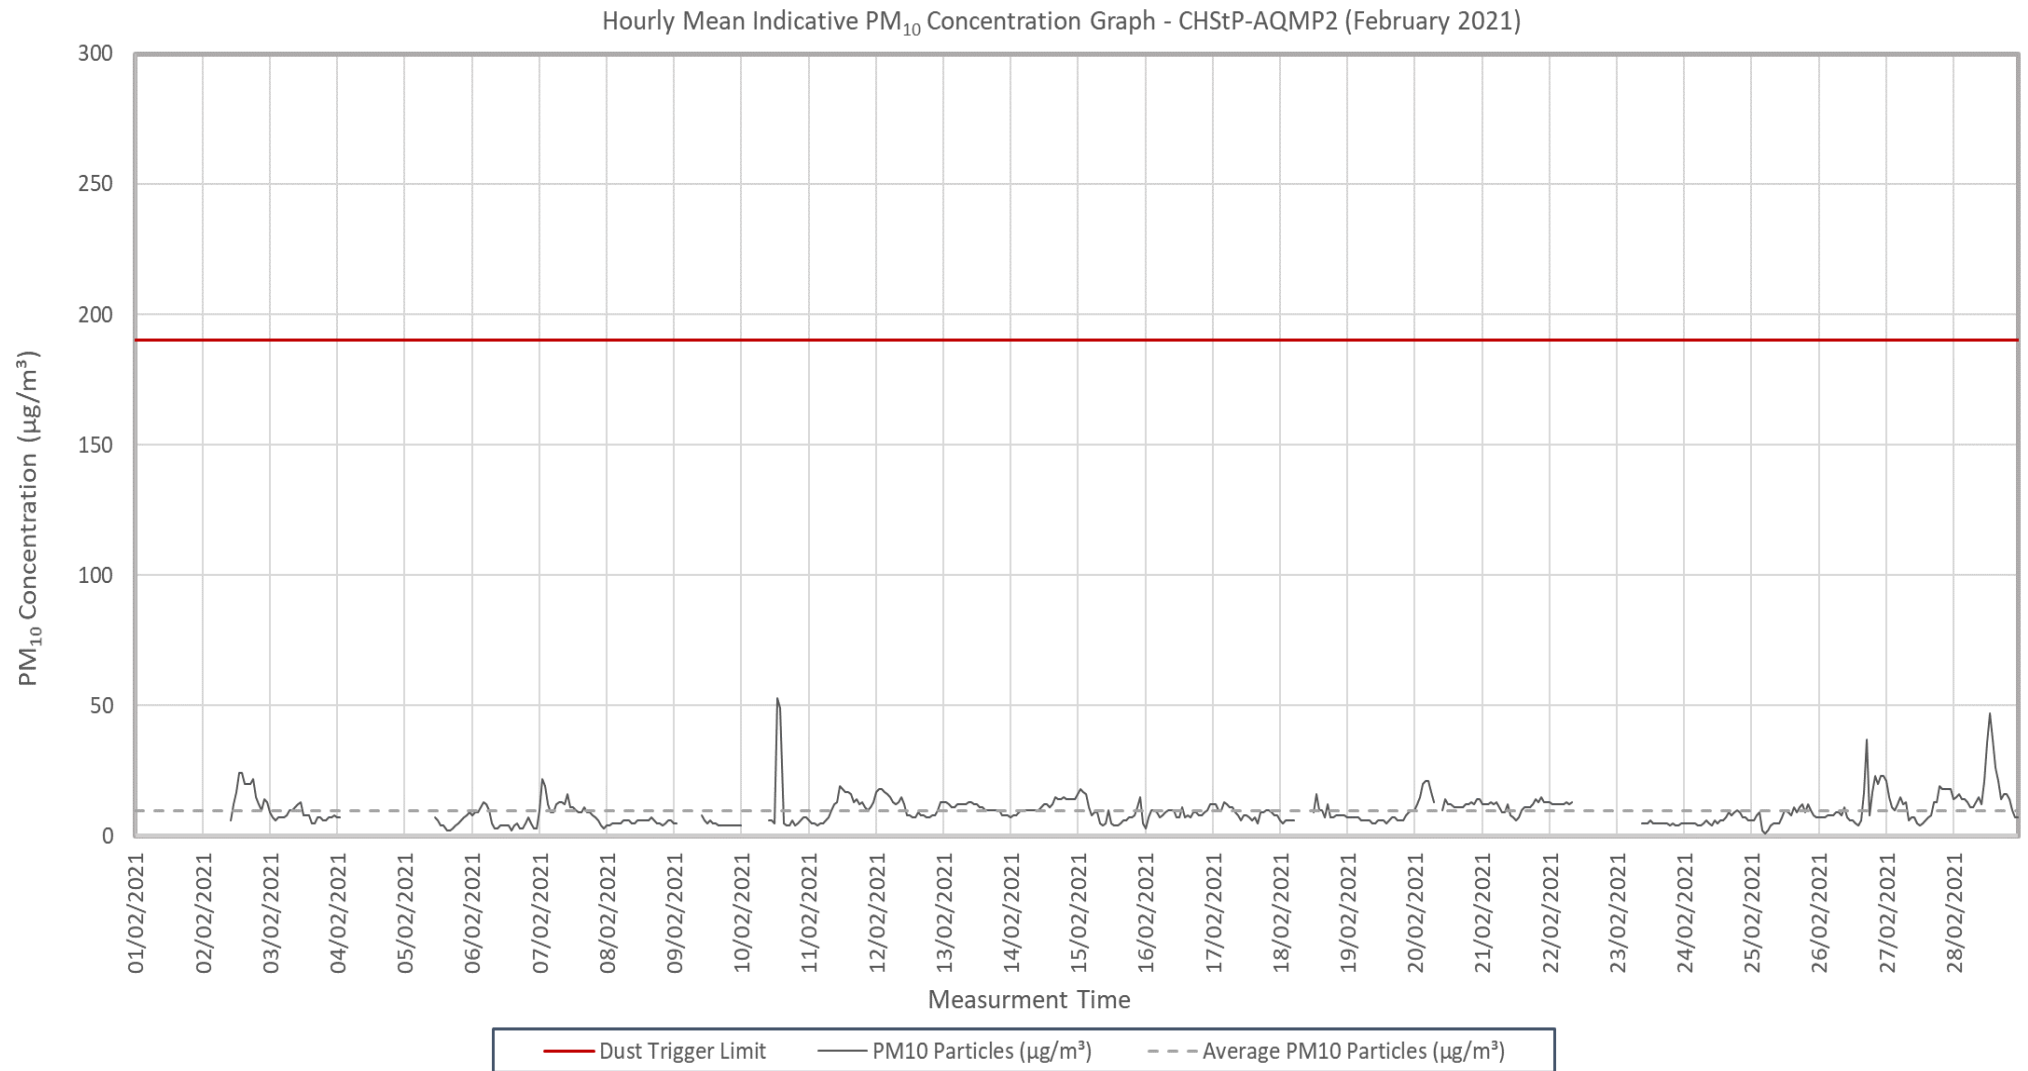
Figure 9: Continuous dust 1-hour mean indicative PM₁₀ concentration for CHStP-AQMP2 for February 2021

| Monitoring site ID | Coordinates (X,Y) | Location description | Dust risk rating for site | Monitoring site active during period | Change to site since previous period report | Mean 1-hour PM ₁₀ concentration (µg/m ³) | Minimum 1-hour PM ₁₀ concentration (µg/m ³) | Maximum 1-hour PM ₁₀ concentration (µg/m ³) | Number of 1-hour periods exceeding trigger level of 190 µg/m ³ | Data capture (%) |
|---|---|---|---|---|---|---|--|--|---|---|
| CHStP-AQMP2 | 499893, 193341 | On the western boundary of the site | M | Yes | Yes | 9.6 | 1.0 | 53.0 | 0 | 83 |

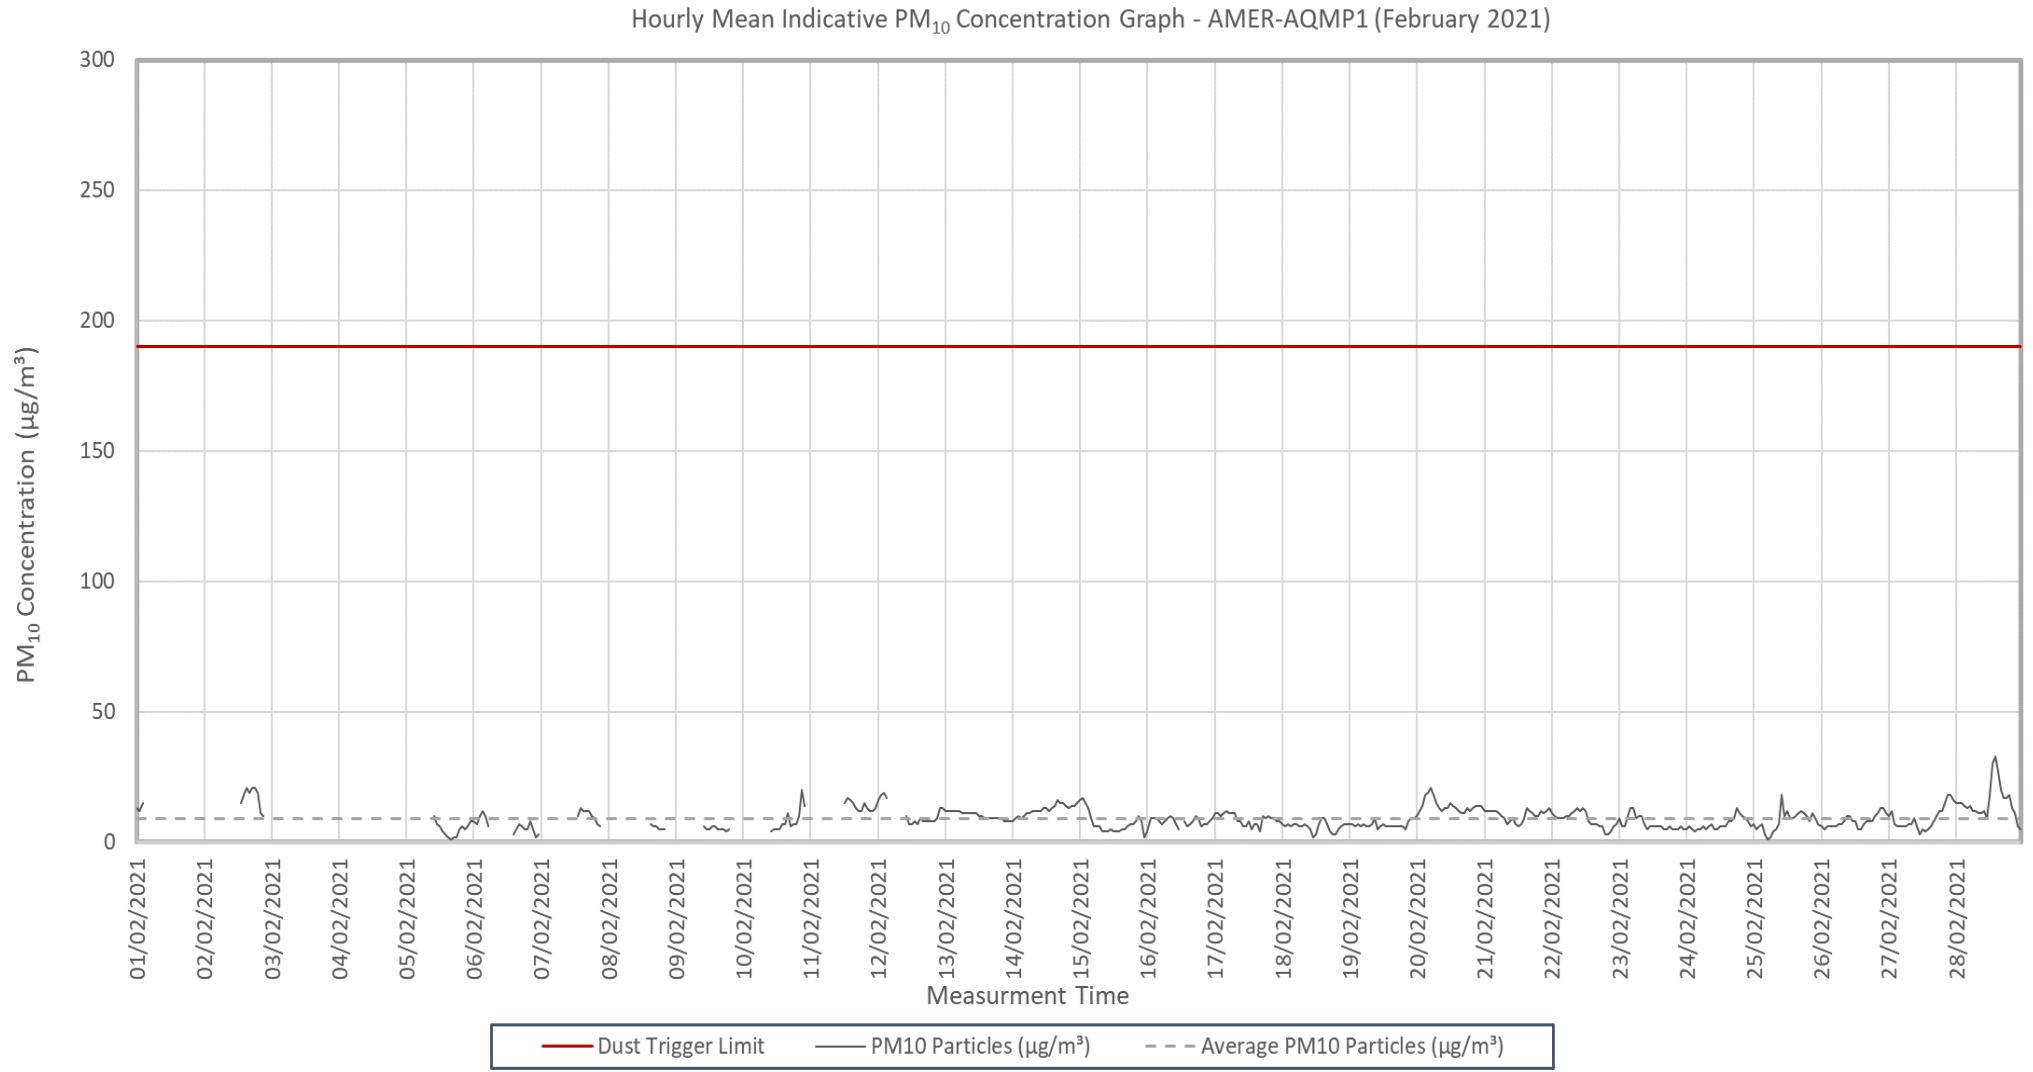
Figure 10: Continuous dust 1-hour mean indicative PM₁₀ concentration for AMER-AQMP1 for February 2021

| Monitoring site ID | Coordinates (X,Y) | Location description | Dust risk rating for site | Monitoring site active during period | Change to site since previous period report | Mean 1-hour PM ₁₀ concentration (µg/m ³) | Minimum 1-hour PM ₁₀ concentration (µg/m ³) | Maximum 1-hour PM ₁₀ concentration (µg/m ³) | Number of 1-hour periods exceeding trigger level of 190 µg/m ³ | Data capture (%) |
|---|---|---|---|---|---|---|--|--|---|---|
| AMER-AQMP1 | 495440, 196733 | On the north-eastern boundary of Amersham | M | Yes | Yes | 9.1 | 1.0 | 33.0 | 0 | 73 |

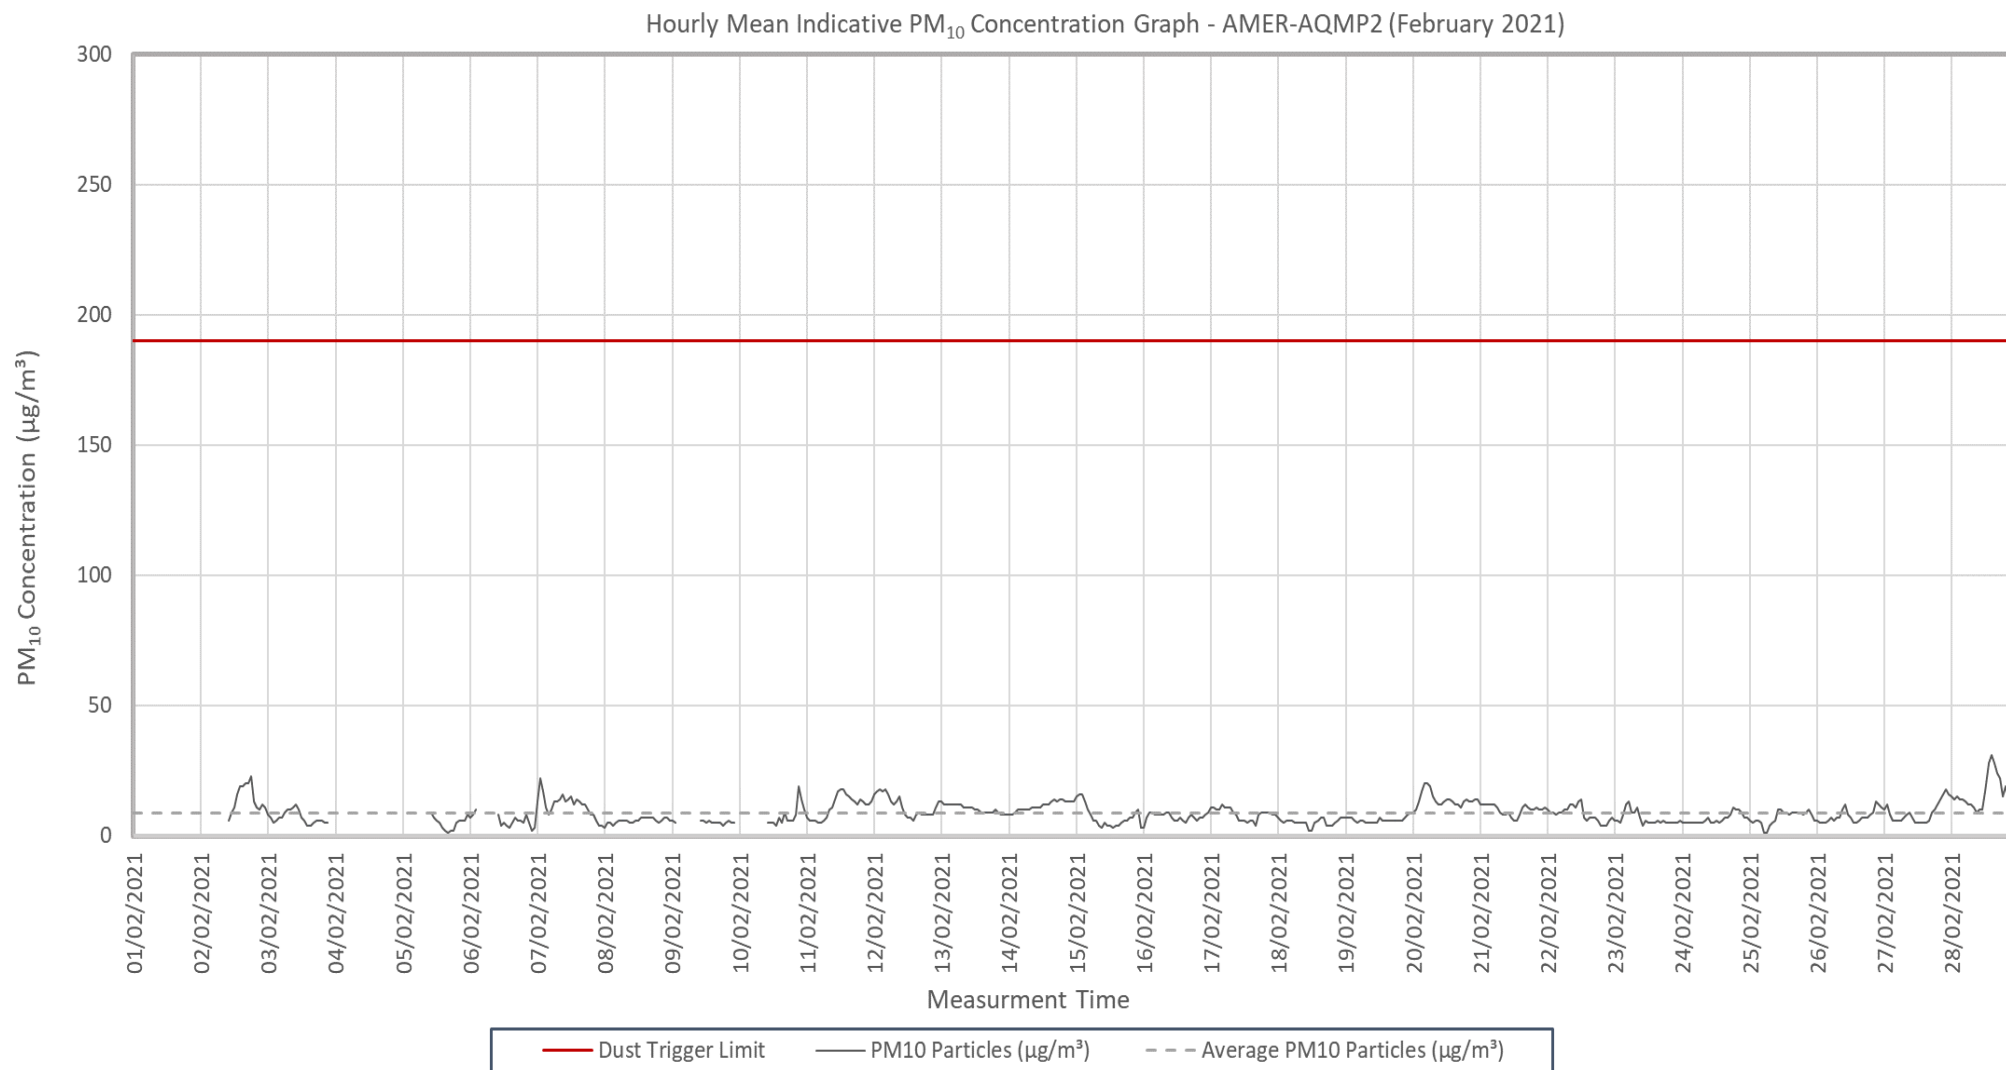
Figure 11: Continuous dust 1-hour mean indicative PM₁₀ concentration for AMER-AQMP2 for February 2021

| Monitoring site ID | Coordinates (X,Y) | Location description | Dust risk rating for site | Monitoring site active during period | Change to site since previous period report | Mean 1-hour PM ₁₀ concentration (µg/m ³) | Minimum 1-hour PM ₁₀ concentration (µg/m ³) | Maximum 1-hour PM ₁₀ concentration (µg/m ³) | Number of 1-hour periods exceeding trigger level of 190 µg/m ³ | Data capture (%) |
|---|---|---|---|---|---|---|--|--|---|---|
| AMER-AQMP2 | 495280, 196532 | On the south-western boundary of Amersham | M | Yes | Yes | 8.8 | 1.0 | 31.0 | 0 | 86 |

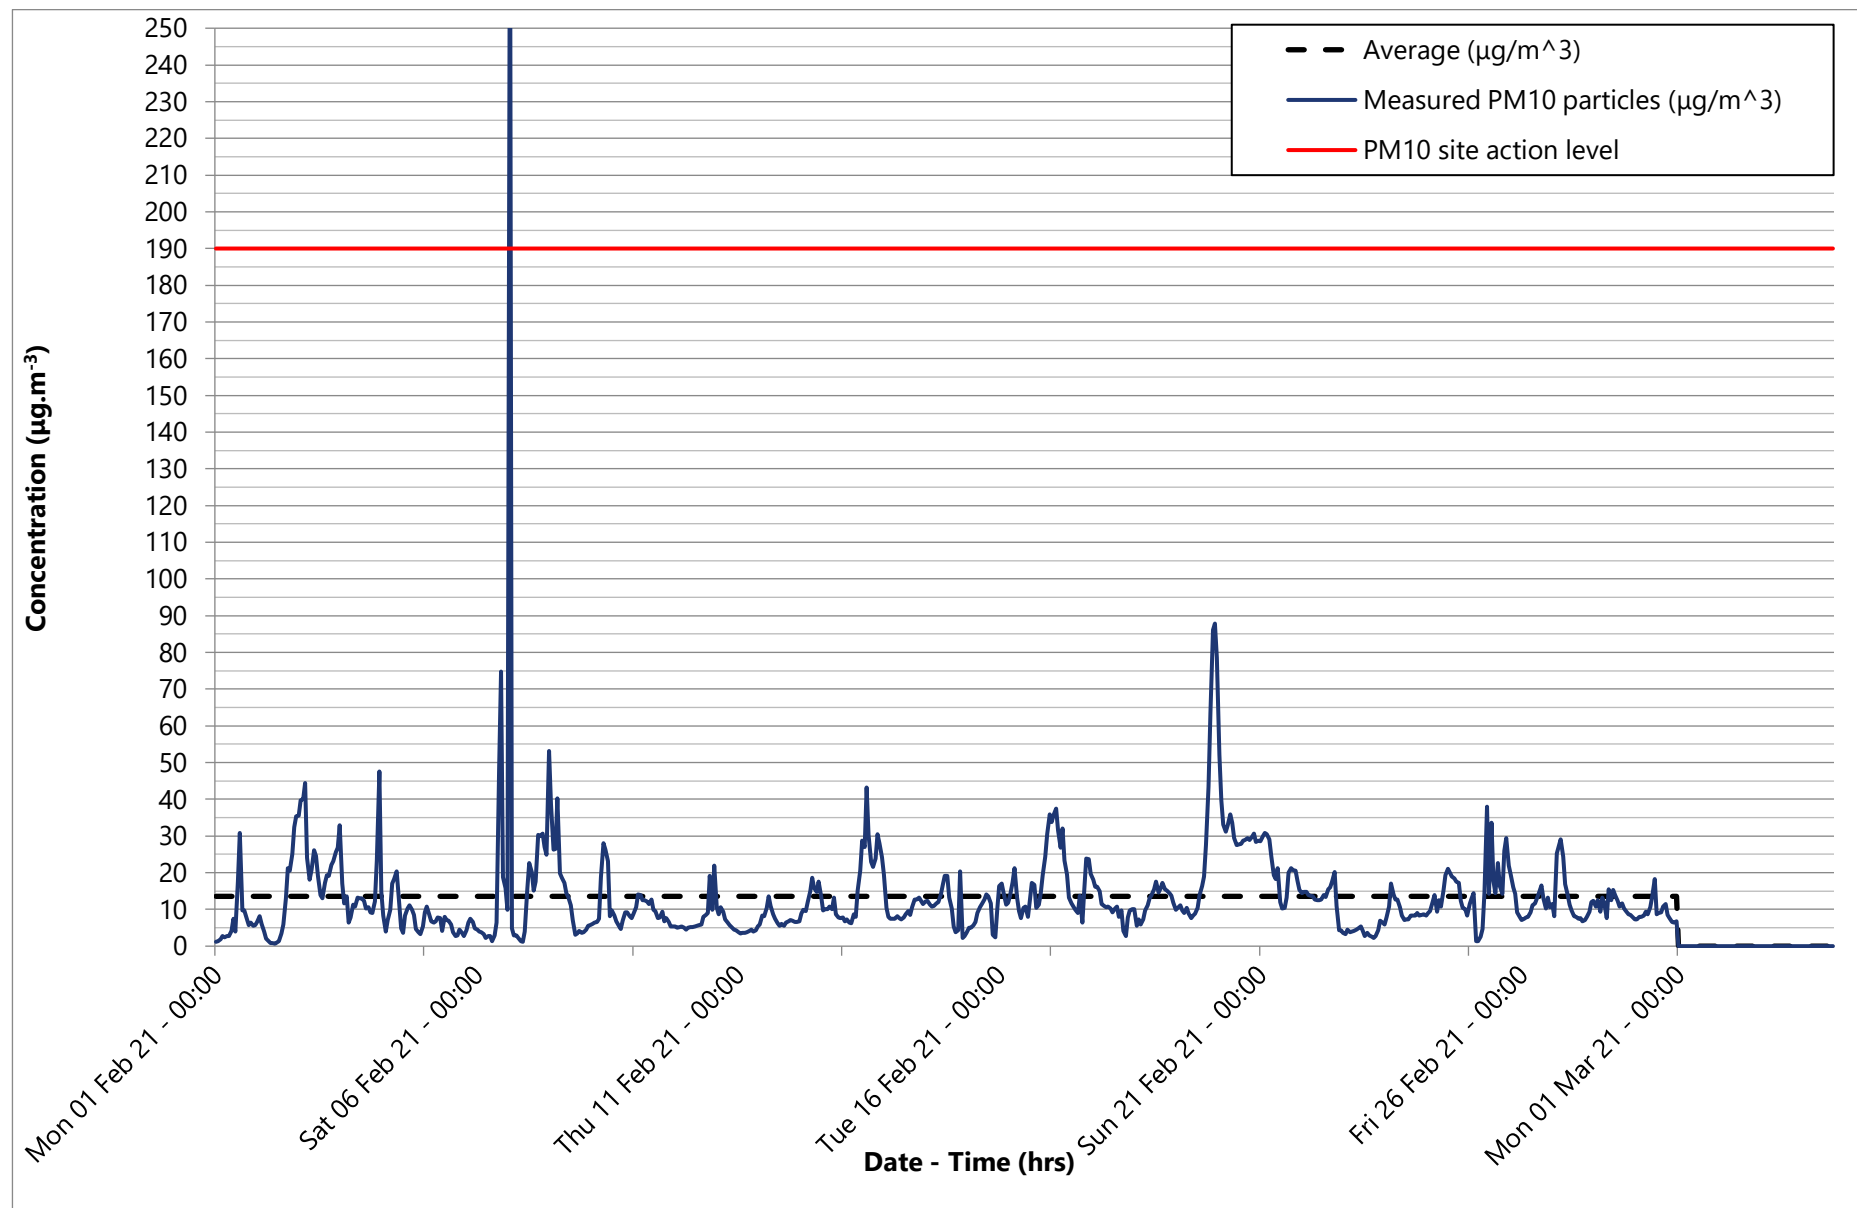
Figure 12: Continuous dust 1-hour mean indicative PM₁₀ concentration for 3252Dust2 (Elm Tree Cottage) for February 2021

| Monitoring Site ID | Period of trigger alert & Concentration recorded | Investigation | Outcomes / Resolution / Remedial measures implemented |
|---|---|---|---|
| 3252Dust2 | 06/02/2021 16:01 – 17:00: 301.3 µg/m ³ | On investigation, it was identified that there were no HS2 works at this time and it was believed the trigger alert may have been caused by renovation works at the property adjacent to the monitor. | N/A |

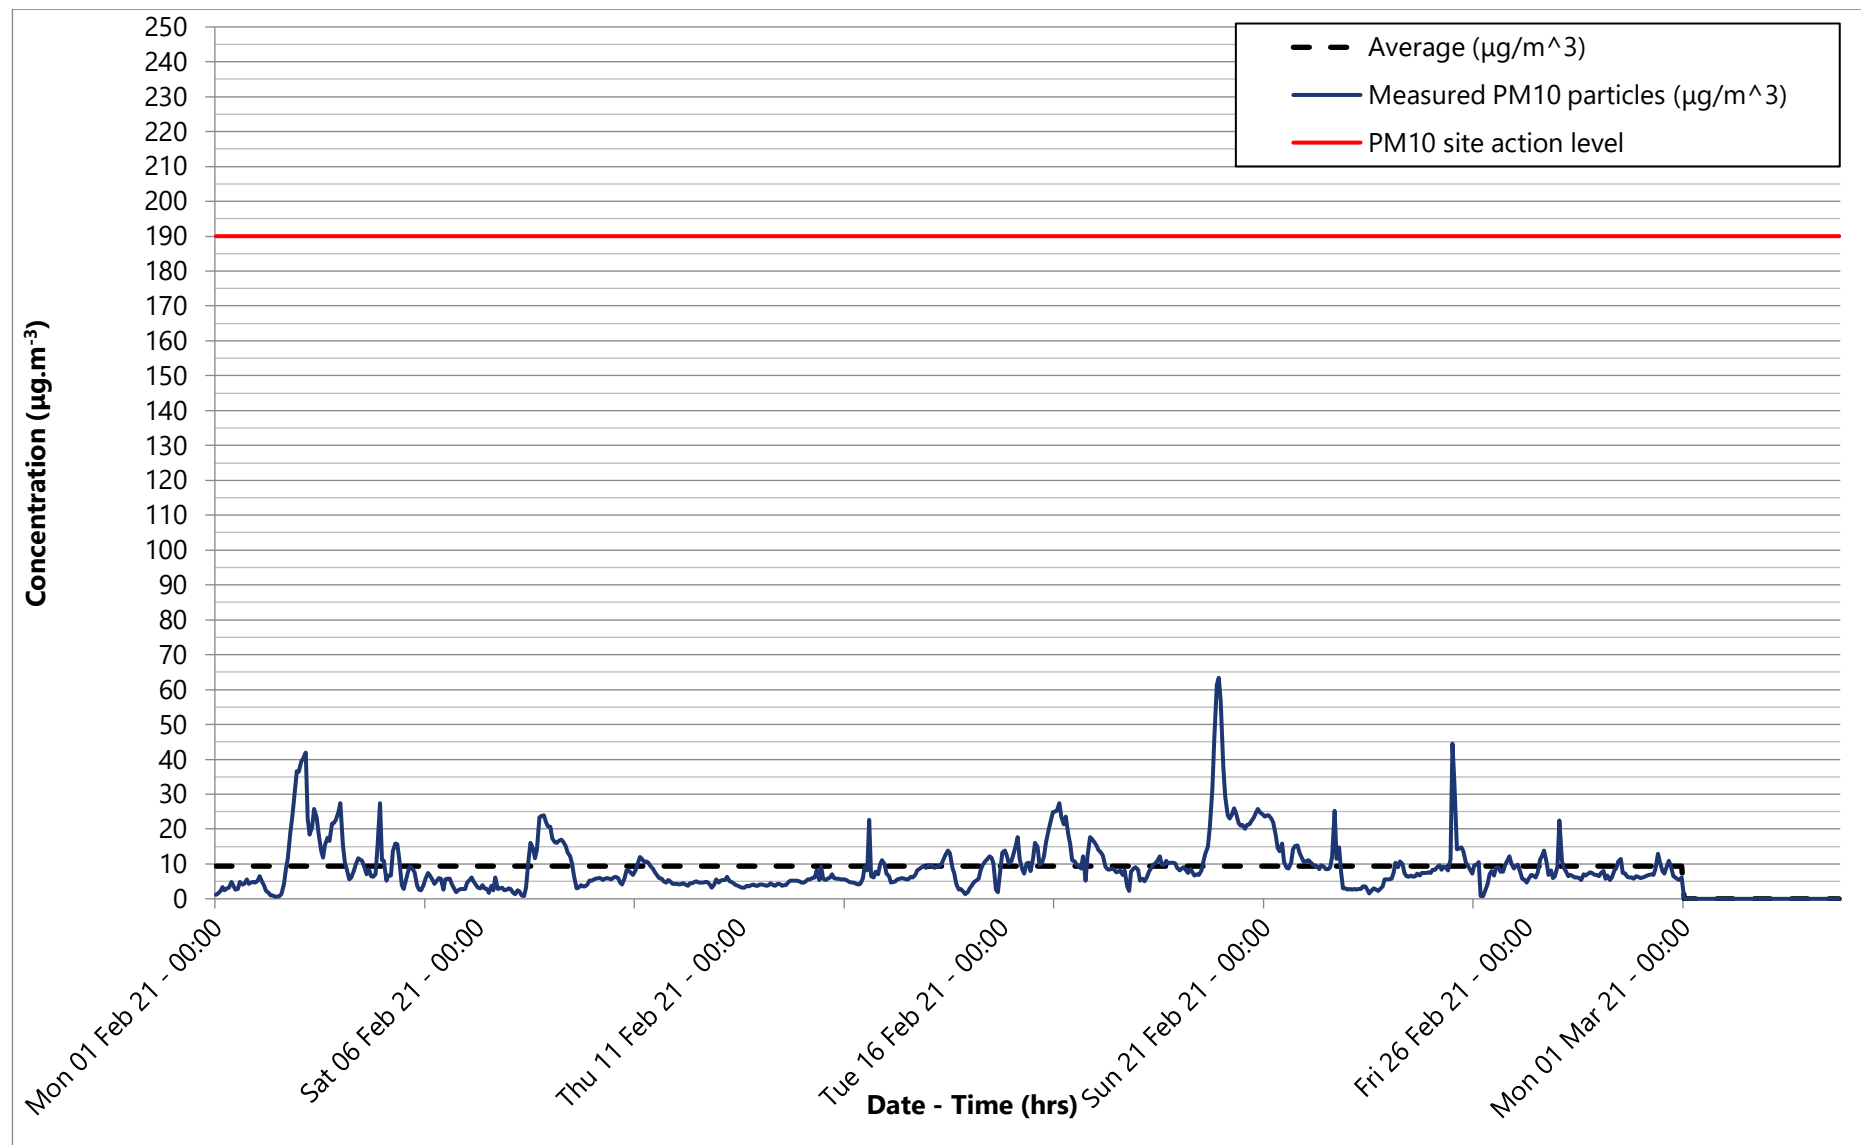
Figure 13: Continuous dust 1-hour mean indicative PM₁₀ concentration for 3252Dust3 (Lower Bottom House Farm) for February 2021
