Air Quality and Dust Monitoring Monthly Report – February 2021 **Buckinghamshire** Council

A report prepared by EWCs and MWCCs on behalf of HS2 Ltd.

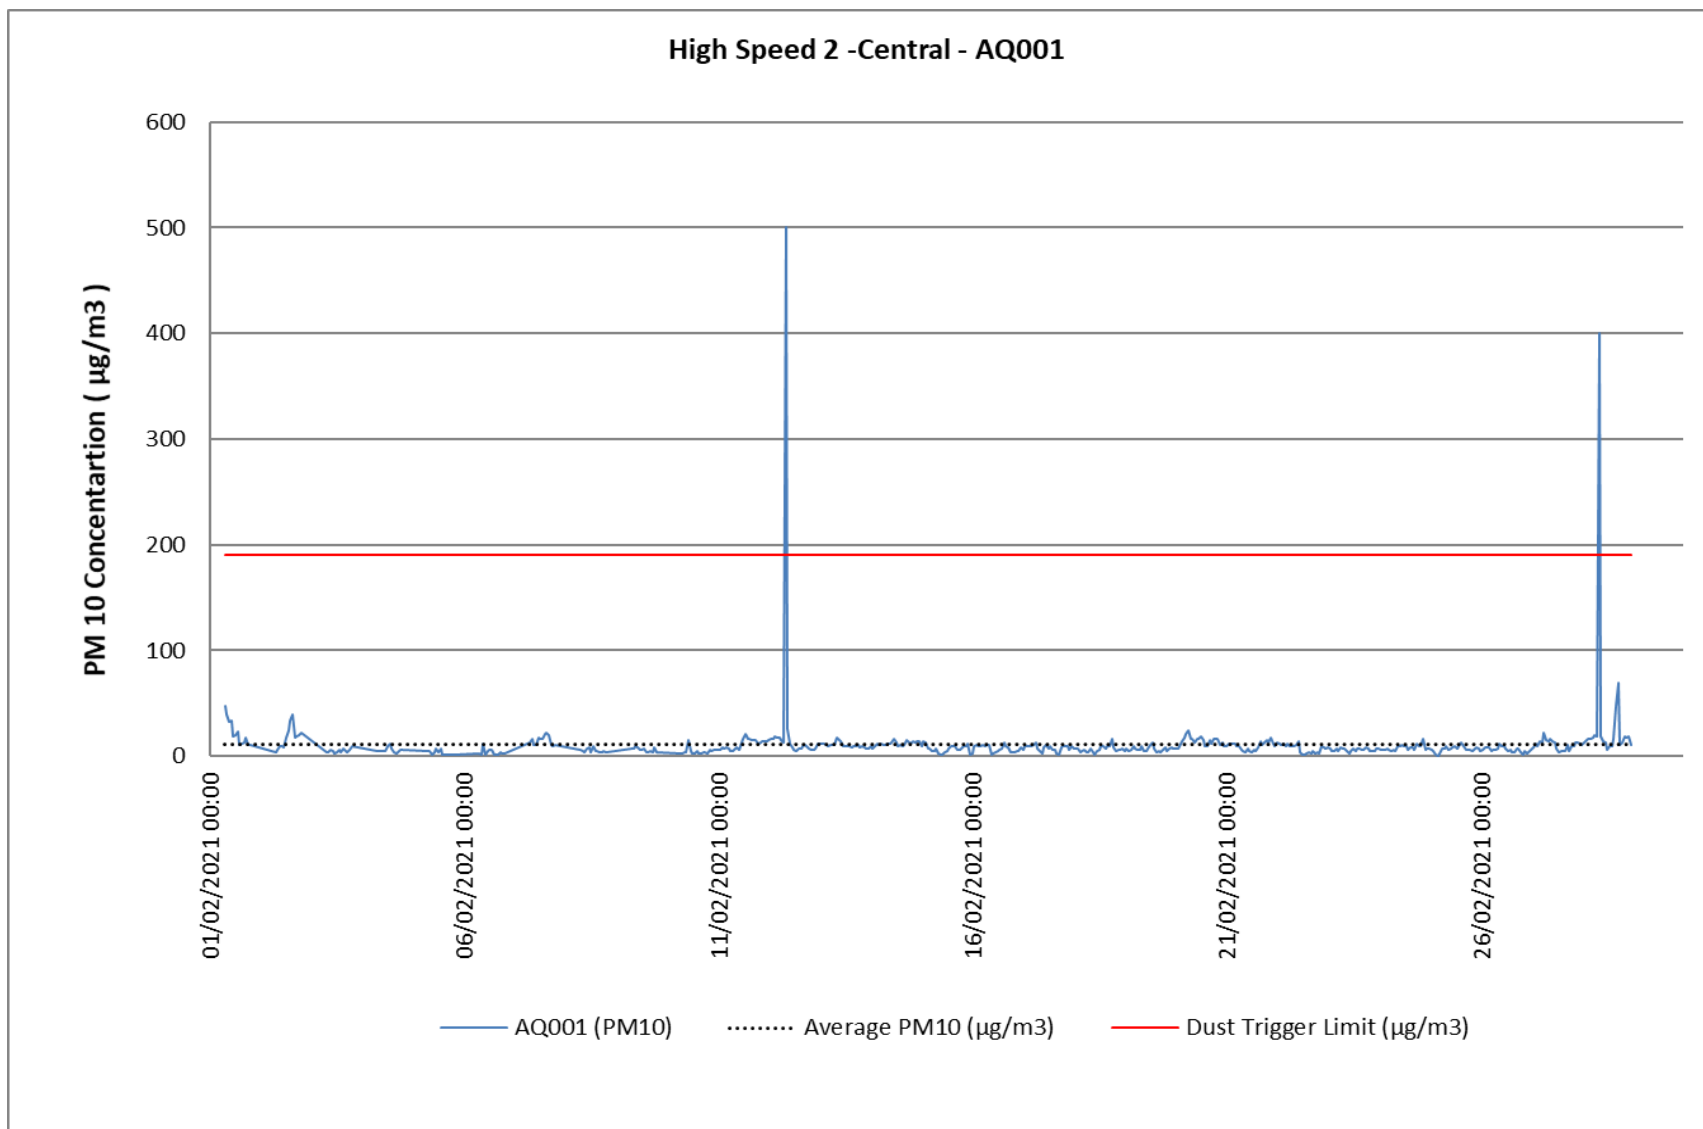
Figure 14: Continuous dust 1-hour mean indicative PM10 concentration for AQ001 for February 2021

- 1.1.6 Dust monitoring locations and results for February 2021 are presented in Appendix B, Table 1, together with a line chart of monthly data from each dust monitor presented in Figures 6 to 15. All continuous dust monitoring is undertaken using indicative monitors. Despite being Environment Agency (MCERTS) certified, indicative monitors carry a higher level of uncertainty than reference monitors, and therefore cannot be strictly compared with Air Quality Standards for human health and the environment. The purpose of the monitoring undertaken is to ensure the effectiveness of the on-site mitigation.

| AQ001 | 471524, 221329 | Woodlands Farm | M | Yes | No | 10.8 | 1 | 500* | 2 | 100 |

* As noted in Table 2, these concentrations are considered to be due to a monitor fault (monitor maintenance schedule in place).

| Monitoring Site ID | Period of trigger alert & Concentration recorded | Investigation | Outcomes / Resolution / Remedial measures implemented |
|---|---|---|---|
| | 28/02/2021 08:01 – 09:00: 400 µg/m ³ | | |

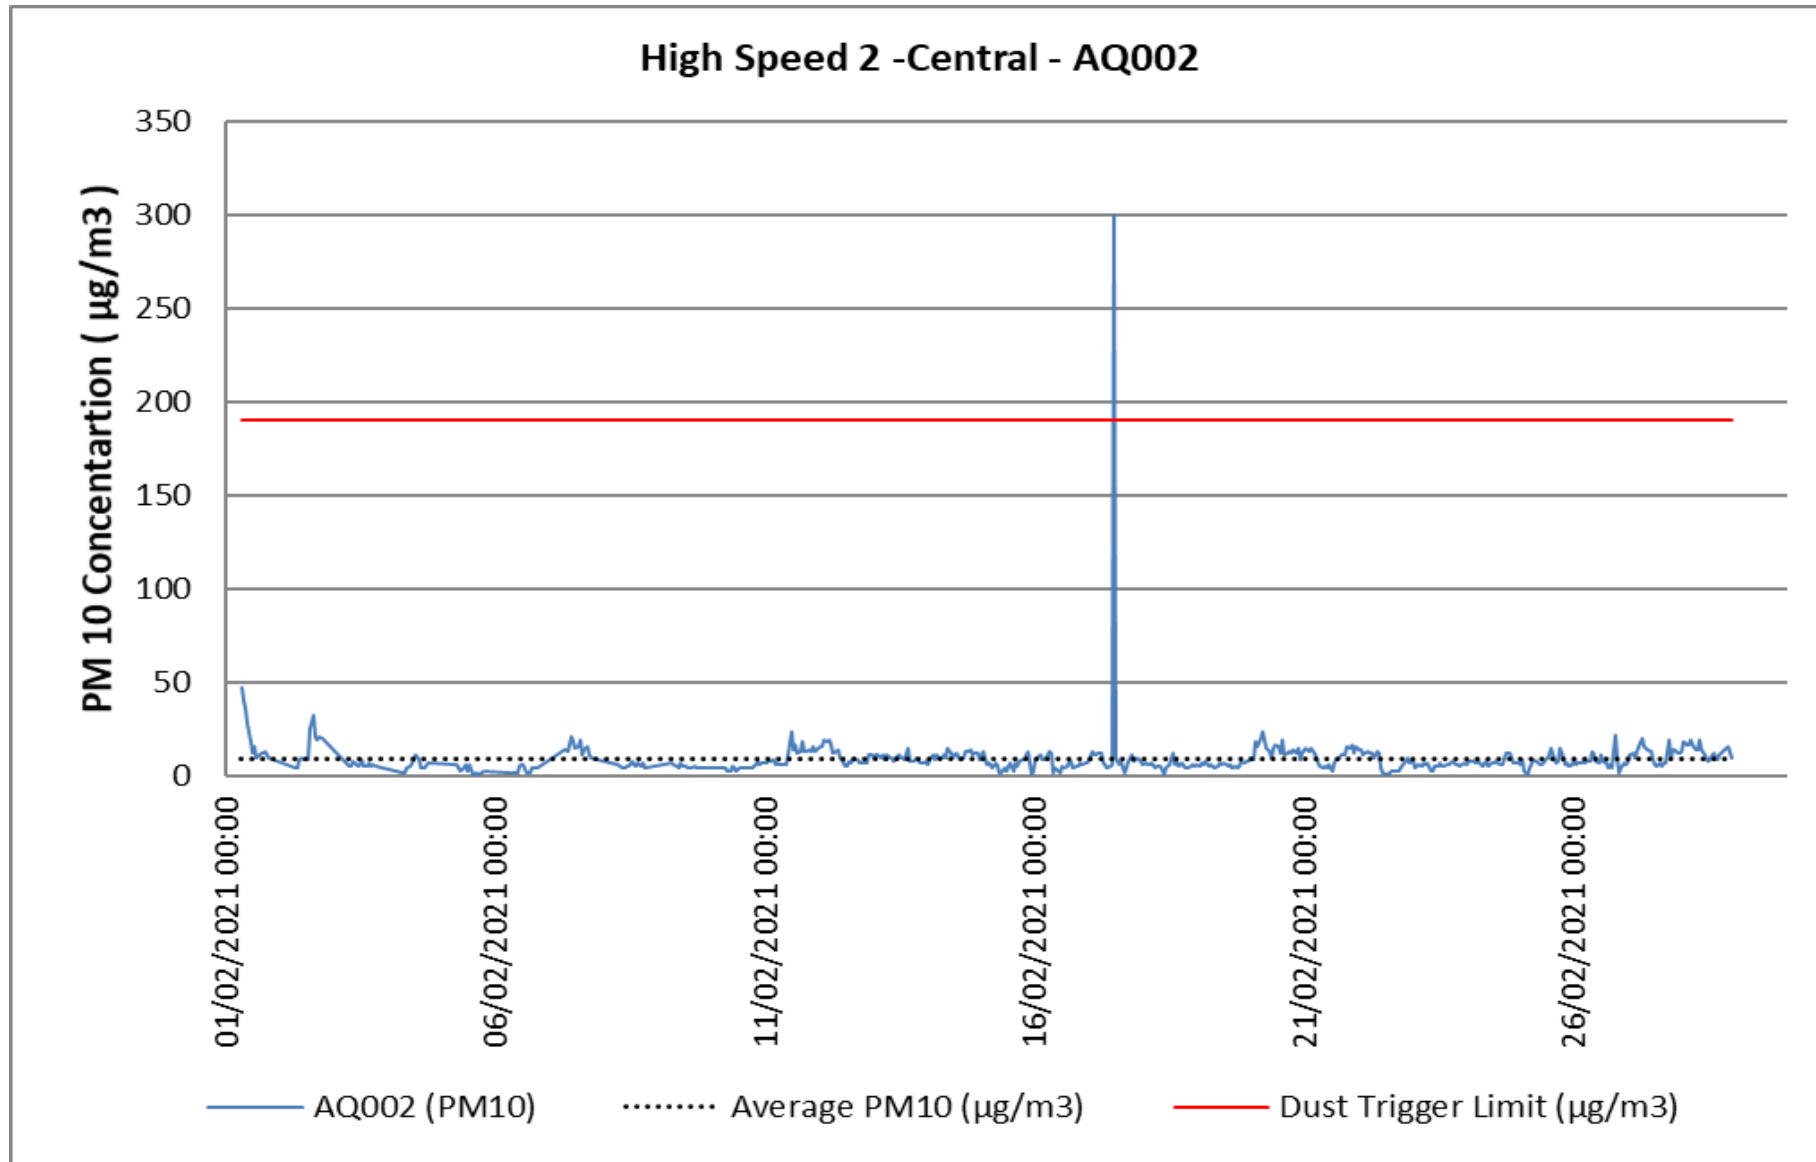
Figure 15: Continuous dust 1-hour mean indicative PM10 concentration for AQ002 for February 2021

| AQ002 | 471654, 221030 | Woodlands Cottage | M | Yes | No | 9.3 | 1 | 300* | 1 | 100 |

| Monitoring Site ID | Period of trigger alert & Concentration recorded | Investigation | Outcomes / Resolution / Remedial measures implemented |
|---|---|---|---|
| AQ002 | 17/02/2021 12:01 – 13:00: 300 µg/m ³ | | |
