April 2021

Construction noise and vibration Monthly Report – February 2021

Buckinghamshire

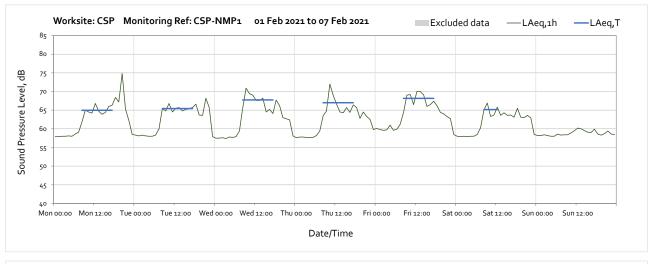
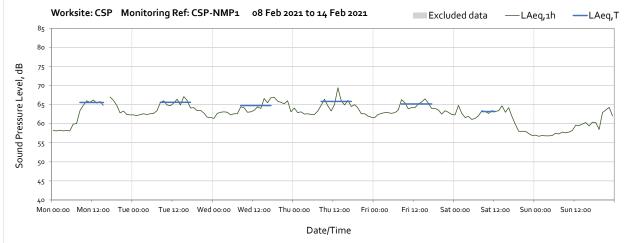
Worksite: CSP – Monitoring Ref: CSP-NMP1

The following graphs show the hourly measured ambient noise level $L_{Aeq,1h}$ and, where relevant, the averaged noise level $L_{Aeq,T}$ values, where the time period T is as specified in Table 1 of HS2 Information Paper E23. Periods with adversely weather affected noise levels are greyed out and have been excluded from the calculation of the $L_{Aeq,T}$ values in Table 3 of the main report.

Note: Missing data between 16:00 and 17:00 on Monday 8th February was due to the monitoring being paused during maintenance operations.

2.1.3 Appendix C presents graphs of the noise and vibration monitoring data over the month for each of the measurement locations. Noise data presented consists of the hourly L_{Aeq} values and, where relevant, the L_{Aeq,T} values (where the time period T has been taken to be the averaging period as specified in Table 1 of HS2 Information Paper E23). Vibration data presented consist of hourly PPV values. The full data set for the monitoring equipment can be found at the following location: https://data.gov.uk/dataset/24542ae7-dd44-444f-b259-871c4cc43b5e/environmental-monitoring-data.

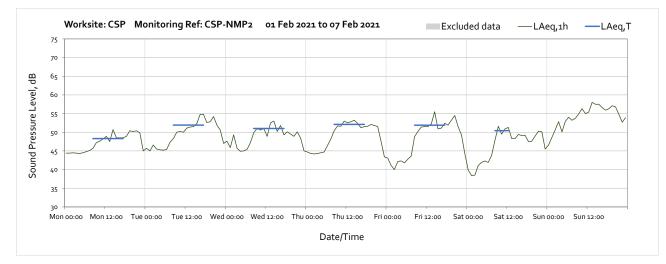
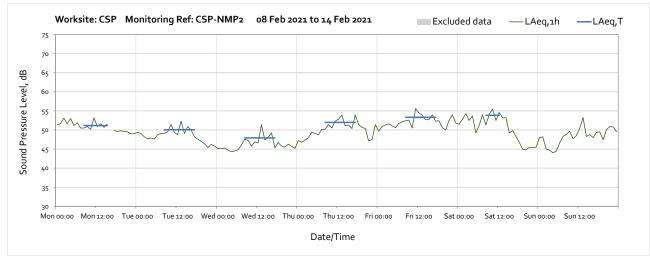
Worksite: CSP - Monitoring Ref: CSP-NMP2

Note: Missing data between 16:00 and 17:00 on Monday 8th February was due to the monitoring being paused during maintenance operations.

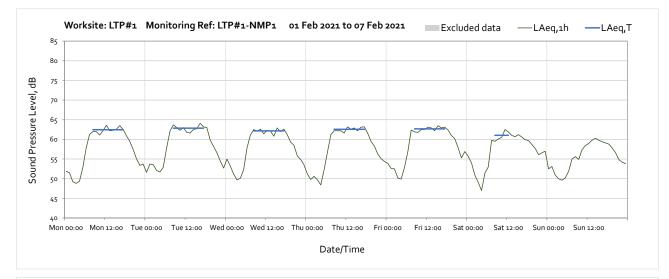
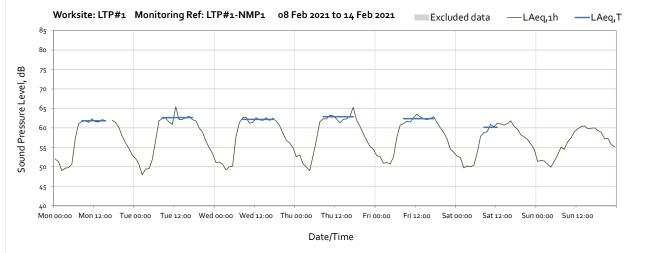
Worksite: LPT#1 - Monitoring Ref: LPT#1-NMP1

Note: Missing data between 16:00 and 17:00 on Monday 8th February was due to the monitoring being paused during maintenance operations and setting adjustments.

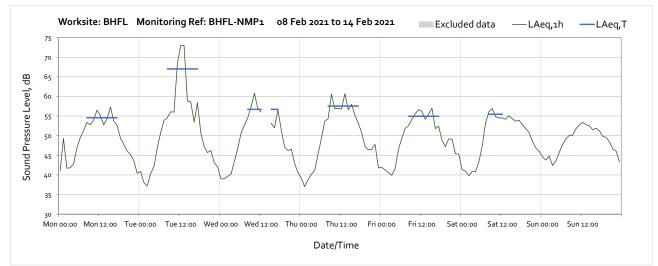
Worksite: BHFL – Monitoring Ref: BHFL-NMP1

Note: Missing data from 13:00 until 15:00 on Wednesday 10th February was due to the reinstallation of the microphone.

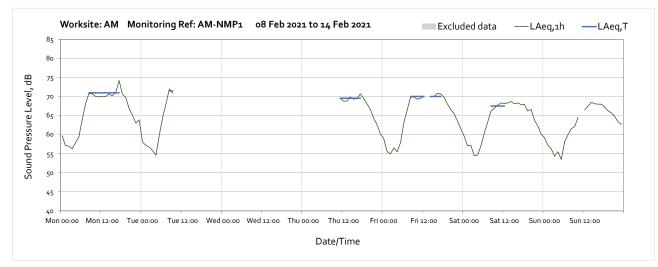
Worksite: AM - Monitoring Ref: AM-NMP1

Note: Missing data from 10:00 on Tuesday 9th February until 11:00 on Thursday 11th February was due to power supply failure (adverse weather), also missing data sporadically throughout February was due to the monitoring being paused during maintenance operations and setting adjustments.

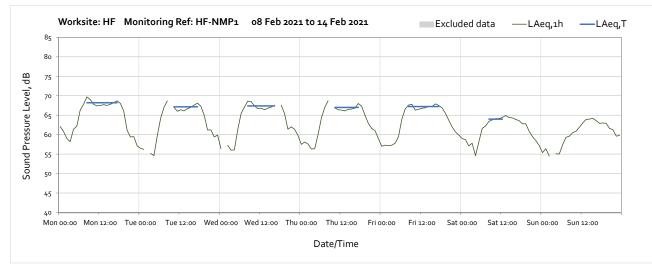
Note: Missing data sporadically throughout February was due to equipment failure. OFFICIAL

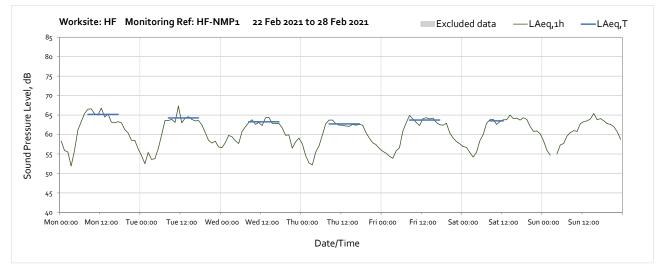
Note: Missing data sporadically throughout February was due to equipment failure.

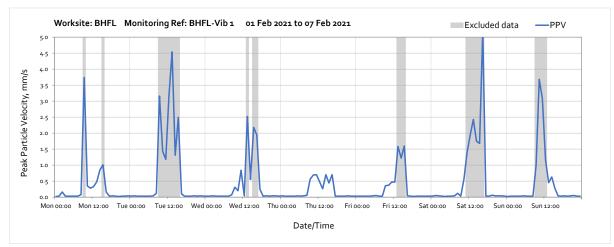
Worksite: BHFL - Monitoring Ref: BHFL-Vib 1

The following graphs show the hourly measured peak particle velocity PPV recorded during the monitoring period. The graphs show the highest PPV of the three orthogonal axes x, y and z. Where high values of PPV were caused by local interference with the vibration monitor, which are not representative of HS2 construction works, these values have been greyed out in the following charts and have been excluded to calculate values in Table 4 of the main report.

Note: High PPV values greyed out were due to renovation works in the property.

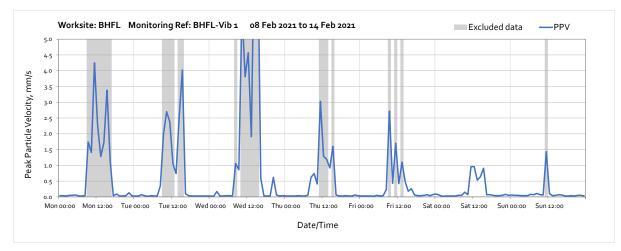
Note: High PPV values greyed out were due to renovation works in the property.

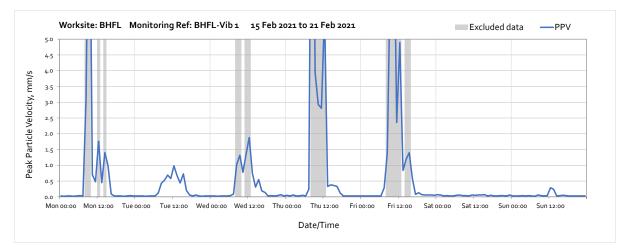
Note: High PPV values greyed out were due to renovation works in the property.

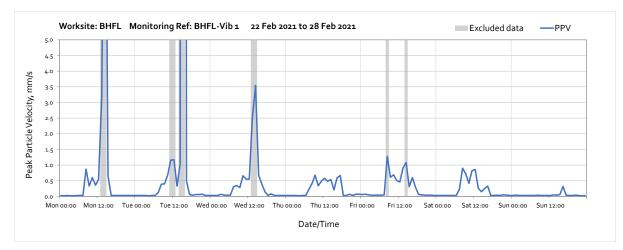
Note: High PPV values greyed out were due to renovation works in the property.
