Construction noise and vibration Monthly Report – May 2021

London Borough of Camden

Non-Technical Summary

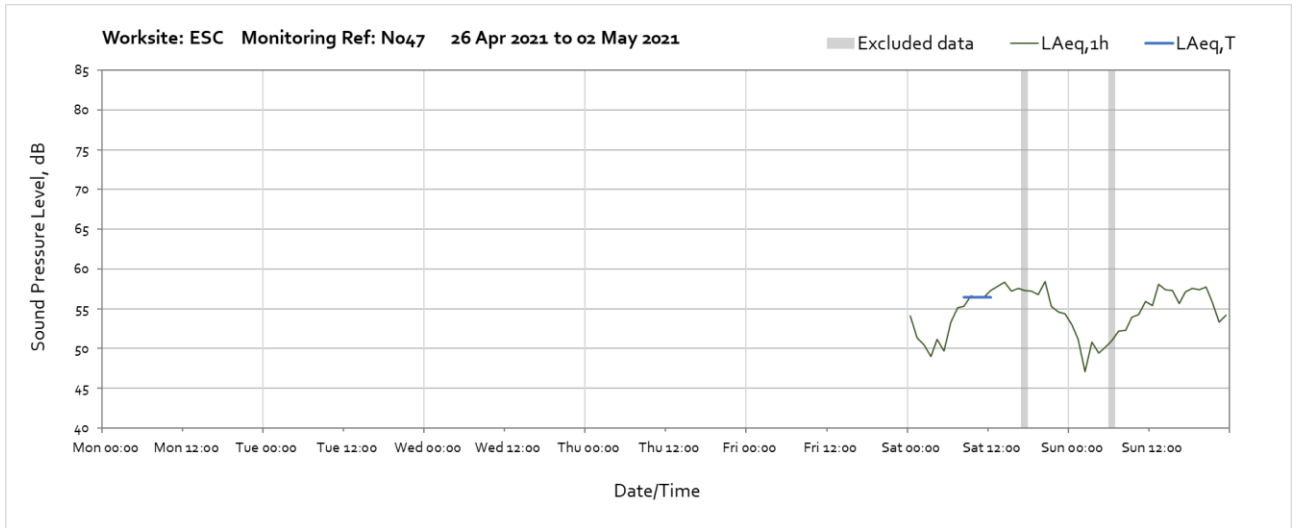
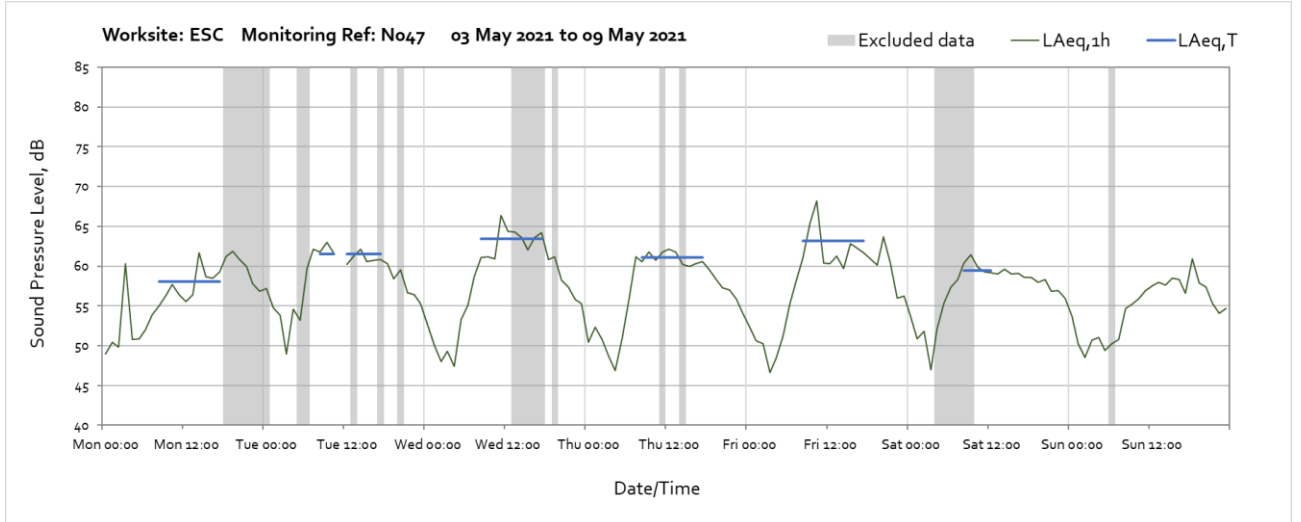
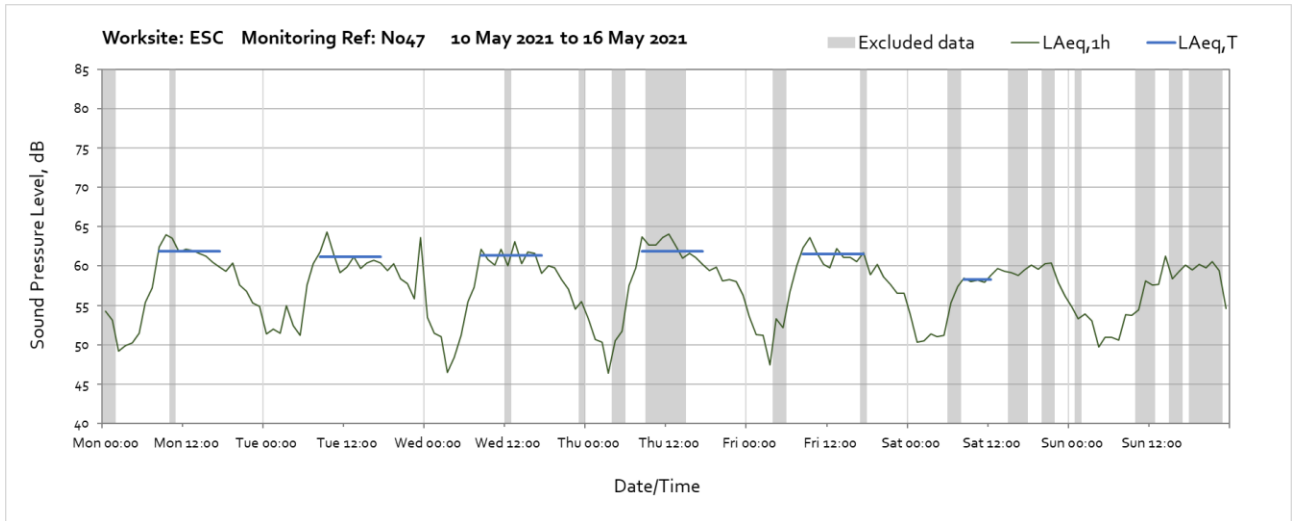
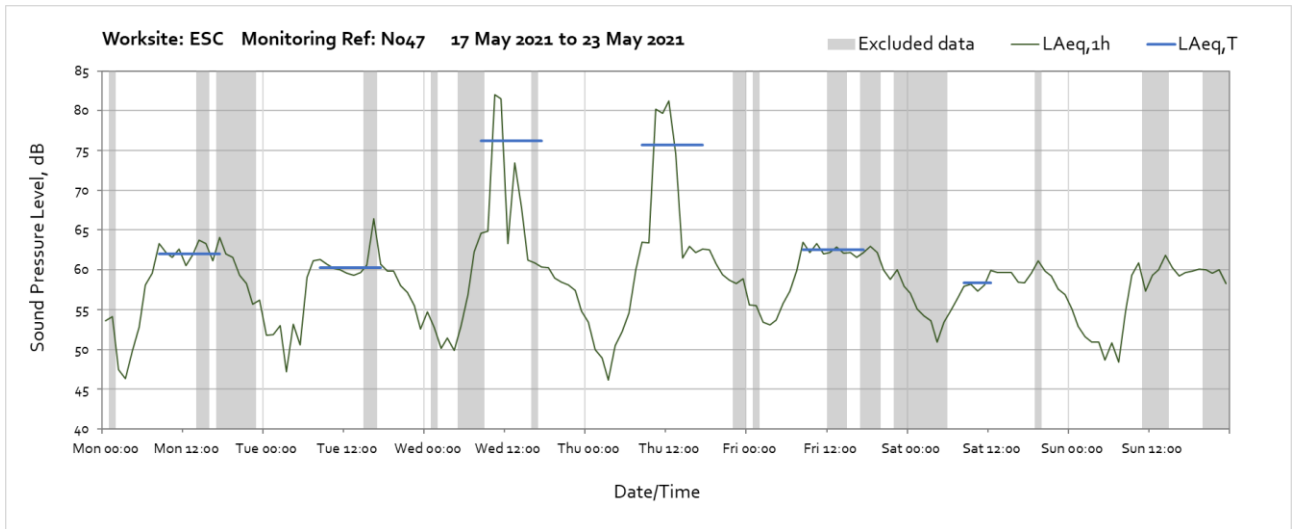
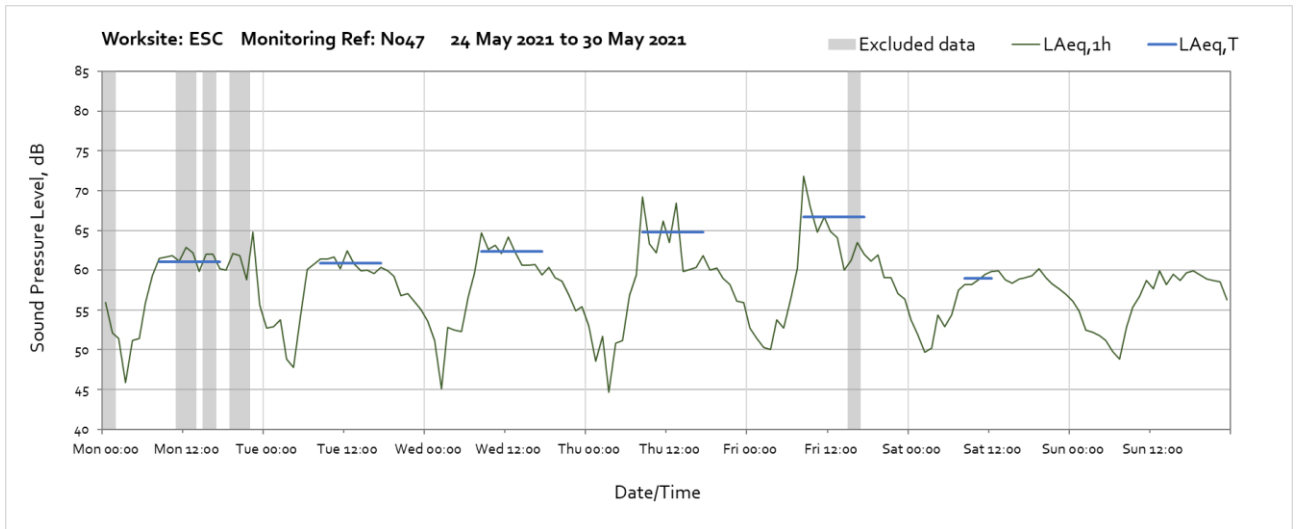
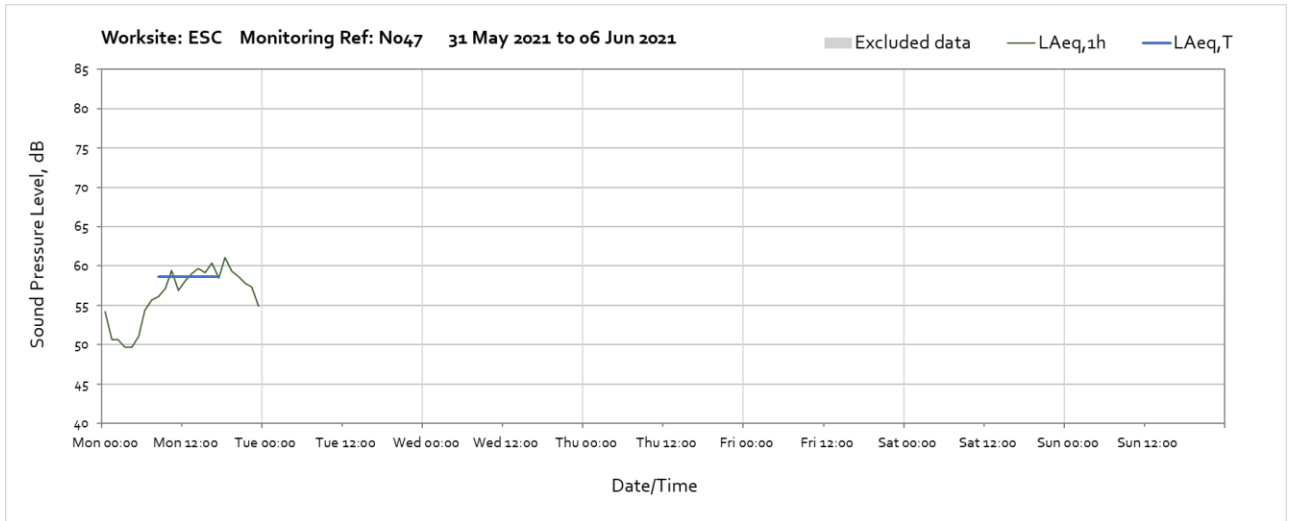
Worksite: ESC – Monitoring Ref: N047

Note: Missing data between 11:00 until 12:00 on Tuesday 4th May was due to a memory card error.

2.1.3 Appendix C presents graphs of the noise and vibration monitoring data over the month for each of the measurement locations. Noise data presented consists of the hourly L_{Aeq} values and, where relevant, the $L_{Aeq,T}$ values (where the time period T has been taken to be the averaging period as specified in Table 1 of HS2 Information Paper E23). Vibration data presented consist of hourly PPV values. The full data set for the monitoring equipment can be found at the following location: <https://data.gov.uk/dataset/24542ae7-dd44-444f-b259-871c4cc43b5e/environmental-monitoring-data>.

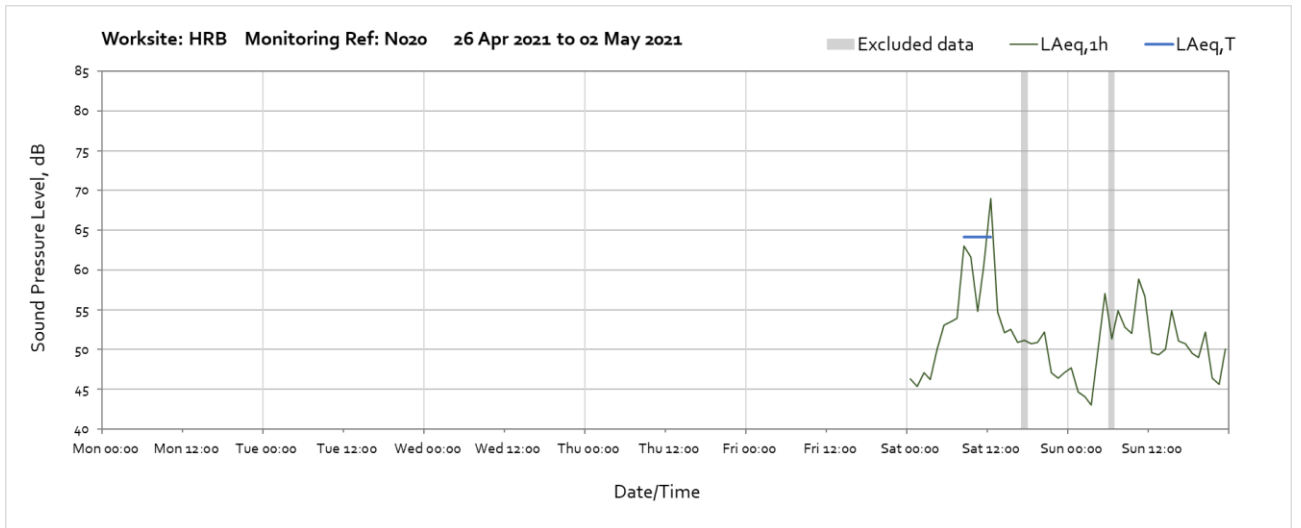
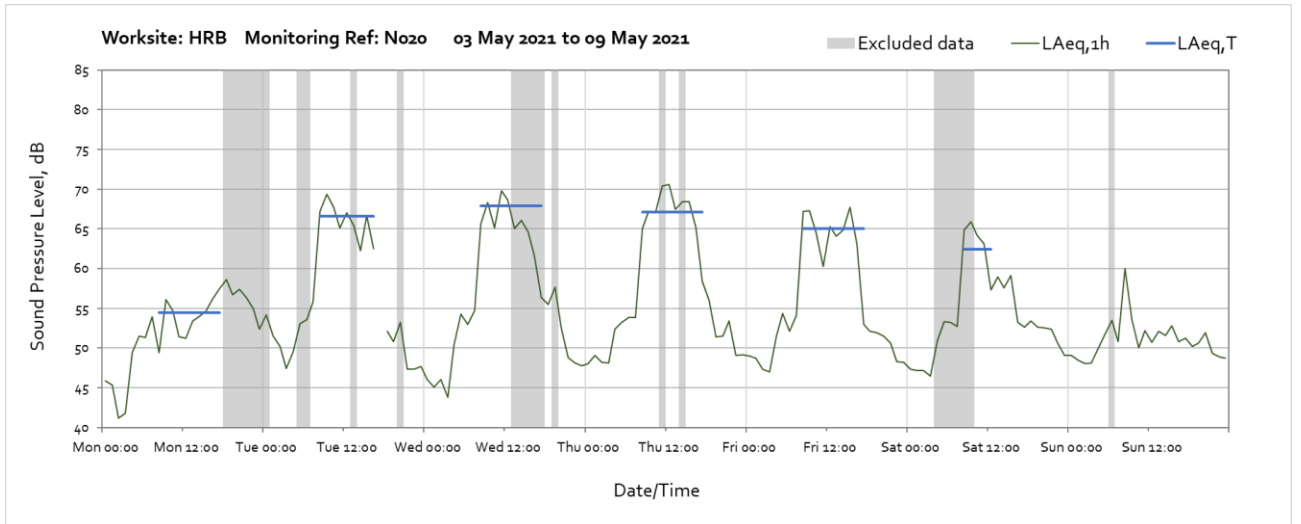
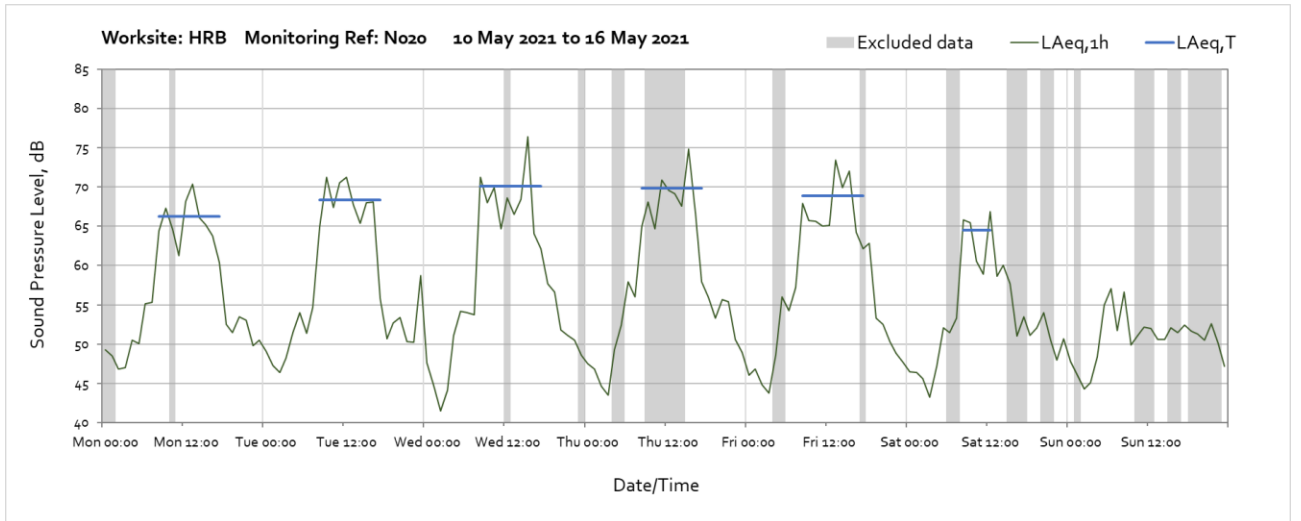
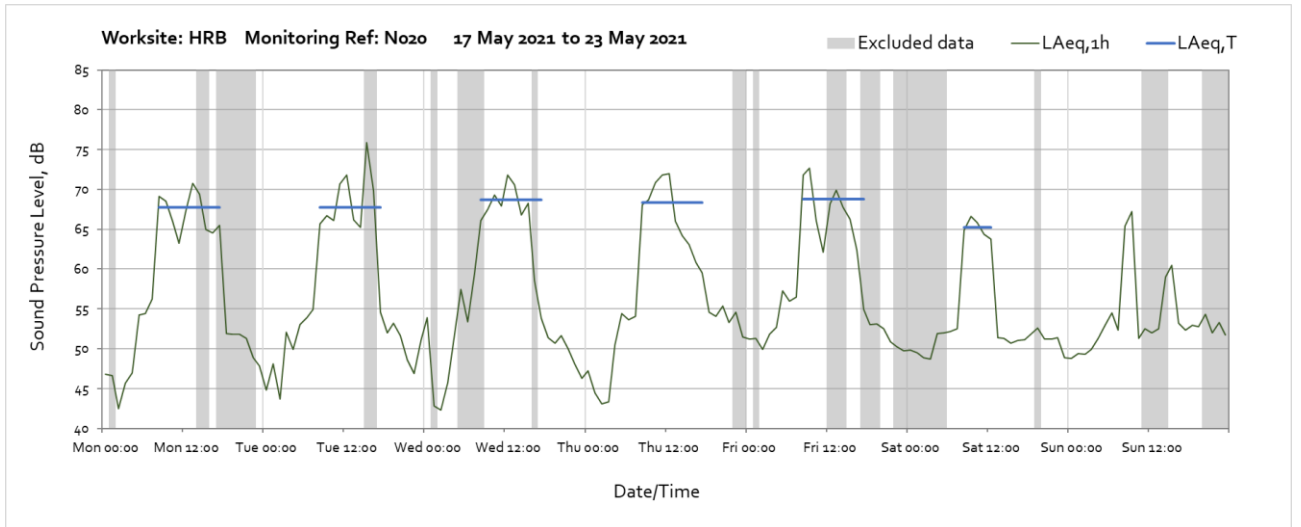
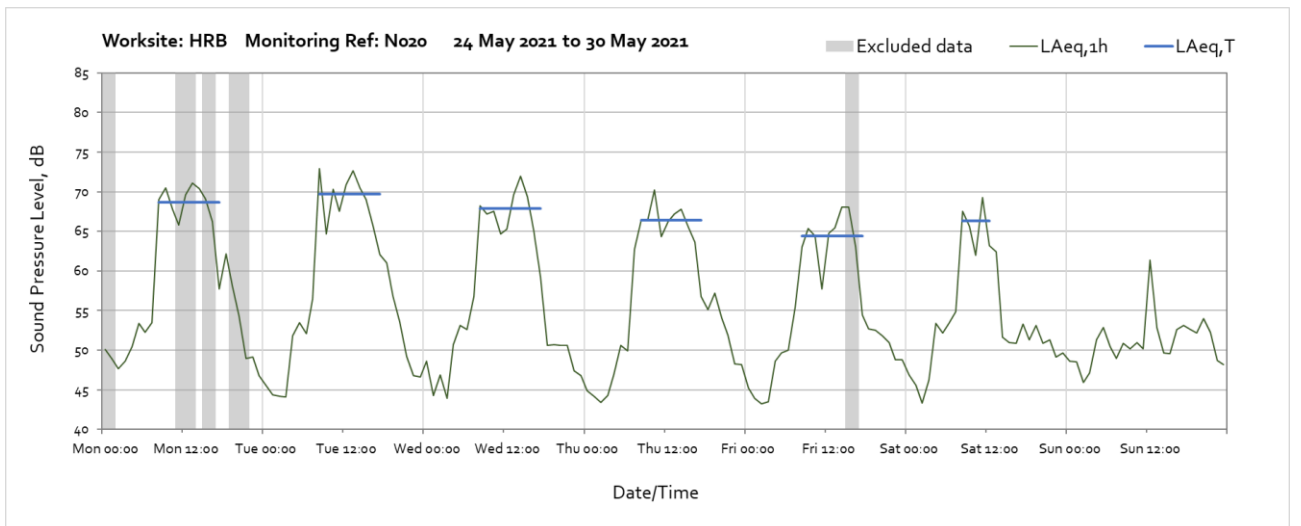
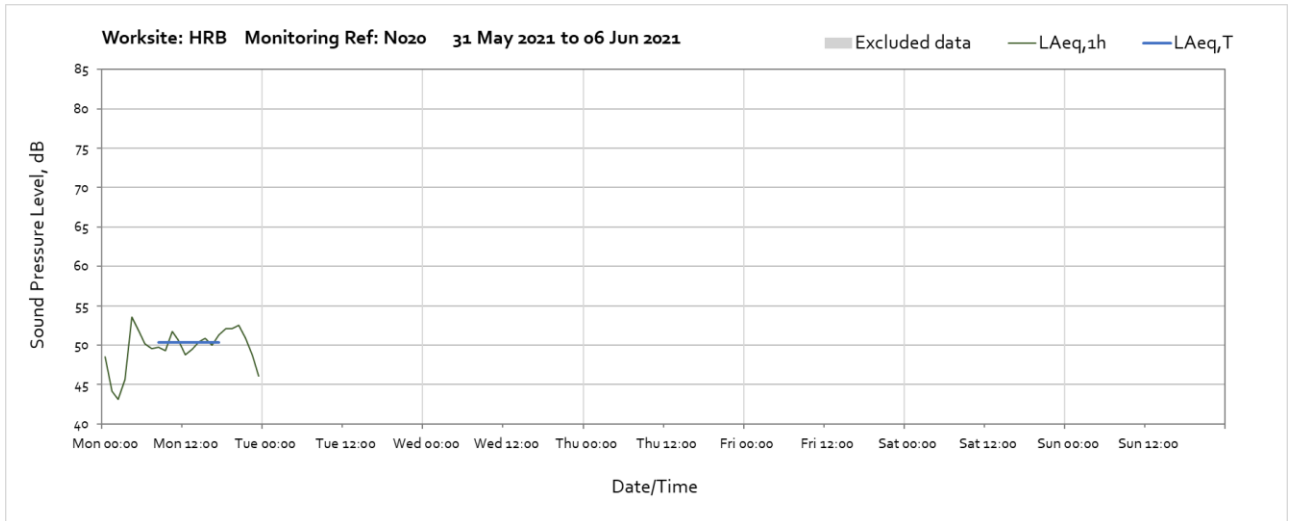
Worksite: HRB – Monitoring Ref: N020

Note: Missing data from 17:00 until 18:00 on Tuesday 4th May was due to a memory card error.

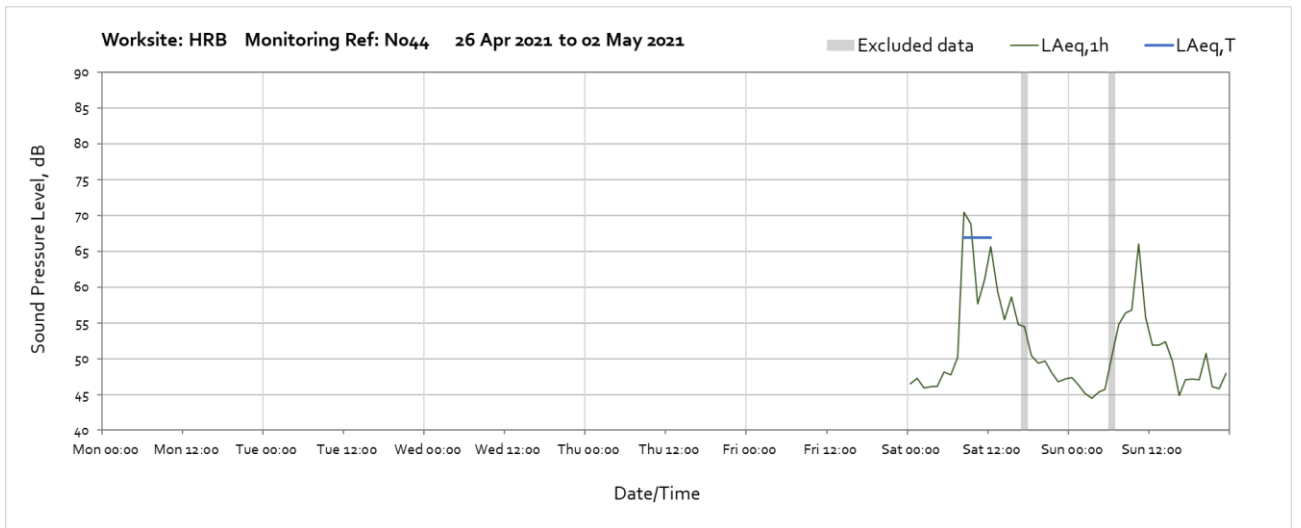
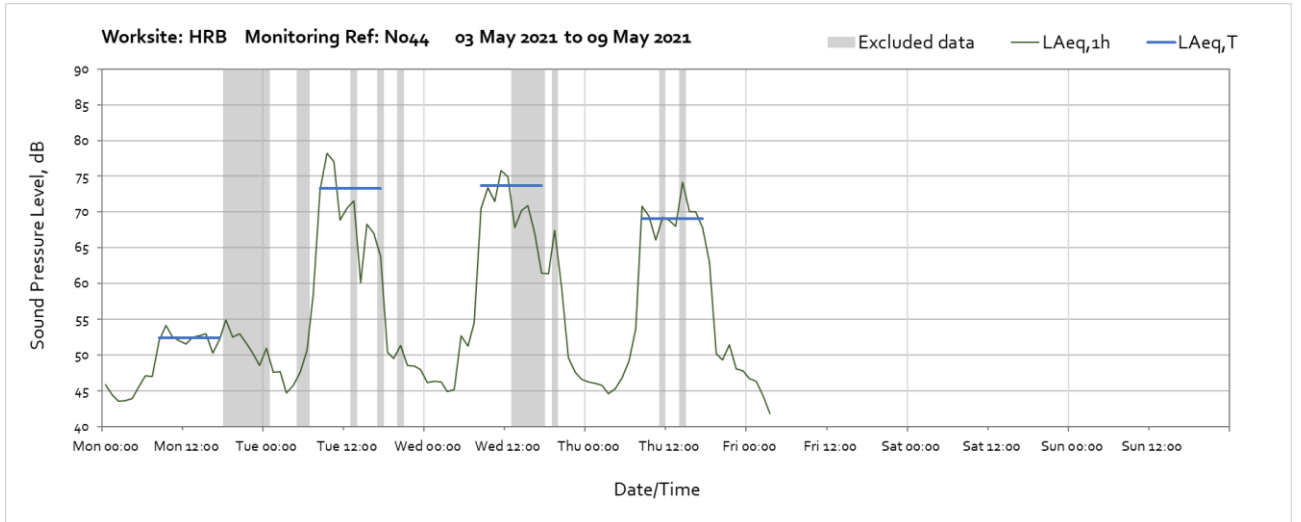
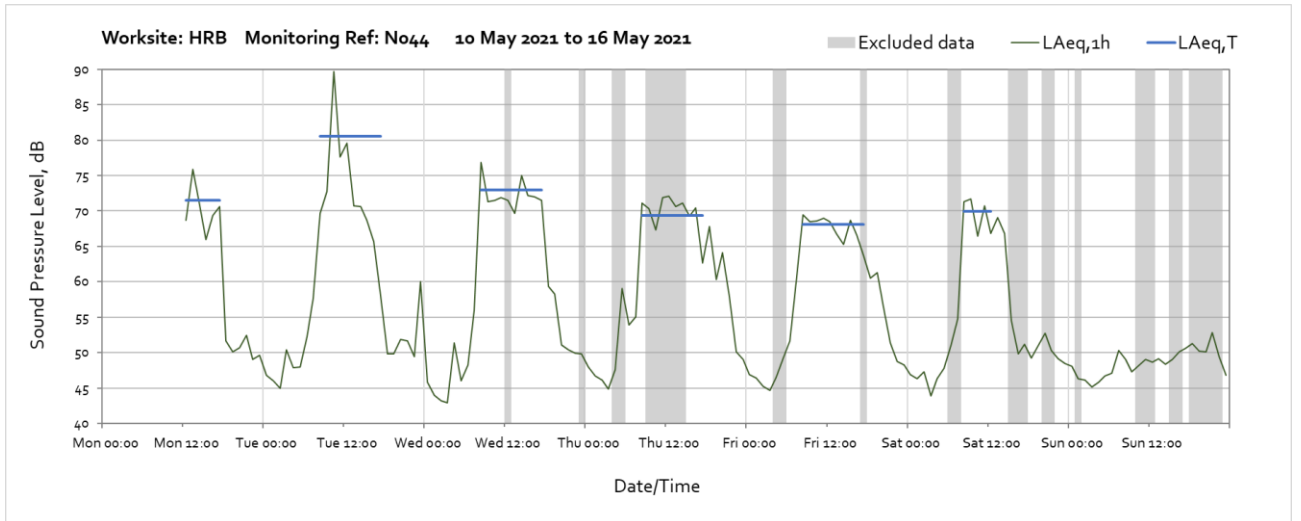
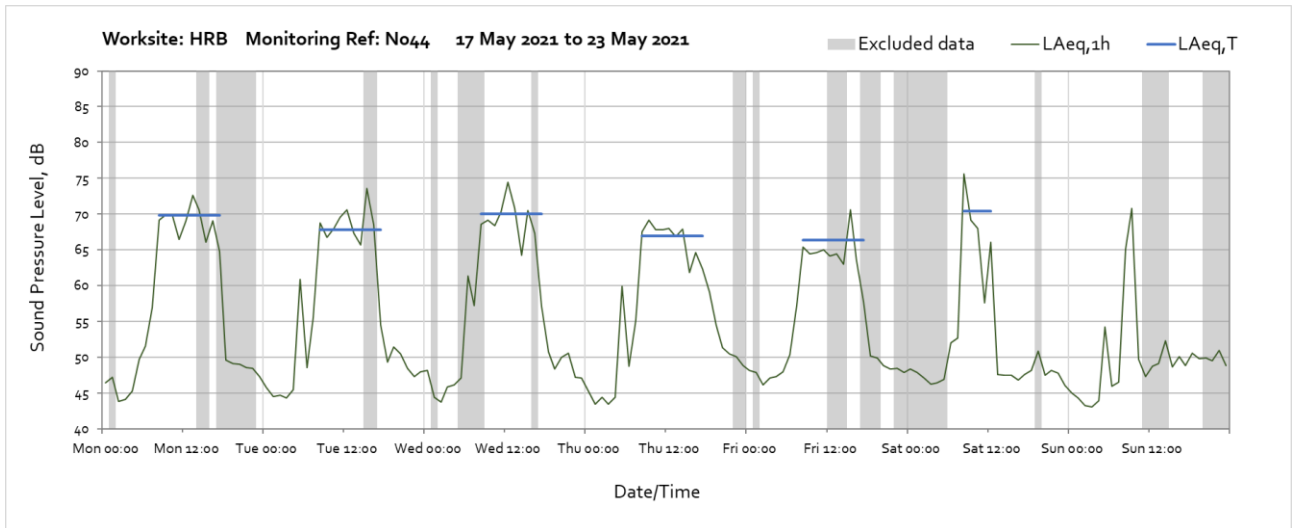
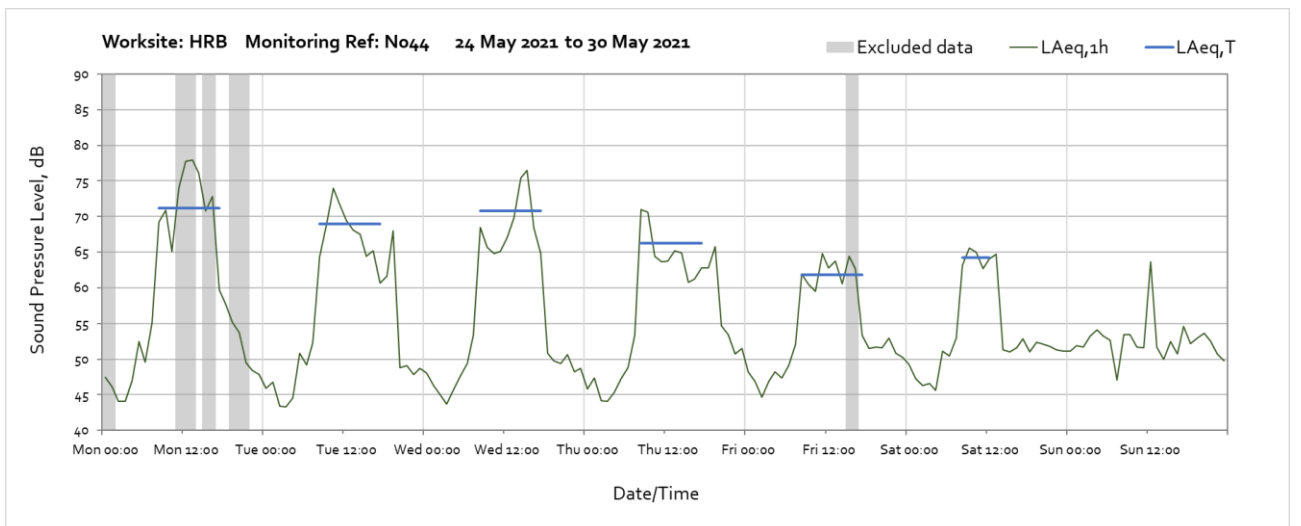
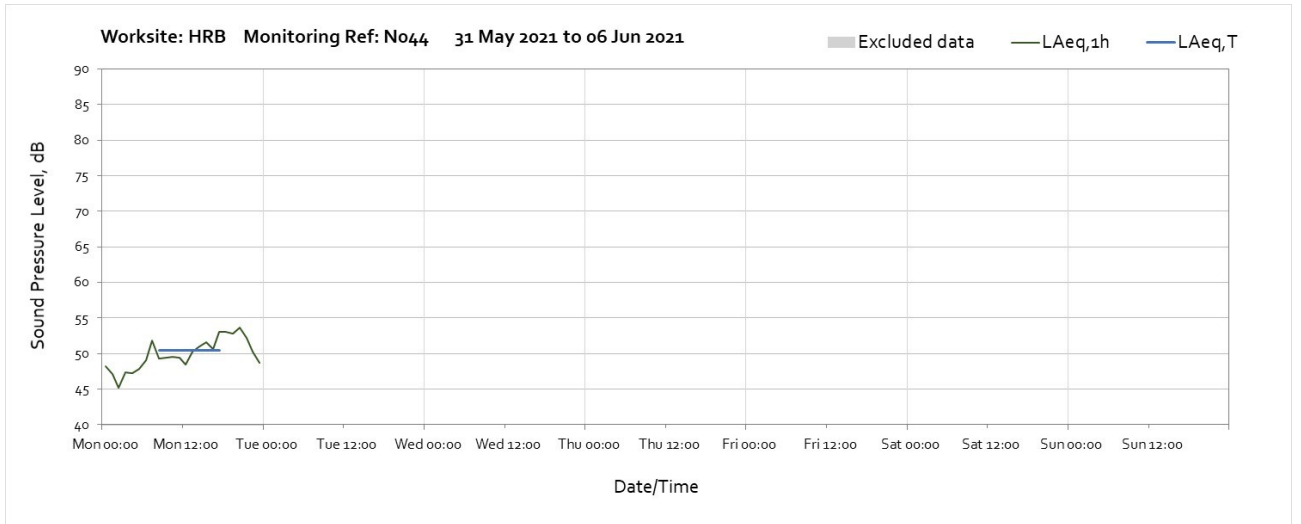
Worksite: HRB – Monitoring Ref: N044

Note: Missing data from 04:00 on Friday 7th May until 12:00 on Monday 10th May was due to a loss of site power.

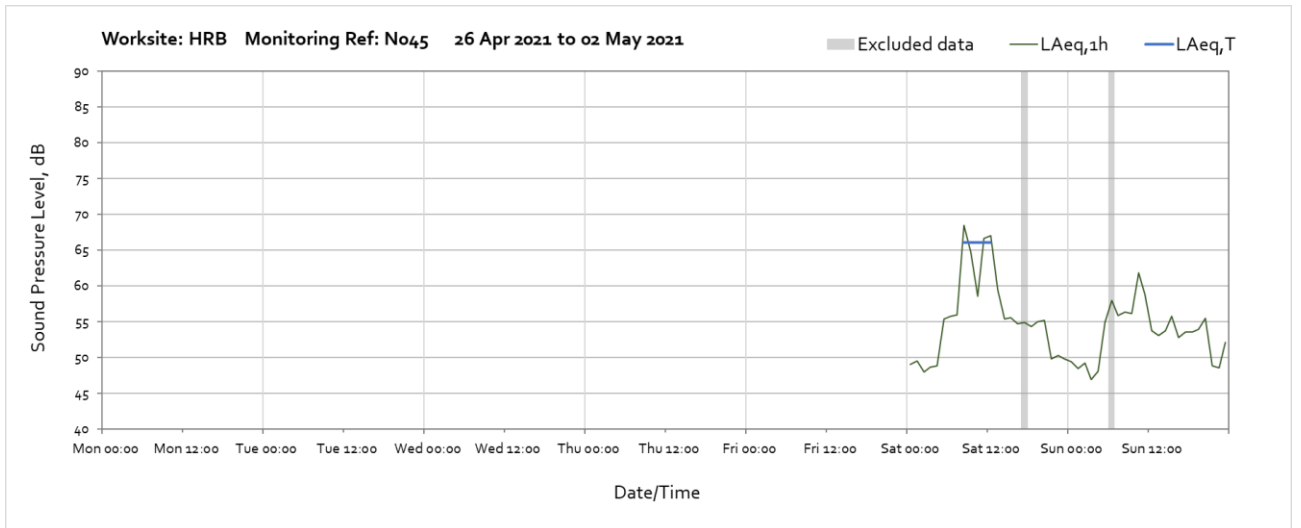
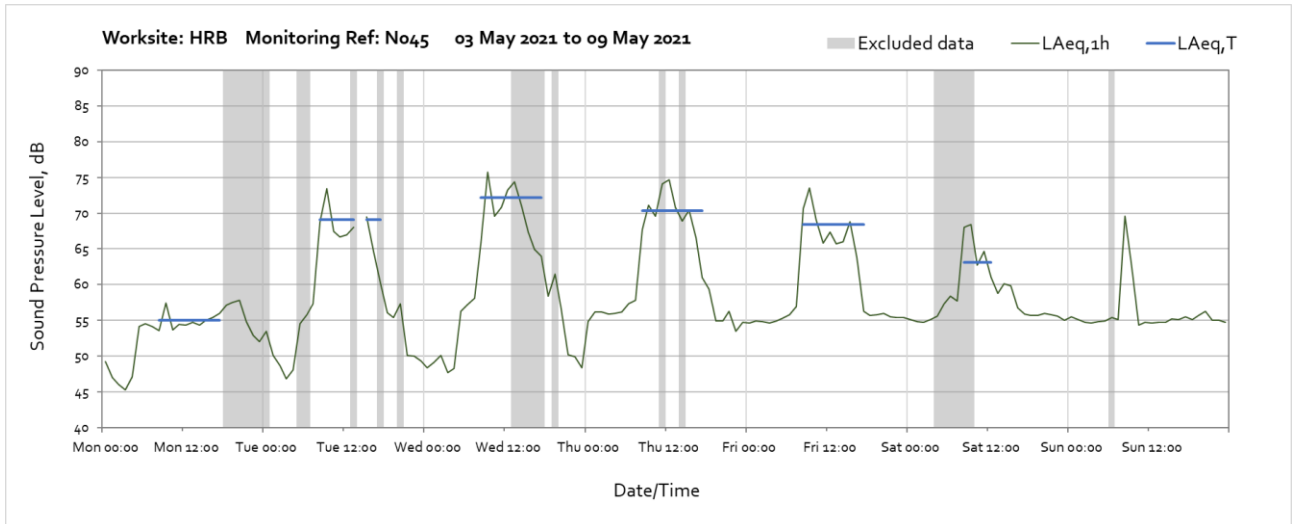
Worksite: HRB – Monitoring Ref: N045

Note: Missing data from 14:00 until 15:00 on Tuesday 4th May was due to a memory card error.

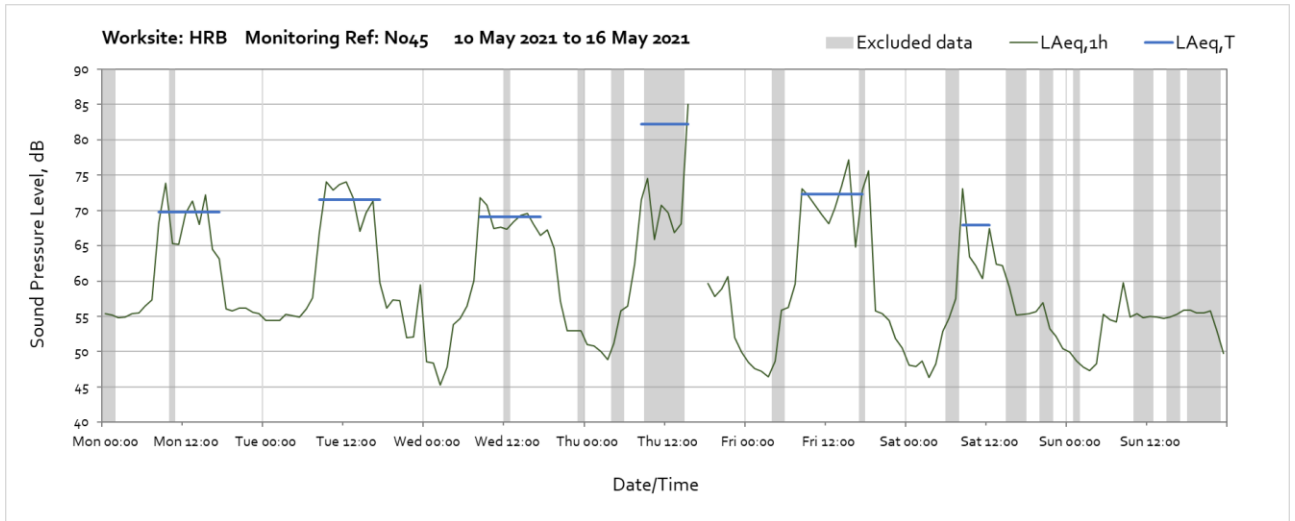
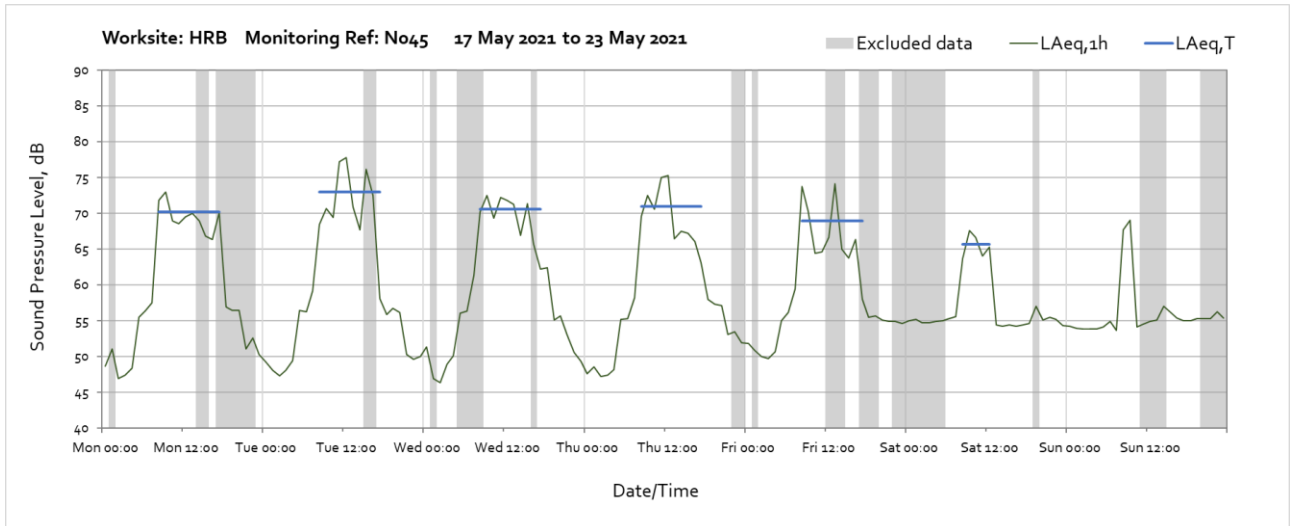
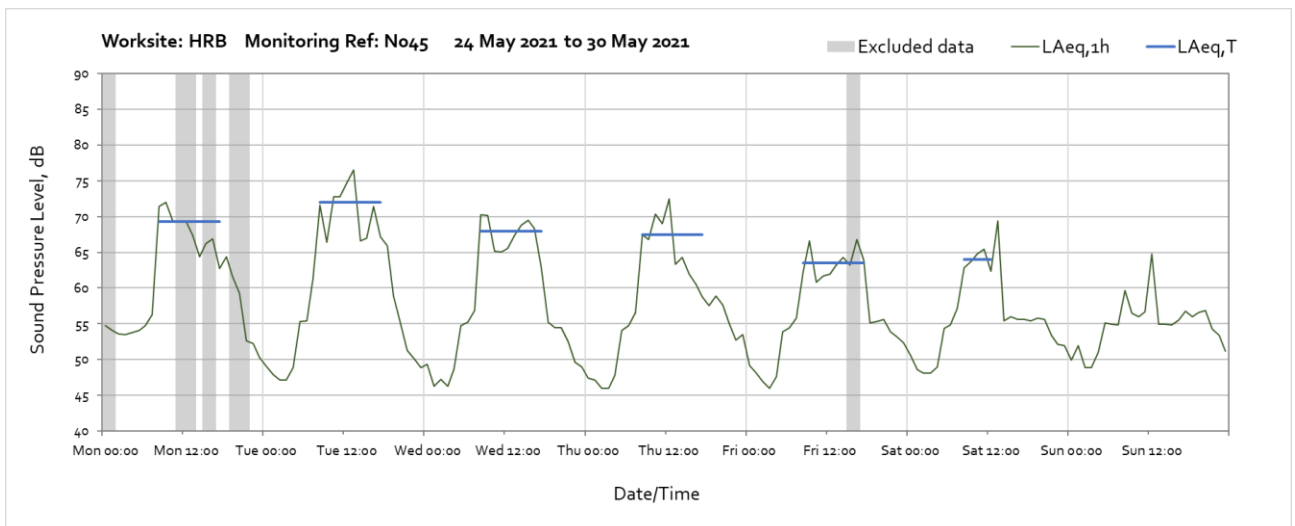
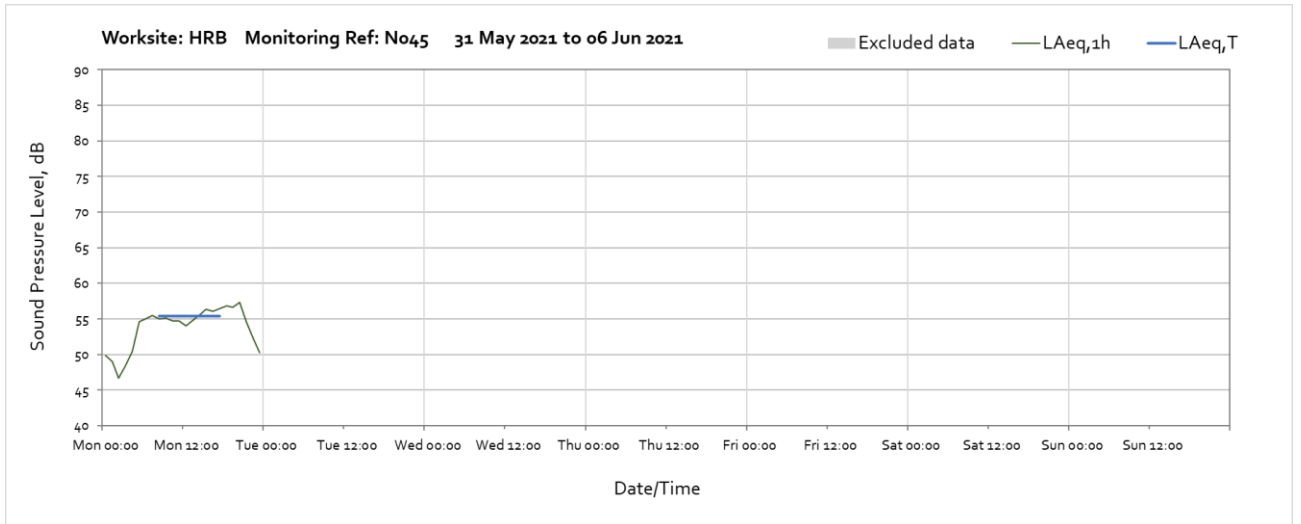
Note: Missing data from 16:00 until 18:00 on Thursday 13th May was due to a memory card error.

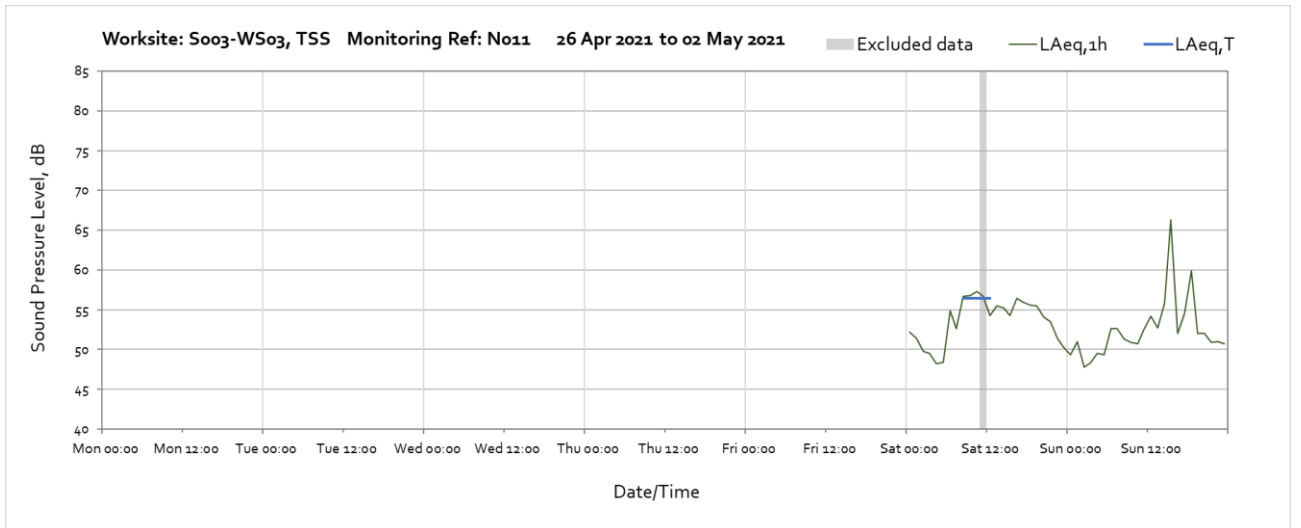
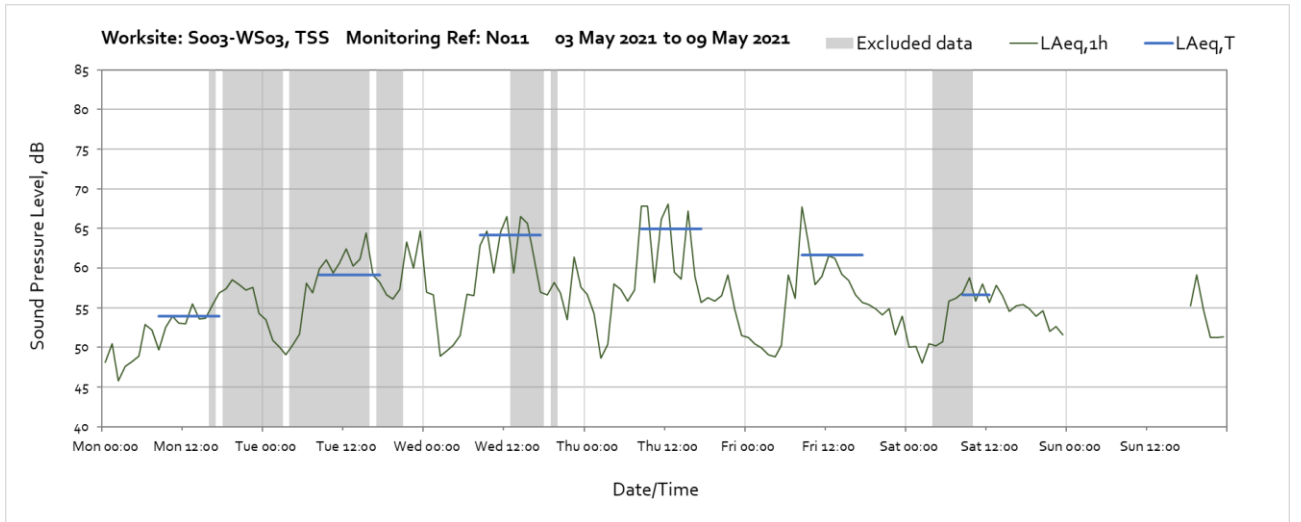
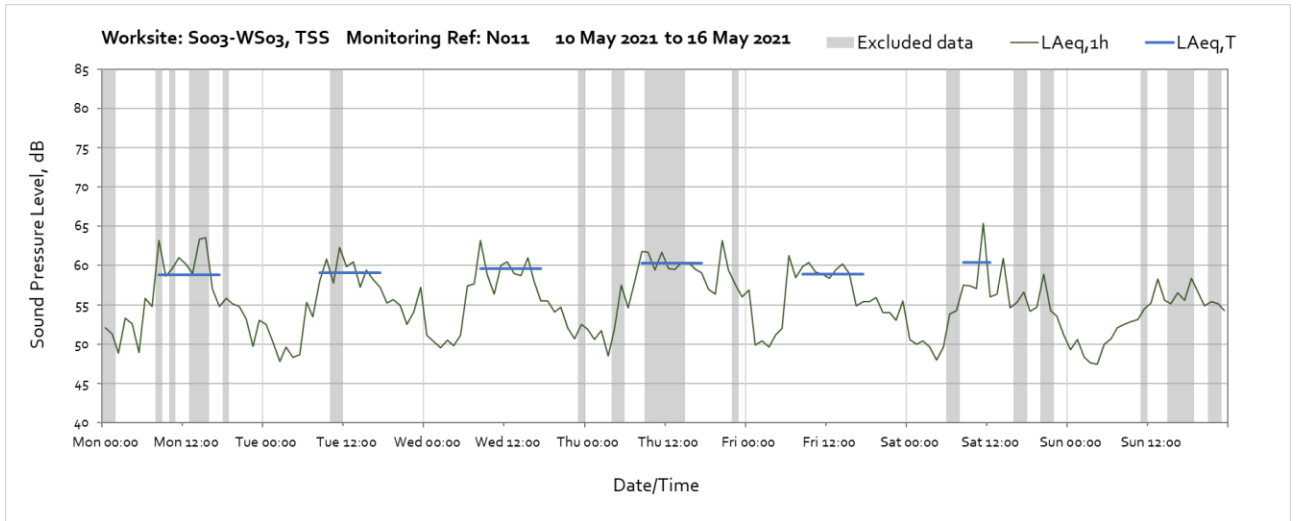
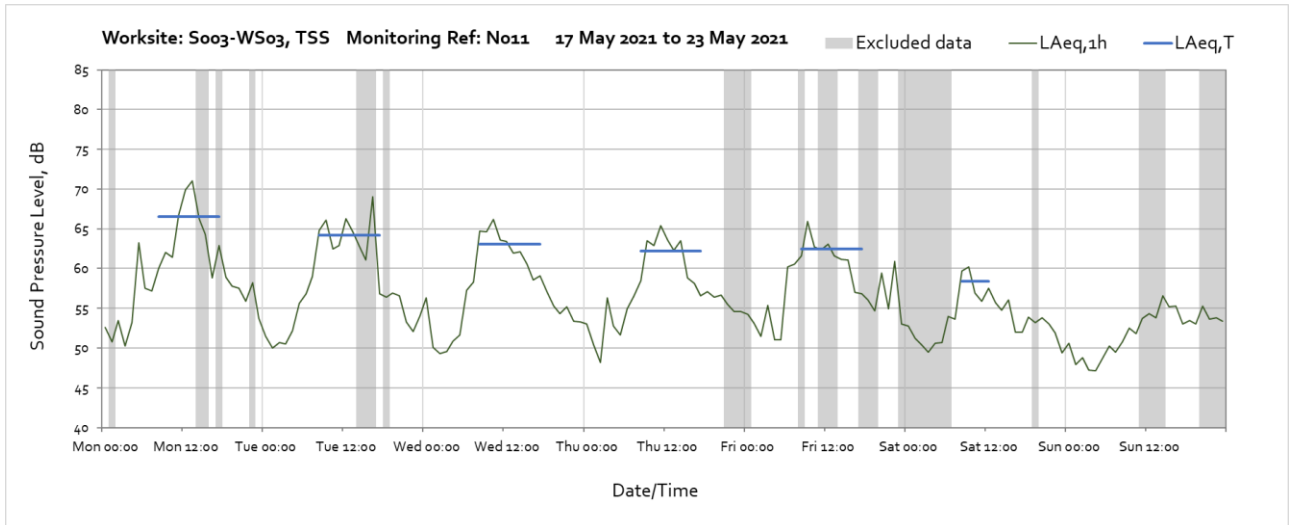
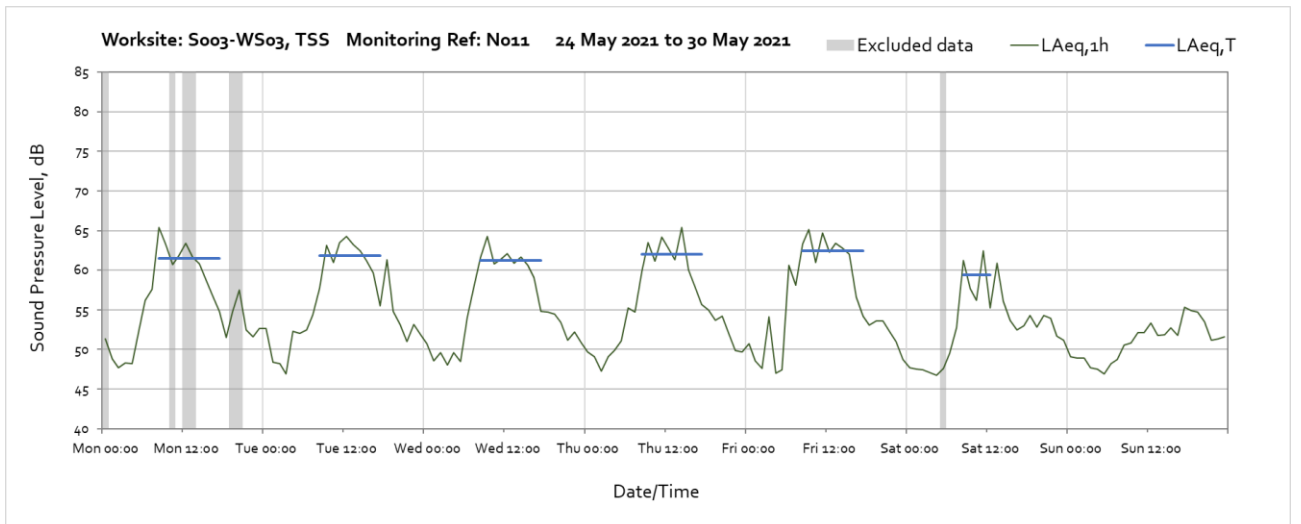
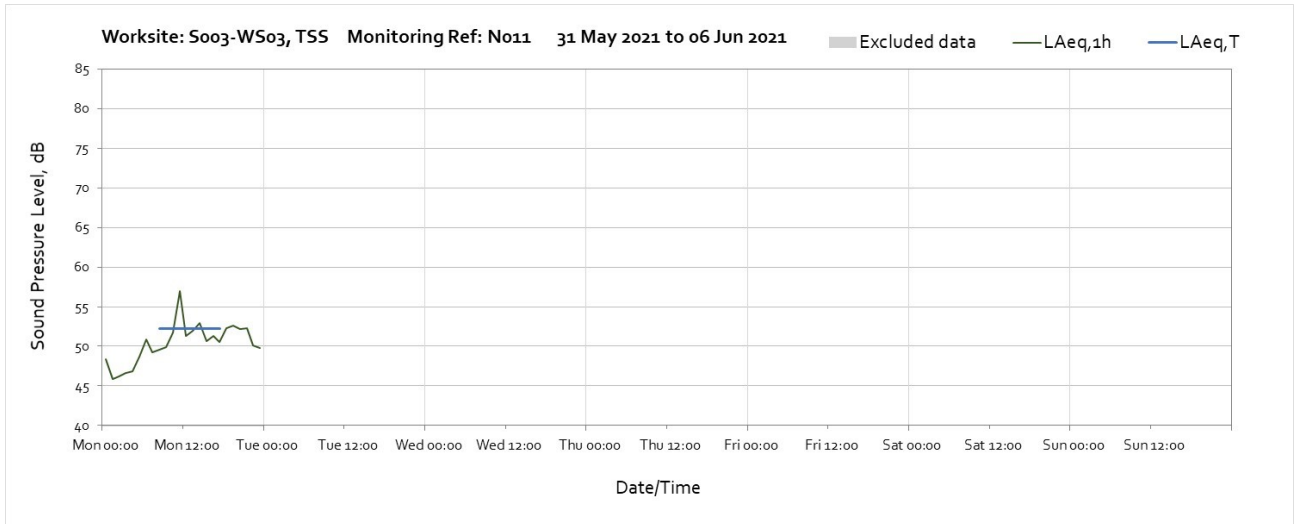
Worksite: S003-WS03 – Monitoring Ref: N011

Note: Missing data from 00:00 until 18:00 on Sunday 9th May was due to a fault with the monitoring station. The monitoring station has been replaced with view of minimising further loss of data.
