Construction noise and vibration Monthly Report – May 2021

London Borough of Camden

Non-Technical Summary

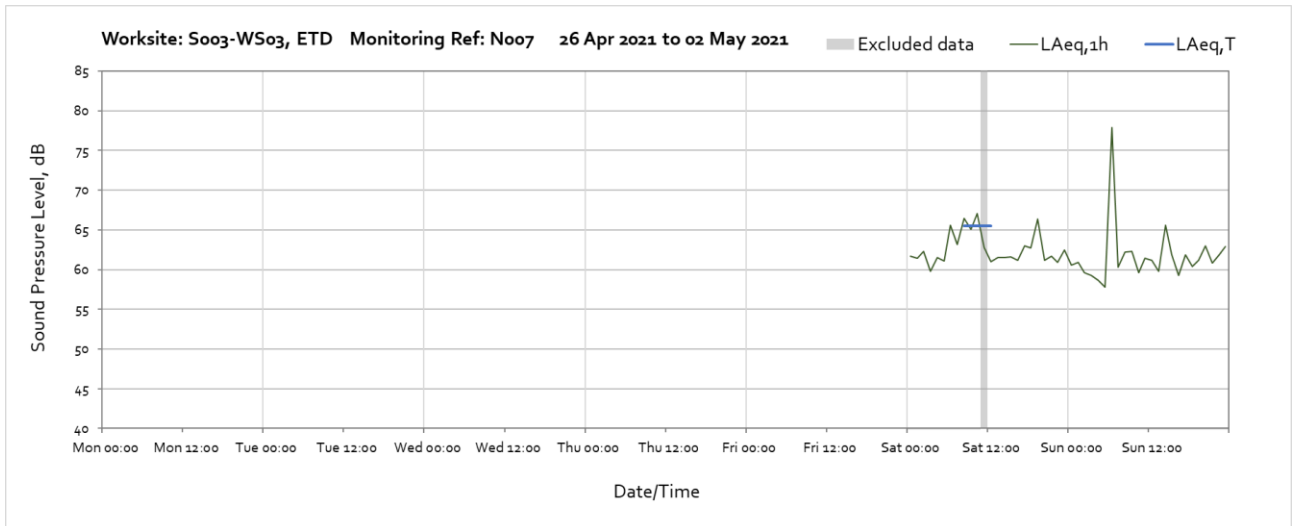
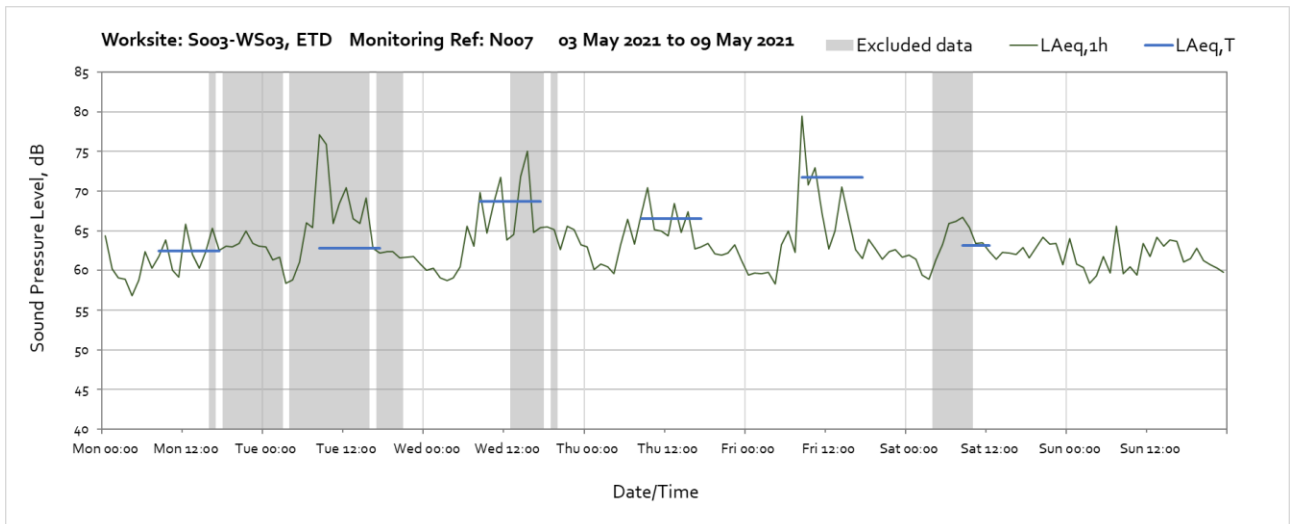
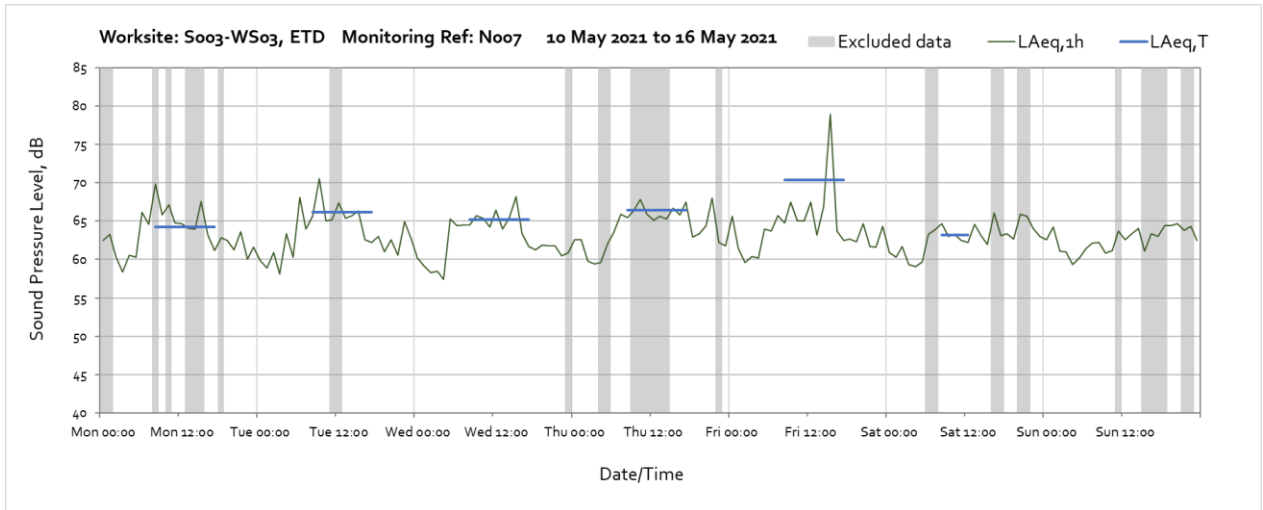
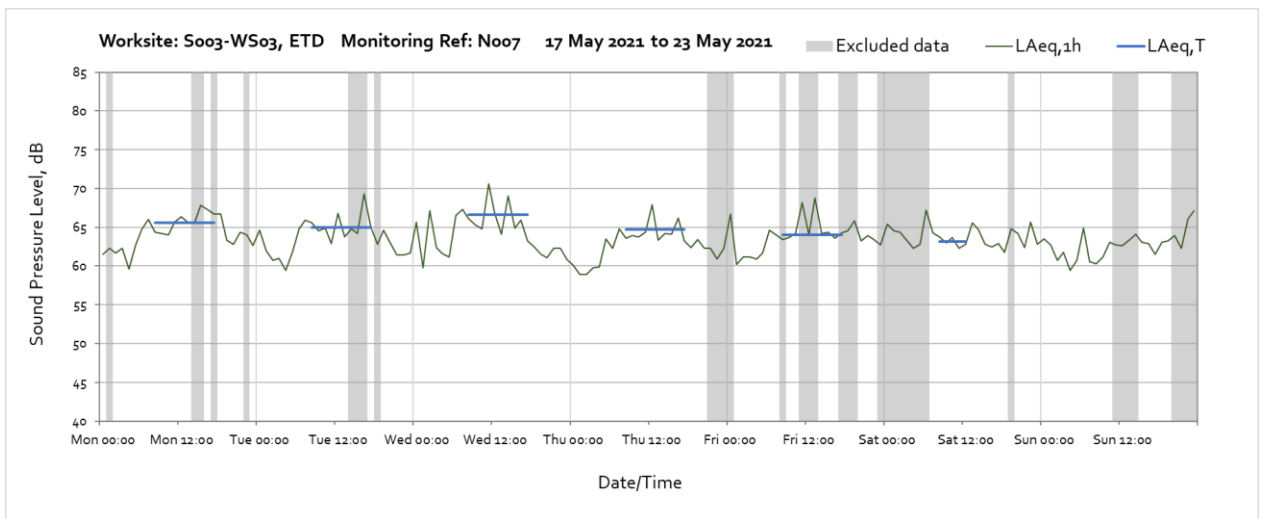
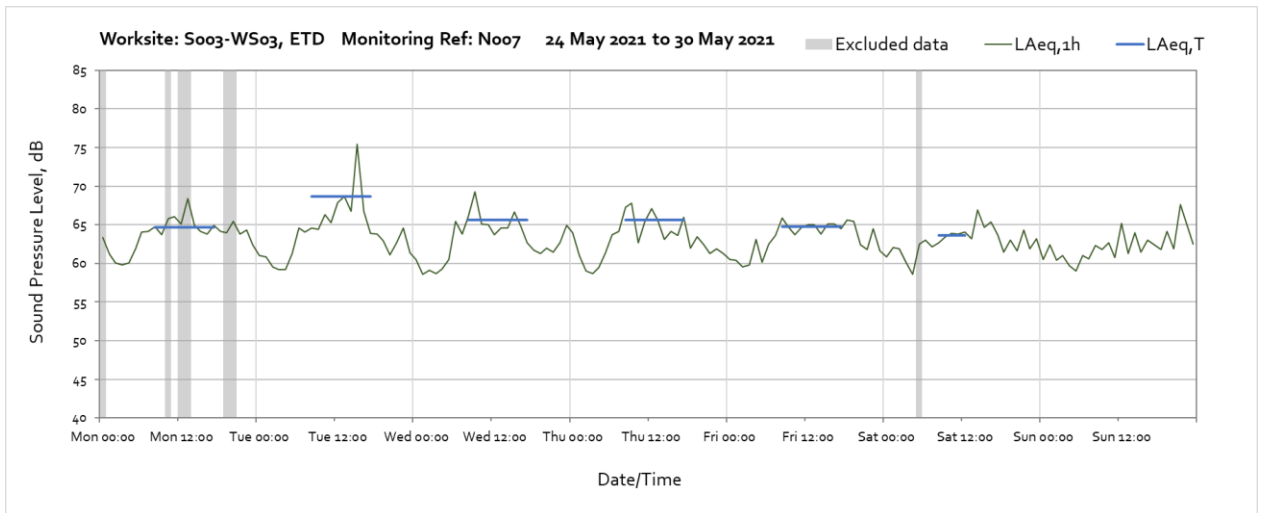
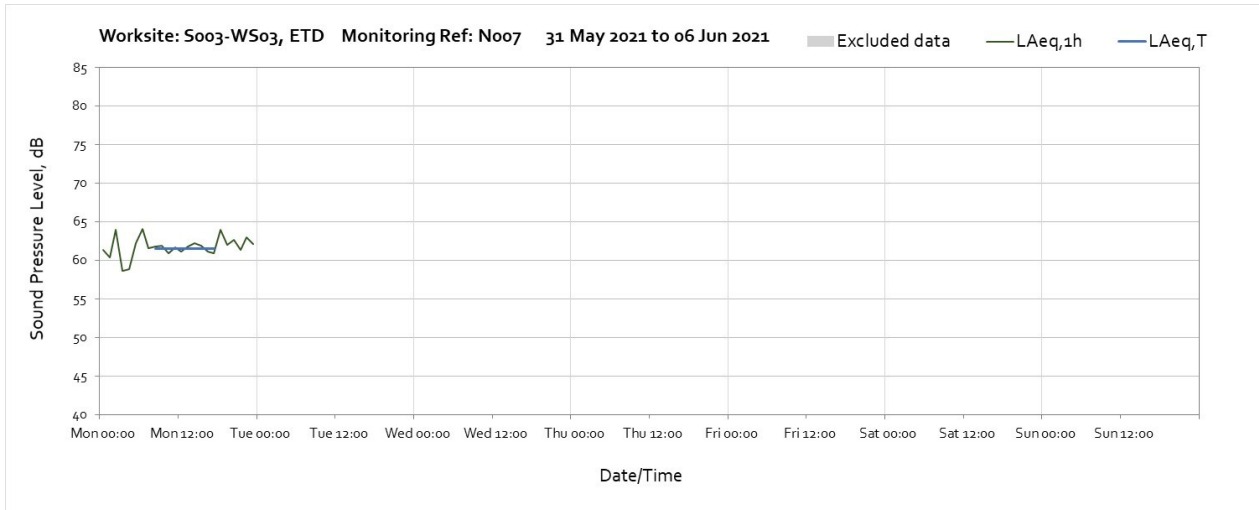
Worksite: S003-WS03, ETD – Monitoring Ref: N007

2.1.3 Appendix C presents graphs of the noise and vibration monitoring data over the month for each of the measurement locations. Noise data presented consists of the hourly L_{Aeq} values and, where relevant, the $L_{Aeq,T}$ values (where the time period T has been taken to be the averaging period as specified in Table 1 of HS2 Information Paper E23). Vibration data presented consist of hourly PPV values. The full data set for the monitoring equipment can be found at the following location: <https://data.gov.uk/dataset/24542ae7-dd44-444f-b259-871c4cc43b5e/environmental-monitoring-data>.

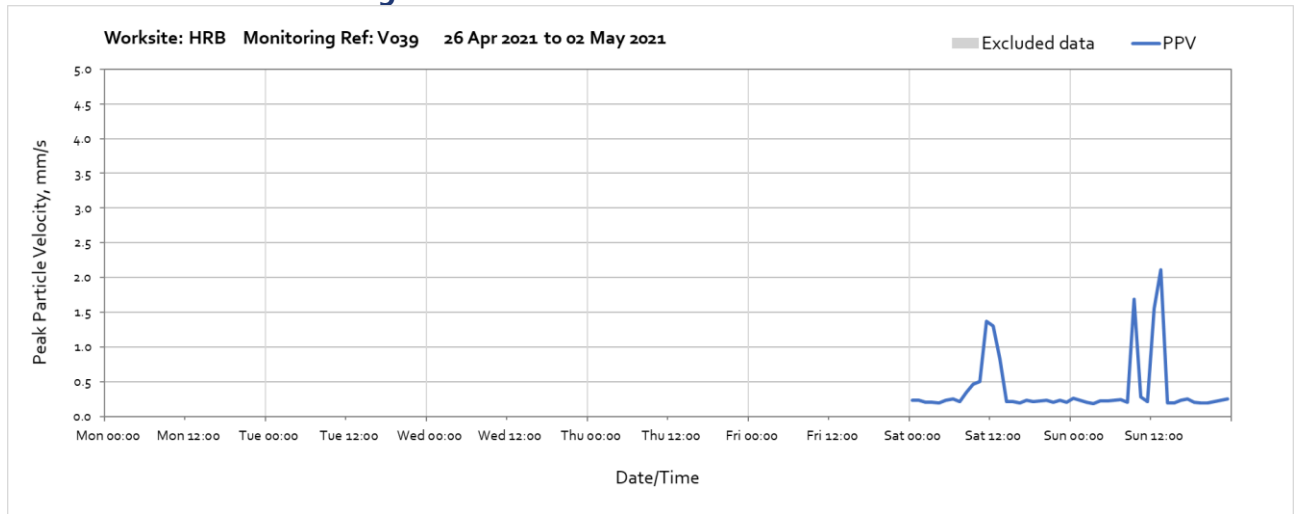
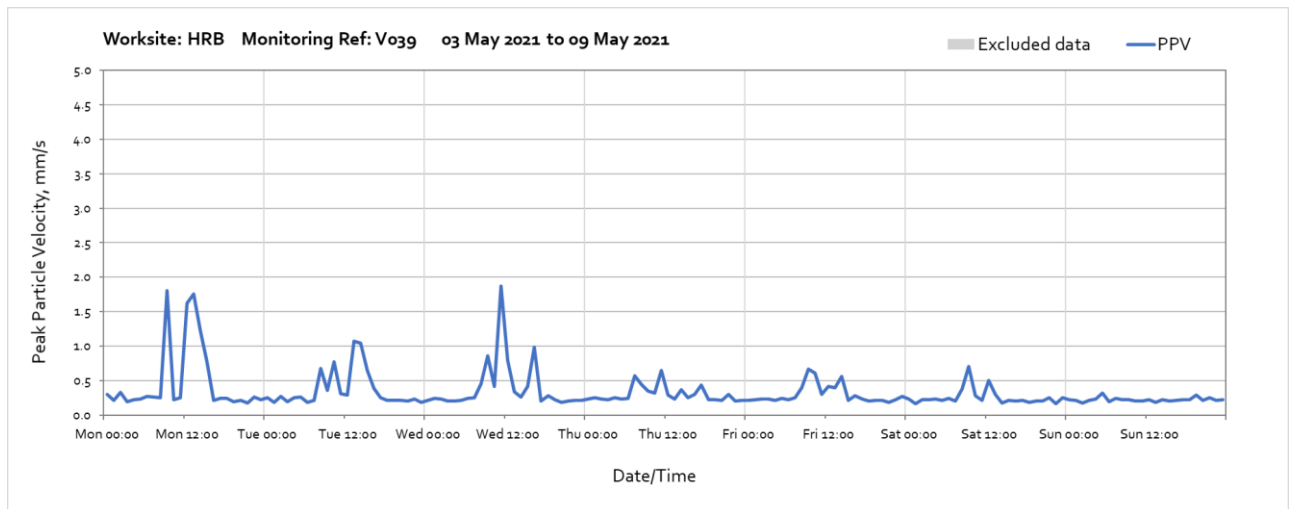
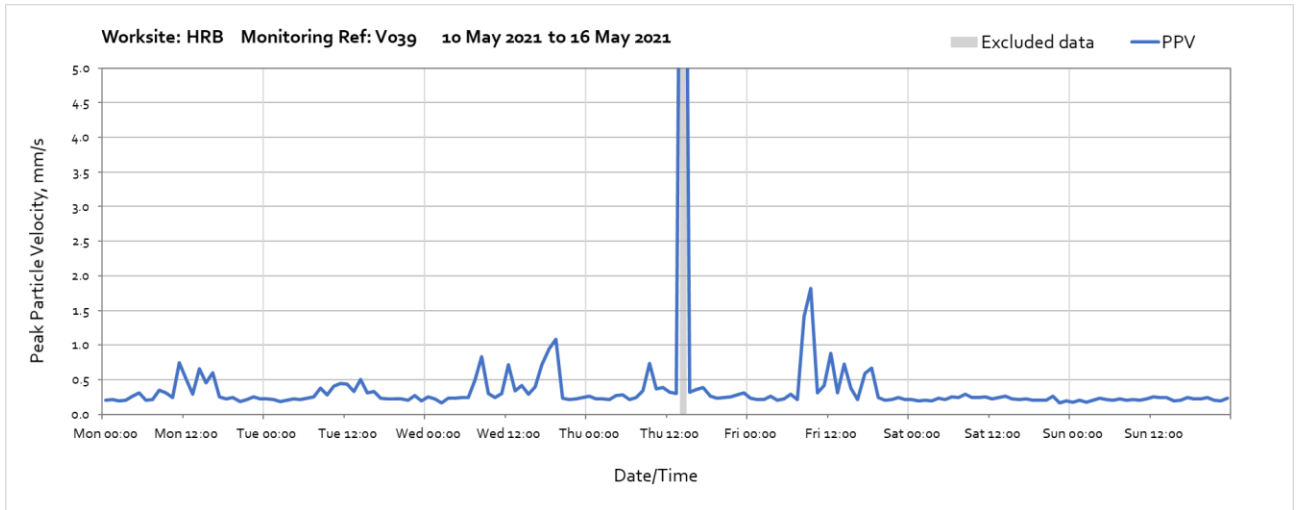
Worksite: HRB – Monitoring Ref: V039

The following graphs show the hourly measured peak particle velocity PPV recorded during the monitoring period. The graphs show the resultant PPV due to vibration components on three orthogonal axes x, y and z. Where resultant PPV data is not available (monitors V039 and V043), the highest vibration component in either of the three axes is presented for each 1hr measurement period respectively. Where high values of PPV were caused by local interference with the vibration monitor, which are not representative of HS2 construction works, these values have been greyed out in the following charts and have been excluded to calculate values in Table 4 of the main report.

Note: High vibration levels measured at 14:00 on Thursday 13th May were due to local interference of the monitor and are not representative of HS2 vibration levels.

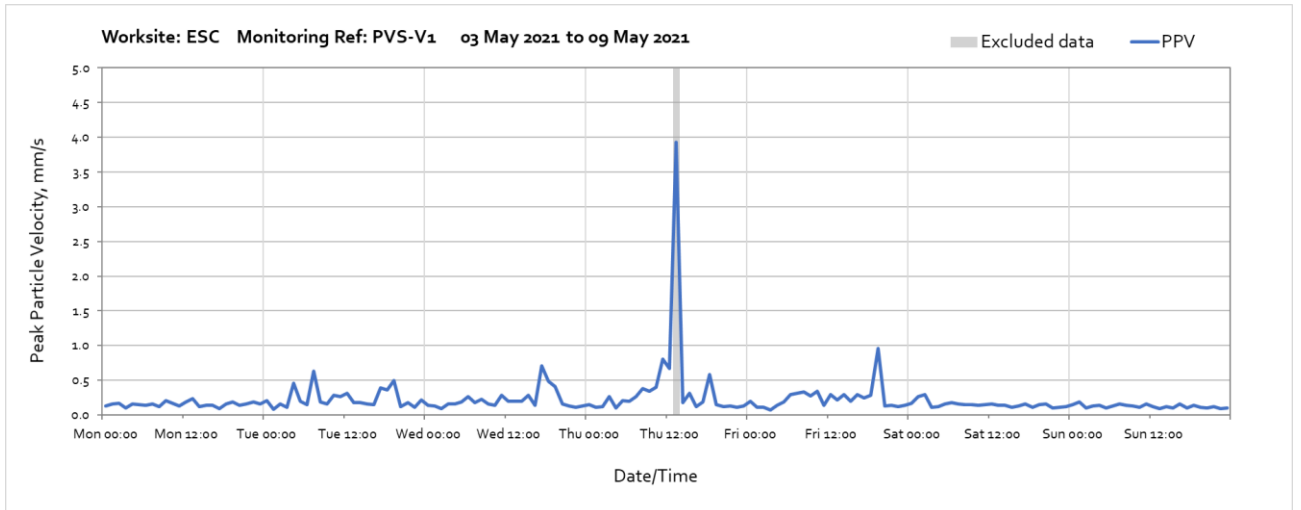
Note: High vibration levels measured between 13:00 and 14:00 on Thursday 6th May were due to local interference of the monitor and are not representative of HS2 vibration levels.

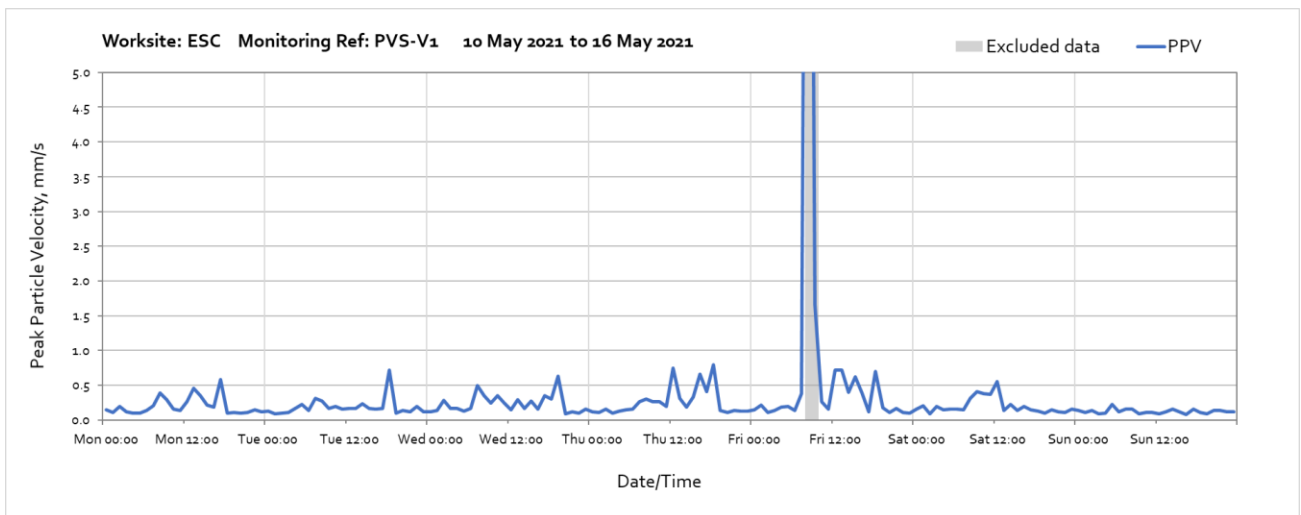
Note: High vibration levels measured between 08:00 and 10:00 on Friday 14th May were due to local interference of the monitor and are not representative of HS2 vibration levels.

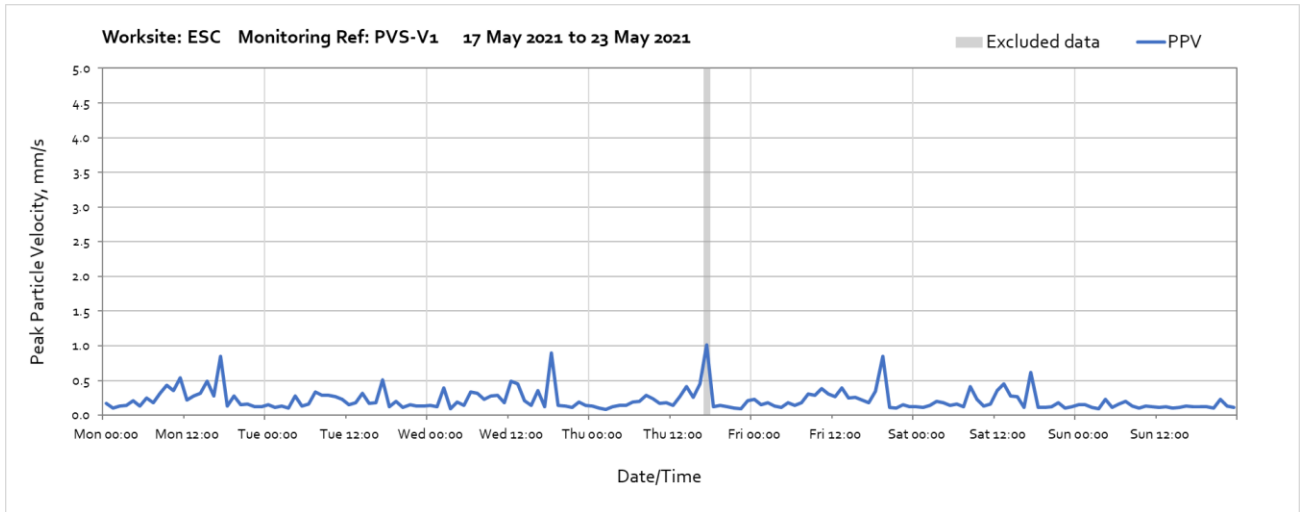
Note: Higher vibration levels measured between 17:00 and 18:00 were due to works being undertaken within close proximity of the monitoring station and are not representative of HS2 vibration levels.

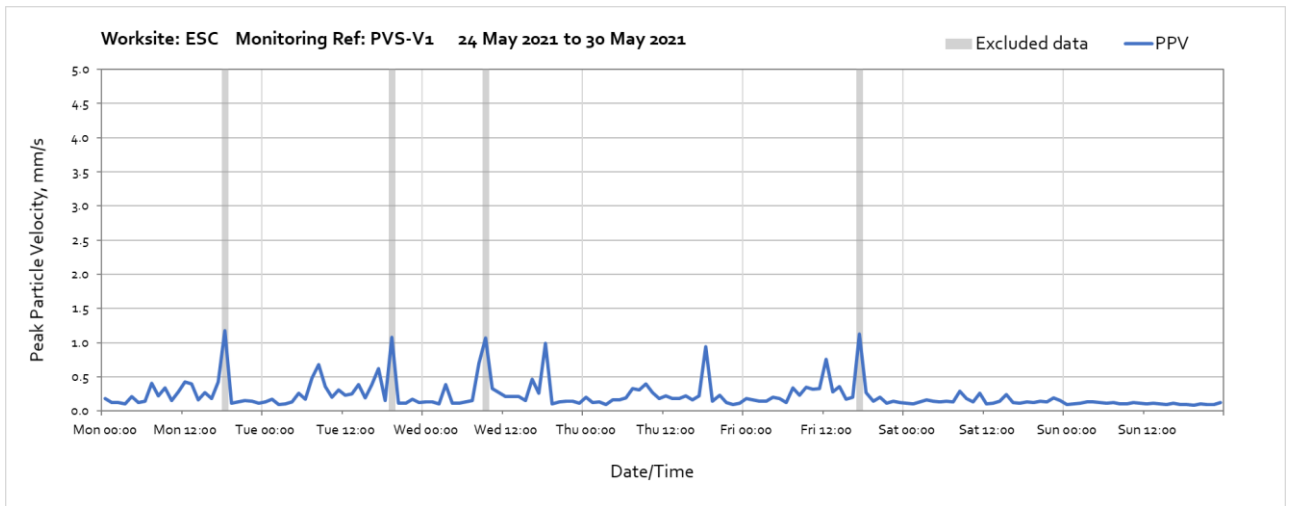
Note: Higher vibration levels measured throughout the week were due to works being undertaken within close proximity of the monitoring station and are not representative of HS2 vibration levels.

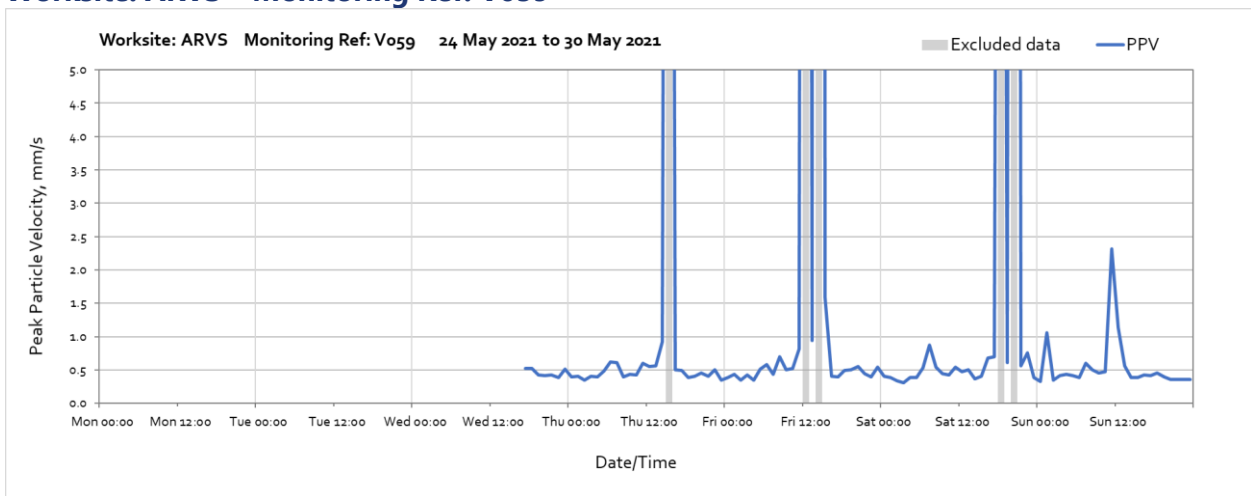
Worksite: ARVS – Monitoring Ref: V059

Note: Monitor was installed at 17:00 on Wednesday 26th May. High vibration levels measured throughout the week were due to local interference of the monitor and are not representative of HS2 vibration levels.

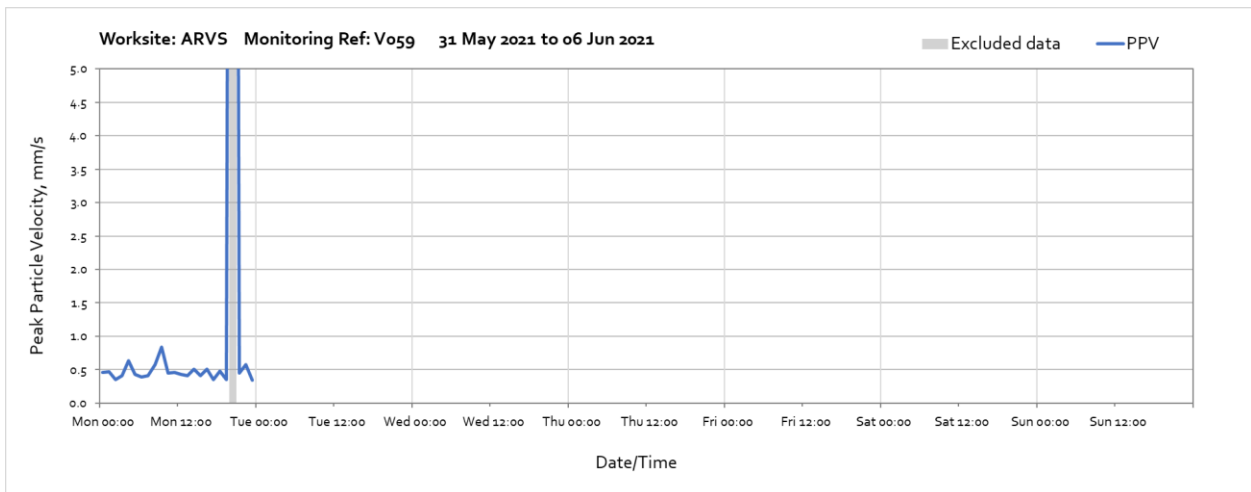
Note: High vibration levels measured between 20:00 and 21:00 on Monday 31st May were due to local interference of the monitor and are not representative of HS2 vibration levels.
