Construction noise and vibration Monthly Report – June 2021

London Borough of Ealing

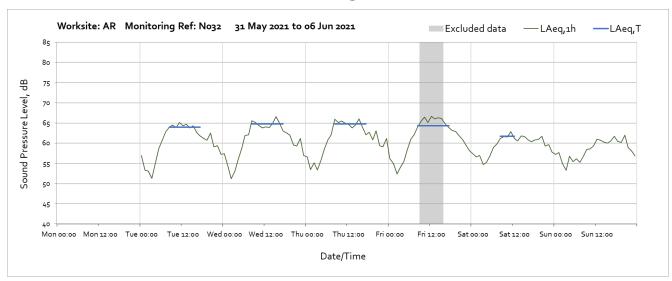
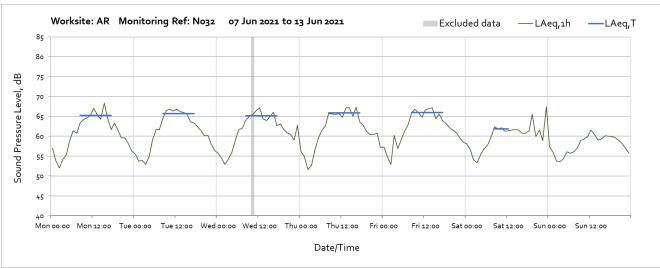
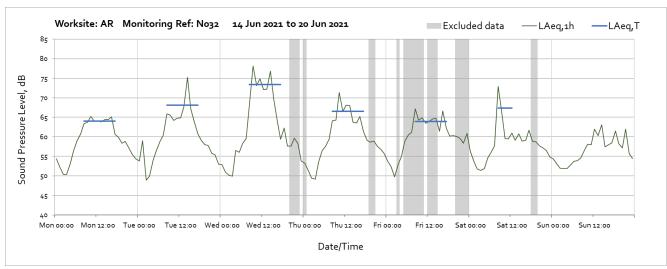
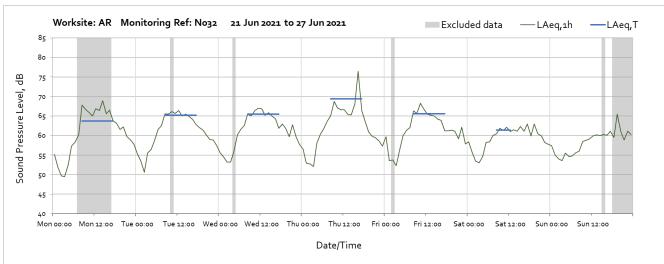
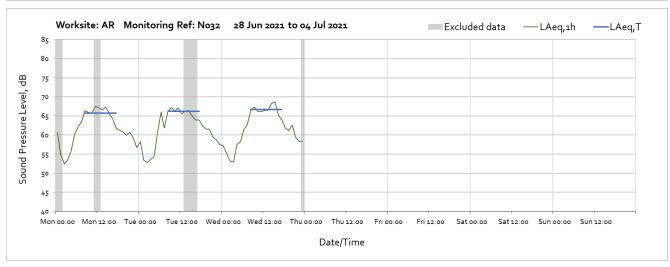
Worksite: Atlas Road worksite (AR) - Monitoring Ref: N032

The following graphs show the hourly measured ambient noise level $L_{Aeq,1h}$ and, where relevant, the averaged noise level $L_{Aeq,T}$ values, where the time period T is as specified in Table 1 of HS2 Information Paper E23. Periods with adversely weather affected noise levels are greyed out and have been excluded from the calculation of the $L_{Aeq,T}$ values in Table 3 of the main report.

2.1.3 Appendix C presents graphs of the noise and vibration monitoring data over the month for each of the measurement locations. Noise data presented consists of the hourly L_{Aeq} values and, where relevant, the L_{Aeq,T} values (where the time period T has been taken to be the averaging period as specified in Table 1 of HS2 Information Paper E23). Vibration data presented consist of hourly PPV values. The full data set for the monitoring equipment can be found at the following location: https://data.gov.uk/dataset/24542ae7-dd44-444f-b259-871c4cc43b5e/environmental-monitoring-data.

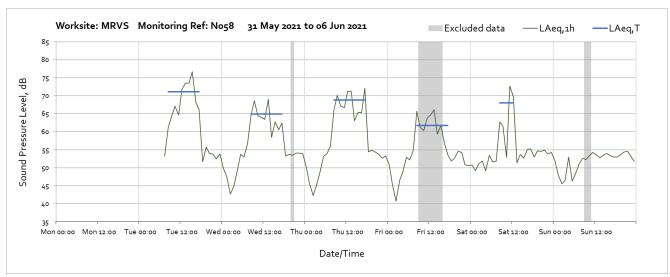
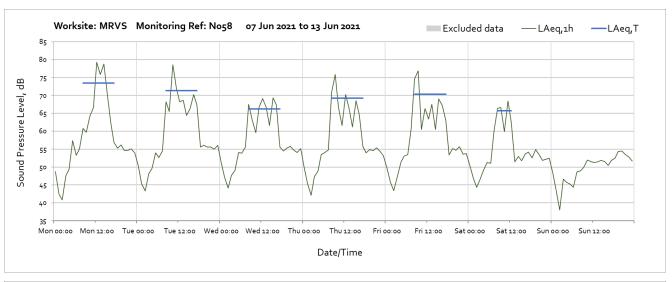
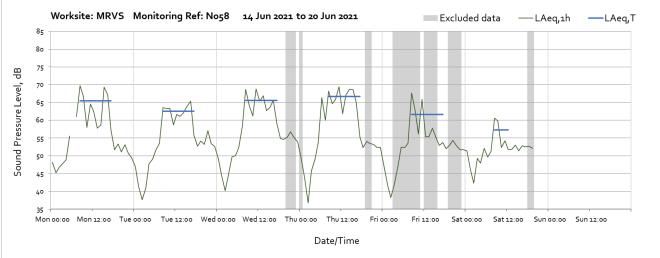
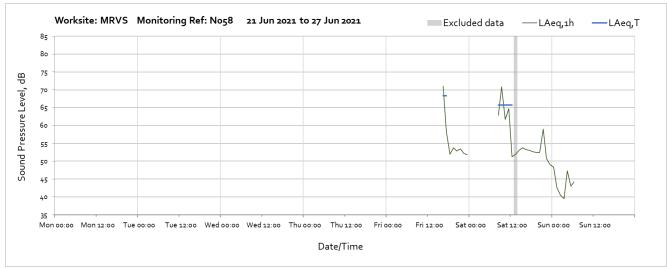
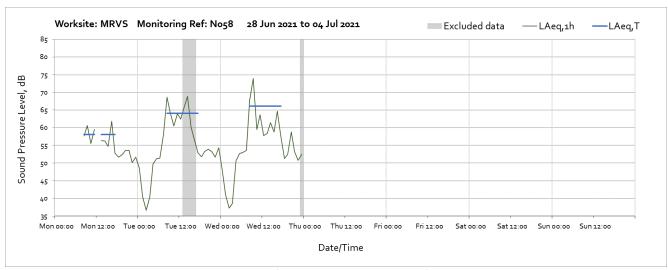
Worksite: Mandeville Road Ventilation Shaft (MRVS) - Monitoring Ref: N058

Note: Missing data between 00:00 and 07:00 on Tuesday 1st June 2021 was due to loss of power at the monitor location.

Note: Missing data at 06:00 on Monday 14th June 2021 and between 20:00 on Sunday 20th June 2021 and 15:00 on Friday 25th June 2021 was due to loss of power at the monitor location. The main power connection had to be disconnected due to building demolision works ans site team is working on restabilised a stable connection as soon as possible.

Note: Missing data across the week was due to loss of power at the monitor location.

Note: Missing data between 07:00 on Sunday 27th and 08:00 on Monday 28th June 2021 and at 12:00 on Monday 28th June 2021 was due to loss of power at the monitor location.

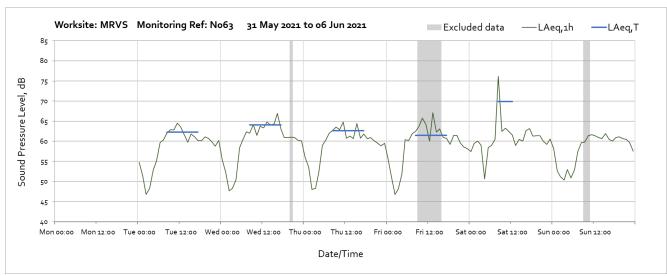
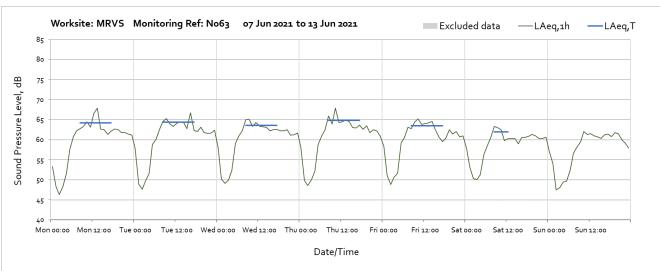
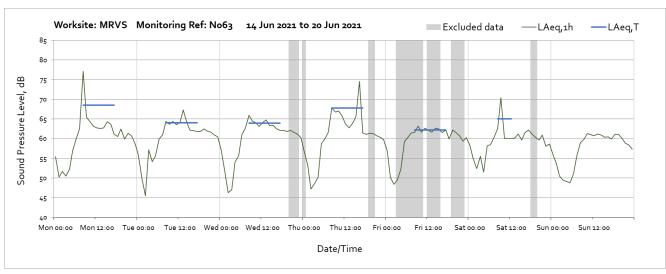
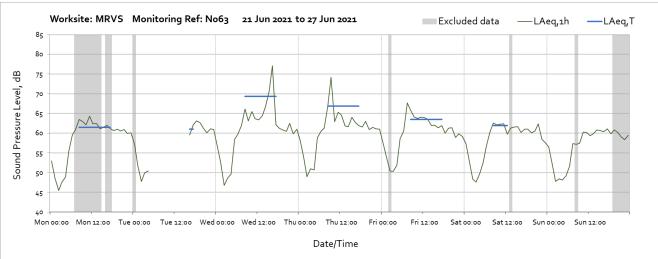
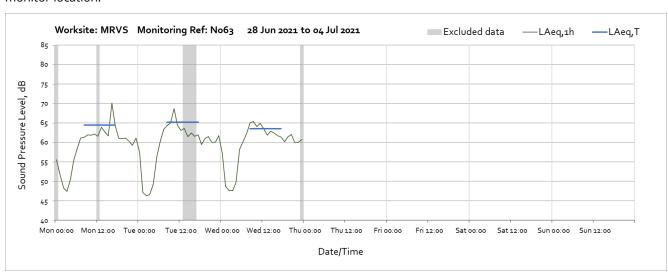
Worksite: Mandeville Road Ventilation Shaft (MRVS) - Monitoring Ref: N063

Note: Missing data between 05:00 and 16:00 on Tuesday 22^{nd June} 2021 was due to loss of power at the monitor location.

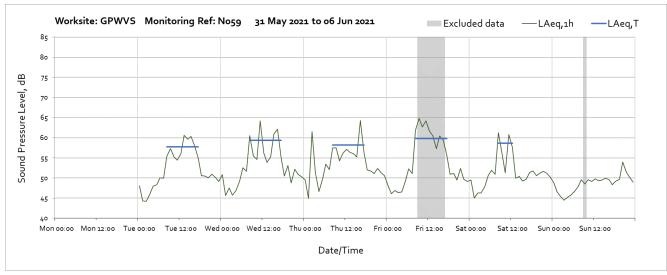
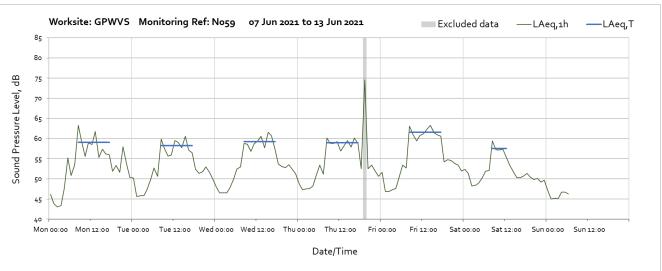
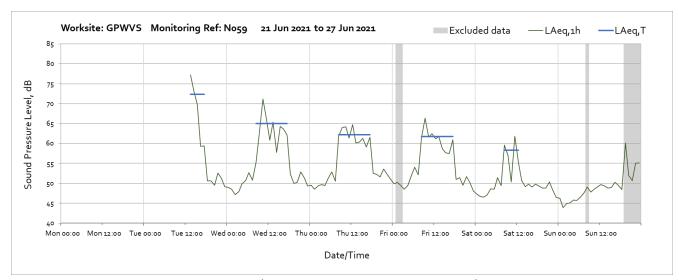
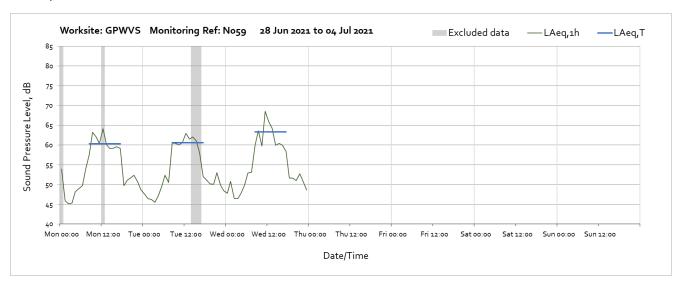
Worksite: Green Park Way Vent Shaft (GPWVS) - Monitoring Ref: N059

Note: Missing data from 07:00 on Sunday 13th June 2021 and 13:00 on Tuesday 22^{nd June} 2021 was due to loss of power at the monitor location.

Note: Missing data from 07:00 on Sunday 13th June 2021 and 13:00 on Tuesday 22nd June 2021 was due to loss of power at the monitor location.

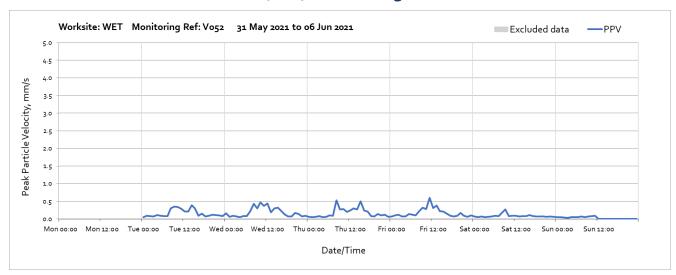
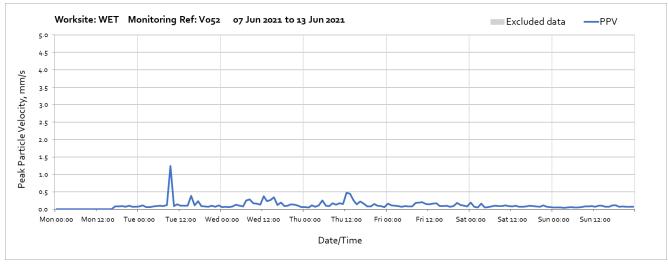
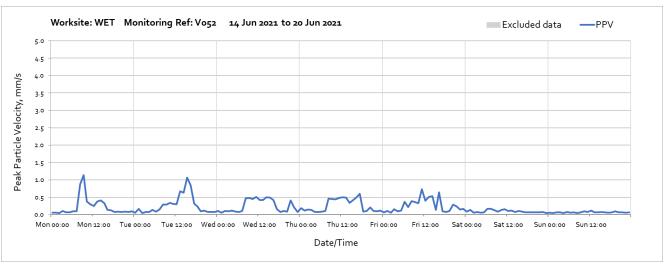
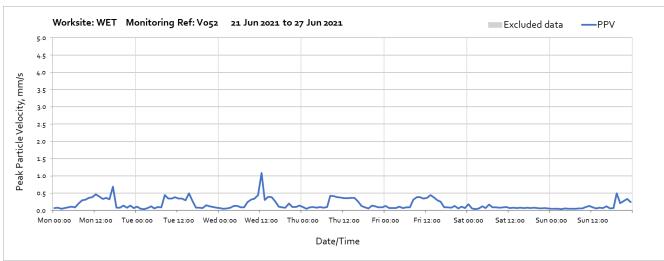
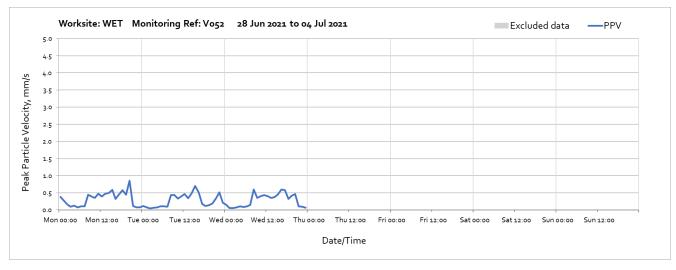
Worksite: Willesden Euro Terminal (WET) - Monitoring Ref: V052

The following graphs show the hourly measured peak particle velocity PPV recorded during the monitoring period. The graphs show the highest PPV of the three orthogonal axis x, y and z. Where high values of PPV were caused by local interference with the vibration monitor, which are not representative of HS2 construction works, these values have been greyed out in the following charts and have been excluded to calculate values in Table 4 of the main report.

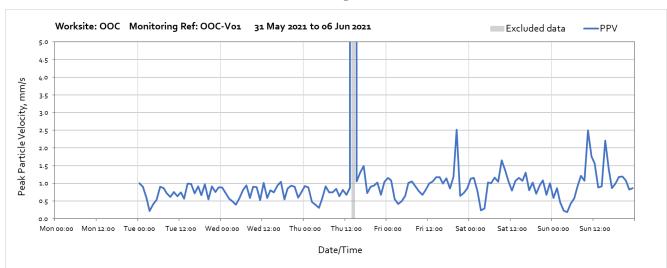
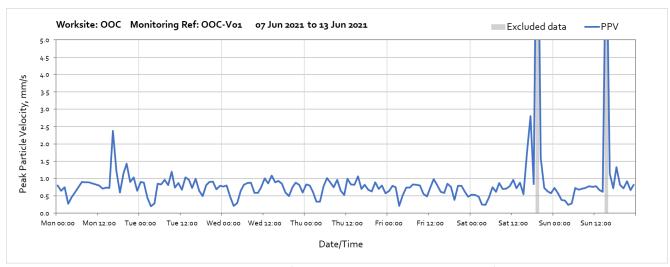
Worksite: Old Oak Common (OOC) - Monitoring Ref: OOC-V01

Note: High vibration levels at 14:00 on Thursday 3rd June 2021 were due to local disturbance at the monitor location.

Note: High vibration levels at 19:00 on Saturday 12th June 2021 and 15:00 on Sunday 13th june 2021 were due to local disturbance at the monitor location.

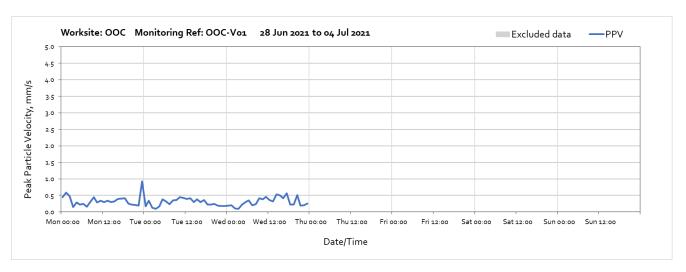
Note: High vibration levels at 15:00 on Sunday 27th june 2021 were due to local disturbance at the monitor location.

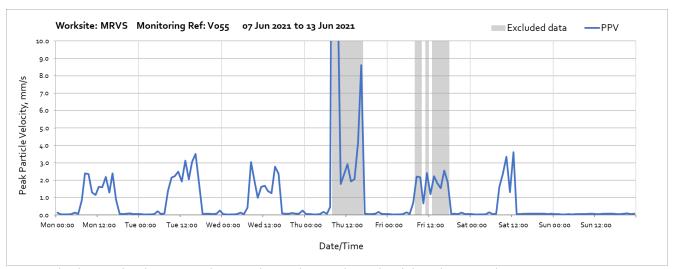
Note: High vibration levels measured across the week were due to local disturbance at the monitor location.

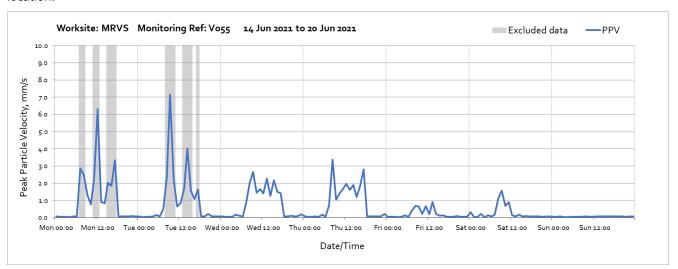
Note: High vibration levels measured across the week were due to local disturbance at the monitor location.

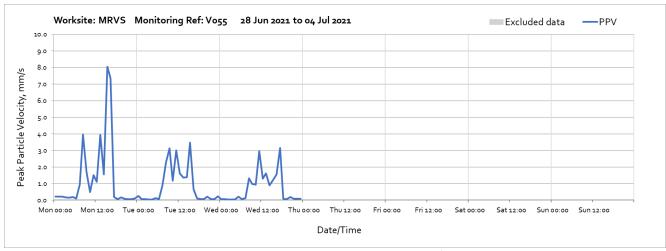
Note: High vibration levels measured between 08:00 and 17:00 on Monday 28th June 2021 was due to building demolition works undertaken near to the monitoring location. The nearest residential receptors are further away from the works and vibration levels at the receptor will therefore be lower.

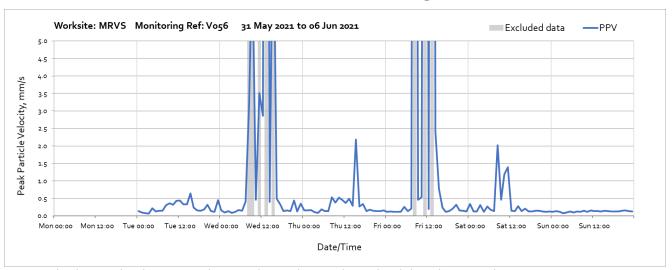
Worksite: Mandeville Road Vent Shaft (MRVS) - Monitoring Ref: V056

Note: High vibration levels measured across the week were due to local disturbance at the monitor location.

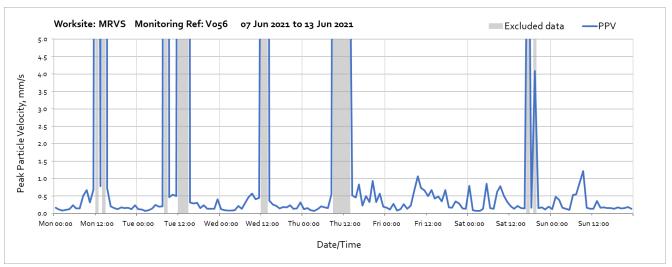
Note: High vibration levels measured across the week were due to local disturbance at the monitor location.

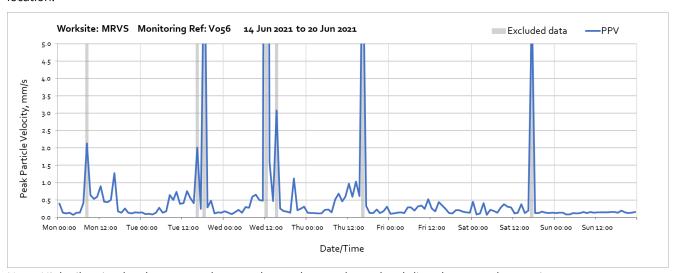
Note: High vibration levels measured across the week were due to local disturbance at the monitor location.

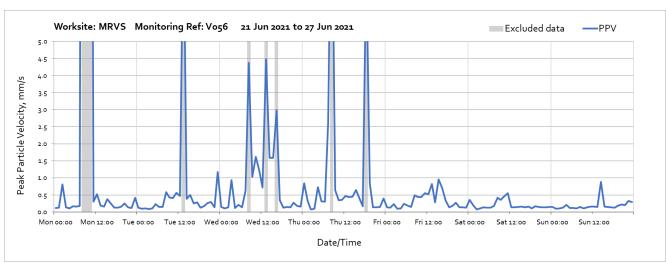
Note: High vibration levels measured across the week were due to local disturbance at the monitor location.

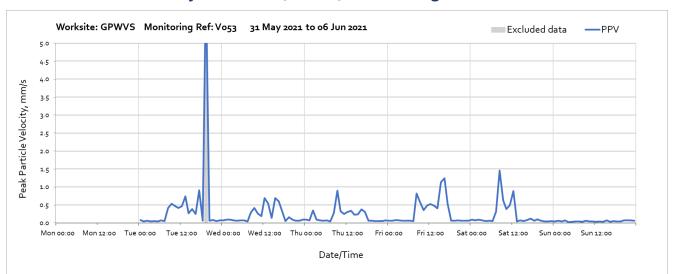
Worksite: Green Park Way Vent Shaft (GPWVS) - Monitoring Ref: V053

Note: High vibration levels measured at 19:00 on Tuesday 1st June 2021 were due to local disturbance at the monitor location.

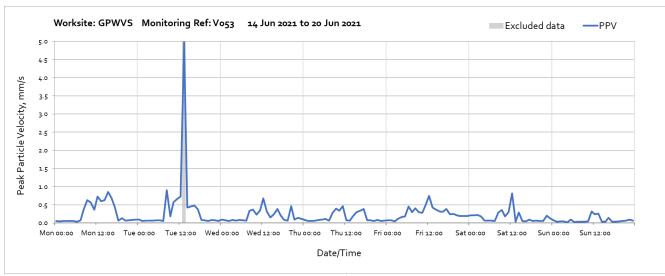
Note: High vibration levels measured at 13:00 on Tuesday 15th June 2021 were due to local disturbance at the monitor location.

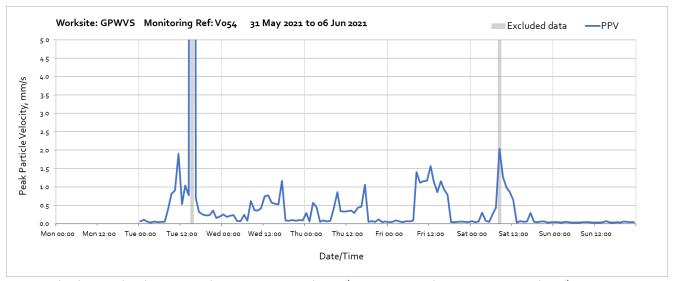
Worksite: Green Park Way Vent Shaft (GPWVS) - Monitoring Ref: V054

Note: High vibration levels measured at 15:00 on Tuesday 15th June 2021 and at 08:00 on Saturday 5th June 2021 were due to local disturbance at the monitor location.

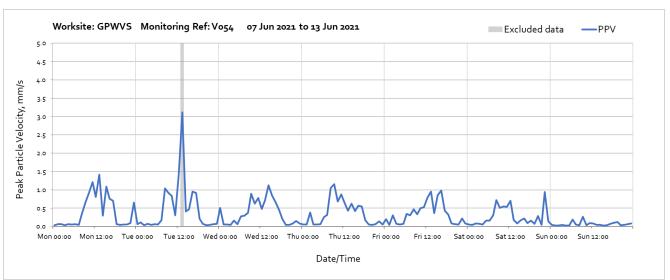
Note: High vibration levels measured at 13:00 on Tuesday 8th June 2021 were due to local disturbance at the monitor location.

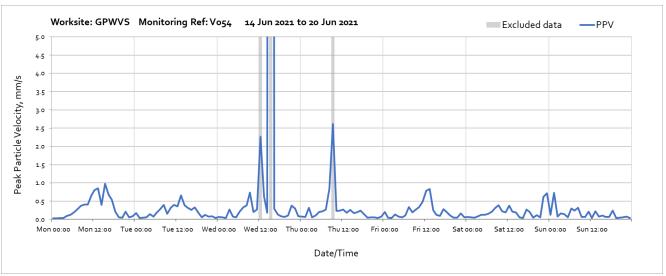
Note: High vibration levels measured between 12:00 and 15:00 on Wednesday 16th June 2021 and 09:00 on Thursday 17th June 2021 were due to local disturbance at the monitor location.

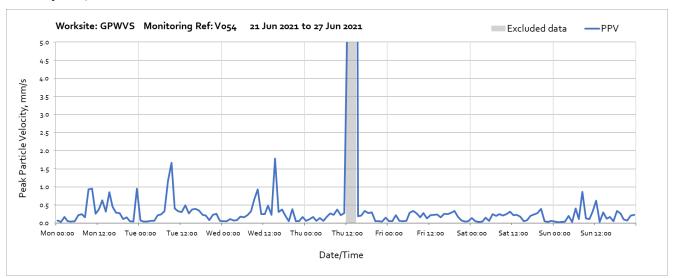
Note: High vibration levels measured between 12:00 and 14:00 on Thursday 24th june 2021 were due to local disturbance at the monitor location.
