Air Quality and Dust Monitoring Monthly Report – July 2021

London Borough of Hammersmith and
Fulham

A report prepared by EWCs and MWCCs on behalf of HS2 Ltd.

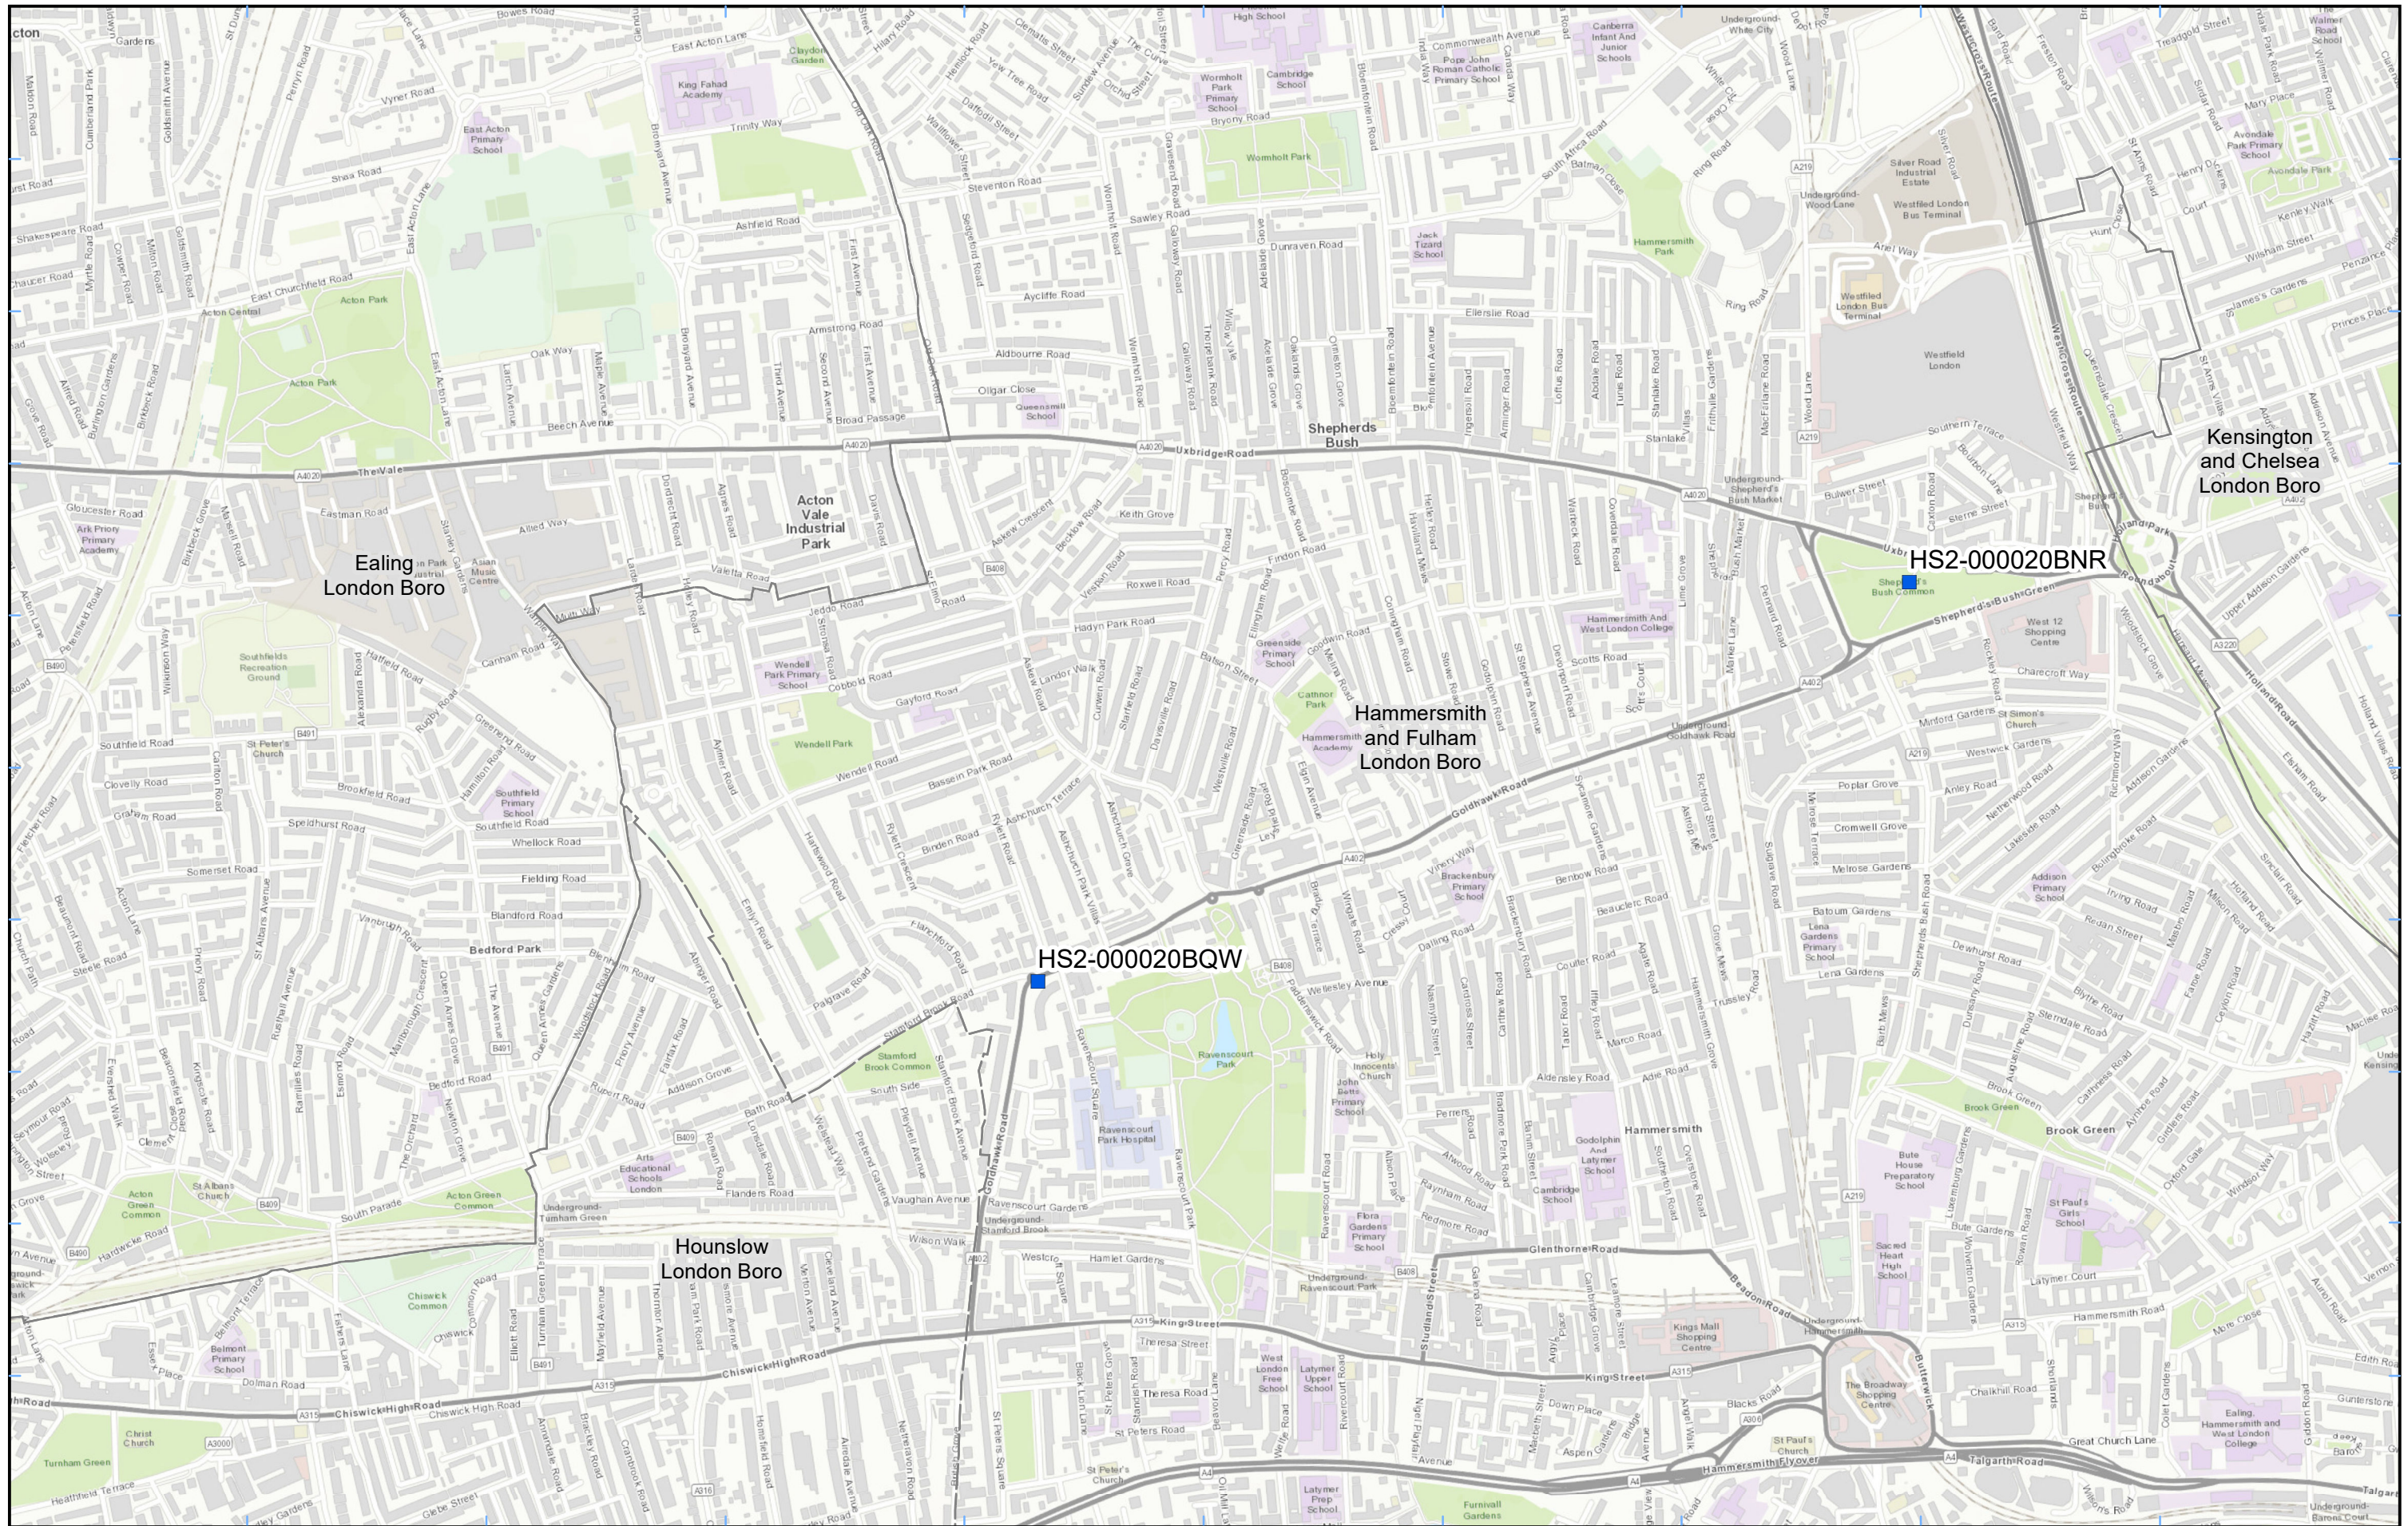
Map Number
 Map Name
**Monitoring Locations In LBHF
 (Sheet 2)**
**London Borough of Hammersmith
 and Fulham**

Legend
 Diffusion Tube
 District Borough Unitary Boundaries

- 1.1.2 Figure 1 and Figure 2 in Appendix A present the current worksite together with air quality and dust monitoring locations.
- 1.1.3 This summary should be read in conjunction with the overview monitoring report available from www.gov.uk/government/collections/monitoring-the-environmental-effects-of-hs2, which highlights: the applicable standards and guidance, as well as the air quality and dust monitoring methodologies to be implemented by nominated undertakers throughout construction.
