Air Quality and Dust Monitoring Monthly Report – July 2021 London Borough of Hillingdon

A report prepared by EWCs and MWCCs on behalf of HS2 Ltd.

Appendix A – Worksites and Monitoring Locations

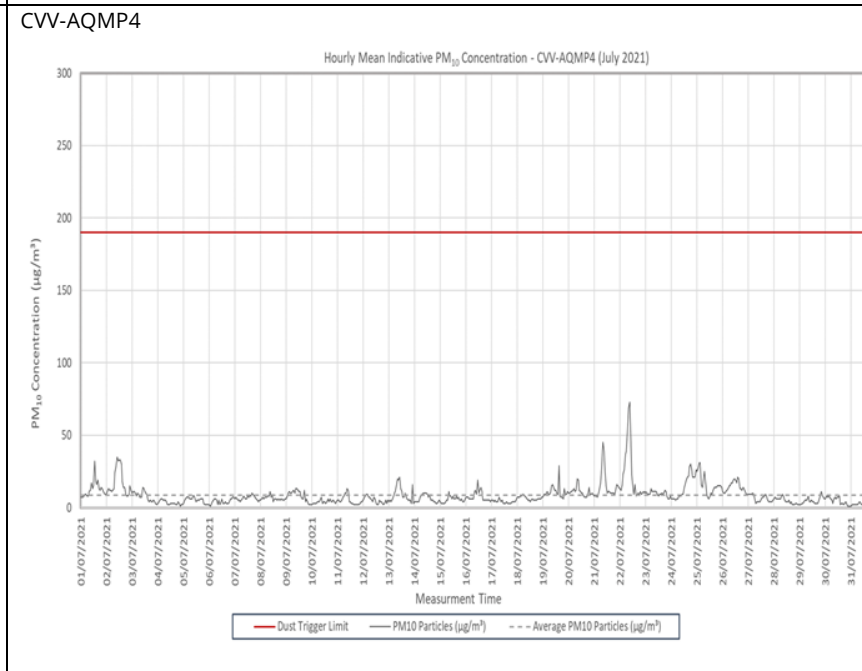
Figure 6: Construction dust 1-hour mean indicative PM₁₀ concentration for dust monitors

- 1.1.7 Dust monitoring locations and results are presented in Appendix B, together with line charts of monthly data from each dust monitor in Figure 6. All continuous dust monitoring is undertaken using indicative monitors. Despite being Environment Agency (MCERTS) certified, indicative monitors carry a higher level of uncertainty than reference monitors, and therefore cannot be strictly compared with Air Quality Standards for human health and the environment. The purpose of the monitoring undertaken is to ensure the effectiveness of the on-site mitigation.

- 1.1.9 There were seven (7) dust trigger alerts recorded during the monitoring period (July 2021). Triggers are presented in Appendix B, Table 3, it should be noted that not all alerts were attributed to the on-site activities, and monitor servicing and calibration has been undertaken. All other results were in line with the expected ranges.

Monitoring site ID	Period exceeding trigger level	Investigation	Outcomes / Resolution / Remedial measures implemented
AQ041	16/07/2021 14:01 – 15:00; 221.3 µg/m ³	AQ041 is currently located at the southwestern site boundary with the railway (opposite The Greenway). At the time of the trigger alert it is considered that the trigger was associated with nearby machinery movements and loading of wagons in the stockpile area directly adjacent to the monitor despite a dust canon operational at the location which was observed to be effective.	There are five dust canons deployed to this south-eastern section of the site and moved around according to the activities taking place. In addition, the on-site bowser and road sweeper maintain circuits of internal haul routes throughout each day. The site team will continue to remain vigilant of the need to maintain dust suppression in all areas of the site, especially in the vicinity of this operation, during the continued dry weather.

AQ050	01/07/2021 00:01 -01:00; 244.4 µg/m ³ 02/07/2021 06:01 – 07:00; 209.5 µg/m ³ 04/07/2021 07:01- 08:00; 403.8 µg/m ³	AQ050 is currently located near the Cophall South compound near Harvil Road. At the time of the trigger there were no works or vehicle movements associated with the HS2 site and the weather was wet. A number of subsequent erratic data spikes and trigger alerts during the early hours of the morning and wet weather in June (reported in previous report) and July indicate the monitor was potentially being affected by high humidity and moisture due to a faulty internal heater.	The monitor was serviced and calibrated in early July 2021.
