## **Construction noise and vibration Monthly Report – July 2021**

**London Borough of Ealing**

# Non-Technical Summary

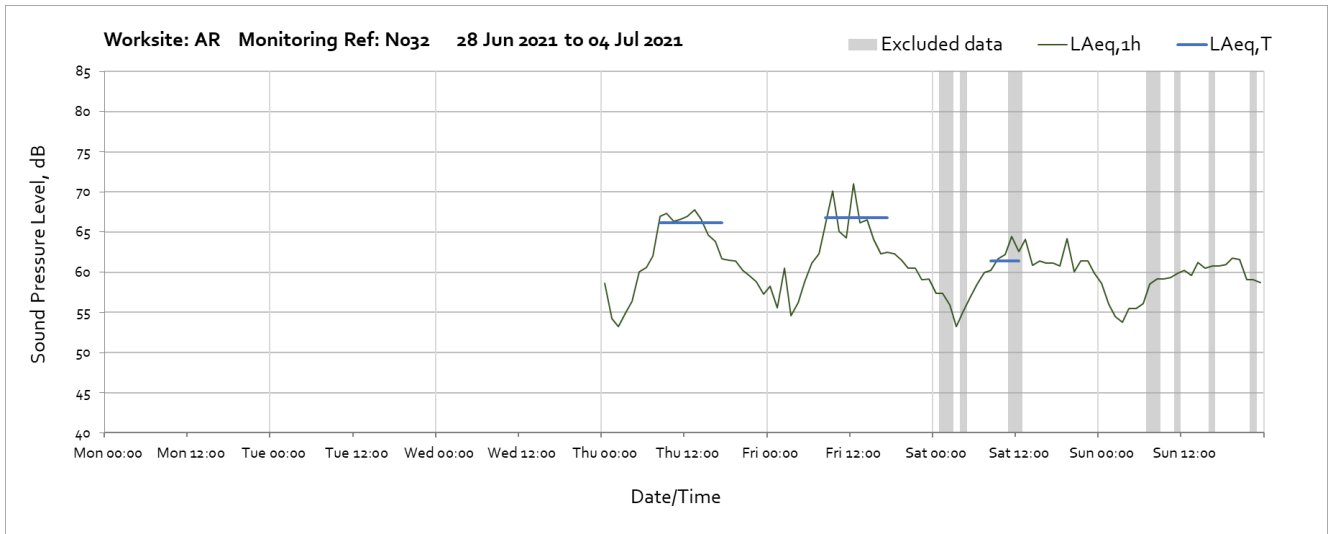
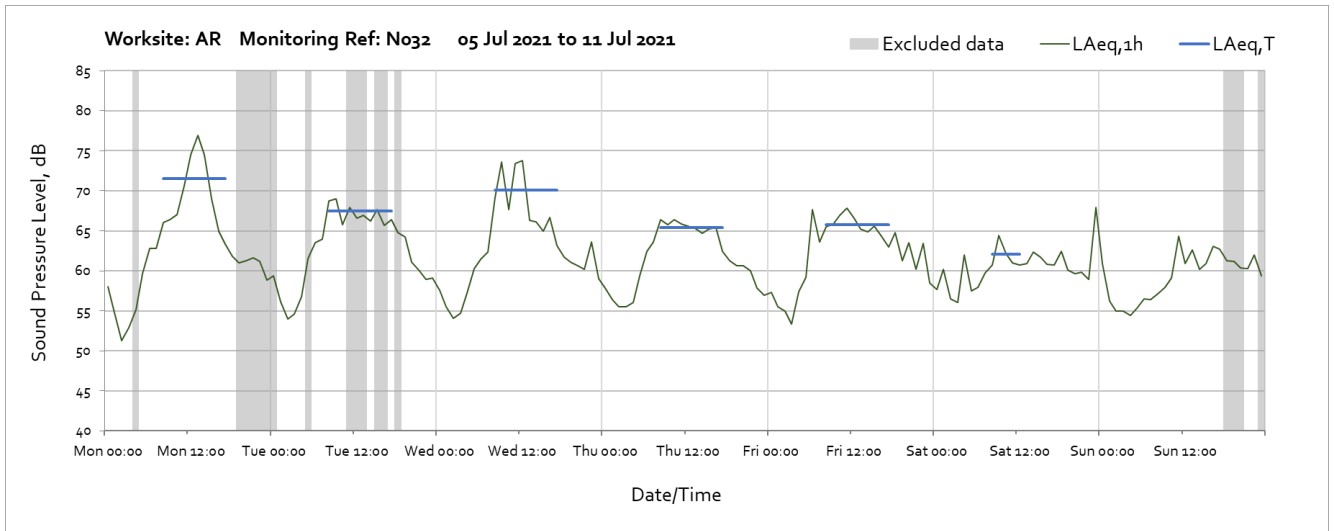
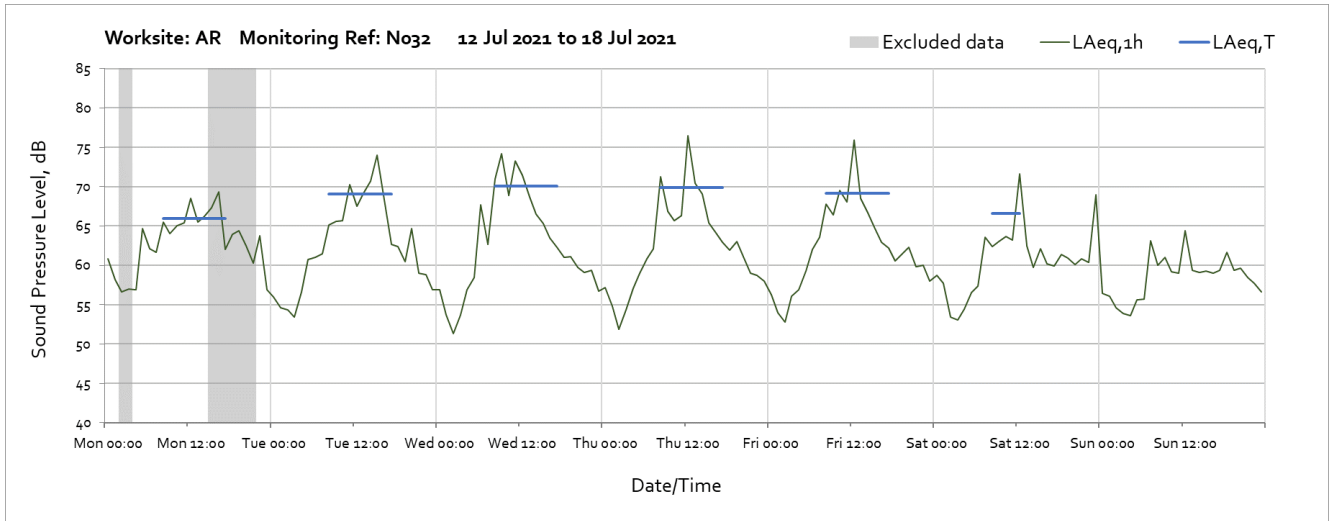
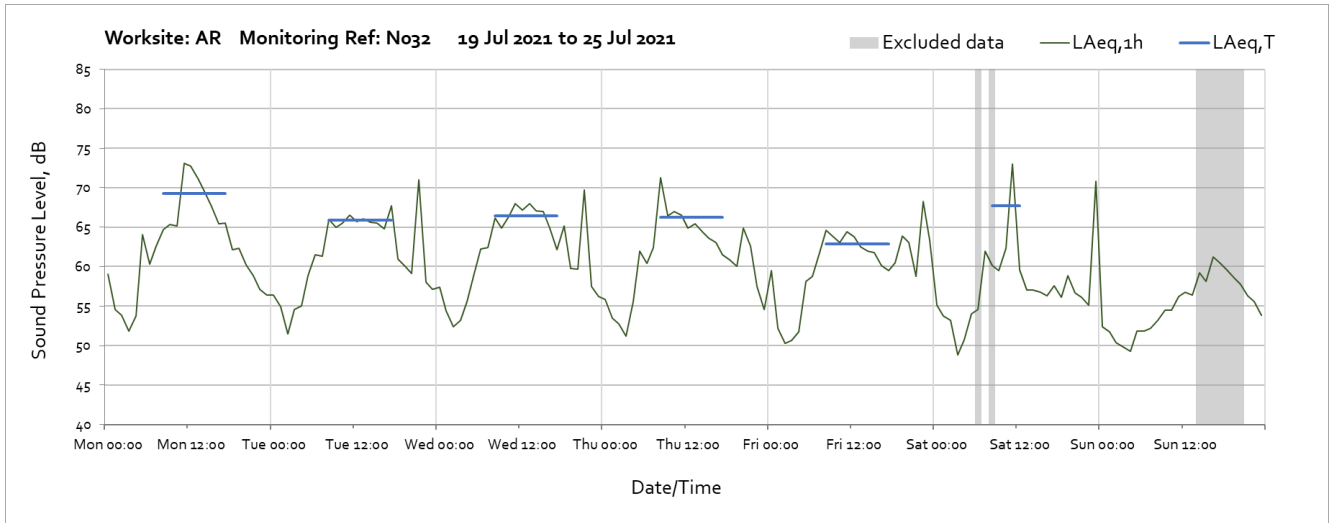
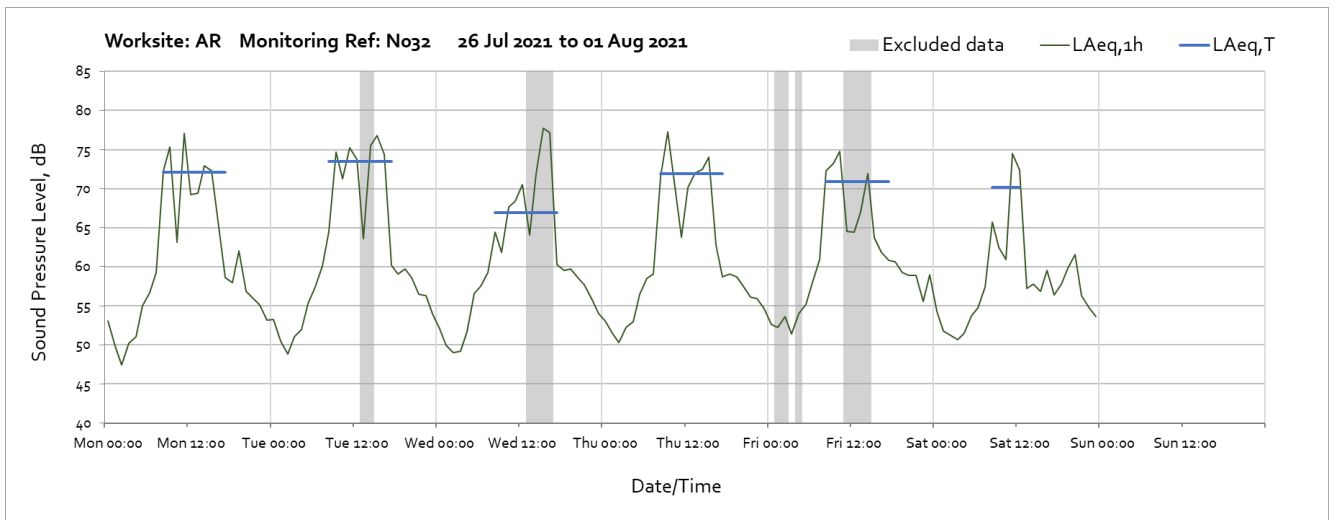
### Worksite: Atlas Road worksite (AR) – Monitoring Ref: N032

The following graphs show the hourly measured ambient noise level  $L_{Aeq,1h}$  and, where relevant, the averaged noise level  $L_{Aeq,T}$  values, where the time period T is as specified in Table 1 of HS2 Information Paper E23. Periods with adversely weather affected noise levels are greyed out and have been excluded from the calculation of the  $L_{Aeq,T}$  values in Table 3 of the main report.

2.1.3 Appendix C presents graphs of the noise and vibration monitoring data over the month for each of the measurement locations. Noise data presented consists of the hourly  $L_{Aeq}$  values and, where relevant, the  $L_{Aeq,T}$  values (where the time period T has been taken to be the averaging period as specified in Table 1 of HS2 Information Paper E23). Vibration data presented consist of hourly PPV values. The full data set for the monitoring equipment can be found at the following location: <https://data.gov.uk/dataset/24542ae7-dd44-444f-b259-871c4cc43b5e/environmental-monitoring-data>.

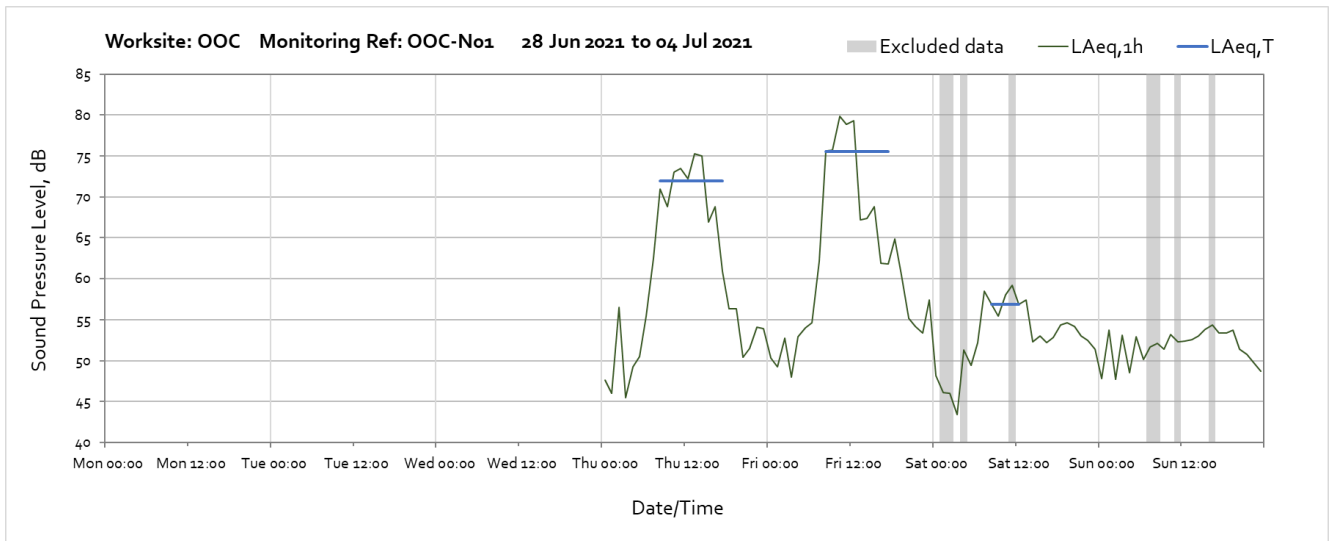
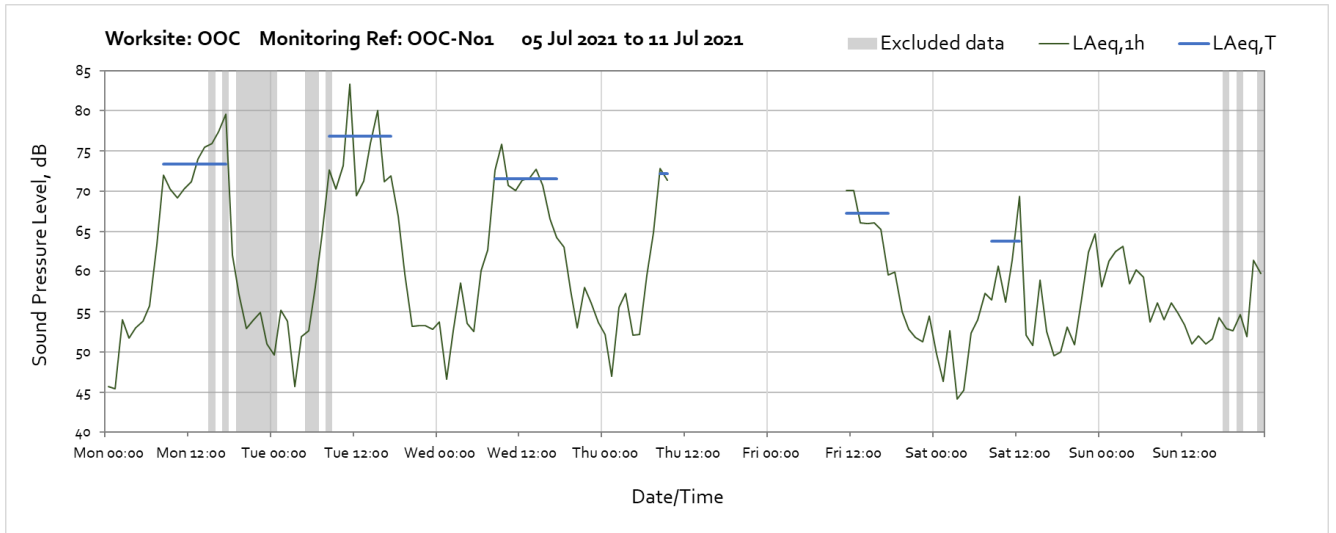
**Worksite: Oal Oak Common (OOC) - Monitoring Ref: OOC-N01**

Note: Missing data between 10:00 on Thursday 8<sup>th</sup> July and 11:00 on Friday 9<sup>th</sup> July 2021 was due to removal of power at the monitoring location to enable vegetation clearance.

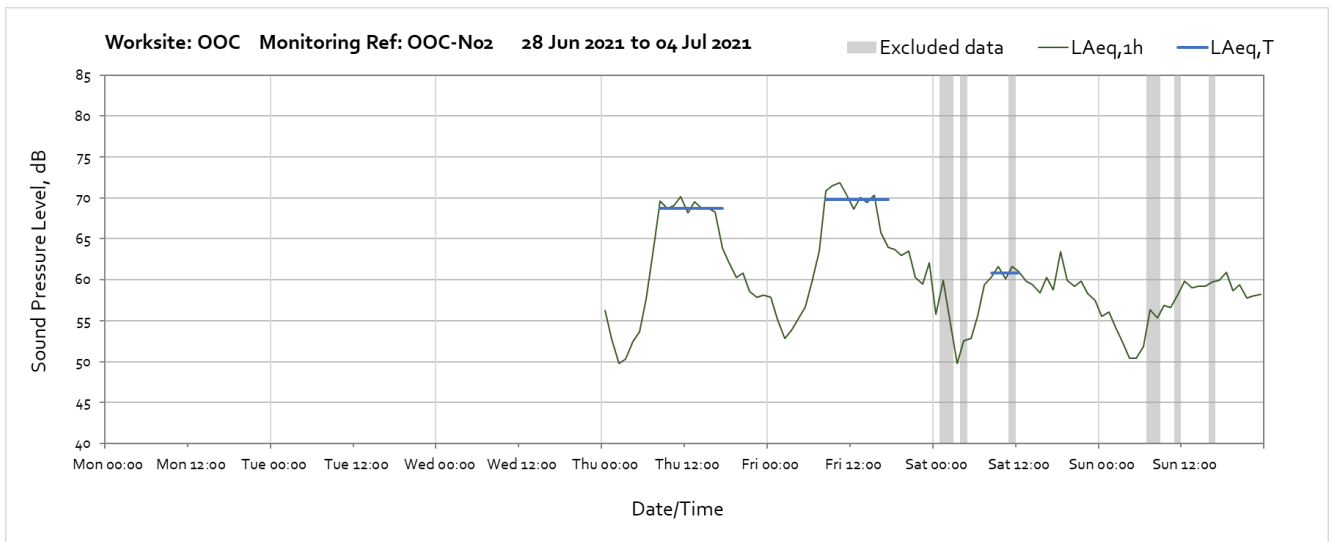
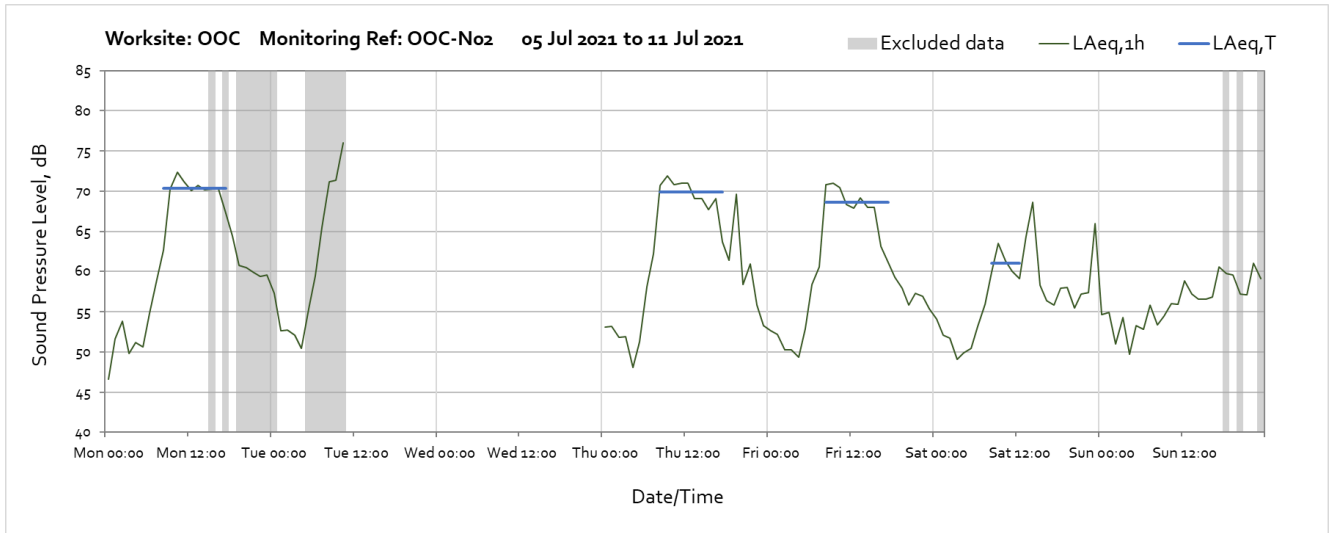
**Worksite: Oal Oak Common (OOC) – Monitoring Ref: OOC-N02**

Note: High noise levels measured between 09:00 and 10:00 on Tuesday 6<sup>th</sup> July were due to routine maintenance at the monitoring station. Missing data between 11:00 on Tuesday 6<sup>th</sup> July and 00:00 on Thursday 8<sup>th</sup> July 2021 was due to a monitoring station software error.

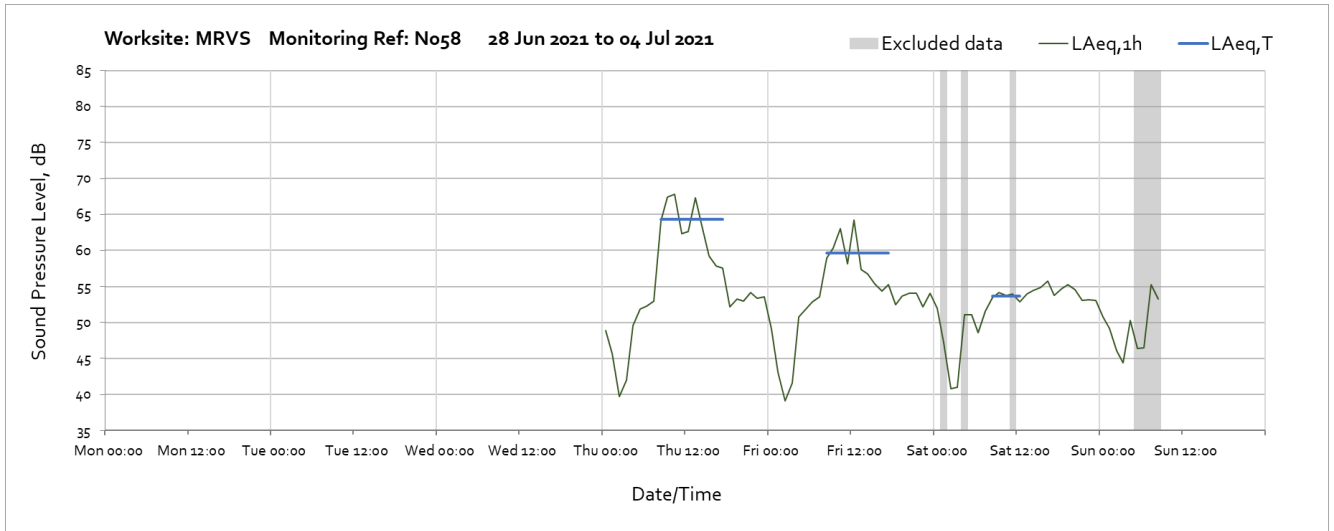
## Worksite: Mandeville Road Ventilation Shaft (MRVS) – Monitoring Ref: N058

Note: Missing data between 09:00 on Sunday 4<sup>th</sup> July and 08:00 on Monday 5<sup>th</sup> July 2021 was due to loss of power at the monitor location.

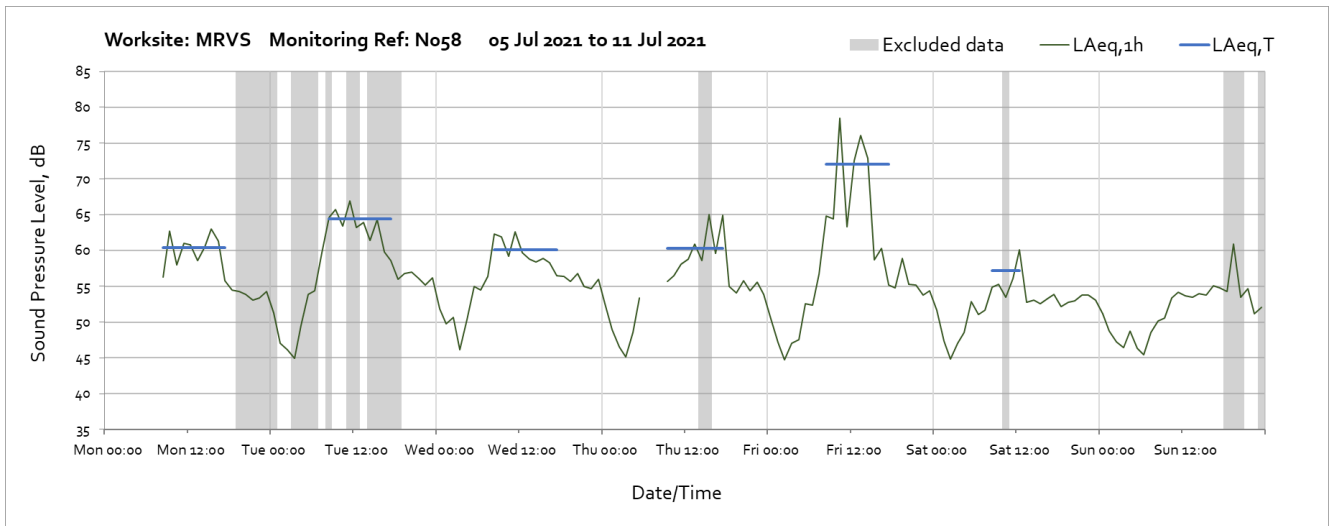
Note: Missing data between 09:00 on Sunday 4<sup>th</sup> July and 08:00 on Monday 5<sup>th</sup> July and between 06:00 and 08:00 on Thursday 8<sup>th</sup> July 2021 was due to loss of power at the monitor location.

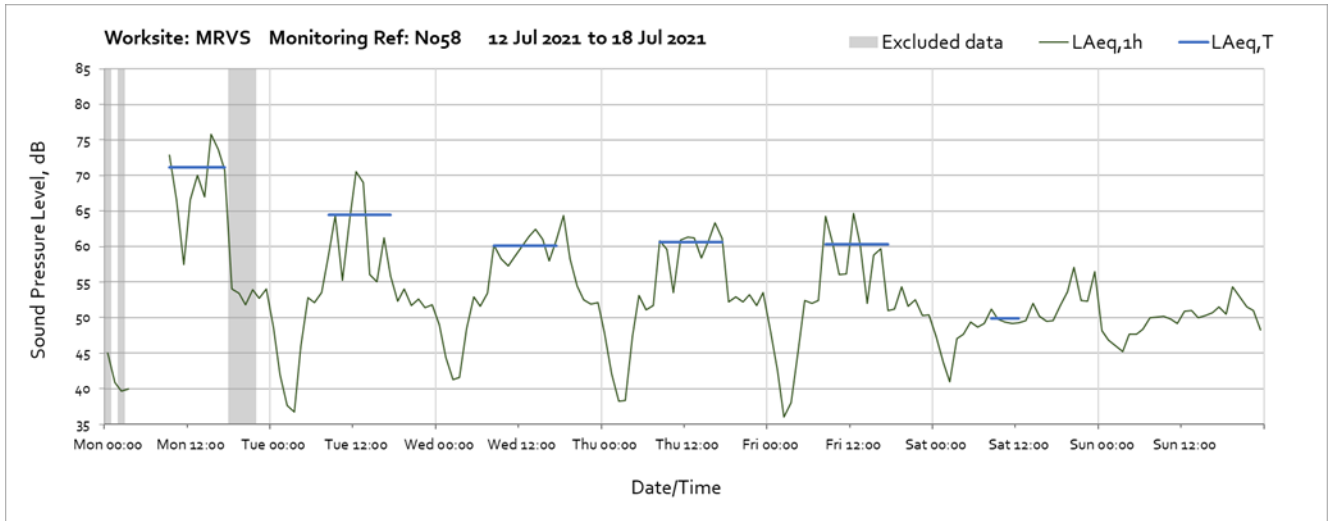
Note: Missing data between 04:00 and 08:00 on Monday 12<sup>th</sup> July 2021 was due to loss of power at the monitor location.

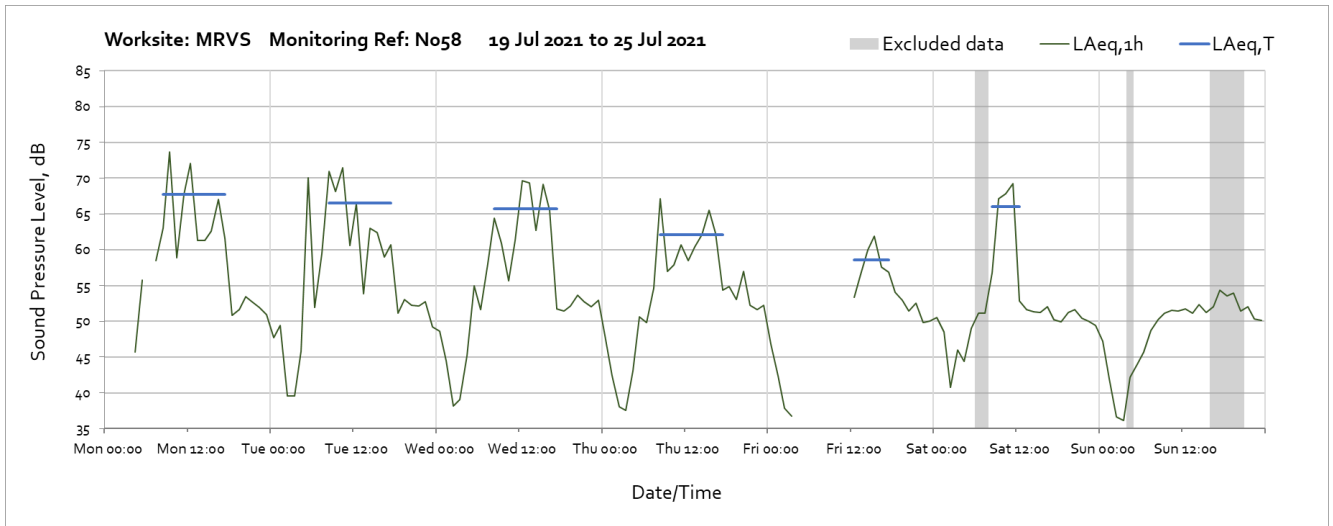
Note: Missing data between 00:00 and 06:00 on Monday 19<sup>th</sup> July 2021 was due to a monitoring station software error and missing data between 04:00 and 12:00 on Friday 23<sup>rd</sup> July 2021 was due to loss of power at the monitor location.

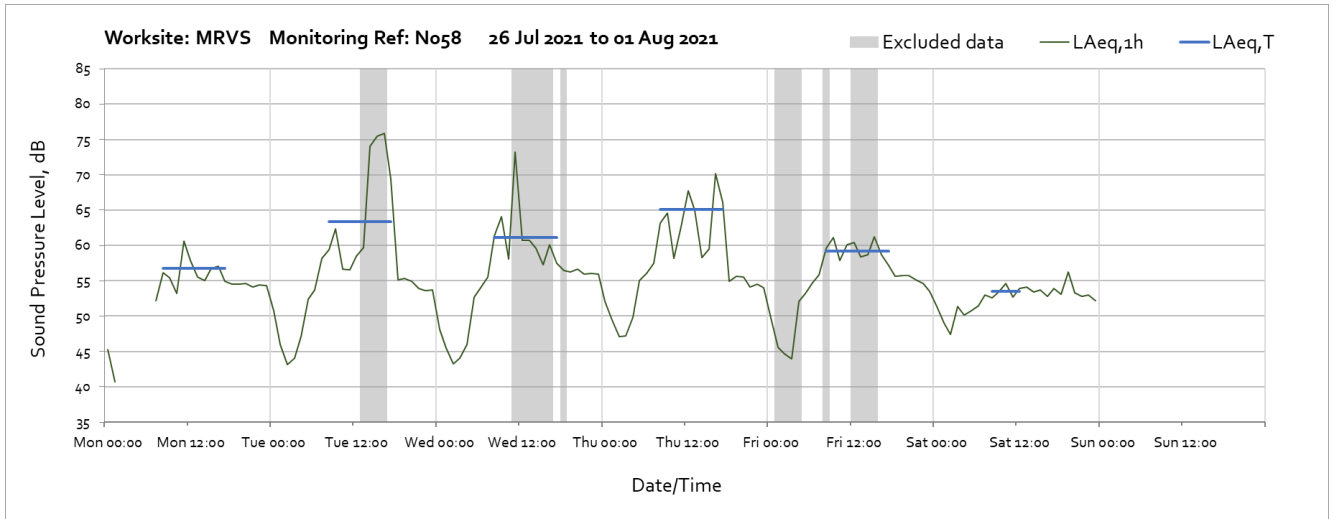
Note: Missing data between 02:00 and 07:00 on Friday 26<sup>th</sup> July 2021 was due to loss of power at the monitor location..

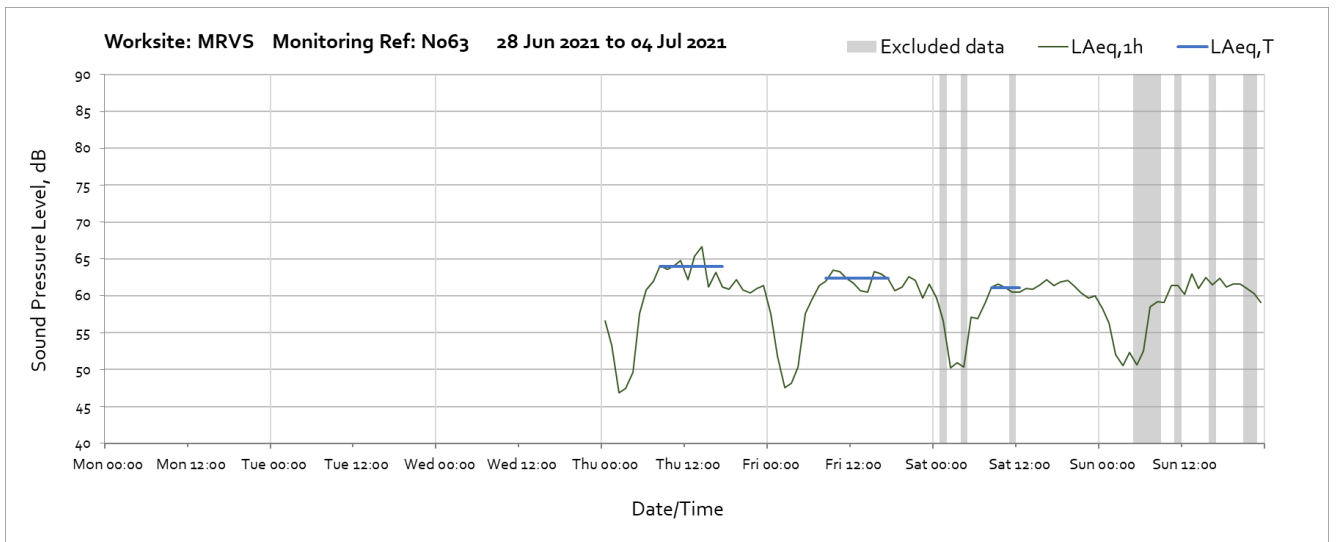
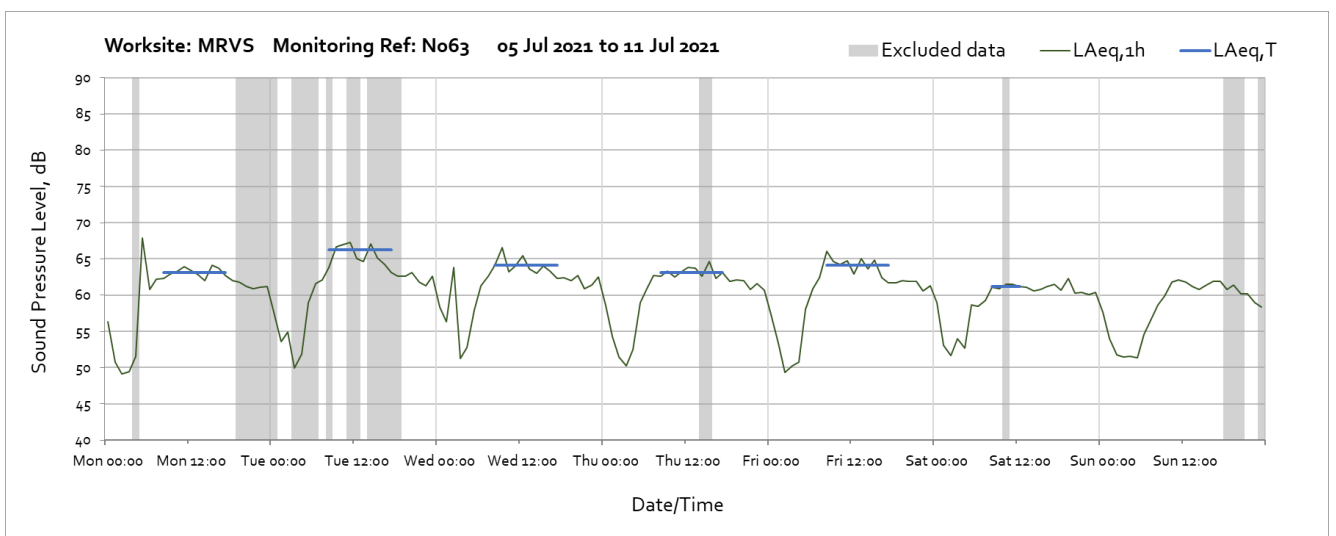
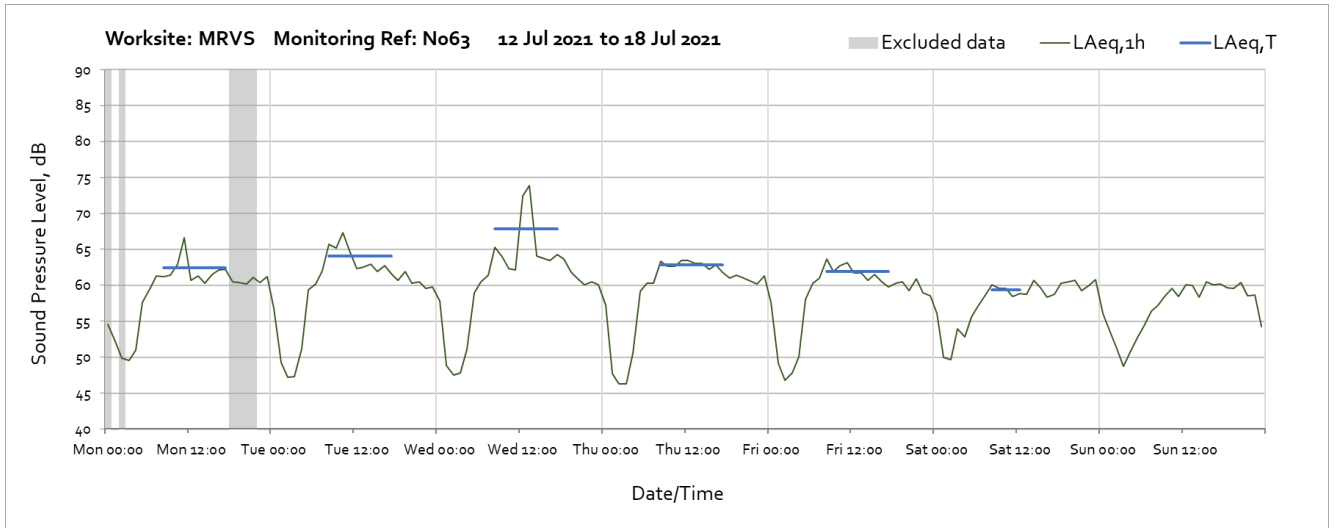
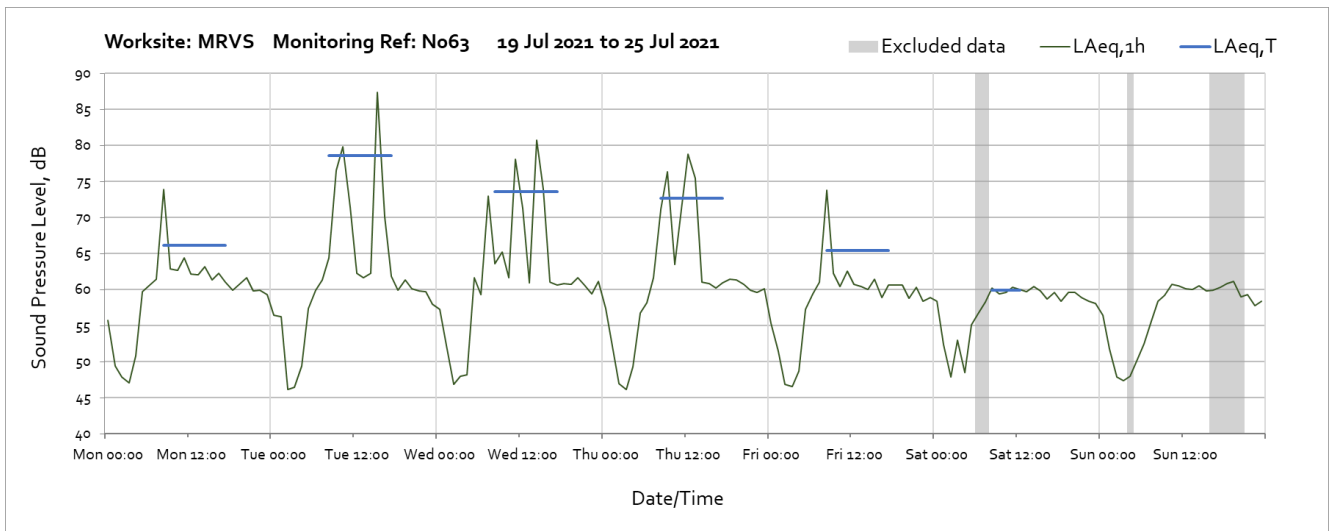
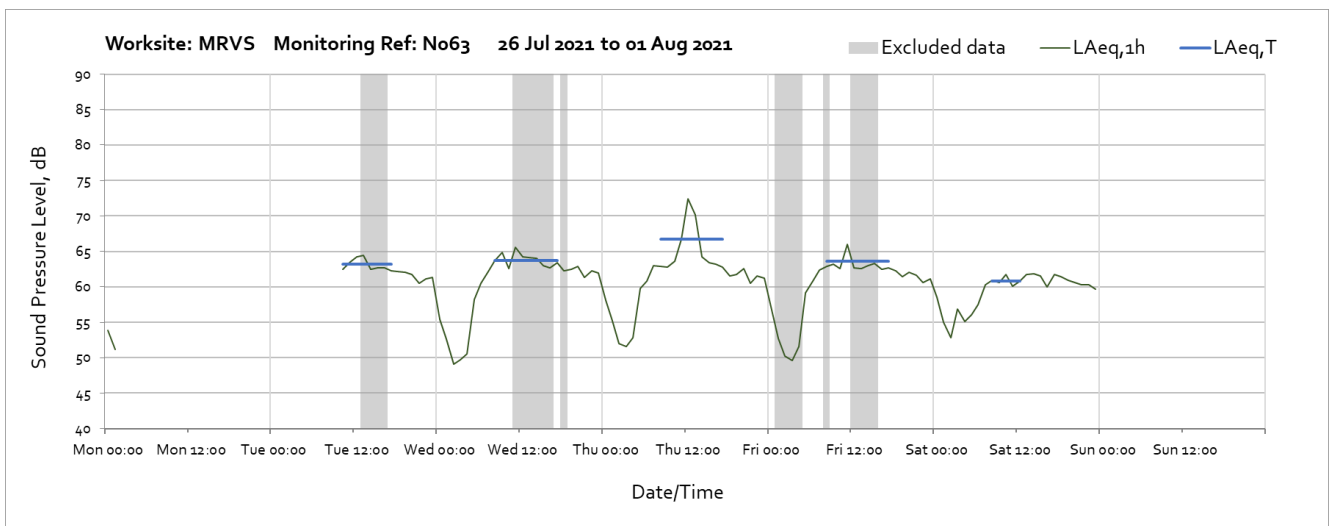
### Worksite: Mandeville Road Ventilation Shaft (MRVS) – Monitoring Ref: N063

Note: Missing data between 02:00 on Monday 26<sup>th</sup> July and 10:00 on Tuesday 27<sup>th</sup> July 2021 was due to loss of power at the monitor location.

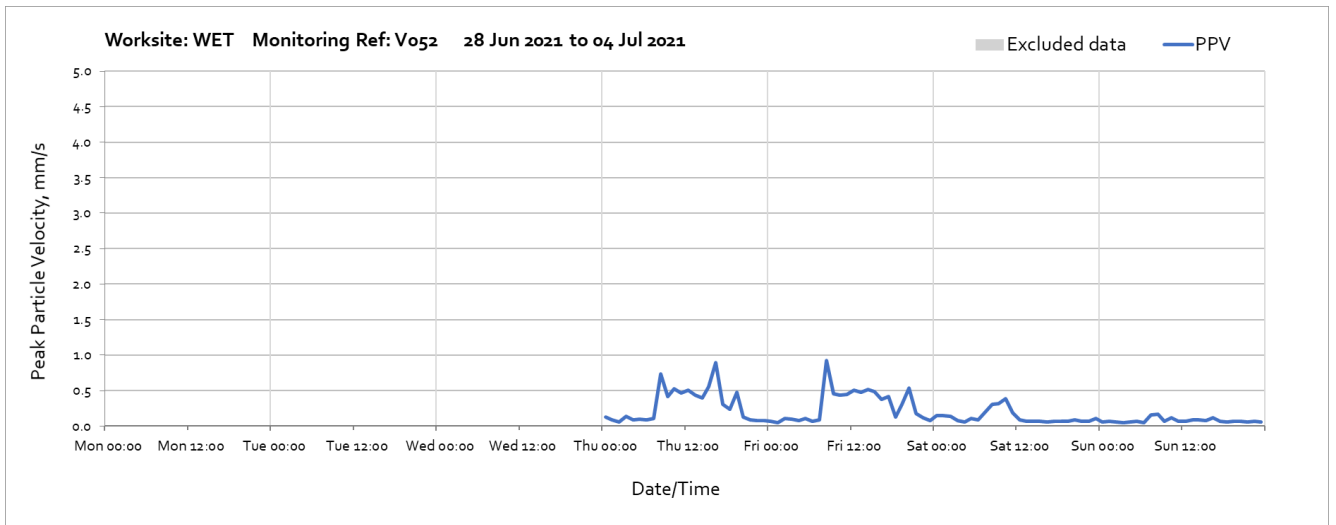
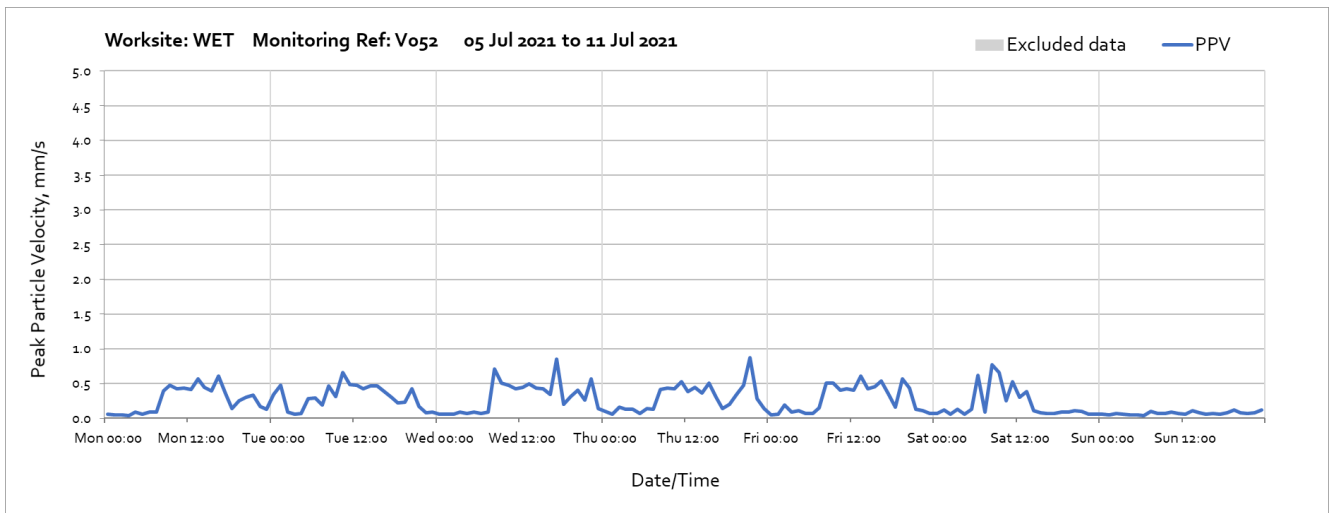
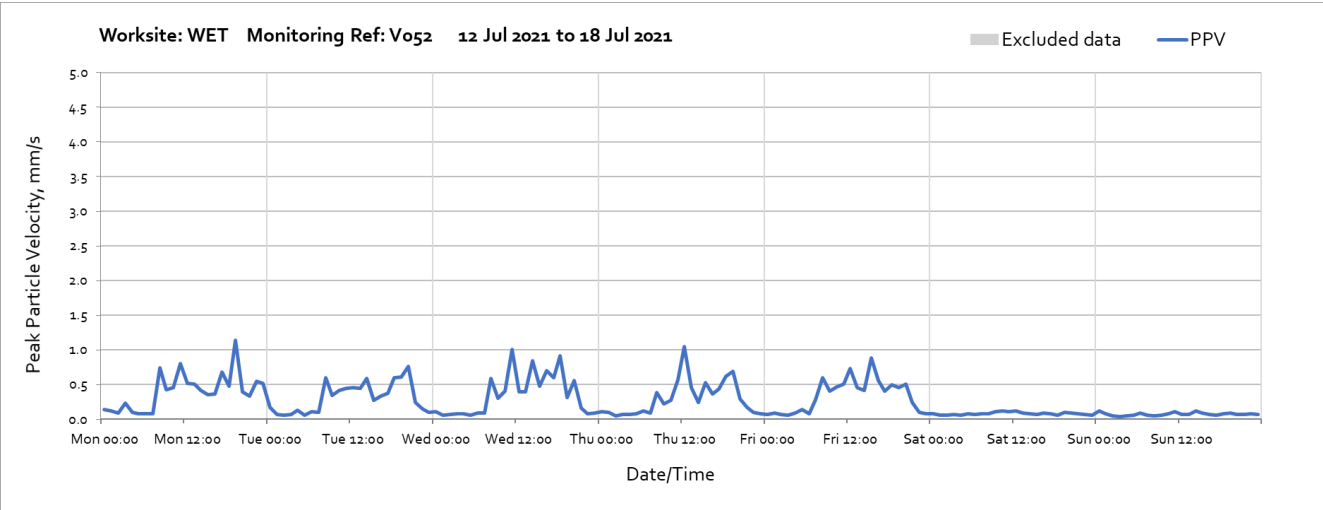
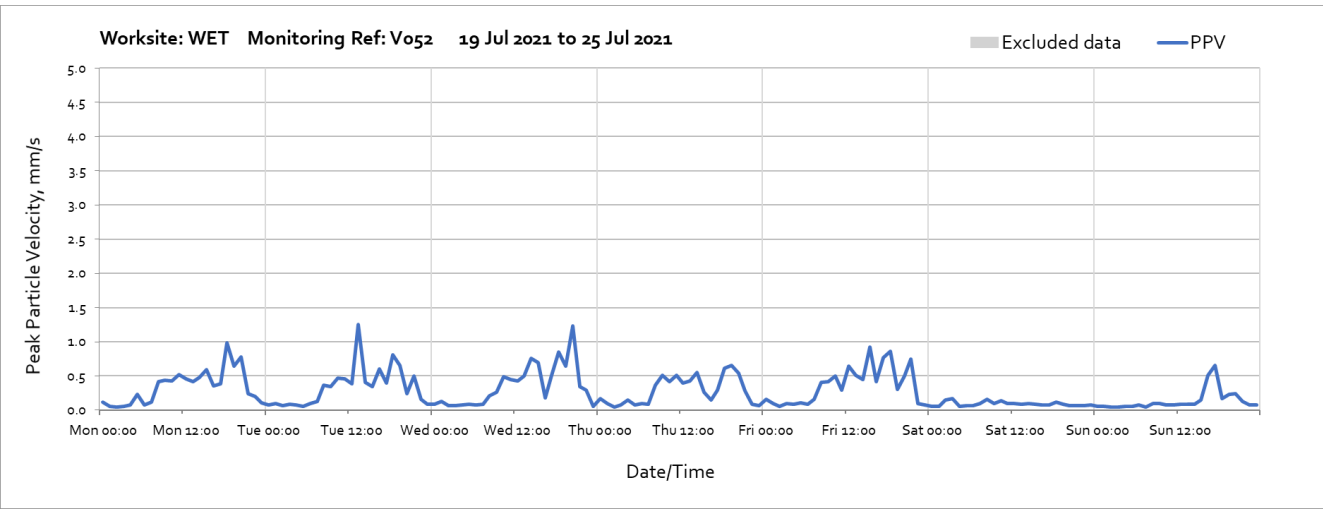
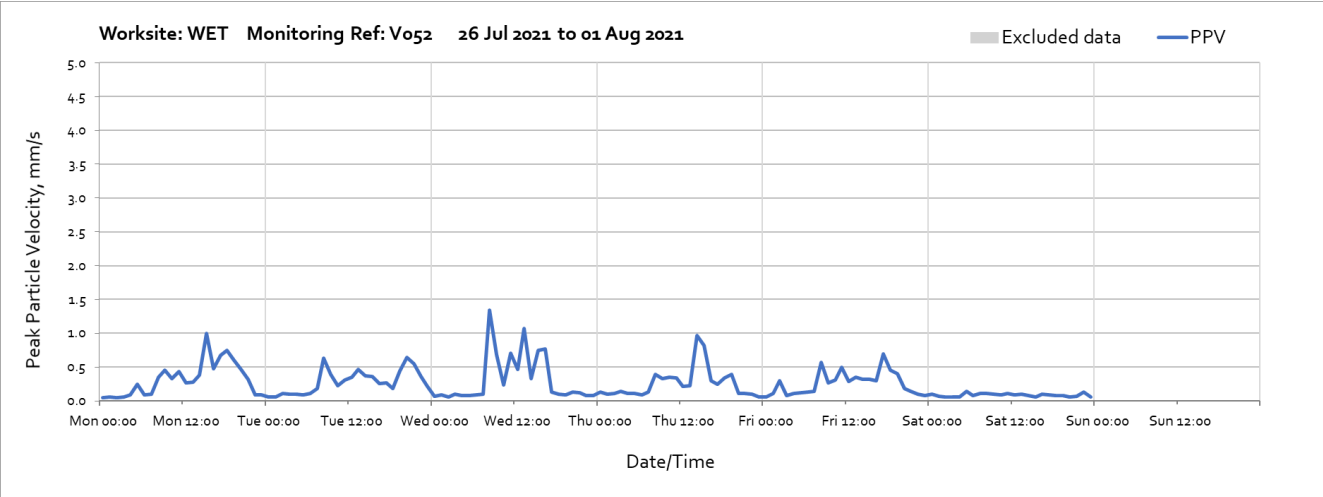
### Worksite: Willesden Euro Terminal (WET) – Monitoring Ref: V052

The following graphs show the hourly measured peak particle velocity PPV recorded during the monitoring period. The graphs show the highest PPV of the three orthogonal axis x, y and z. Where high values of PPV were caused by local interference with the vibration monitor, which are not representative of HS2 construction works, these values have been greyed out in the following charts and have been excluded to calculate values in Table 4 of the main report.

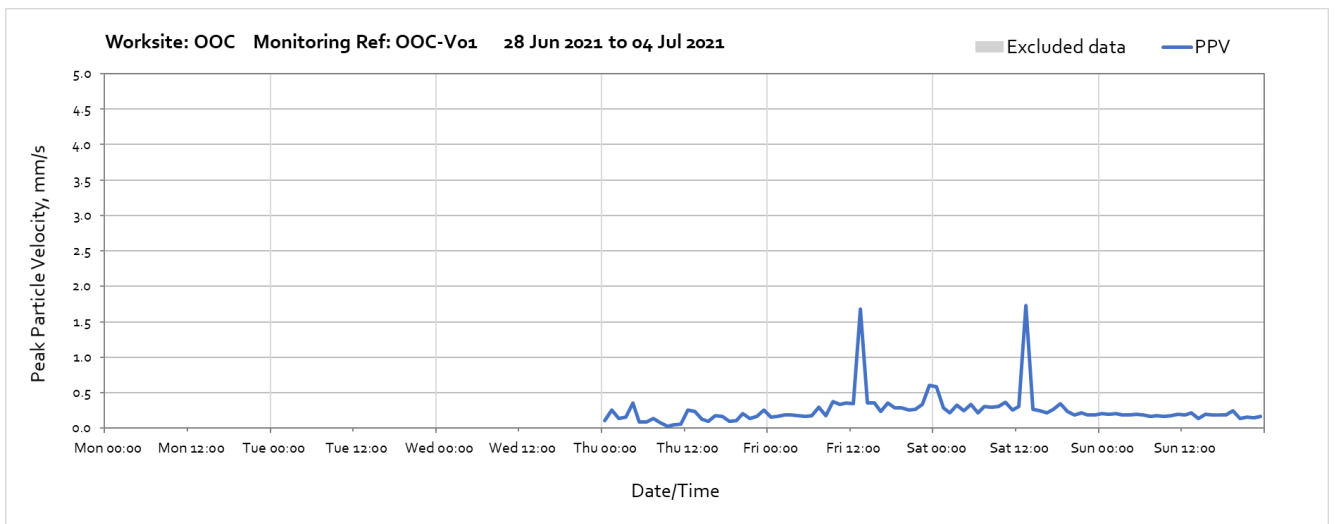
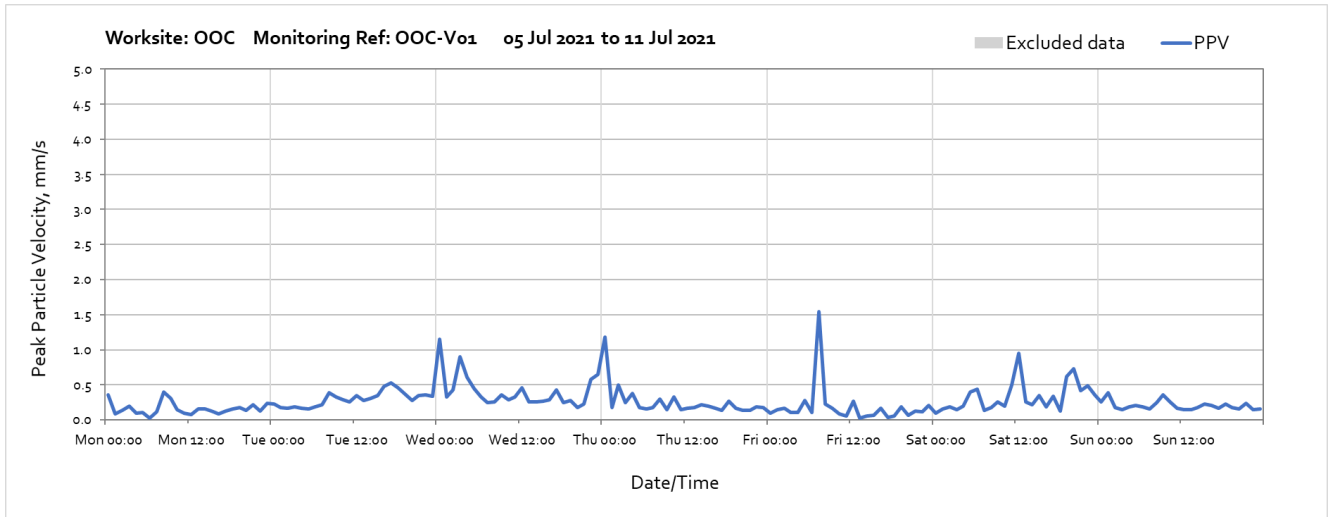
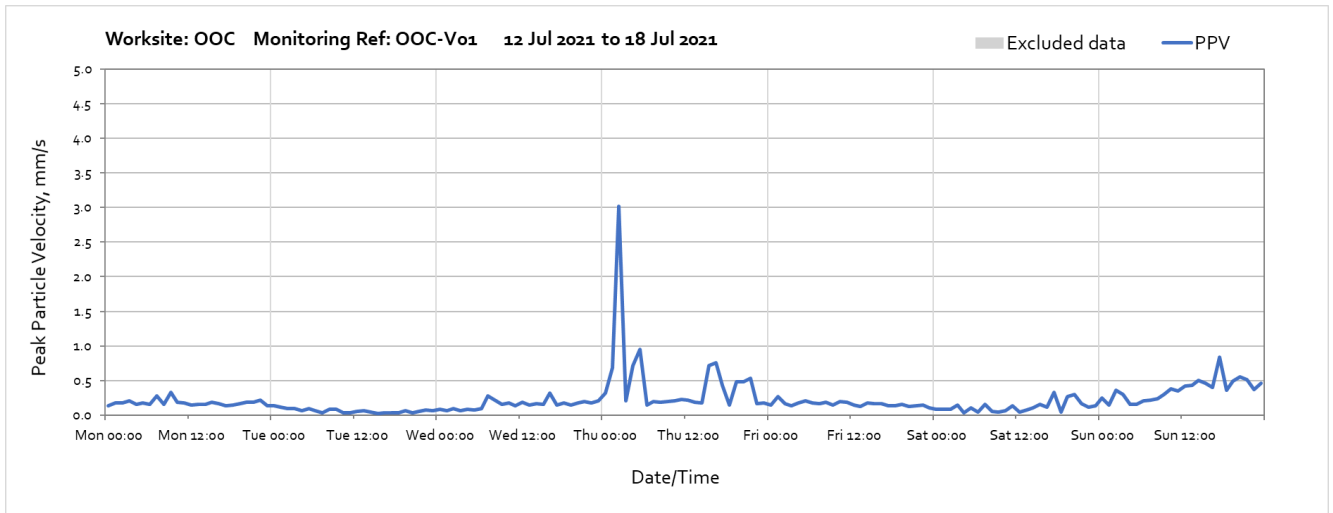
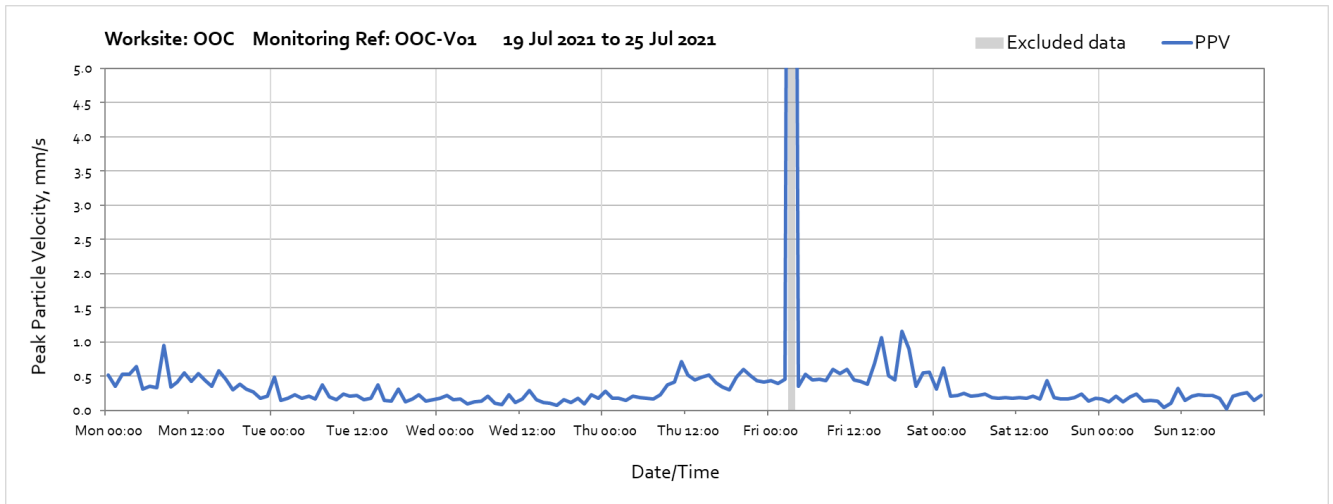
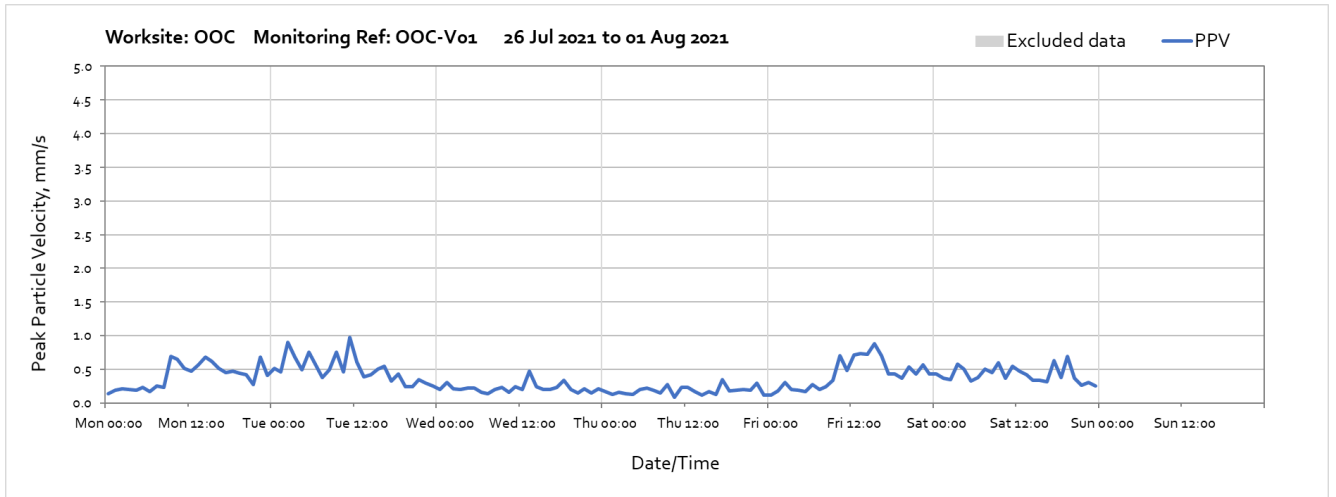
**Worksite: Old Oak Common (OOC) – Monitoring Ref: OOC-V01**

Note: High vibration levels measured at 03:00 on Friday 23<sup>rd</sup> July 2021 was due to local disturbance at the monitor station and not representative of HS2 works.
