## **Construction noise and vibration Monthly Report – July 2021**

**London Borough of Ealing**

# Non-Technical Summary

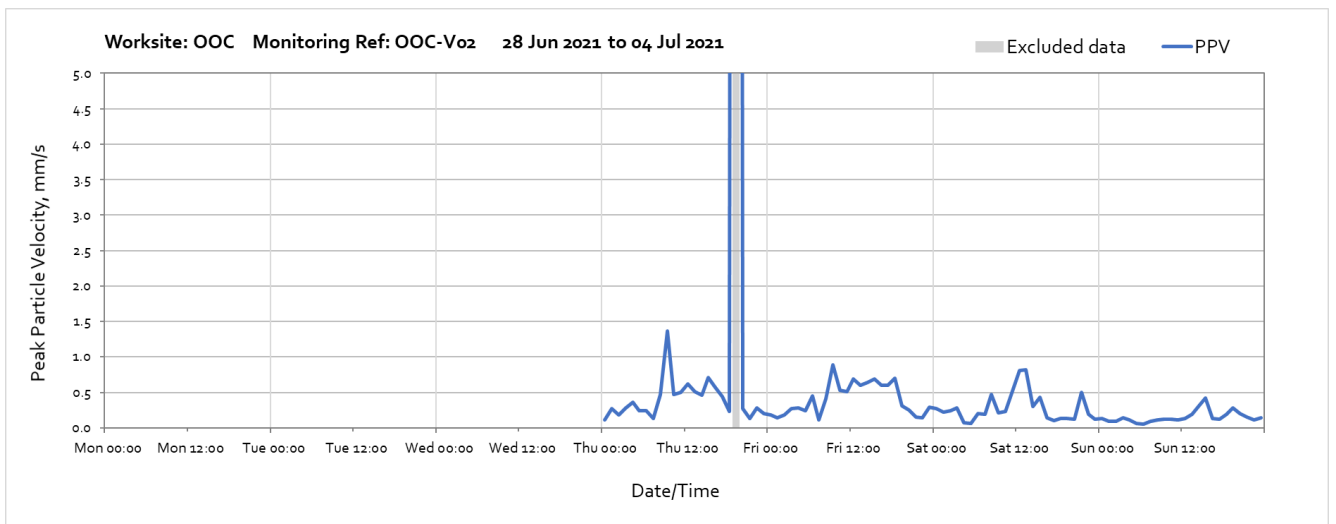
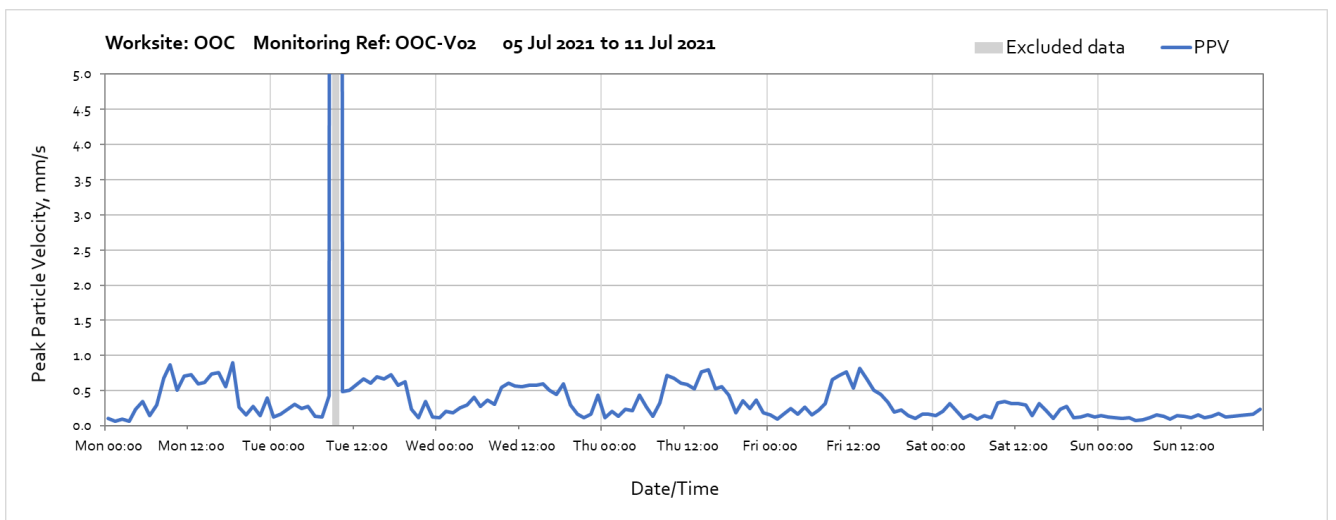
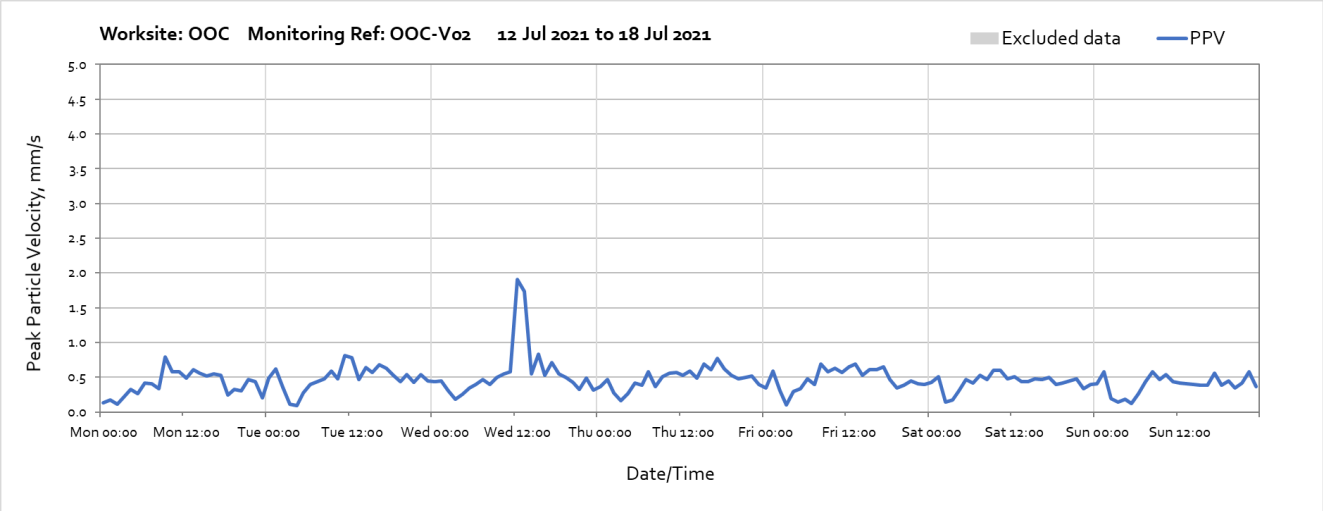
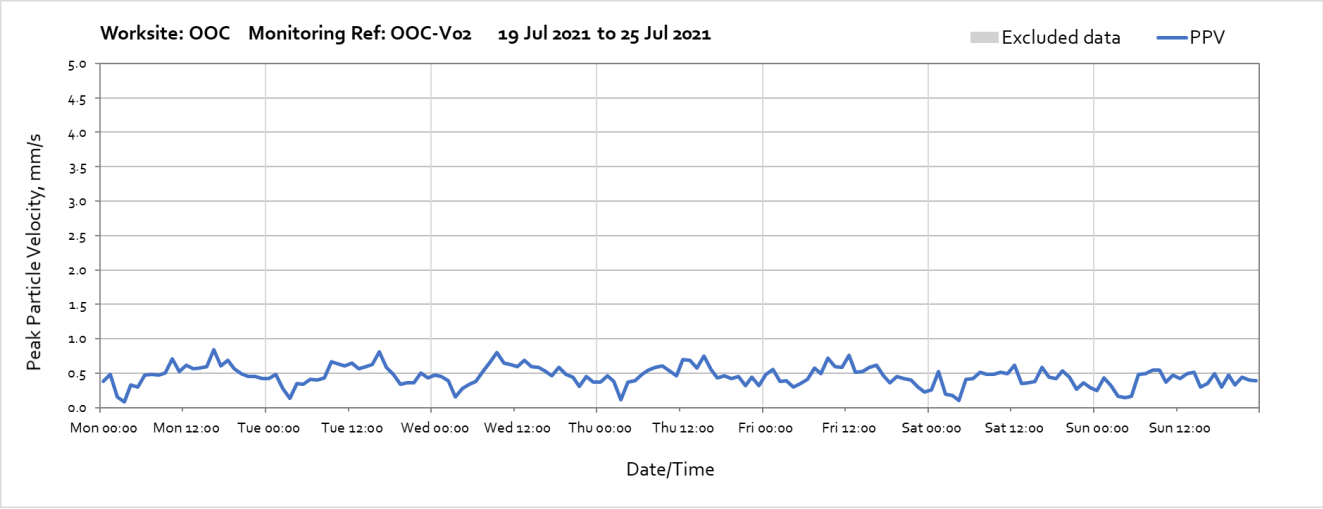
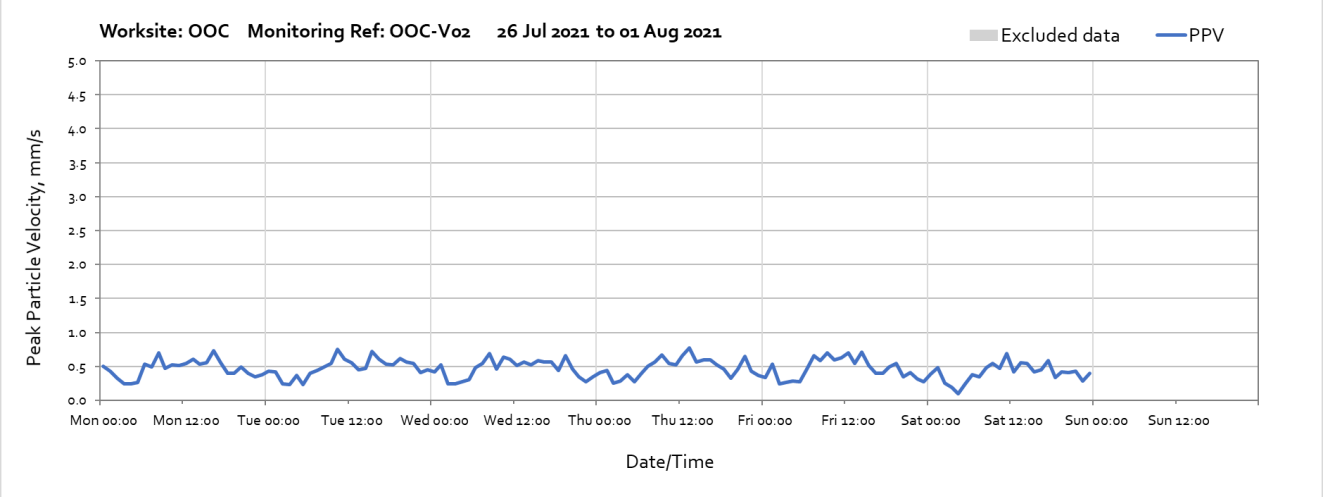
### Worksite: Old Oak Common (OOC) – Monitoring Ref: OOC-V02

Note: High vibration levels measured at 19:00 on Thursday 1<sup>st</sup> July 2021 was due to local disturbance at the monitor station and not representative of HS2 works.

Note: High vibration levels measured at 09:00 on Tuesday 6<sup>th</sup> July 2021 was due to routine maintenance of the monitoring station.

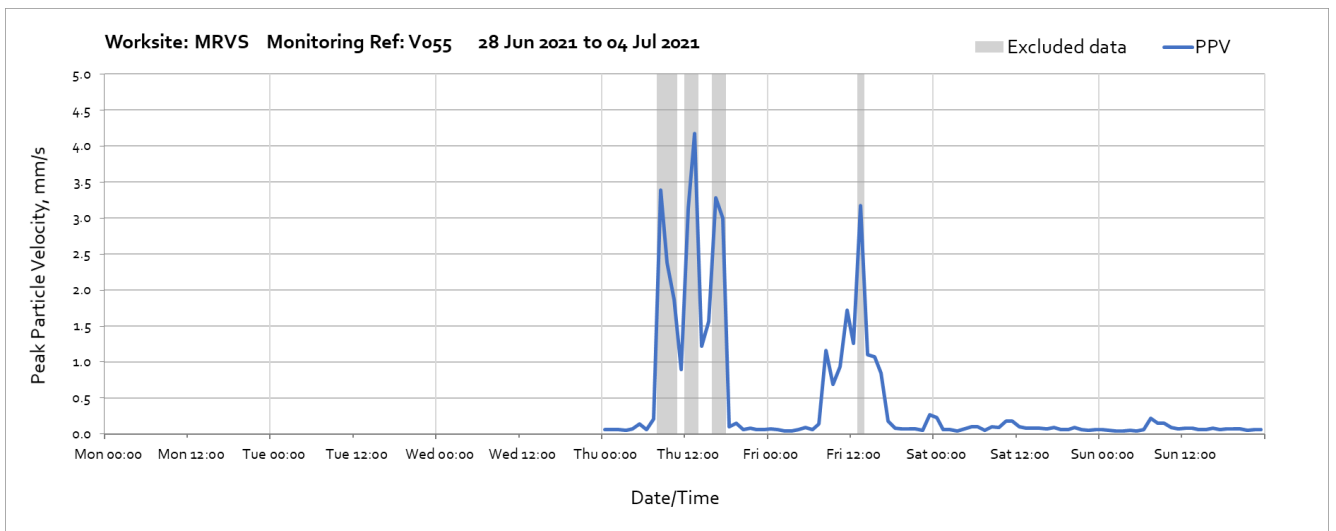
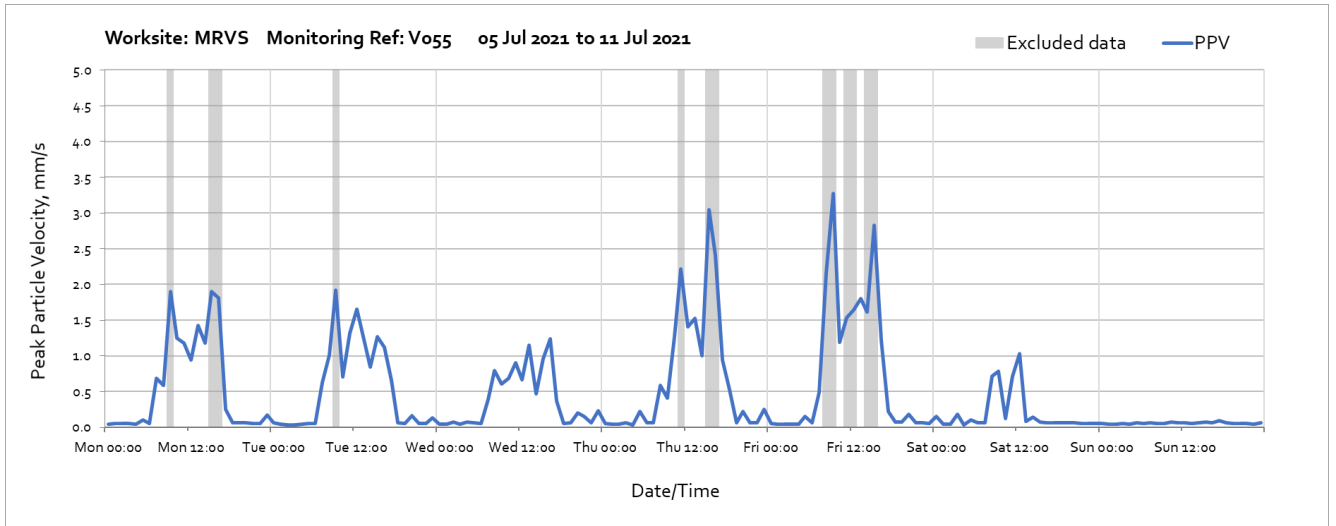
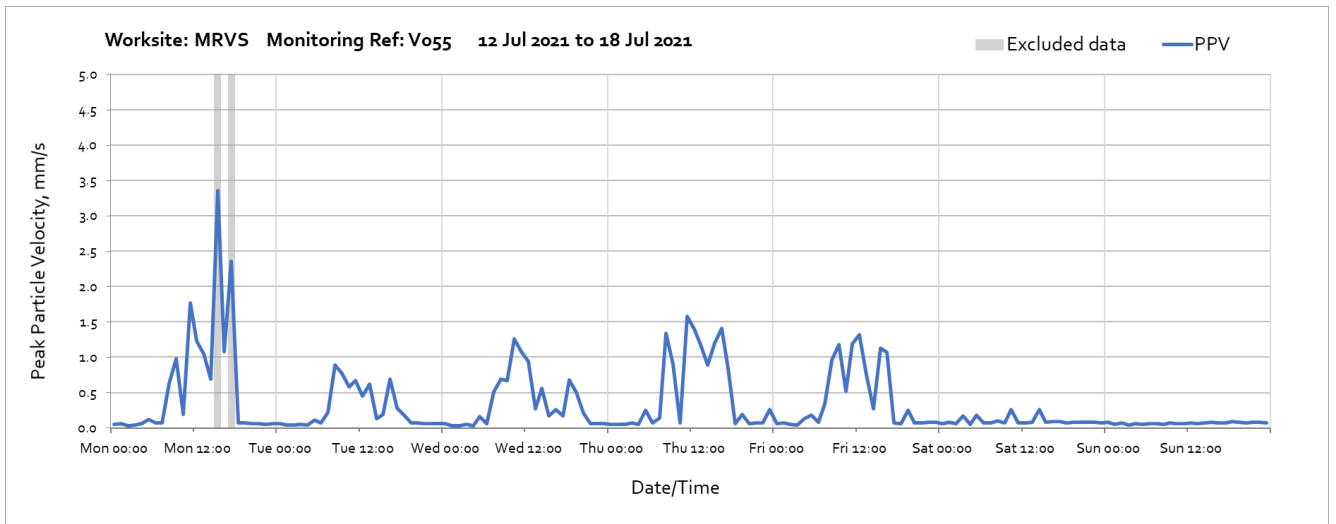
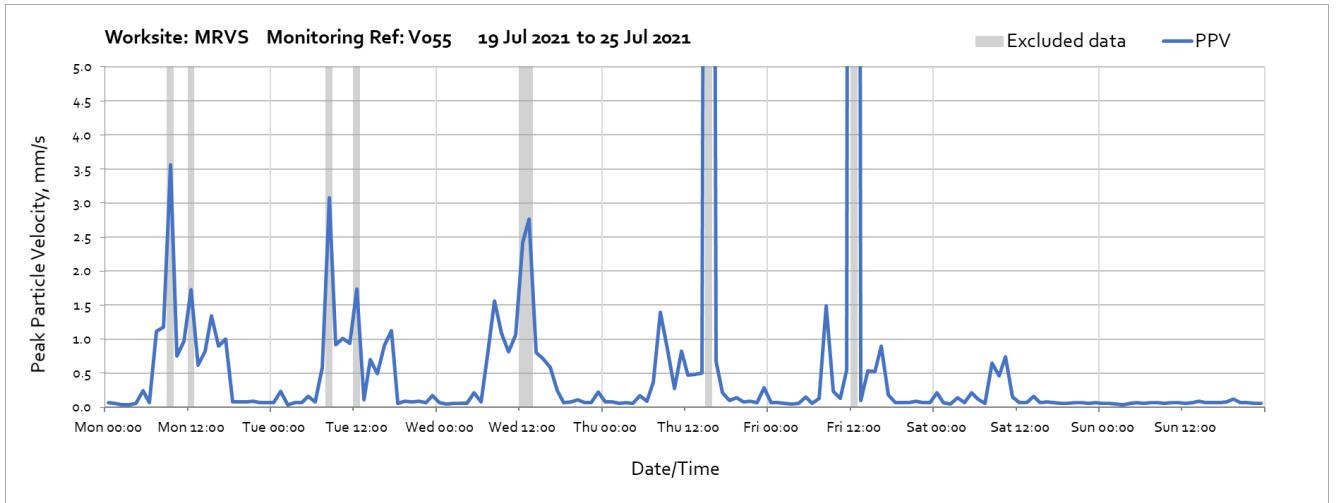
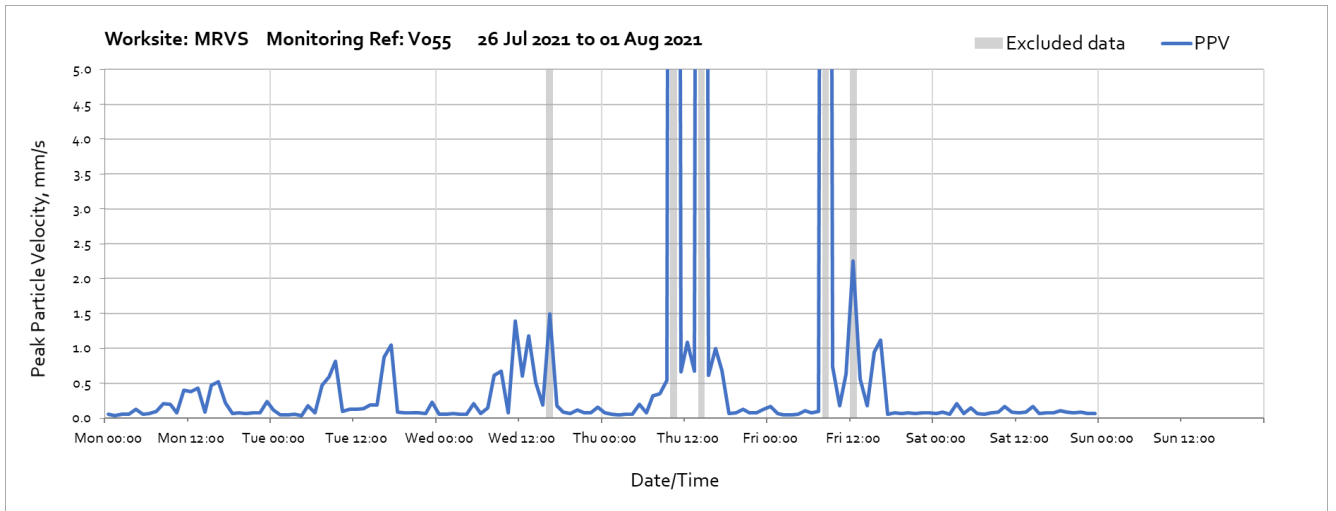
**Worksite: Mandeville Road Vent Shaft (MRVS) – Monitoring Ref: V055**

Note: High vibration levels measured across the week were due hoarding works undertaken near to the monitor location. The nearest residential receptors are further away from the works and vibration levels at the receptor will therefore be lower.

Note: High vibration levels measured across the week were due site maintenance works undertaken near to the monitor location. The nearest residential receptors are further away from the works and vibration levels at the receptor will therefore be lower.

Note: High vibration levels measured across the week were due site maintenance works undertaken near to the monitor location. The nearest residential receptors are further away from the works and vibration levels at the receptor will therefore be lower. High vibration levels measured at 15:00 on Thursday 22<sup>nd</sup> July and 12:00 on Friday 23<sup>rd</sup> July 2021 were due to local disturbance at the monitor location and not representative of HS2 works.

Note: High vibration levels measured on Thursday 29<sup>th</sup> July and Friday 30<sup>th</sup> July 2021 were due to local disturbance at the monitor location and not representative of HS2 works.

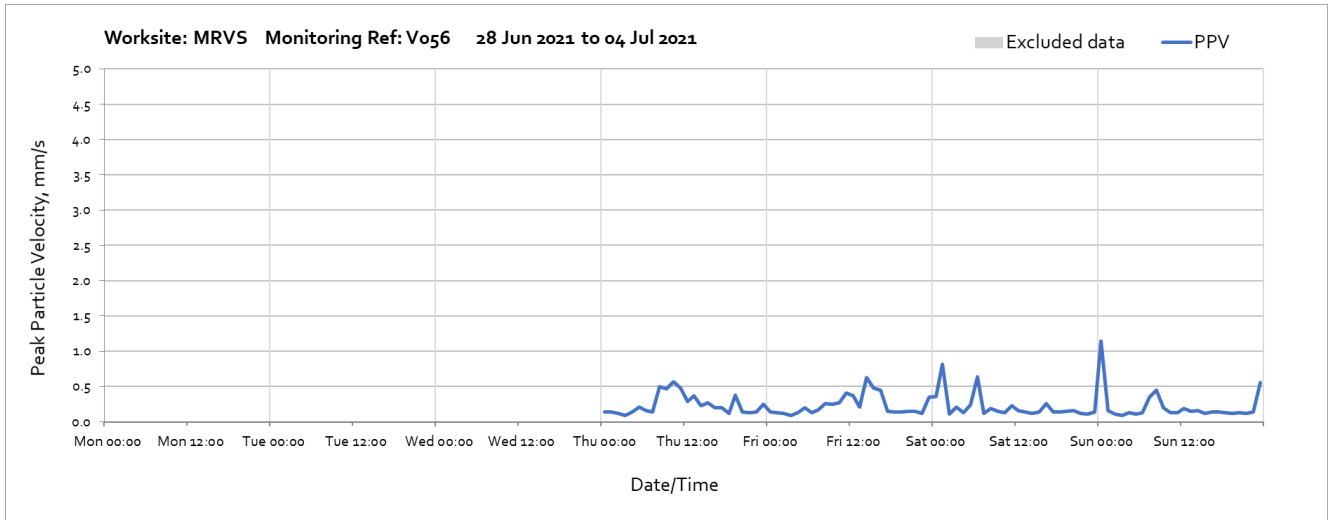
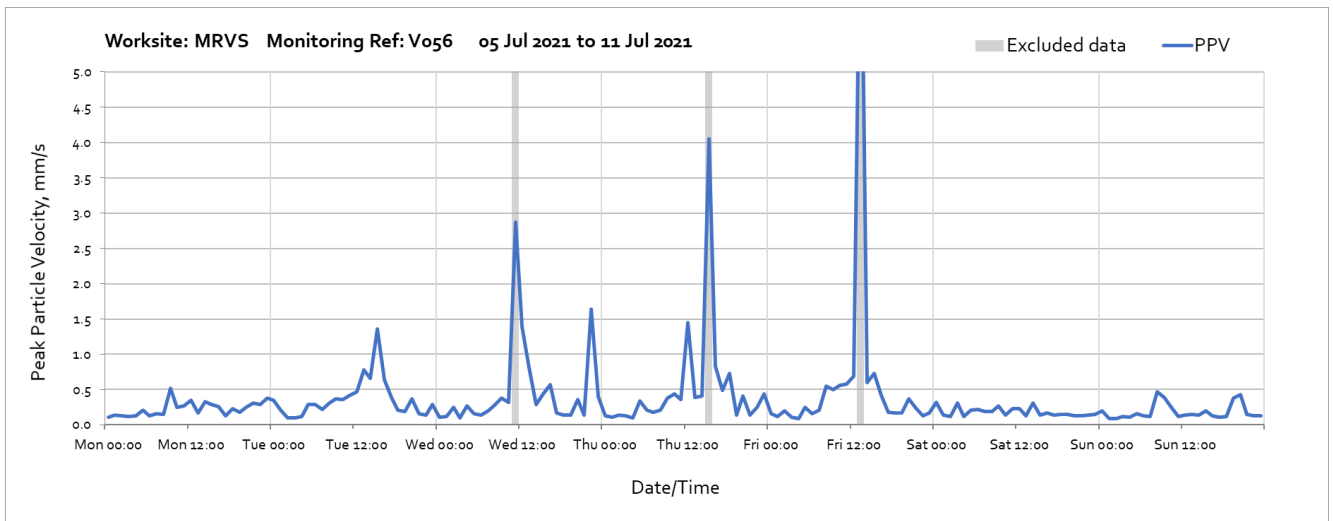
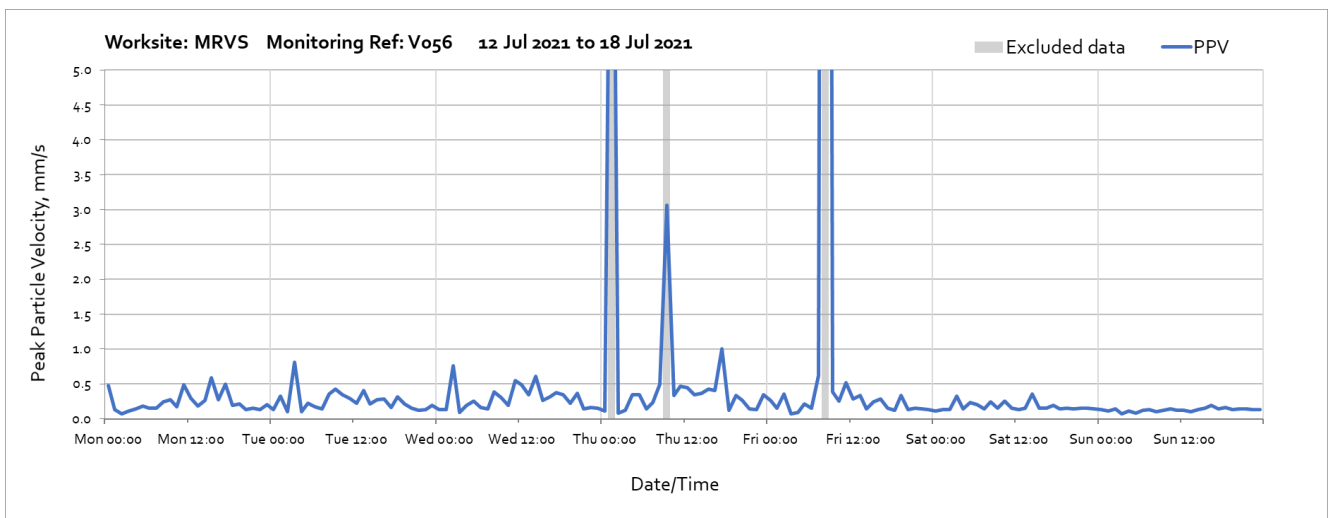
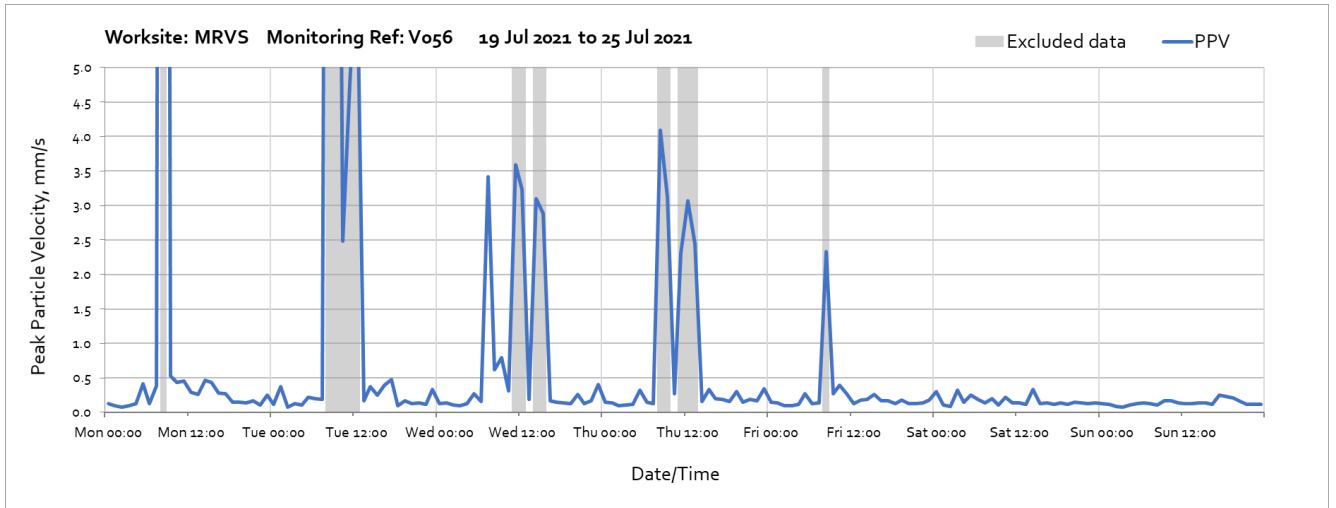
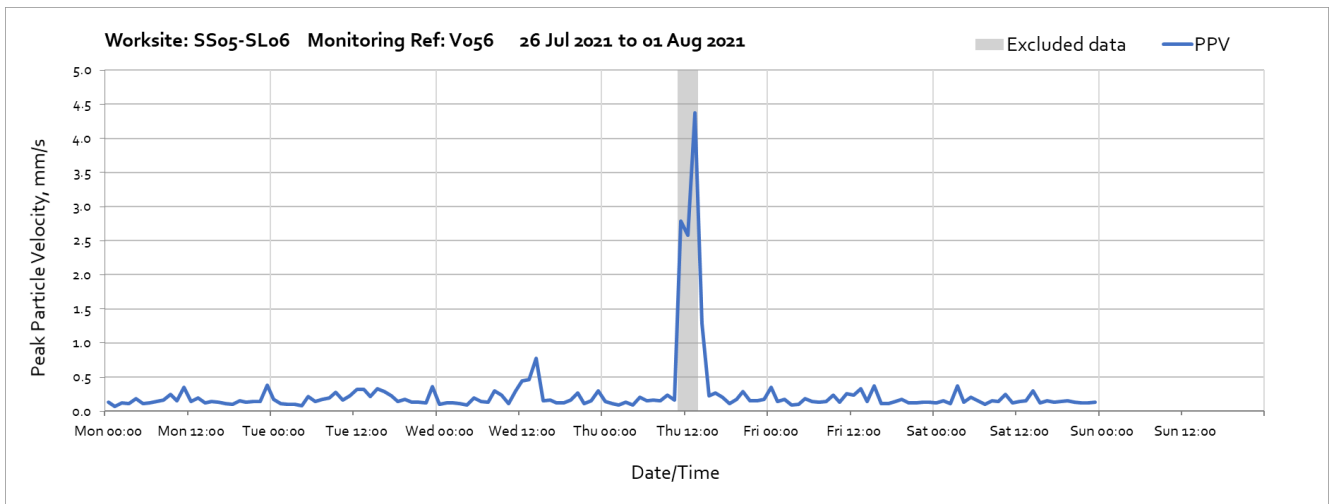
## Worksite: Mandeville Road Vent Shaft (MRVS) – Monitoring Ref: V056

Note: High vibration levels measured across the week were due to local disturbance at the monitor location and not representative of HS2 works.

Note: High vibration levels measured between 11:00 and 13:00 on Thursday 29<sup>th</sup> July 2021 were due to local disturbance at the monitor location and not representative of HS2 works.

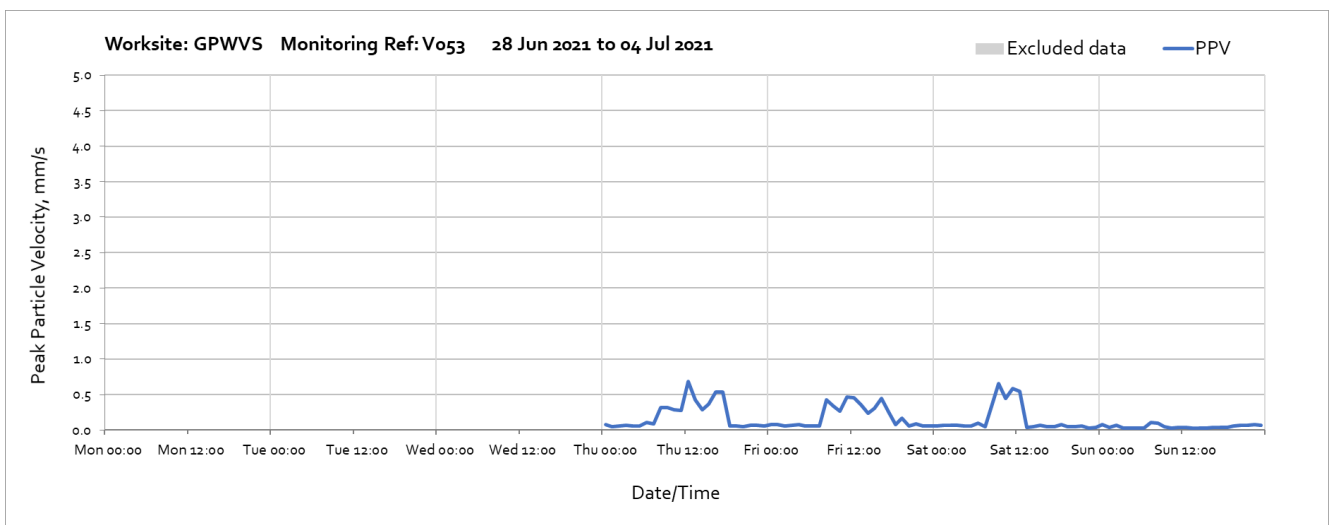
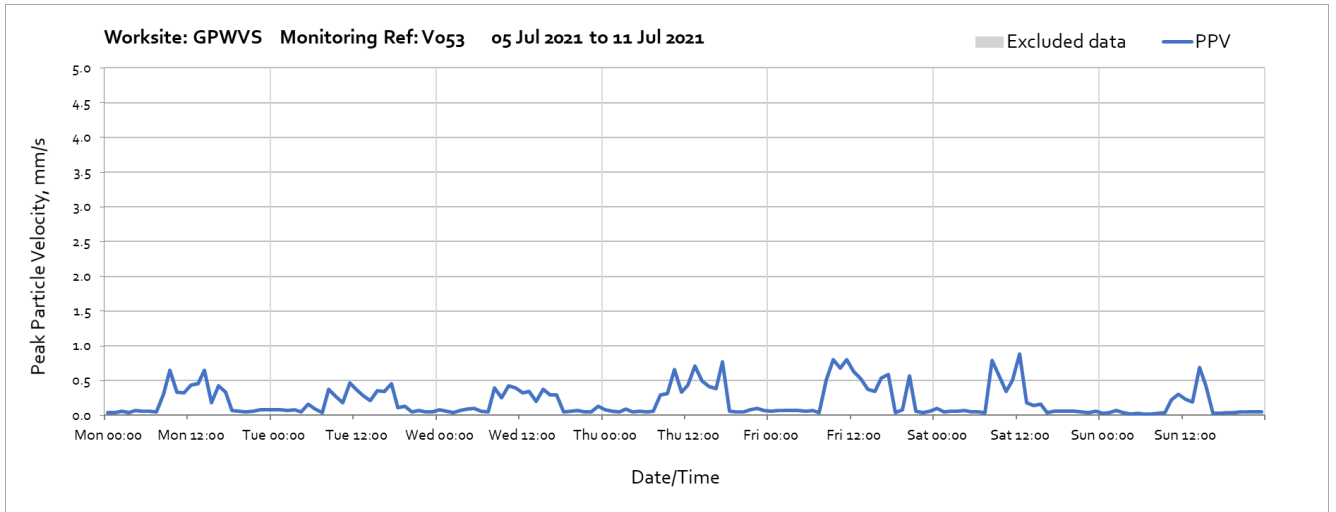
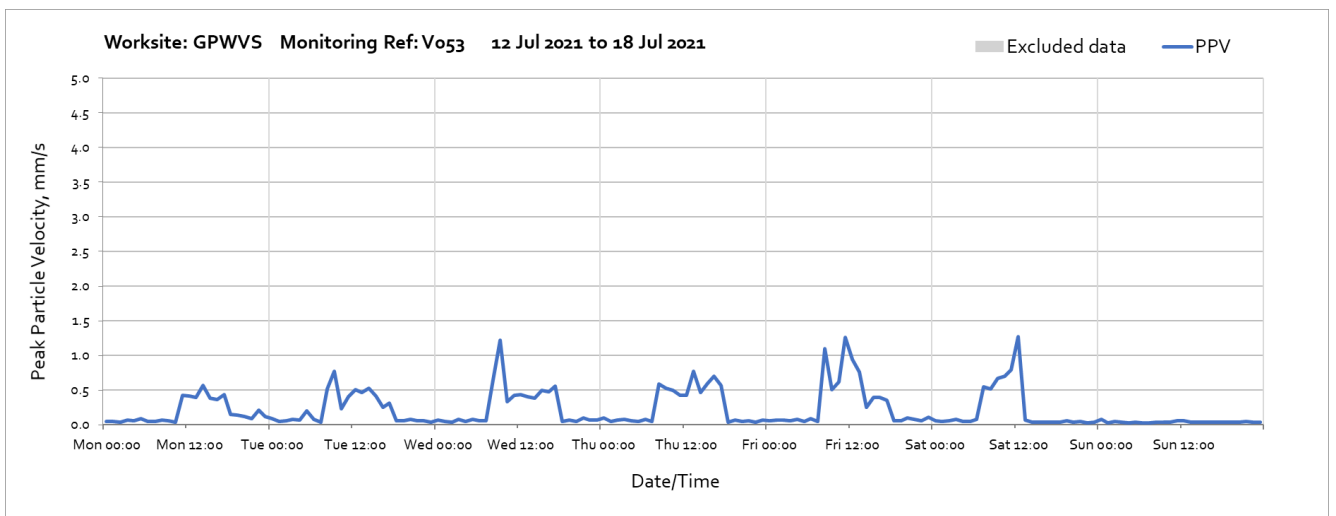
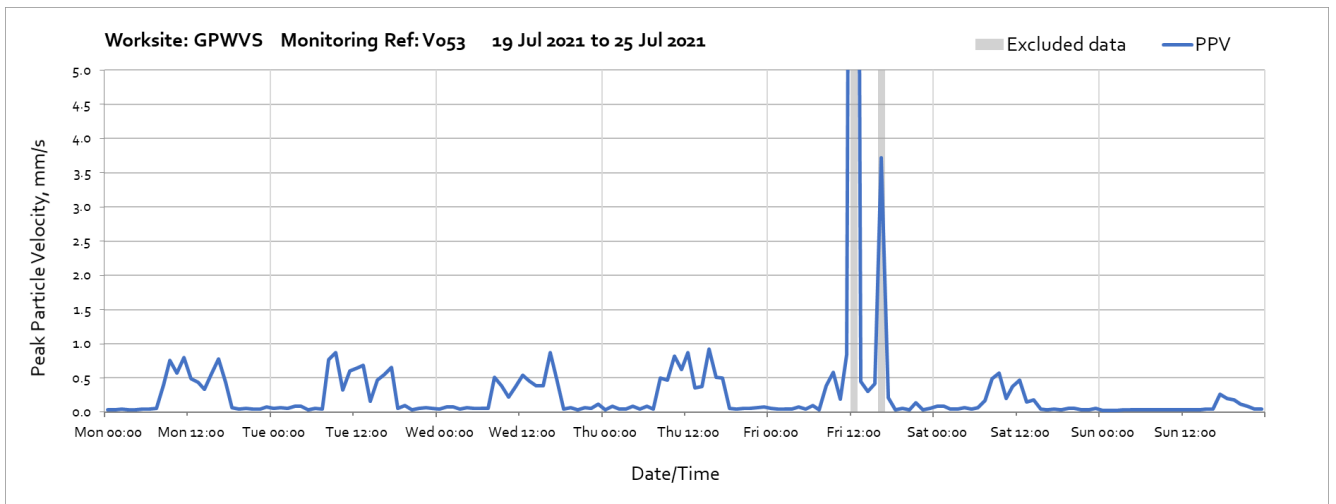
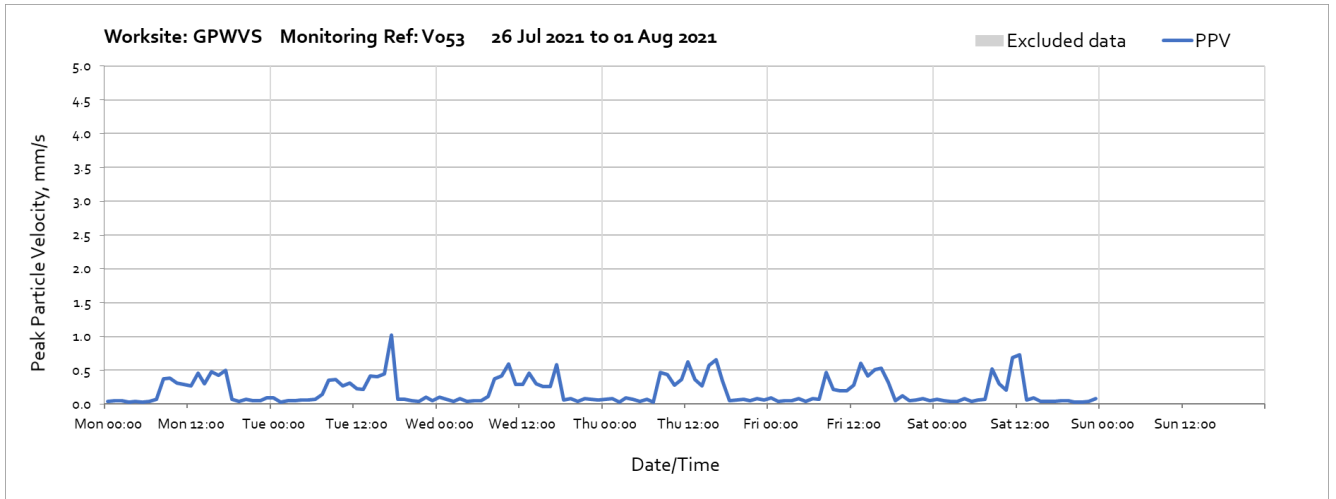
**Worksite: Green Park Way Vent Shaft (GPWVS) – Monitoring Ref: V053**

Note: High vibration levels measured at 12:00 and at 16:00 on Friday 23<sup>rd</sup> June 2021 were due to local disturbance at the monitor location and not representative of HS2 works.

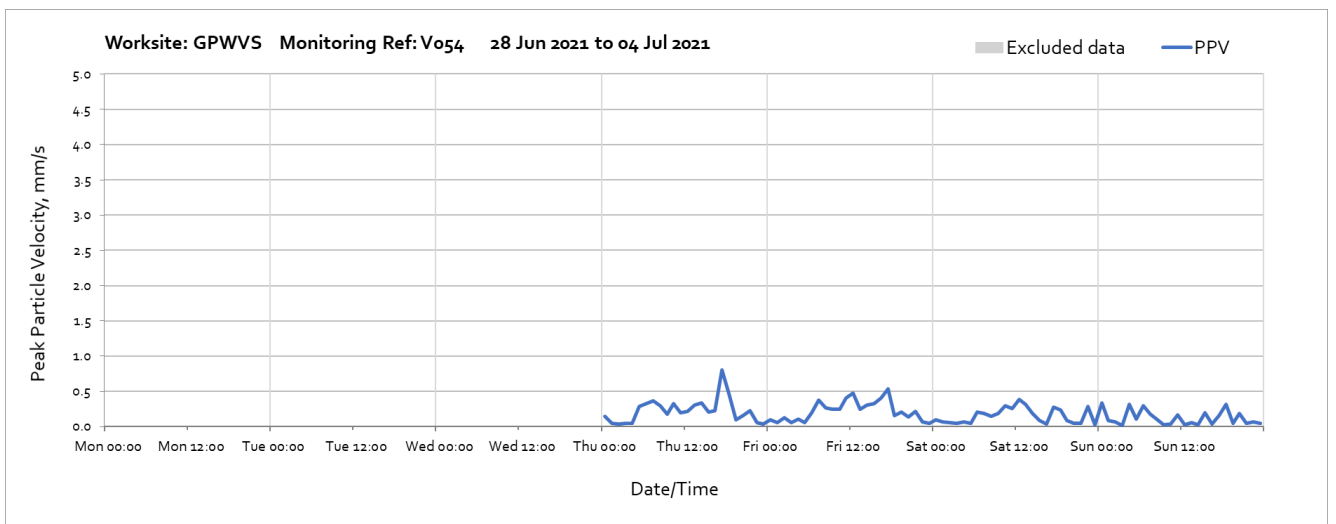
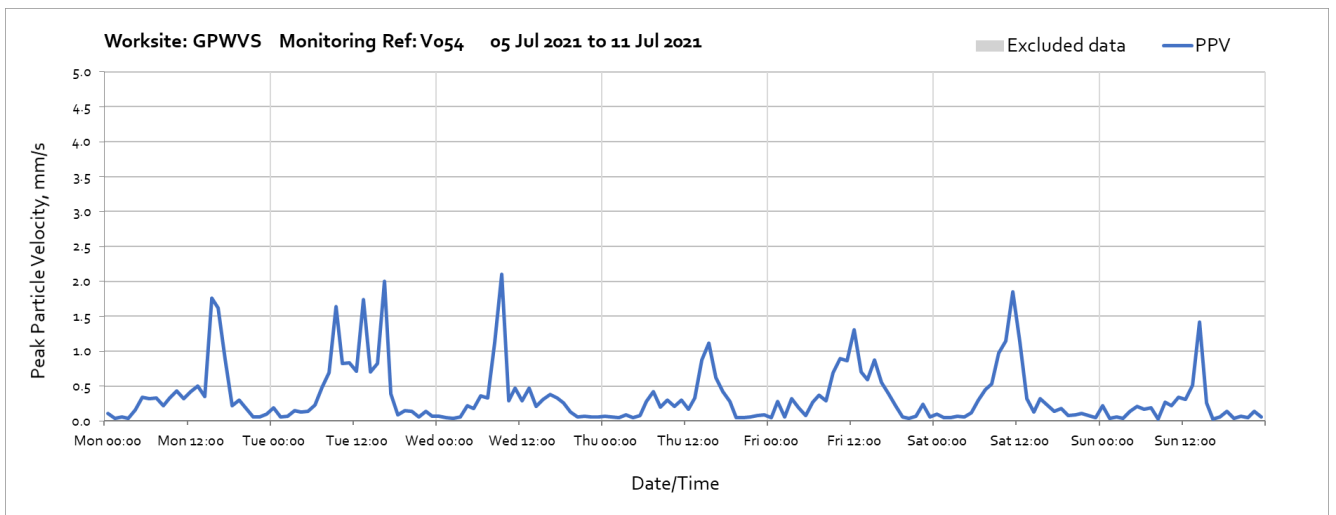
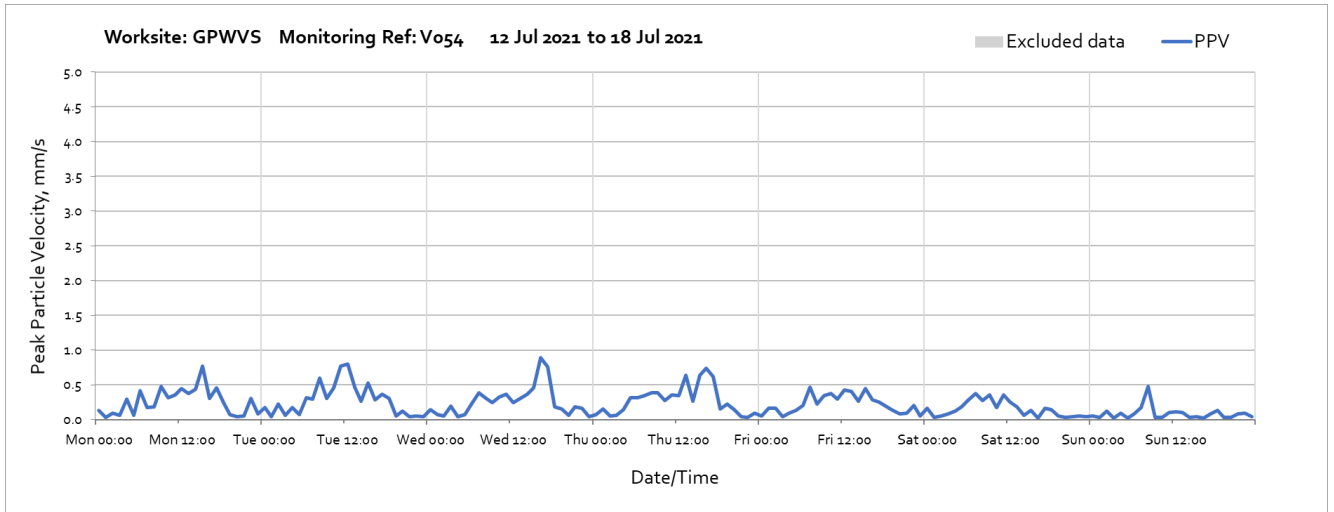
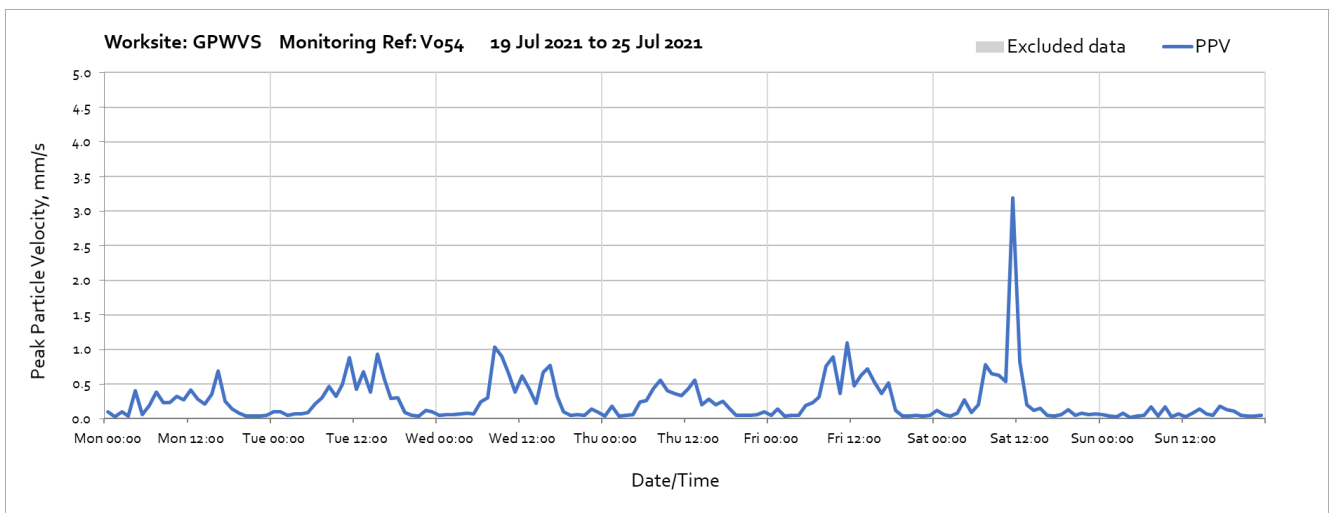
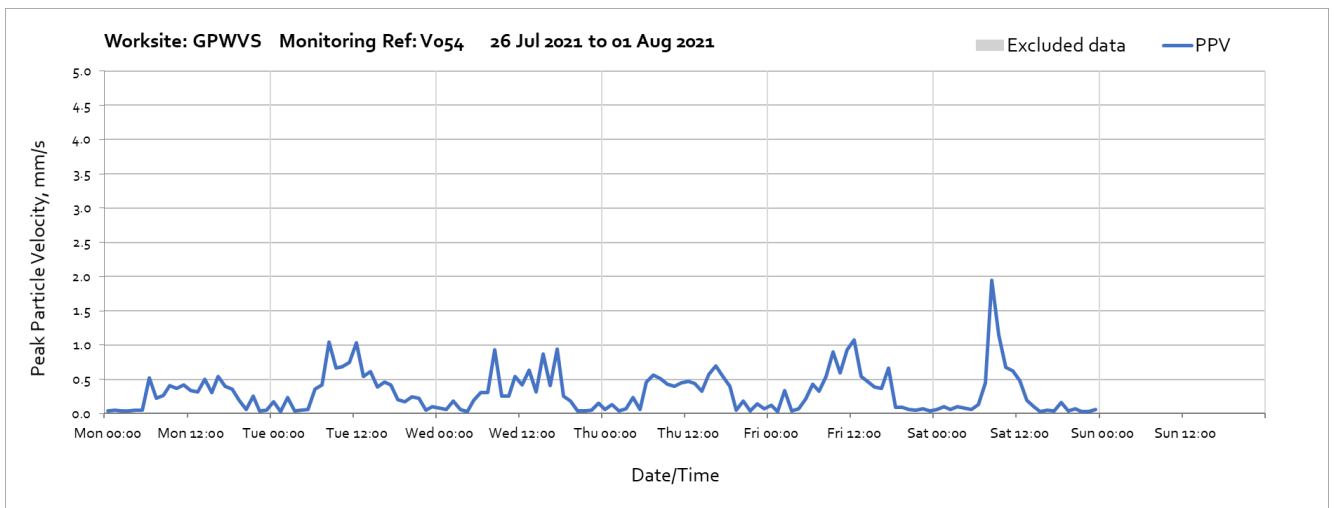
**Worksite: Green Park Way Vent Shaft (GPWVS) – Monitoring Ref: V054**

The following graphs show the hourly measured peak particle velocity PPV recorded during the monitoring period. The graphs show the highest PPV of the three orthogonal axis x, y and z. Where high values of PPV were caused by local interference with the vibration monitor, which are not representative of HS2 construction works, these values have been greyed out in the following charts and have been excluded to calculate values in Table 4 of the main report.
