## **Construction noise and vibration Monthly Report – August 2021**

**London Borough of Camden**

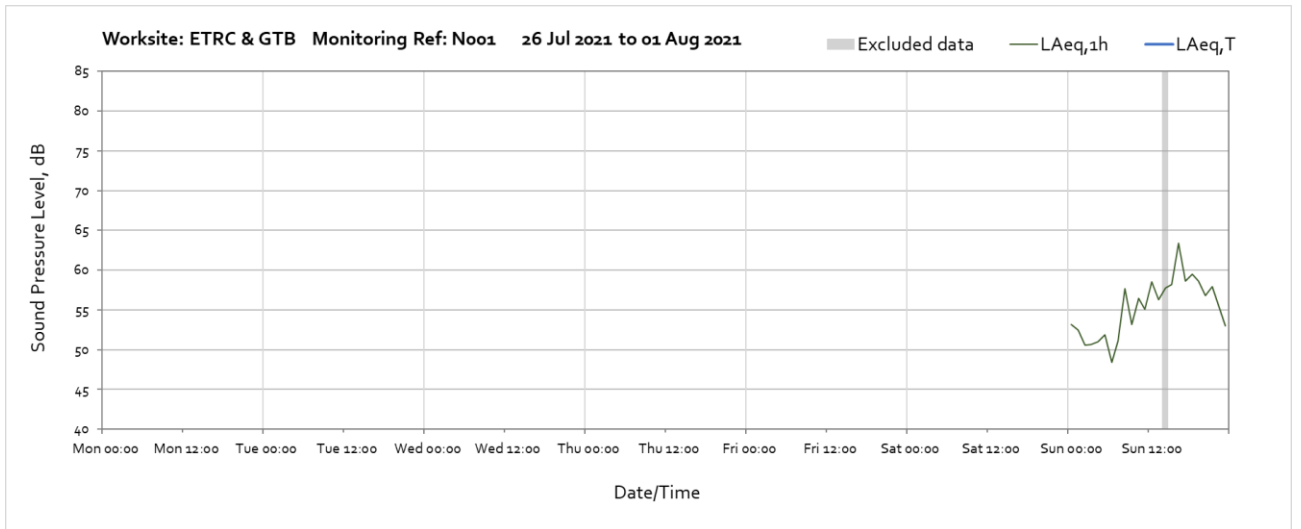
**Worksite: ETRC & GTB – Monitoring Ref: N001**

Note: Missing data from 22:00 on Thursday 12<sup>th</sup> August until 09:00 on Friday 13<sup>th</sup> August was due to a memory card error. The memory card has been reformatted with view of avoiding further loss of data.

2.1.3 Appendix C presents graphs of the noise and vibration monitoring data over the month for each of the measurement locations. Noise data presented consists of the hourly  $L_{Aeq}$  values and, where relevant, the  $L_{Aeq,T}$  values (where the time period T has been taken to be the averaging period as specified in Table 1 of HS2 Information Paper E23). Vibration data presented consist of hourly PPV values. The full data set for the monitoring equipment can be found at the following location:

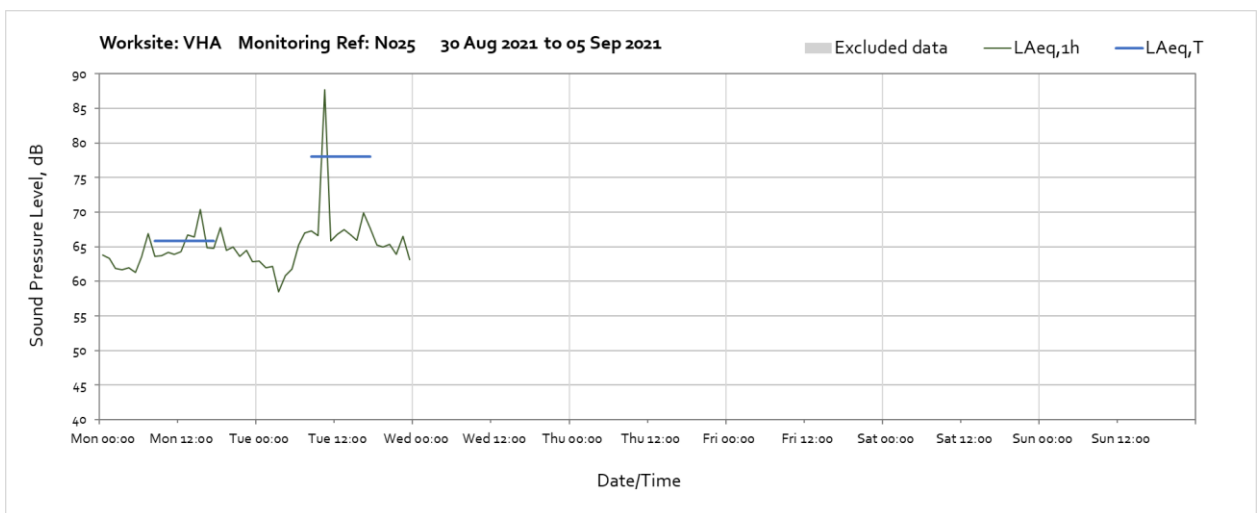
## Vehicle Holding Area (VHA) – Monitoring Ref: N025

Note: Missing data from 19:00 on Thursday 12<sup>th</sup> August until 09:00 on Friday 13<sup>th</sup> August was due to a memory card error. The memory card has been reformatted with view of avoiding further loss of data.

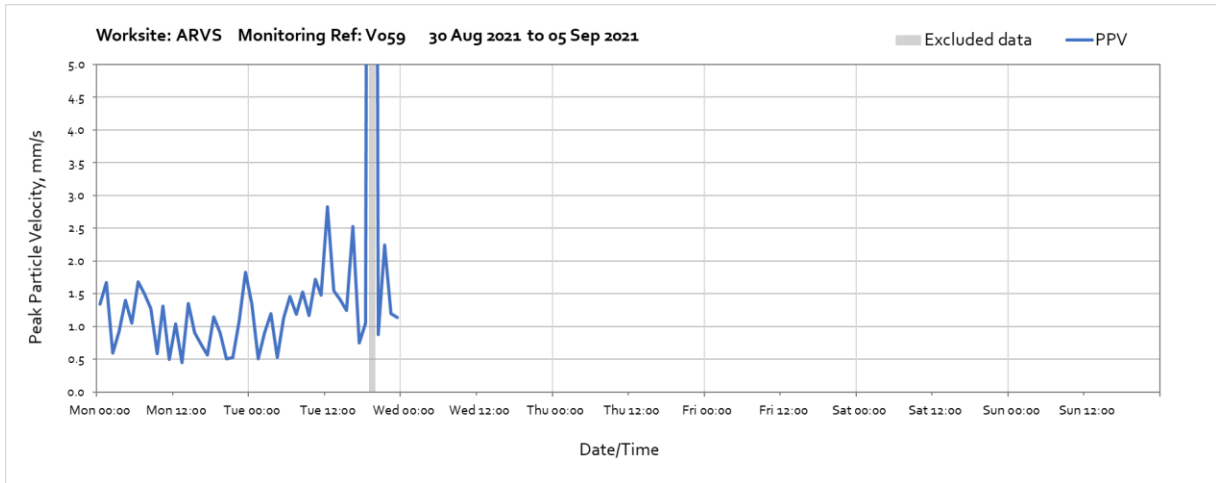
Note: High vibration levels measured from 19:00 until 20:00 on Wednesday 30<sup>th</sup> August were due to local interference of the monitor and are not representative of HS2 vibration levels at the receptor.
