ACCIDENT

Aircraft Type and Registration:	UAVE Prion Mk 3 (UAS, registration n/a)	
No & Type of Engines:	1 Valach piston engine	
Year of Manufacture:	2019 (Serial no: 3-007)	
Date & Time (UTC):	3 February 2021 at 1138 hrs	
Location:	MoD Area 7, Salisbury Plain, Chitterne, Wiltshire	
Type of Flight:	Training	
Persons on Board:	Crew - None	Passengers - None
Injuries:	Crew - N/A	Passengers - N/A
Nature of Damage:	Substantial damage to forward fuselage, front skids, both wings, propeller and rear boom	
Commander's Licence:	Other	
Commander's Age:	61 years	
Commander's Flying Experience:	351 hours (of which 3 were on type) Last 90 days - 3 hours Last 28 days - 3 hours	
Information Source:	Aircraft Accident Report Form submitted by the pilot

Synopsis

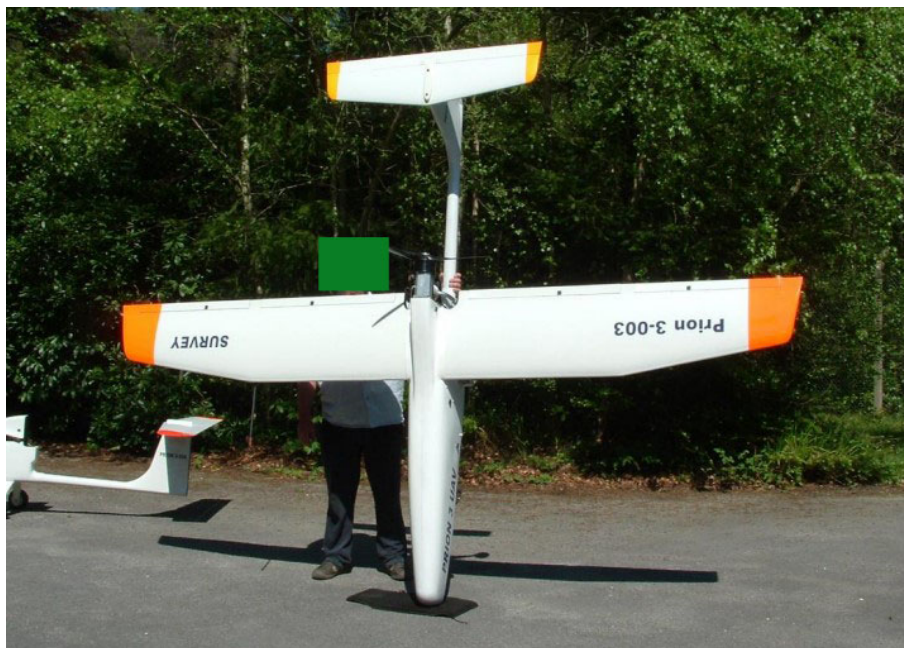
Figure 1

The UAVE Prion Mk3 is a fixed-wing unmanned aircraft with a 3.8 m wingspan and a 45 kg maximum takeoff mass (Figure 1). It was being operated by the aircraft manufacturer on a training flight in a protected area of Salisbury Plain. The flight crew consisted of a Remote Pilot Station Operator (RPSO), a Safety Pilot and a Flight Operation Manager. The flight was conducted within Visual Line of Sight rules and the Safety Pilot was the PIC. The RPSO was sat inside a van equipped with a control station, while the Safety Pilot stood outside the van with a remote controller, in a position to be able to monitor both the aircraft and the displays inside the van. The Safety Pilot is able to take manual control within five seconds or less.

UAVE Prion Mk 3
