Air Quality and Dust Monitoring Monthly Report – September 2021

London Borough of Ealing

A report prepared by EWCs and MWCCs on behalf of HS2 Ltd.

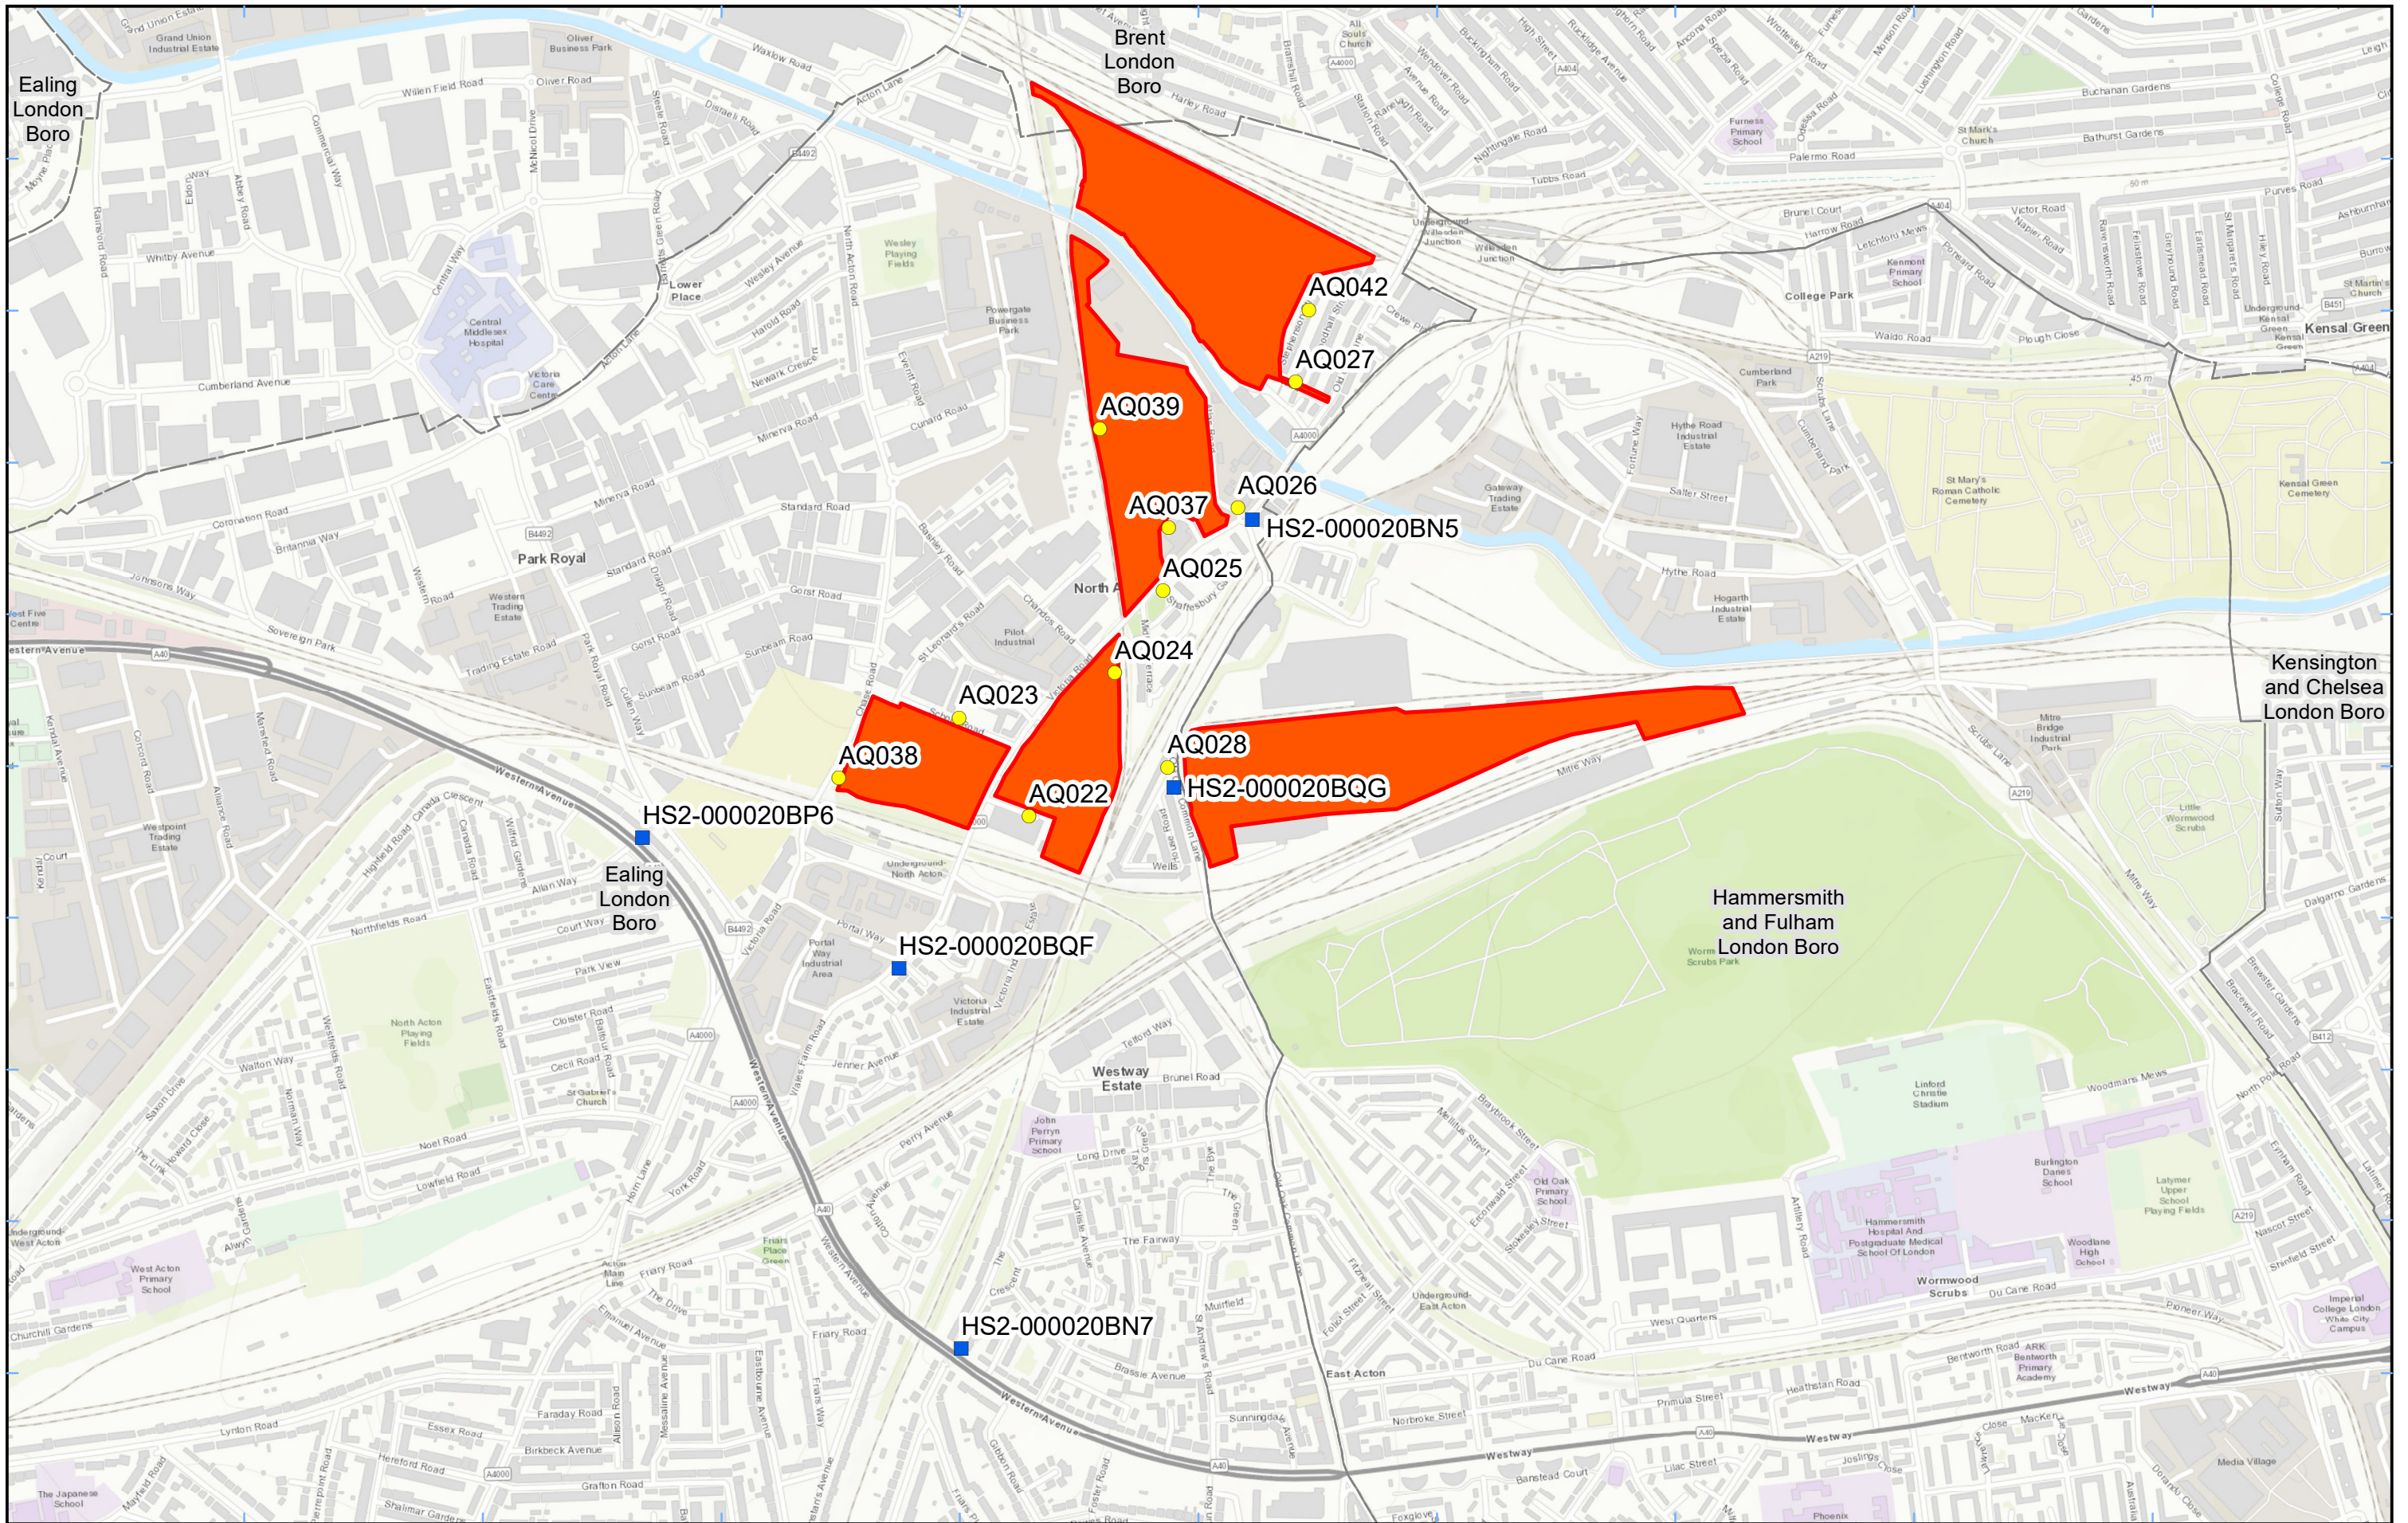
**Worksite and Monitoring Locations
In LBE (Sheet 1)**

Figure 1 to 3: Worksites and monitoring locations within the LBE

- 1.1.2 Figure 1 to Figure 3 in Appendix A indicate the current worksites together with air quality and dust monitoring locations.
- 1.1.3 This summary should be read in conjunction with the overview monitoring report available from www.gov.uk/government/collections/monitoring-the-environmental-effects-of-hs2, which highlights: the applicable standards and guidance, as well as the air quality and dust monitoring methodologies to be implemented by nominated undertakers throughout construction.

- 1.1.4 The current phase of construction works commenced in October 2019 and is expected to be completed by 2025. The current worksites, as presented in Appendix A, Figures 1 to 3, include:
