Air Quality and Dust Monitoring Monthly Report – September 2021

Stratford-on-Avon District Council

A report prepared by EWCs and MWCCs on behalf of HS2 Ltd.

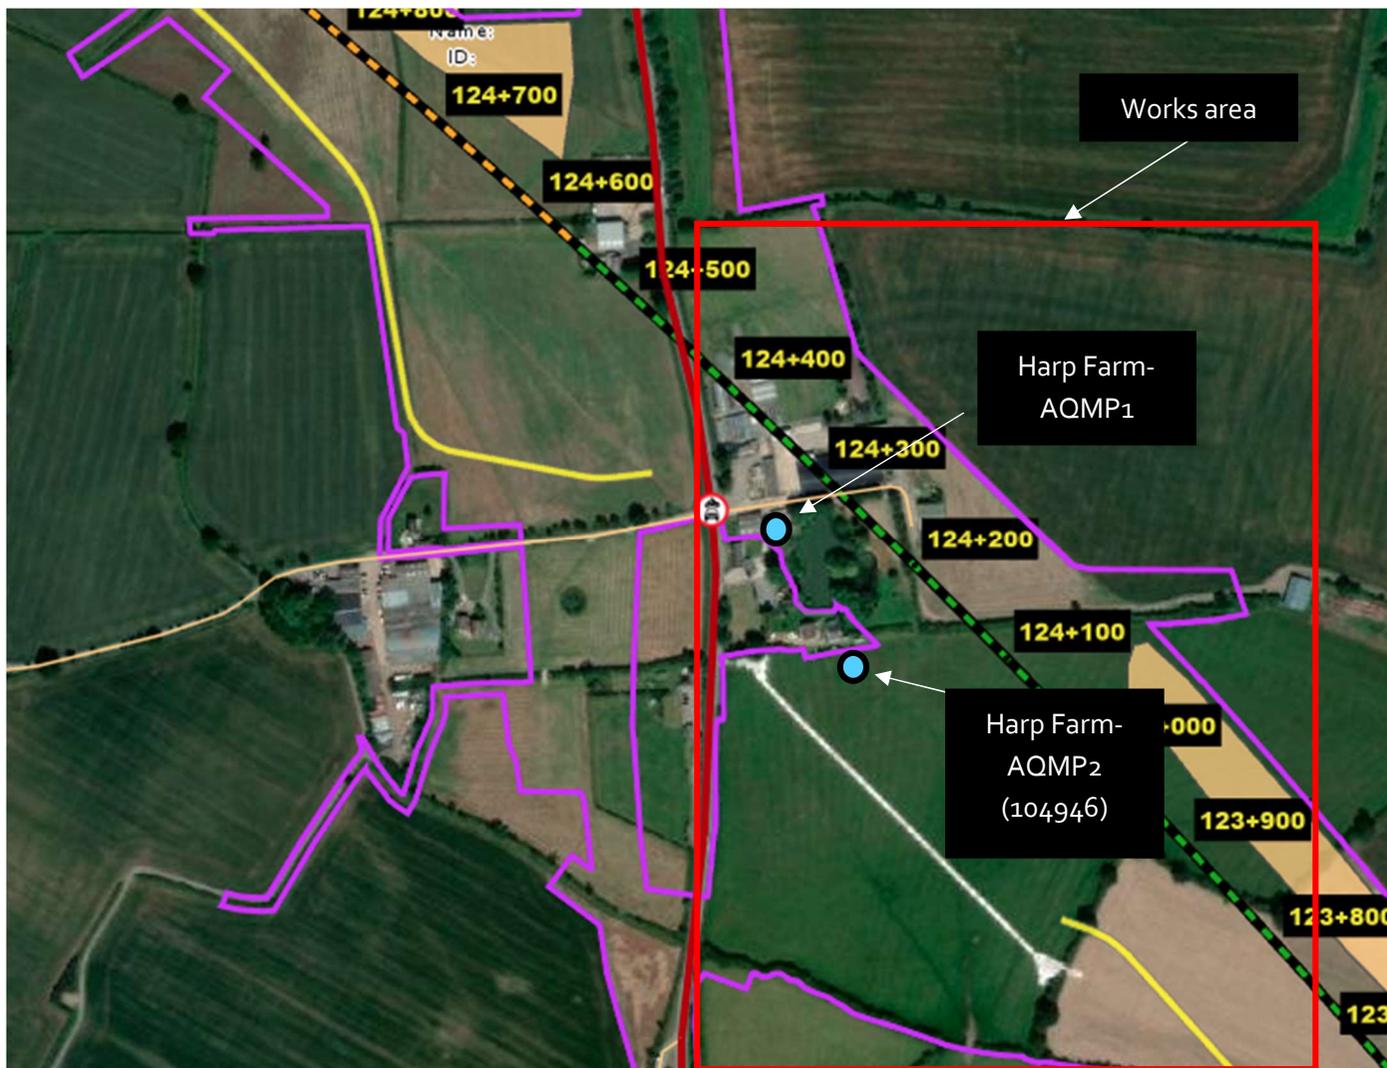
Figure 1: Worksite and monitoring locations during September 2021 – Harp Farm

1.1.2 Figure 1 to Figure 3 in Appendix A indicate the current worksites together with dust monitoring locations.

1.1.4 The current phase of construction works commenced in July 2021 and is expected to be completed by 2025. The current worksites, as presented in Appendix A, Figure 1 to Figure 3, include:

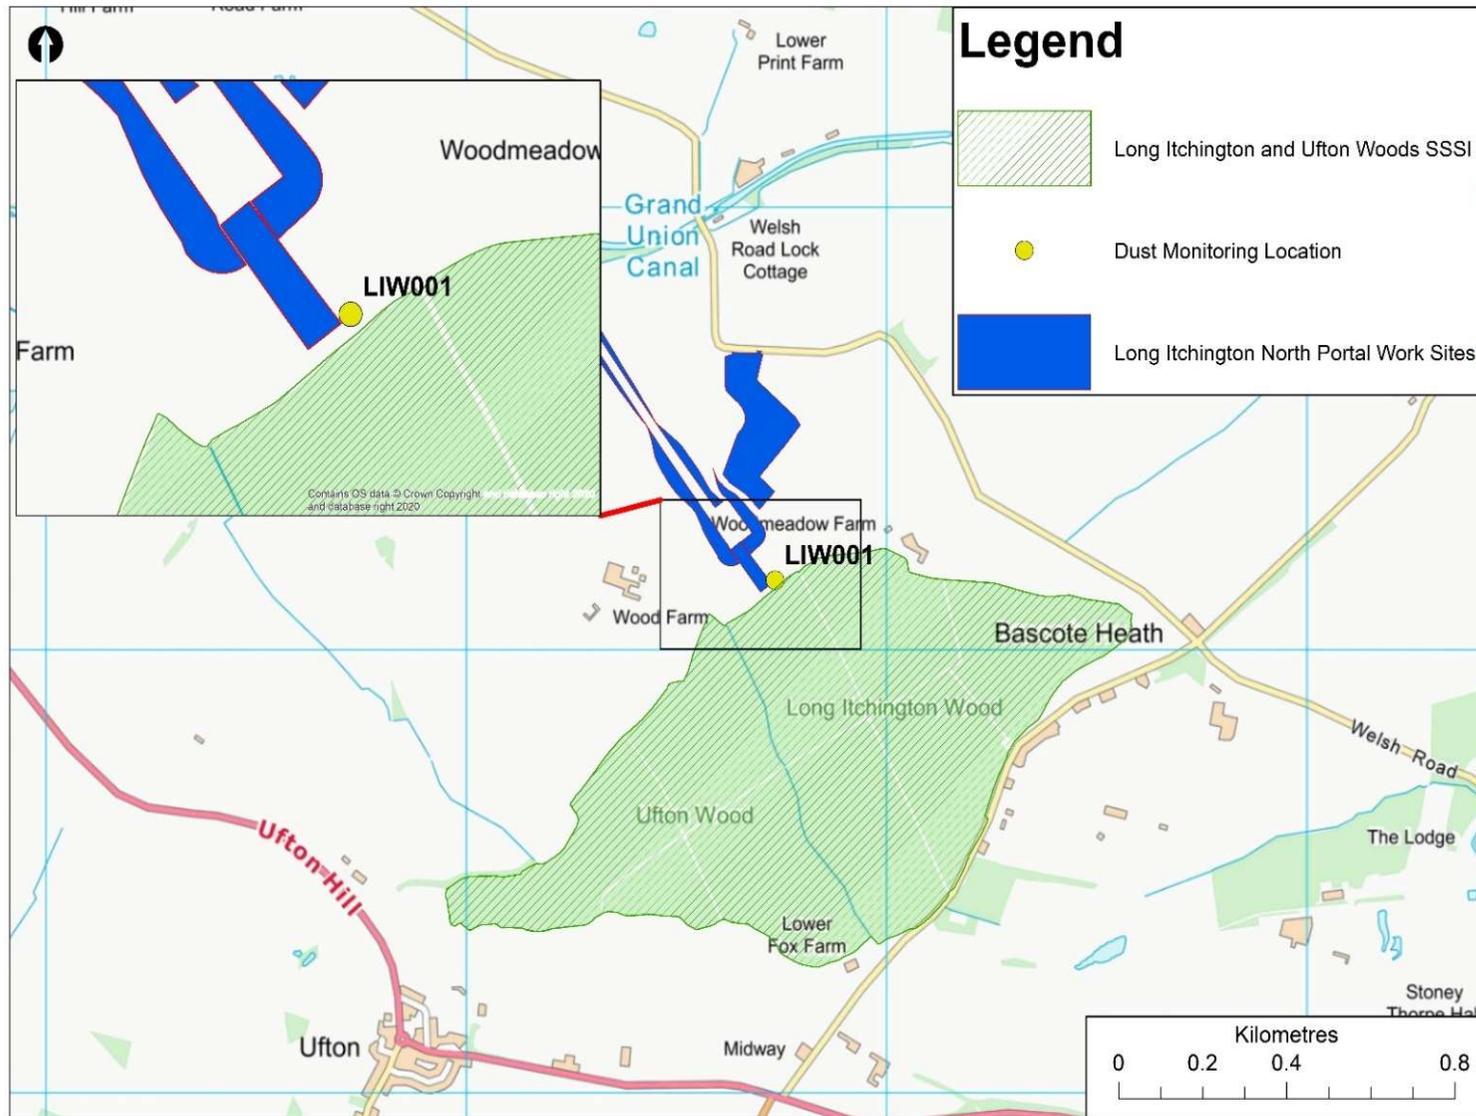
Figure 2: Worksites and monitoring locations during September 2021 - Long Itchington North Portal

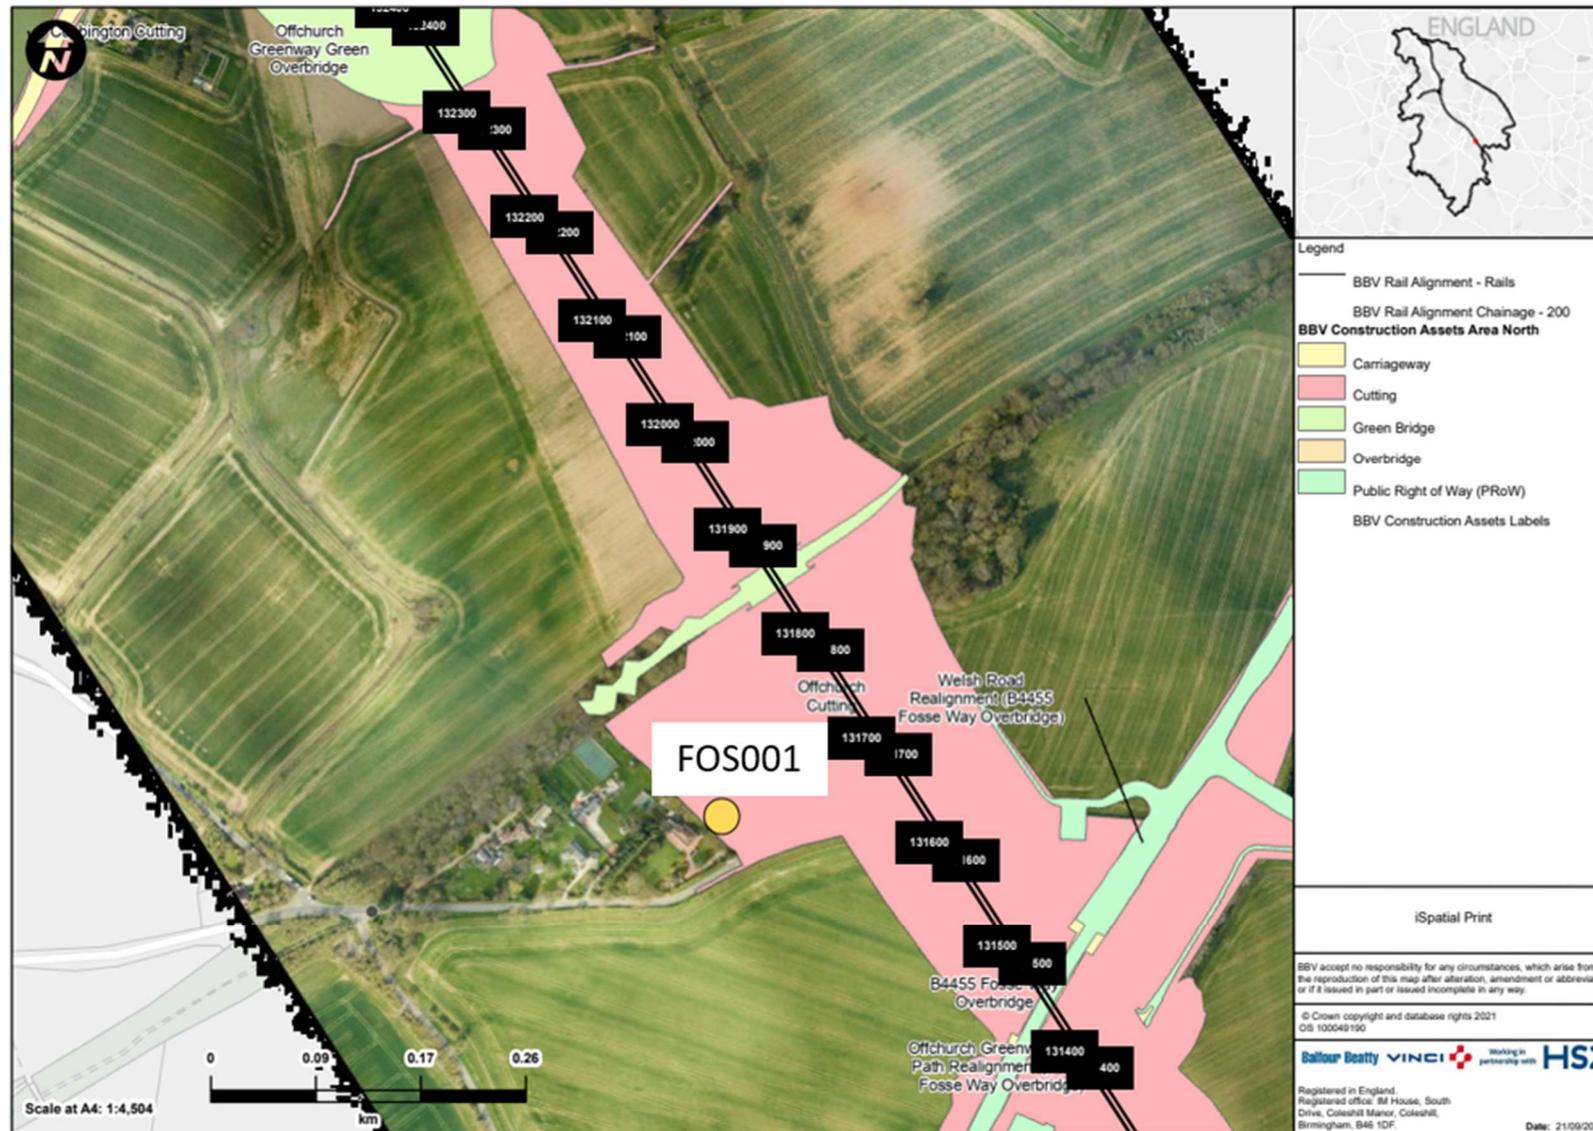
Figure 3: Worksites and monitoring locations during September 2021 - Fosse Way Compound

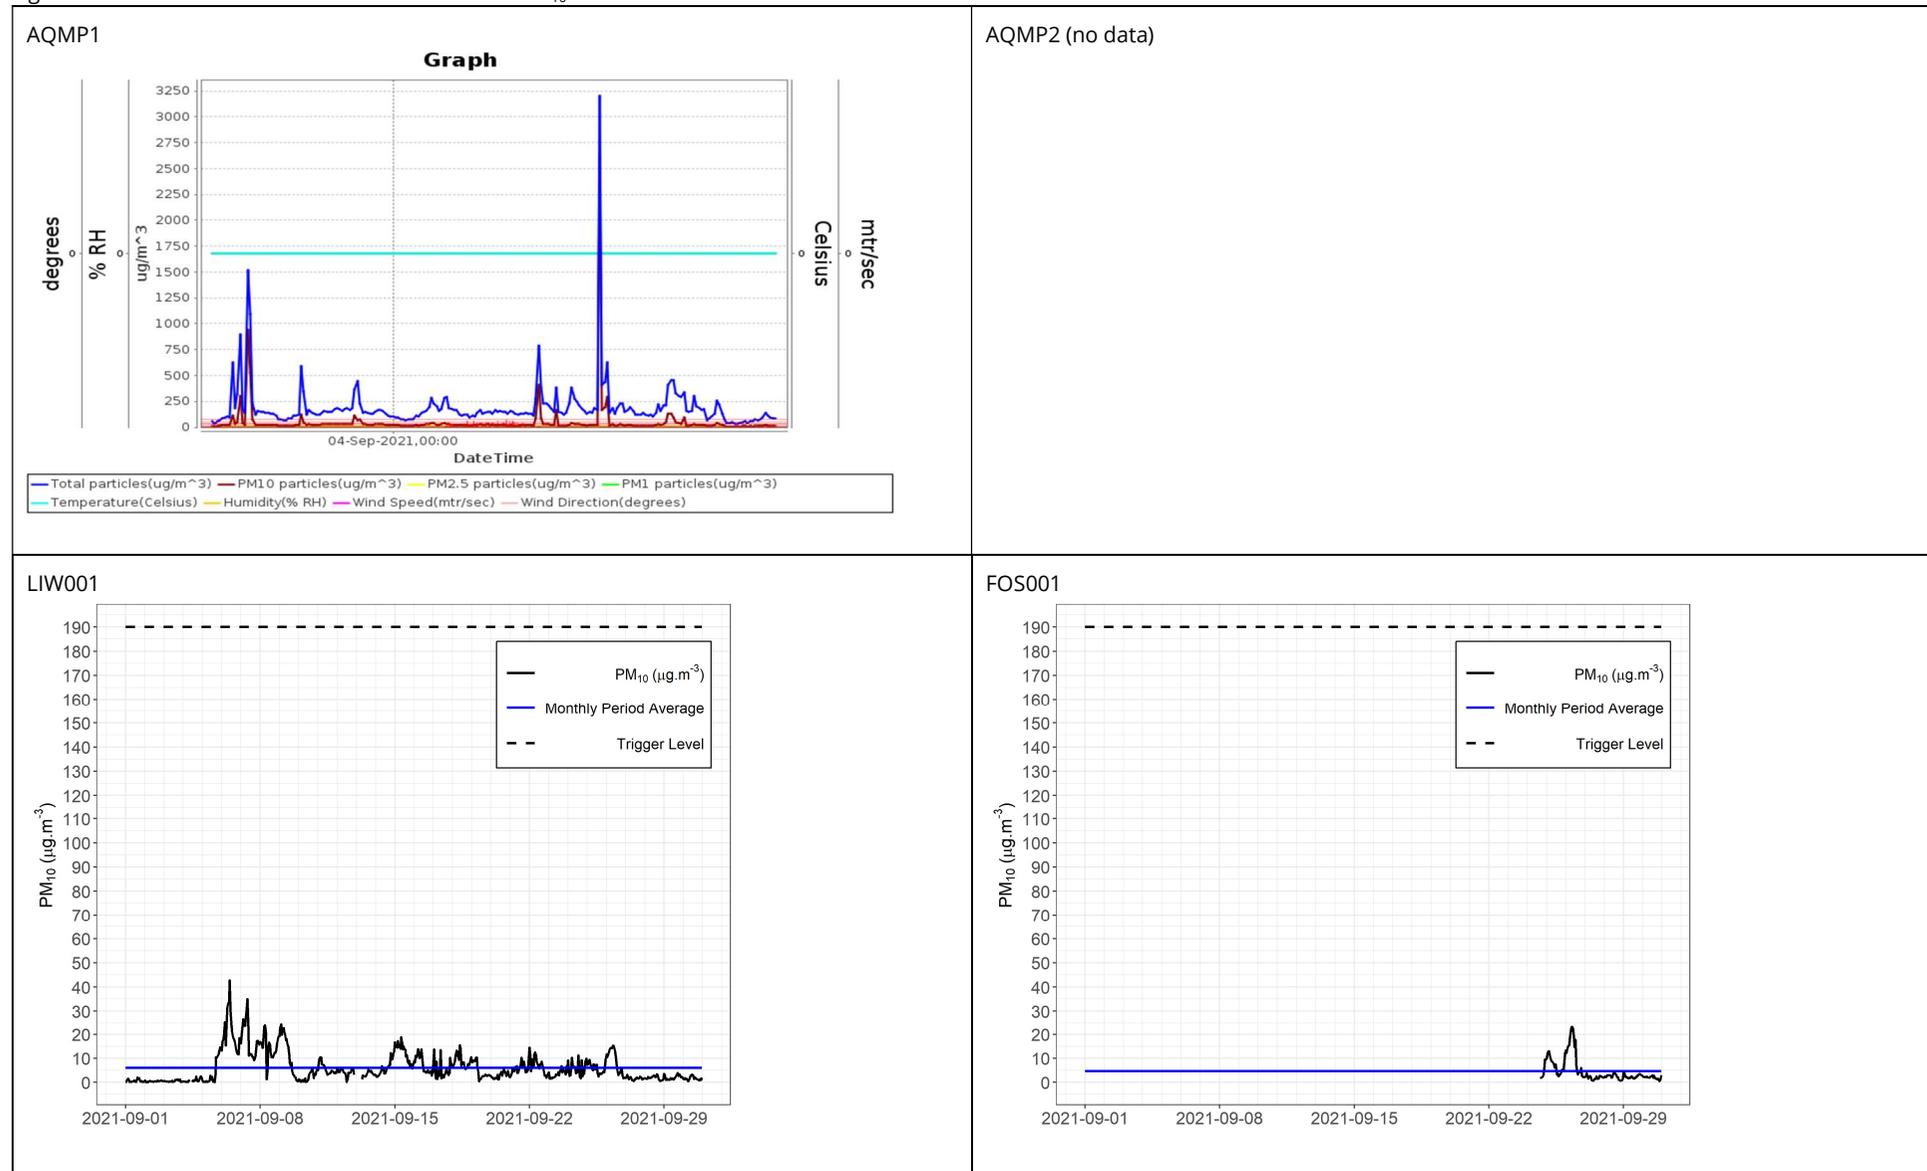
Figure 4: Construction dust 1-hour mean indicative PM₁₀ concentration for dust monitors

- 1.1.6 Dust monitoring locations and results are presented in Appendix B, Table 1, together with line charts of monthly data from the dust monitors in Figure 4. All continuous dust monitoring is undertaken using indicative monitors. Despite being Environment Agency (MCERTS) certified, indicative monitors carry a higher level of uncertainty than reference monitors, and therefore cannot be strictly compared with Air Quality Standards for human health and the environment. The purpose of the monitoring undertaken is to ensure the effectiveness of the on-site mitigation.
