WP 029 D Historic Environment Works – Jerrings Hall Farm – Enabling Works North Contract

Works Method Statement for Alterations to Jerrings Hall Farm

Document Number: 1EWo4-LMJ_DJV-EV-MST-N000-029004

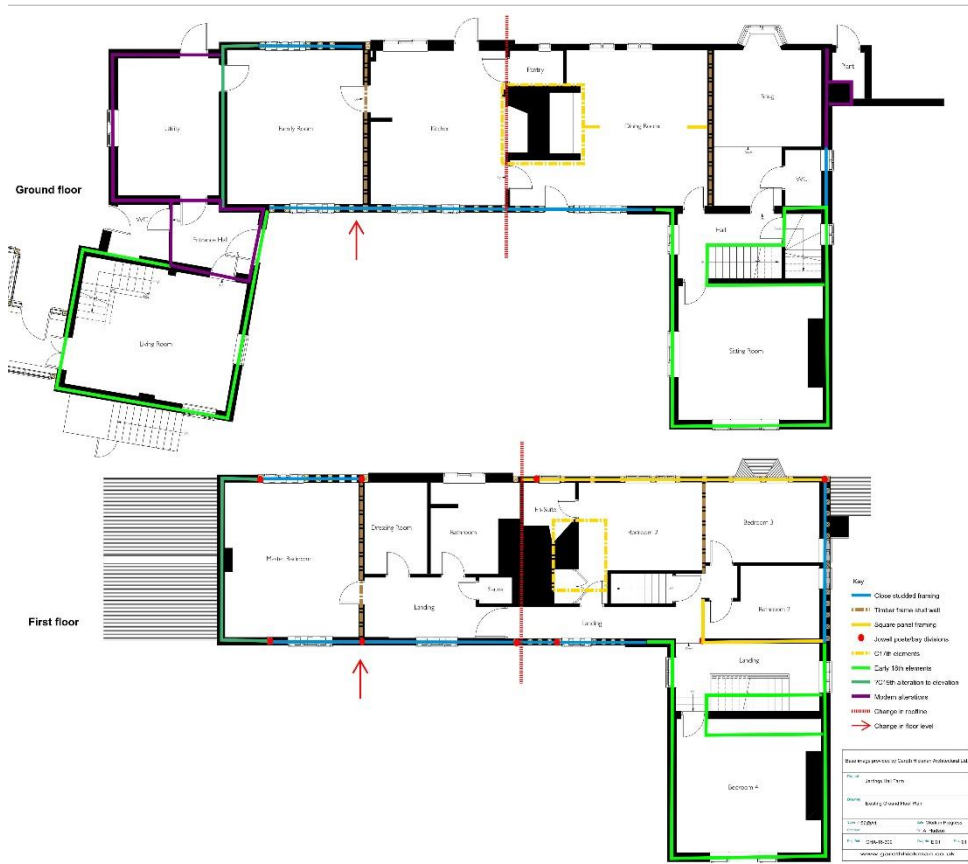
Figure 1: Tentative phasing of the building and locations of timber framed elements and datable features to ground and first floors

- 2.2.6 The extent of replacement work means that it is difficult to know how far current understanding of the east and west elevations are conjectural, and this impacts on how confidently the elements of the structure can be dated. However, they generally point to a 16th century date, as close-studding appeared in the West of England around the middle of the 15th century in the highest status buildings, with its peak during the 16th century. Whilst this practice continued until the early 17th century, the spacing of the close-stud work at Jerrings Hall - at intervals approximately equal to their own width - indicate that these elements may date to the 16th century. The higher roof height of the three northern bays suggests that they are of the late 16th/early 17th century, a date which is indicated by decorative bracing to the north elevation gable and more extensive square-panelled framing to the first floor of the western elevation.

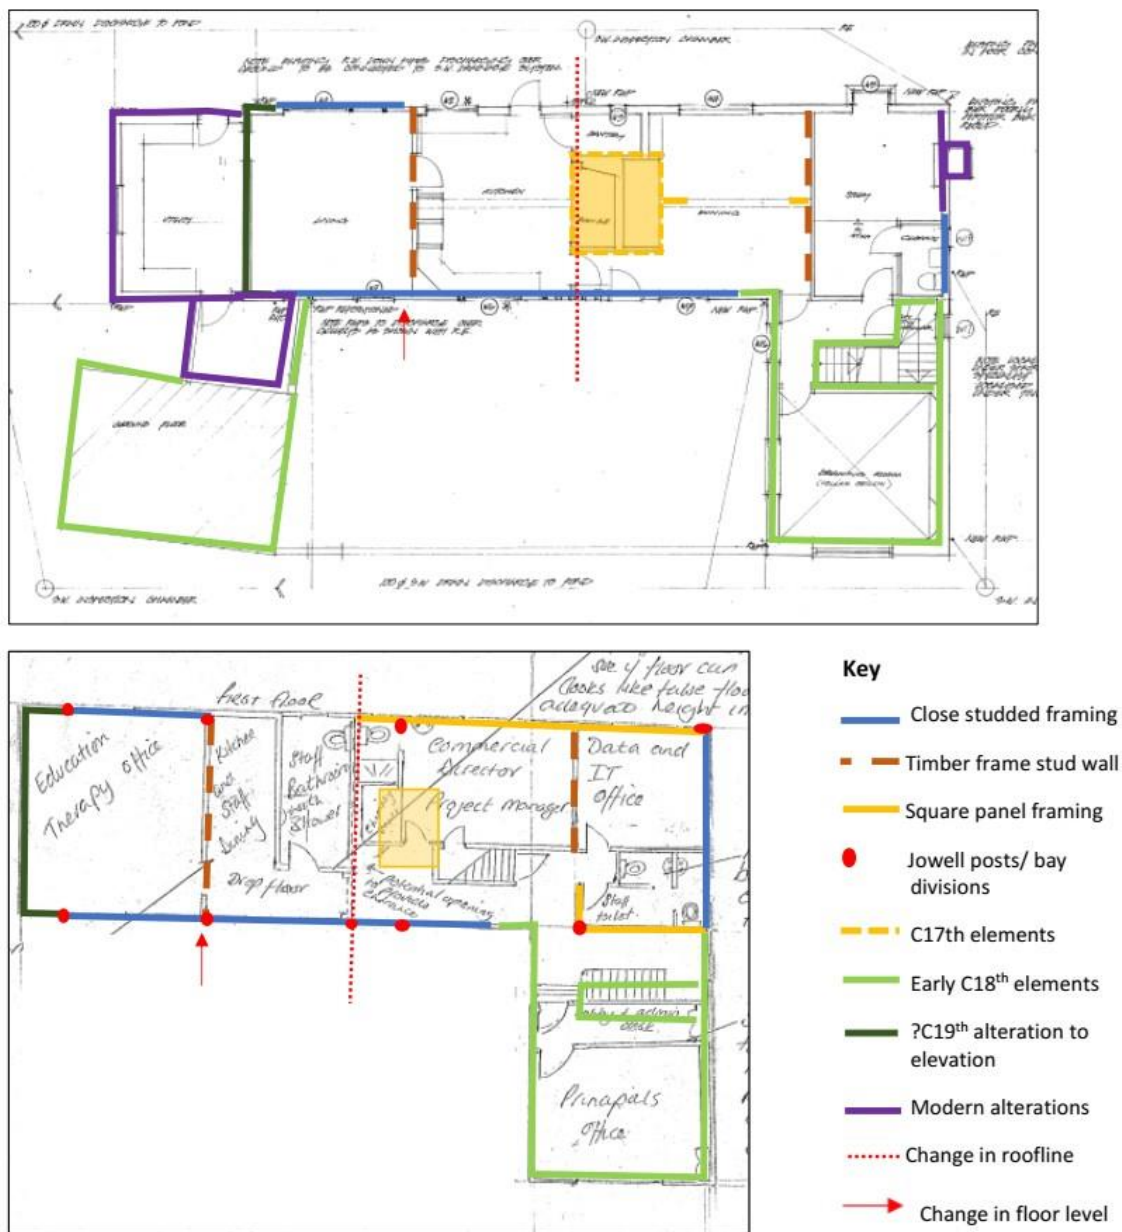
Figure 1: Tentative phasing of the building and locations of timber framed elements and datable features to ground and first floors

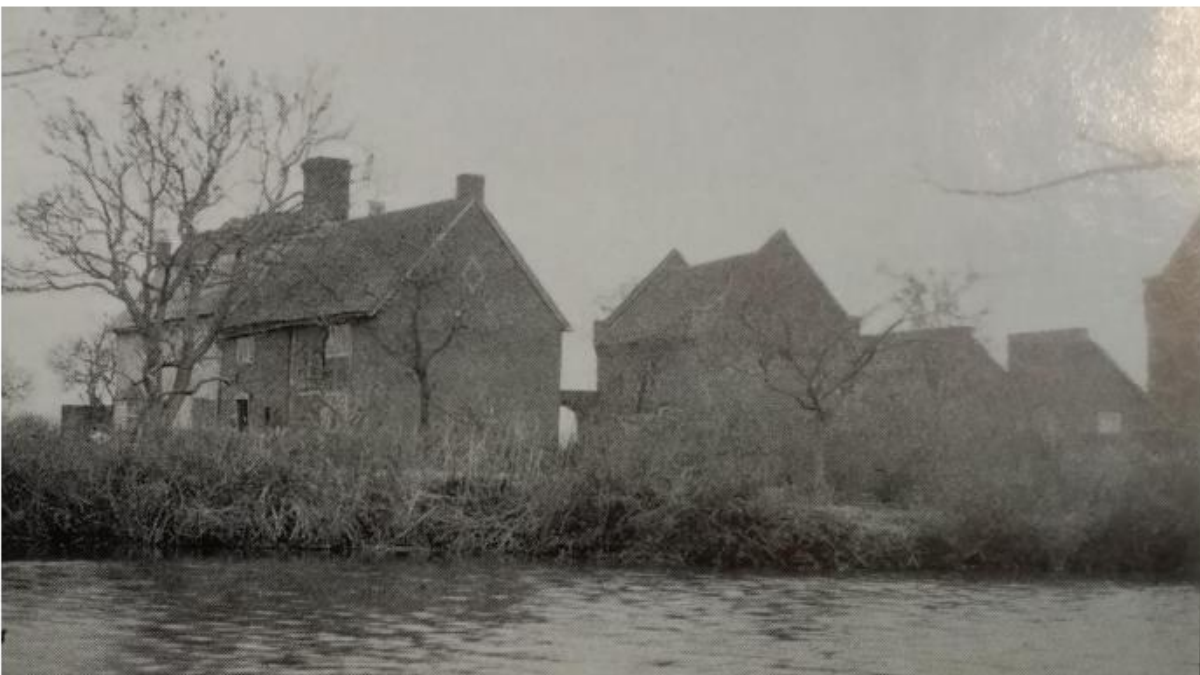
West and south elevations

- 2.3.4 The western elevation (southern end) has full height close-studding at ground and first floor level, which is in accordance with the 'early framing' shown on early 20th century photographs (Appendix C)¹⁵ and Victoria County History (VCH) description, but is all new work. This section includes a blocked window opening to each floor. There is square panelling at first floor level to the northern section of the elevation, incorporating diagonal bracings from the posts to the wall plate, which indicates that these bays are of later date (Photo 4).
