## **Construction noise and vibration Monthly Report – October 2021**

### **London Borough of Camden**

# Non-Technical Summary

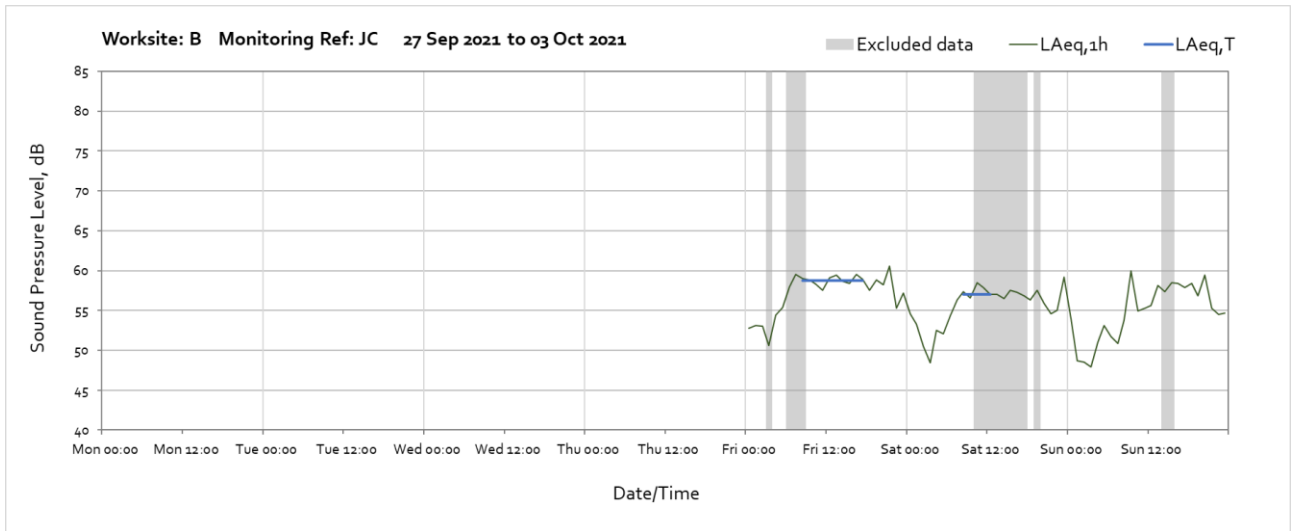
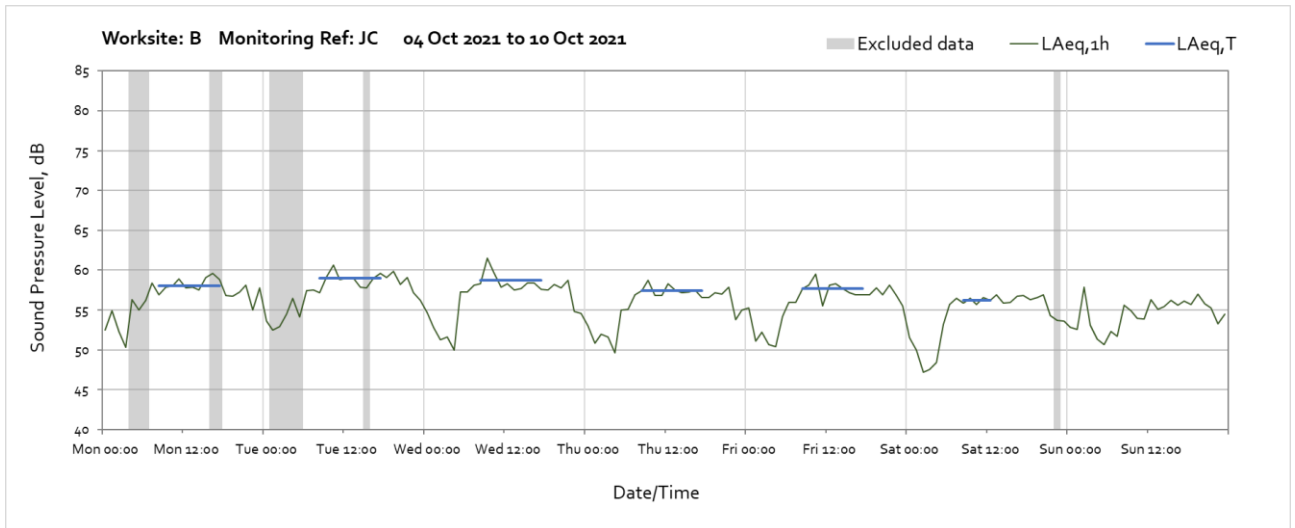
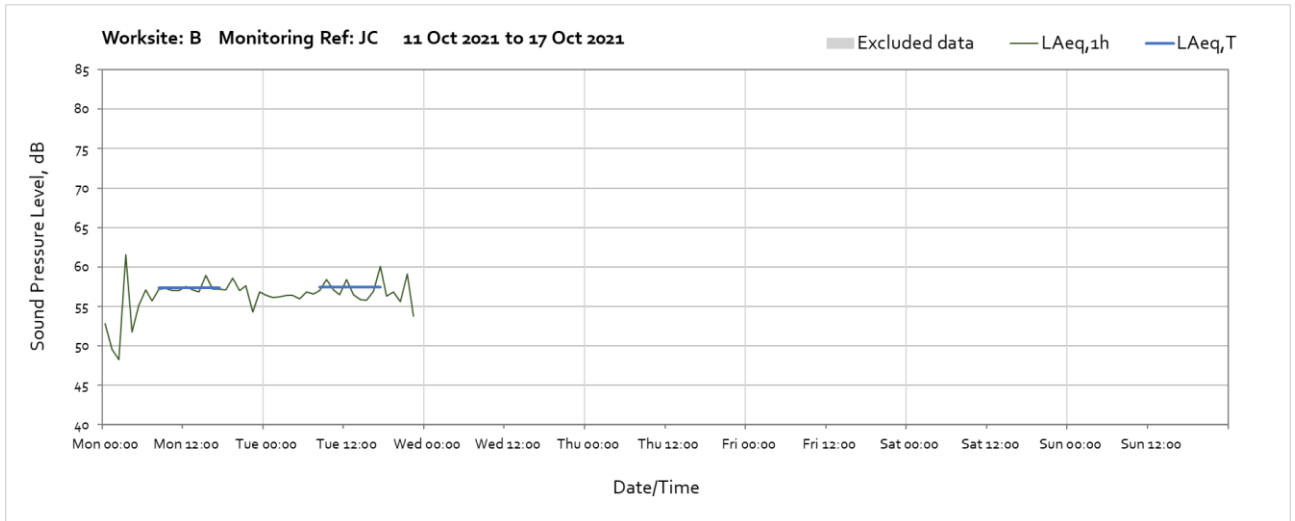
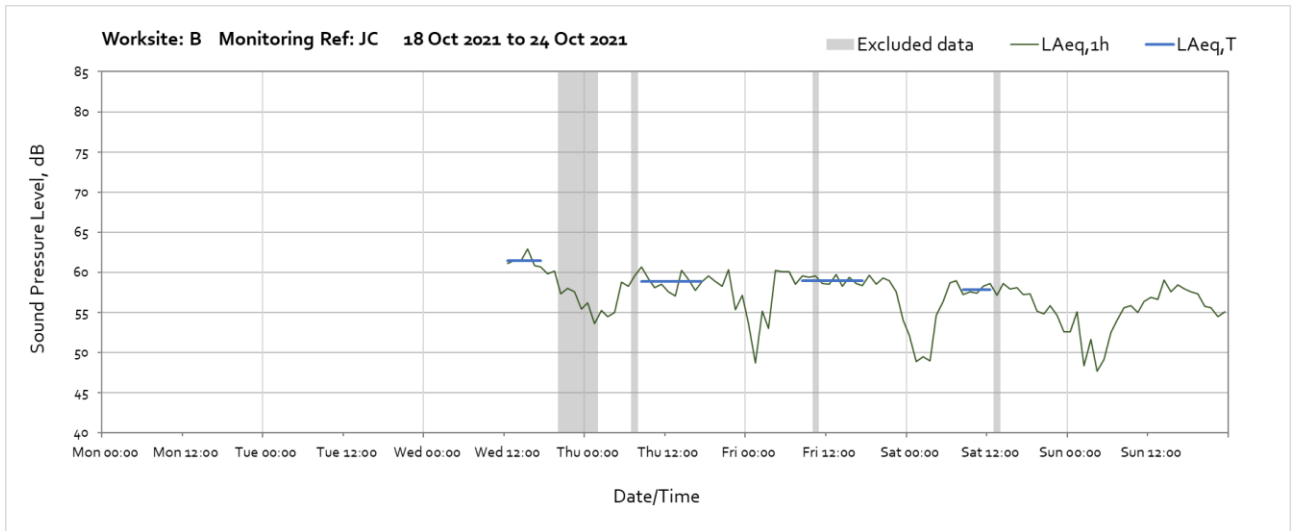
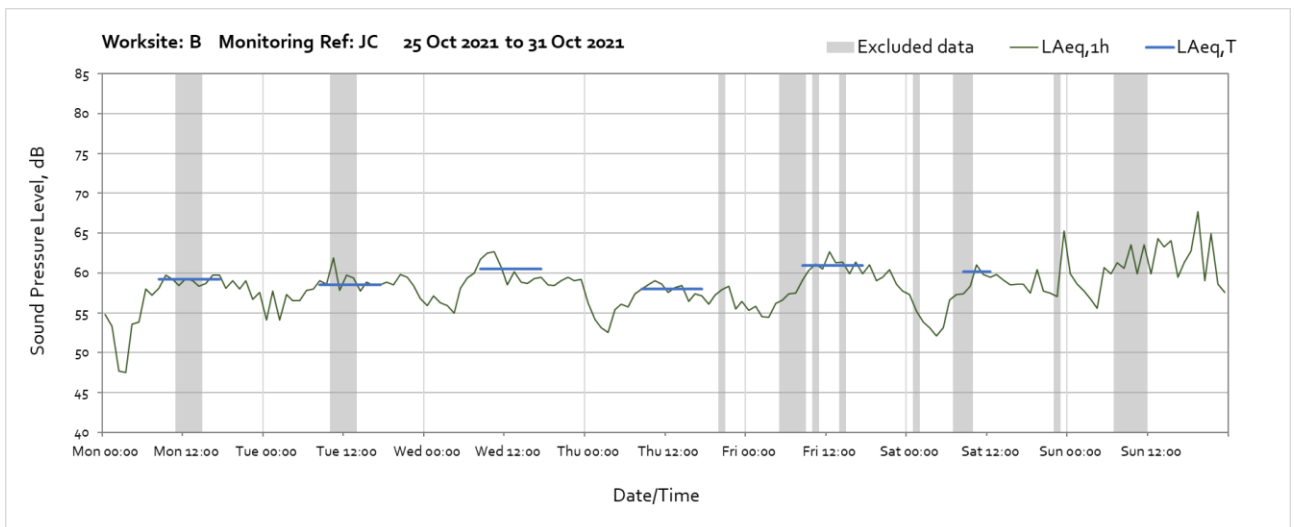
### Worksite: B – Monitoring Ref: JC

Note: Missing data from 23:00 ON Tuesday 12<sup>th</sup> October until 12:00 on Wednesday 20<sup>th</sup> October was due to loss of power to the monitoring station.

2.1.3 Appendix C presents graphs of the noise and vibration monitoring data over the month for each of the measurement locations. Noise data presented consists of the hourly  $L_{Aeq}$  values and, where relevant, the  $L_{Aeq,T}$  values (where the time period T has been taken to be the averaging period as specified in Table 1 of HS2 Information Paper E23). Vibration data presented consist of hourly PPV values. The full data set for the monitoring equipment can be found at the following location:

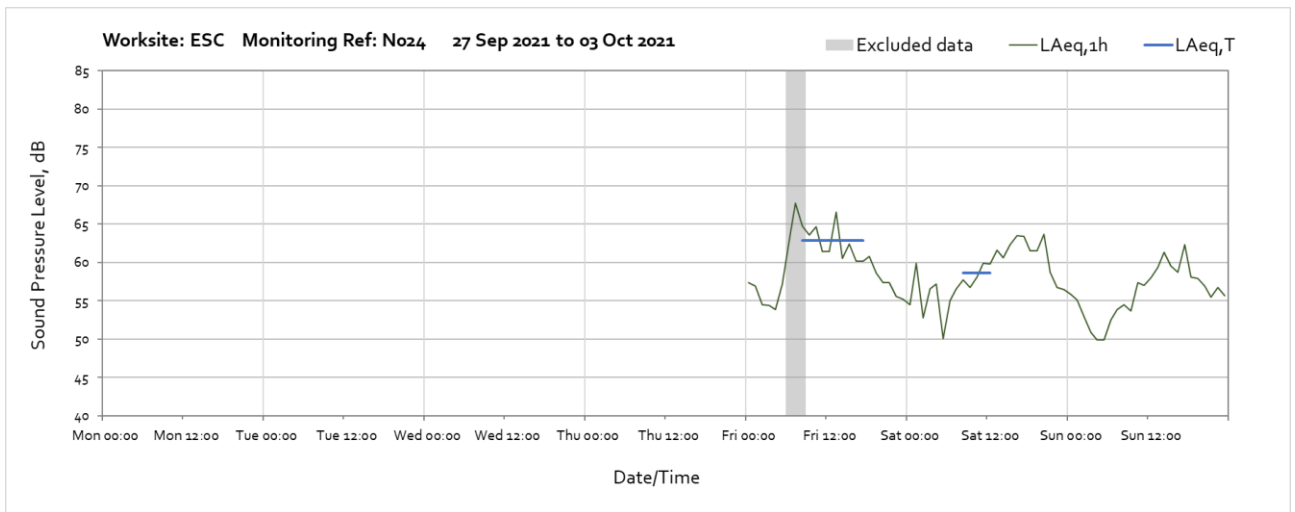
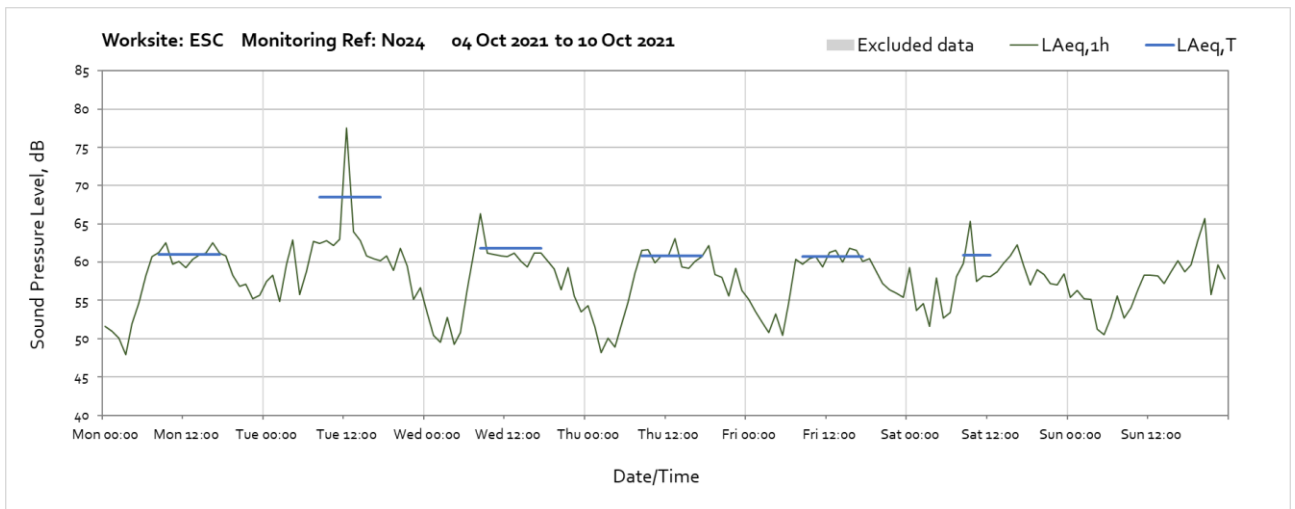
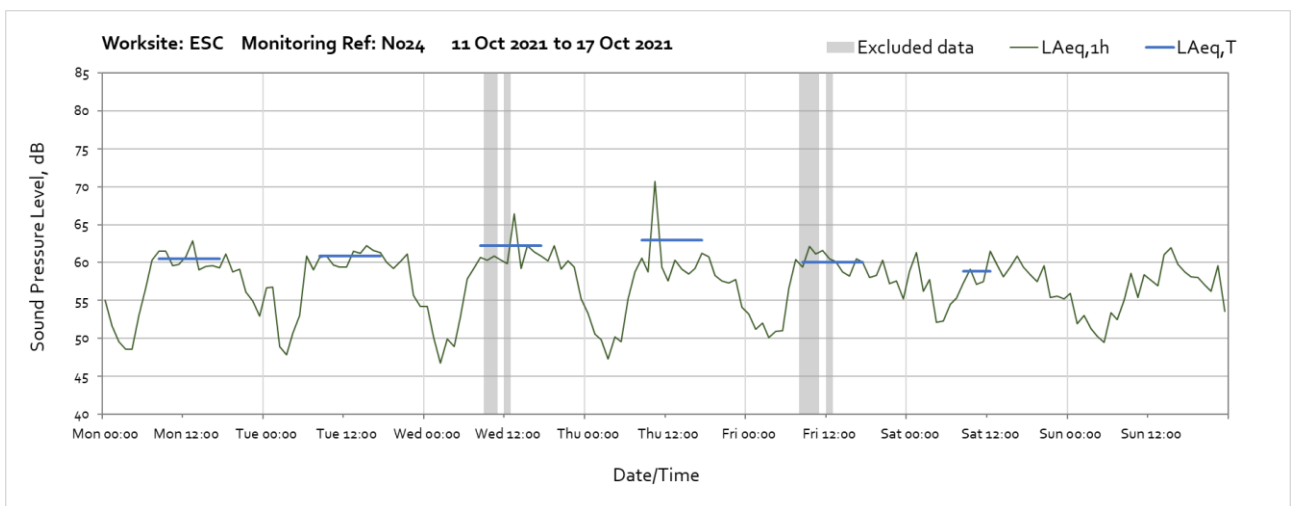
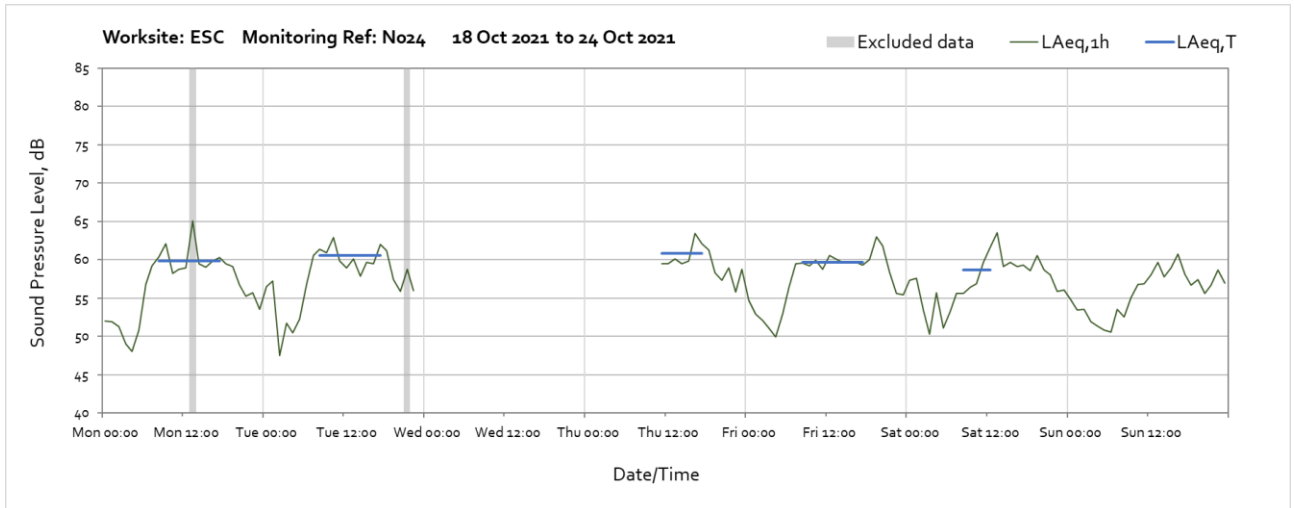
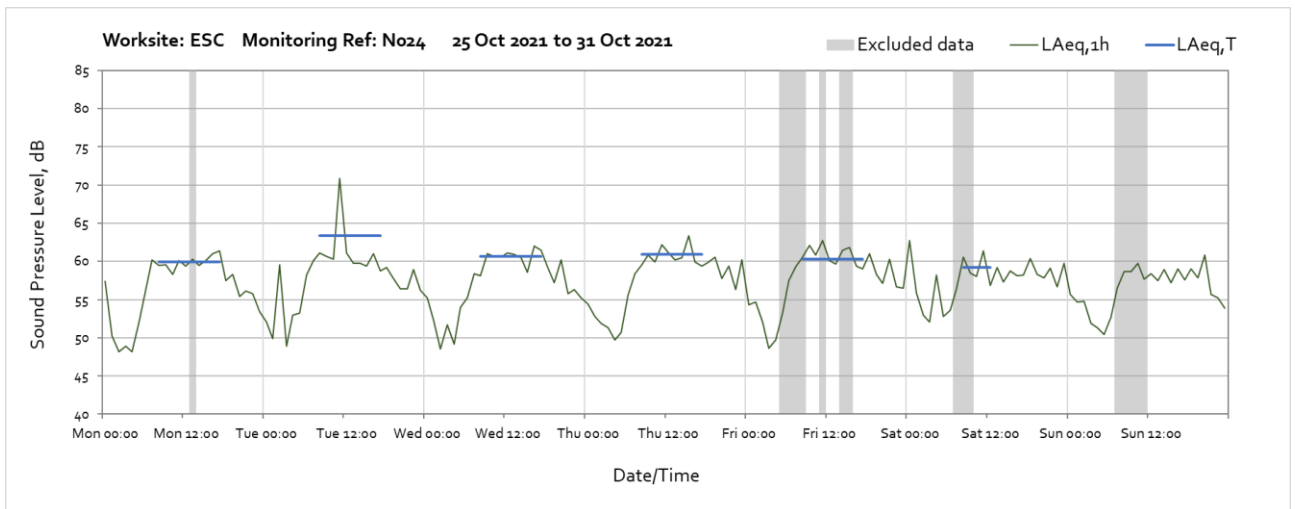
## Worksite: ESC - Monitoring Ref: N024

Note: Missing data from 23:00 on Tuesday 19<sup>th</sup> October until 11:00 on Thursday 21<sup>st</sup> October was due to a memory card error.

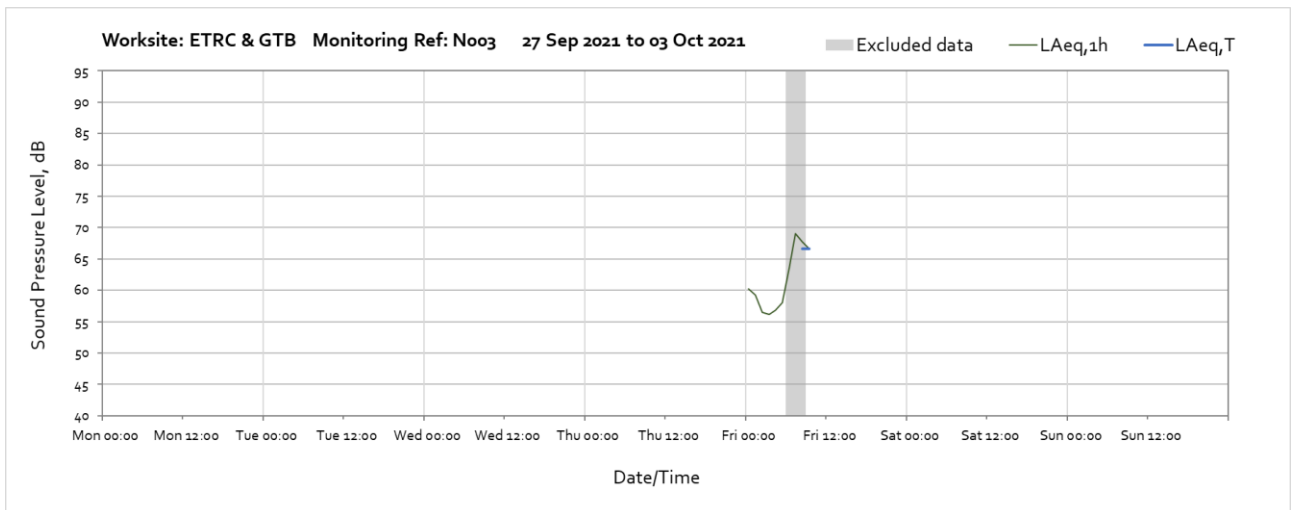
## Worksite: ETRC & GTB – Monitoring Ref: N003

Note: Missing data from 10:00 on Friday 1<sup>st</sup> October until 11:00 on Thursday 7<sup>th</sup> October was due to a memory card error. The memory card has been replaced on Thursday 7<sup>th</sup> October.

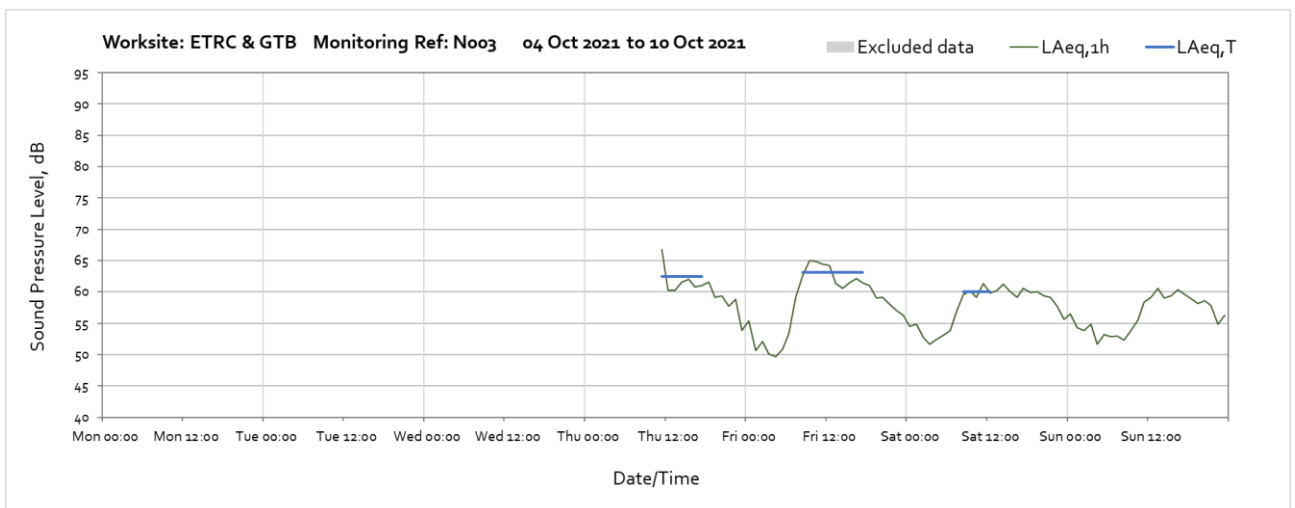
Note: Missing data from 10:00 on Friday 1<sup>st</sup> October until 11:00 on Thursday 7<sup>th</sup> October was due to a memory card error. The memory card has been replaced on Thursday 7<sup>th</sup> October.

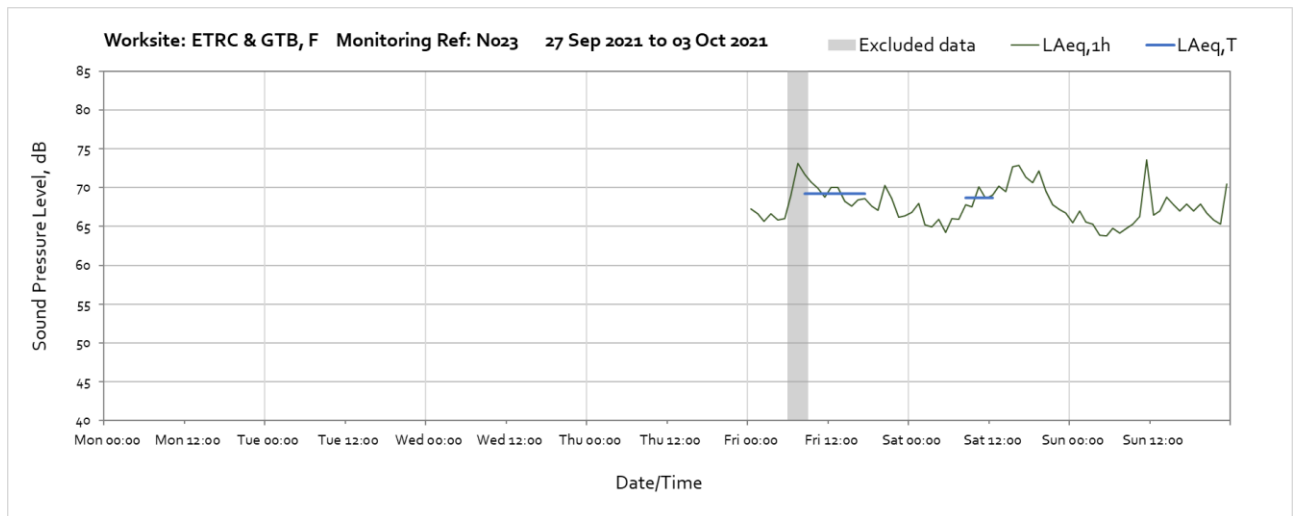
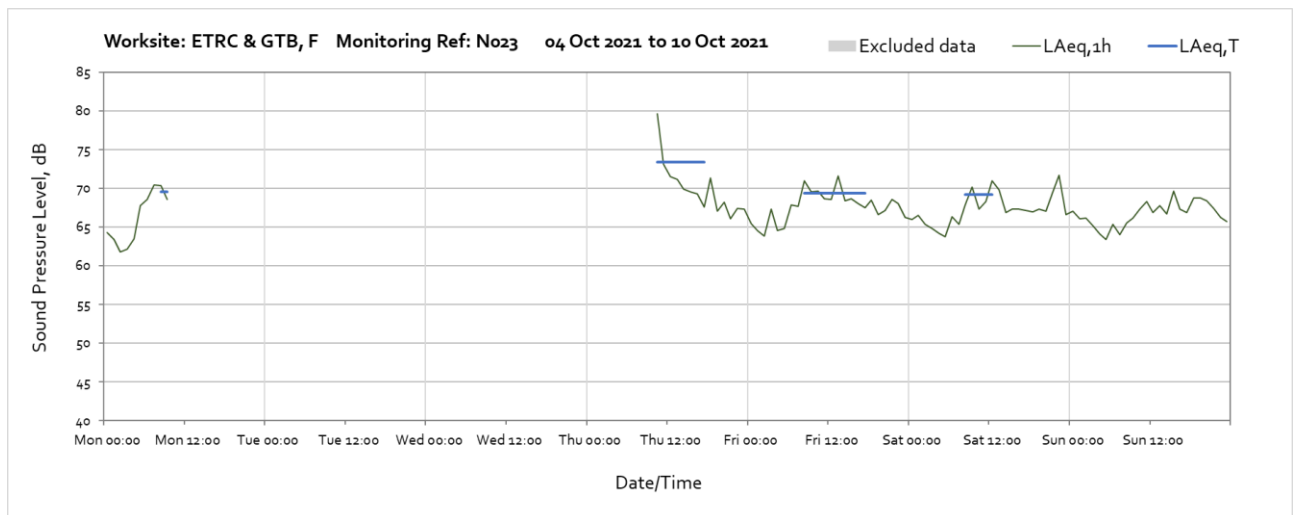
## Worksite: ETRC & GTB, F – Monitoring Ref: N023

Note: Missing data from 11:00 on Monday 4<sup>th</sup> October until 10:00 on Thursday 7<sup>th</sup> October was due to a memory card error. The memory card has been replaced on Thursday 7<sup>th</sup> October.

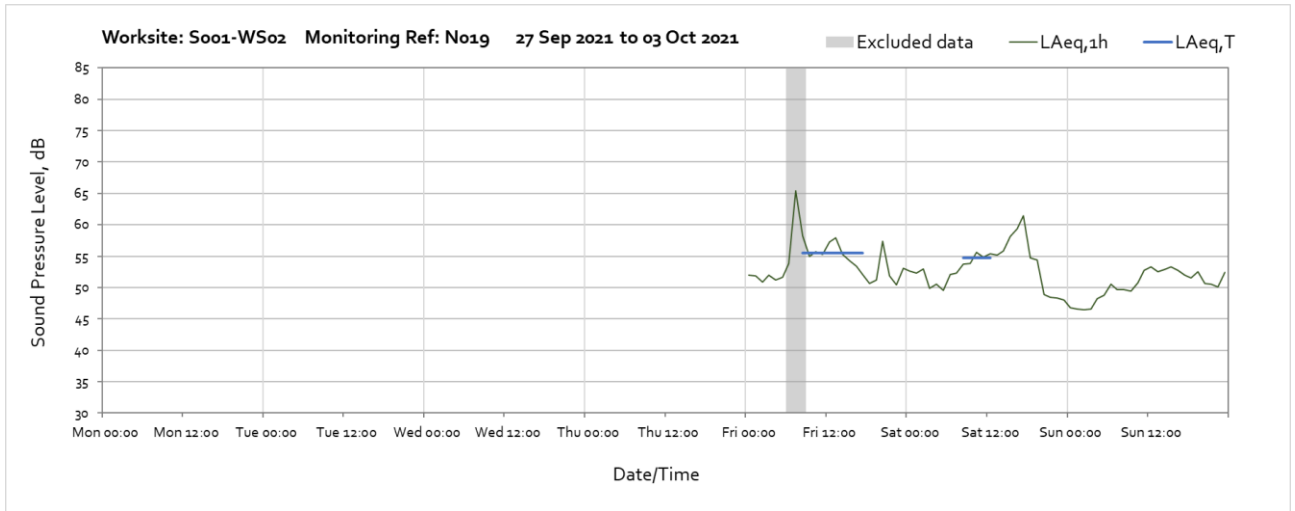
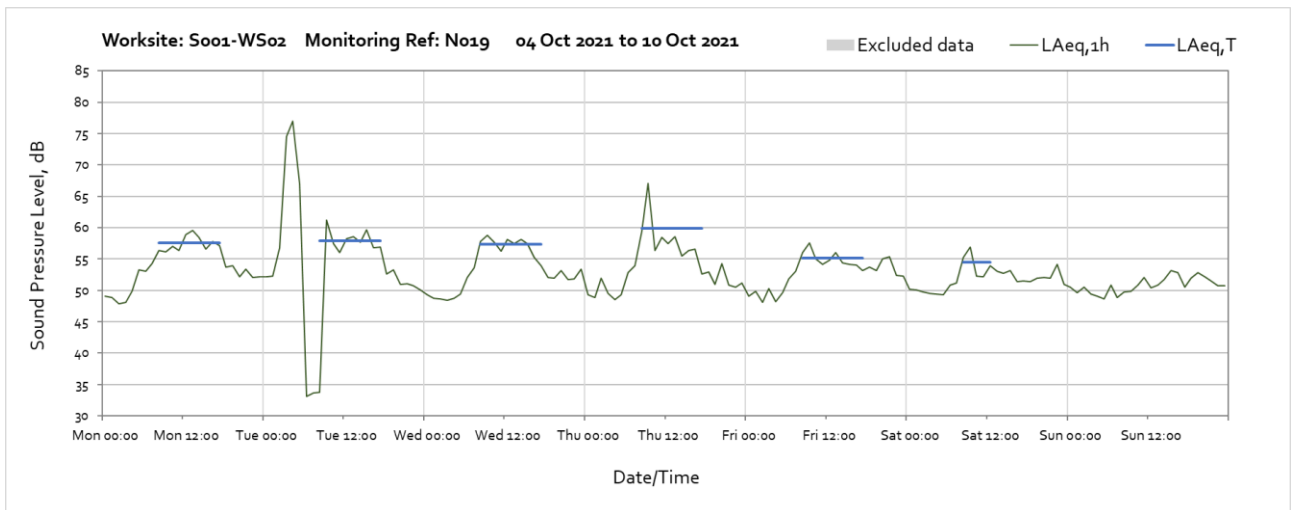
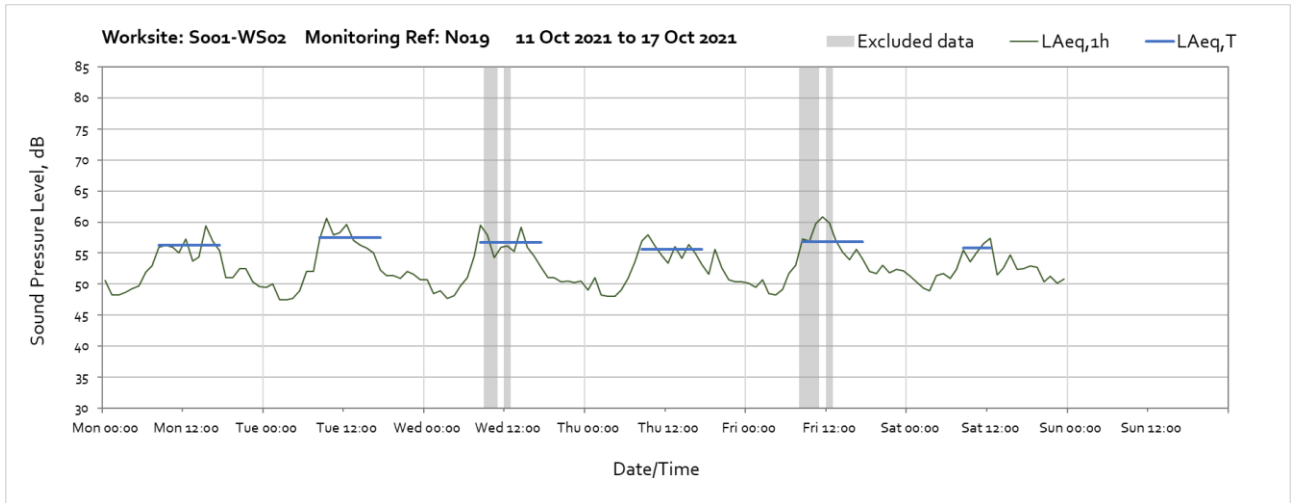
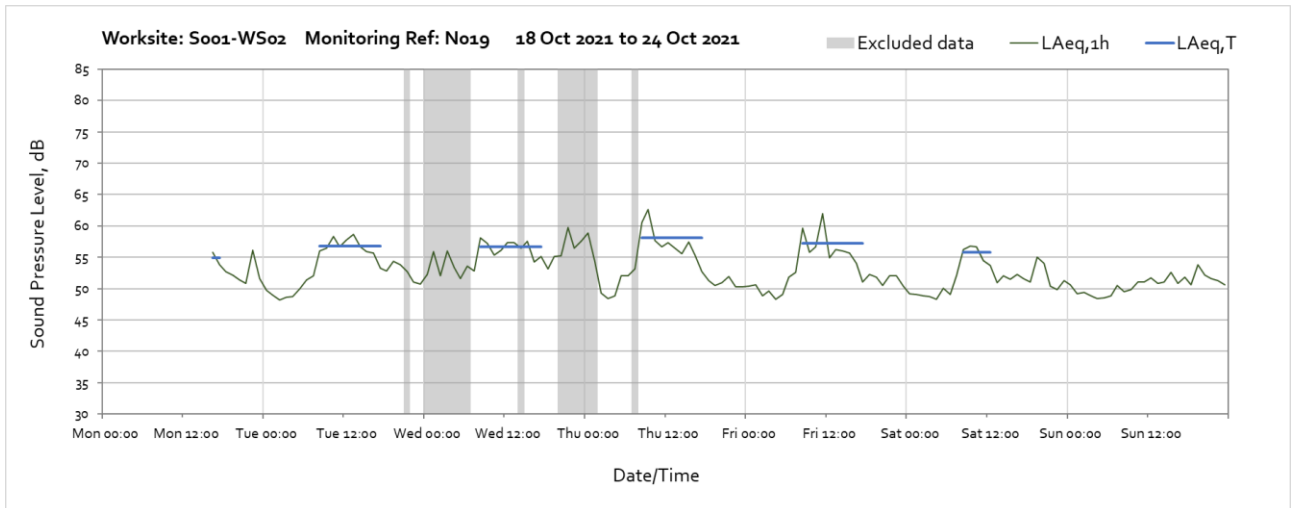
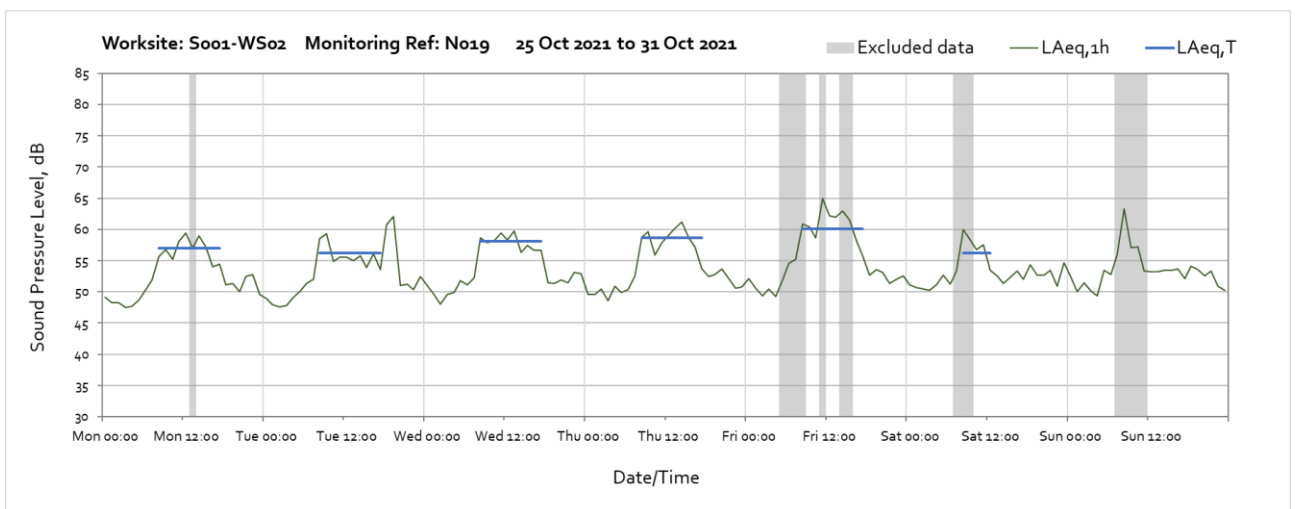
**Worksite: S001-WS02 – Monitoring Ref: N019**

Note: Missing data from 00:00 on Sunday 5<sup>th</sup> October until 16:00 on Monday 18<sup>th</sup> October was due to a memory card error.

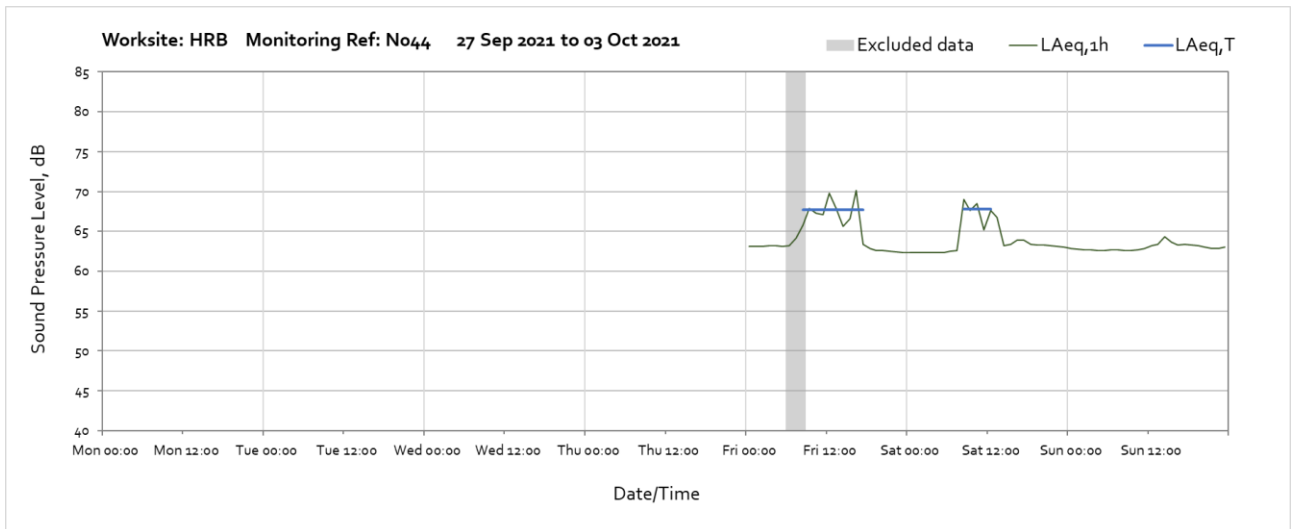
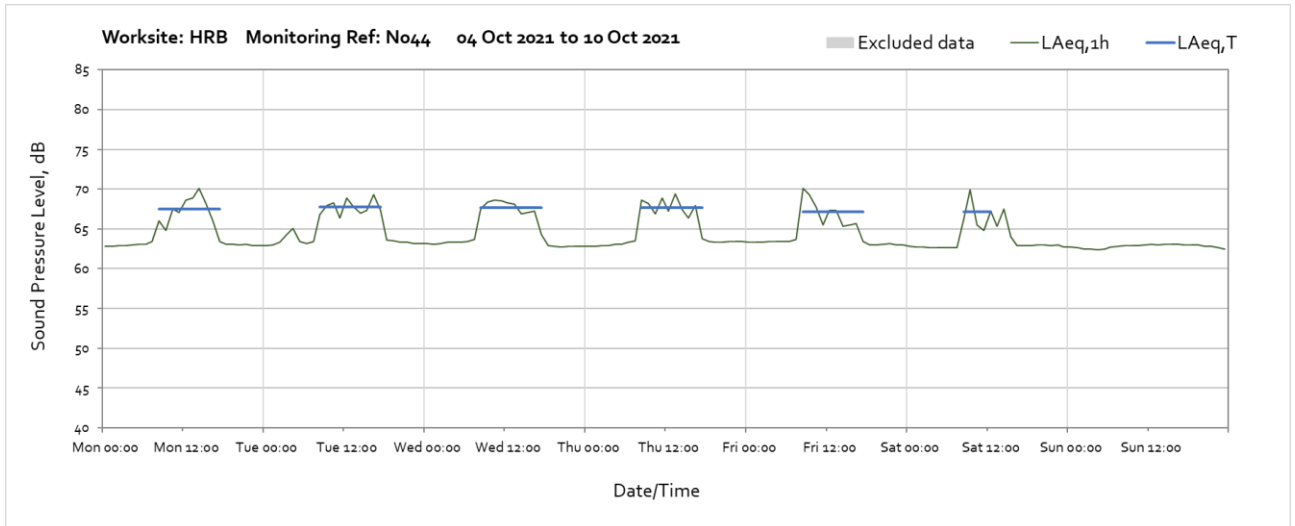
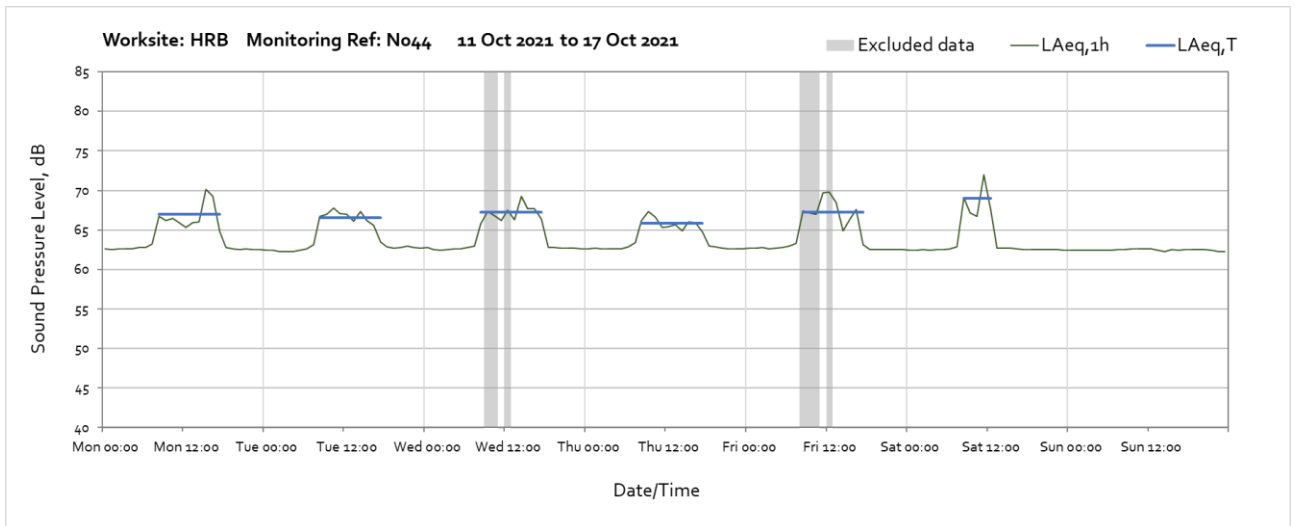
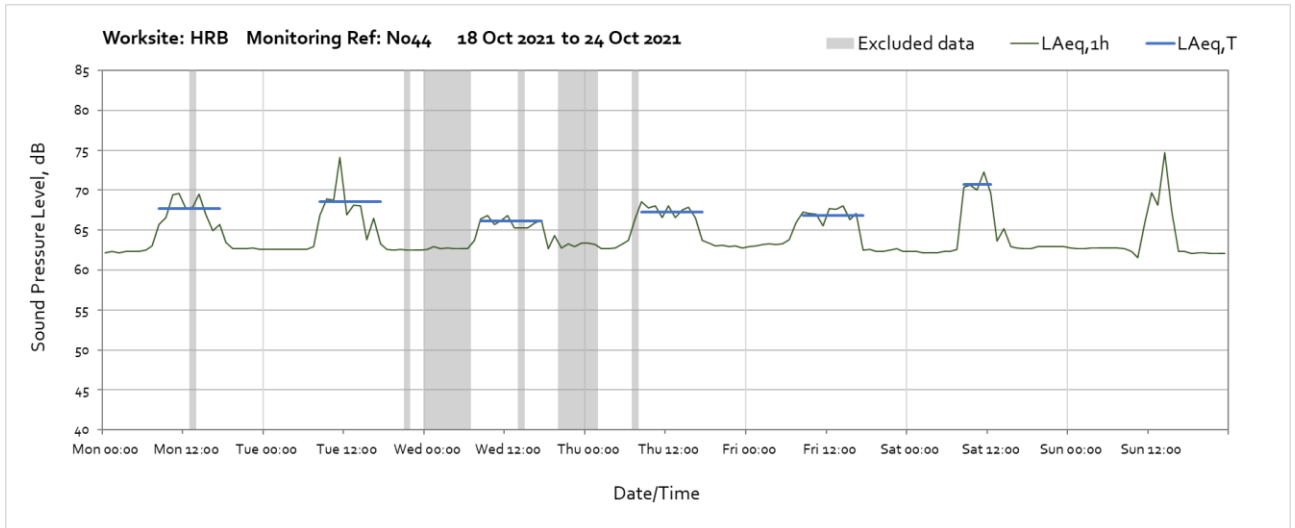
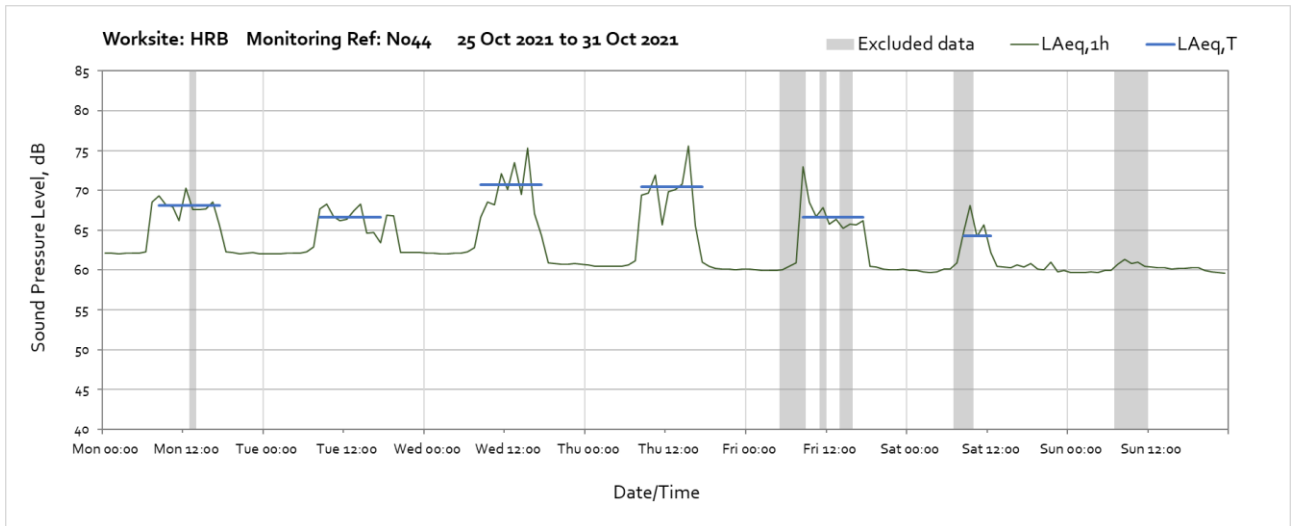
**Worksite: HRB – Monitoring Ref: N044**

Note: Continuous noise levels measured throughout the week were caused by an operational generator near to the monitor. The nearest receptor is located further from the generator and will therefore experience lower noise levels.

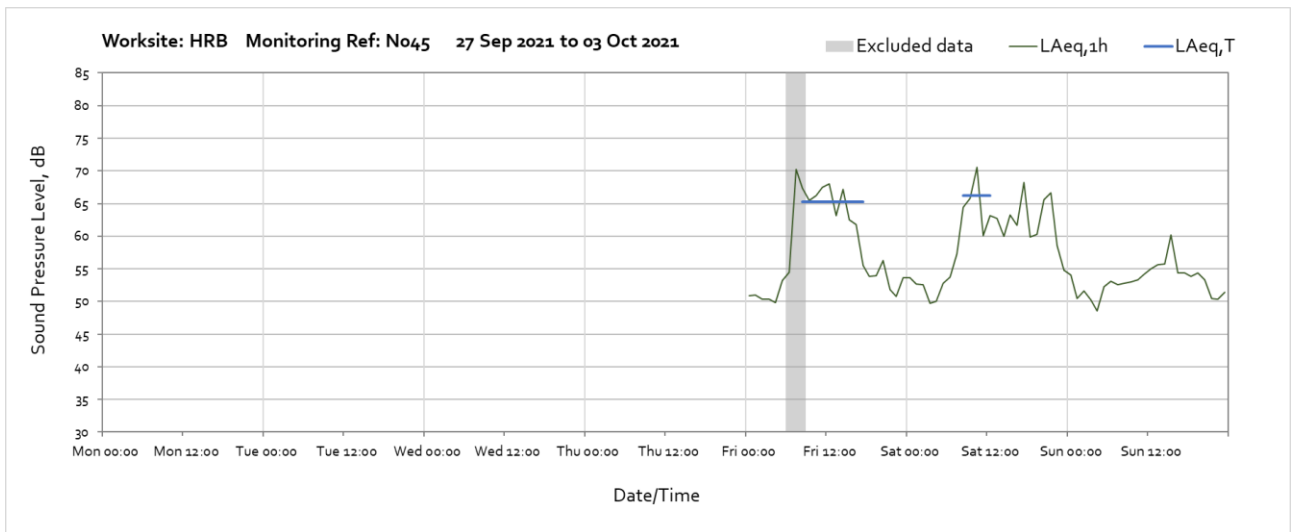
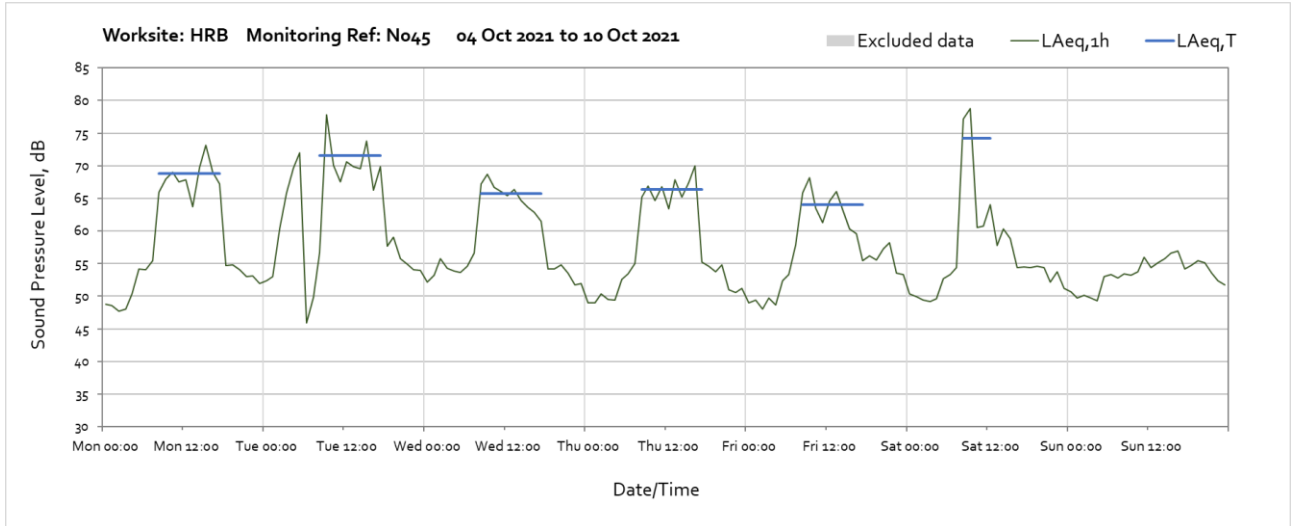
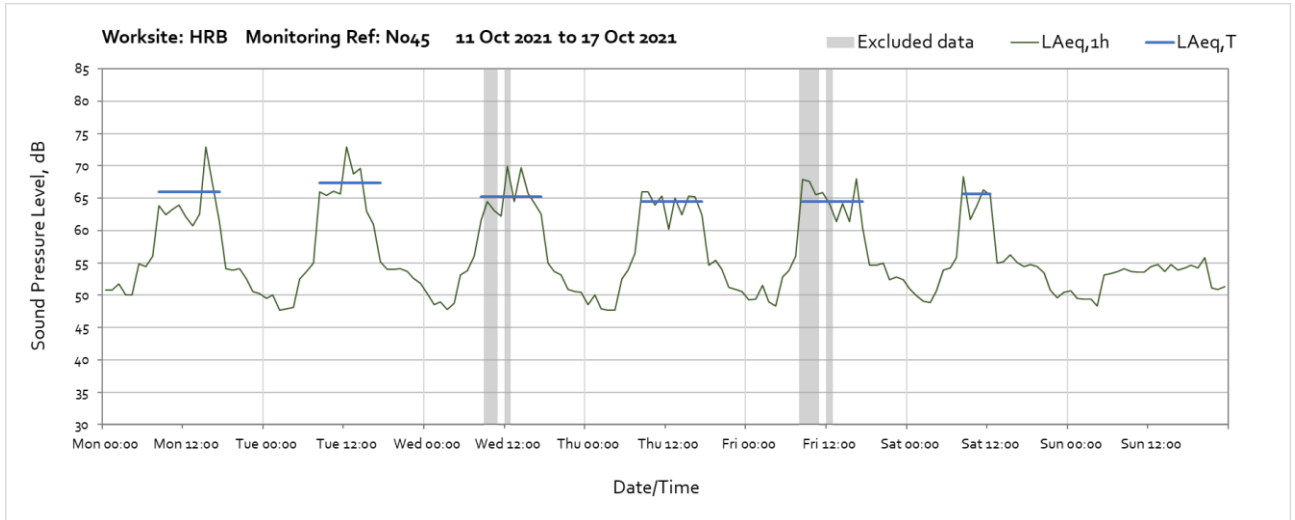
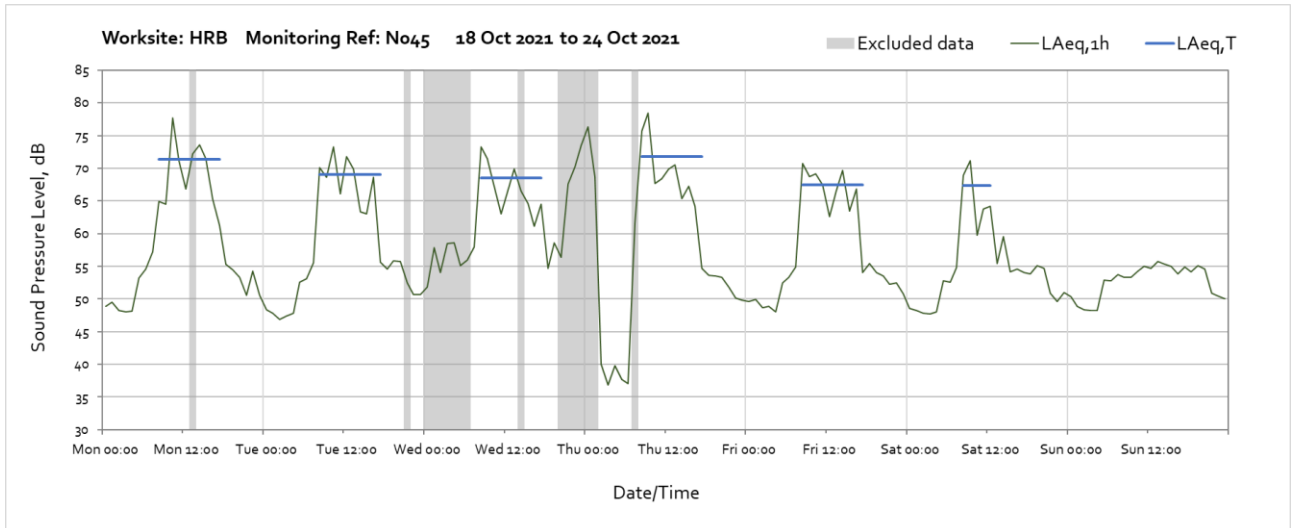
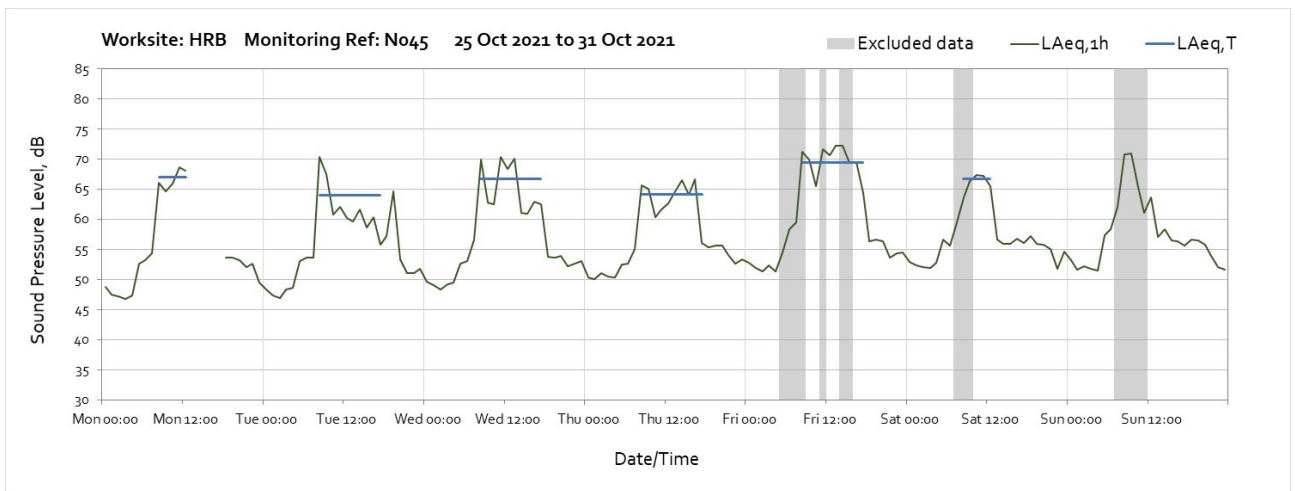
## Worksite: HRB – Monitoring Ref: N045

Note: Missing data between 13:00 and 17:00 on Monday 25<sup>th</sup> October were due to a software issue occurred at the monitoring station.
