## **Construction noise and vibration Monthly Report – October 2021**

### **London Borough of Camden**

# Non-Technical Summary

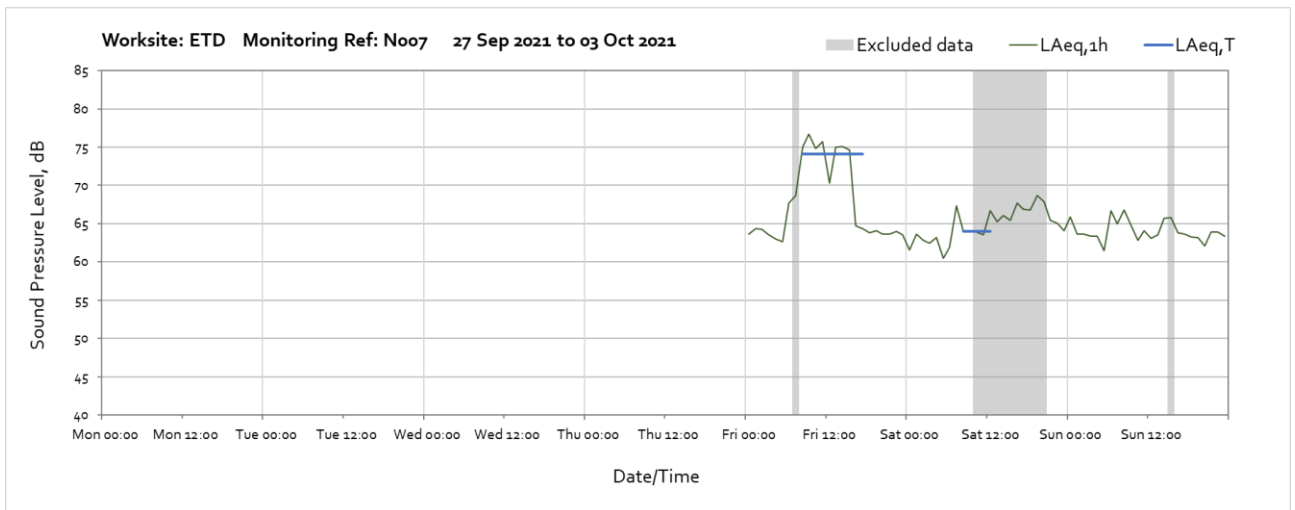
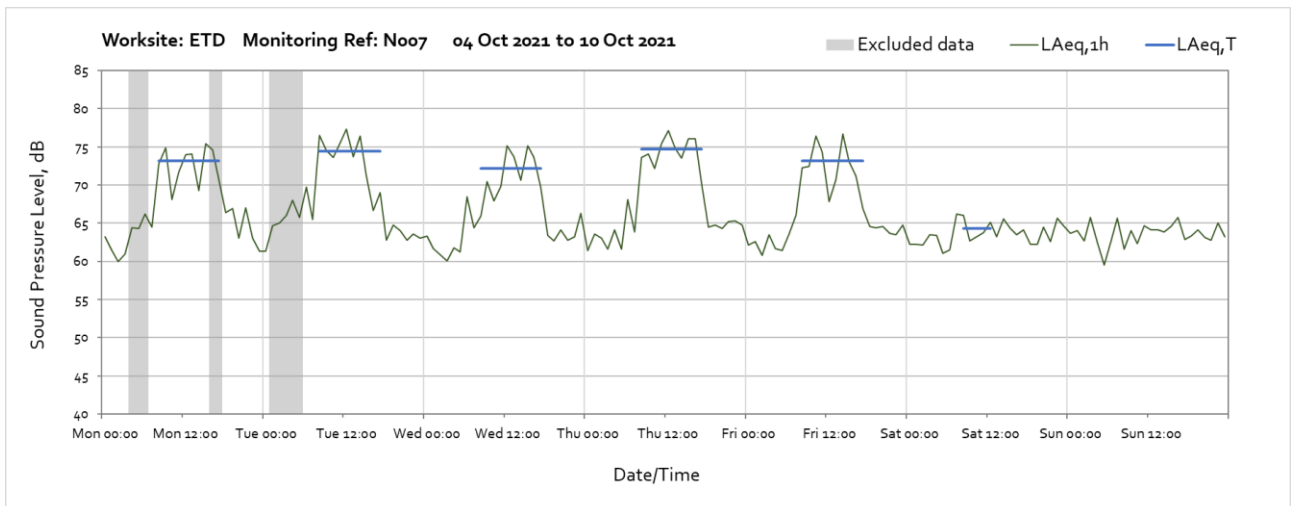
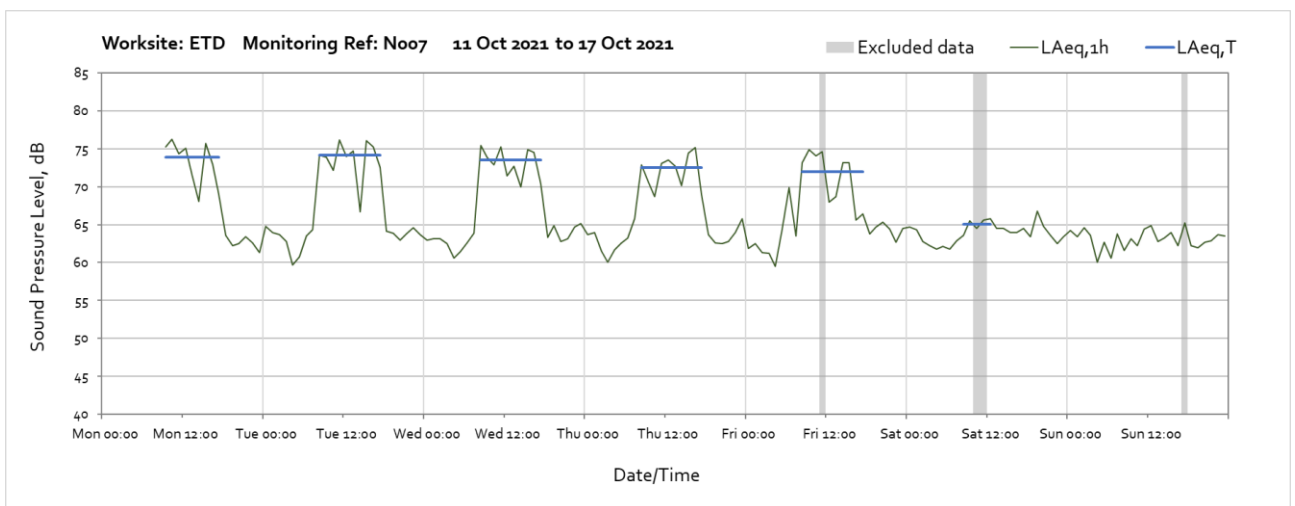
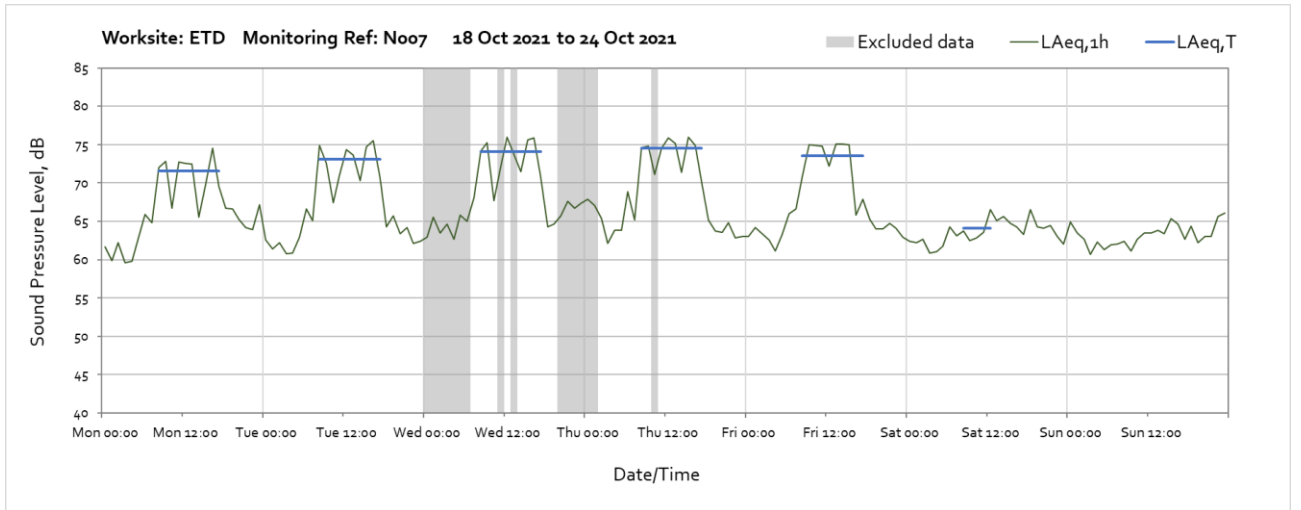
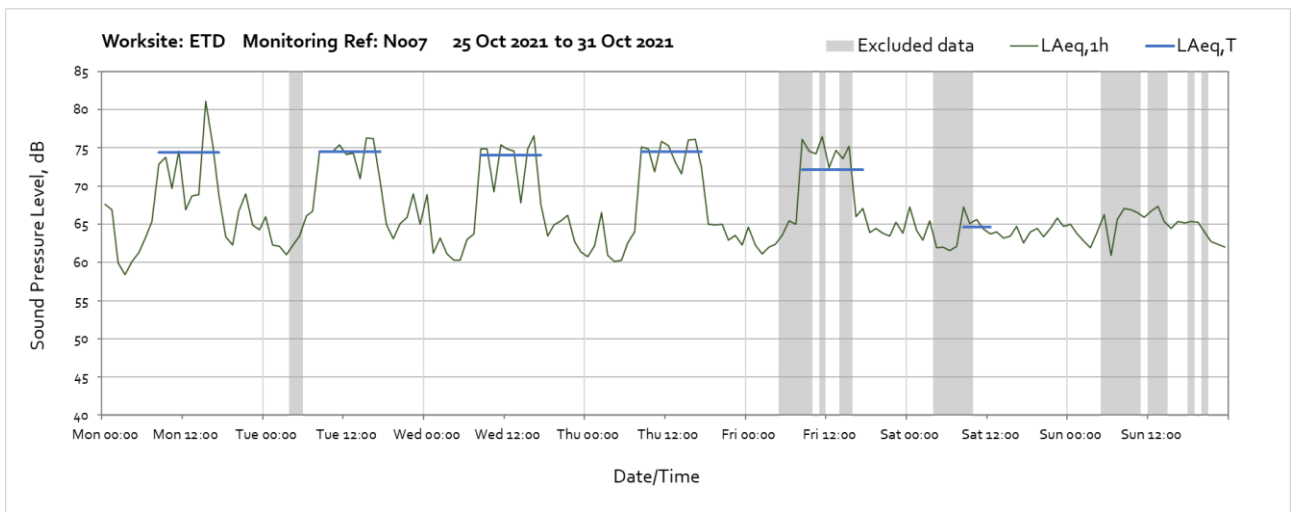
## Worksite: ETD – Monitoring Ref: N007

Note: Missing data from 00:00 to 09:00 on Monday 11<sup>th</sup> October was due to a temporary fault of the monitoring station.

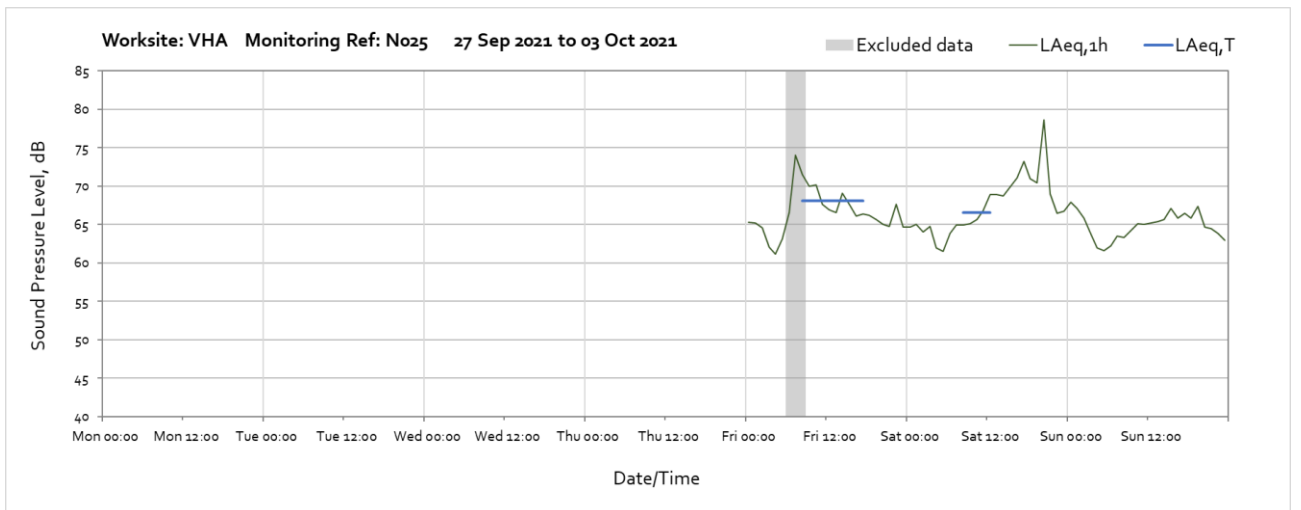
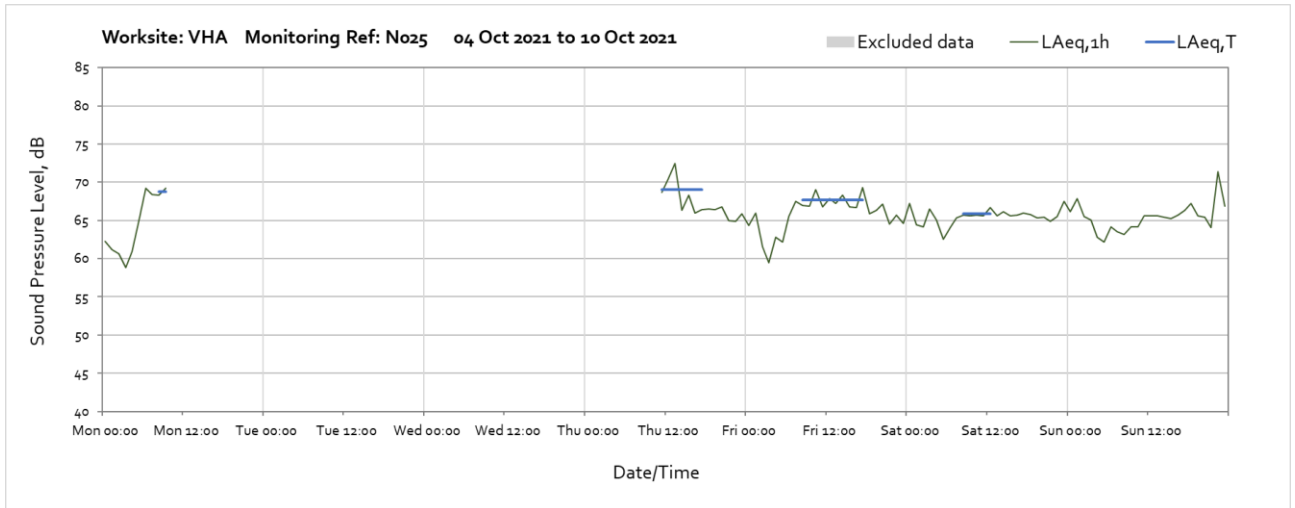
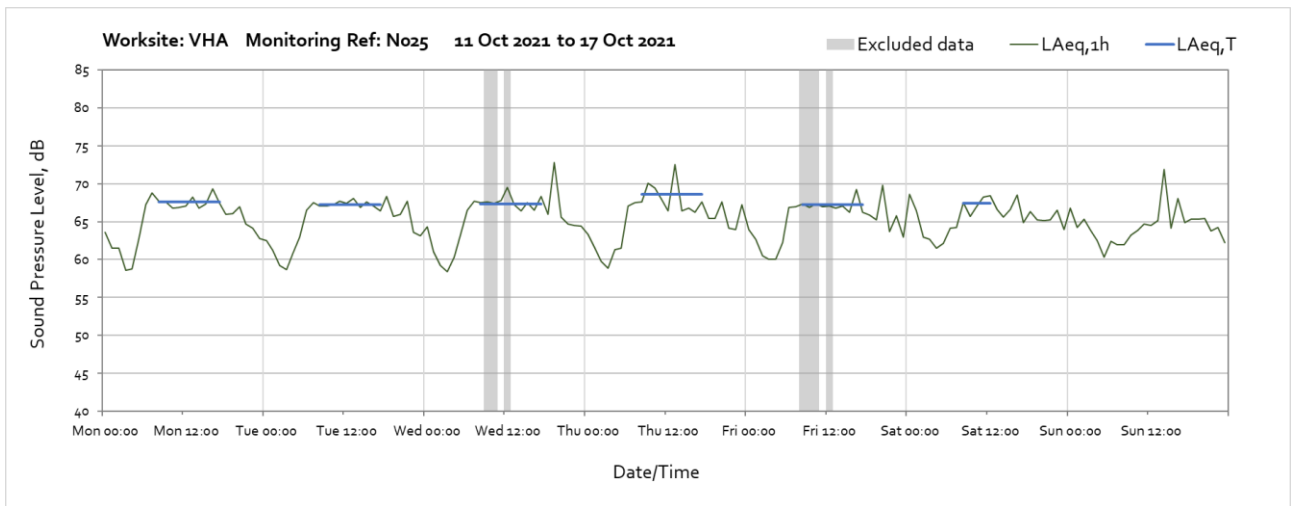
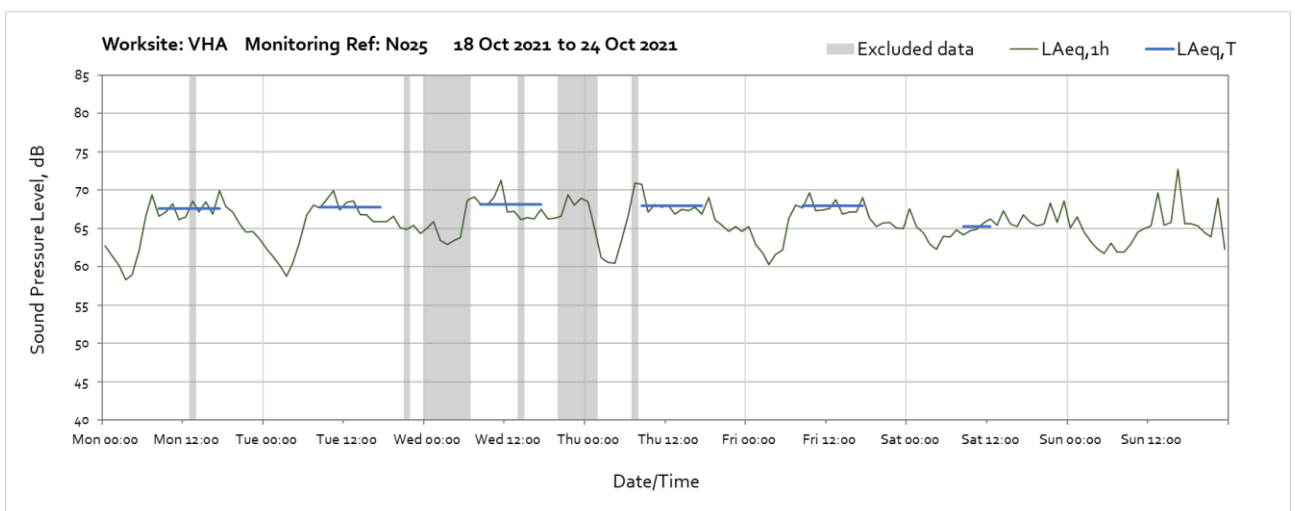
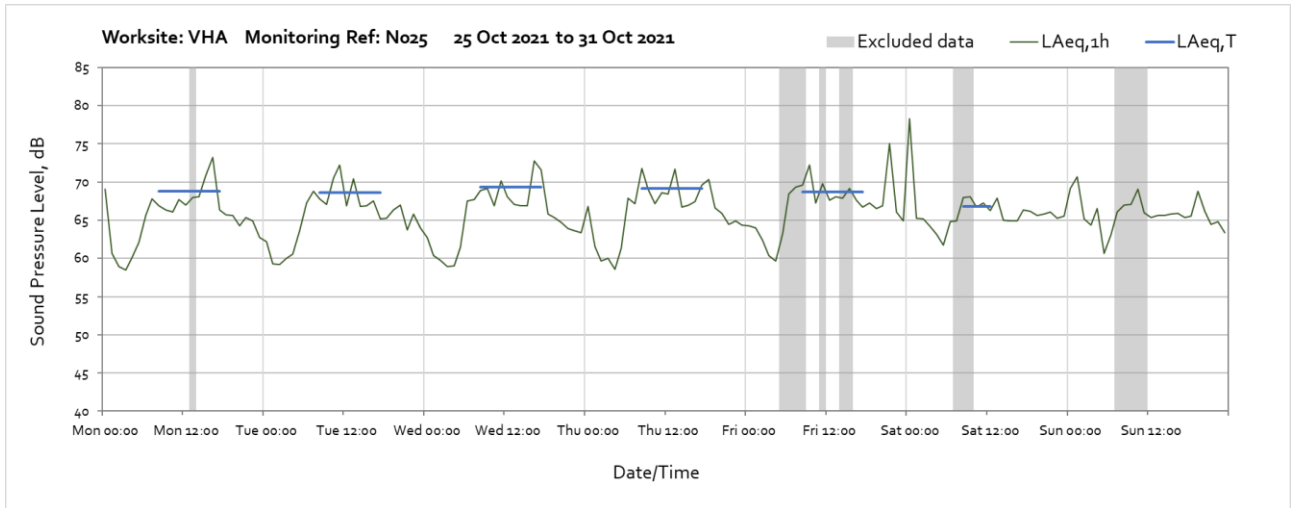
**Vehicle Holding Area (VHA) - Monitoring Ref: N025**

Note: Missing data from 10:00 on Monday 4<sup>th</sup> October to 11:00 on Thursday 7<sup>th</sup> October was due to a memory card error. The memory card has been replaced on Thursday 7<sup>th</sup> October.

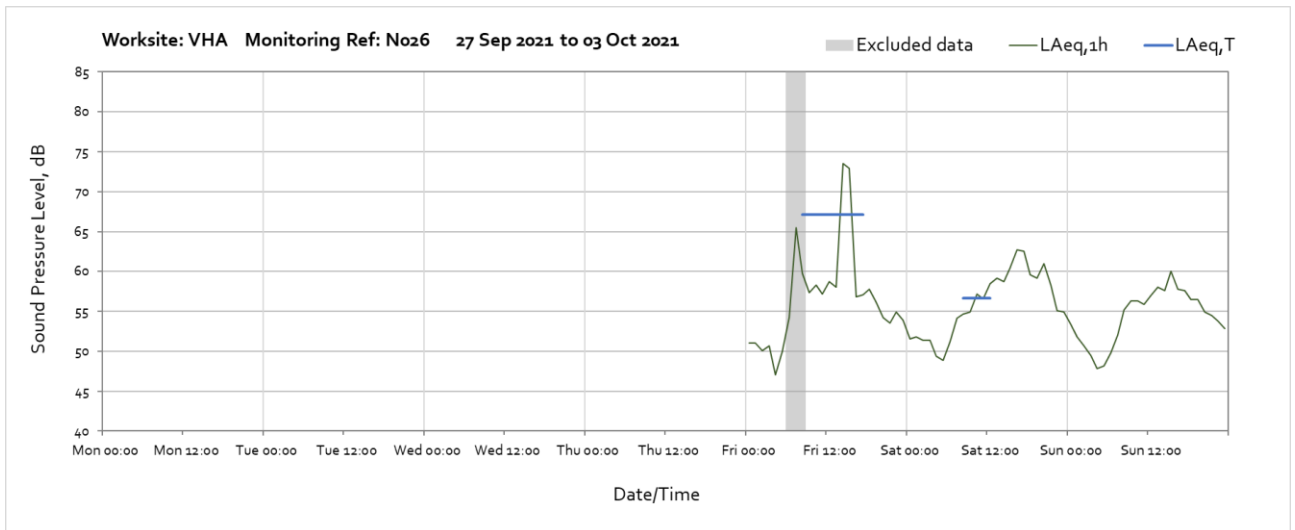
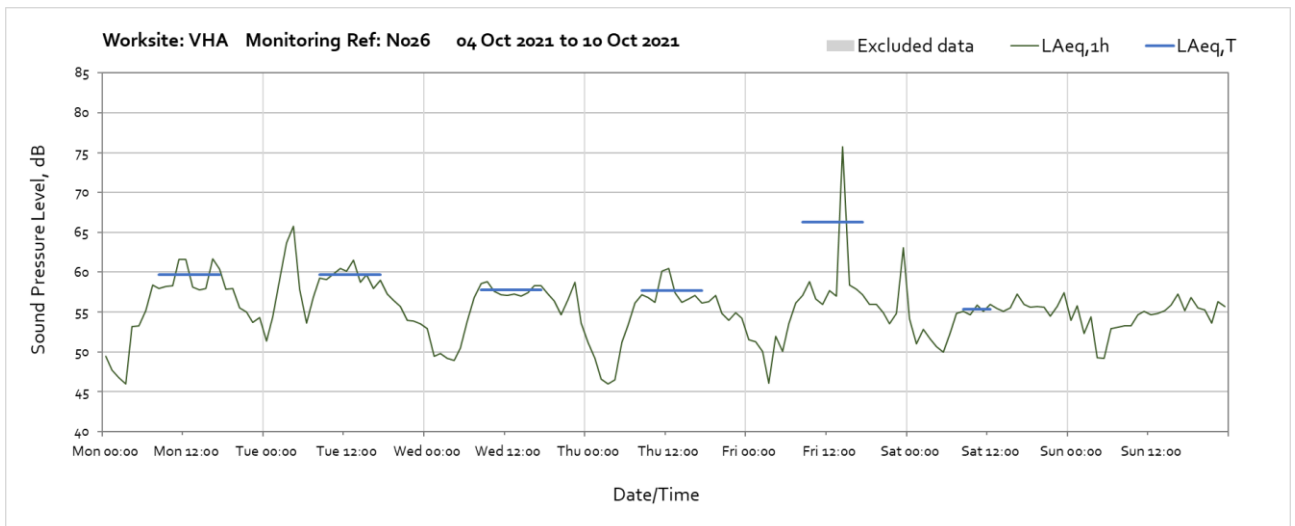
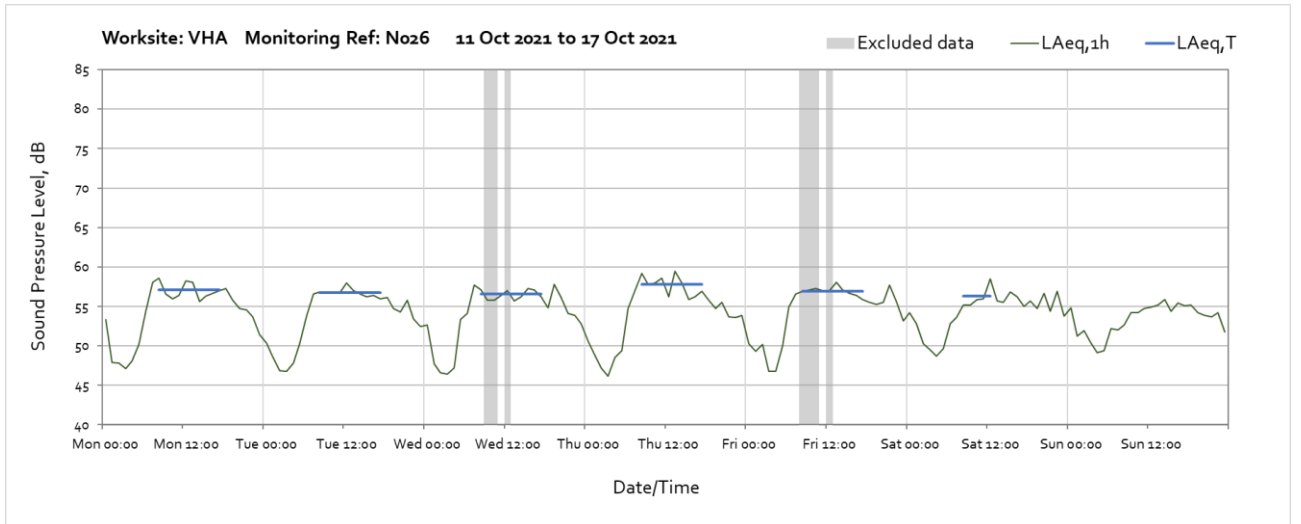
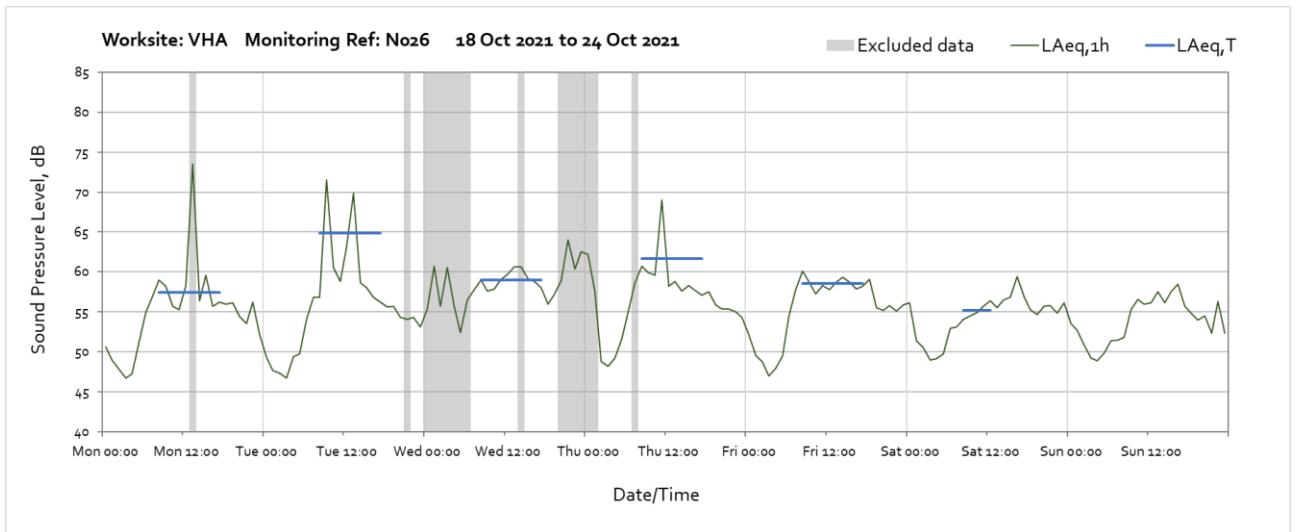
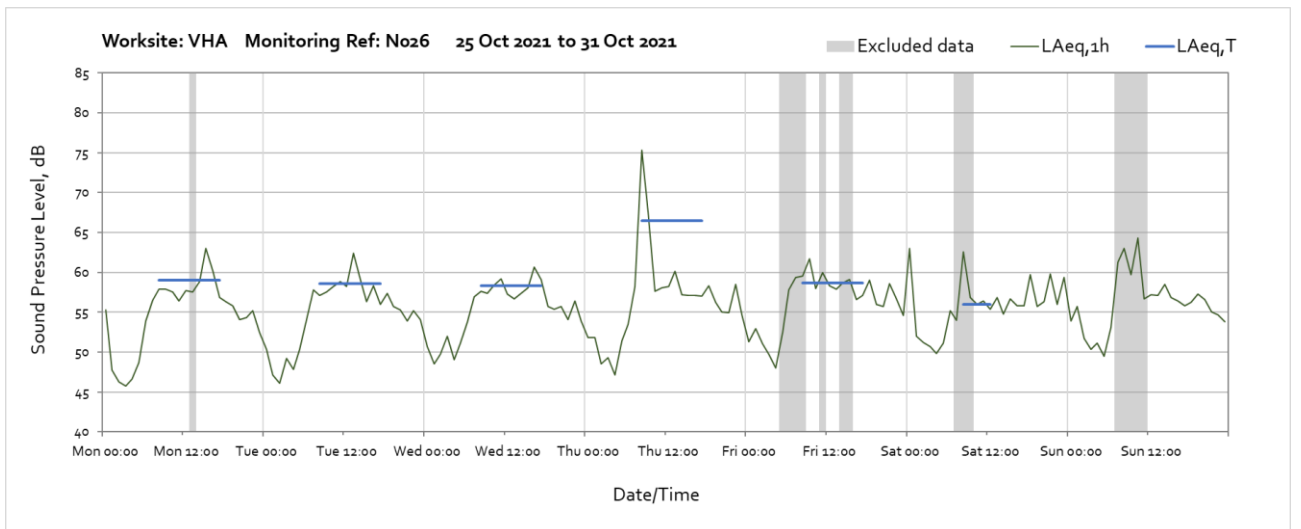
### Vehicle Holding Area (VHA) – Monitoring Ref: N026

2.1.3 Appendix C presents graphs of the noise and vibration monitoring data over the month for each of the measurement locations. Noise data presented consists of the hourly  $L_{Aeq}$  values and, where relevant, the  $L_{Aeq,T}$  values (where the time period T has been taken to be the averaging period as specified in Table 1 of HS2 Information Paper E23). Vibration data presented consist of hourly PPV values. The full data set for the monitoring equipment can be found at the following location:

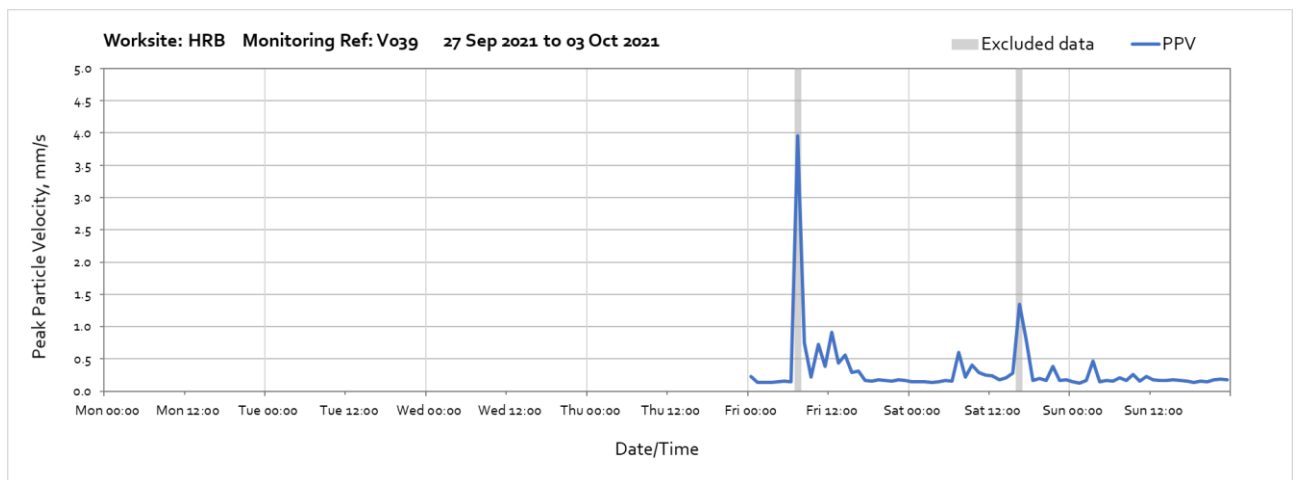
### Worksite: HRB – Monitoring Ref: V039

The following graphs show the hourly measured peak particle velocity PPV recorded during the monitoring period. The graphs show the resultant PPV due to vibration components on three orthogonal axes x, y and z. Where resultant PPV data is not available (monitors V039 and V043), the highest vibration component in either of the three axes is presented for each 1hr measurement period respectively. Where high values of PPV were caused by local interference with the vibration monitor, which are not representative of HS2 construction works, these values have been greyed out in the following charts and have been excluded to calculate values in Table 4 of the main report.

Note: High vibraton levels measured throughout the week were due to local interference of the monitor and are not representative of HS2 vibration levels at the receptor.

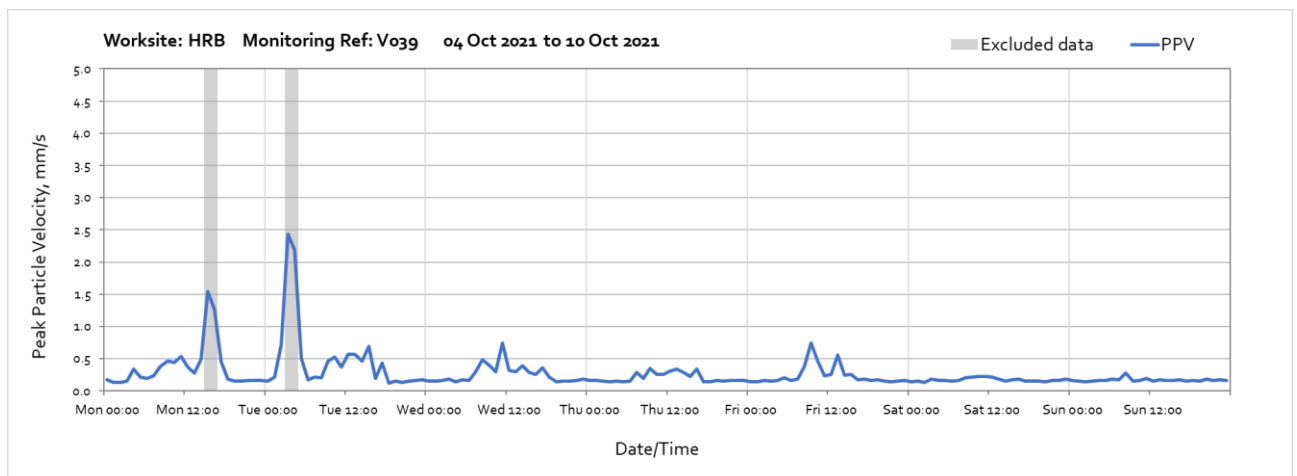
Note: High vibraton levels measured throughout the week were due to local interference of the monitor and are not representative of HS2 vibration levels at the receptor.

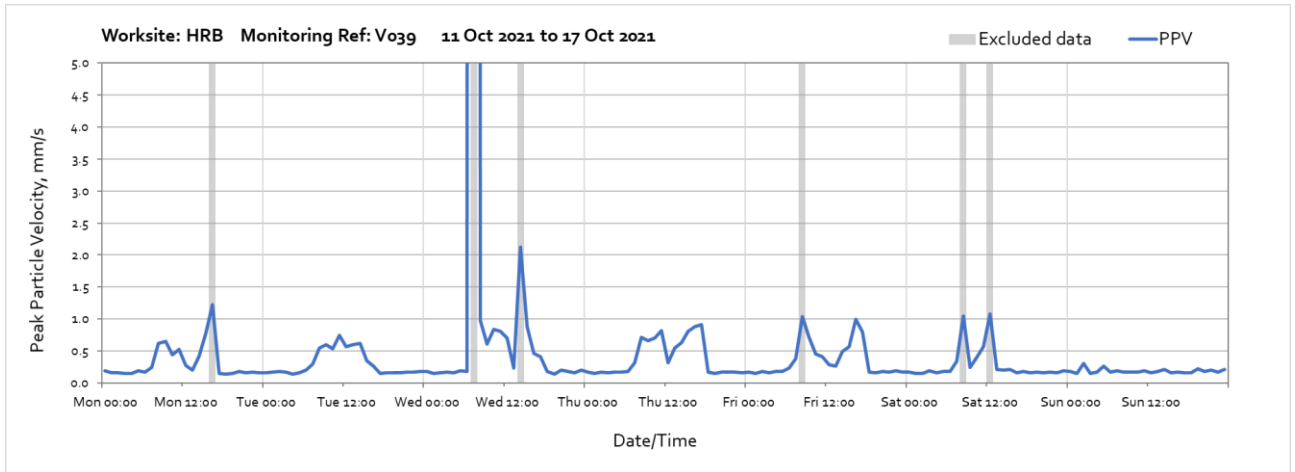
Note: High vibraton levels measured throughout the week were due to local interference of the monitor and are not representative of HS2 vibration levels at the receptor

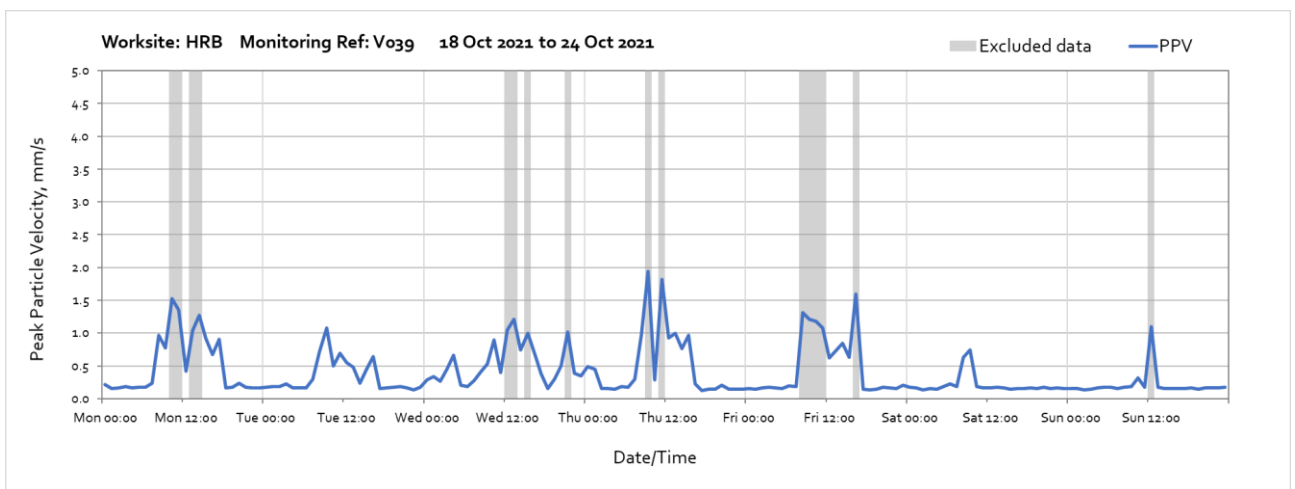
Note: High vibraton levels measured throughout the week were due to local interference of the monitor and are not representative of HS2 vibration levels at the receptor

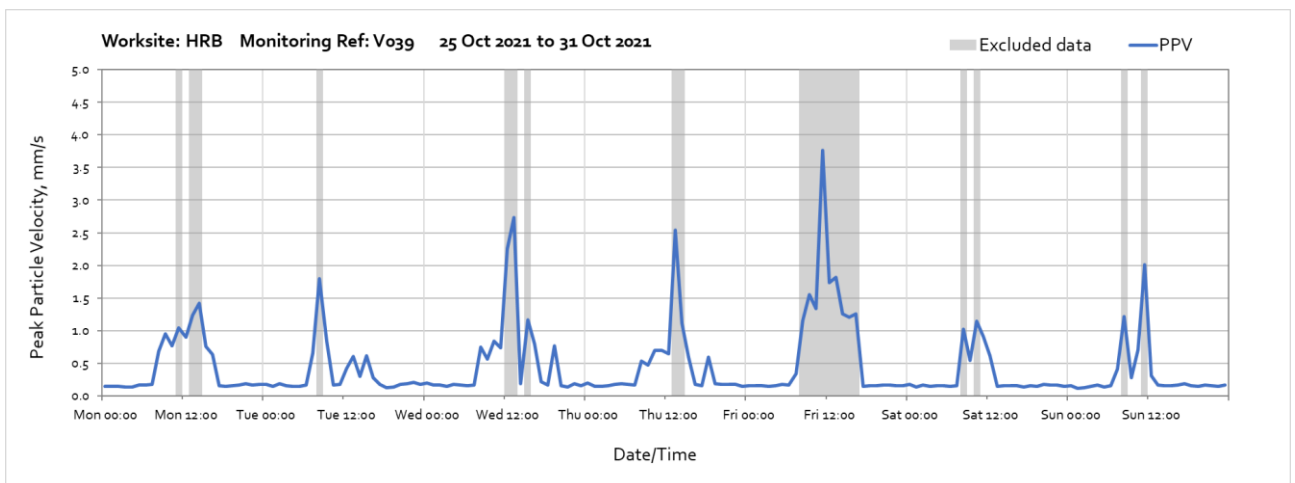
Note: High vibration levels measured throughout the week were due to local interference of the monitor and are not representative of HS2 vibration levels at the receptor

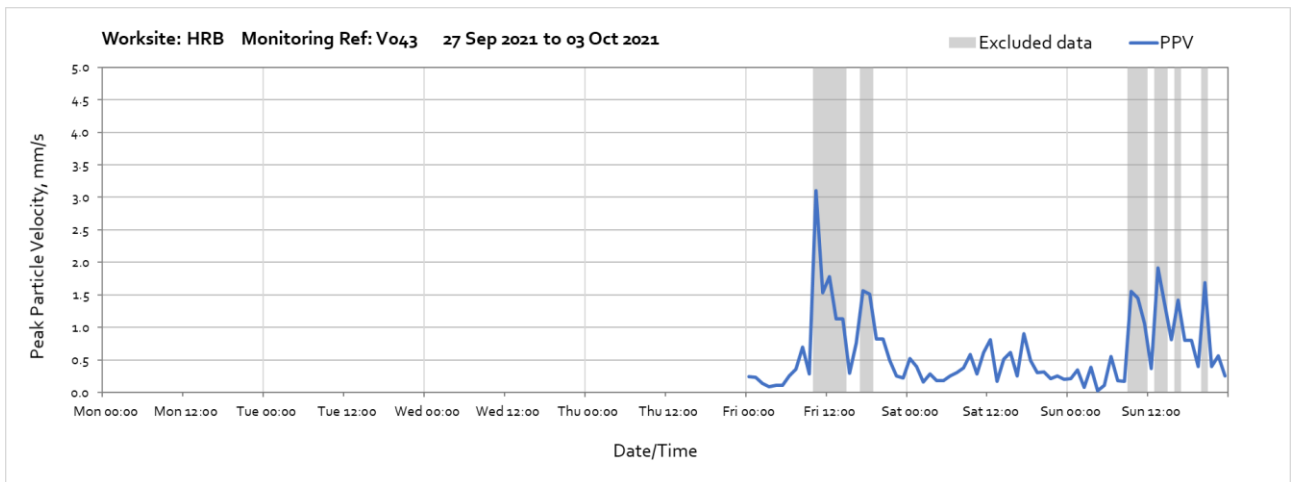
## Worksite: HRB – Monitoring Ref: V043

Note: High vibration levels measured throughout the week were due to local interference of the monitor and are not representative of HS2 vibration levels at the receptor.

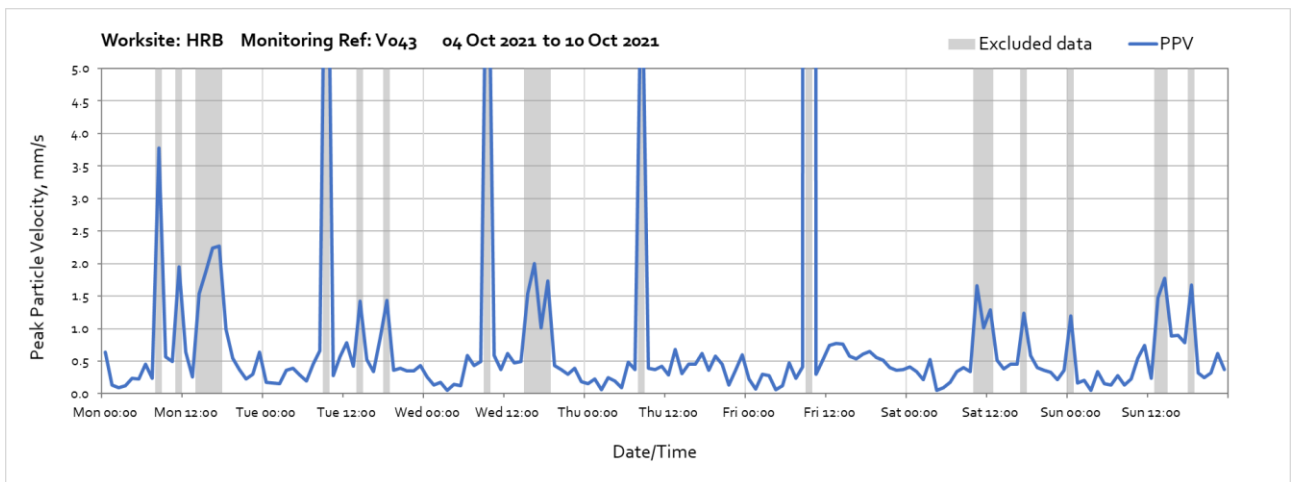
Note: High vibration levels measured throughout the week were due to local interference of the monitor and are not representative of HS2 vibration levels at the receptor.

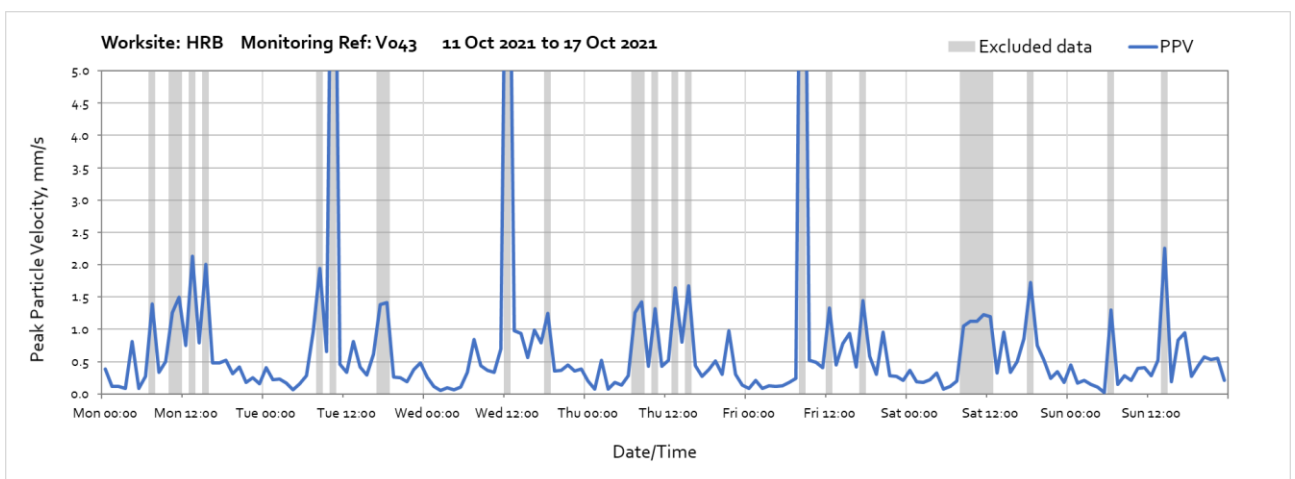
Note: High vibration levels measured throughout the week were due to local interference of the monitor and are not representative of HS2 vibration levels at the receptor.

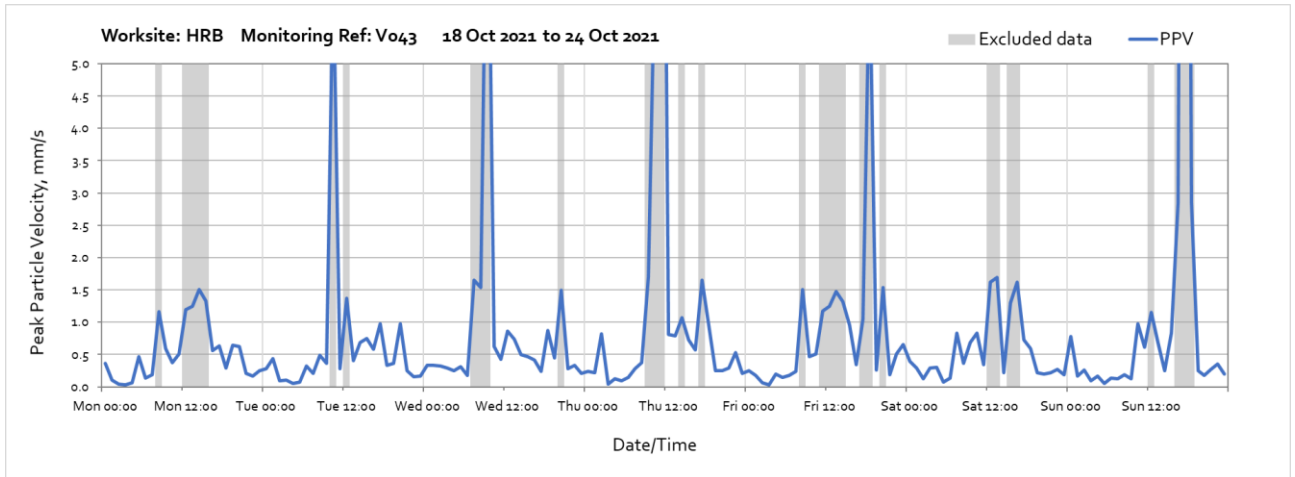
Note: High vibration levels measured throughout the week were due to local interference of the monitor and are not representative of HS2 vibration levels at the receptor.

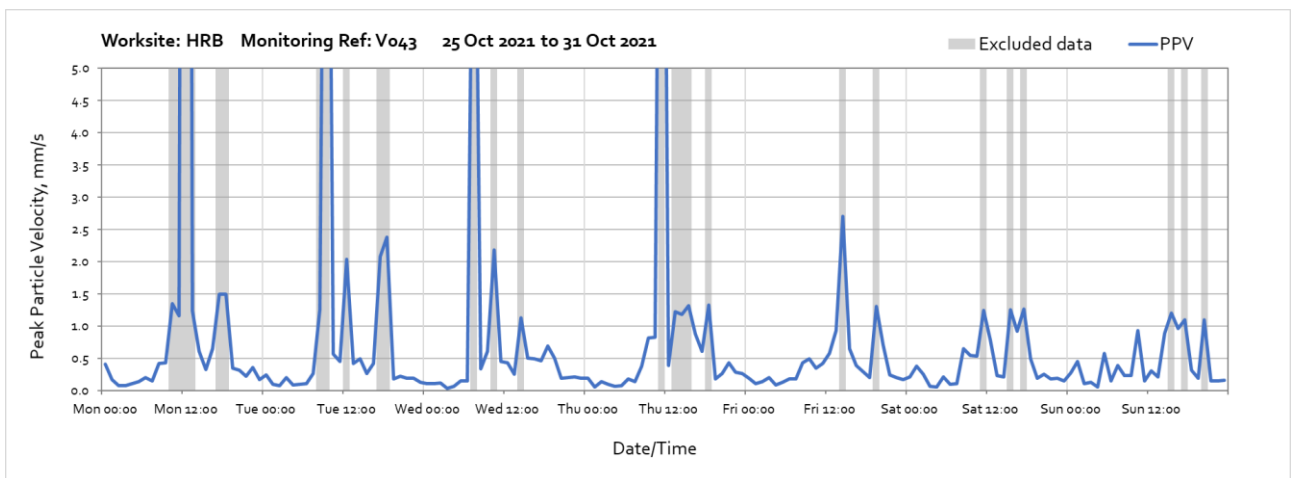
Note: High vibration levels measured throughout the week were due to local interference of the monitor and are not representative of HS2 vibration levels at the receptor.

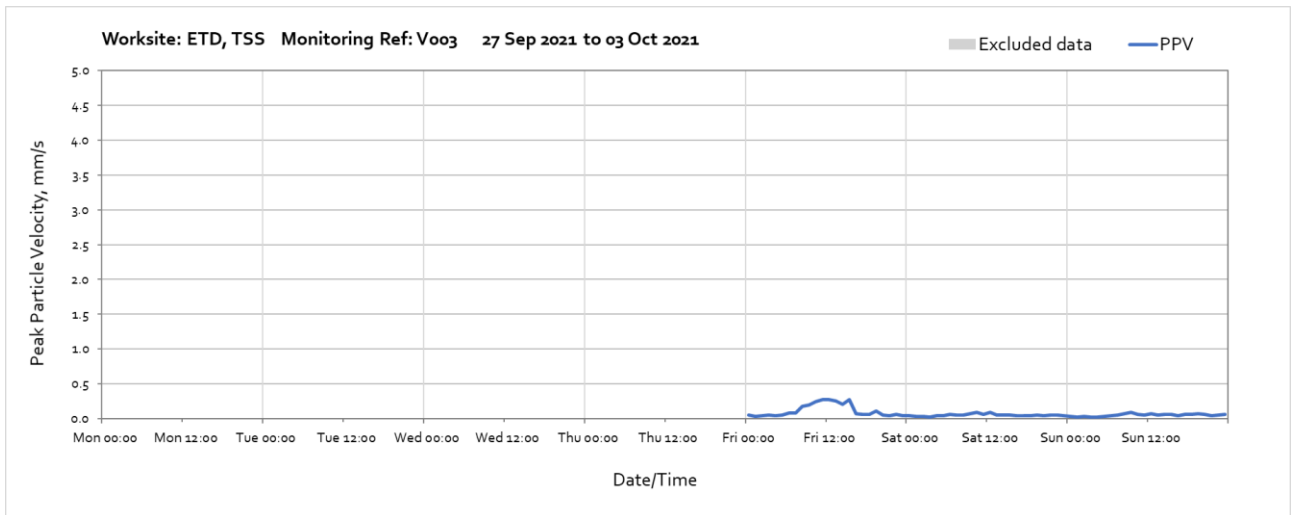
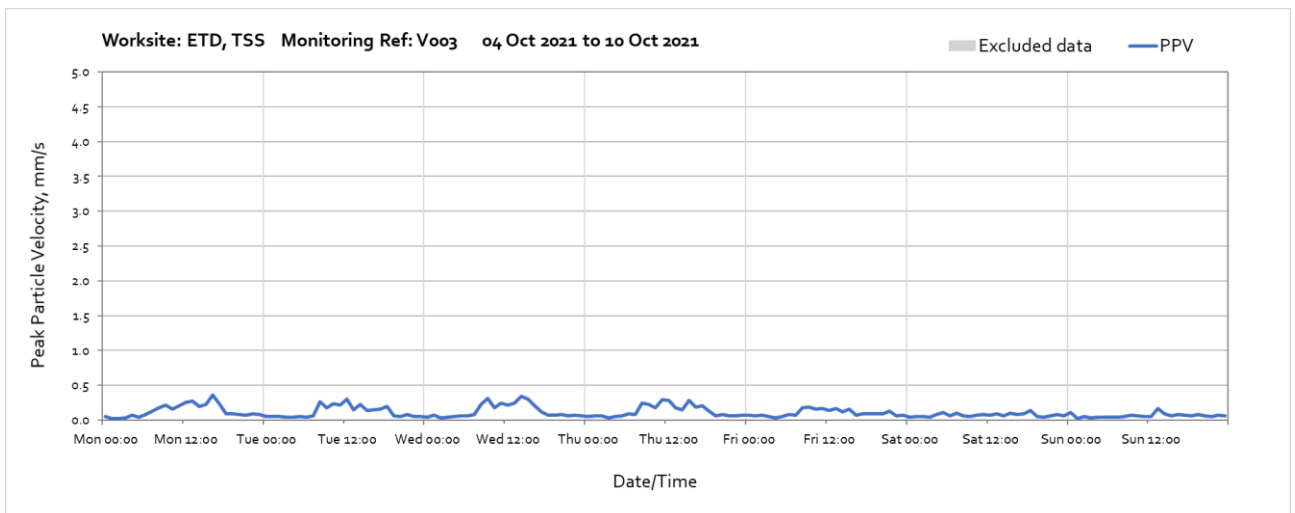
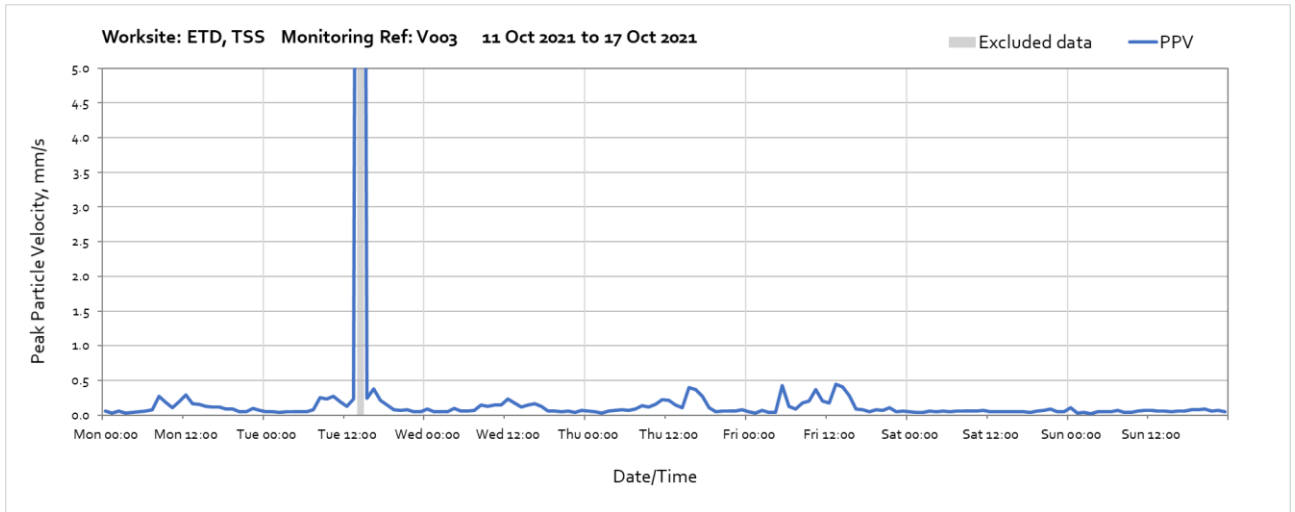
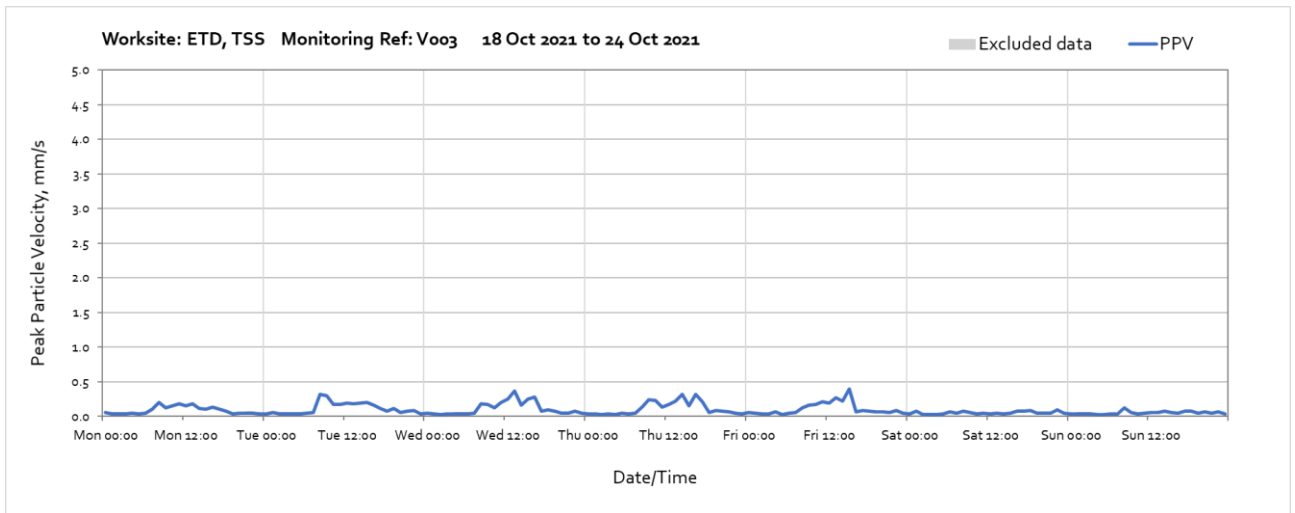
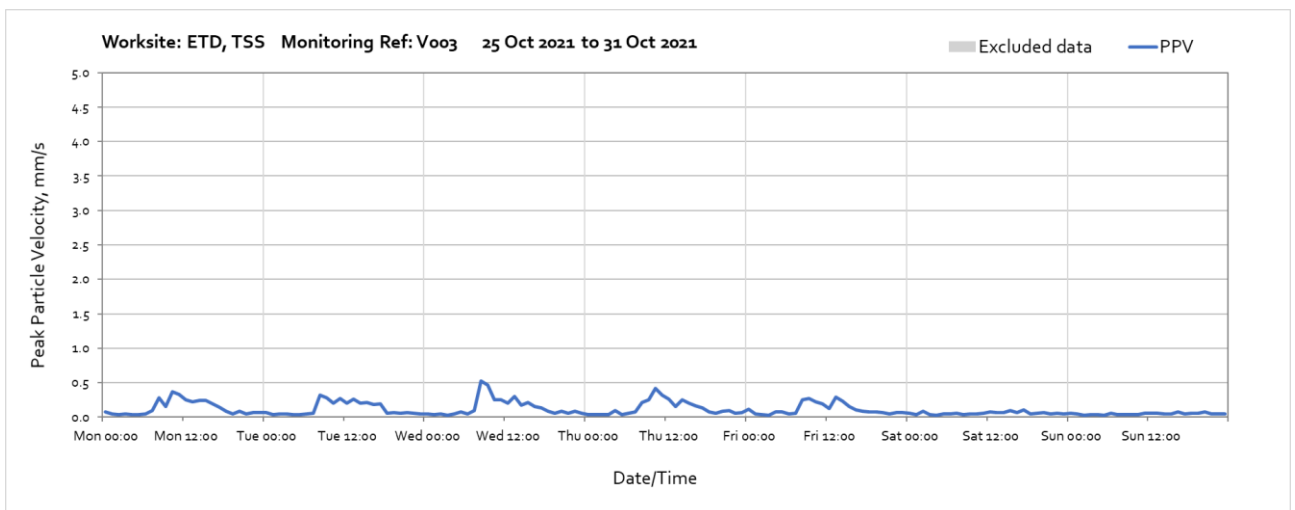
**Worksite: ETD – Monitoring Ref: V003**

Note: High vibration levels measured at 14:00 on Tuesday 12<sup>th</sup> October were due to local interference of the monitor and are not representative of HS2 vibration levels at the receptor.
