## **Construction noise and vibration Monthly Report – October 2021**

### **London Borough of Camden**

# Non-Technical Summary

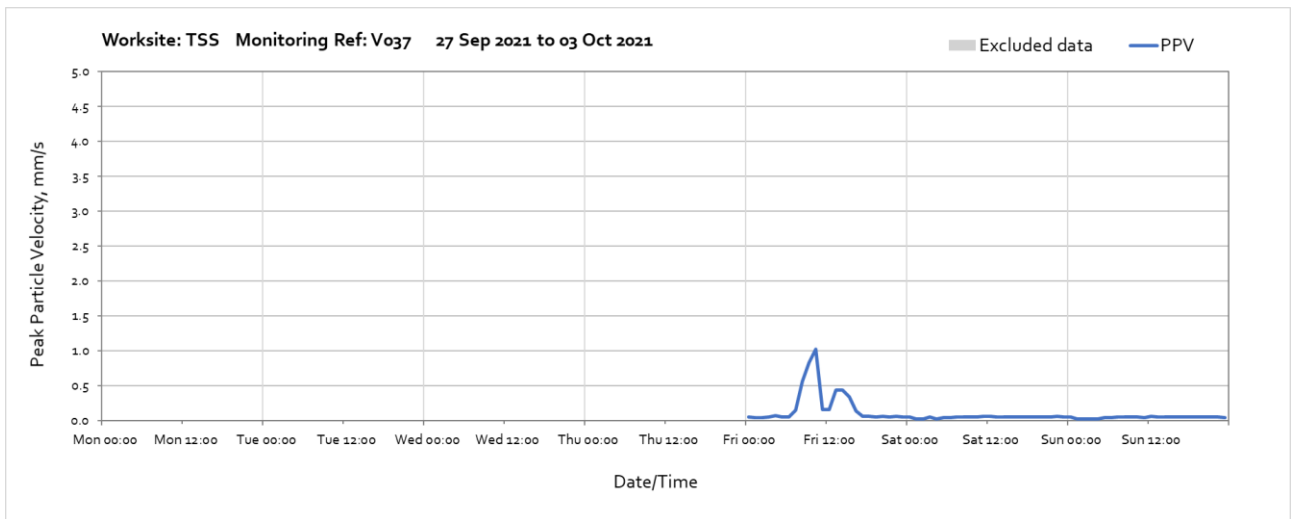
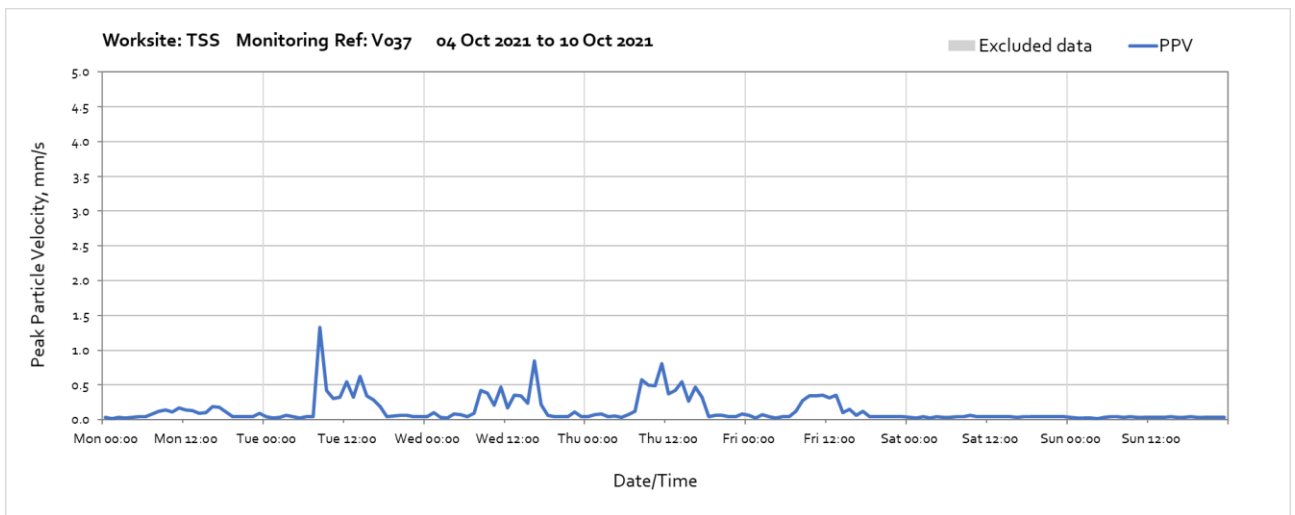
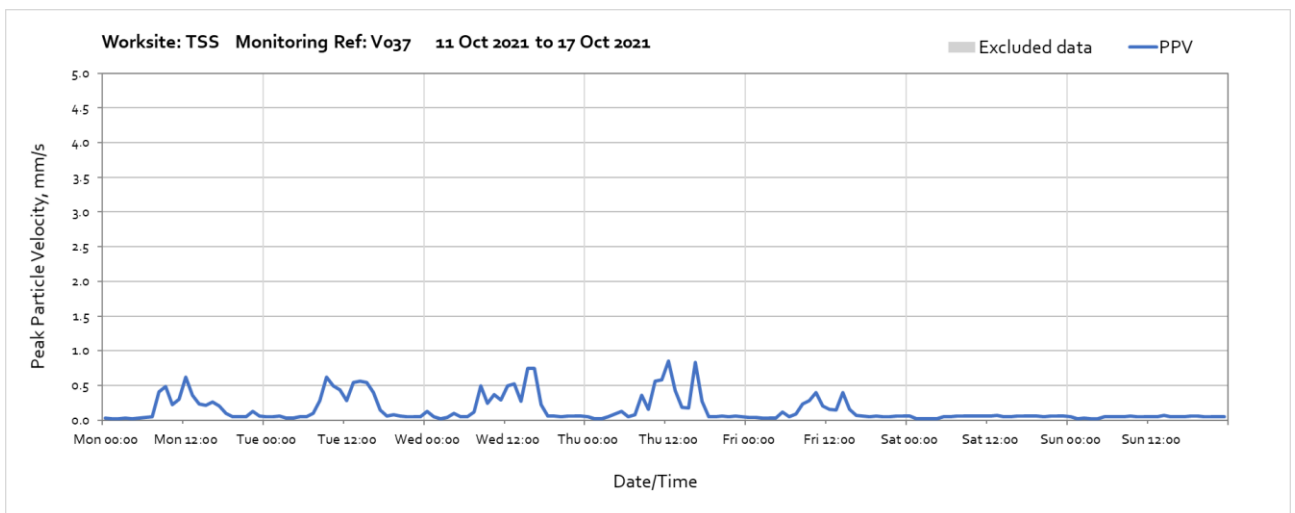
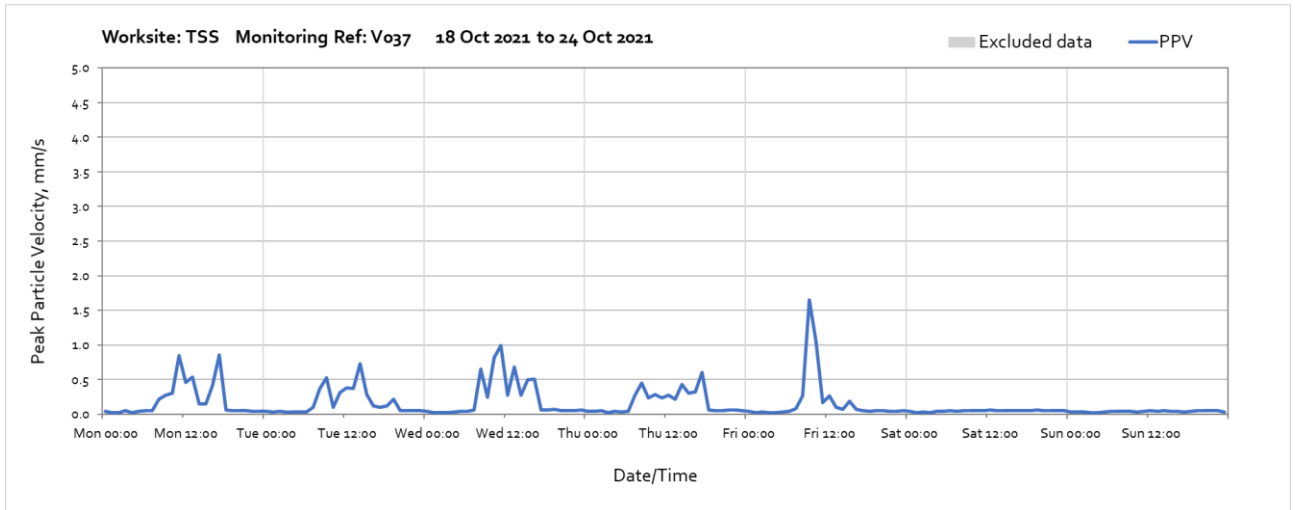
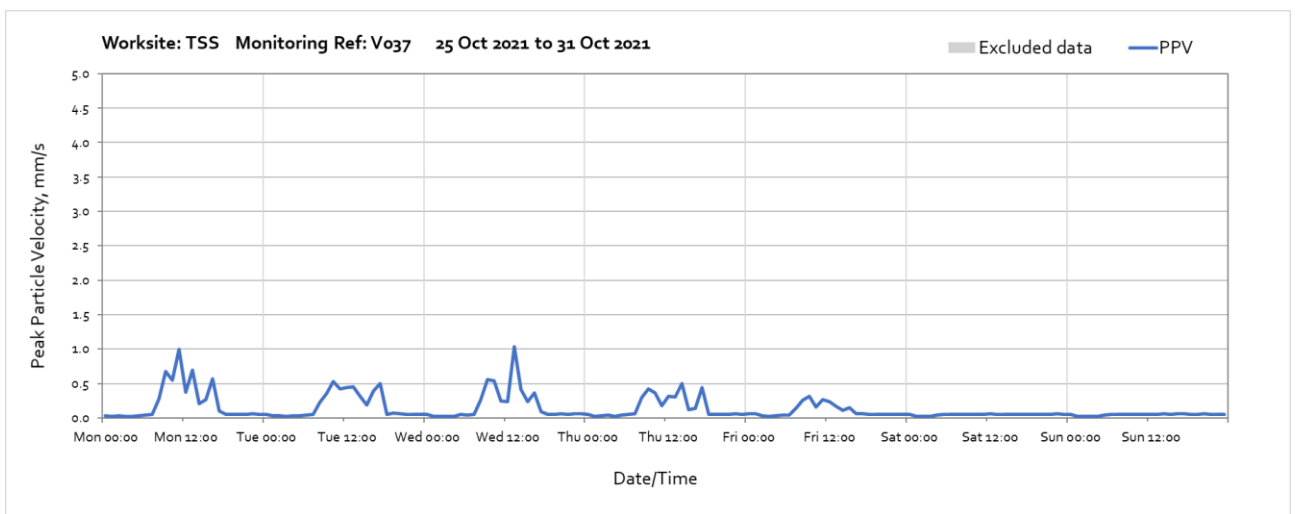
## Worksite: TSS - Monitoring Ref: V037

The following graphs show the hourly measured peak particle velocity PPV recorded during the monitoring period. The graphs show the resultant PPV due to vibration components on three orthogonal axes x, y and z. Where resultant PPV data is not available (monitors V039 and V043), the highest vibration component in either of the three axes is presented for each 1hr measurement period respectively. Where high values of PPV were caused by local interference with the vibration monitor, which are not representative of HS2 construction works, these values have been greyed out in the following charts and have been excluded to calculate values in Table 4 of the main report.

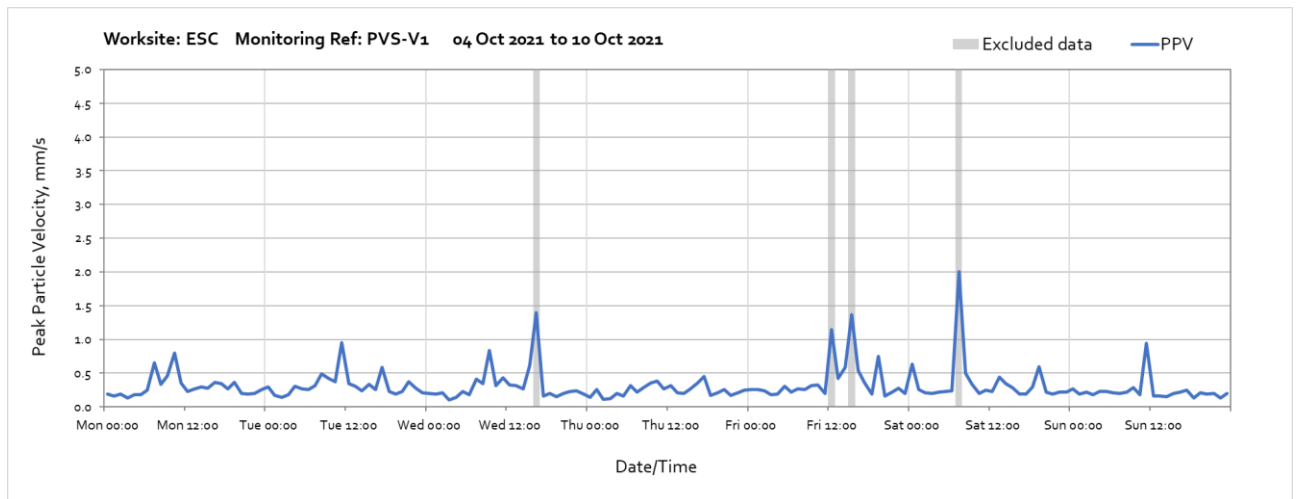
## Worksite: ESC – Monitoring Ref: PVS-V1

Note: High vibration levels measured throughout the week were due to local interference of the monitor and are not representative of HS2 vibration levels at the receptor.

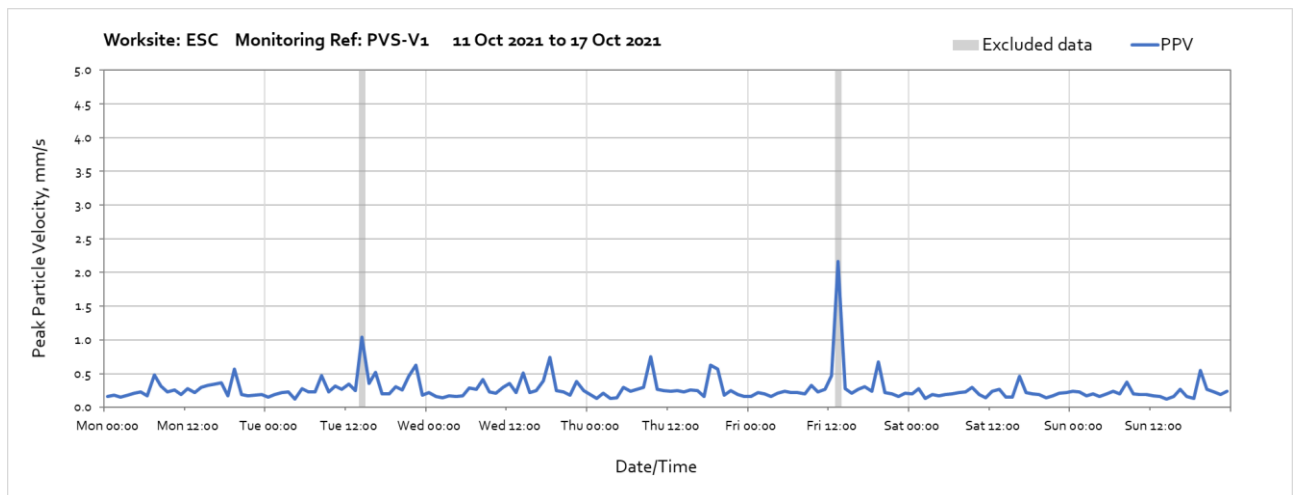
Note: High vibration levels measured throughout the week were due to local interference of the monitor and are not representative of HS2 vibration levels at the receptor.

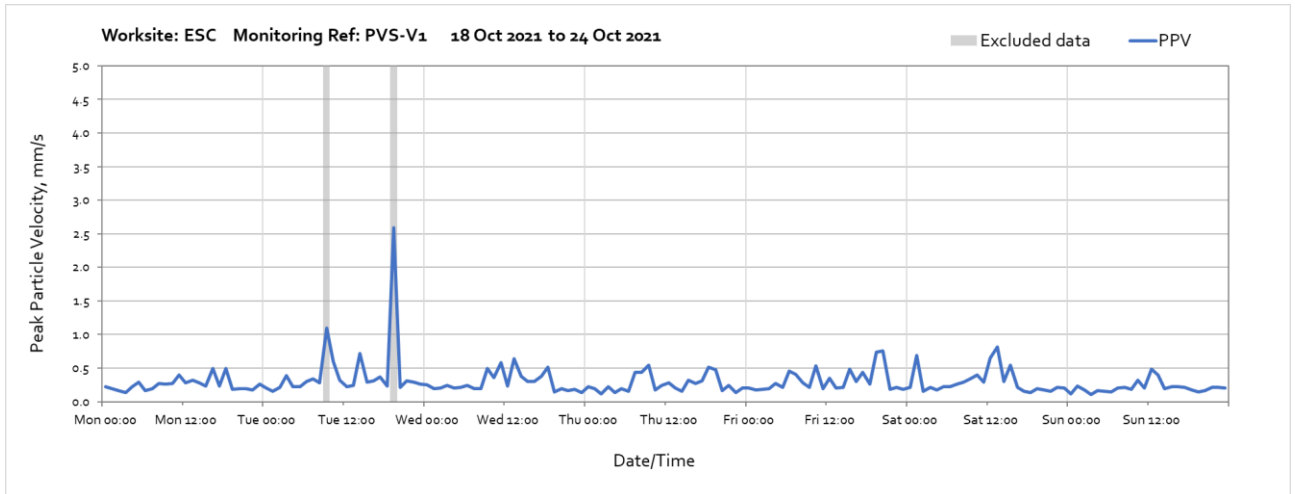
Note: High vibration levels measured throughout the week were due to local interference of the monitor and are not representative of HS2 vibration levels at the receptor.

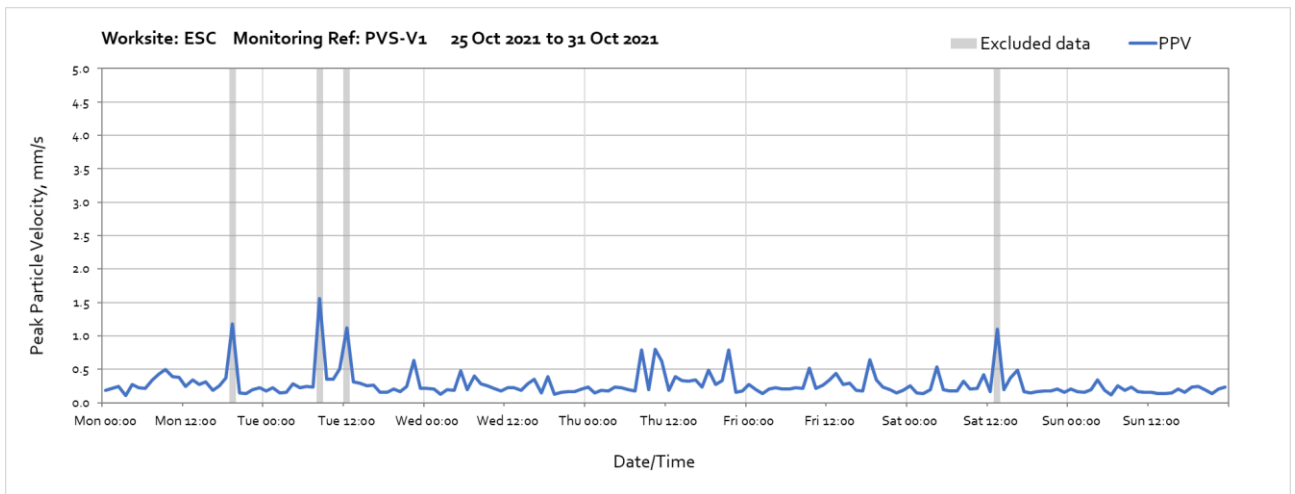
Note: High vibration levels measured throughout the week were due to local interference of the monitor and are not representative of HS2 vibration levels at the receptor.

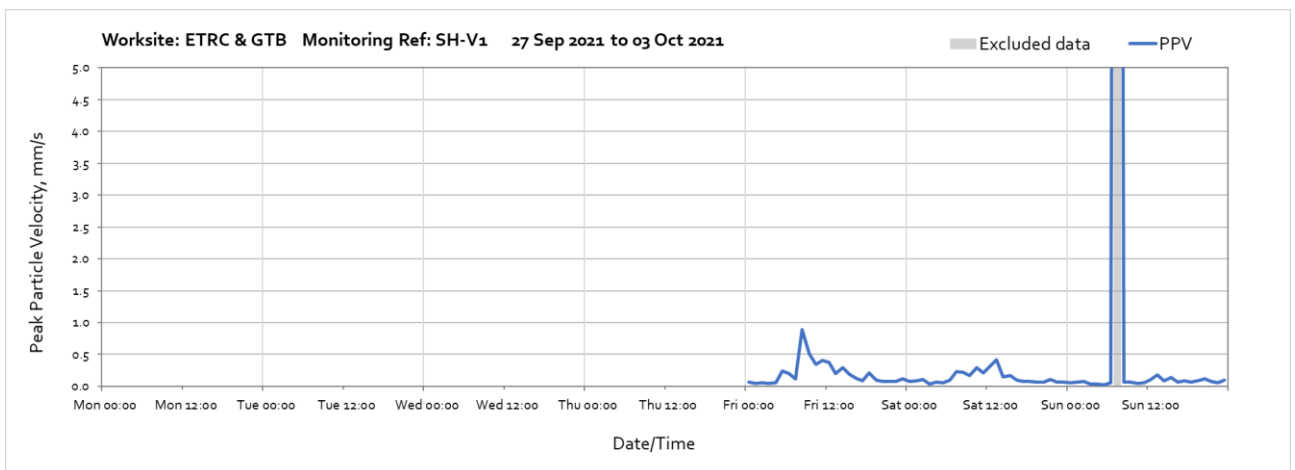
**Worksite: ETRC & GTB – Monitoring Ref: SH-V1**

Note: High vibration levels measured at 07:00 on Sunday 3<sup>rd</sup> October were due to local interference of the monitor and are not representative of HS2 vibration levels at the receptor.

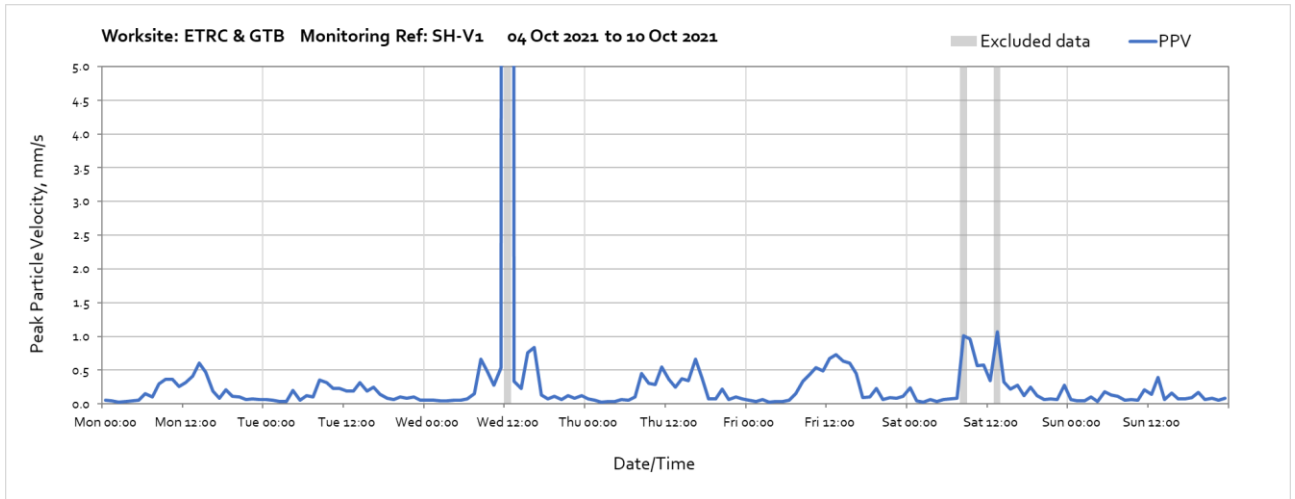
Note: High vibration levels measured throughout the week were due to local interference of the monitor and are not representative of HS2 vibration levels at the receptor.

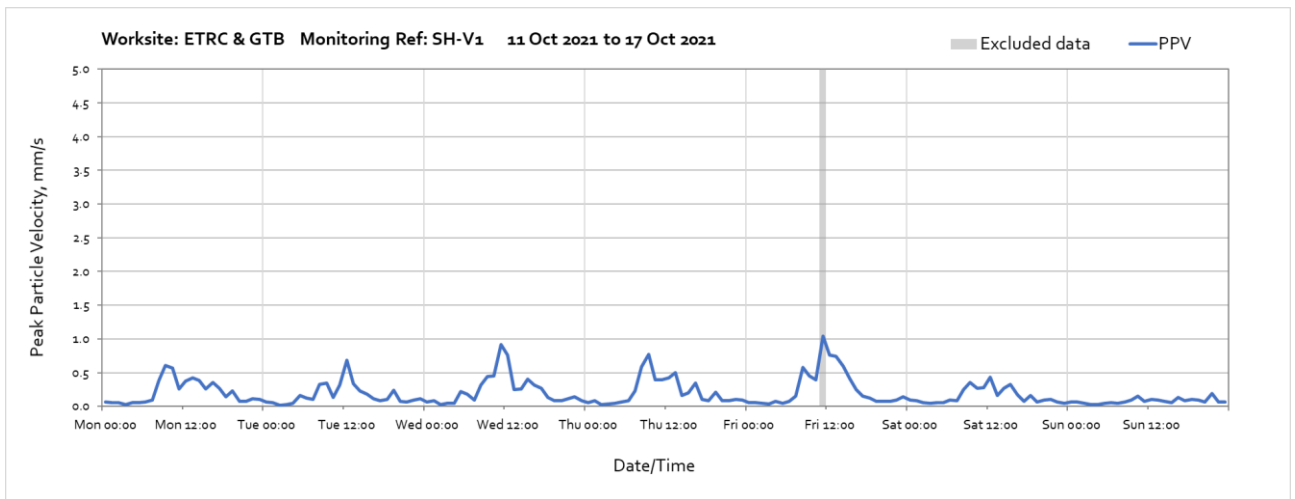
Note: High vibration levels measured at 11:00 on Friday 15<sup>th</sup> October were due to local interference of the monitor and are not representative of HS2 vibration levels at the receptor.

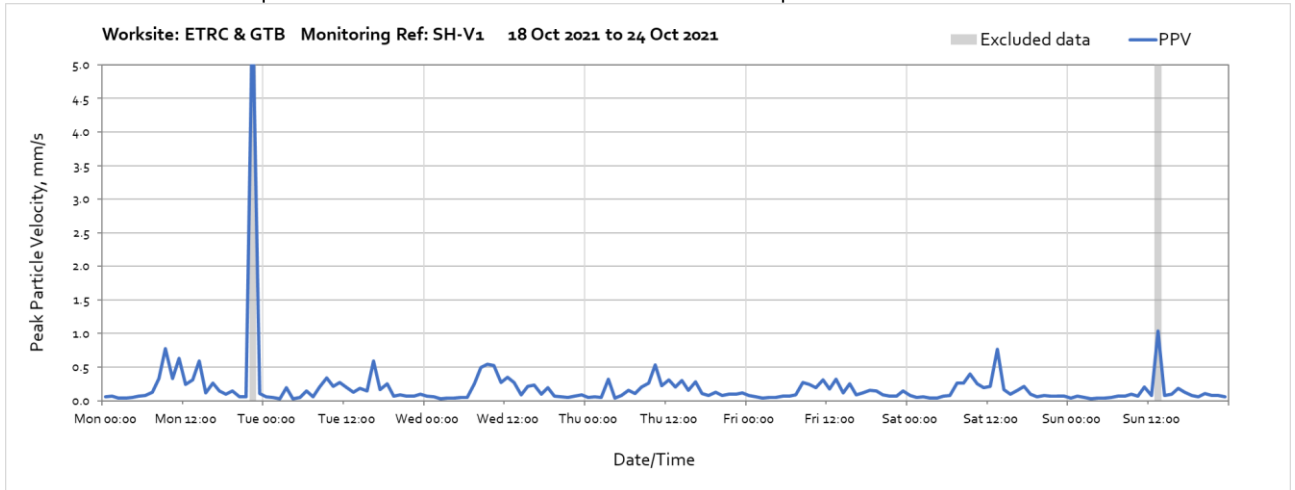
Note: High vibration levels measured throughout the week were due to local interference of the monitor and are not representative of HS2 vibration levels at the receptor.

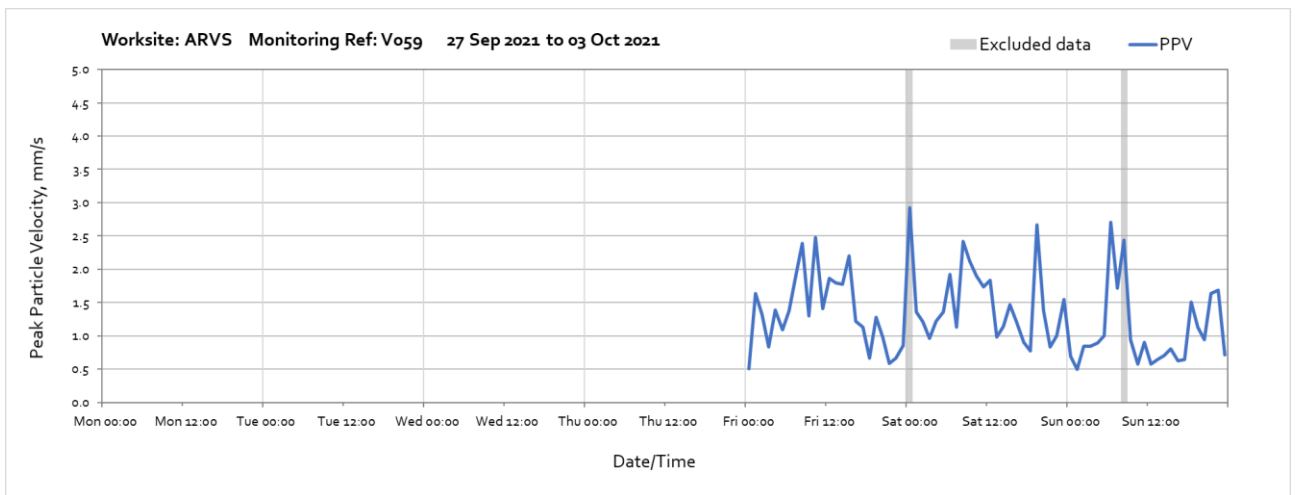
**Worksite: ARVS – Monitoring Ref: V059**

Note: High vibration levels measured at 00:00 on Saturday 2<sup>nd</sup> October and at 08:00 on Sunday 3<sup>rd</sup> October were due to local interference of the monitor and are not representative of HS2 vibration levels at the receptor.

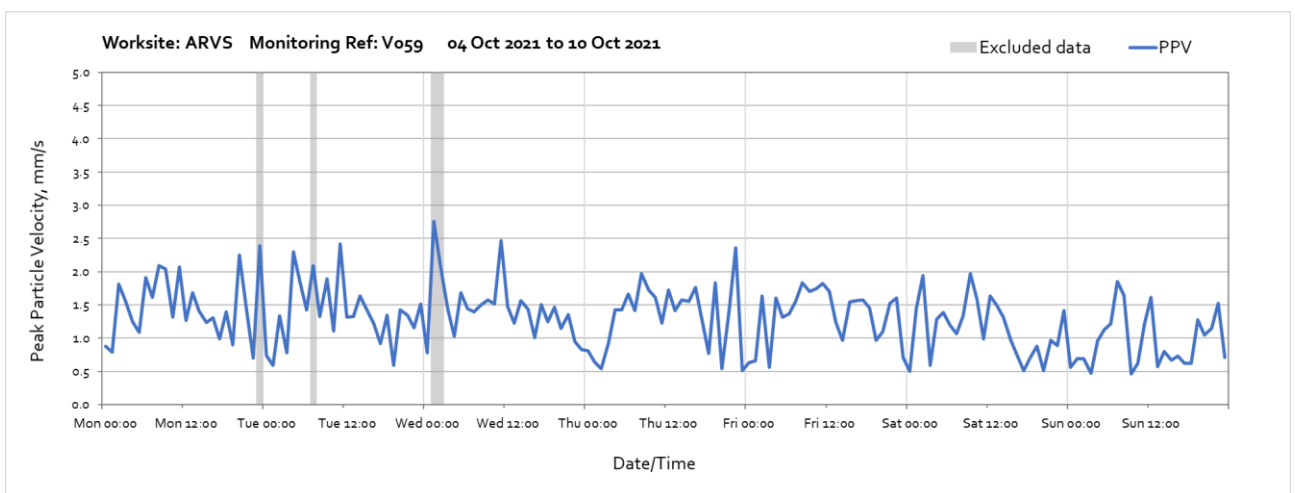
Note: High vibration levels measured at 23:00 on Monday 4<sup>th</sup> October, at 07:00 on Tuesday 5<sup>th</sup> October and at 02:00 on Wednesday 6<sup>th</sup> October were due to local interference of the monitor and are not representative of HS2 vibration levels at the receptor.

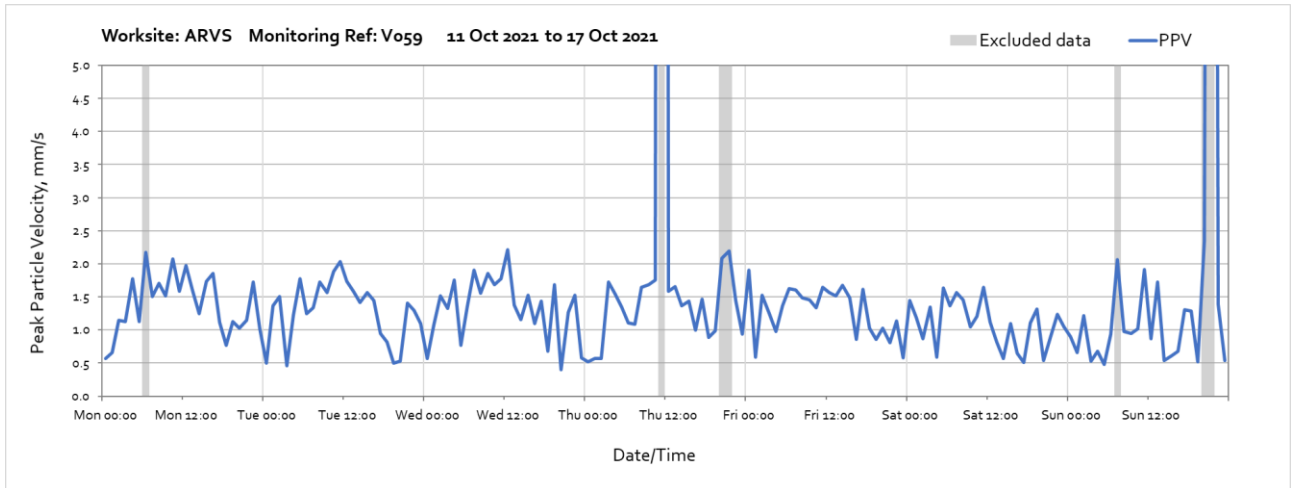
Note: High vibration levels measured throughout the week were due to local interference of the monitor and are not representative of HS2 vibration levels at the receptor.

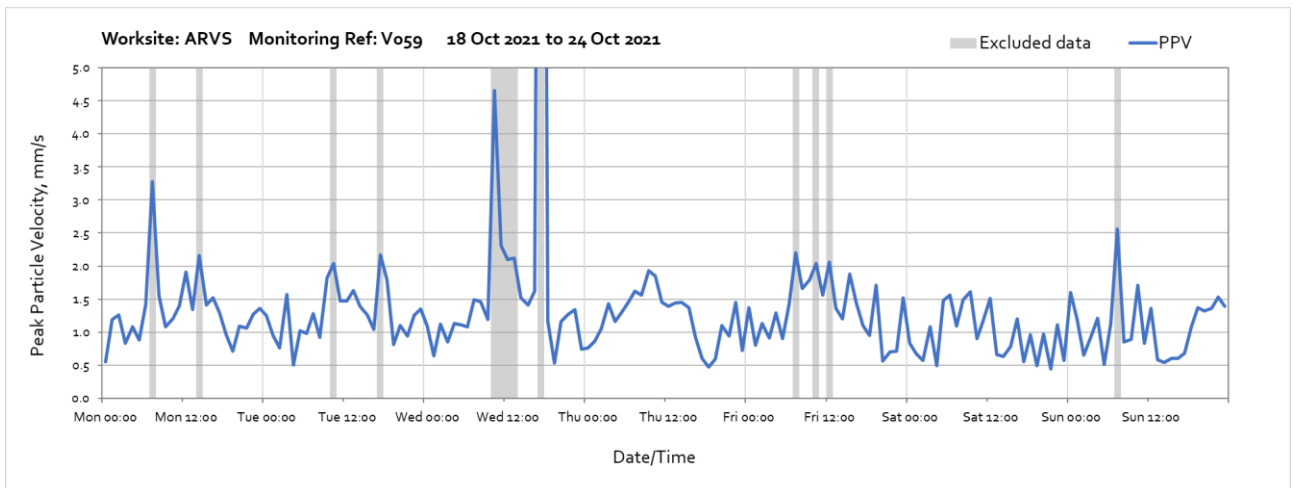
Note: High vibration levels measured throughout the week were due to local interference of the monitor and are not representative of HS2 vibration levels at the receptor.

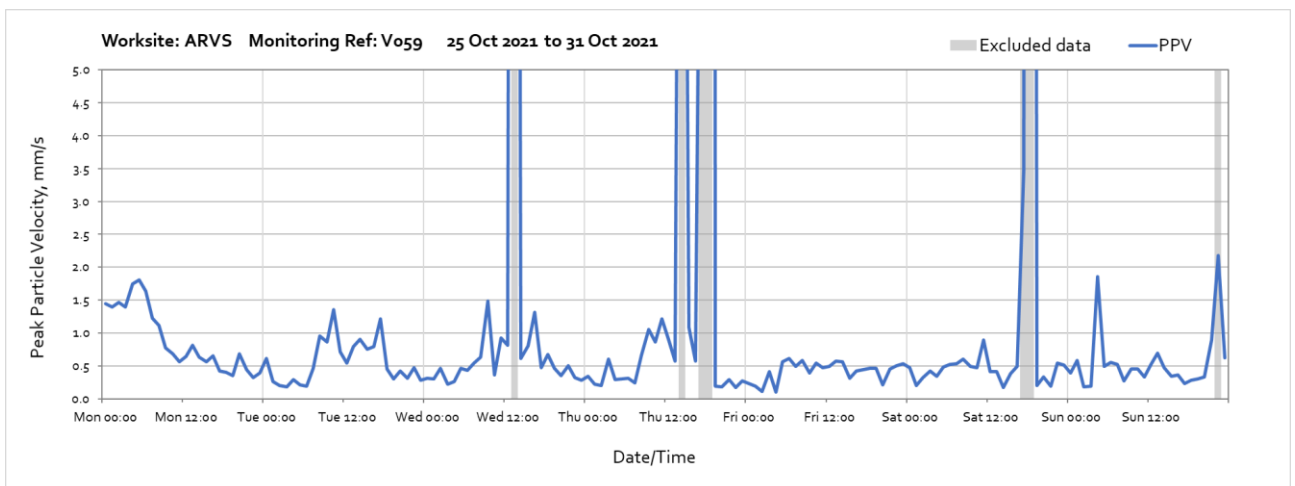
Note: High vibration levels measured throughout the week were due to local interference of the monitor and are not representative of HS2 vibration levels at the receptor.
