## **Construction noise and vibration Monthly Report – October 2021**

**London Borough of Ealing**

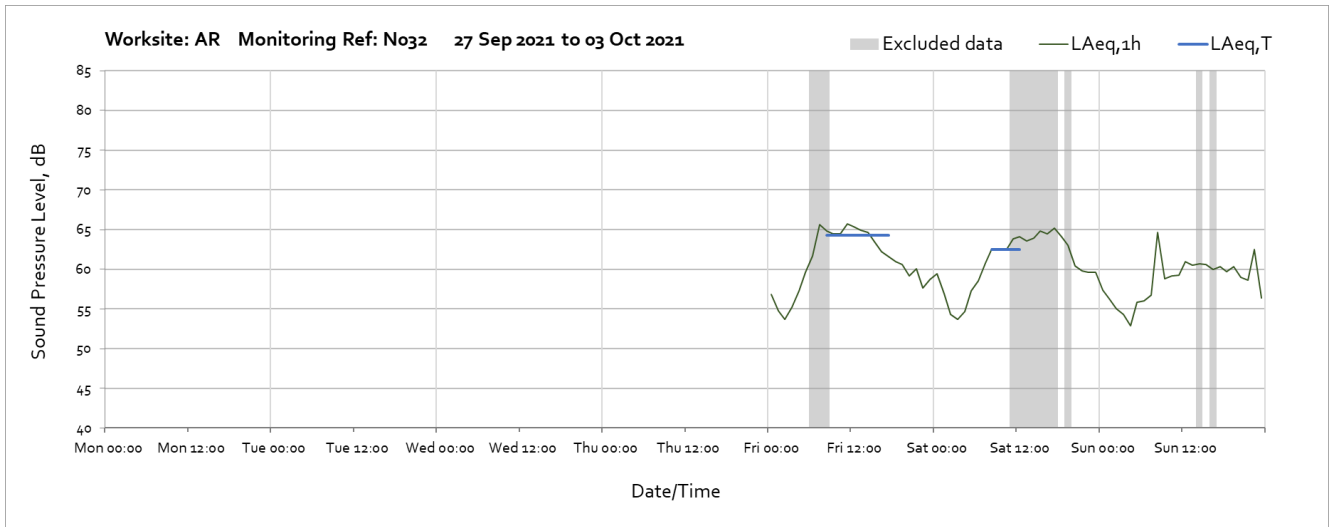
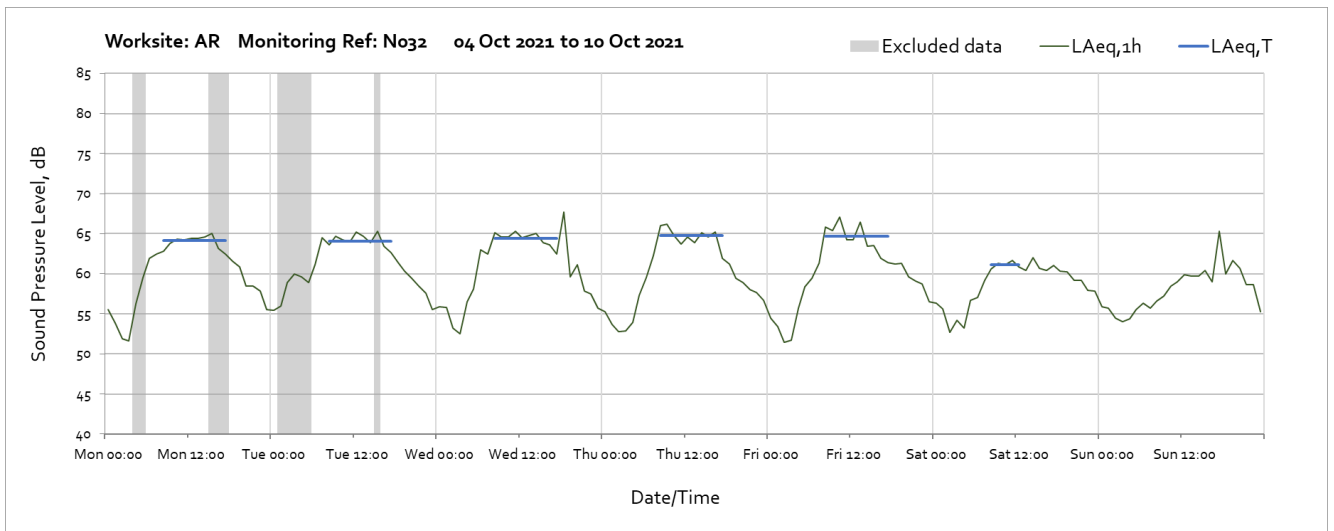
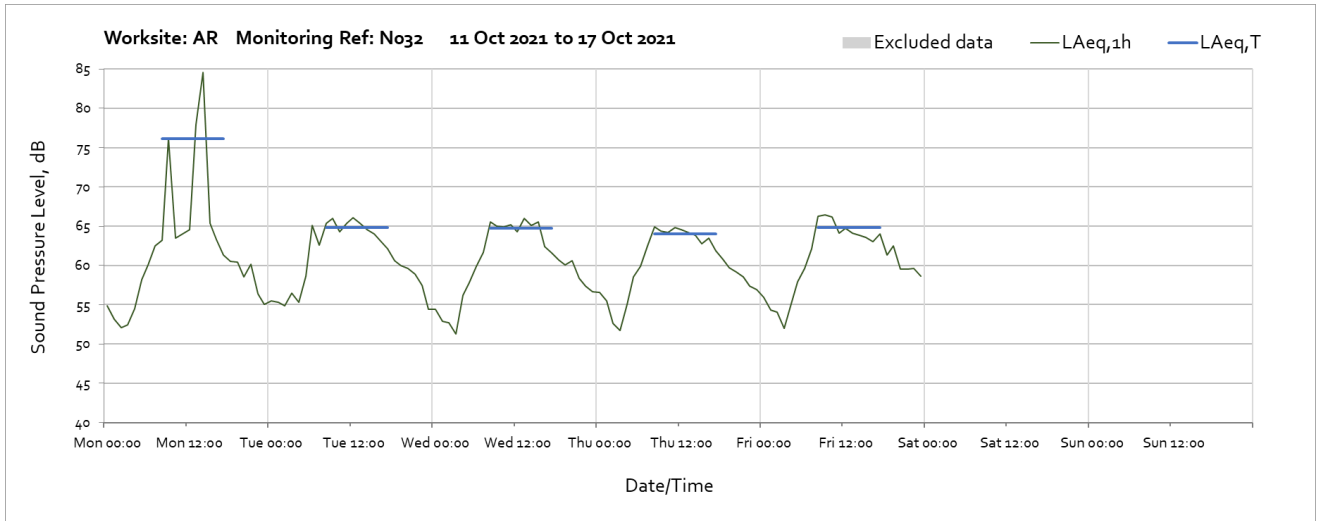
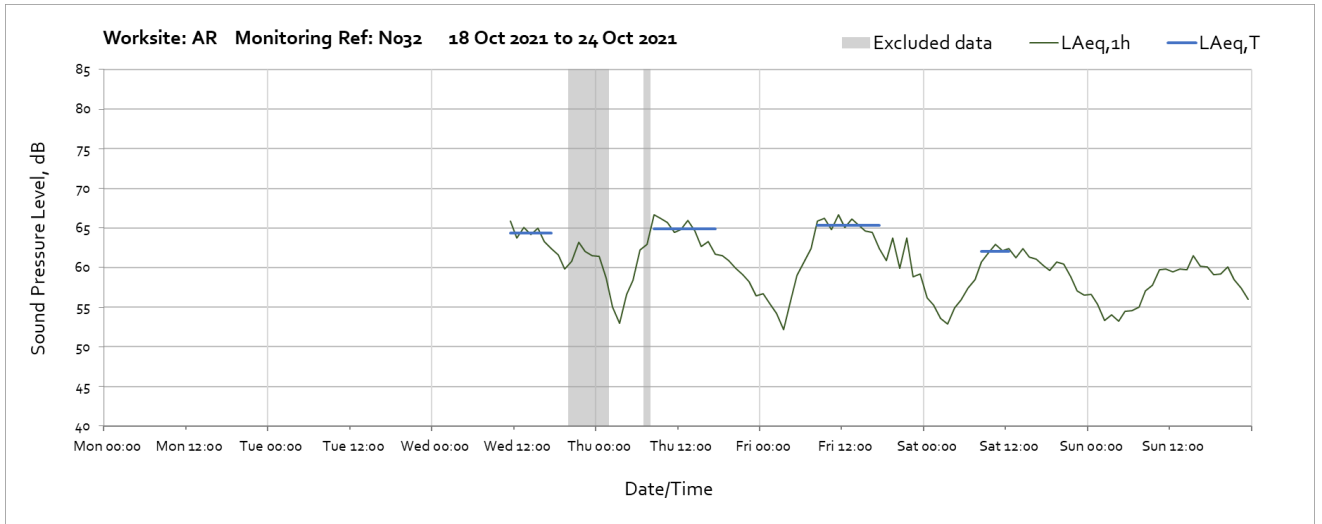
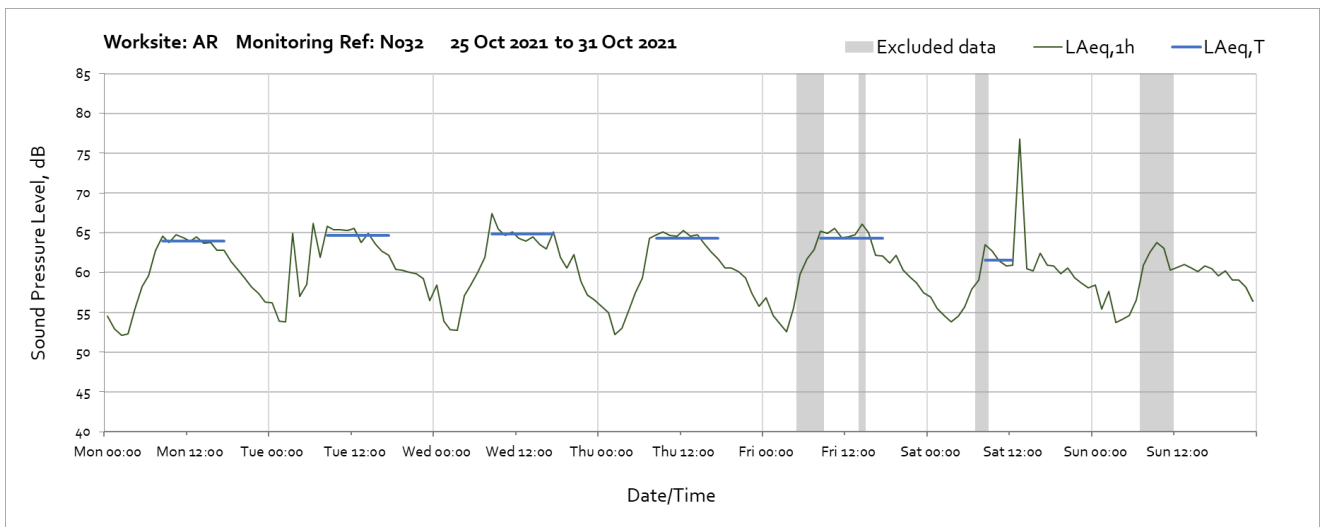
### Worksite: Atlas Road worksite (AR) – Monitoring Ref: N032

The following graphs show the hourly measured ambient noise level  $L_{Aeq,1h}$  and, where relevant, the averaged noise level  $L_{Aeq,T}$  values, where the time period T is as specified in Table 1 of HS2 Information Paper E23. Periods with adversely weather affected noise levels are greyed out and have been excluded from the calculation of the  $L_{Aeq,T}$  values in Table 3 of the main report.

Note: Missing data between 00:00 on Saturday 16<sup>th</sup> October and 11:00 on Wednesday 20<sup>th</sup> October 2021 was due to memory card verification failure at the monitor location.

2.1.3 Appendix C presents graphs of the noise and vibration monitoring data over the month for each of the measurement locations. Noise data presented consists of the hourly  $L_{Aeq}$  values and, where relevant, the  $L_{Aeq,T}$  values (where the time period T has been taken to be the averaging period as specified in Table 1 of HS2 Information Paper E23). Vibration data presented consist of hourly PPV values. The full data set for the monitoring equipment can be found at the following location: <https://data.gov.uk/dataset/24542ae7-dd44-444f-b259-871c4cc43b5e/environmental-monitoring-data>.

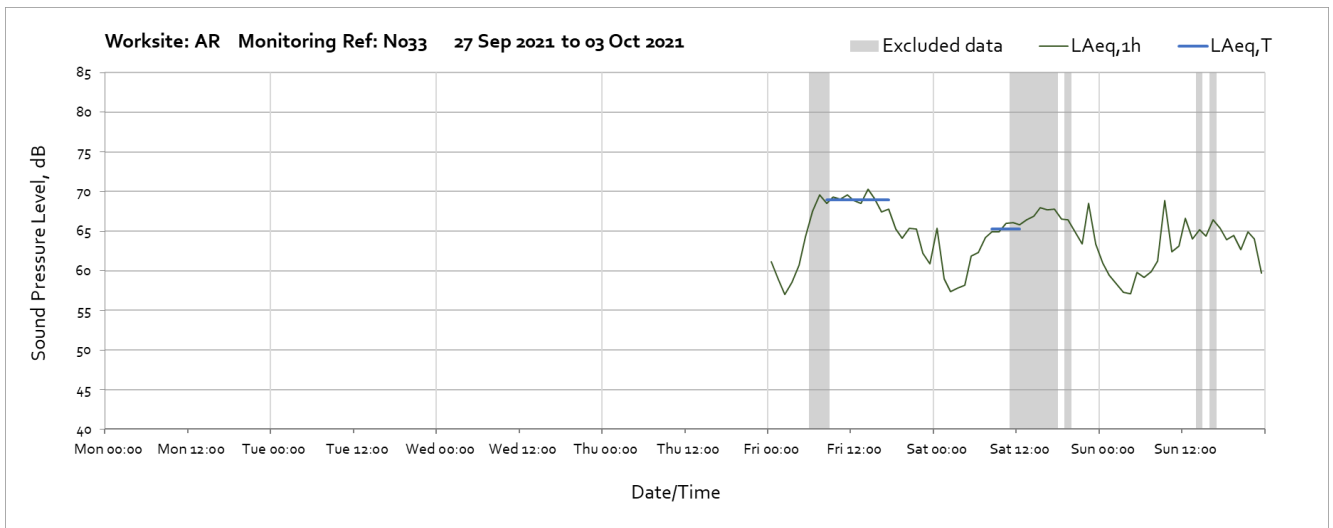
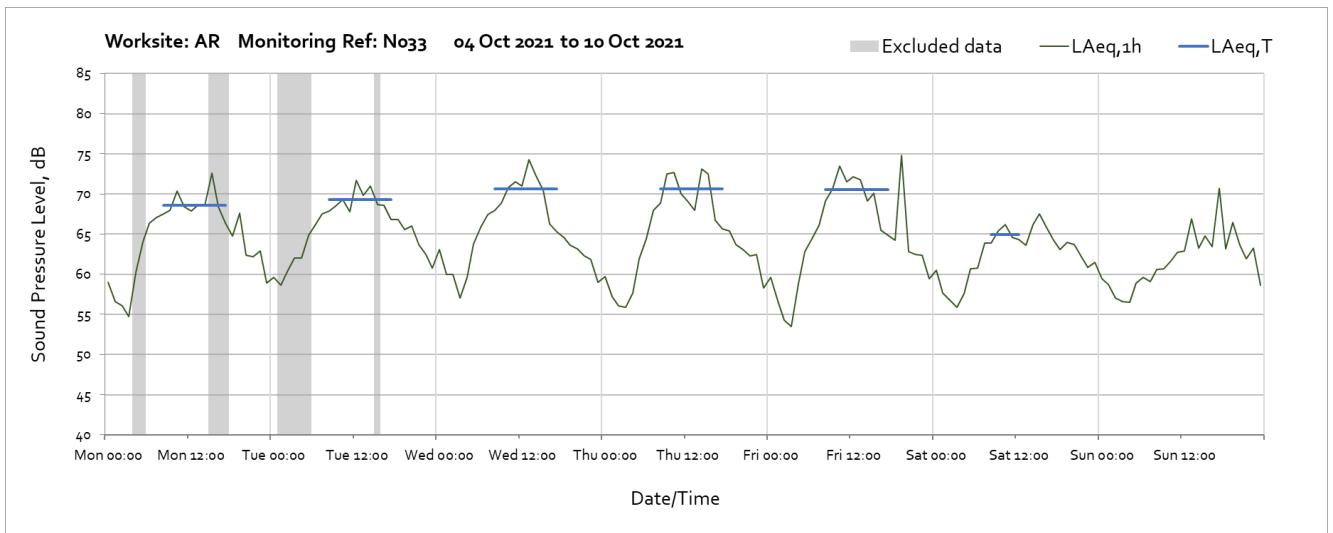
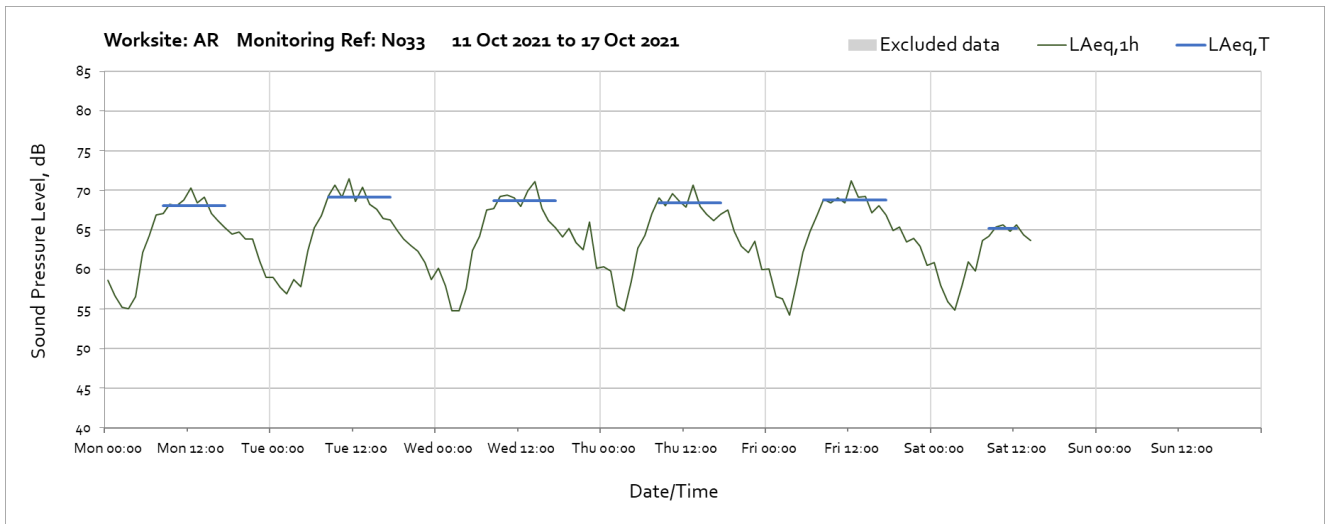
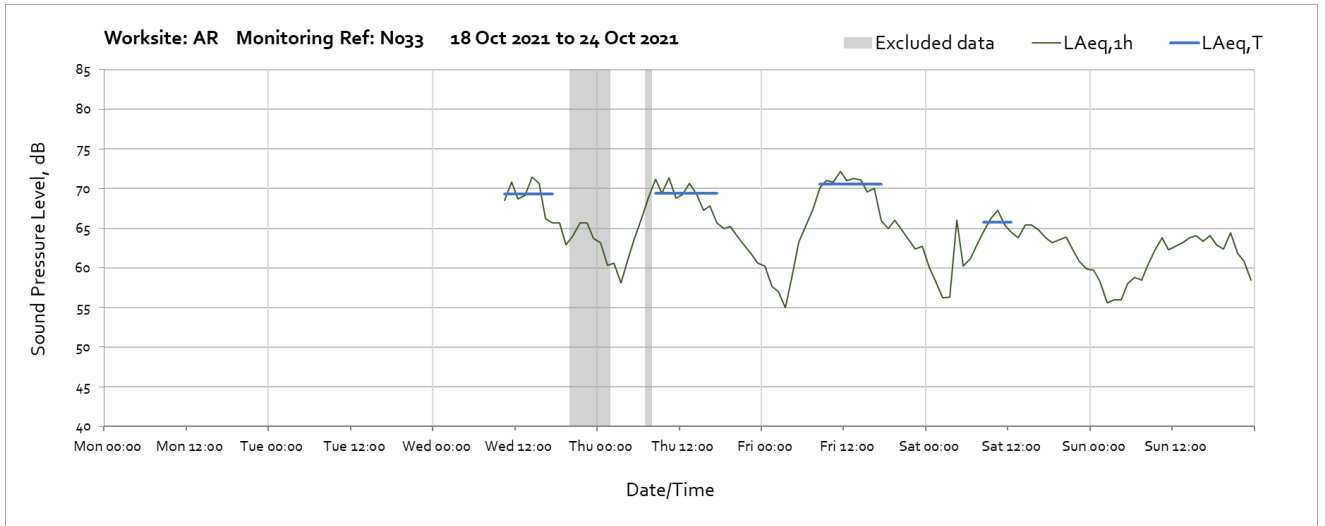
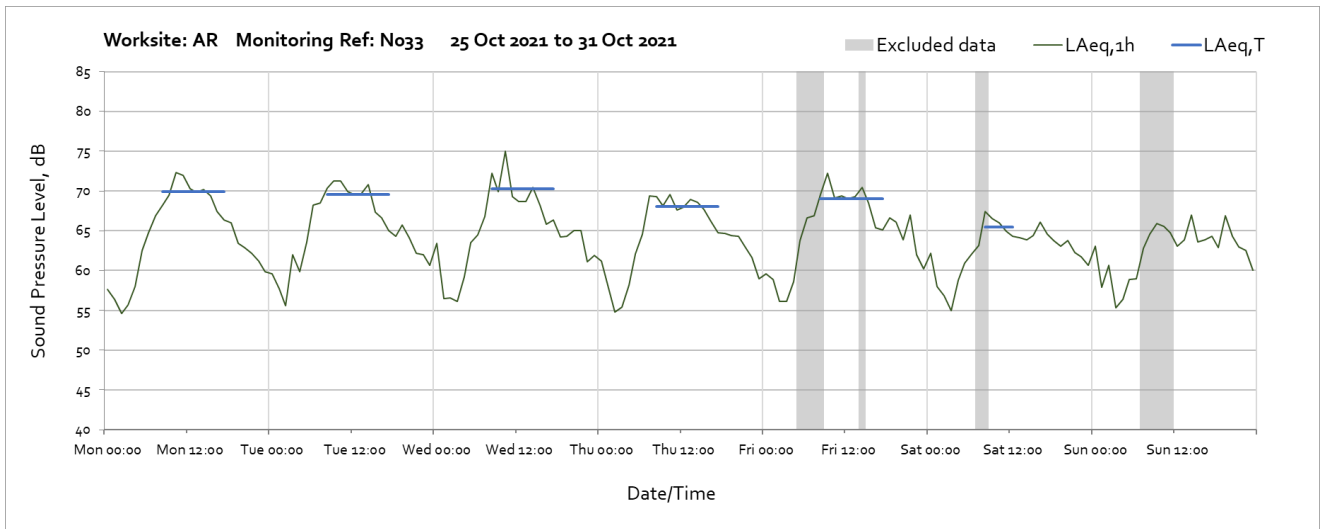
## Worksite: Atlas Road worksite (AR) – Monitoring Ref: N033

Note: Missing data between 15:00 on Saturday 16<sup>th</sup> October and 10:00 on Wednesday 20<sup>th</sup> October 2021 was due to memory card error and failure at the monitor location.

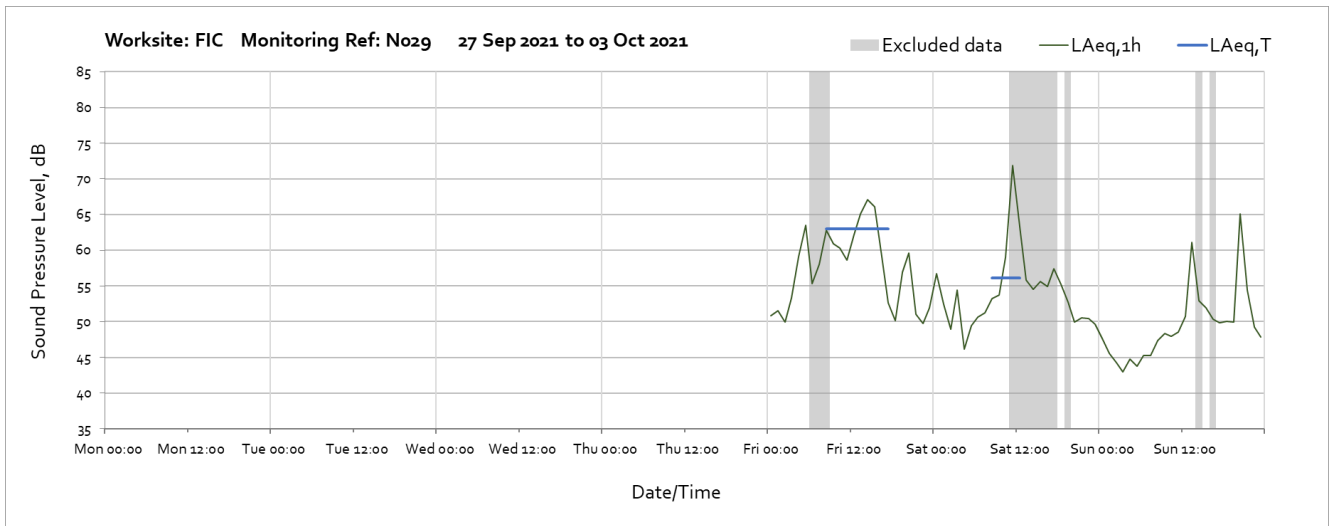
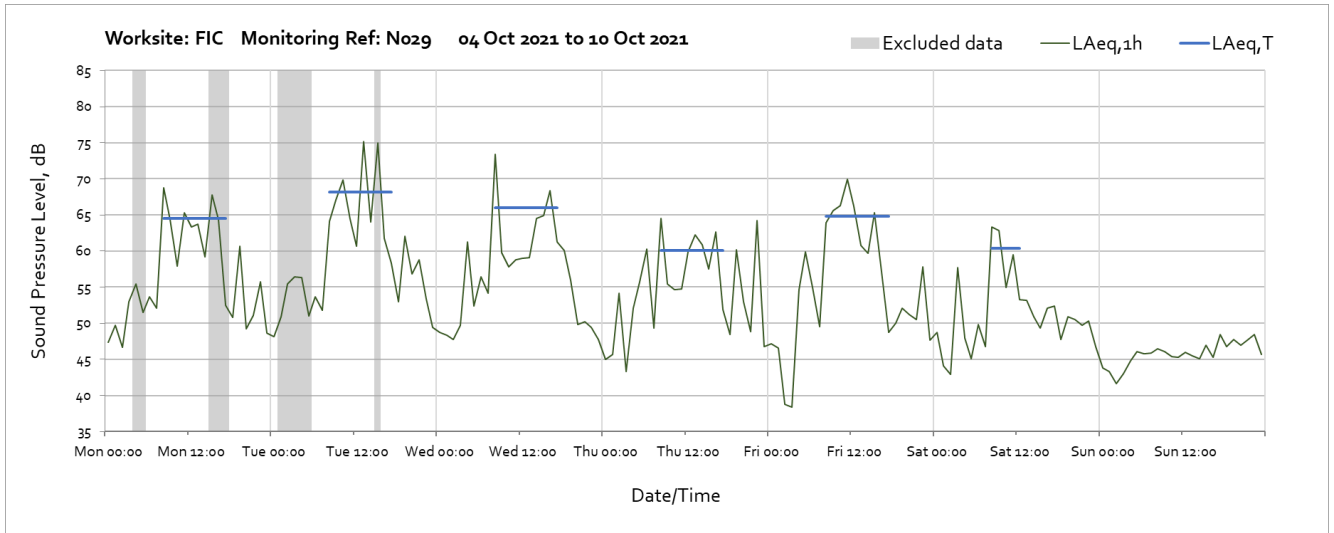
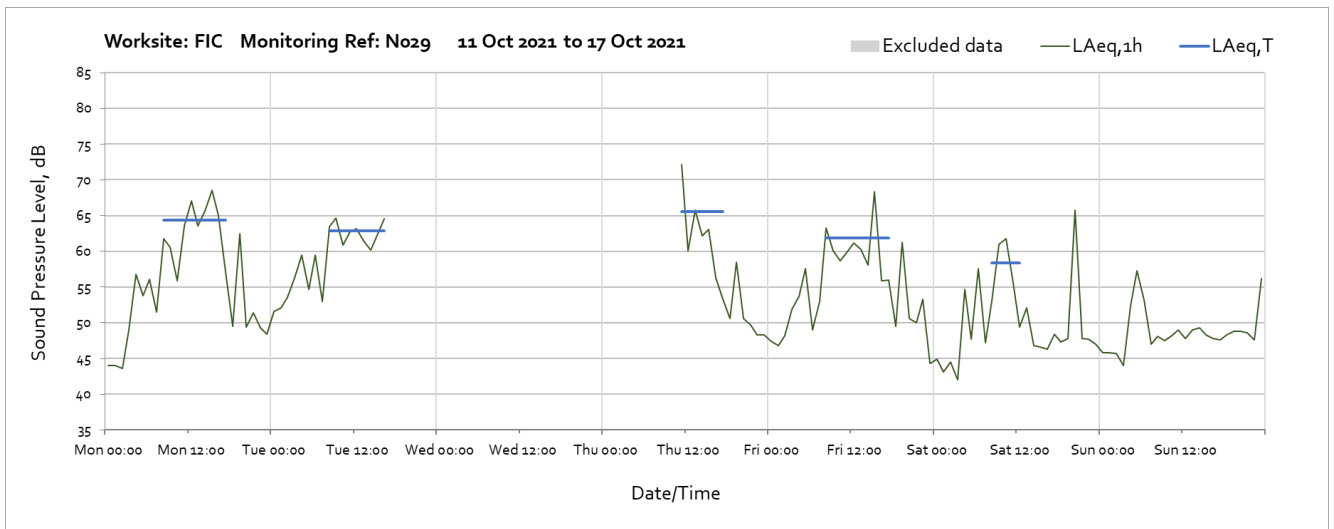
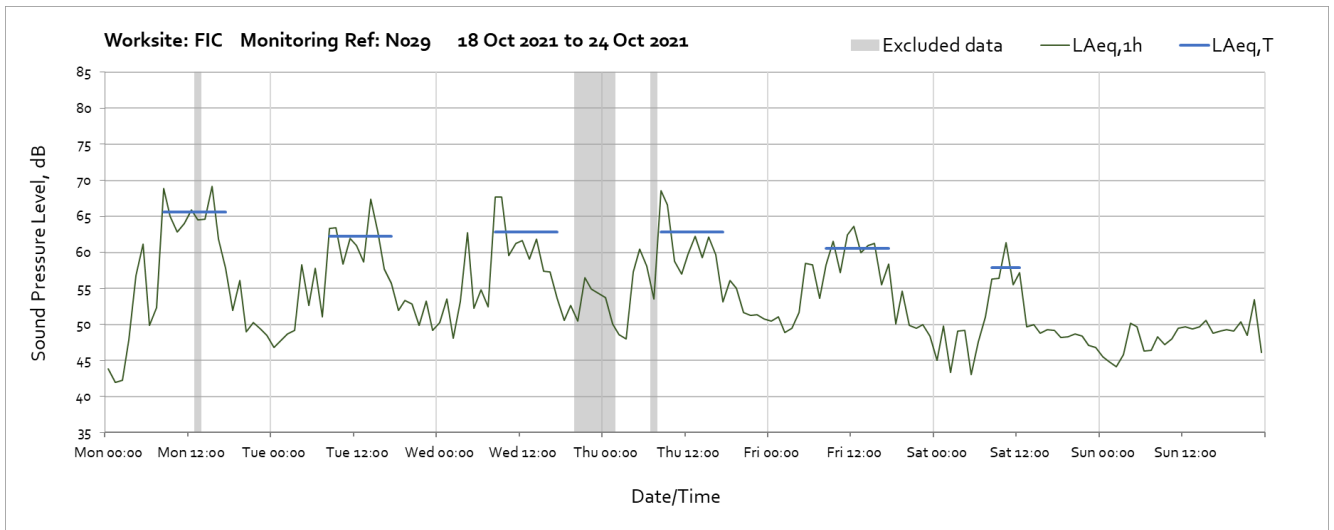
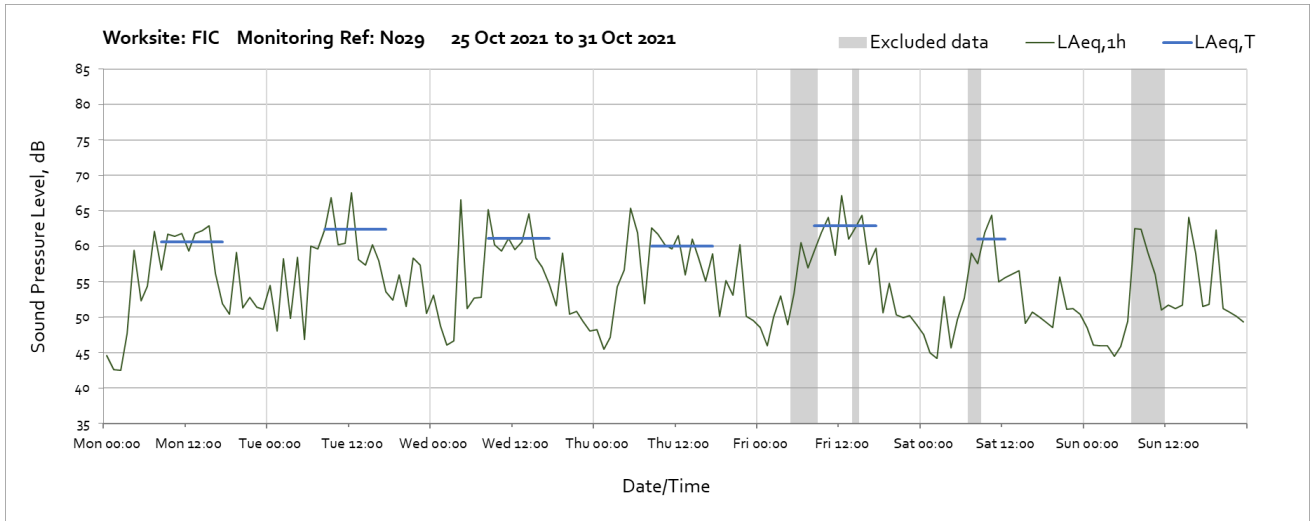
**Worksite: Flat Iron Compound (FIC) – Monitoring Ref: N029**

Note: Missing data between 17:00 on Tuesday 12<sup>th</sup> October and 07:00 on Thursday 14<sup>th</sup> October 2021 was due to memory card error and failure at the monitor location.

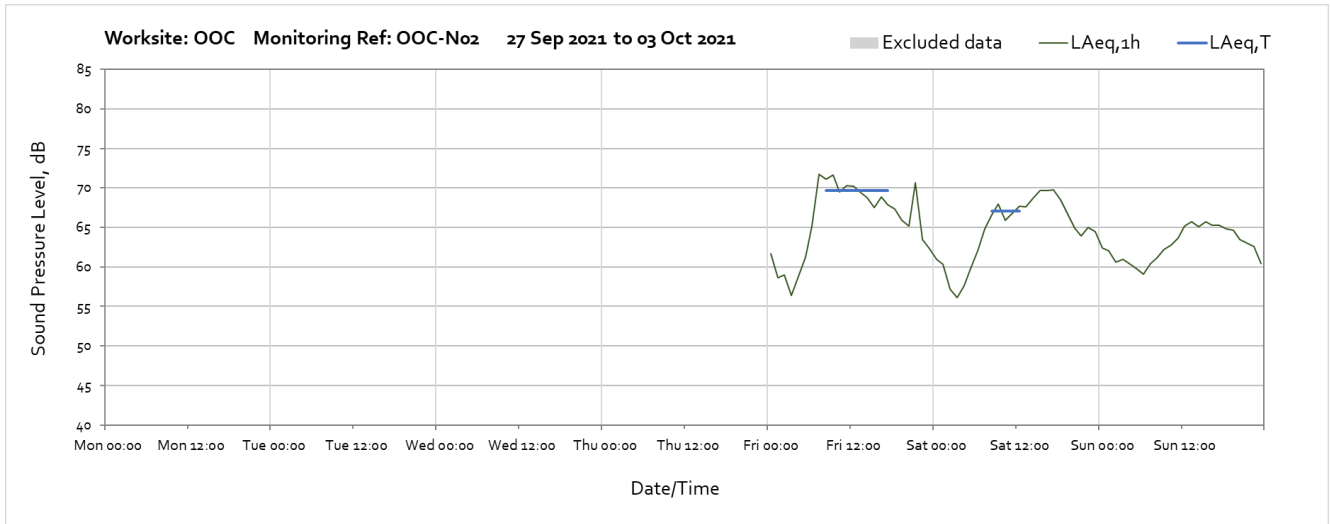
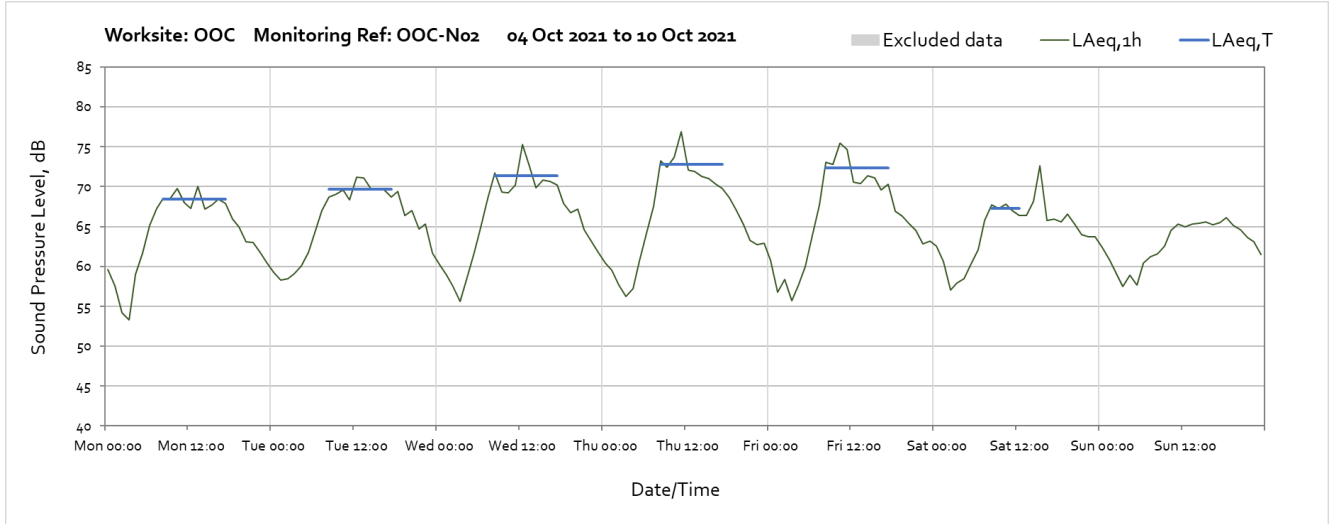
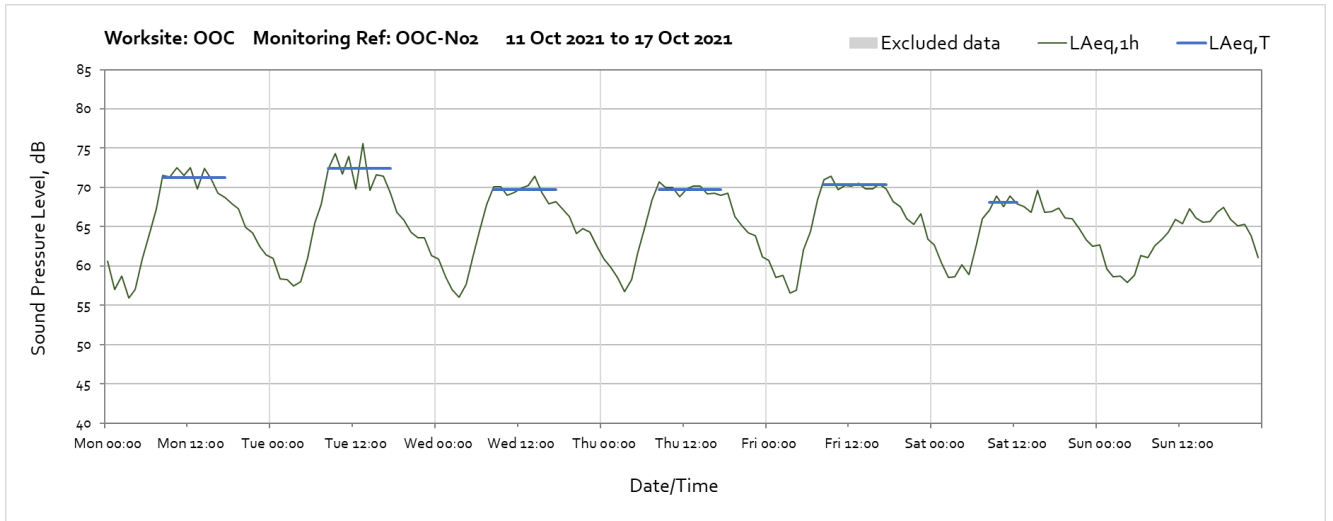
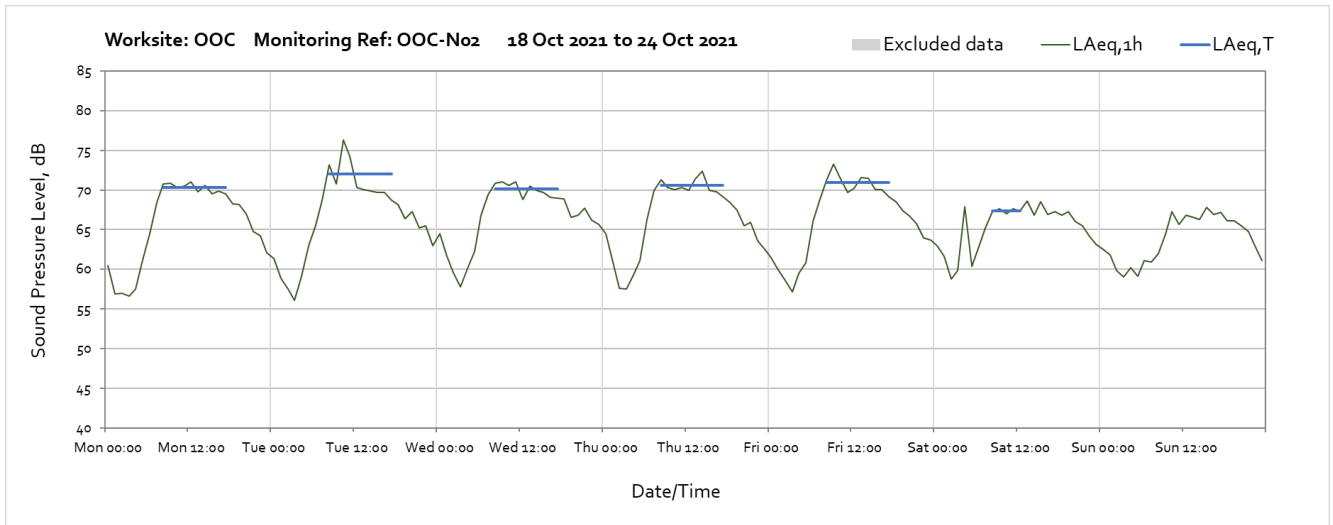
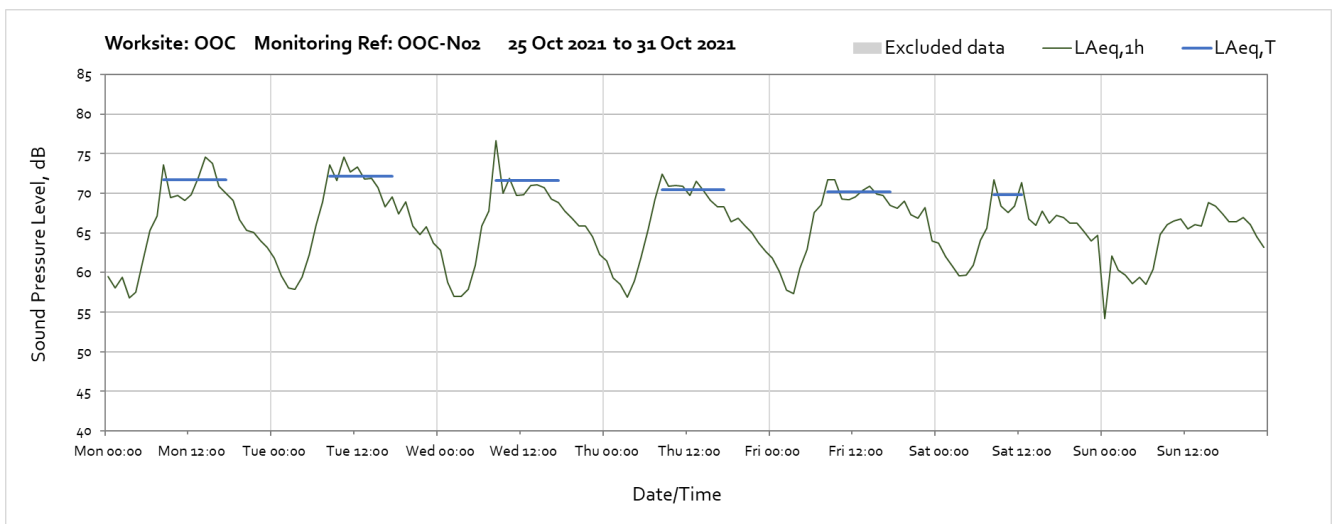
**Worksite: Oal Oak Common (OOC) – Monitoring Ref: OOC-N02**

Note: Unusually low levels between 00:00 and 01:00 on the 31<sup>st</sup> October have been excluded due to a daylight saving adjustment.

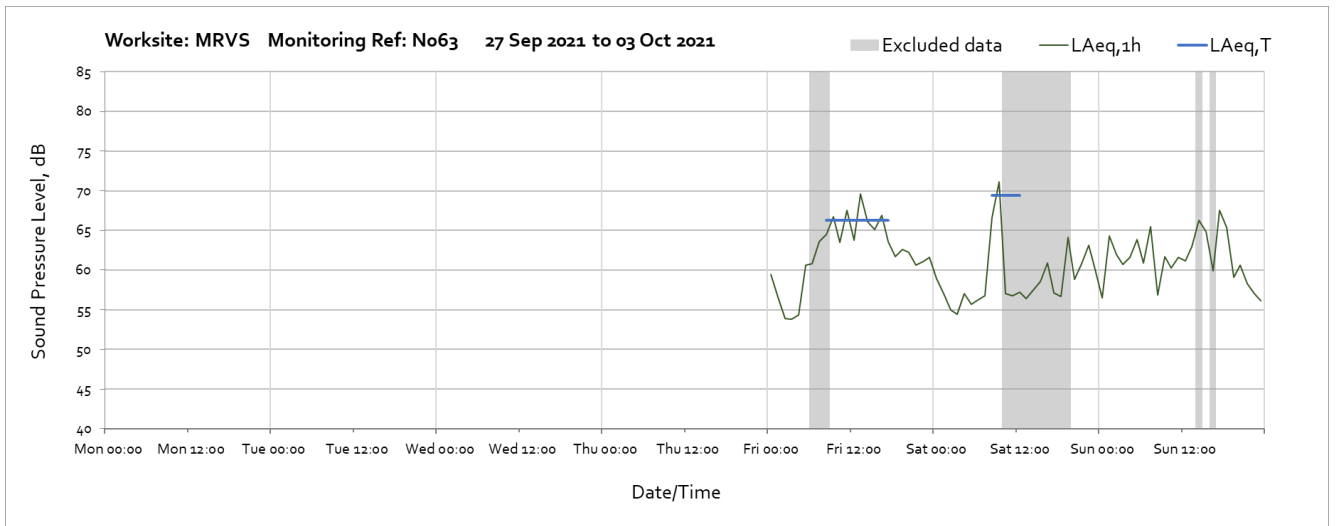
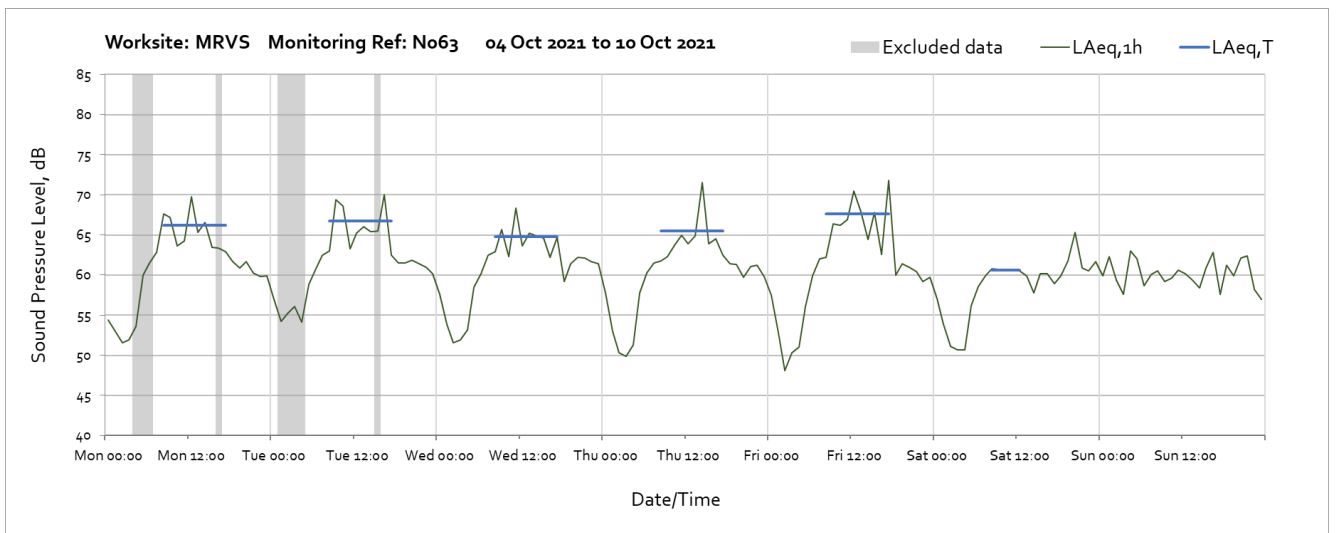
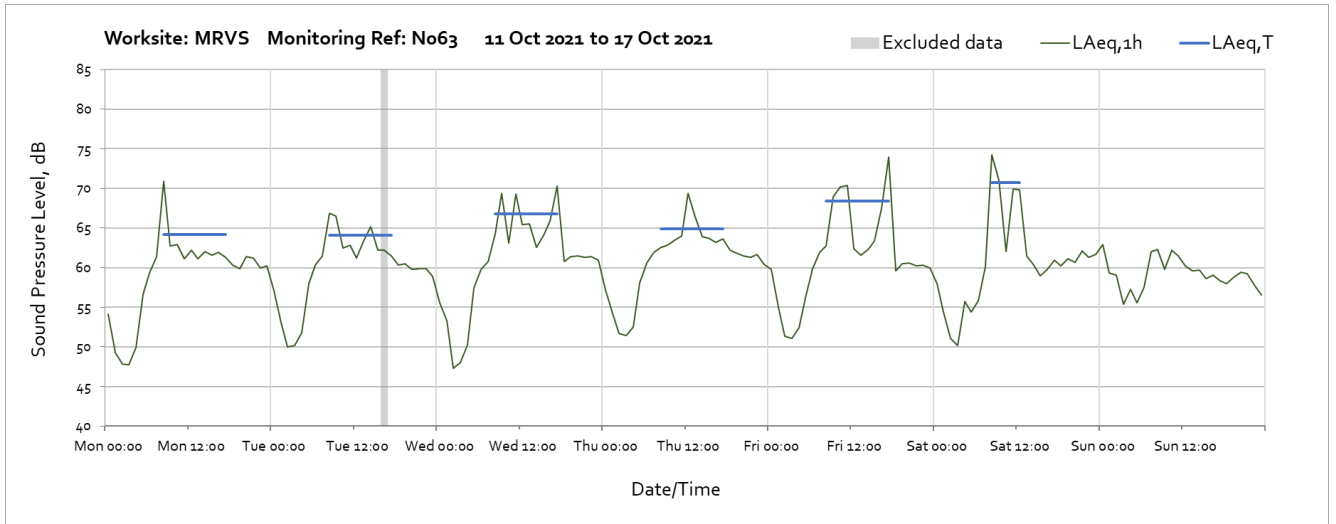
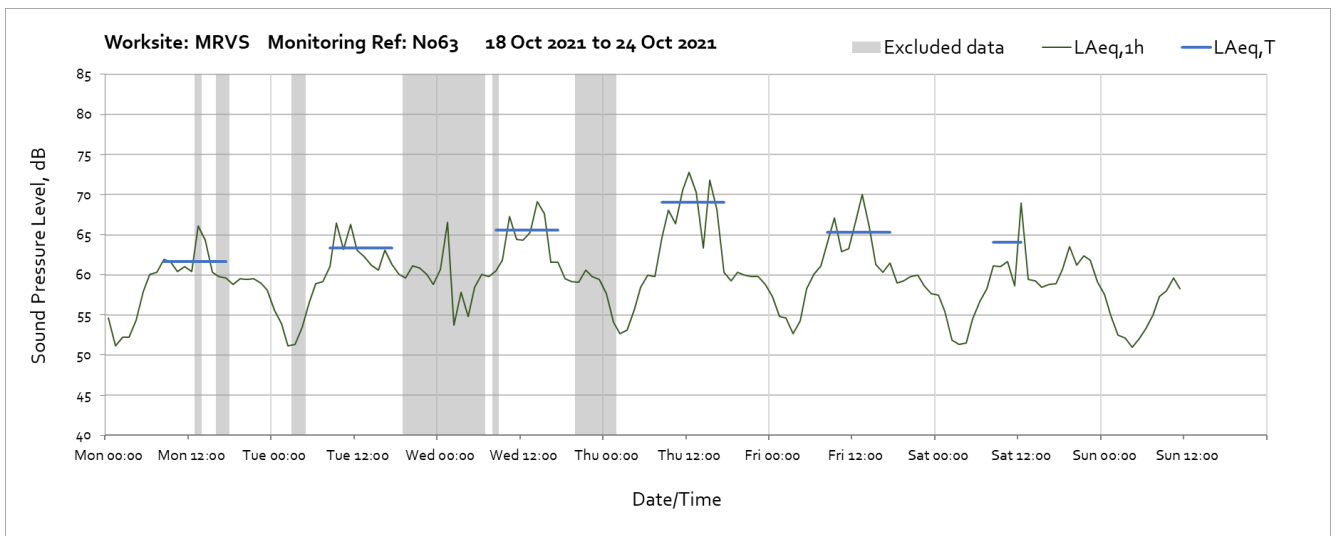
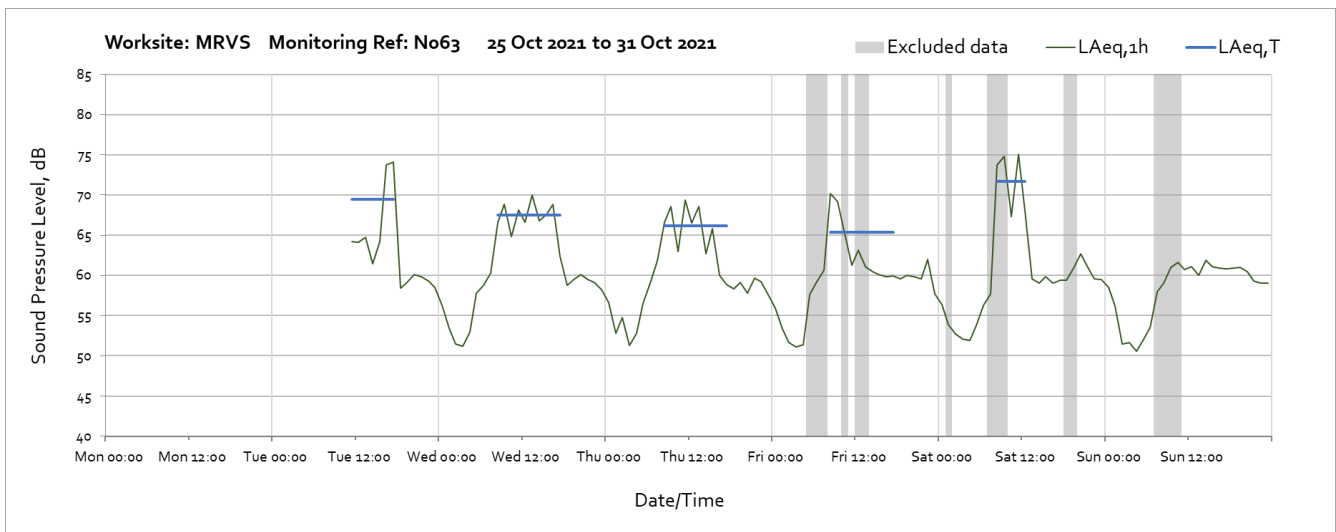
**Worksite: Mandeville Road Ventilation Shaft (MRVS) – Monitoring Ref: N063**

Note: Missing data between 12:00 on Sunday 24<sup>th</sup> October and 11:00 on Tuesday 26<sup>th</sup> October was due loss of continuous power at the monitoring station.

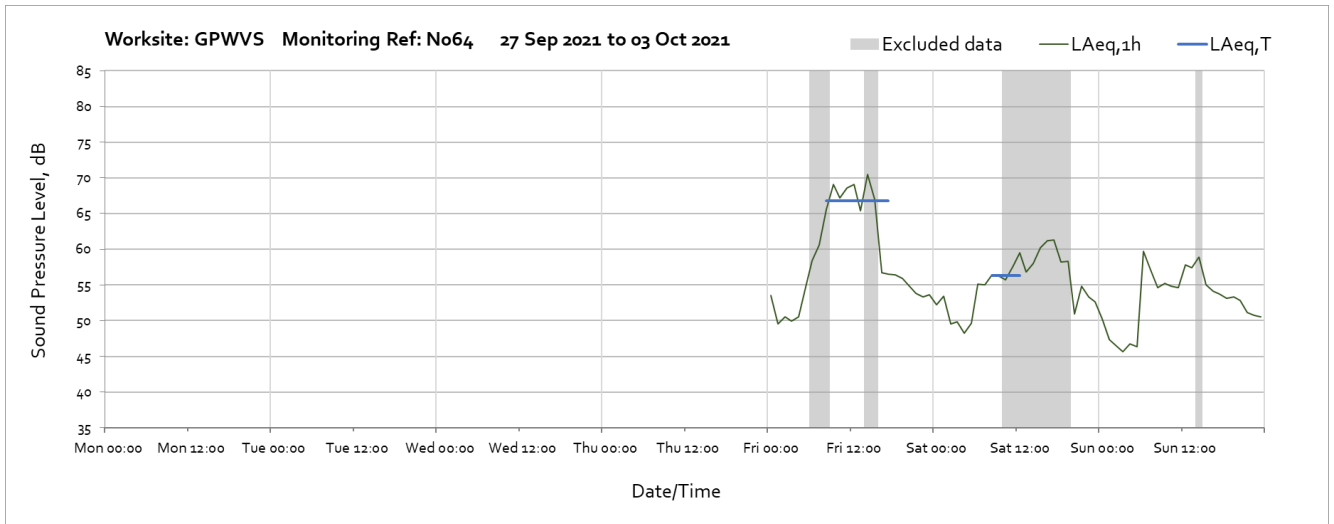
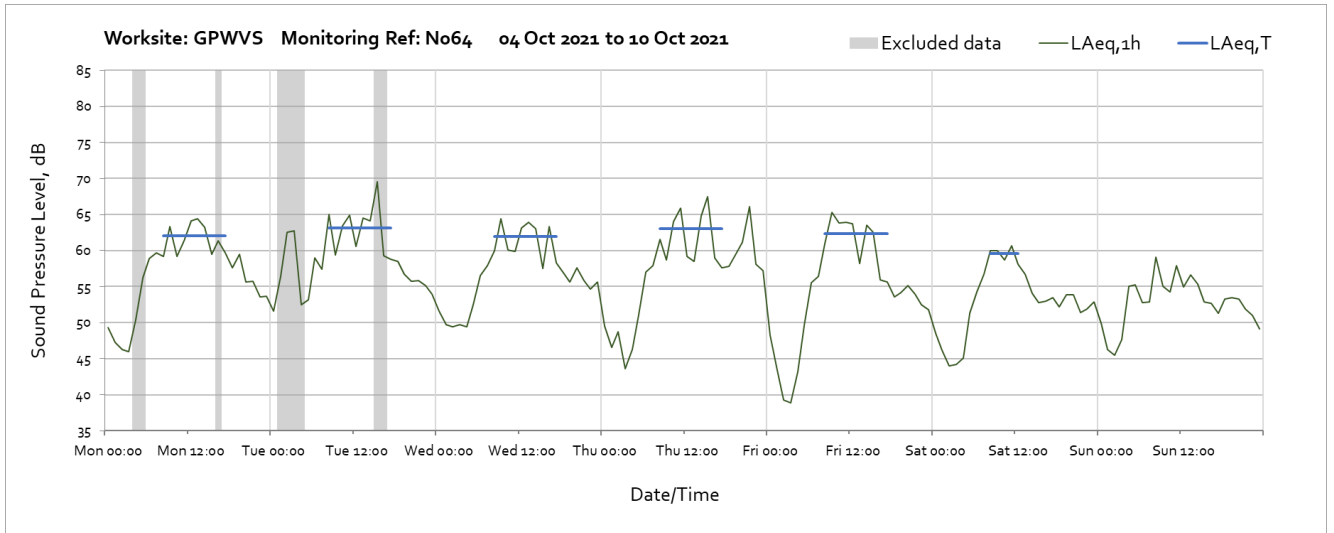
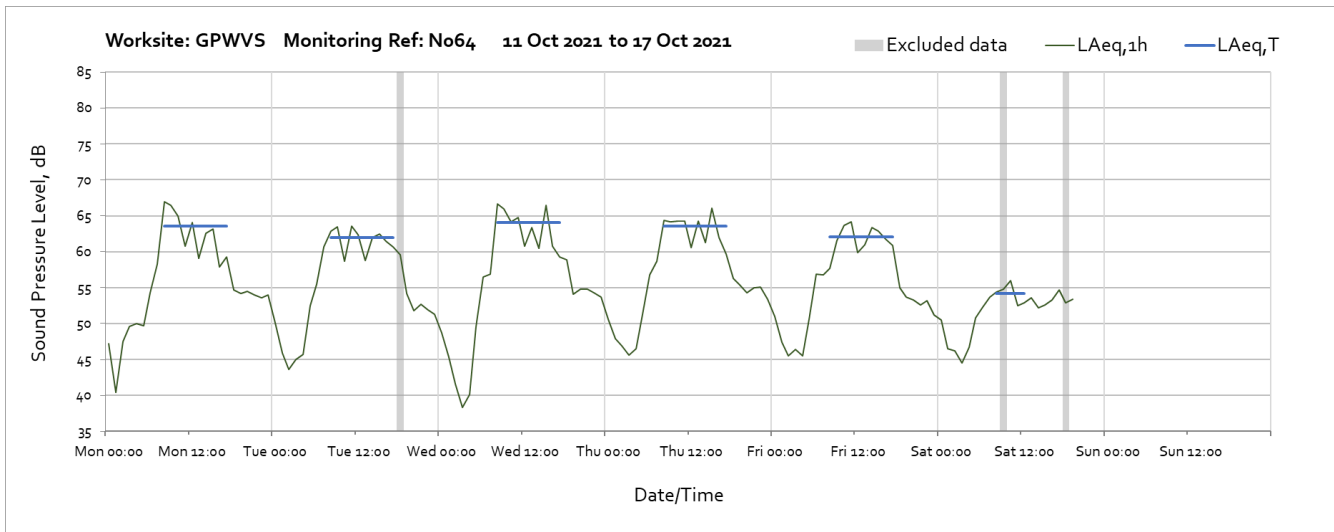
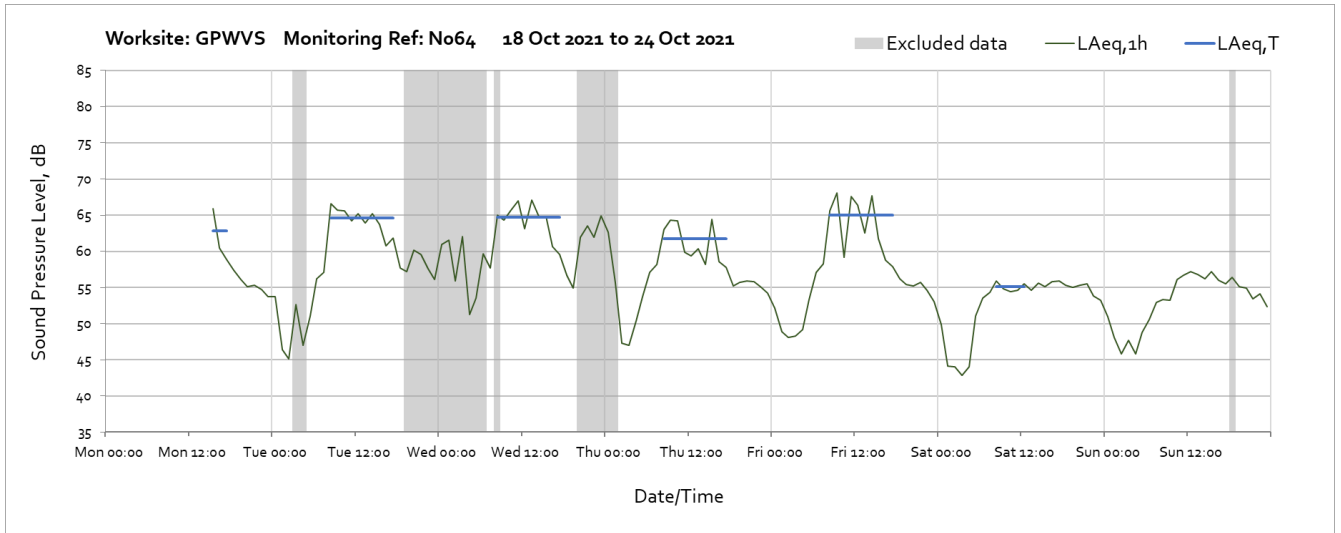
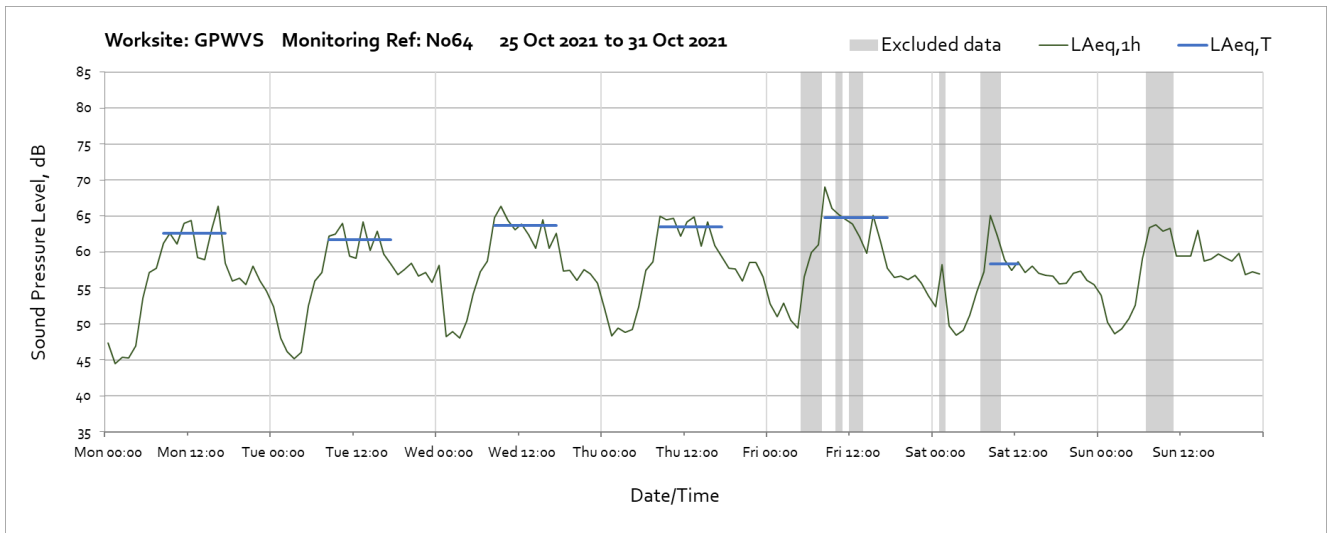
**Worksite: Green Park Way Vent Shaft (GPWVS) - Monitoring Ref: N064**

Note: Missing data between 20:00 on Saturday 16<sup>th</sup> October and 15:00 on Monday 18<sup>th</sup> October was due loss of continuous power at the monitoring station.

Note: Missing data between 20:00 on Saturday 16<sup>th</sup> October and 15:00 on Monday 18<sup>th</sup> October was due to loss of continuous power at the monitoring station.
