## **Construction noise and vibration Monthly Report – October 2021**

**London Borough of Ealing**

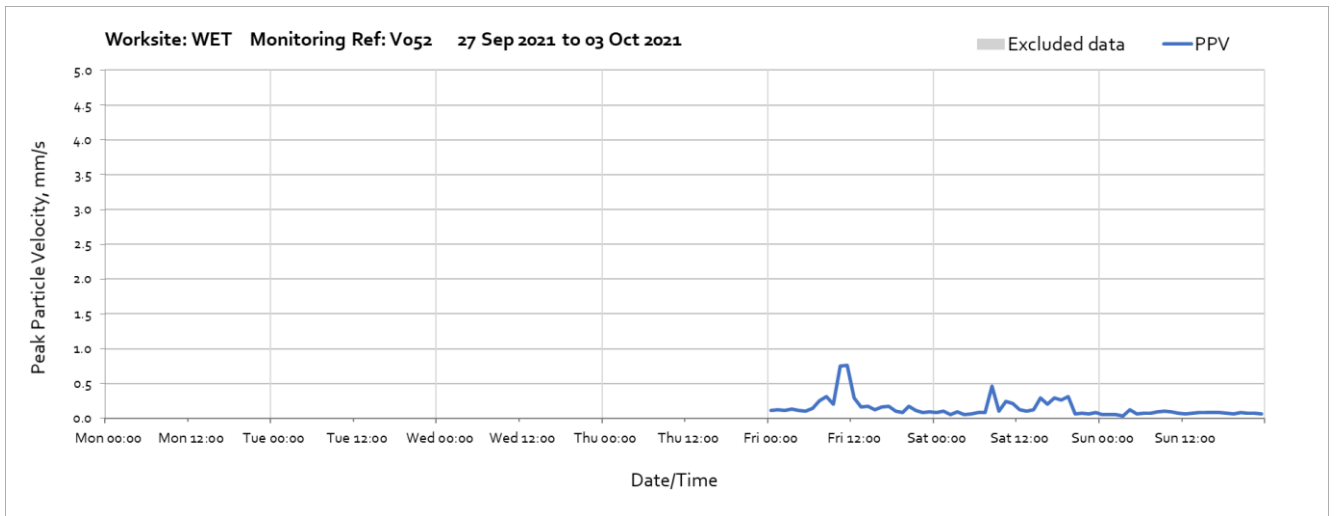
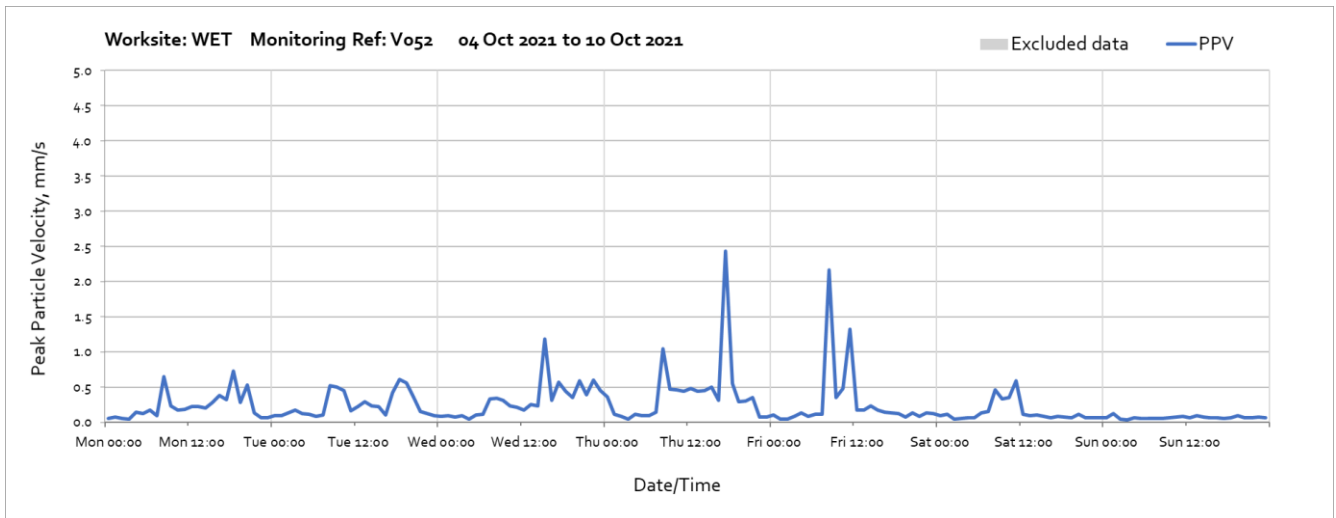
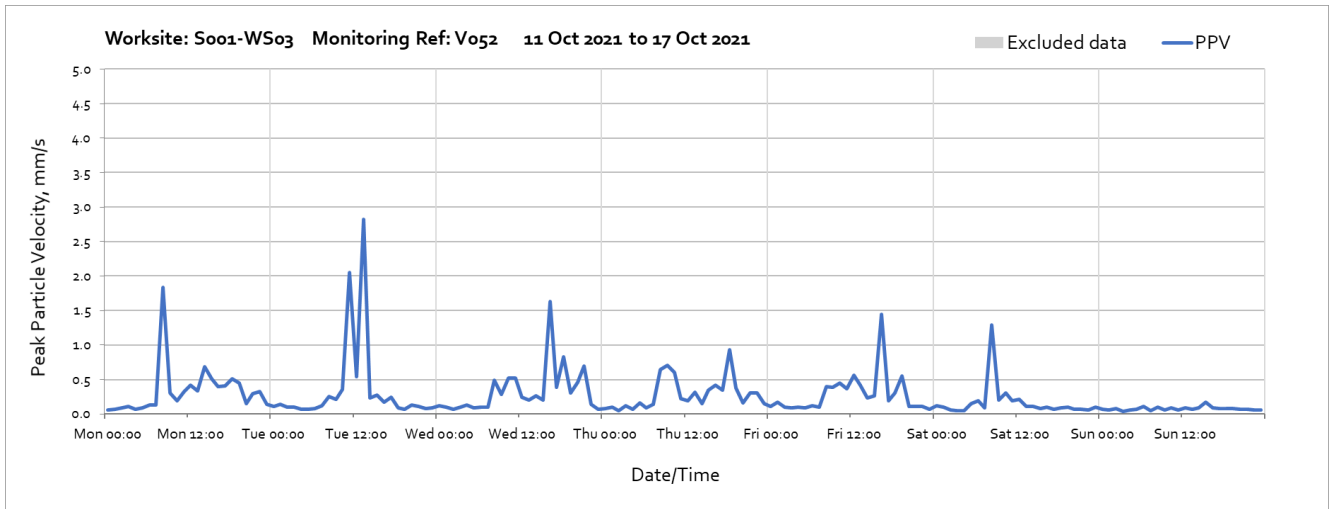
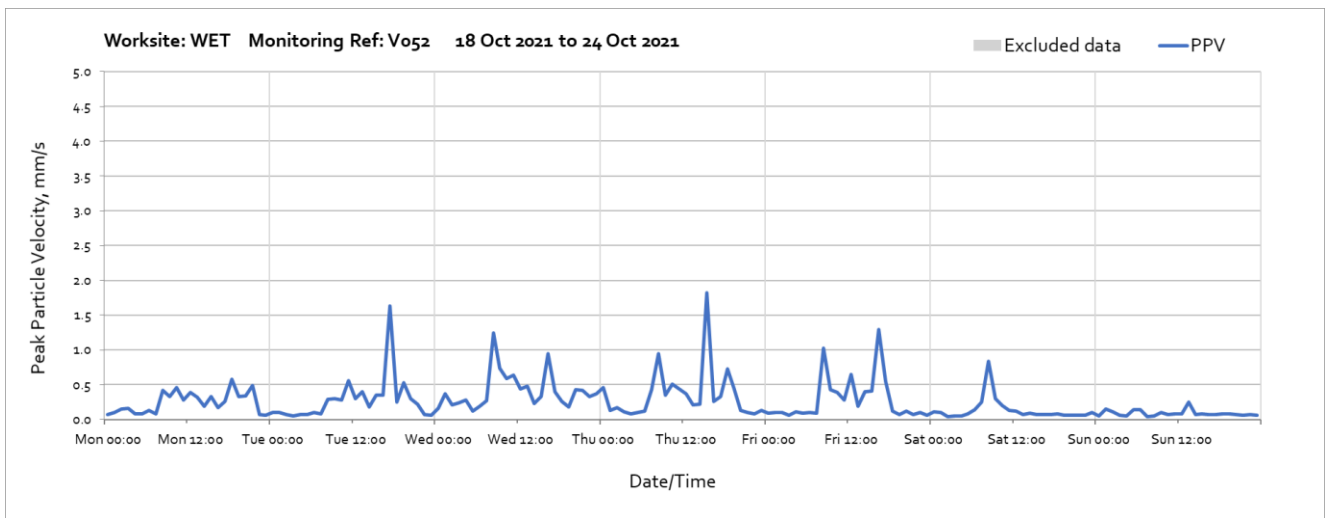
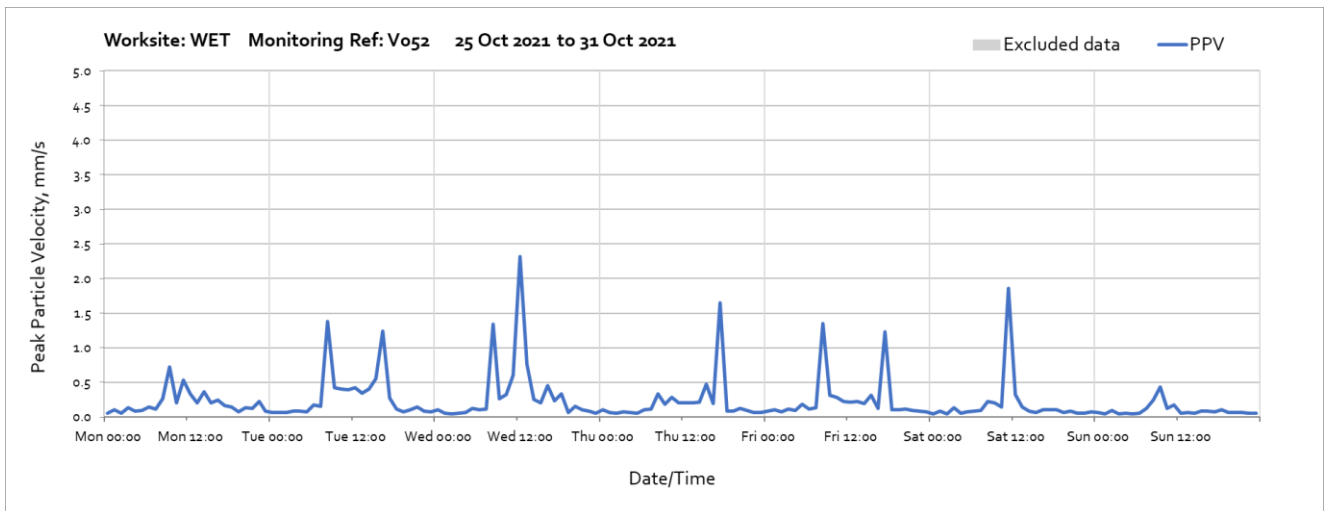
### Worksite: Willesden Euro Terminal (WET) – Monitoring Ref: V052

The following graphs show the hourly measured peak particle velocity PPV recorded during the monitoring period. The graphs show the highest PPV of the three orthogonal axis x, y and z. Where high values of PPV were caused by local interference with the vibration monitor, which are not representative of HS2 construction works, these values have been greyed out in the following charts and have been excluded to calculate values in Table 4 of the main report.

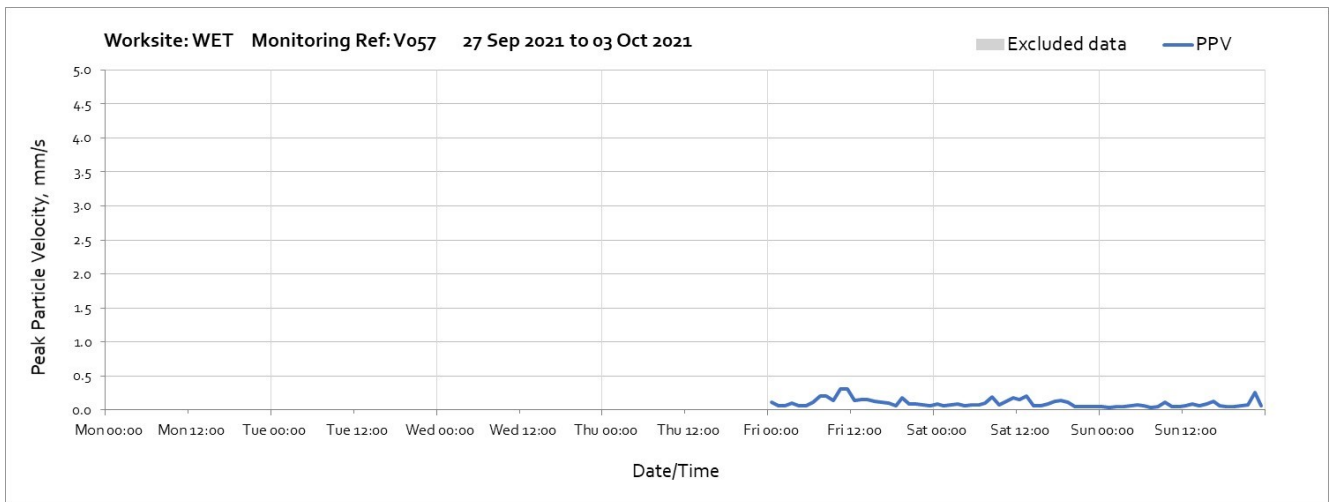
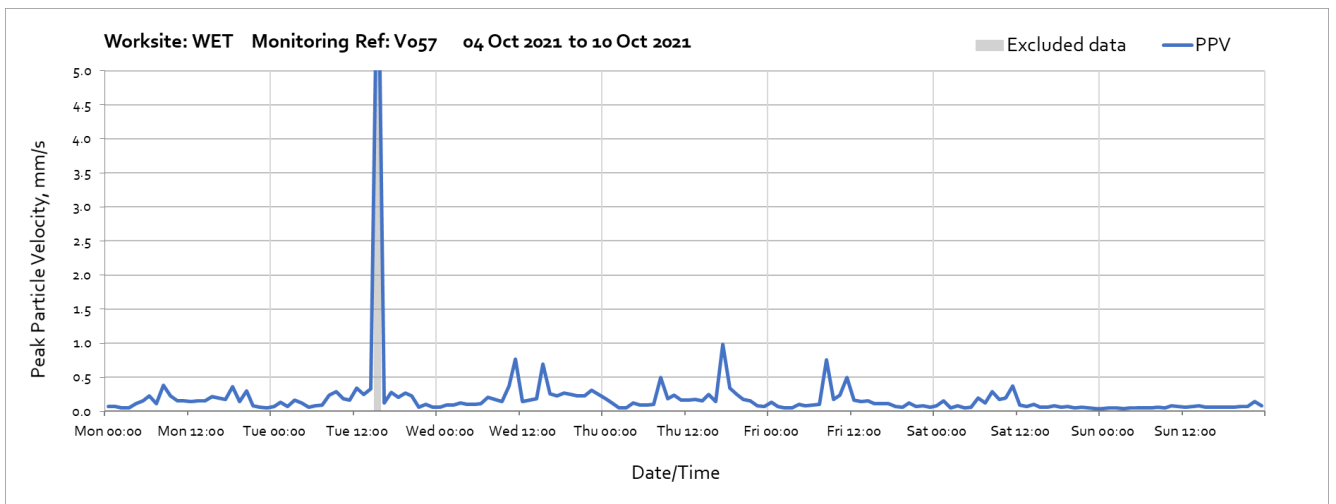
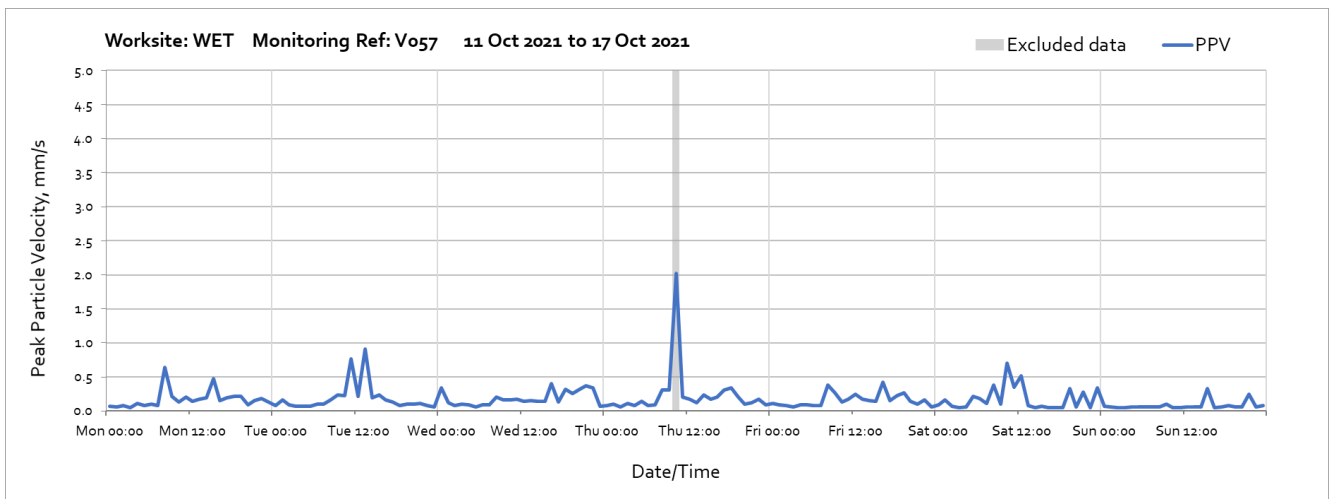
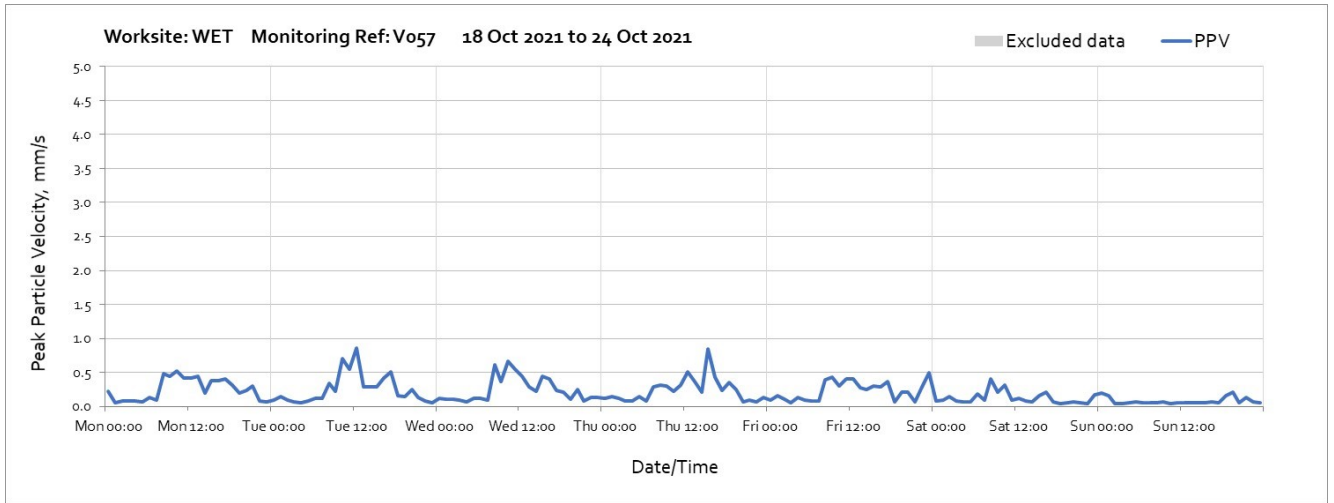
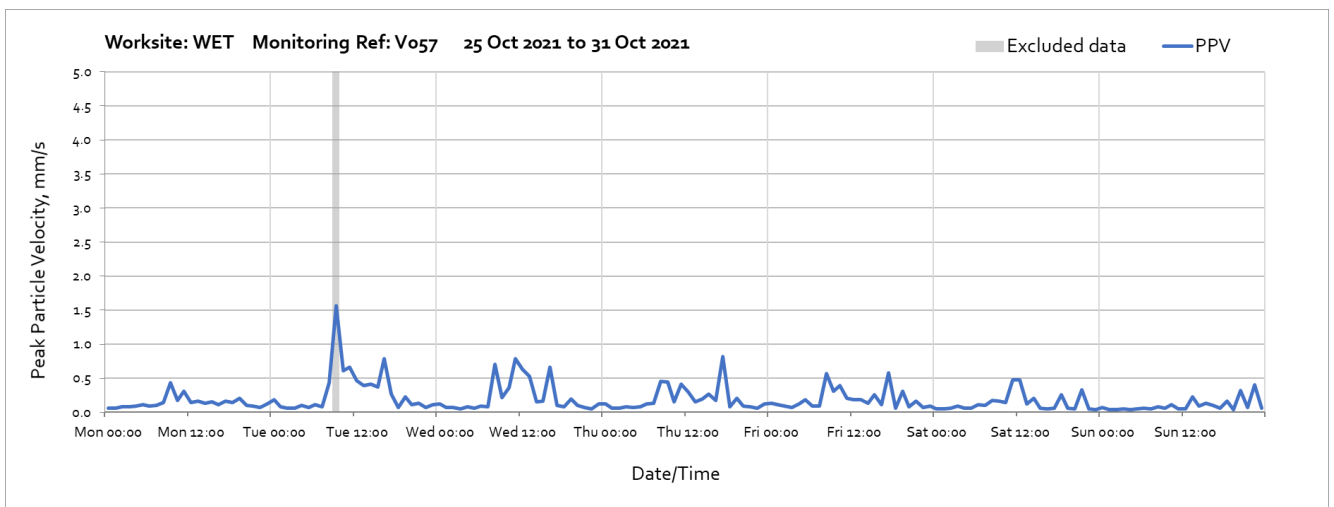
## Worksite: Willesden Euro Terminal (WET) – Monitoring Ref: V057

Note: High vibration levels measured at 15:00 on Tuesday 5<sup>th</sup> October were due to residents activity close to the vibration monitor and not representative of HS2 vibration levels.

Note: High vibration levels measured at 10:00 on Thursday 14<sup>th</sup> October were due to residents activity close to the vibration monitor and not representative of HS2 vibration levels.

Note: High vibration levels measured at 09:00 on Tuesday 26<sup>th</sup> October were due to residents activity close to the vibration monitor and not representative of HS2 vibration levels.

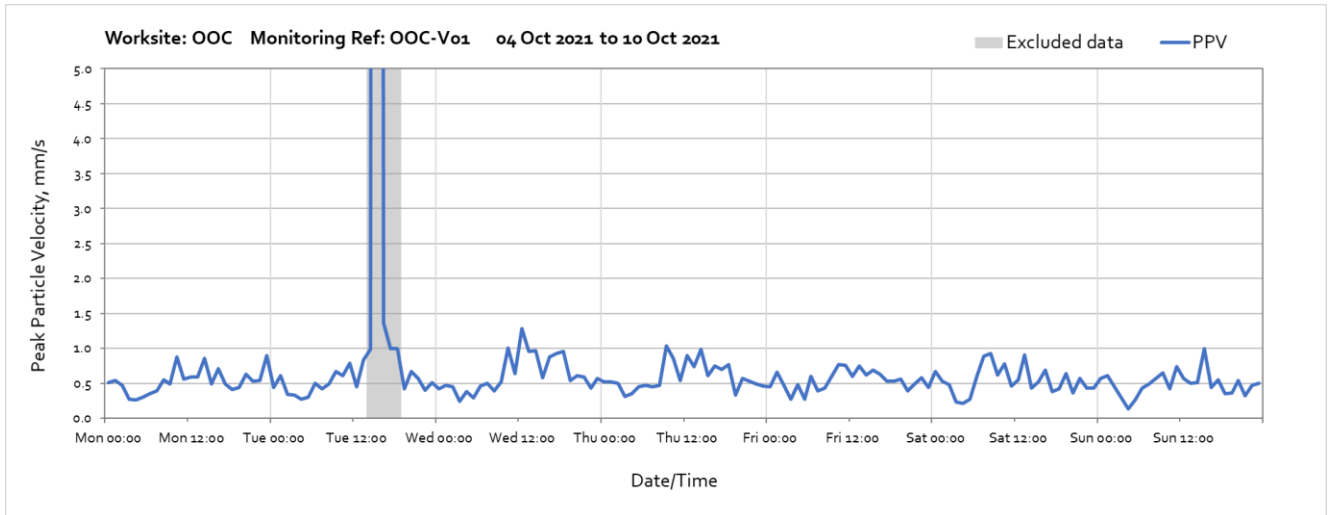
**Worksite: Old Oak Common (OOC) – Monitoring Ref: OOC-V01**

Note: High vibration levels measured between 14:00 and 18:00 on Tuesday 5<sup>th</sup> October were due to residents activity close to the vibration monitor and not representative of HS2 vibration levels.

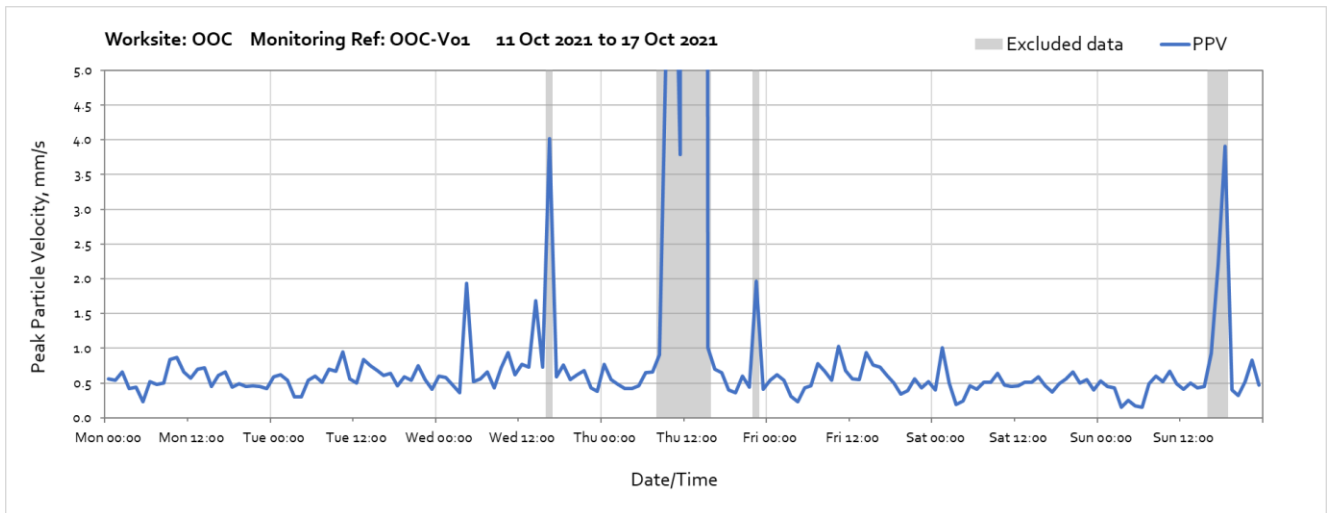
Note: High vibration levels measured across the week were due to residents activity close to the vibration monitor and not representative of HS2 vibration levels.

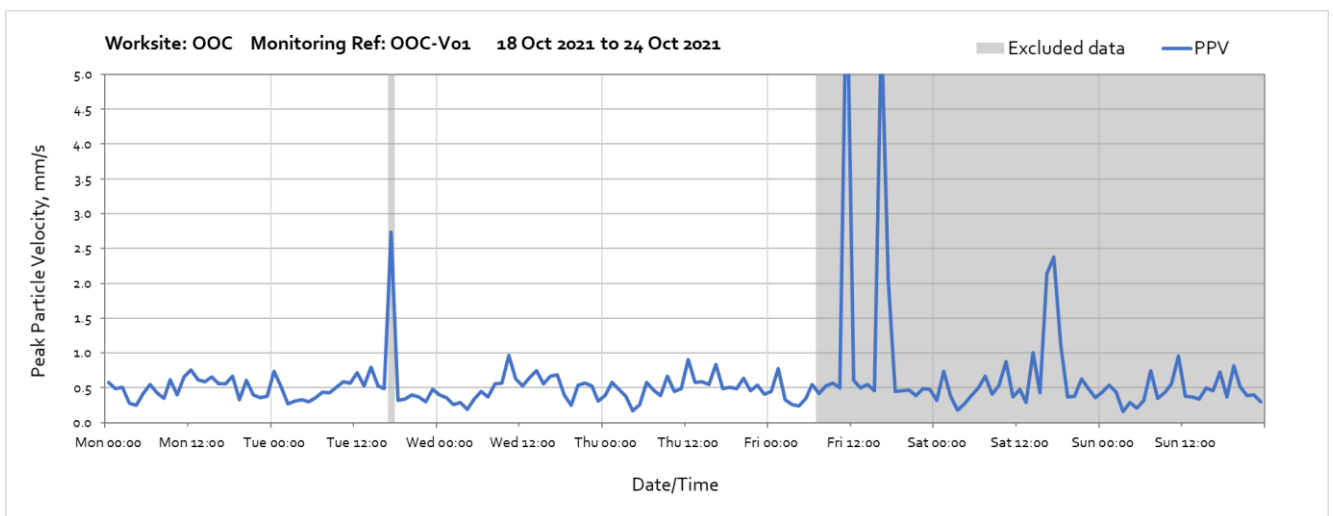
Note: High vibration levels measured across the week were due to residents activity close to the vibration monitor and not representative of HS2 vibration levels.

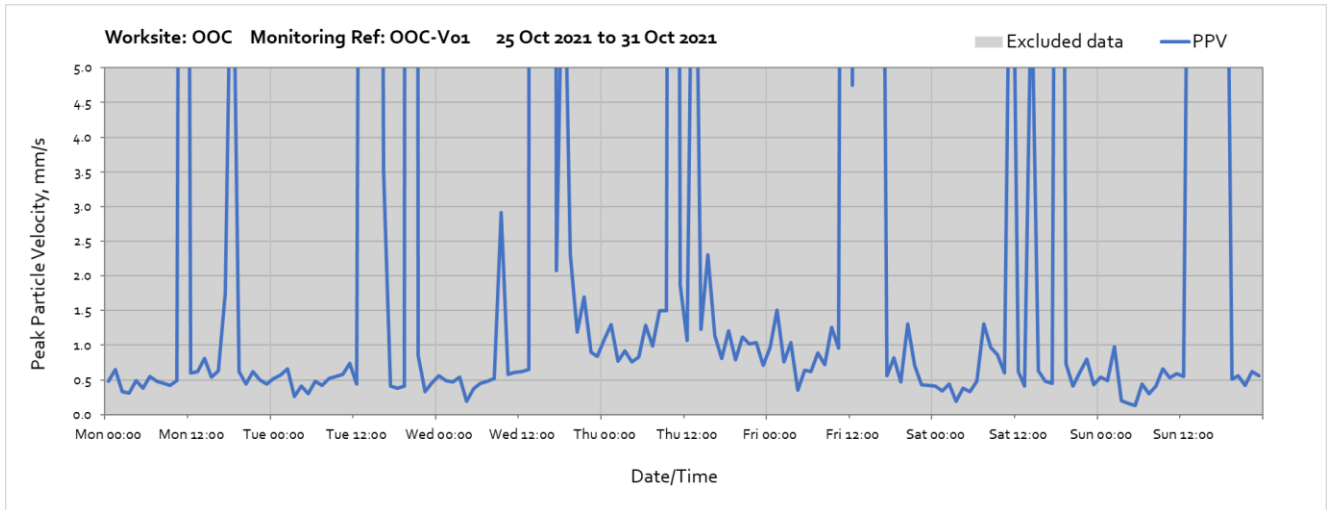
Note: High vibration levels measured across the week were due to slab movement undertaken by residents in close proximity to the vibration monitor and not representative of HS2 vibration levels.

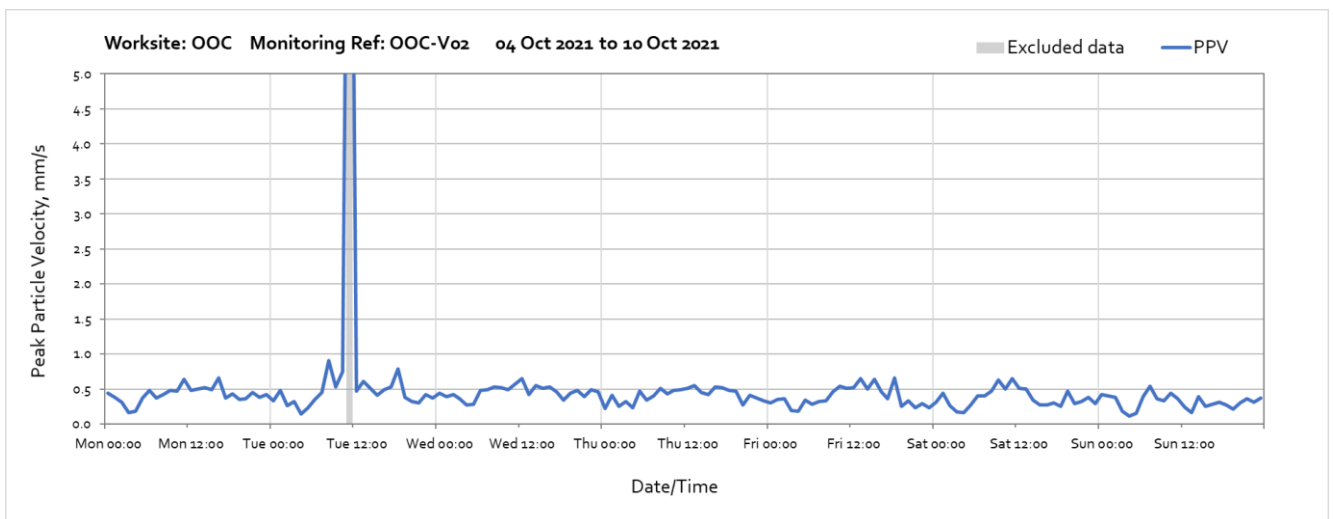
### Worksite: Old Oak Common (OOC) – Monitoring Ref: OOC-V02

Note: High vibration levels measured at 11:00 on Tuesday 5<sup>th</sup> October were due battery changover at the monitoring station and not representative of HS2 vibration levels.

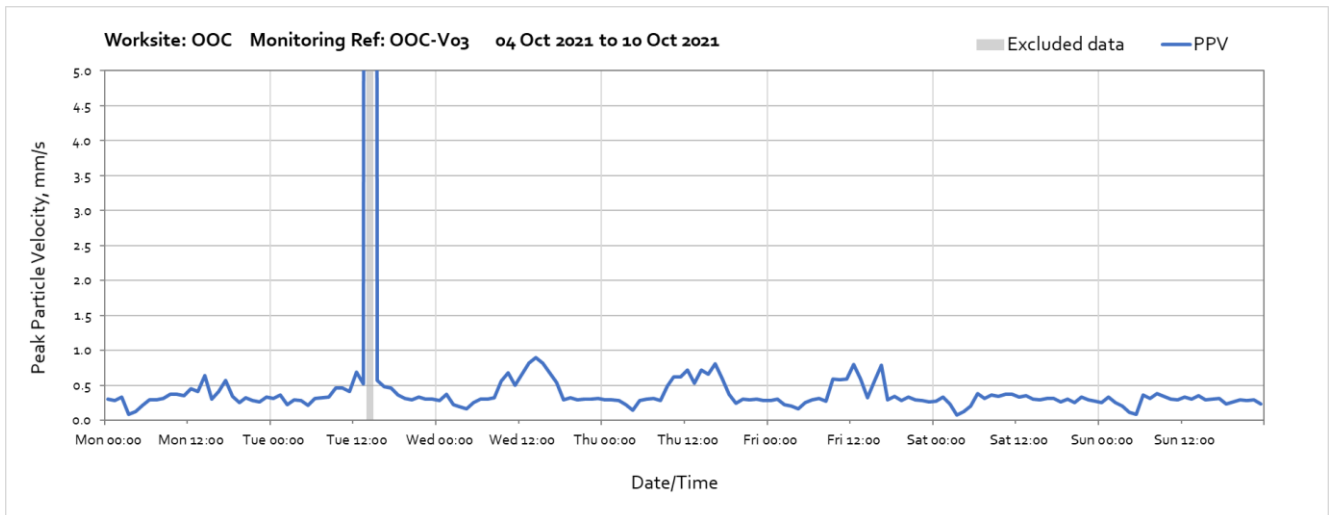
## Worksite: Old Oak Common (OOC) – Monitoring Ref: OOC-V03

Note: High vibration levels measured at 14:00 on Tuesday 5<sup>th</sup> October were due battery changover at the monitoring station and not representative of HS2 vibration levels.

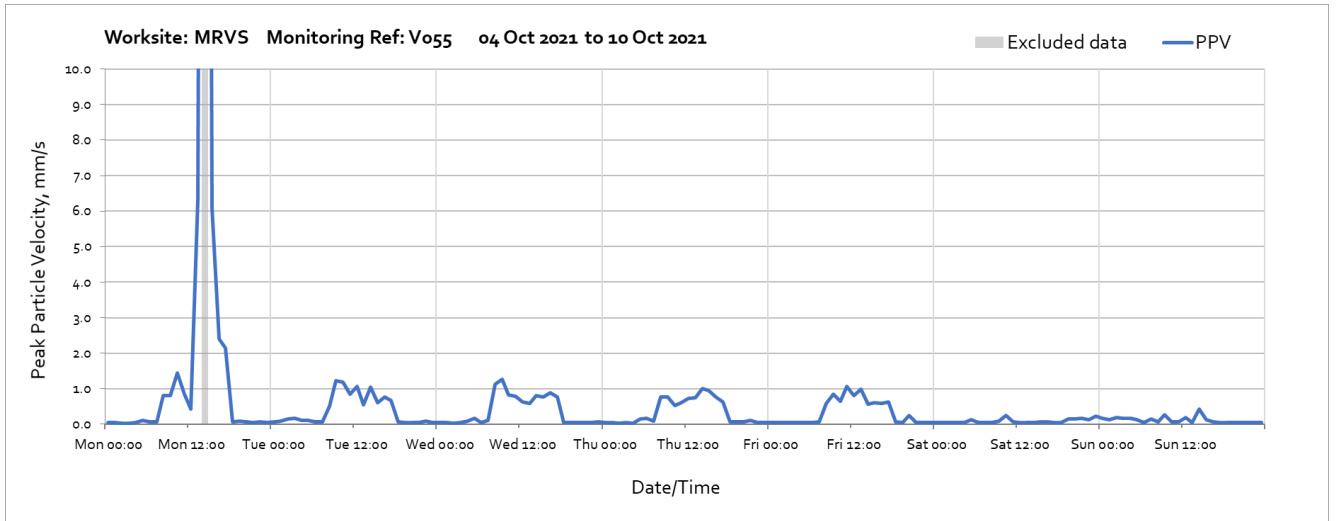
**Worksite: Mandeville Road Vent Shaft (MRVS) - Monitoring Ref: V055**

Note: High vibration levels measured at 14:00 on Monday 4<sup>th</sup> October were due to local disturbance at the monitoring location and not representative of HS2 vibration levels.

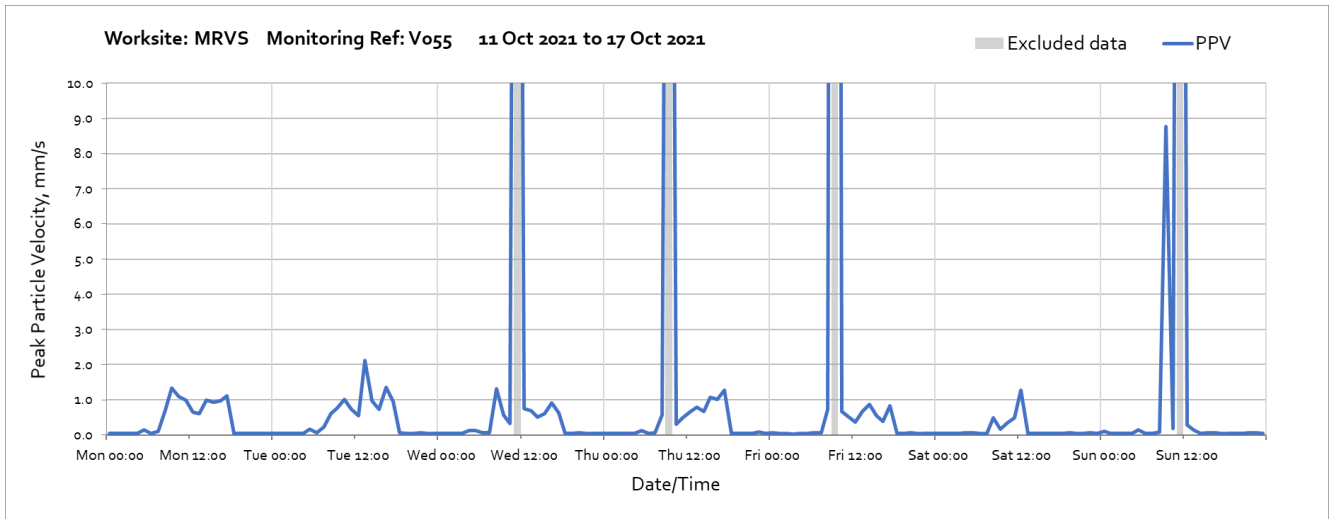
Note: High vibration levels measured across the week were due to local disturbance at the monitoring location and not representative of HS2 vibration levels.

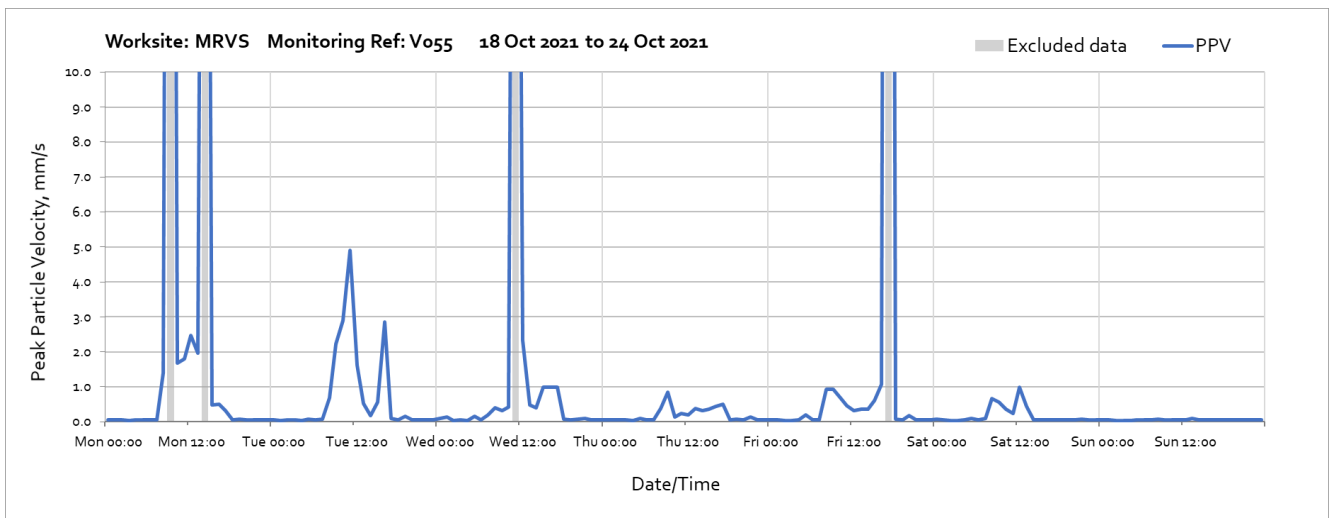
Note: High vibration levels measured across the week were due to local disturbance at the monitoring location and not representative of HS2 vibration levels.

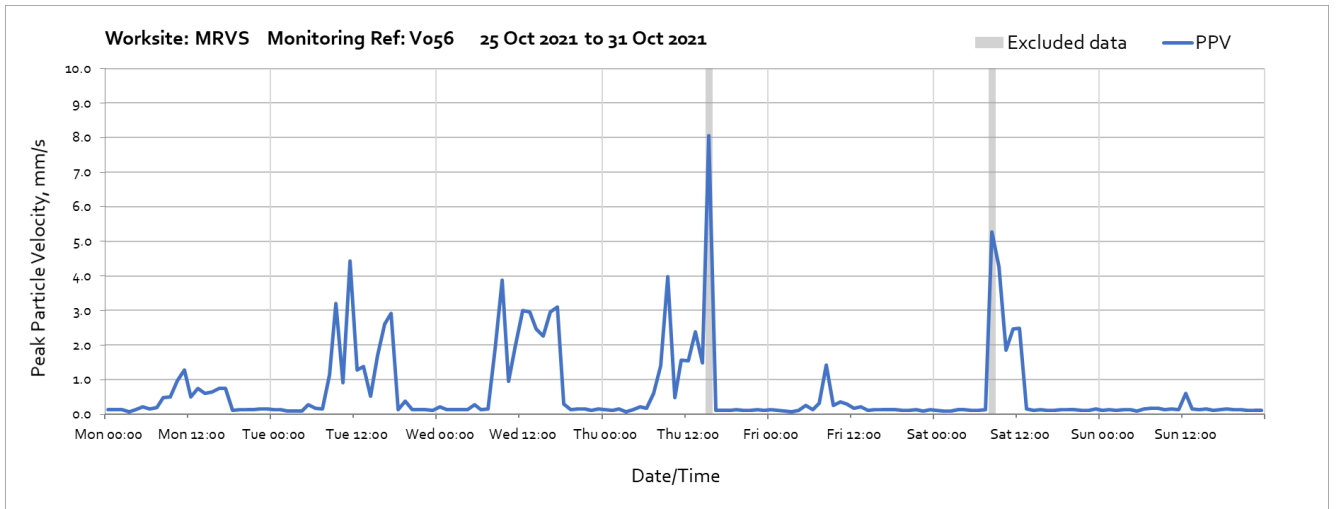
**Worksite: Mandeville Road Vent Shaft (MRVS) – Monitoring Ref: V056**

Note: High vibration levels measured across the week were due to local disturbance at the monitoring location and not representative of HS2 vibration levels.

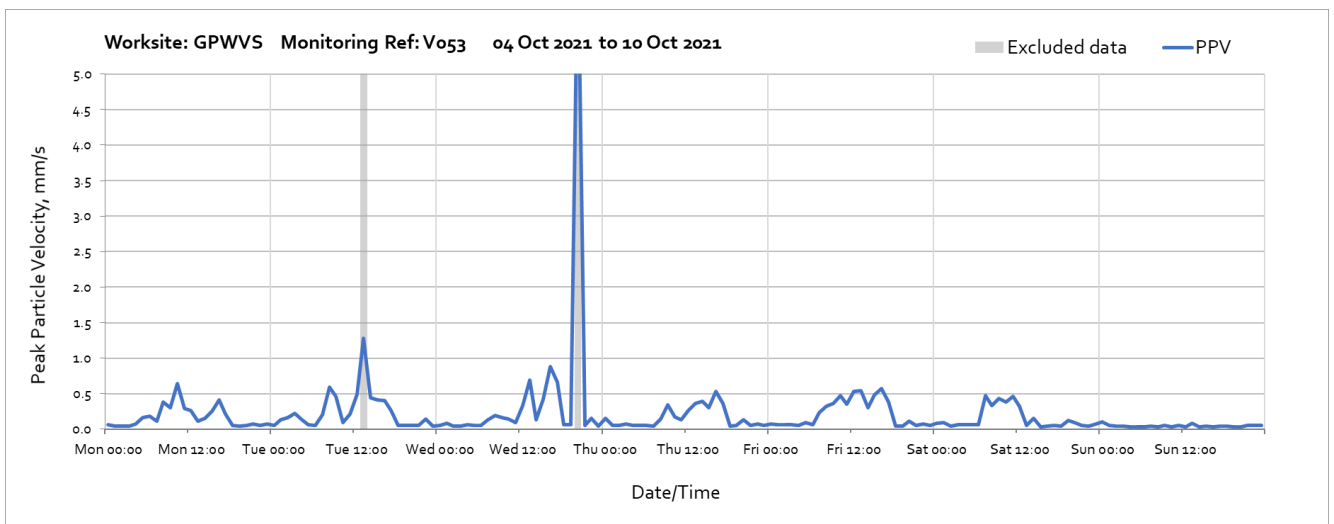
## Worksite: Green Park Way Vent Shaft (GPWVS) – Monitoring Ref: V053

Note: High vibration levels measured across the week were due to local disturbance at the monitoring location and not representative of HS2 vibration levels.

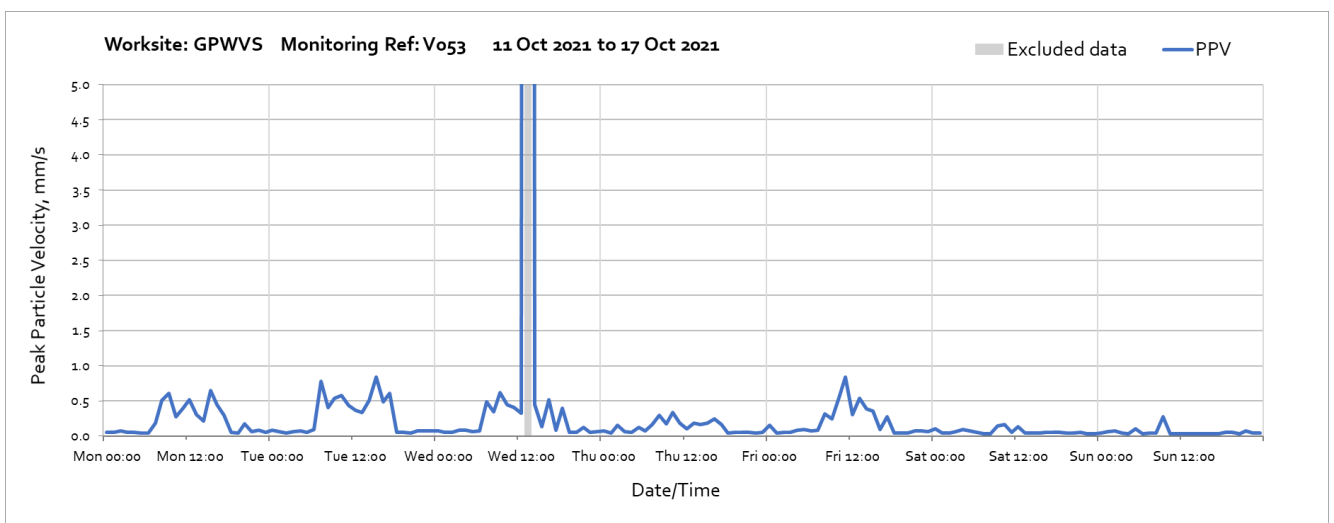
Note: High vibration levels measured at 13:00 on Wednesday 13<sup>th</sup> October were due to local disturbance at the monitoring location and not representative of HS2 vibration levels.

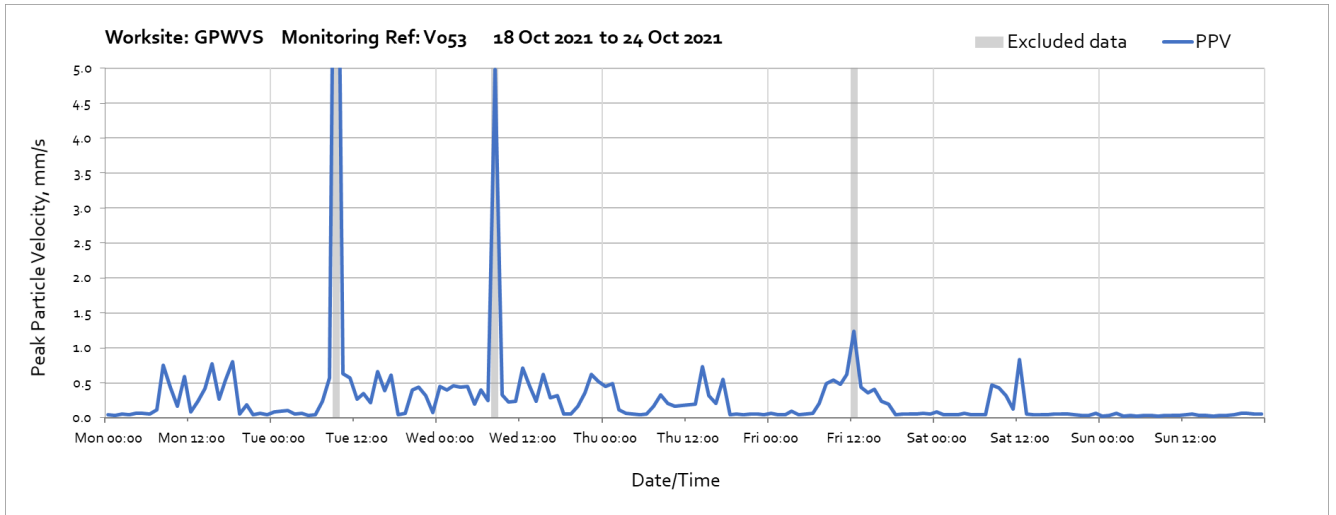
Note: High vibration levels measured across the week were due to local disturbance at the monitoring location and not representative of HS2 vibration levels.

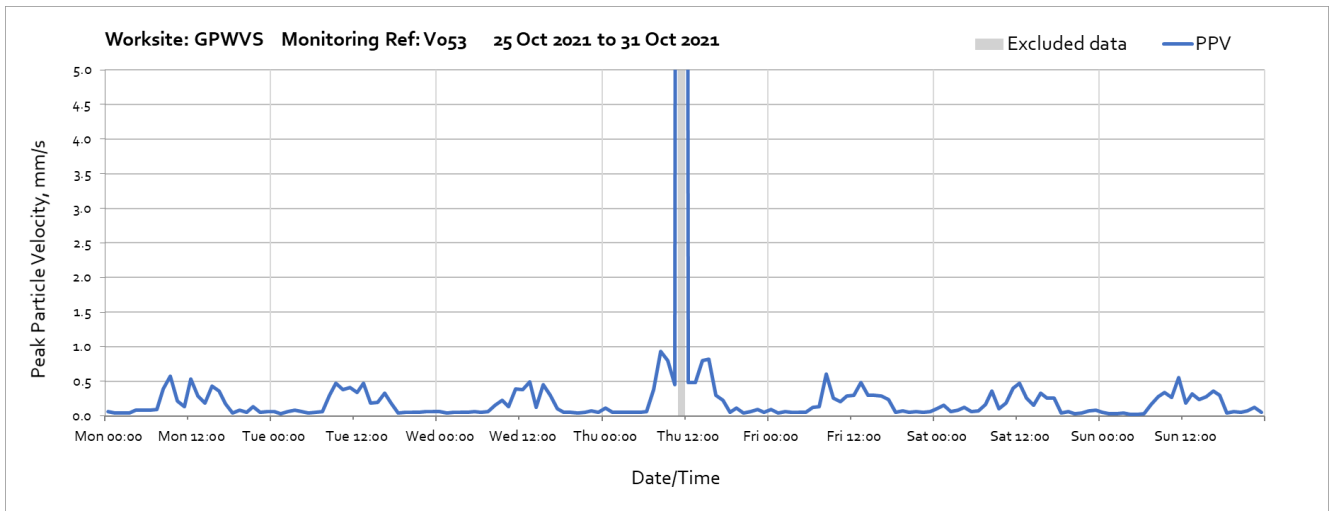
Note: High vibration levels measured at 11:00 on Wednesday 28<sup>th</sup> October were due to local disturbance at the monitoring location and not representative of HS2 vibration levels.

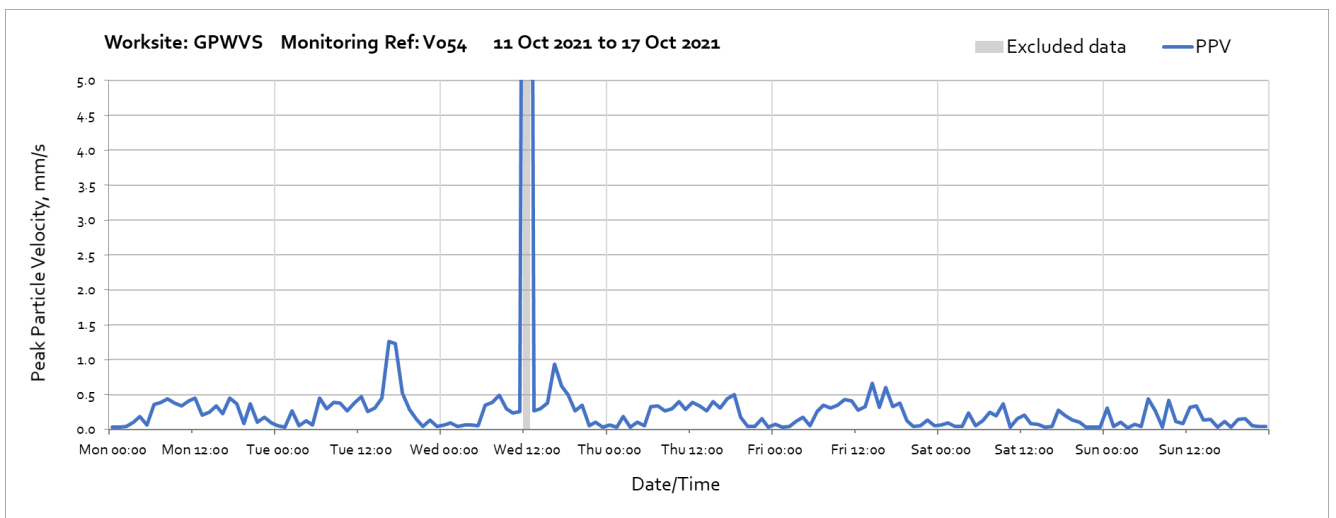
### Worksite: Green Park Way Vent Shaft (GPWVS) – Monitoring Ref: V054

Note: High vibration levels measured at 12:00 on Wednesday 13<sup>th</sup> October were due to local disturbance at the monitoring location and not representative of HS2 vibration levels.

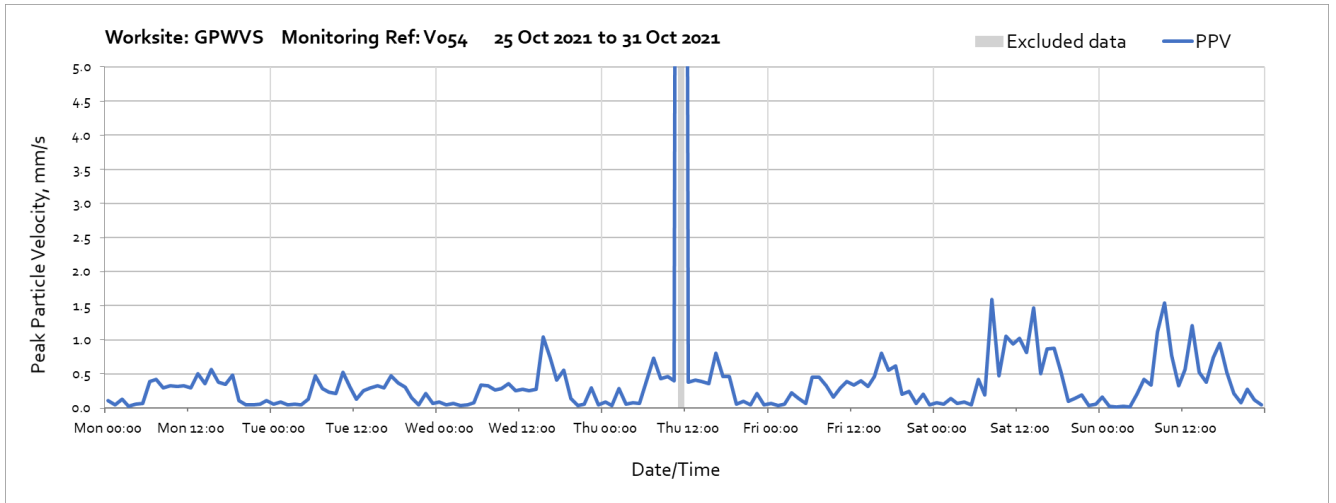
Note: High vibration levels measured at 11:00 on Wednesday 28<sup>th</sup> October were due to local disturbance at the monitoring location and not representative of HS2 vibration levels.
