Construction noise and vibration Monthly Report – November 2021

London Borough of Ealing

This Noise and Vibration Monitoring Report fulfils HS2 Limited's commitment detailed in the Environmental Minimum Requirements (EMRs), Annex 1, Code of Construction Practice, to present the results of noise and vibration monitoring carried out within the London Borough of Ealing (LBE) (including one monitoring location on the boundary with the London Borough of Hammersmith and Fulham) during the month of November 2021.

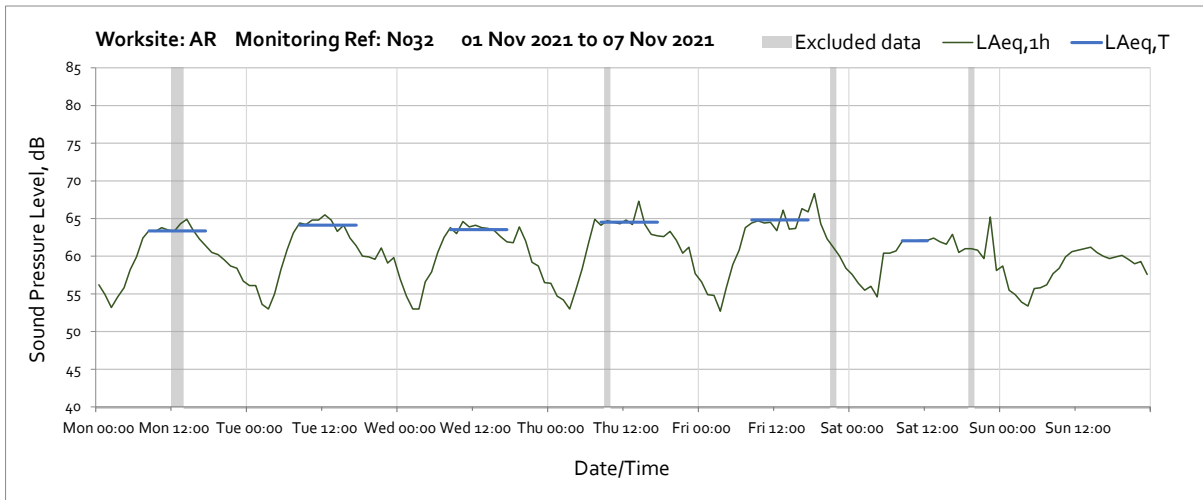
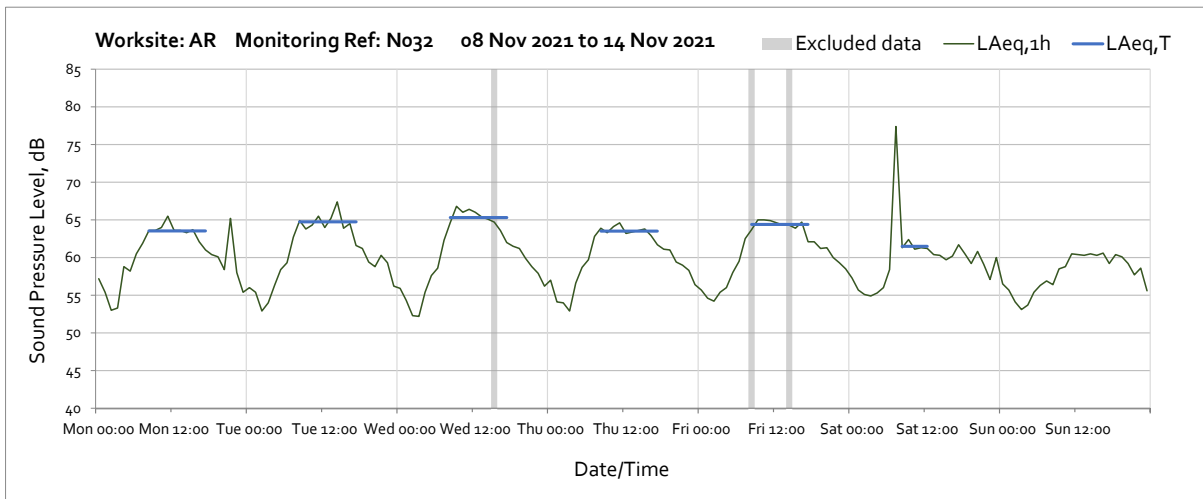
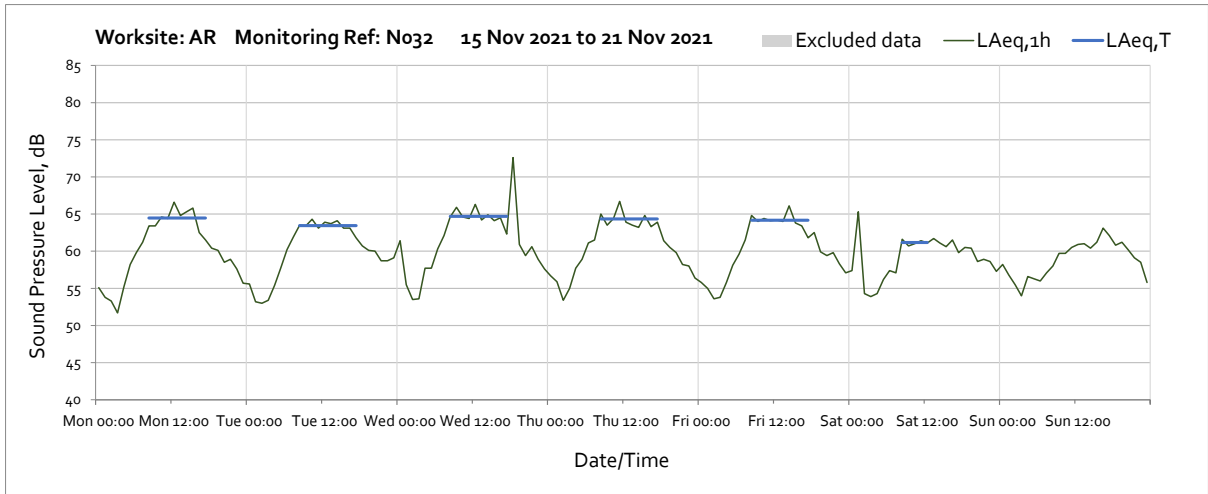
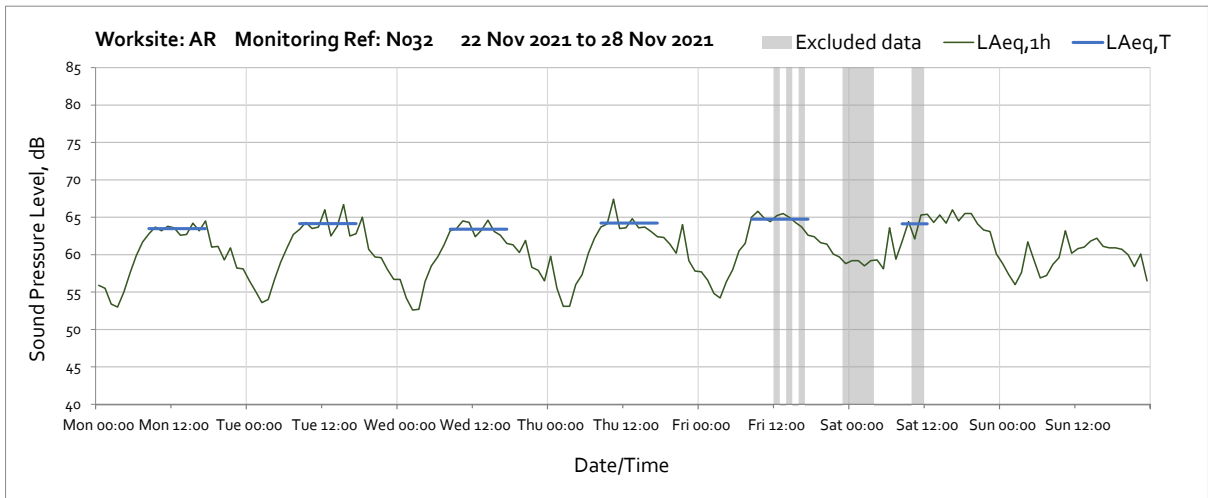
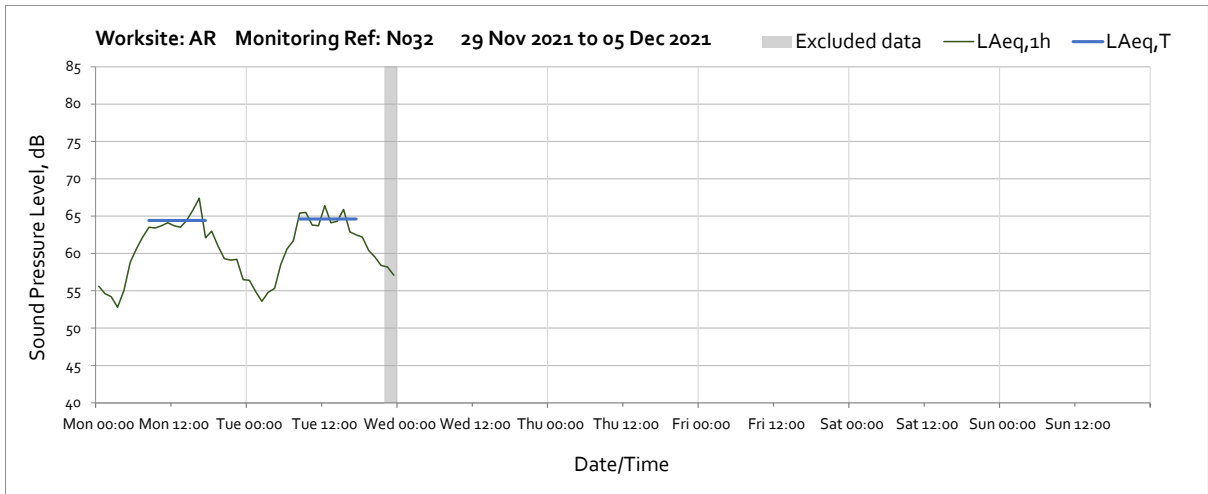
Worksite: Atlas Road worksite (AR) – Monitoring Ref: N032

The following graphs show the hourly measured ambient noise level $L_{Aeq,1h}$ and, where relevant, the averaged noise level $L_{Aeq,T}$ values, where the time period T is as specified in Table 1 of HS2 Information Paper E23. Periods with adversely weather affected noise levels are greyed out and have been excluded from the calculation of the $L_{Aeq,T}$ values in Table 3 of the main report.

2.1.3 Appendix C presents graphs of the noise and vibration monitoring data over the month for each of the measurement locations. Noise data presented consists of the hourly L_{Aeq} values and, where relevant, the $L_{Aeq,T}$ values (where the time period T has been taken to be the averaging period as specified in Table 1 of HS2 Information Paper E23). Vibration data presented consist of hourly PPV values. The full data set for the monitoring equipment can be found at the following location: <https://data.gov.uk/dataset/24542ae7-dd44-444f-b259-871c4cc43b5e/environmental-monitoring-data>.

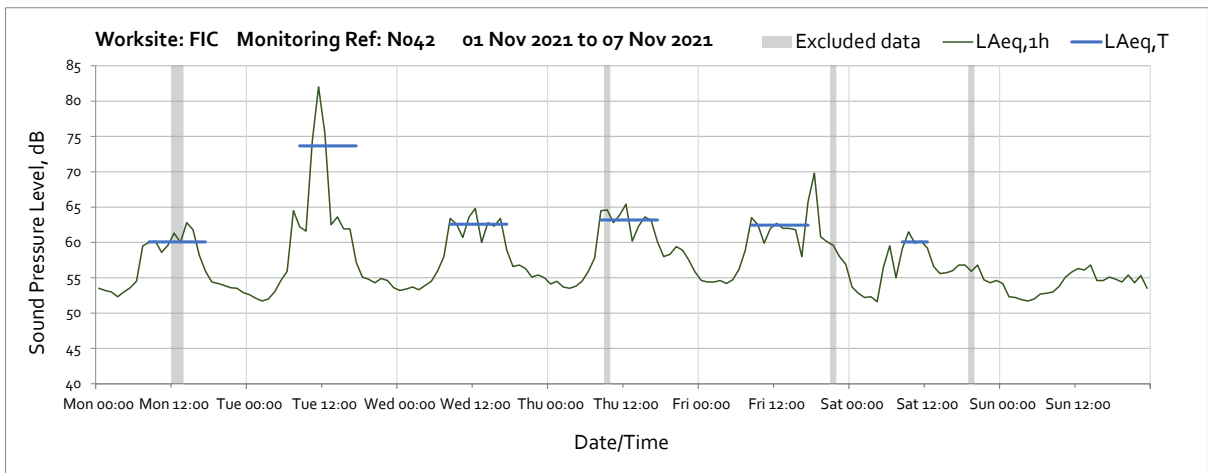
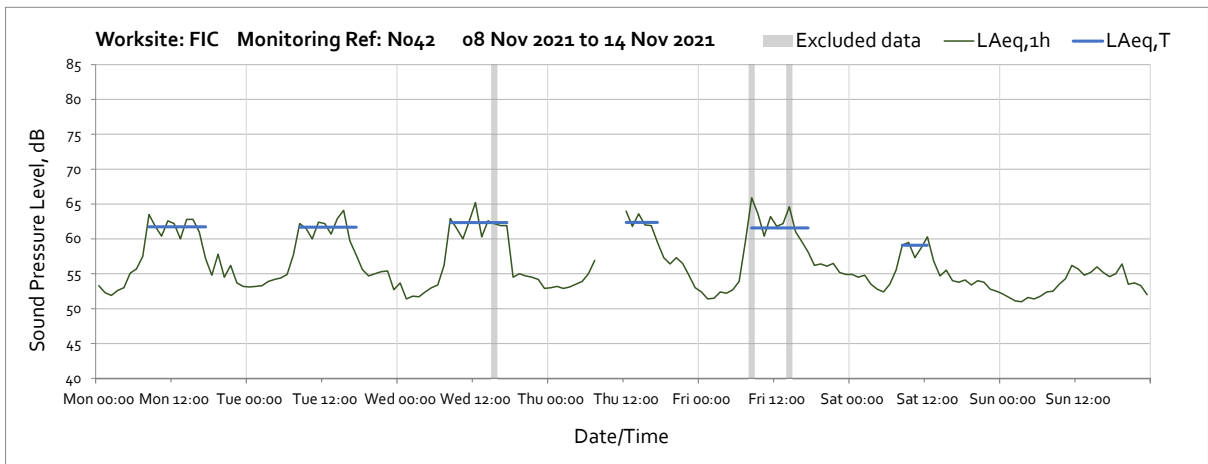
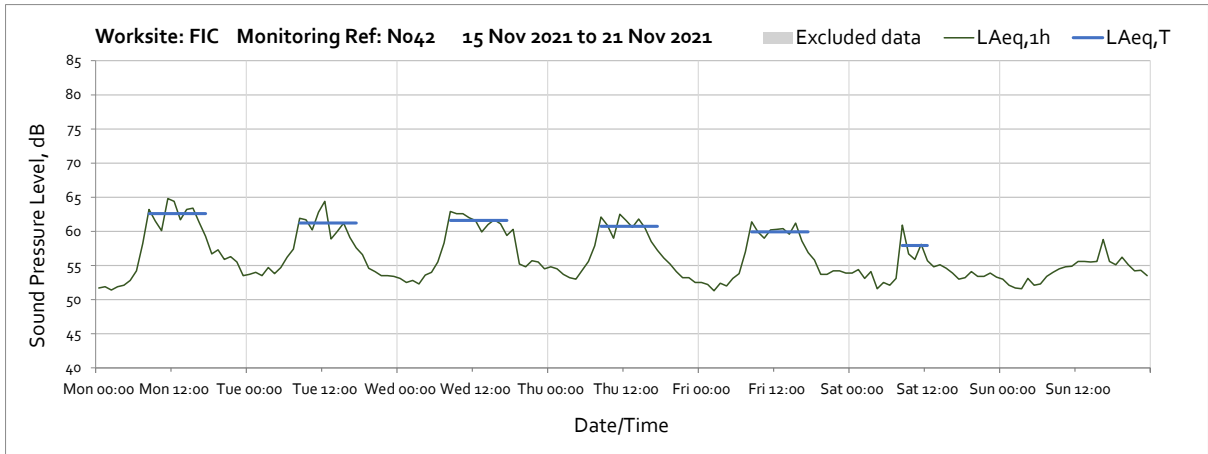
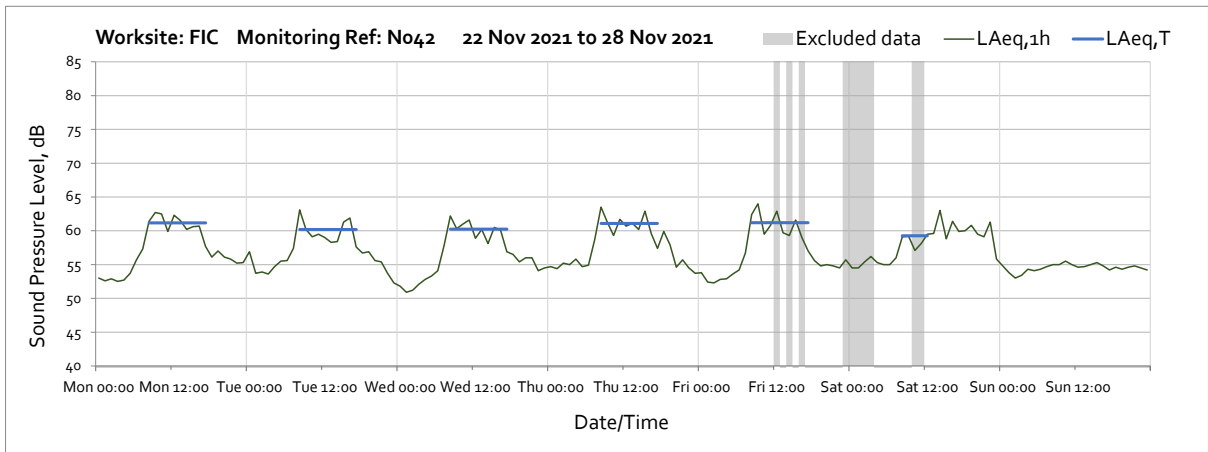
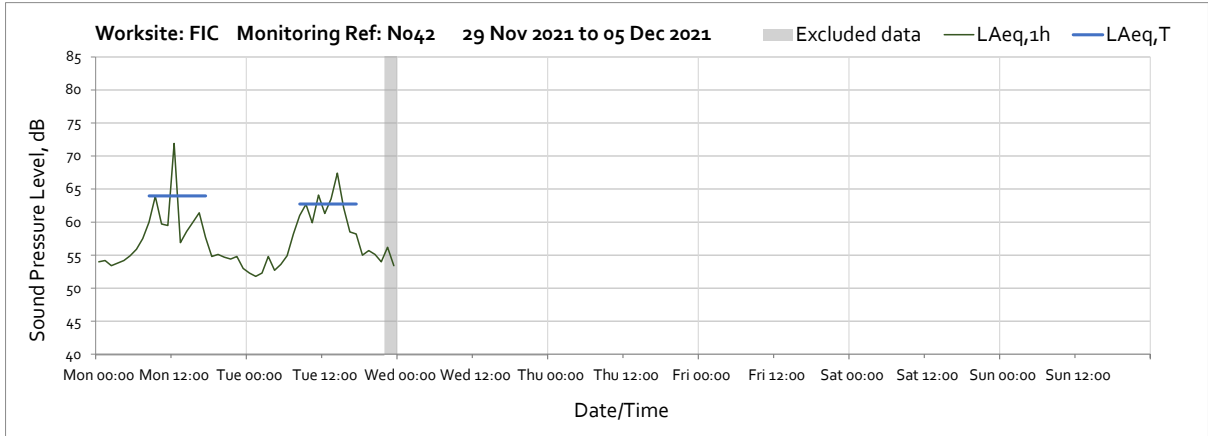
Worksite: Flat Iron Compound (FIC) – Monitoring Ref: N042

Note: Missing data between 08:00 and 11:00 on Thursday 11th November was due to a memory card error.

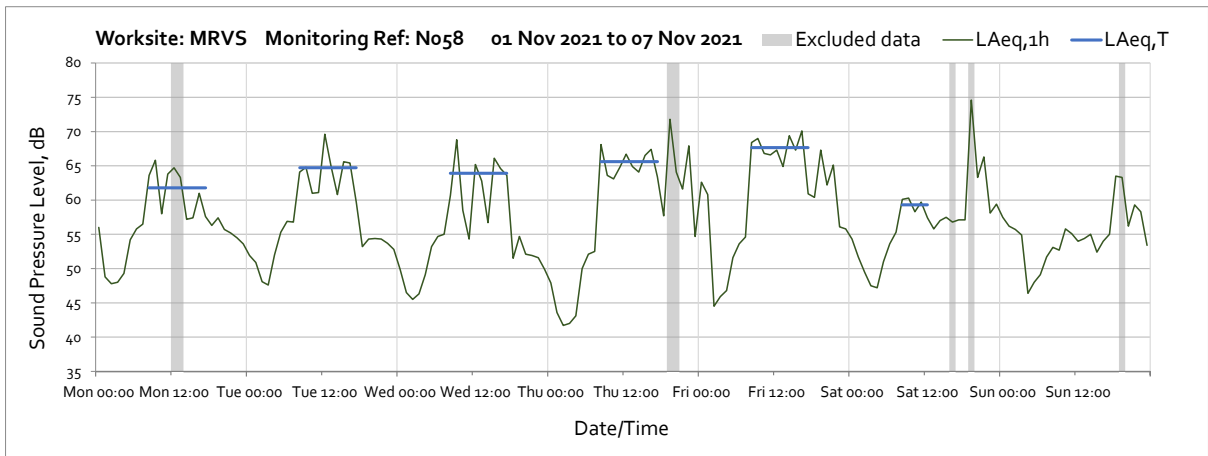
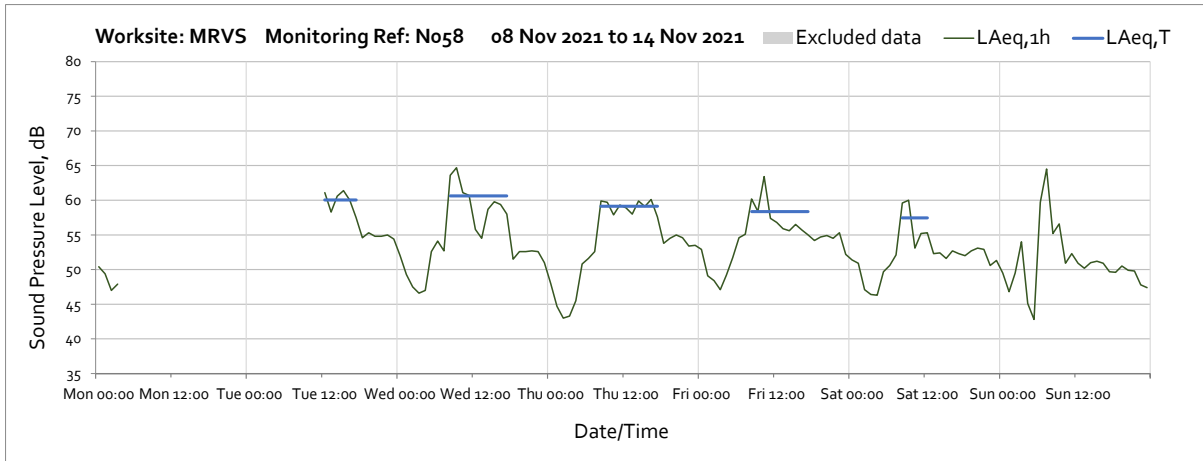
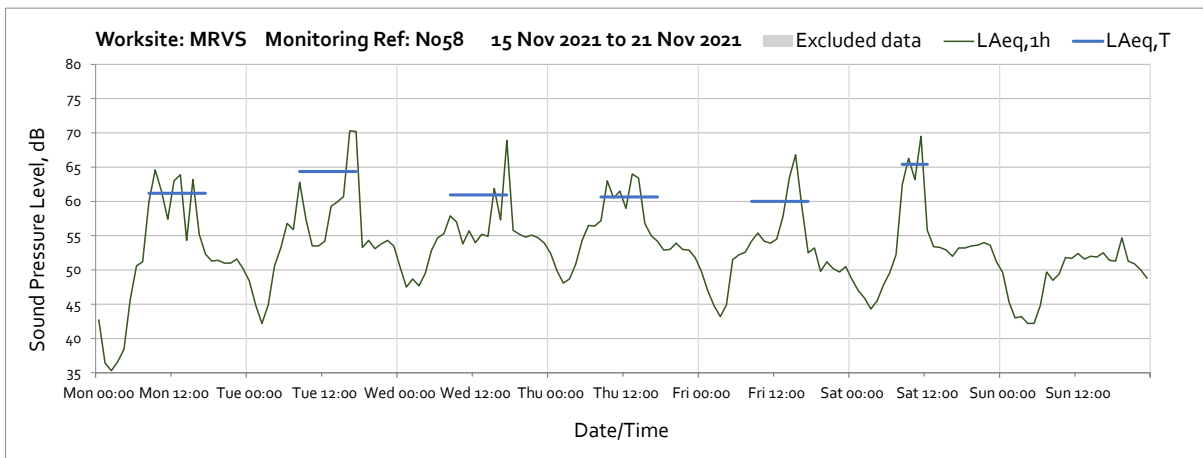
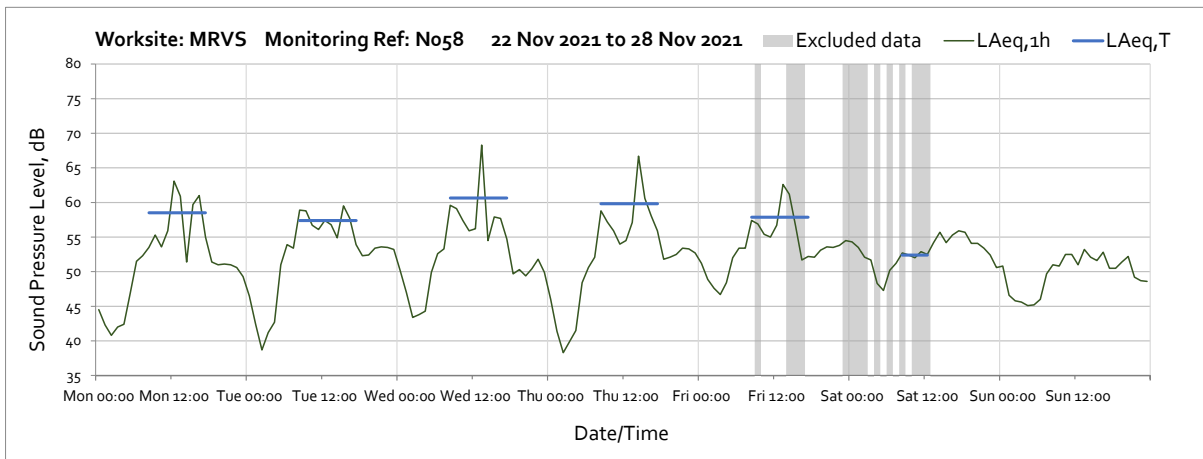
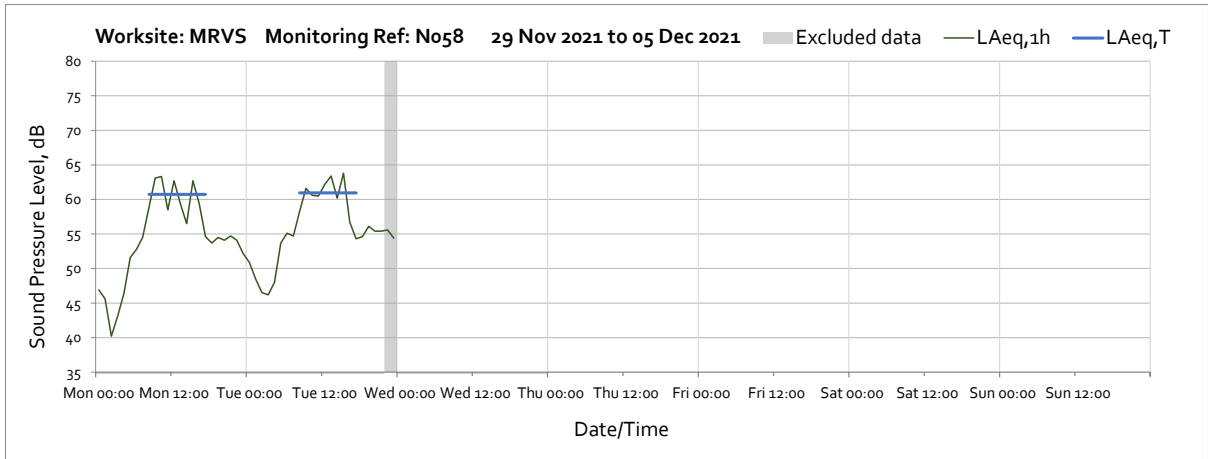
Worksite: Mandeville Road Ventilation Shaft (MRVS) - Monitoring Ref: N058

Note: Missing data between 04:00 on Monday 8th November and 11:00 on Tuesday 9th November was due to loss of continuous power at the monitoring station.

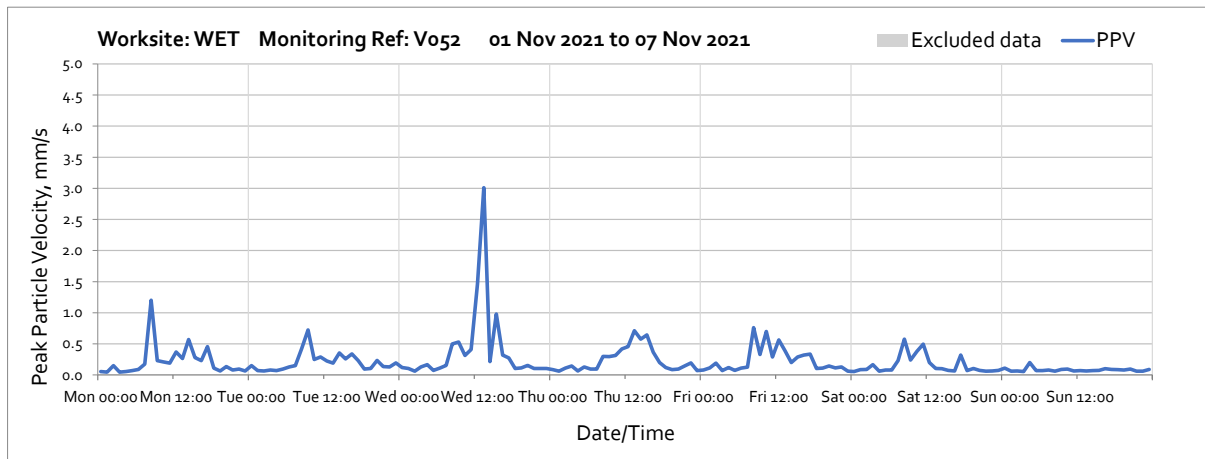
Worksite: Willesden Euro Terminal (WET) – Monitoring Ref: V052

The following graphs show the hourly measured peak particle velocity PPV recorded during the monitoring period. The graphs show the highest PPV of the three orthogonal axis x, y and z. Where high values of PPV were caused by local interference with the vibration monitor, which are not representative of HS2 construction works, these values have been greyed out in the following charts and have been excluded to calculate values in Table 4 of the main report.

Note: High vibration levels measured at 08:00 on Monday 1st November and 13:00 on Wednesday 3rd November were due to concrete cutting using a floor saw.

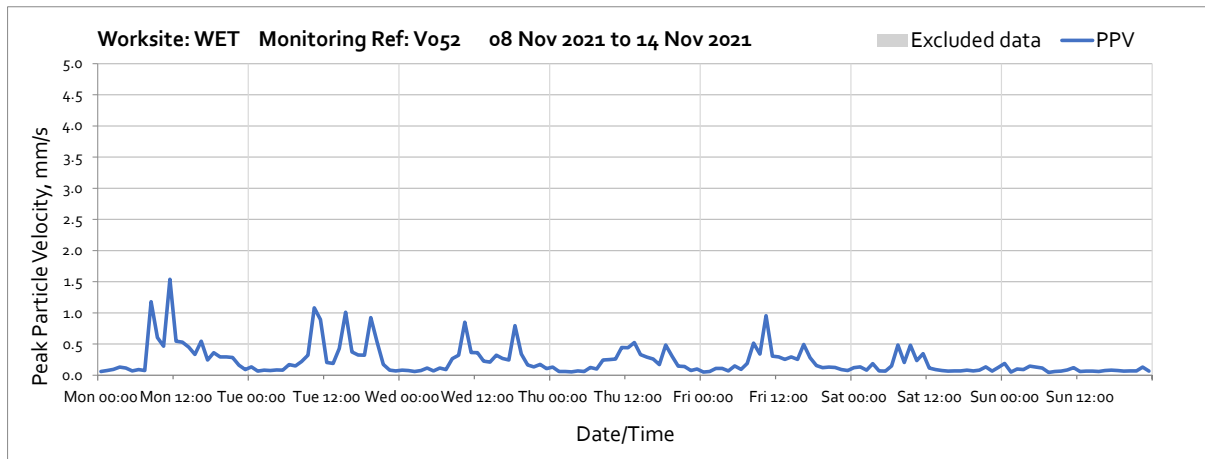
Note: High vibration levels measured at 08:00 and 11:00 on Monday 8th November and 10:00 on Tuesday 9th November were due to concrete cutting using a floor saw.

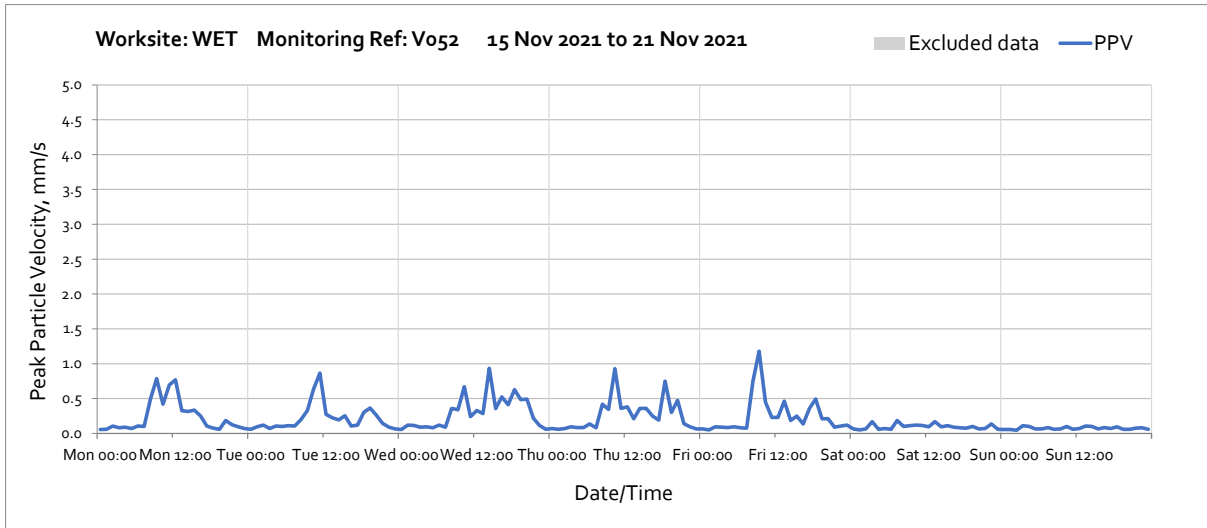
Note: High vibration levels measured at 09:00 on Friday 19th November were due to concrete cutting using a floor saw.

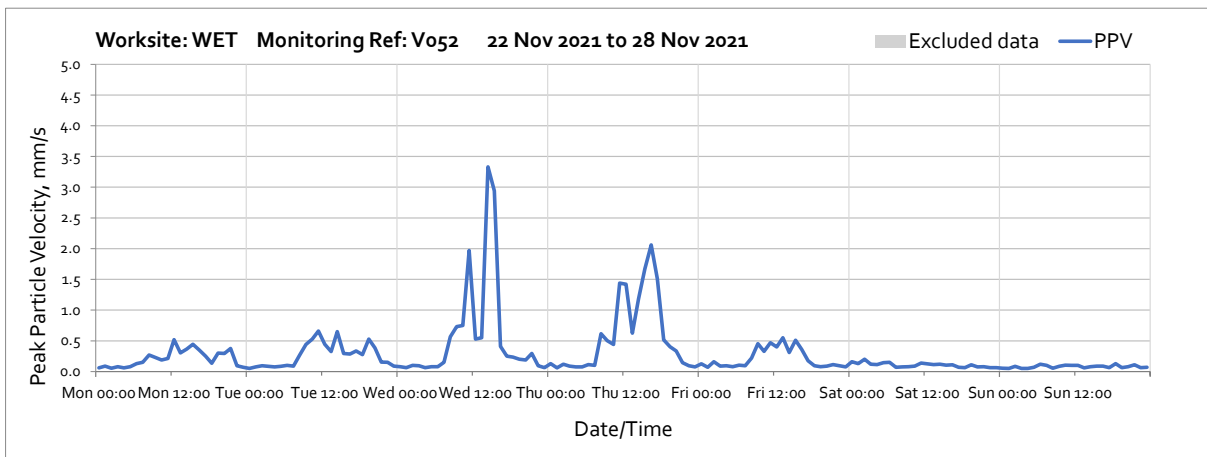
Note: High vibration levels measured from 11:00 until 15:00 on Wednesday 24th November and from 11:00 until 17:00 on Thursday 25th November were due to concrete cutting using a floor saw.

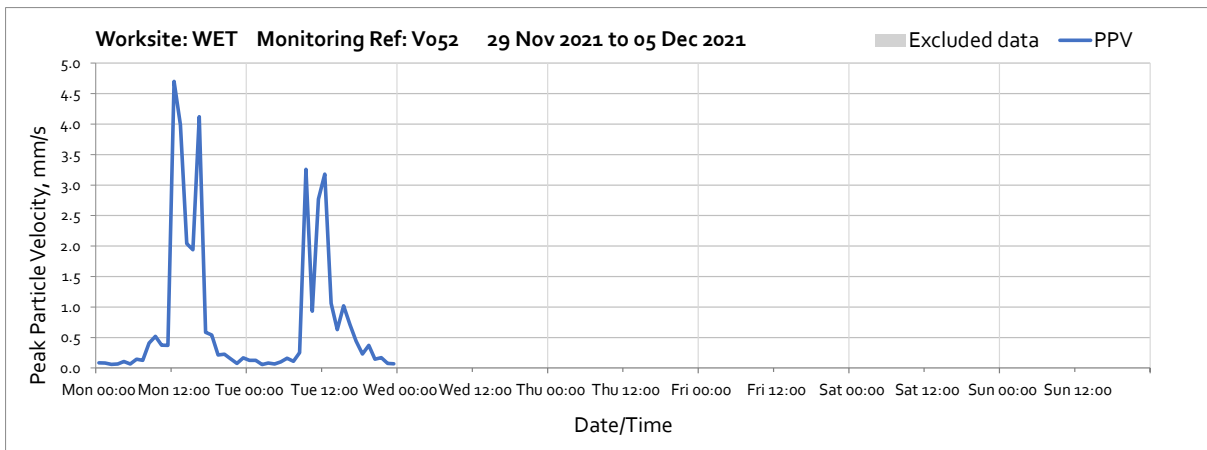
Note: High vibration levels measured from 12:00 until 16:00 on Monday 29th November and from 09:00 until 15:00 on Tuesday 30th November were due to concrete cutting using a floor saw.

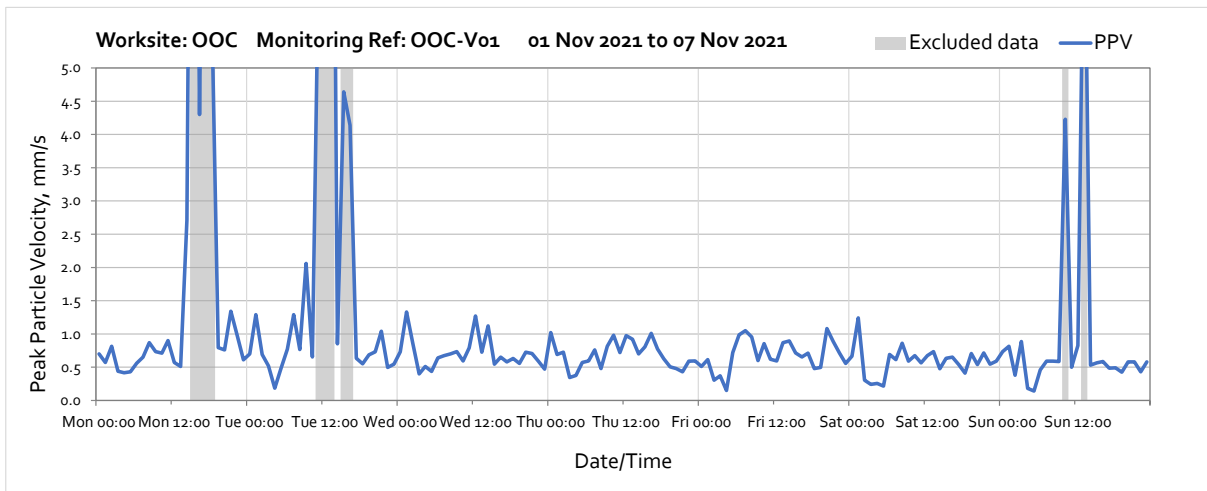
Worksite: Old Oak Common (OOC) – Monitoring Ref: OOC-V01

Note: High vibration levels measured across the week were due to residents activity close to the vibration monitor and not representative of HS2 vibration levels.

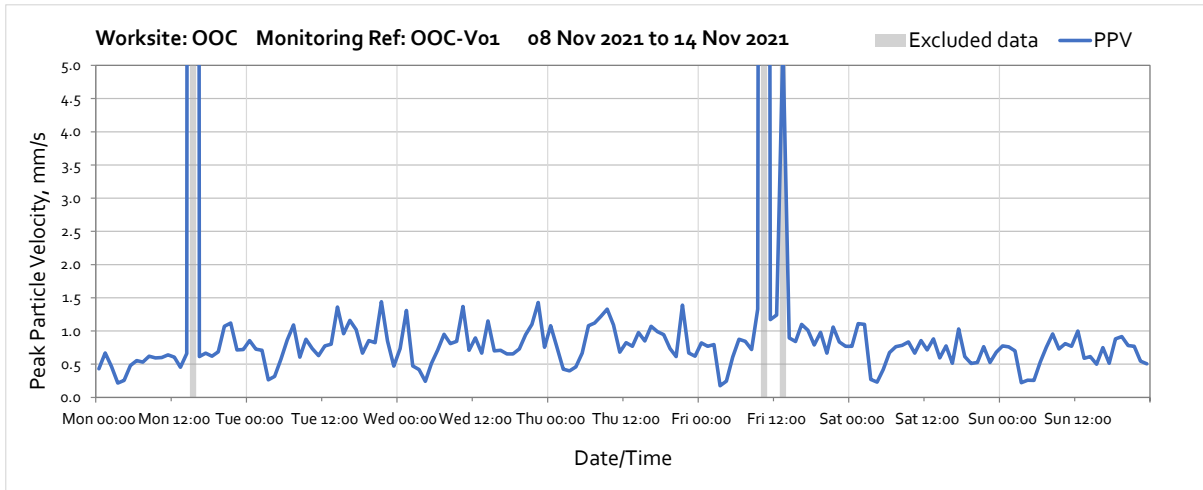
Note: High vibration levels measured across the week were due to residents activity close to the vibration monitor and not representative of HS2 vibration levels.

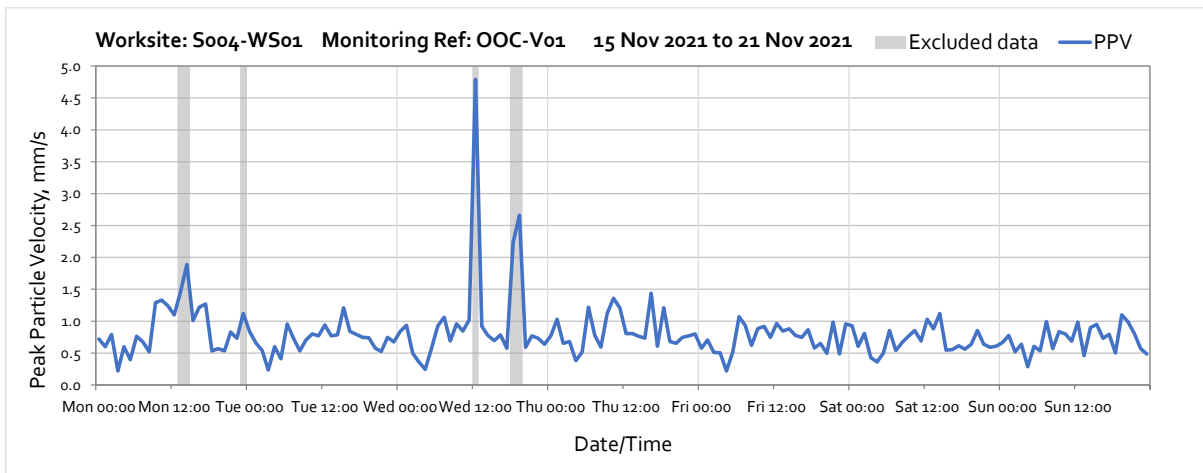
Note: High vibration levels measured across the week were due to residents activity close to the vibration monitor and not representative of HS2 vibration levels.

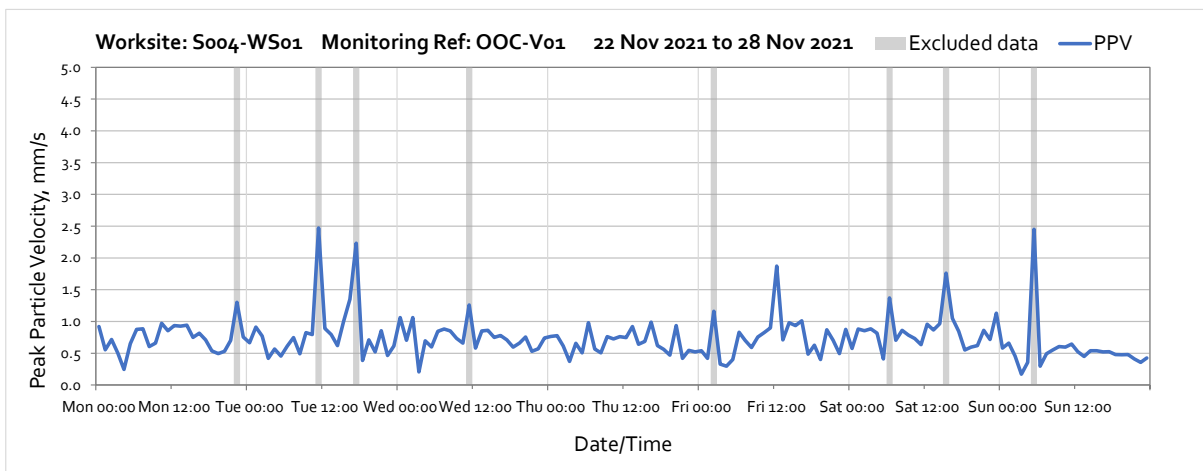
Note: High vibration levels measured across the week were due to residents activity close to the vibration monitor and not representative of HS2 vibration levels.

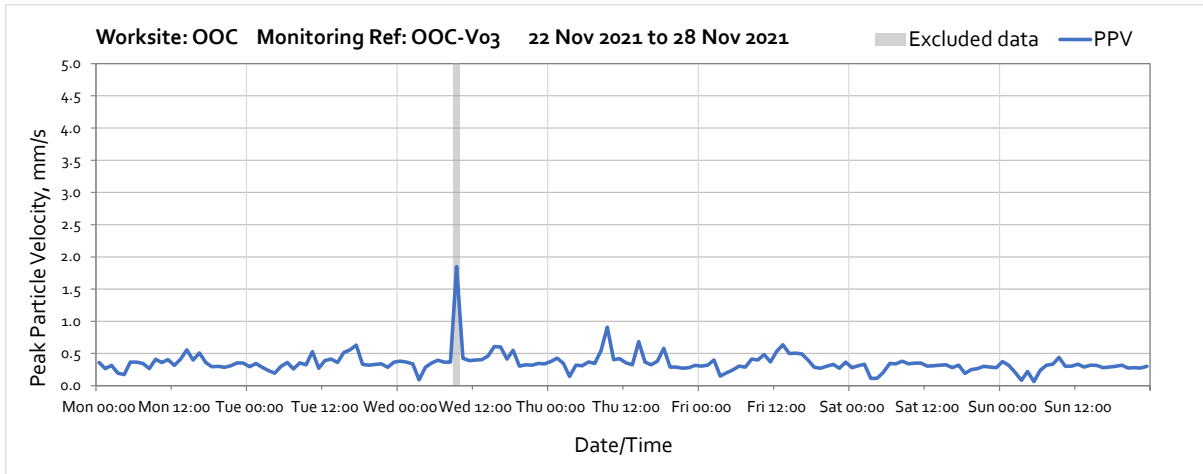
Worksite: Old Oak Common (OOC) – Monitoring Ref: OOC-V03

Note: High vibration levels measured at 09:00 on Wednesday 24th November were due local disturbance and not representative of HS2 vibration levels.

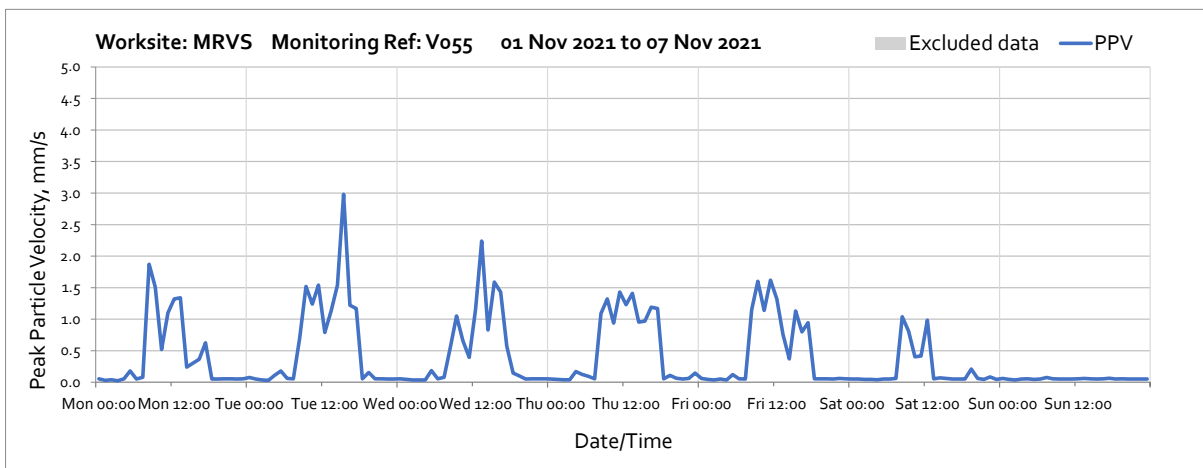
Worksite: Mandeville Road Vent Shaft (MRVS) – Monitoring Ref: V055

Note: High vibration levels measured across the week were caused by the access road maintenance works undertaken in proximity of the vibration monitor location.

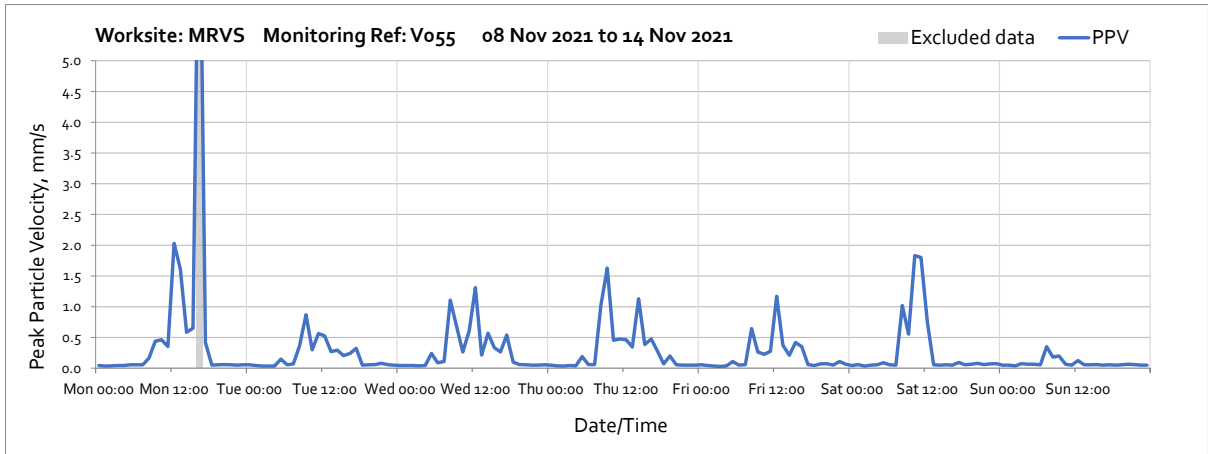
Note: High vibration levels measured across the week were caused by the access road maintenance works undertaken in proximity of the vibration monitor location.

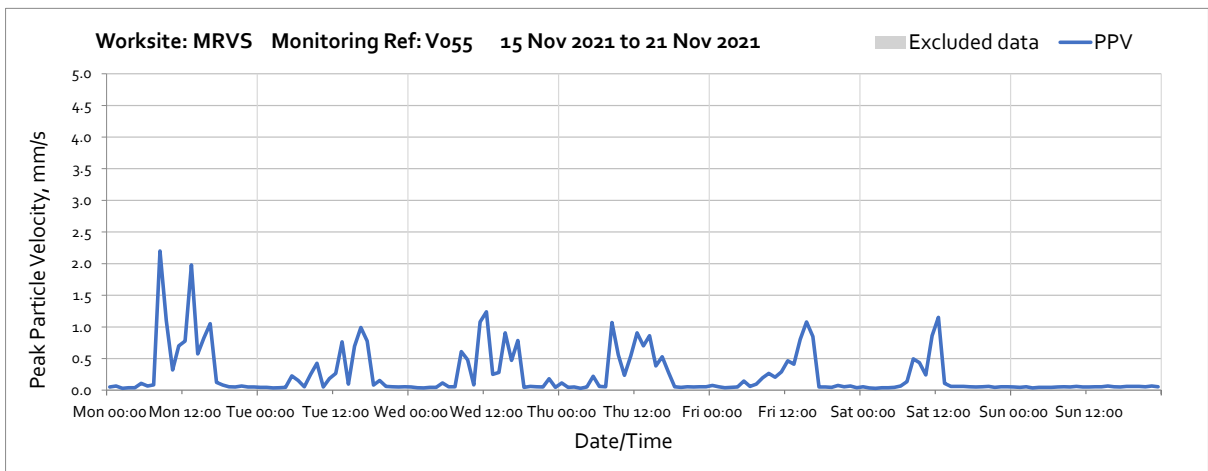
Note: High vibration levels measured across the week were caused by the access road maintenance works undertaken in proximity of the vibration monitor location.

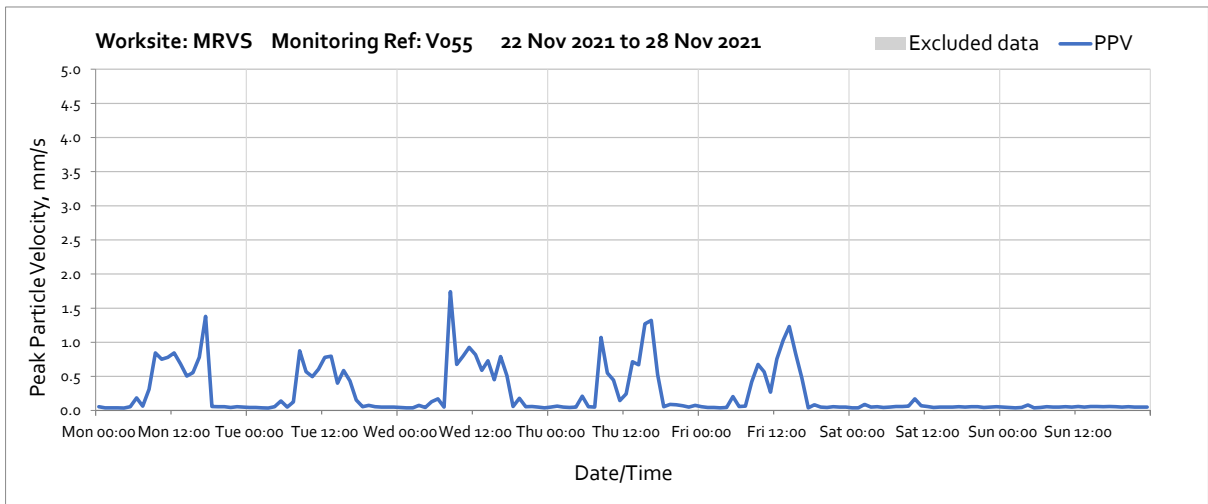
Note: High vibration levels measured across the week were caused by the access road maintenance works undertaken in proximity of the vibration monitor location.

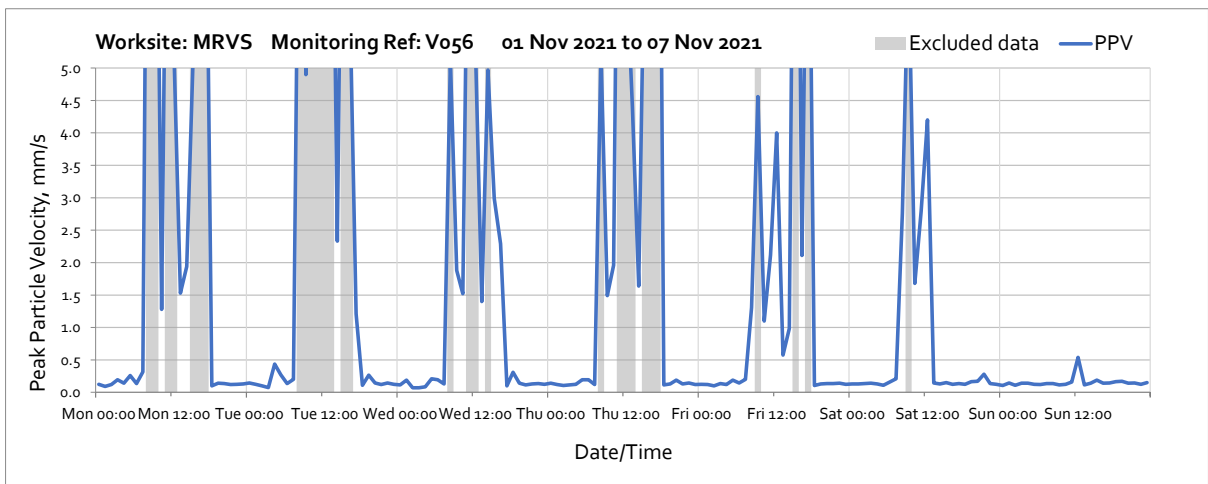
Worksite: Mandeville Road Vent Shaft (MRVS) – Monitoring Ref: V056

Note: High vibration levels measured across the week were caused by the access road maintenance works, the vibration roller compacting the ground very close to monitor and not representative of HS2 vibration levels.

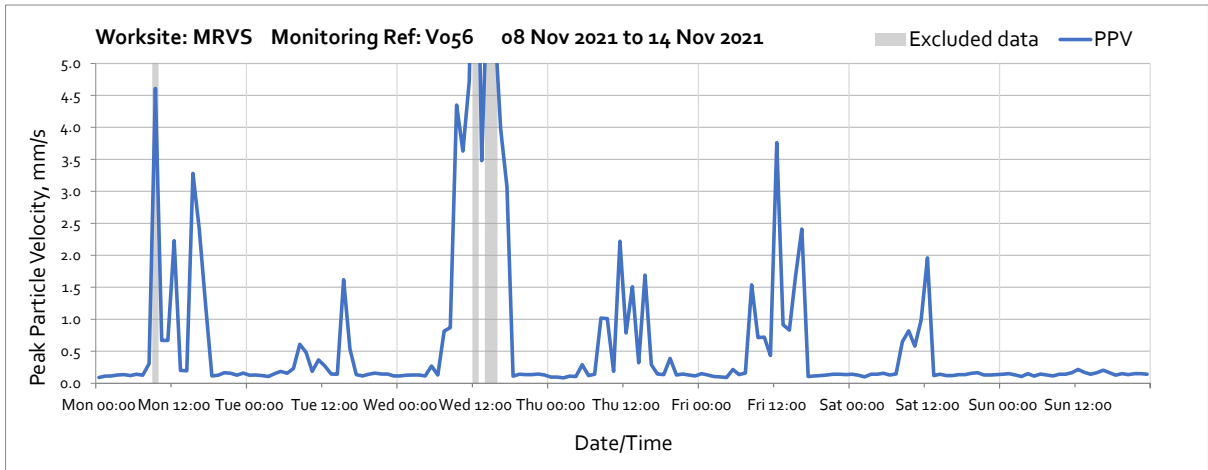
Note: High vibration levels measured across the week were caused by the access road maintenance works, the vibration roller compacting the ground very close to monitor and not representative of HS2 vibration levels.

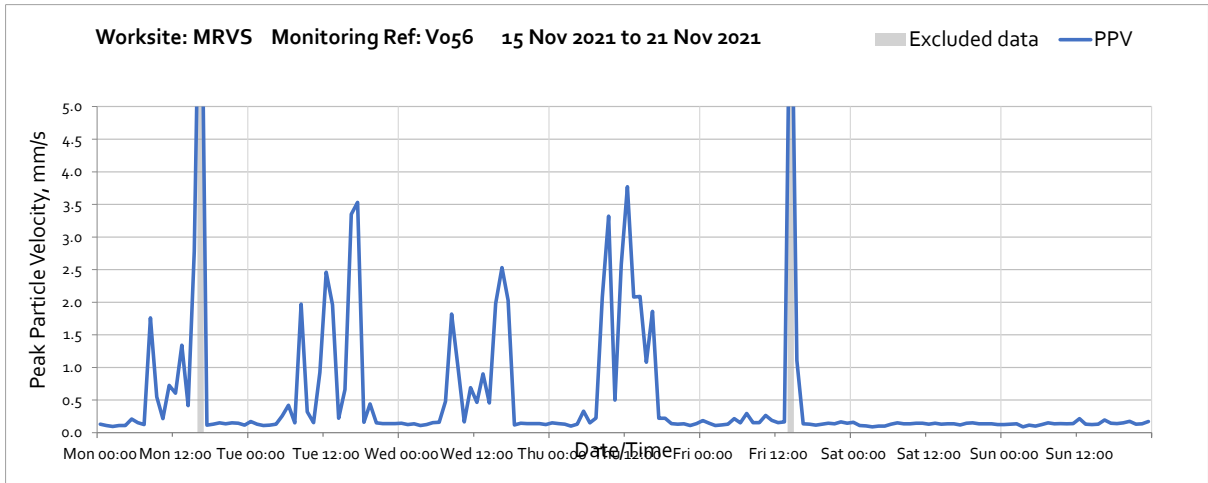
Note: High vibration levels measured across the week were caused by the access road maintenance works, the vibration roller compacting the ground very close to monitor and not representative of HS2 vibration levels.

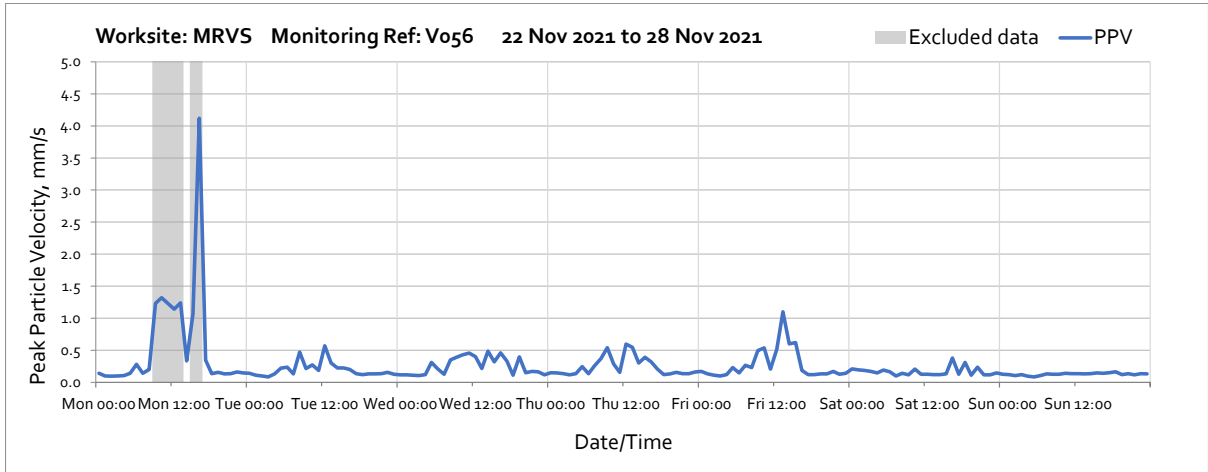
Note: High vibration levels measured across the week were caused by the access road maintenance works, the vibration roller compacting the ground very close to monitor and not representative of HS2 vibration levels.

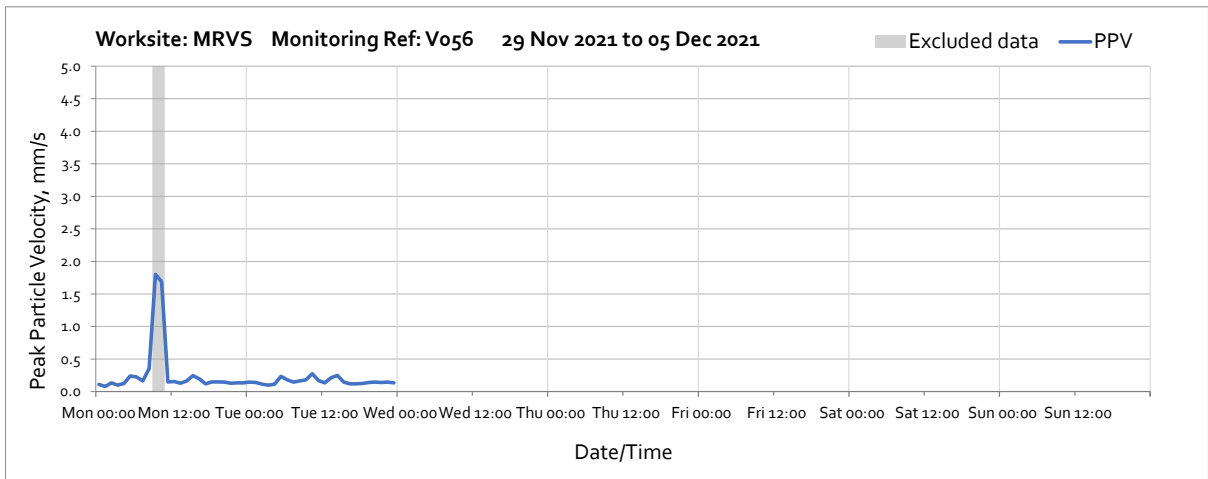
Note: High vibration levels measured across the week were caused by the access road maintenance works, the vibration roller compacting the ground very close to monitor and not representative of HS2 vibration levels.

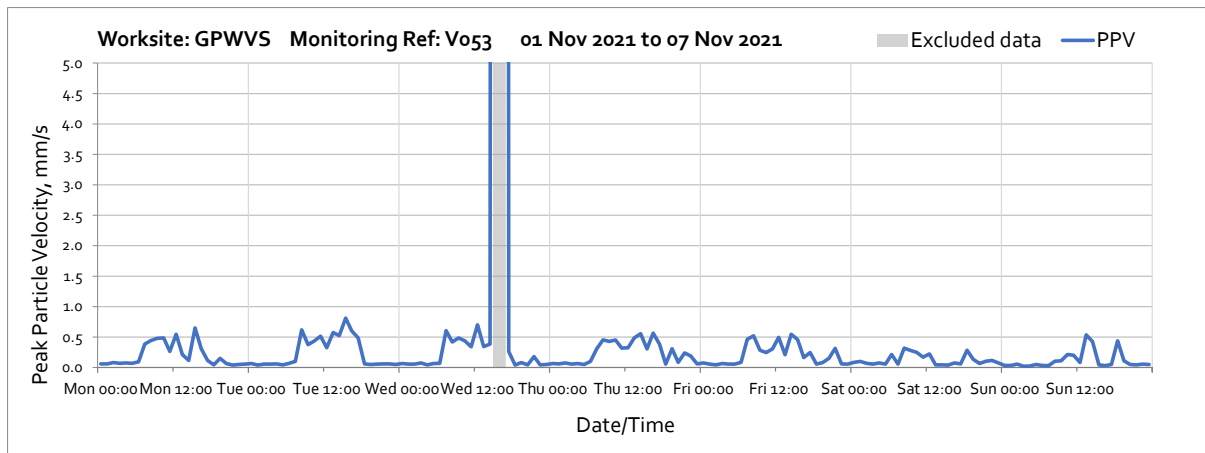
Worksite: Green Park Way Vent Shaft (GPWVS) – Monitoring Ref: V053

Note: High vibration levels measured in between 15:00 and 16:00 on Wednesday 3rd November 2021 were due to residents activity close to the vibration monitor and not representative of HS2 vibration levels.

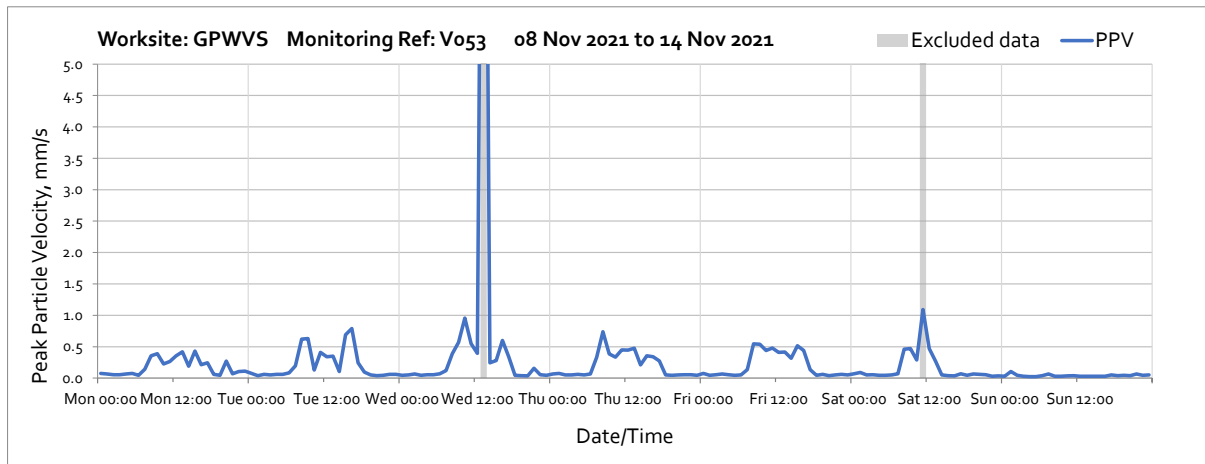
Note: High vibration levels measured 13:00 on Wednesday 3rd November 2021 were due to residents activity close to the vibration monitor and not representative of HS2 vibration levels.

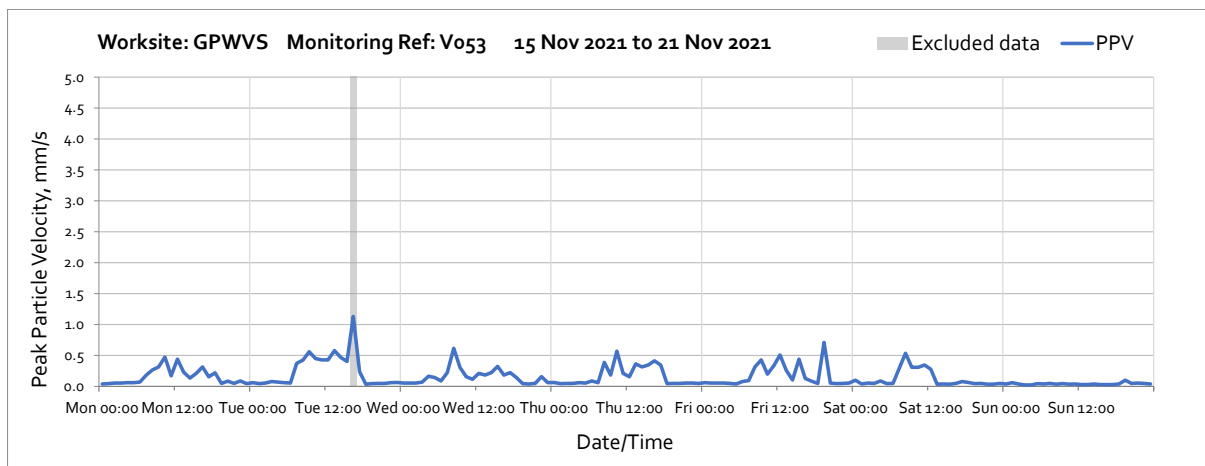
Note: High vibration levels measured 16:00 on Tuesday 16th November 2021 were due to residents activity close to the vibration monitor and not representative of HS2 vibration levels.
