Construction noise and vibration Monthly Report – November 2021

London Borough of Ealing

This Noise and Vibration Monitoring Report fulfils HS2 Limited's commitment detailed in the Environmental Minimum Requirements (EMRs), Annex 1, Code of Construction Practice, to present the results of noise and vibration monitoring carried out within the London Borough of Ealing (LBE) (including one monitoring location on the boundary with the London Borough of Hammersmith and Fulham) during the month of November 2021.

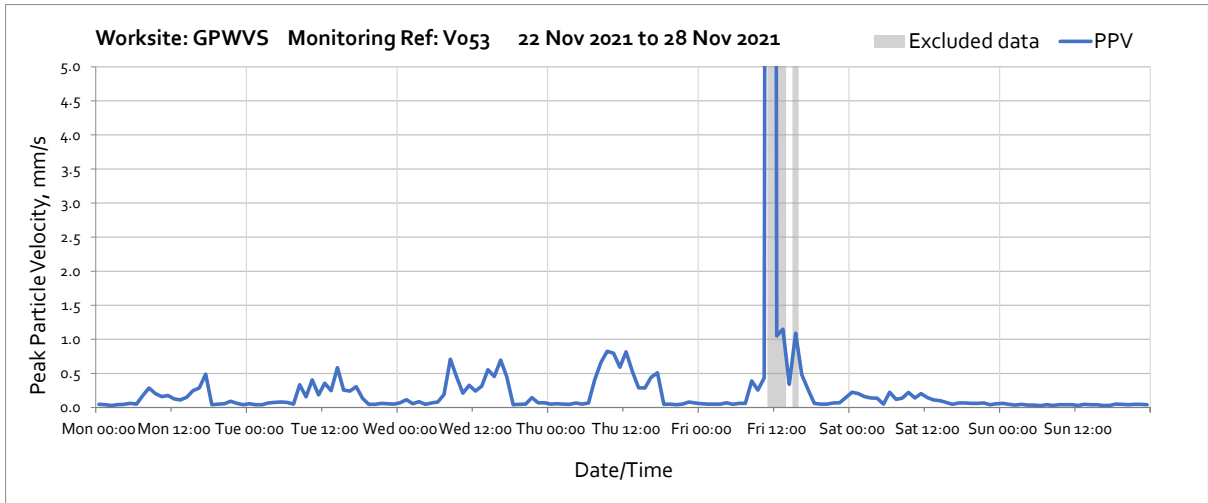
Note: High vibration levels measured in between 11:00 and 15:00 on Friday 26th November 2021 were due to residents activity close to the vibration monitor and not representative of HS2 vibration levels.

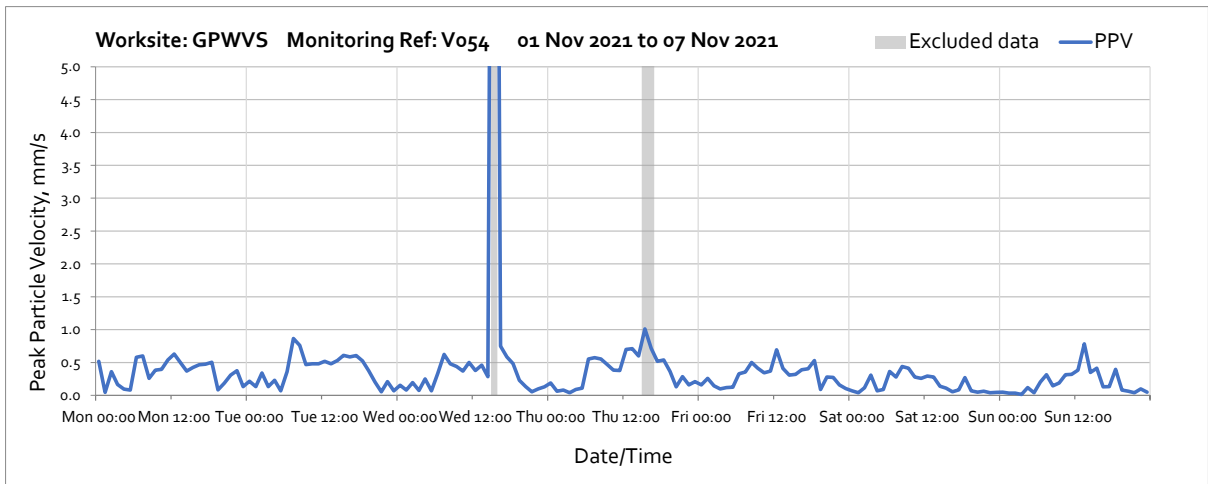
Worksite: Green Park Way Vent Shaft (GPWVS) – Monitoring Ref: V054

Note: High vibration levels measured at 15:00 on Wednesday 3rd November 2021 and from 15:00 until 16:00 on Thursday 4th November were due to residents activity close to the vibration monitor and not representative of HS2 vibration levels.

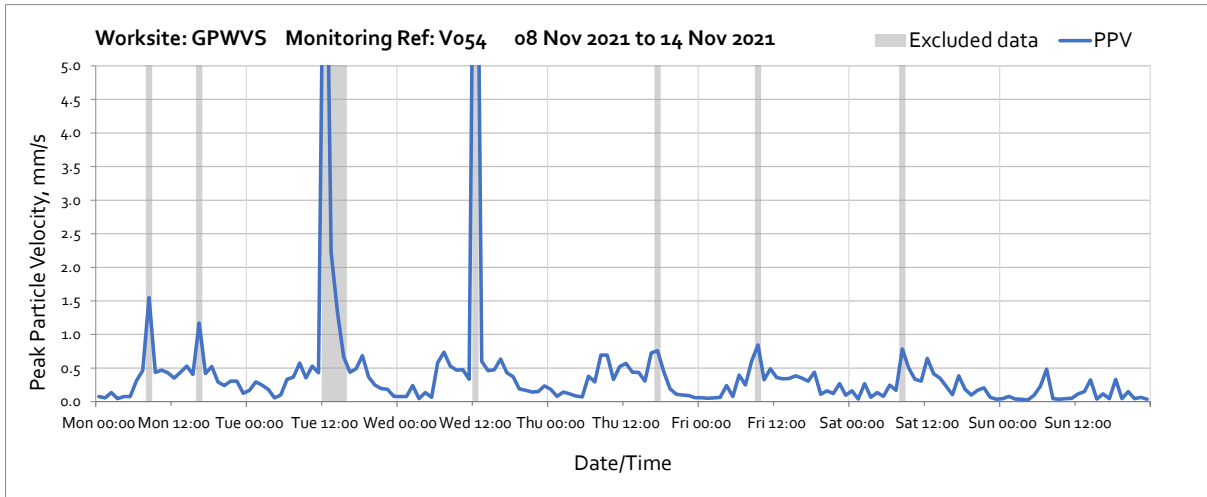
Note: High vibration levels measured across the week were due to residents activity close to the vibration monitor and not representative of HS2 vibration levels.

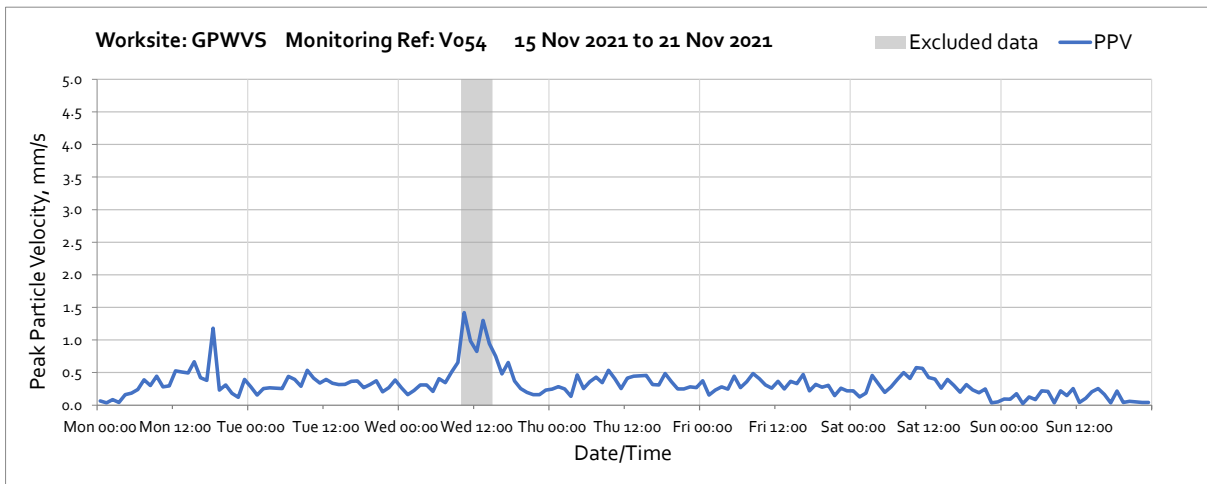
Note: High vibration levels measured across the week were due to residents activity close to the vibration monitor and not representative of HS2 vibration levels.

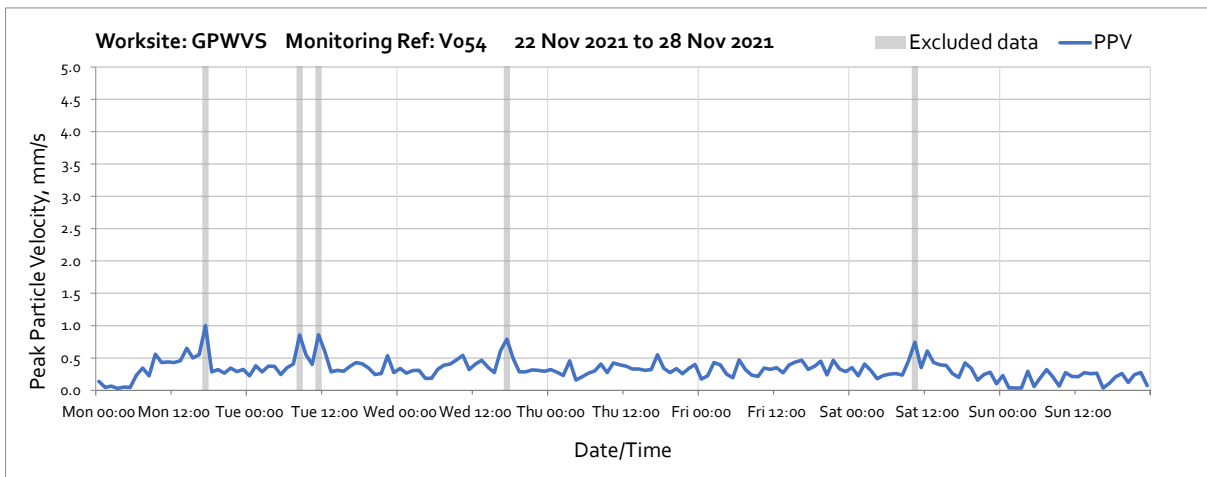
Note: High vibration levels measured across the week were due to residents activity close to the vibration monitor and not representative of HS2 vibration levels.
