Construction noise and vibration Monthly Report – December 2021

Birmingham City

Non-Technical Summary

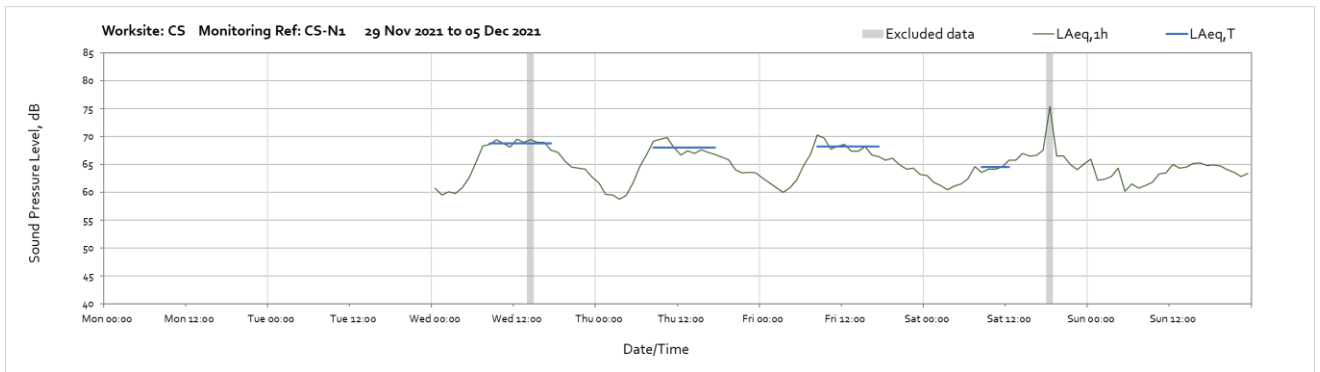
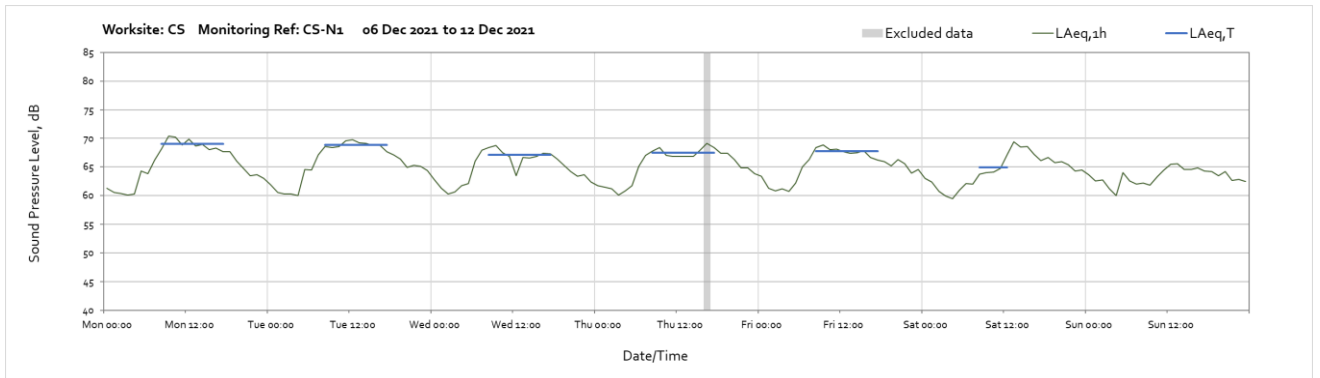
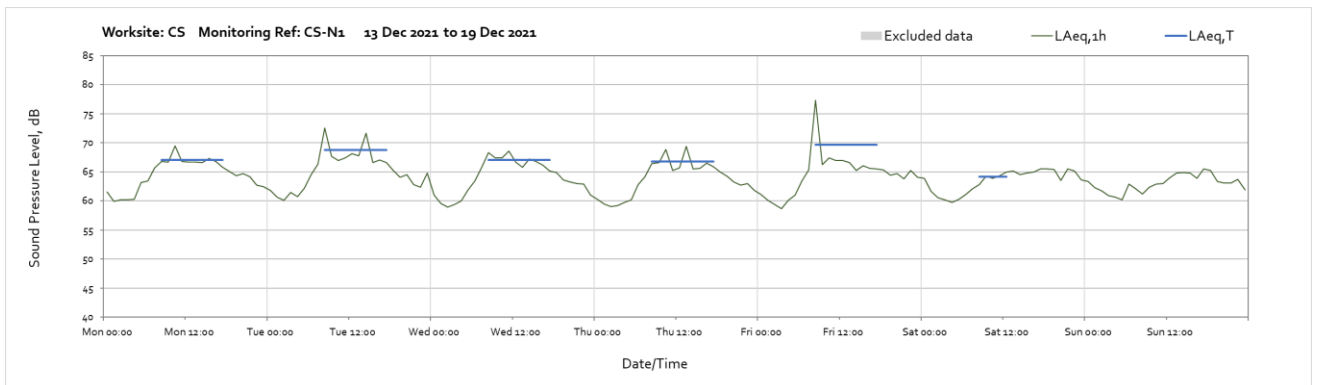
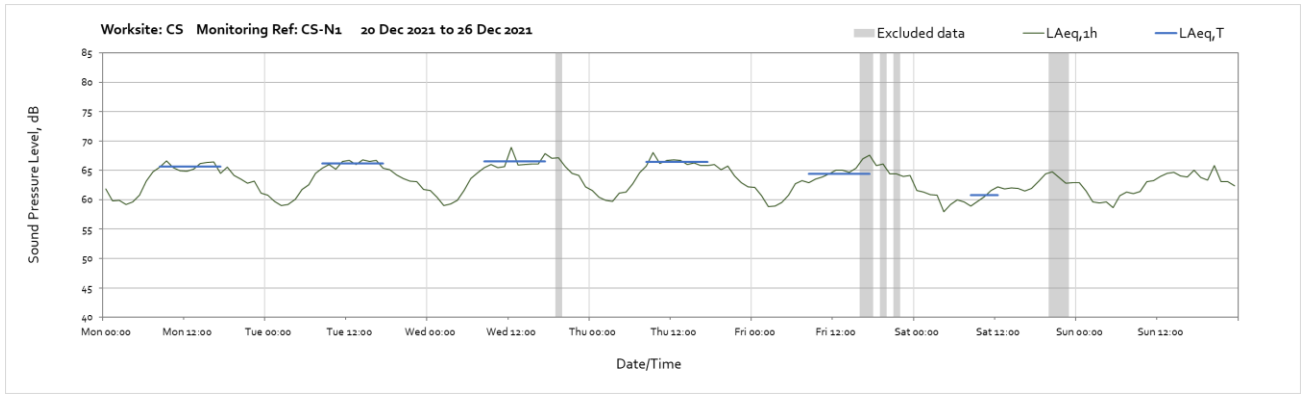
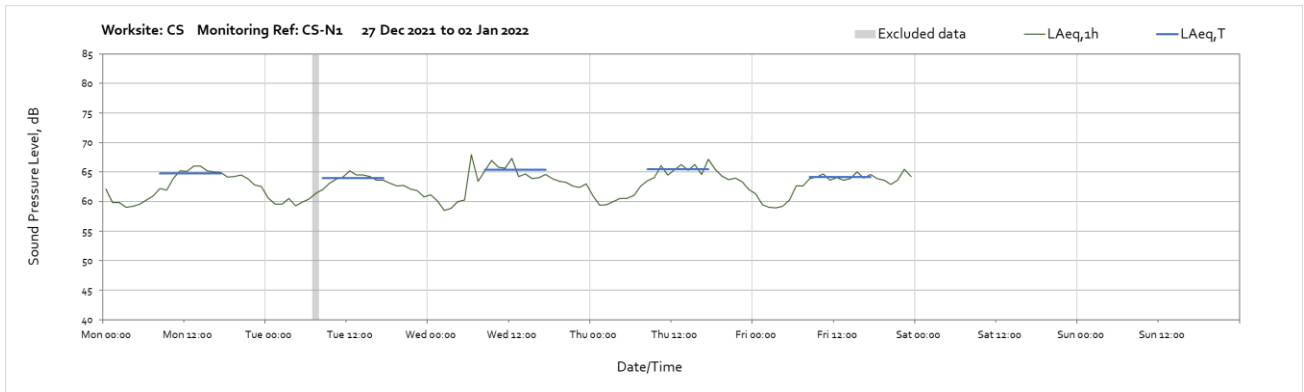
Worksite: Curzon Street (CS) – Monitoring Ref: CS-N1

The following graphs show the hourly measured ambient noise level $L_{Aeq,1h}$ and, where relevant, the averaged noise level $L_{Aeq,T}$ values, where the time period T is as specified in Table 1 of HS2 Information Paper E23. Periods with adversely weather affected noise levels are greyed out and have been excluded from the calculation of the $L_{Aeq,T}$ values in Table 3 of the main report.

2.1.3 Appendix C presents graphs of the noise and vibration monitoring data over the month for each of the measurement locations. Noise data presented consists of the hourly L_{Aeq} values and, where relevant, the $L_{Aeq,T}$ values (where the time period T has been taken to be the averaging period as specified in Table 1 of HS2 Information Paper E23). Vibration data presented consist of hourly PPV values. The full data set for the monitoring equipment can be found at the following location:

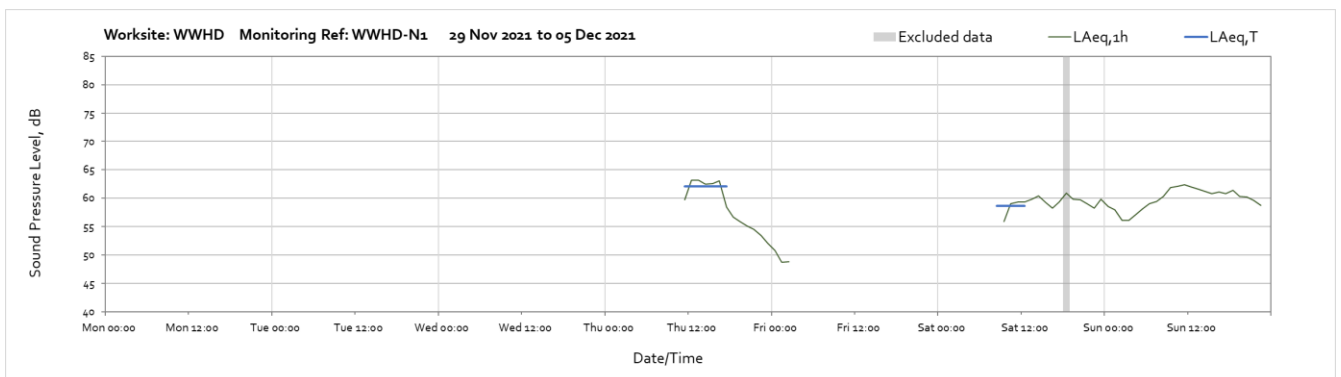
Worksite: Washwood Heath Depot (WWHD) - Monitoring Ref: WWHD-N1

Note: Missing data during the week was due to battery falling below required voltage limit caused by prolonged insufficient sunlight.

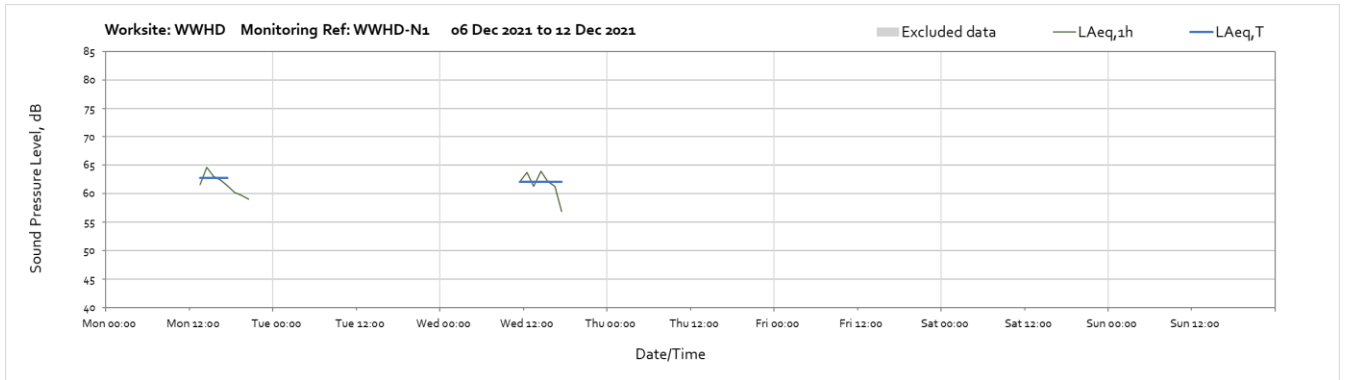
Note: Missing data between 18:00 on Wednesday 8th December and 11:00 on Tuesday 21st December was due to battery falling below required voltage limit caused by prolonged insufficient sunlight.

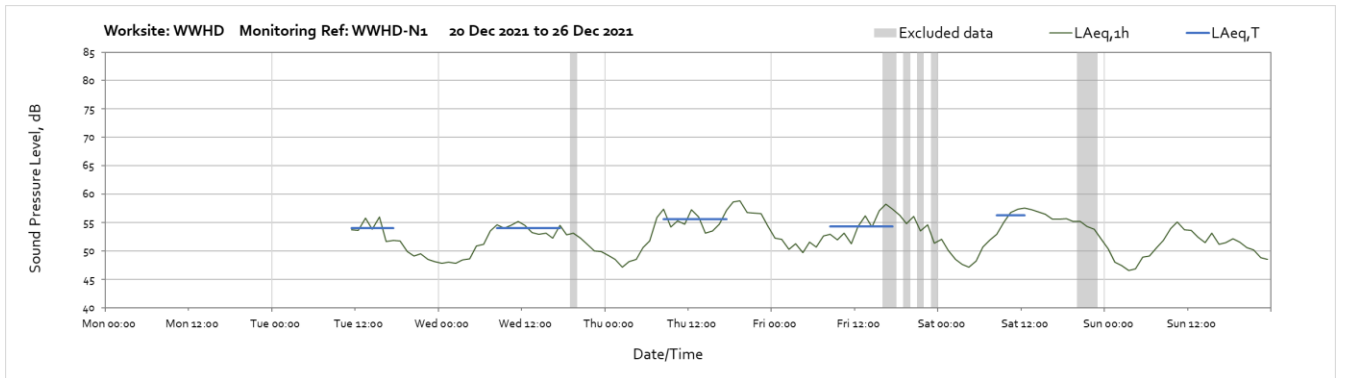
Note: Missing data between 18:00 on Wednesday 8th December and 11:00 on Tuesday 21st December was due to battery falling below required voltage limit caused by prolonged insufficient sunlight.

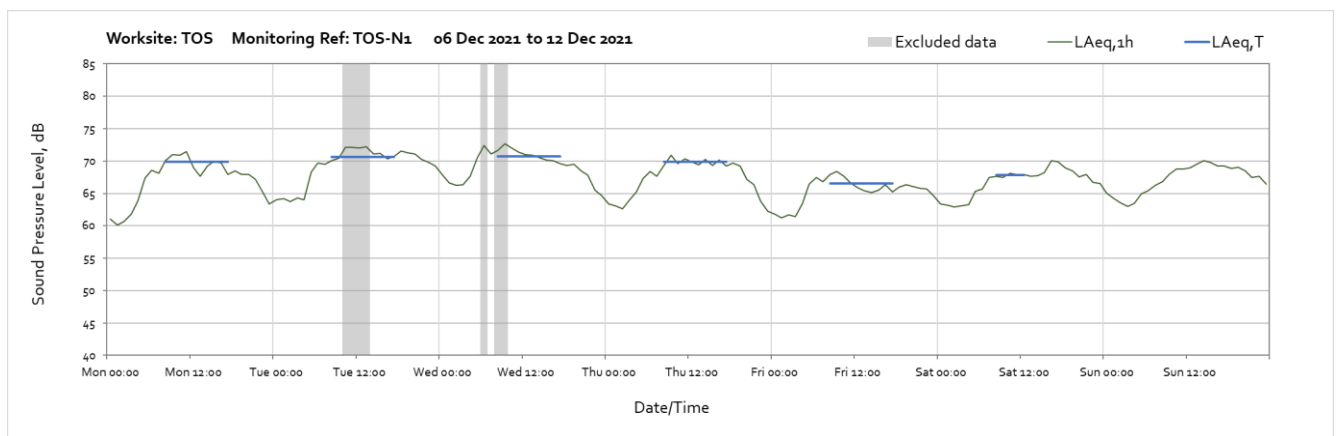
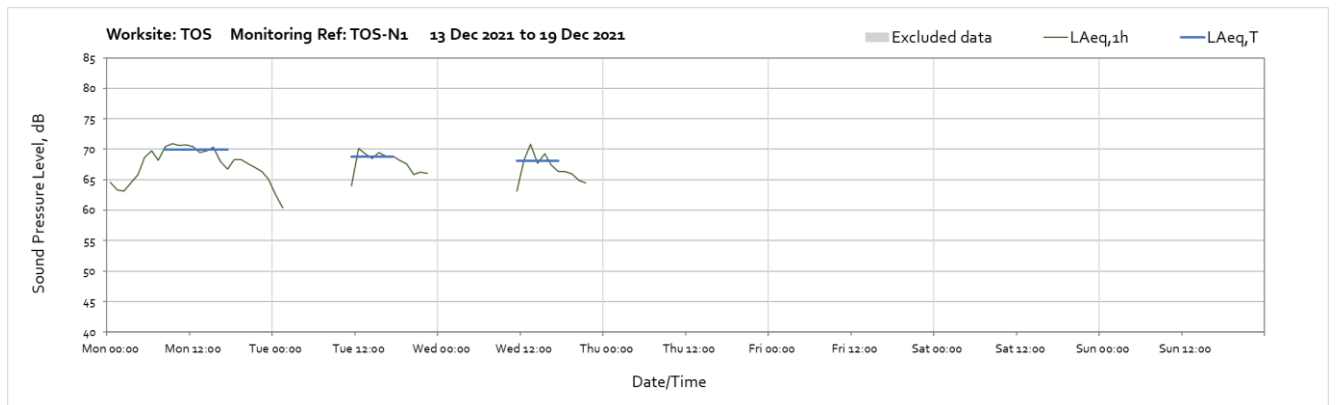
Worksite: Twisted Oak Stables (TOS) – Monitoring Ref: TOS-N1

Note: Missing data between 02:00 and 11:00 on Tuesday 14th December, between 23:00 on Tuesday 14th December and 11:00 on Wednesday 15th December, and between 22:00 on Wednesday 15th December and 14:00 on Tuesday 21st December were due to battery falling below required voltage limit caused by prolonged insufficient sunlight.

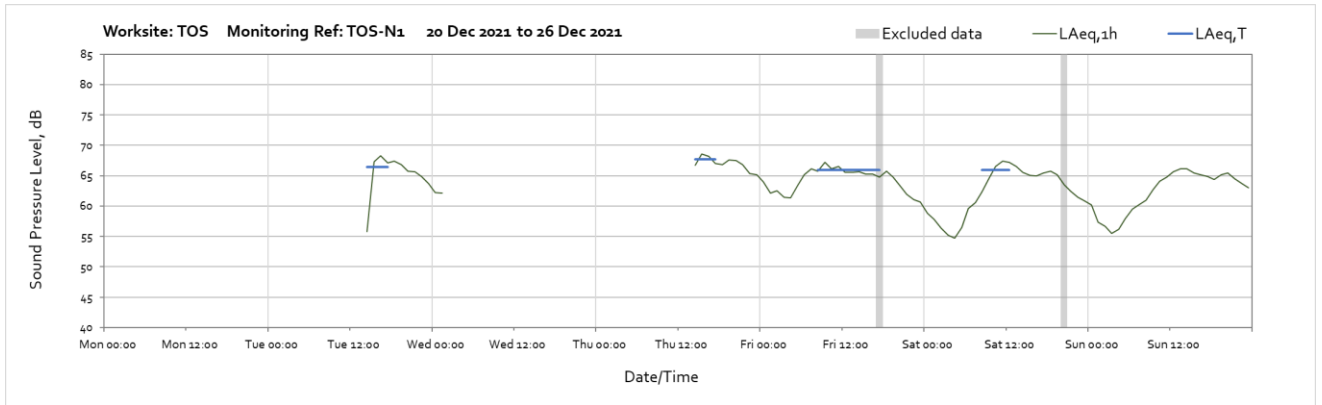
Note: Missing between 22:00 on Wednesday 15th December and 14:00 on Tuesday 21st December, and between 02:00 on Wednesday 22nd December and 14:00 on Thursday 23rd December were due to were due to battery falling below required voltage limit caused by prolonged insufficient sunlight.

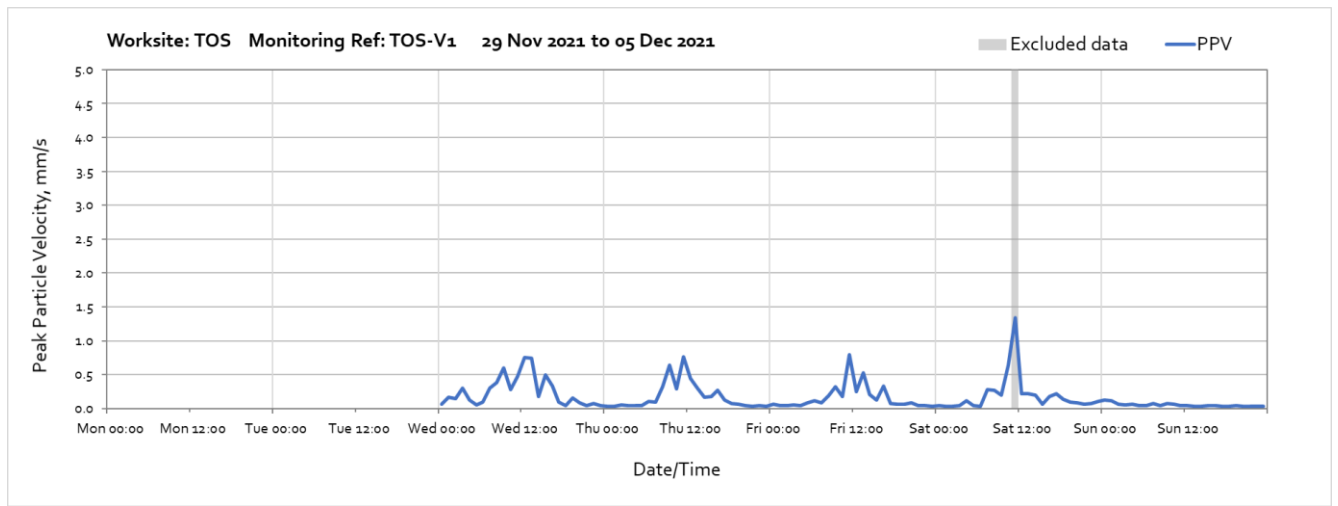
Worksite: Twisted Oak Stables (TOS) – Monitoring Ref: TOS-V1

The following graphs show the hourly measured peak particle velocity PPV recorded during the monitoring period. The graphs show the highest PPV of the three orthogonal axis x, y and z. Where high values of PPV were caused by local interference with the vibration monitor, which are not representative of HS2 construction works, these values have been greyed out in the following charts and have been excluded to calculate values in Table 4 of the main report.

Note: Higher Vibration levels measured at 11:00 on Saturday 4th December was due to local inference with the monitor, which are not representative of HS2 construction works.

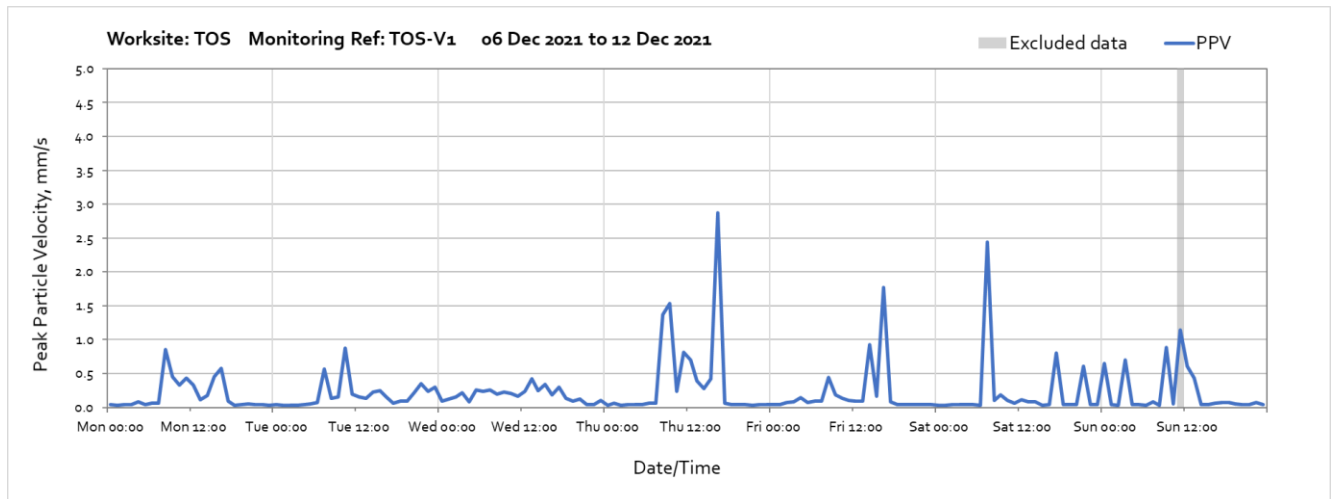
Note: Higher vibration levels measured across the week were due to installation of troughs, steel fixing, pouring of Slurry Treatment Plant (STP) slab, maintenance and operation of crane, and shuttering installation of precast troughs.

Higher Vibration levels measured at 11:00 on Sunday 12th December was due to local inference with the monitor, which are not representative of HS2 construction works.

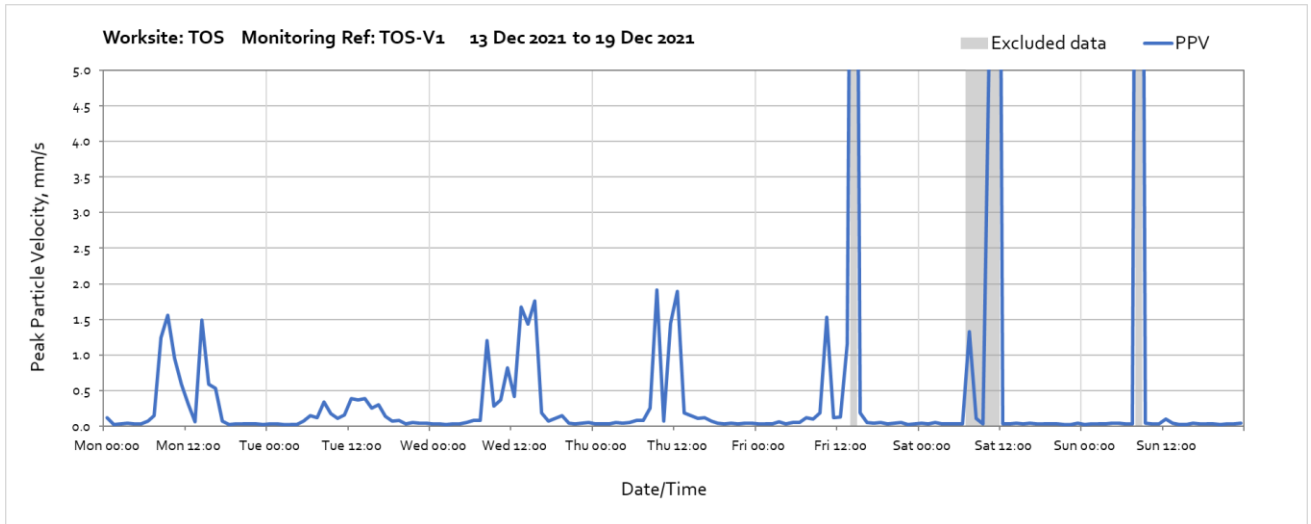
Note: High vibration levels measured at 14:00 on Friday 17th December, between 07:00 and 11:00 on Saturday 18th December and at 08:00 on Sunday 19th December were due to local disturbance of the vibration monitoring station and are not representative of HS2 vibration levels.

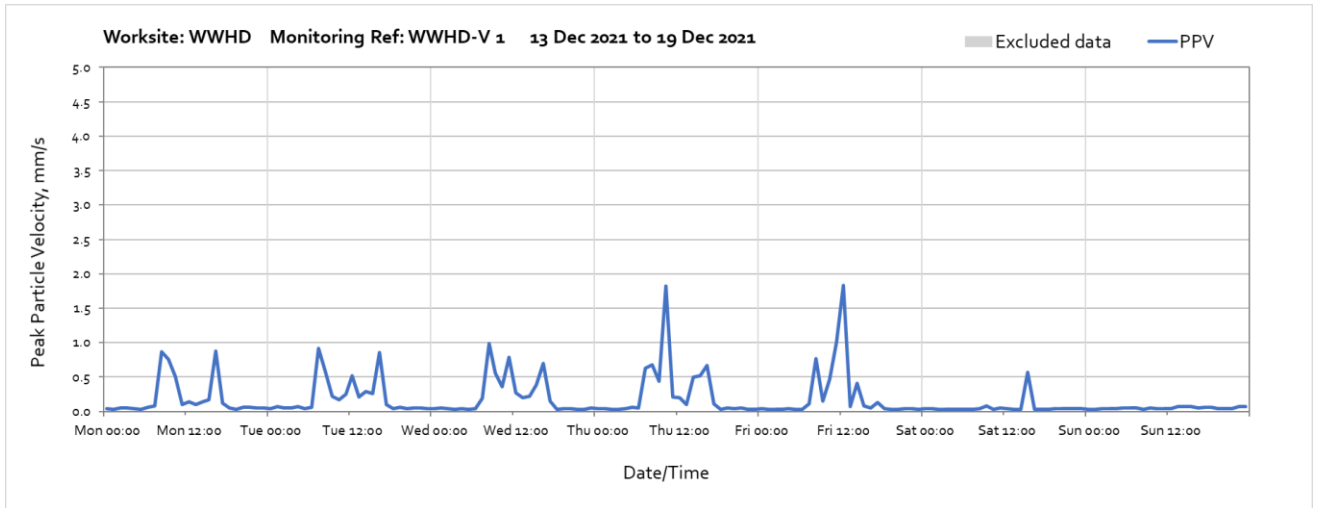
Worksite: Washwood Heath Depot (WWHD) – Monitoring Ref: WWHD-V1

Note: Higher vibration levels measured during the week were due to plant working on north side of haul road, roller and dosser working and ground prep for unexploded ordinance (UXO) survey probing, and plant movement of a 30^t excavator for removing concrete blocks in the area.

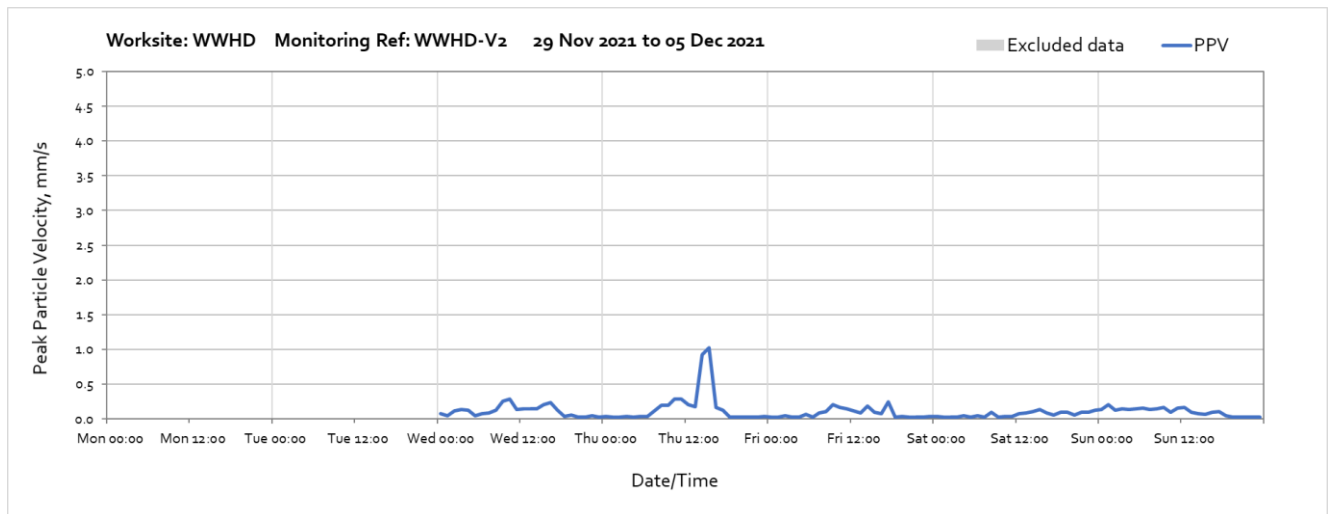
Worksite: Washwood Heath Depot (WWHD) – Monitoring Ref: WWHD-V2

Note: Higher vibration levels measured at 15:00 on Thursday 2nd December was due to excavators movement around the area near to the monitor.

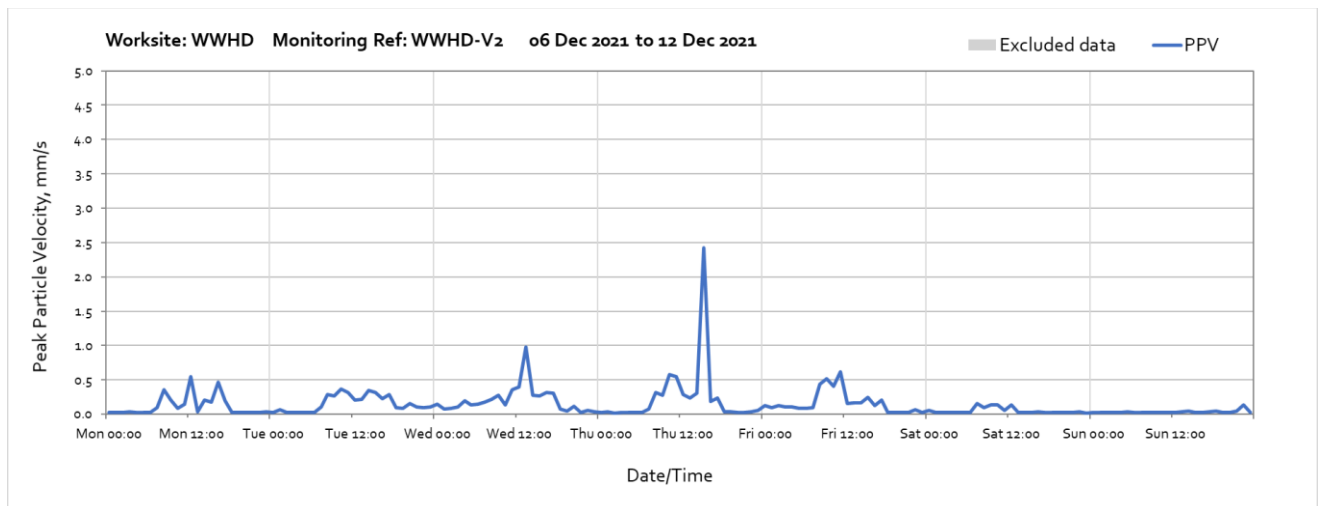
Note: Higher vibration levels measured at 15:00 on Thursday 9th December was due to breaker works.

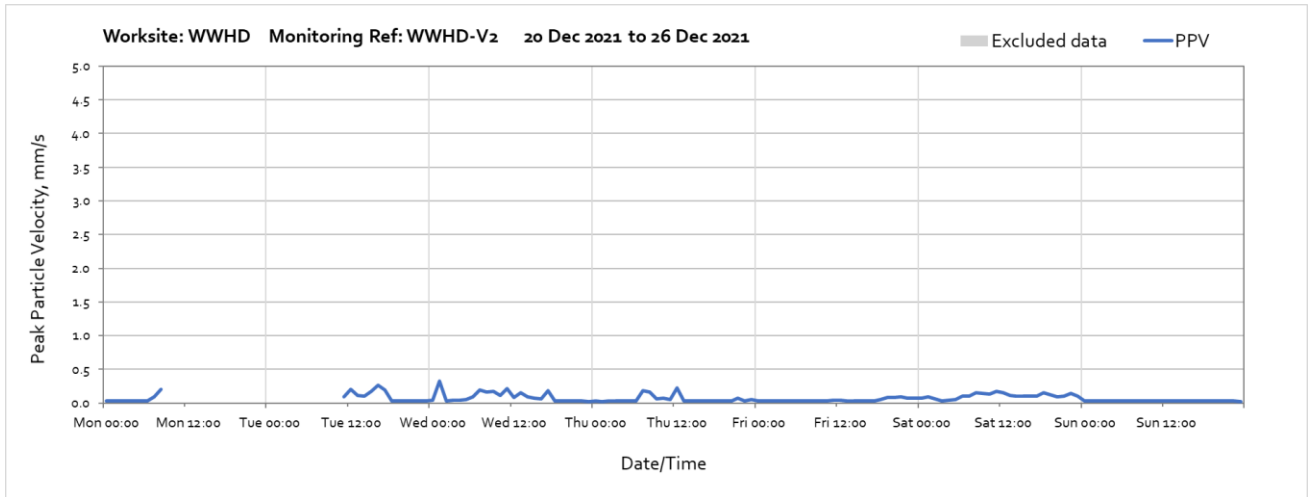
Note: Missing between 09:00 on Monday 20th December and 11:00 on Tuesday 21st December were due to battery falling below required voltage limit caused by prolonged insufficient sunlight.

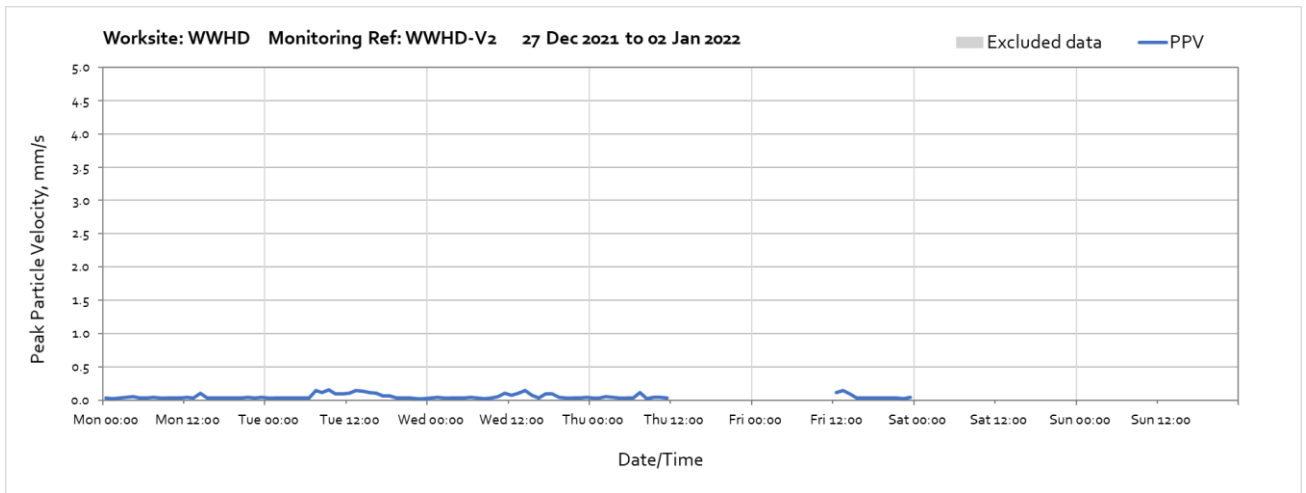
Note: Missing between 12:00 on Thursday 23rd December and 12:00 on Friday 31st December were due to battery falling below required voltage limit caused by prolonged insufficient sunlight.
