February 2022

# HS2

## **Construction noise and vibration Monthly Report – December 2021**

**North Warwickshire Borough Council**

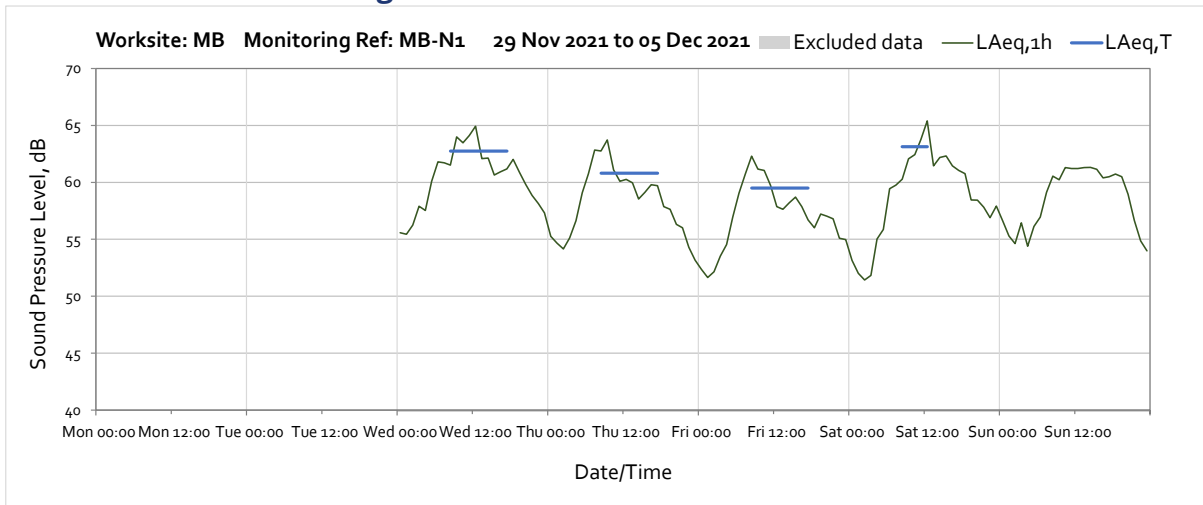
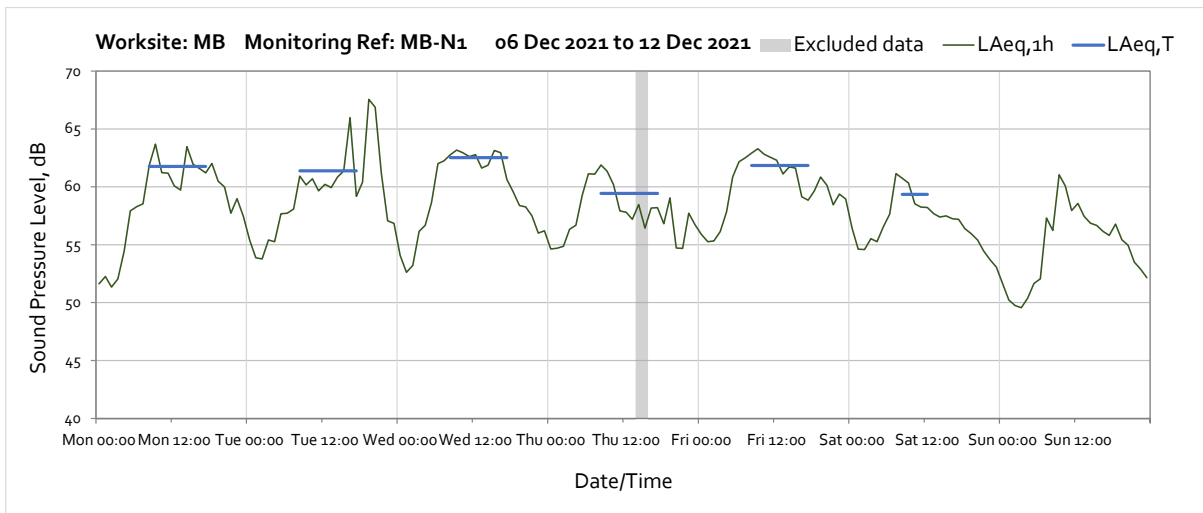
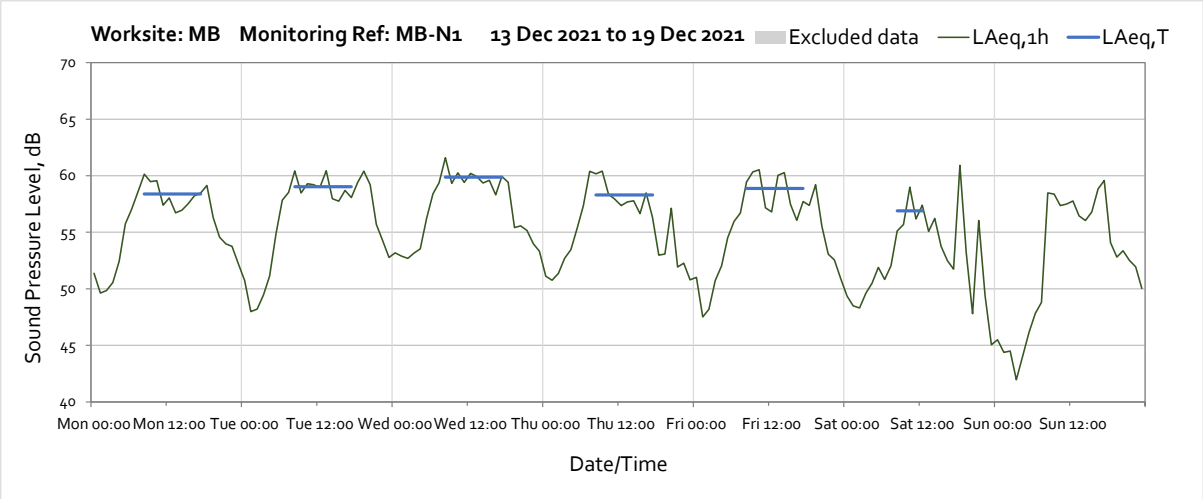
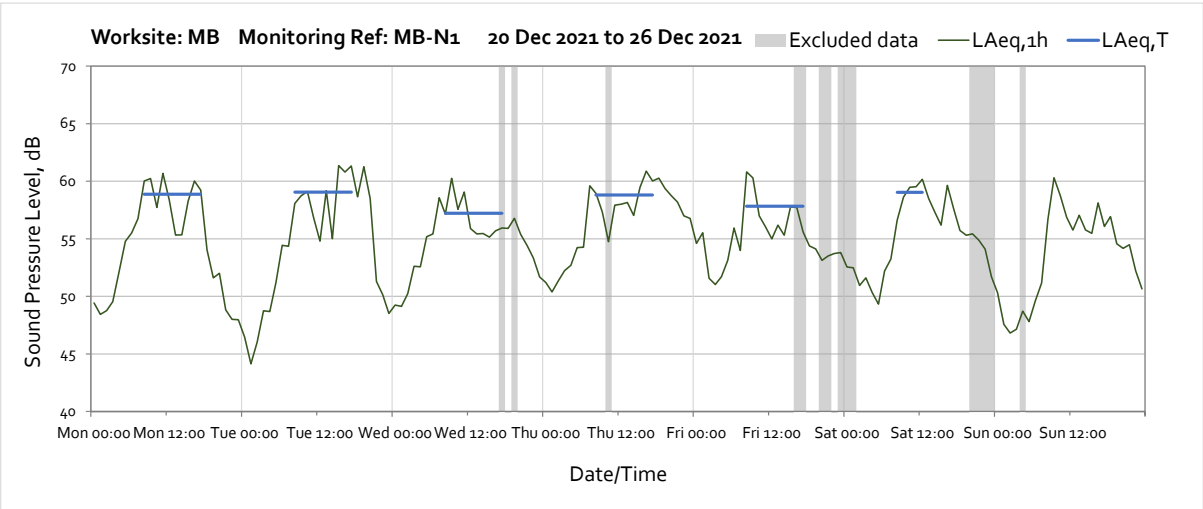
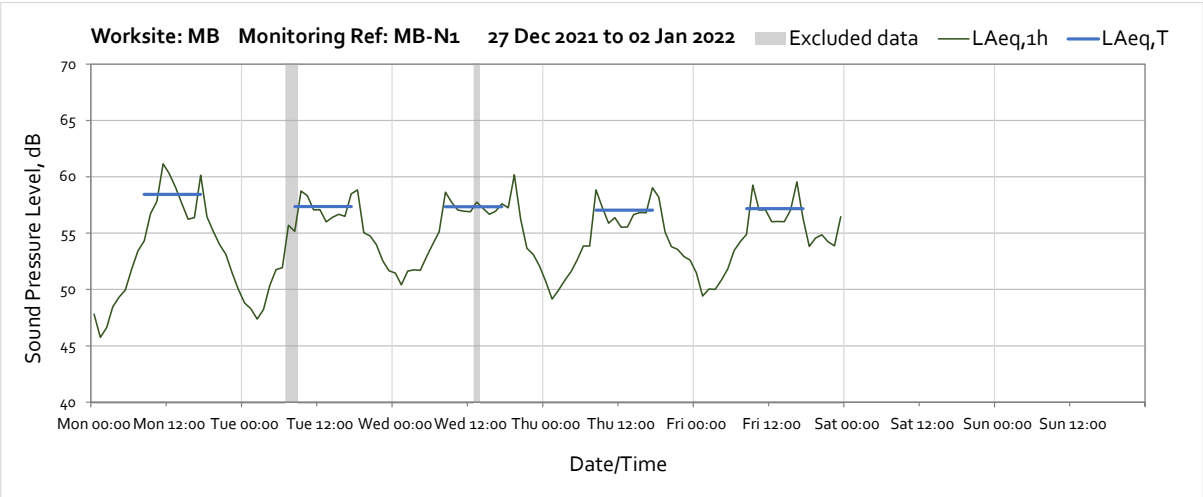
### Worksite: MB – Monitoring Ref: MB-N1

The following graphs show the hourly measured ambient noise level  $L_{Aeq,1h}$  and, where relevant, the averaged noise level  $L_{Aeq,T}$  values, where the time period T is as specified in Table 1 of HS2 Information Paper E23. Periods with adversely weather affected noise levels are greyed out and have been excluded from the calculation of the  $L_{Aeq,T}$  values in Table 3 of the main report.

2.1.3 Appendix C presents graphs of the noise and vibration monitoring data over the month for each of the measurement locations. Noise data presented consists of the hourly  $L_{Aeq}$  values and, where relevant, the  $L_{Aeq,T}$  values (where the time period T has been taken to be the averaging period as specified in Table 1 of HS2 Information Paper E23). Vibration data presented consist of hourly PPV values. The full data set for the monitoring equipment can be found at the following location: <https://data.gov.uk/dataset/24542ae7-dd44-444f-b259-871c4cc43b5e/environmental-monitoring-data>.

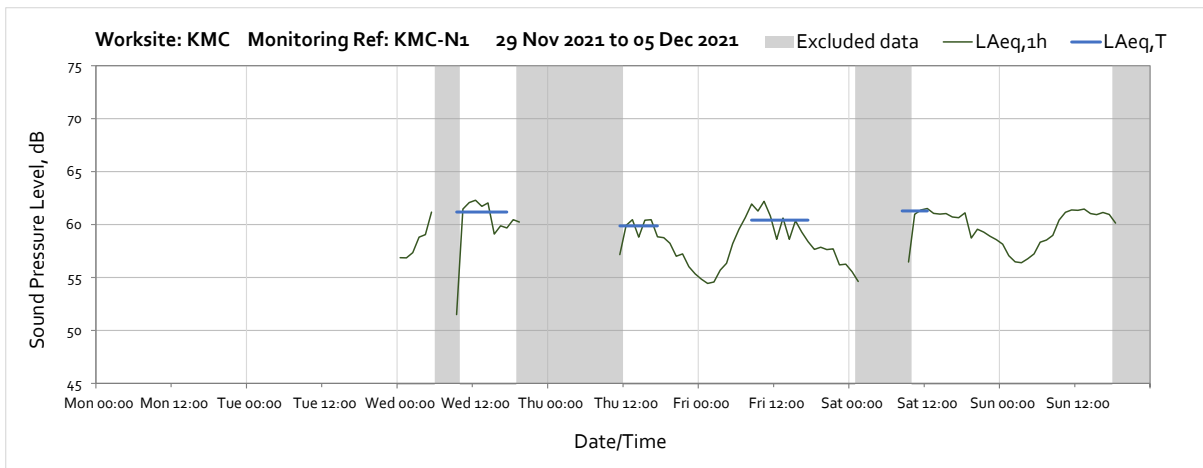
## Worksite: KMC – Monitoring Ref: KMC-N1

Note: Missing data throughout the week was due to battery falling below the required voltage limit caused by prolonged insufficient sunlight. Batteries were replaced on 9<sup>th</sup> December 2021.

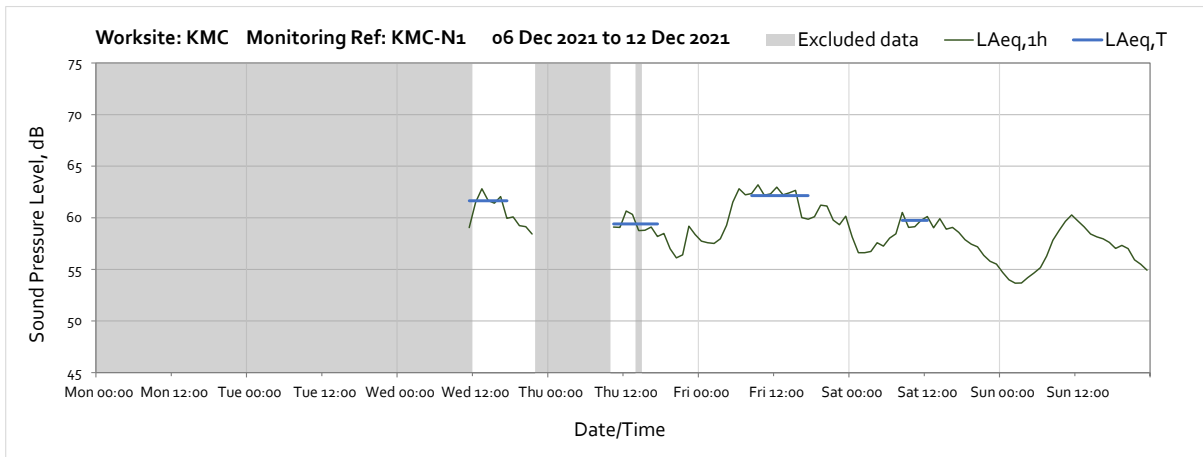
Note: Missing data throughout the week was due to battery falling below the required voltage limit caused by prolonged insufficient sunlight. Batteries were replaced on 9<sup>th</sup> December 2021.

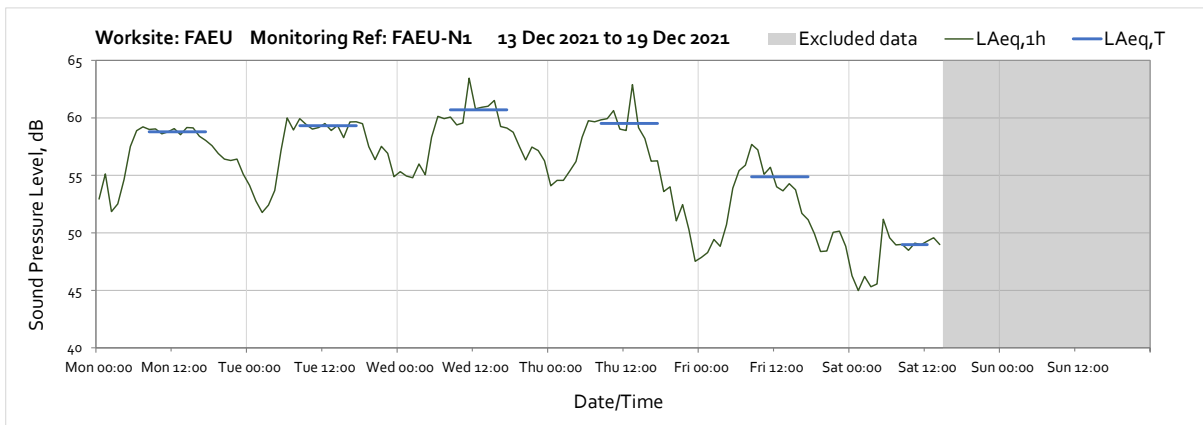
Note: Missing data in between 15:00 on Saturday 18<sup>th</sup> December and 10:00 on Thursday 30<sup>th</sup> December was due to battery falling below the required voltage limit caused by prolonged insufficient sunlight.

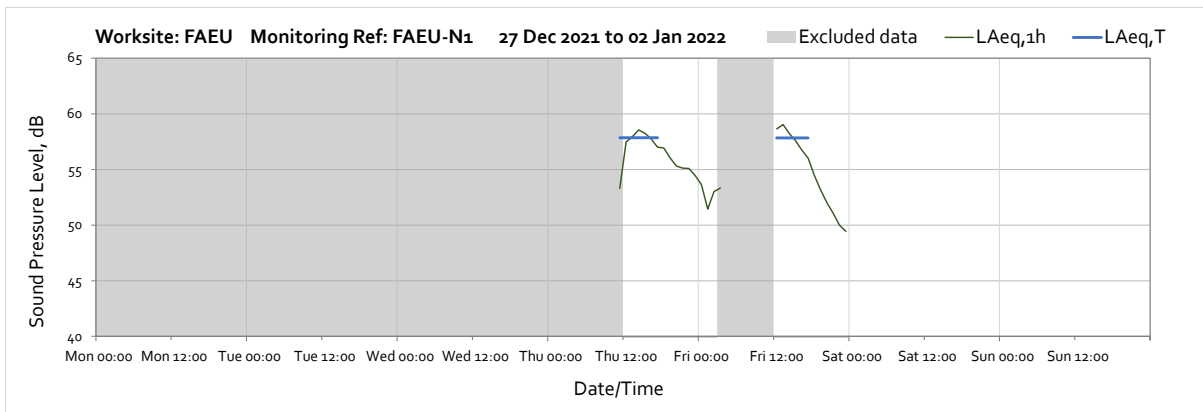
Note: Missing data in between 04:00 and 11:00 on Friday 31<sup>st</sup> December was due to battery falling below the required voltage limit caused by prolonged insufficient sunlight.

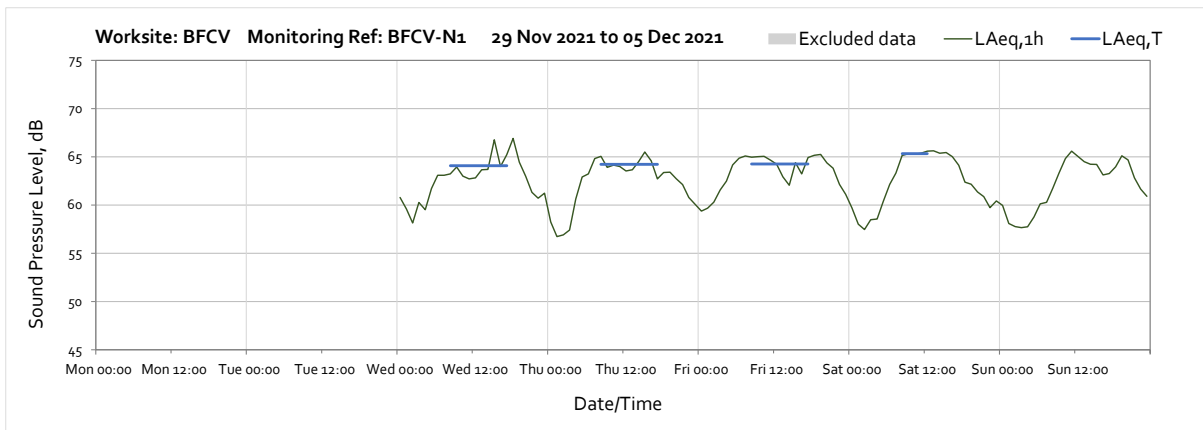
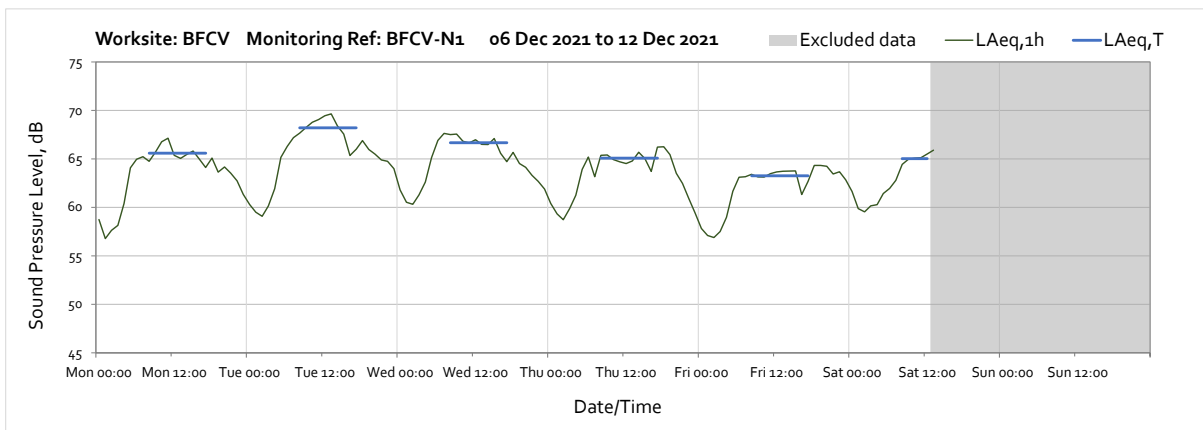
## Worksite: BFCV – Monitoring Ref: BFCV-N1

Note: Missing data in between 14:00 on Saturday 11<sup>th</sup> December and 16:00 on Wednesday 15<sup>th</sup> December was due to battery falling below the required voltage limit caused by prolonged insufficient sunlight.

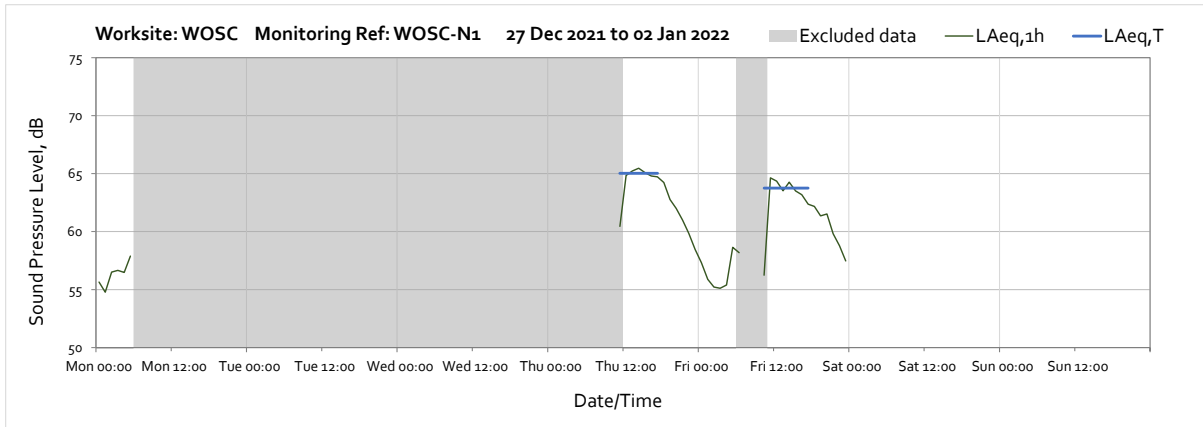
Note: Missing data throughout the week was due to battery falling below the required voltage limit caused by prolonged insufficient sunlight.

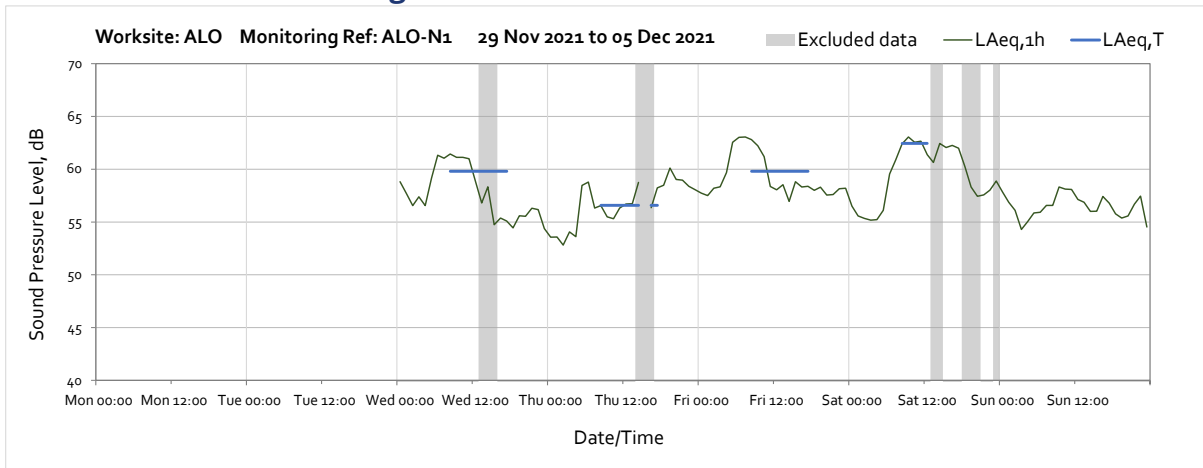
### Worksite: ALO - Monitoring Ref: ALO-N1

Note: Missing data at 15:00 on Thursday 2<sup>nd</sup> December was due to dust equipment being added to the monitoring station.

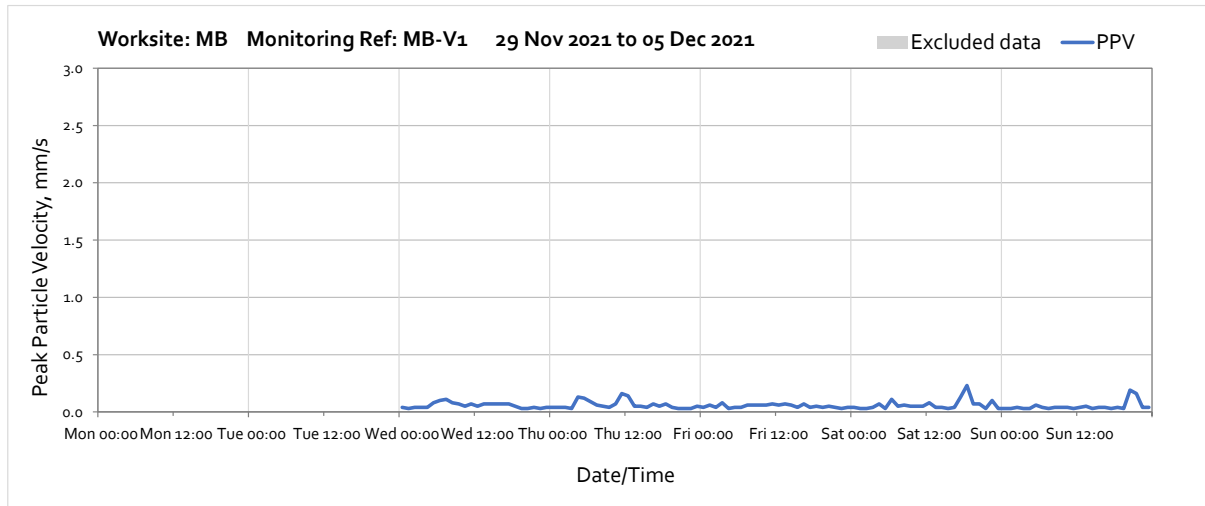
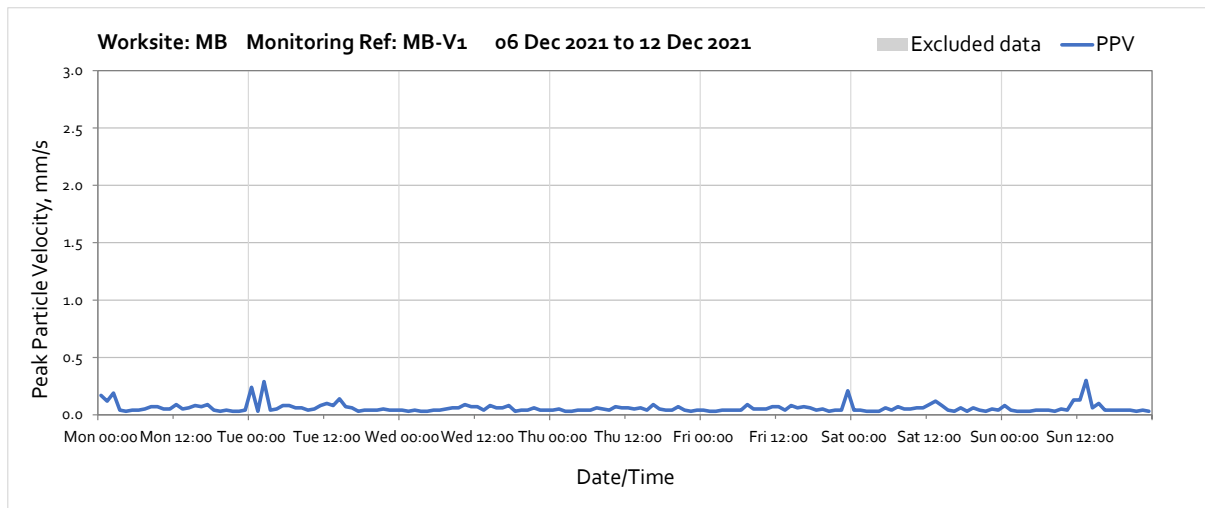
### Worksite: MB – Monitoring Ref: MB-V1

The following graphs show the hourly measured peak particle velocity PPV recorded during the monitoring period. The graphs show the highest PPV of the three orthogonal axes x, y and z. Where high values of PPV were caused by local interference with the vibration monitor, which are not representative of HS2 construction works, these values have been greyed out in the following charts and have been excluded to calculate values in Table 4 of the main report.

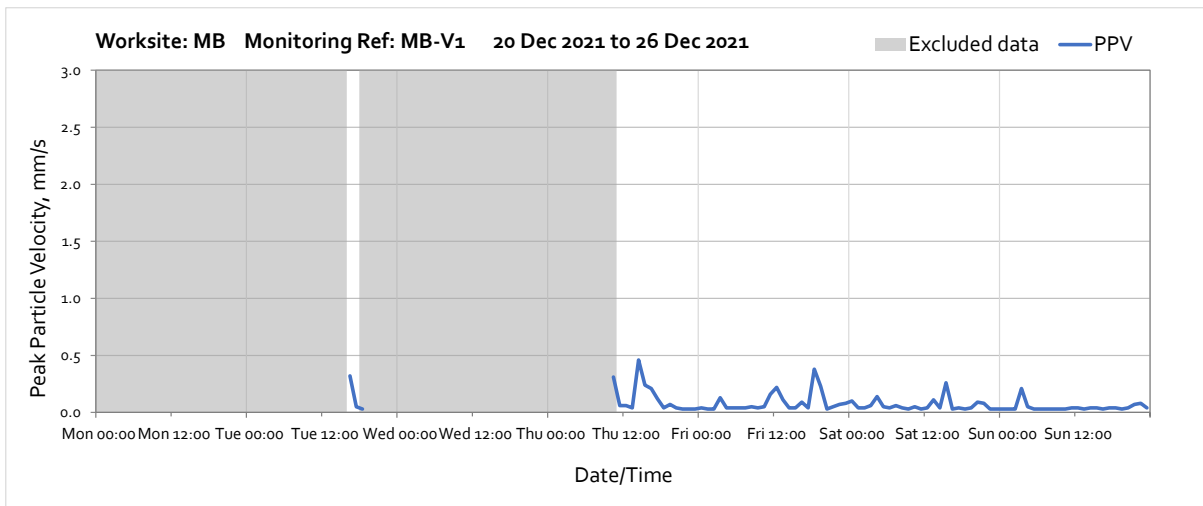
Note: Missing data in between 19:00 on Tuesday 21<sup>st</sup> December and 09:00 on Thursday 23<sup>rd</sup> December was due to battery falling below the required voltage limit caused by prolonged insufficient sunlight. Batteries were replaced on 23<sup>rd</sup> December 2021.

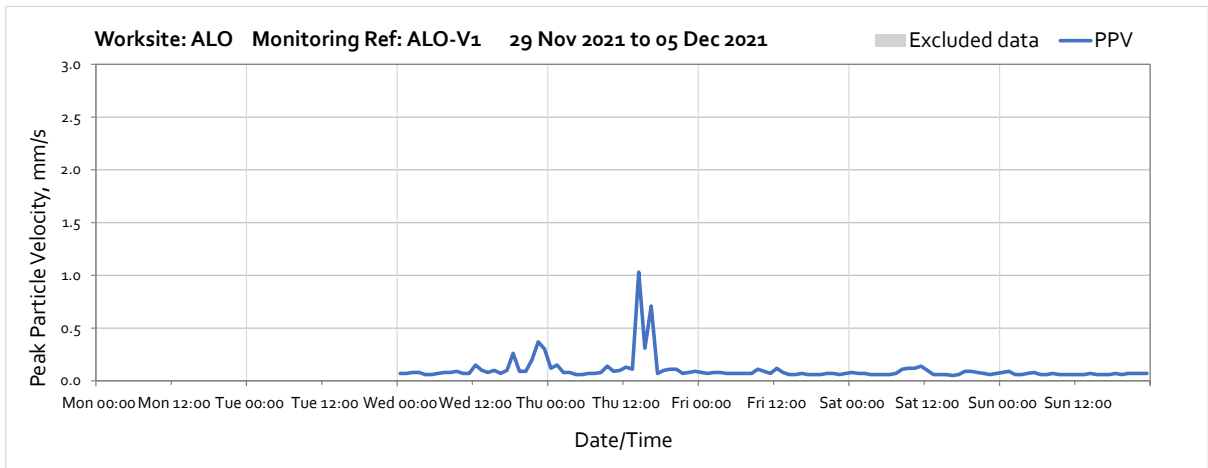
**Worksite: ALO - Monitoring Ref: ALO-V1**

Note: High vibration levels measured at 14:00 on Thursday 2<sup>nd</sup> December were due to stone laying and soil mixing works.

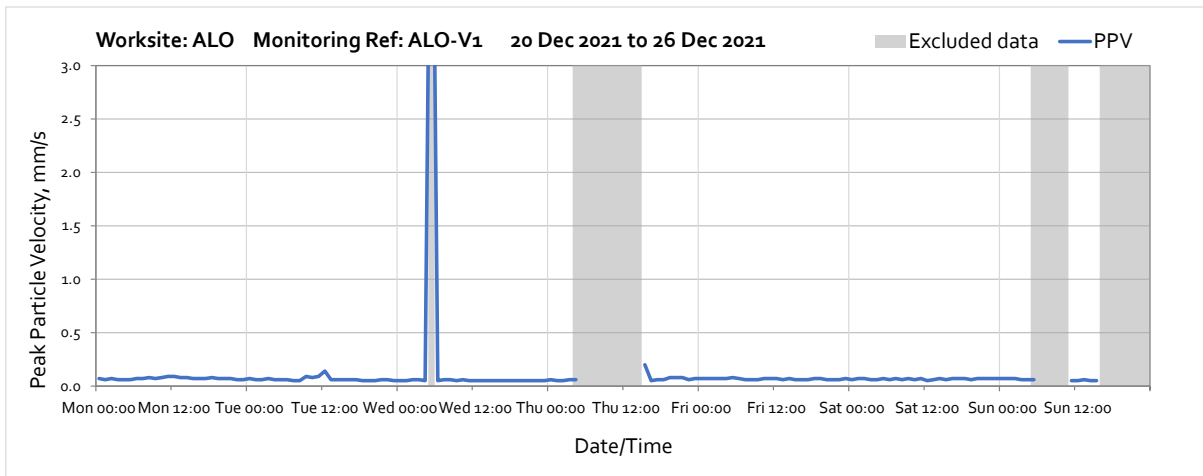
Note: High vibration levels measured at 05:00 on Wednesday 22<sup>nd</sup> December were due to local disturbance, outside of HS2 working hours.

Note: Missing data throughout the week until 23:00 on Friday 31<sup>st</sup> Decemeber was due to battery falling below the required voltage limit caused by prolonged insufficient sunlight.

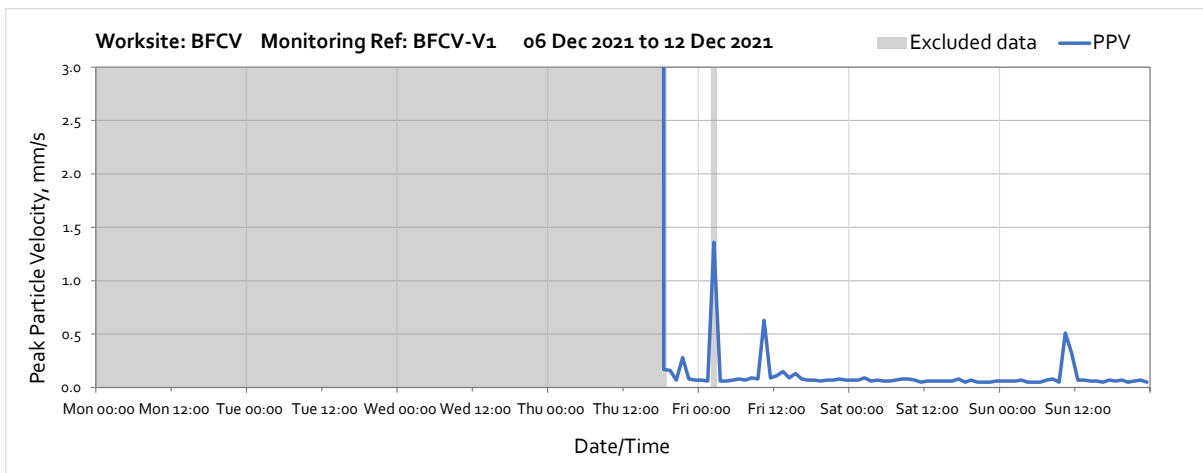
**Worksite: BFCV – Monitoring Ref: BFCV-V1**

Note: The vibration monitor ref:BFCV-V1 was installed at 17:00 on Thursday 9<sup>th</sup> December 2021.

Note: High vibration levels measured at 02:00 on Friday 10<sup>th</sup> December were due to local disturbance, outside of HS2 working hours.

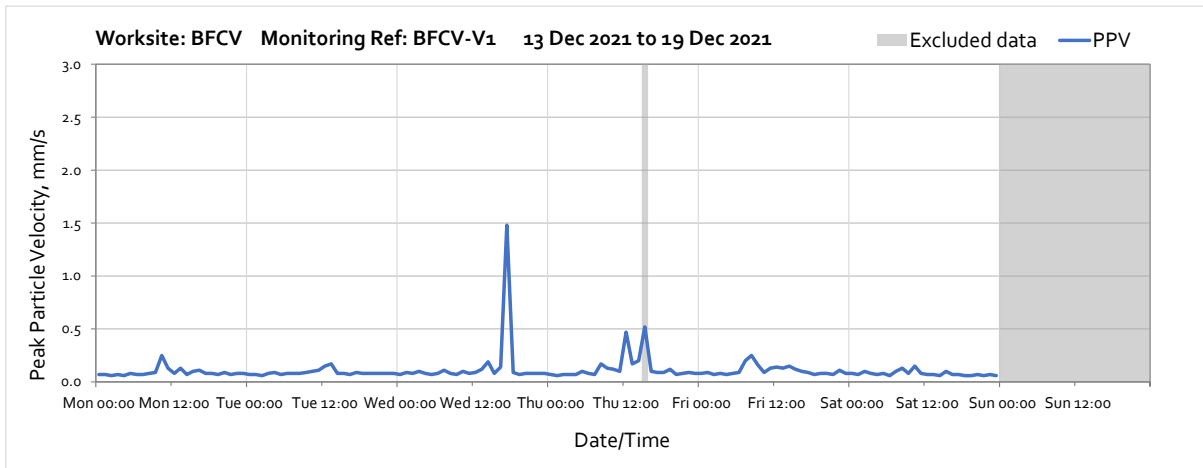
Note: High vibration levels measured at 17:00 on Wednesday 15<sup>th</sup> December were due to construction works undertaken near the monitoring station.

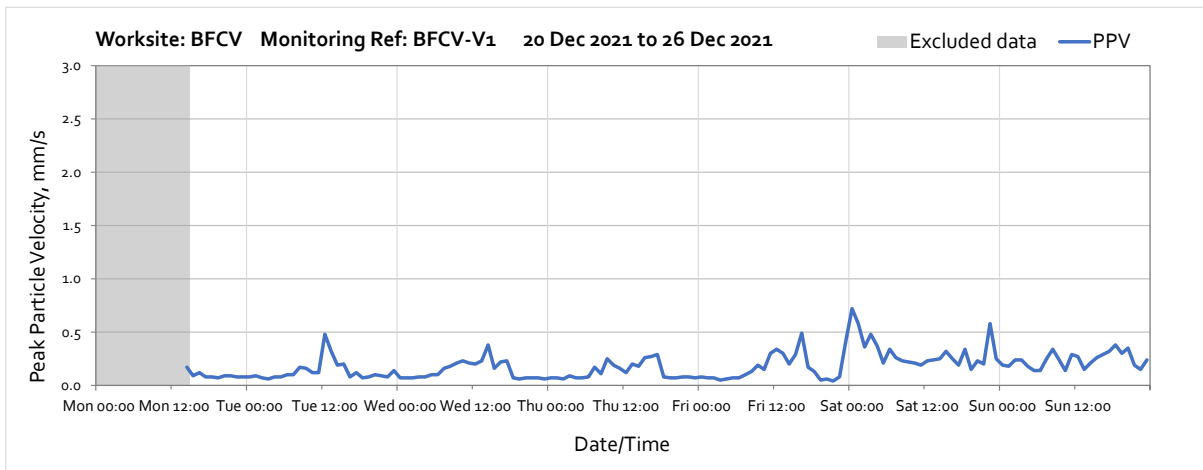
Note: Missing data in between 00:00 on Sunday 19<sup>th</sup> December and 13:00 on Monday 20<sup>th</sup> December was due to battery falling below the required voltage limit caused by prolonged insufficient sunlight.

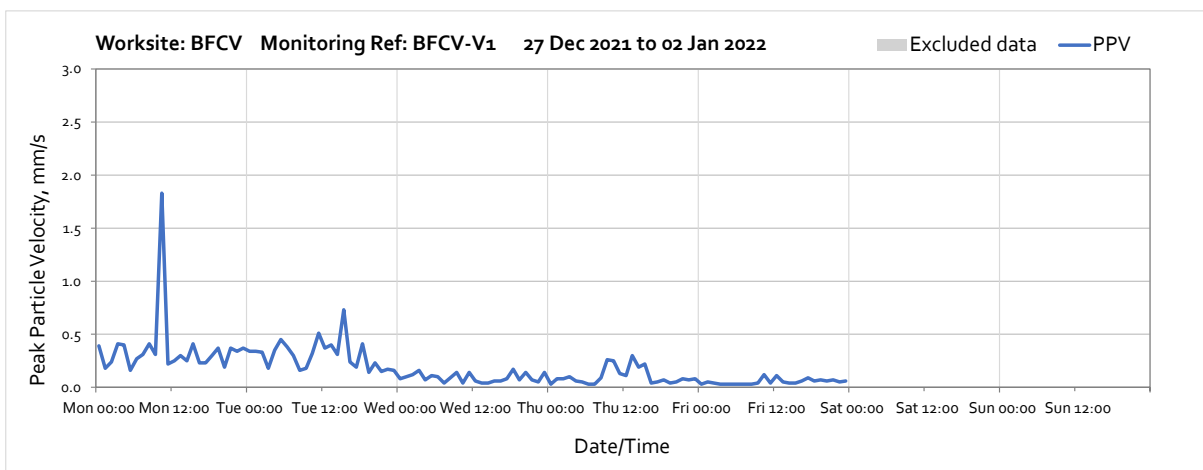
Note: High vibration levels measured at 10:00 on Monday 27<sup>th</sup> December were due to construction works undertaken near the monitoring station.
