Safety Alert Parts A, B & C

Subject: Fuel System VJ Coupling Failure

Number SA 2022/06 Revised

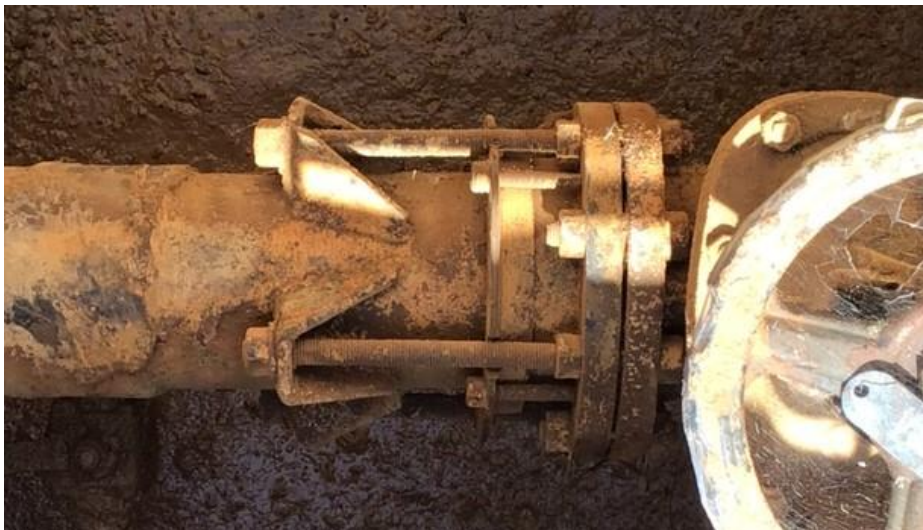
Axial Grip

2. In this Safety Alert (SA) The term 'VJ Coupling' is not to be considered specific to one manufacturer as it is a term used across the estate to identify flexible seal axial clamping pipe couplings. It should also be noted that this mode of failure is common to any coupling using the clamping of a flexible seal as the primary method of creating a liquid tight seal.

9. There has been a trend of fuel leaks on the MoD Estate attributable to the use of flexible seal axial clamping pipe couplings on fuel pipelines. These pipe couplings are often referred to by the trade name Viking Johnson or 'VJ' couplings. The loss of product is normally due to the age of the coupling sealing material and the lack of maintenance resulting in failure of the seals.
10. Where these or similar couplings are present in deep wells or chambers that may be difficult to access it may discourage regular inspection and has resulted in undiscovered leakage followed by catastrophic failure and significant fuel loss.
