# HS2

## Air Quality and Dust Monitoring Monthly Report - February 2022

Stratford-on-Avon District Council

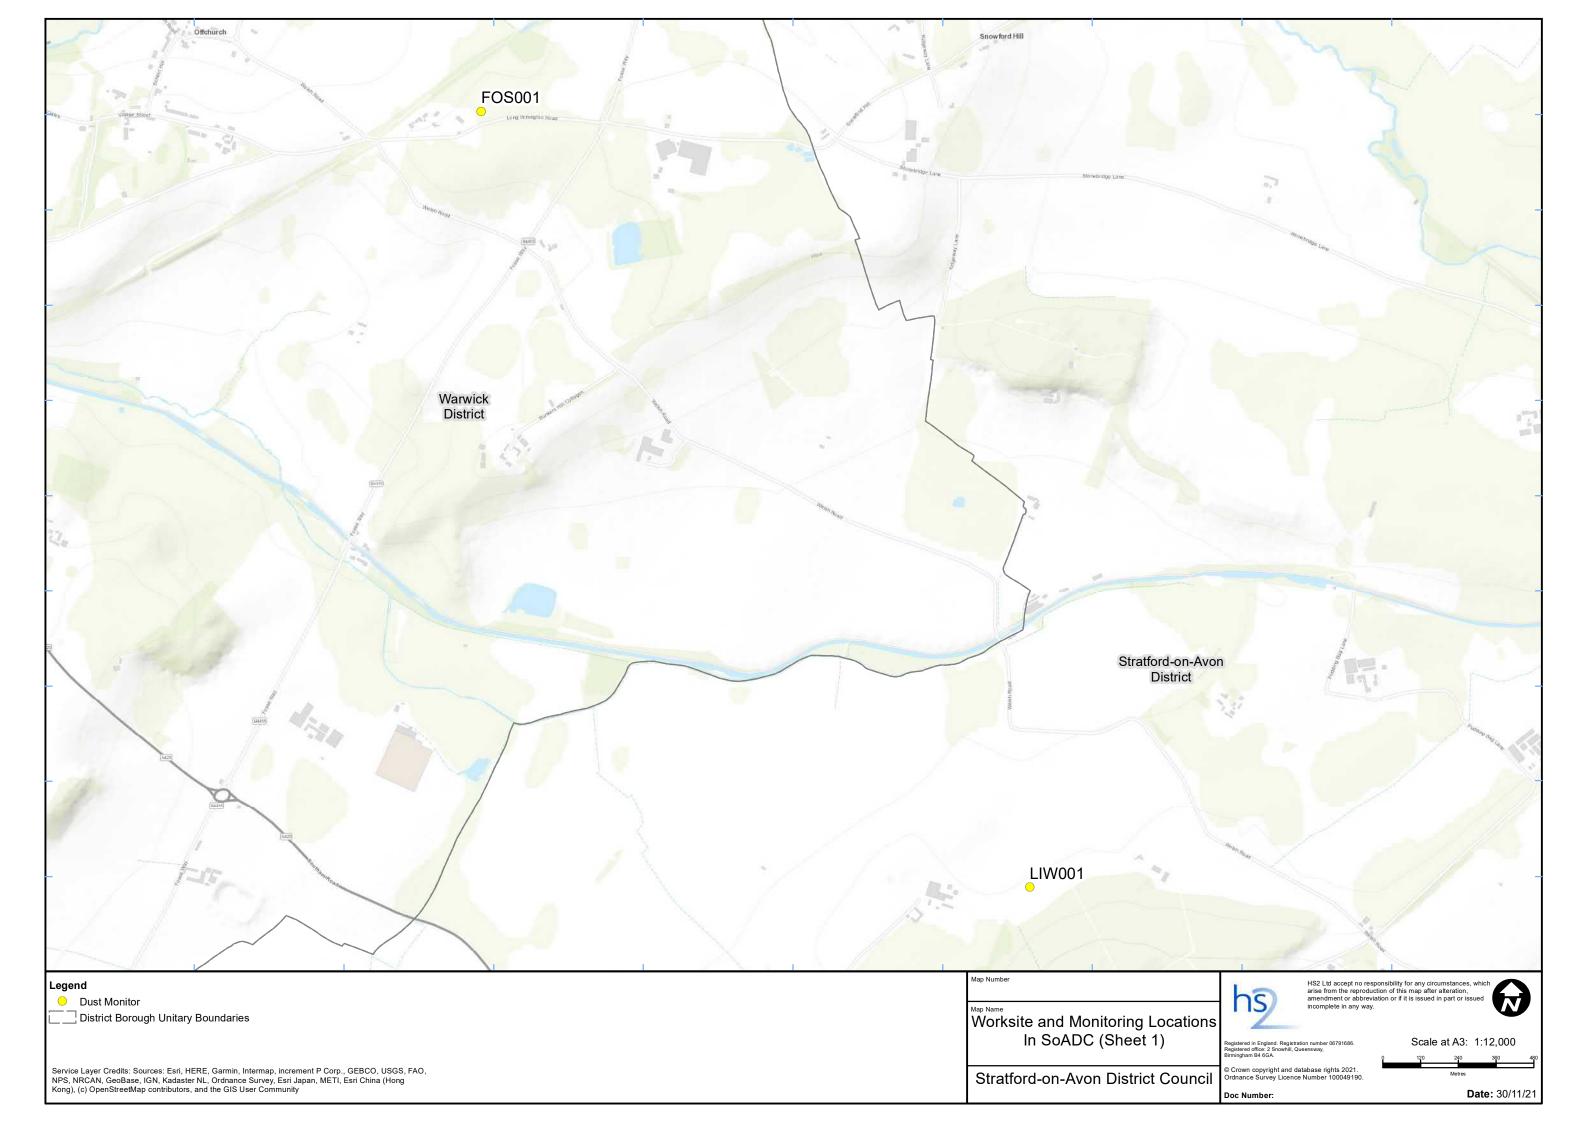
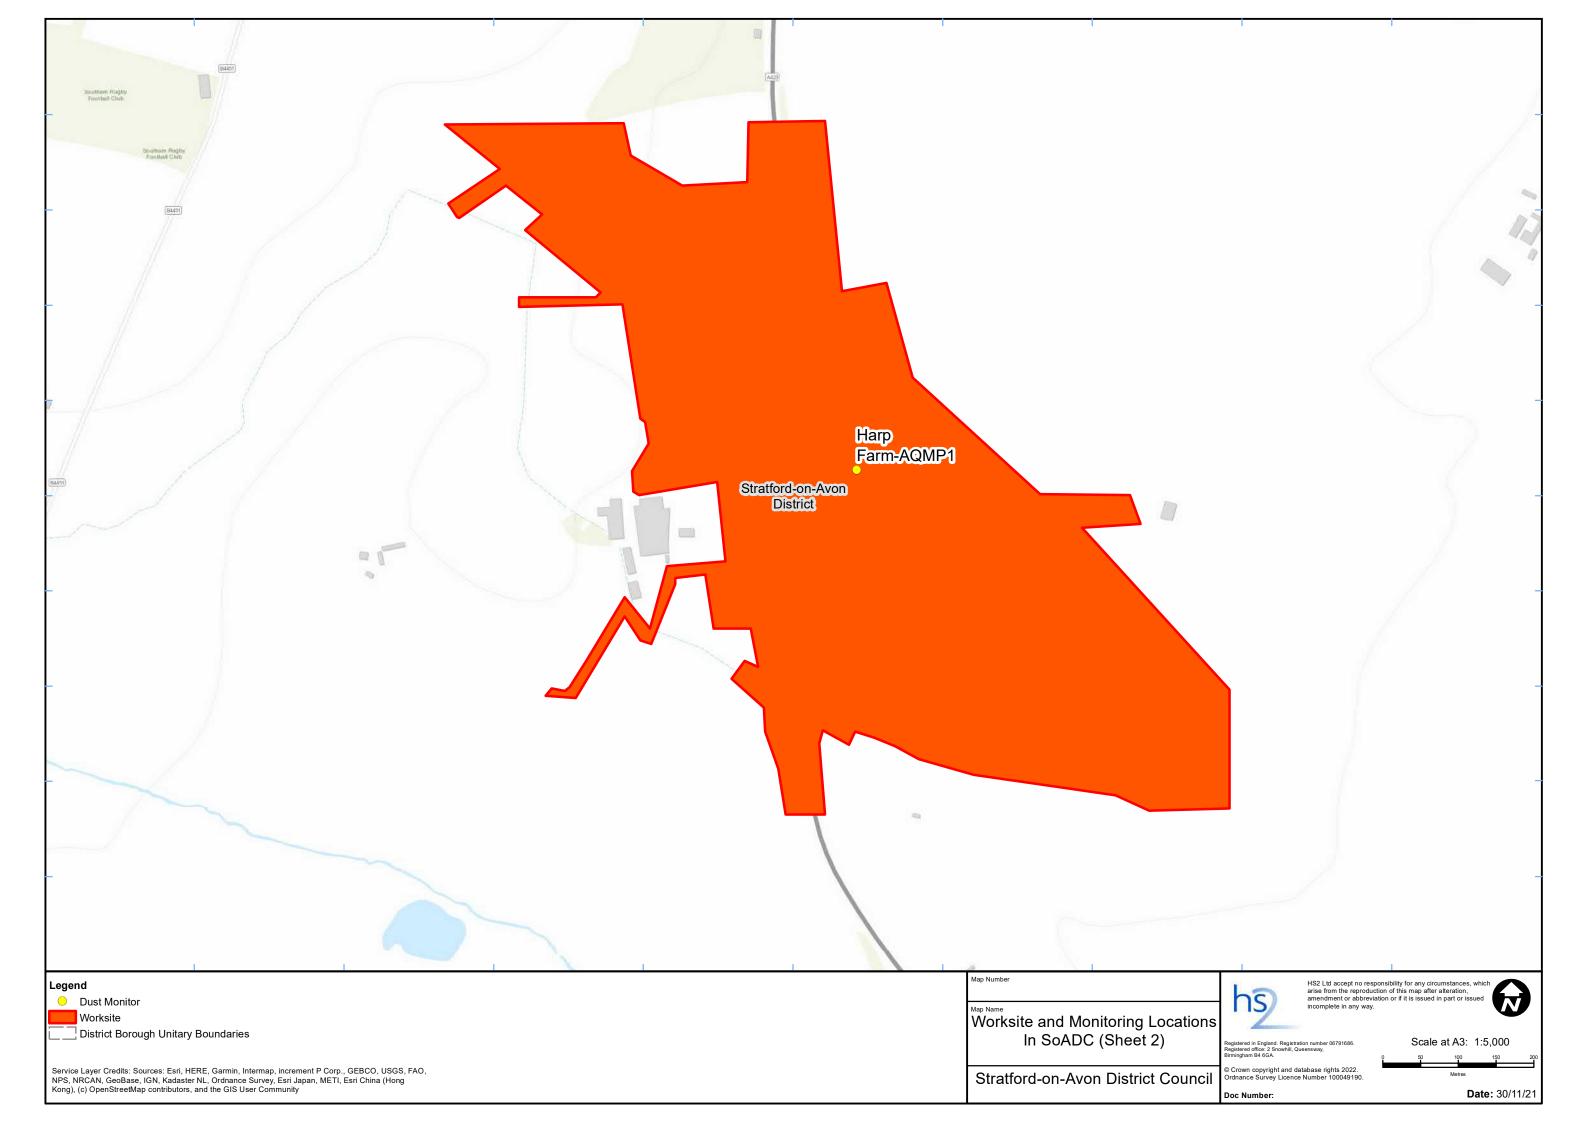
Figure 1 and 2: Worksite and monitoring locations within the SoADC

- 1.1.2 Figures 1 and 2 in Appendix A indicate the current worksites together with the dust monitoring locations for February 2022.
- 1.1.3 This summary should be read in conjunction with the overview monitoring report available from <a href="www.gov.uk/government/collections/monitoring-the-environmental-effects-of-hs2">www.gov.uk/government/collections/monitoring-the-environmental-effects-of-hs2</a>, which highlights: the applicable standards and guidance, as well as the air quality and dust monitoring methodologies to be implemented by nominated undertakers throughout construction.

- 1.1.4 The current worksites, as presented in Appendix A, Figures 1 and 2, include:

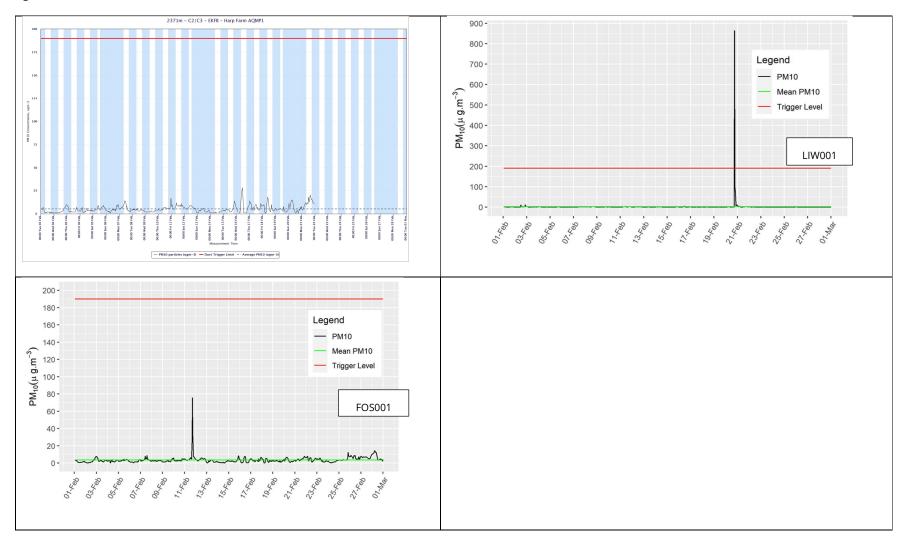
Figure 3: Continuous dust 1-hour mean indicative PM<sub>10</sub> concentration for all monitors

Monitoring site ID	Period exceeding trigger level	Investigation	Outcomes / Resolution / Remedial measures	
			implemented	
LIW001	20/02/2022 17:01 – 18:00; 863.6 μg/m <sup>3</sup>	Currently under investigation as the cause is not clear. At the time of the exceedance, construction work on site was being undertaken, but such an extreme spike in $PM_{10}$ concentration is unexpected, particularly as weather conditions at the time were wet and windy. The nearest Automatic Urban and Rural Network (AURN) monitoring station in Royal Leamington Spa did not record any corresponding rise in $PM_{10}$ concentration around the time of exceedance, suggesting that the high concentration may have been caused by local factors or may have resulted from spurious measurements.	N/A
