Construction Noise and Vibration Monthly Report – March 2022

London Borough of Ealing

This Noise and Vibration Monitoring Report fulfils HS2 Limited's commitment detailed in the Environmental Minimum Requirements (EMRs), Annex 1, Code of Construction Practice, to present the results of noise and vibration monitoring carried out within the London Borough of Ealing (LBE) (including one monitoring location on the boundary with the London Borough of Hammersmith and Fulham) during the month of March 2022.

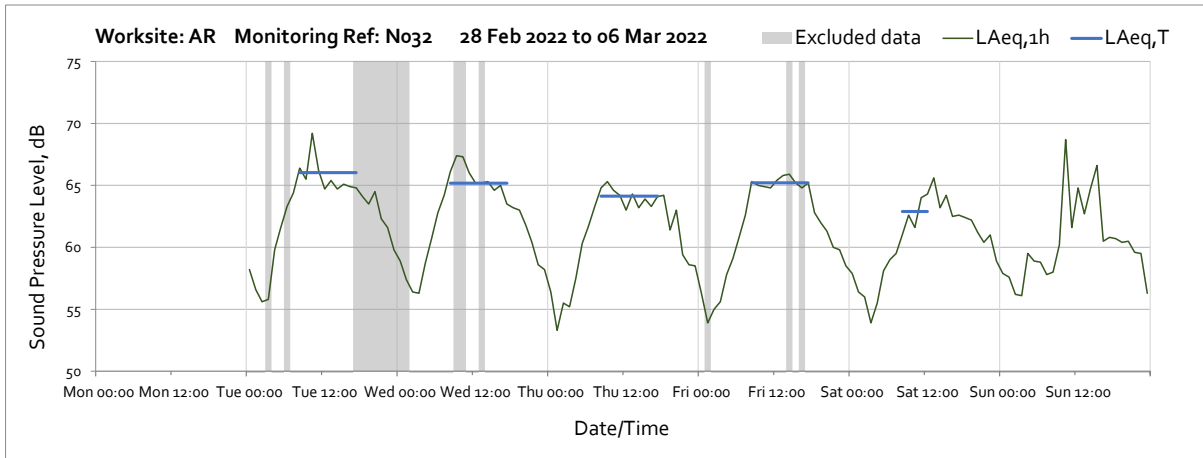
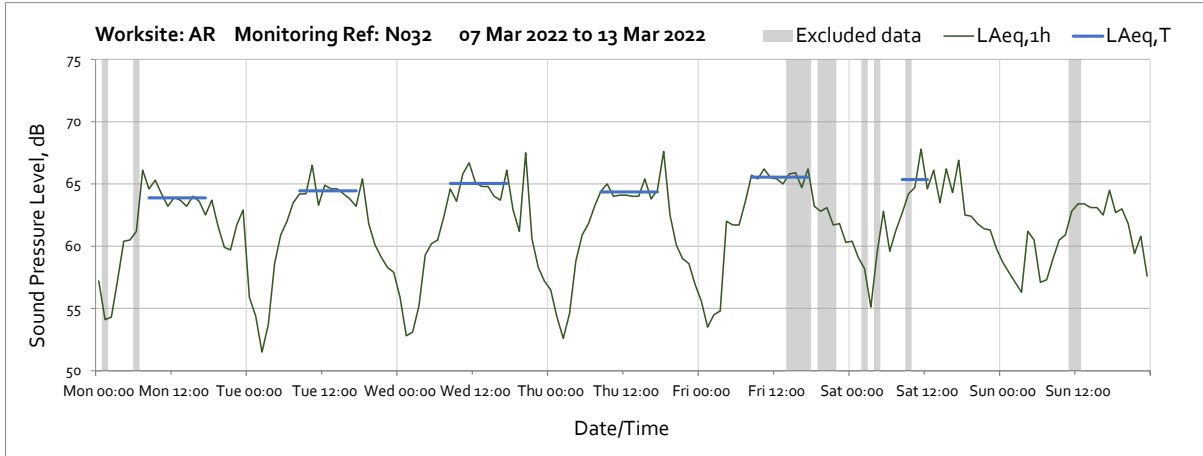
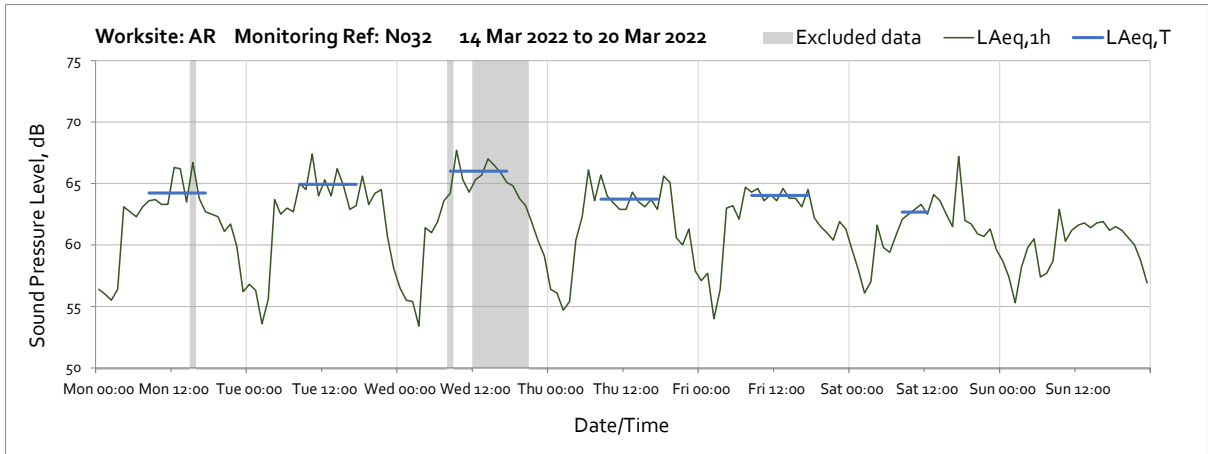
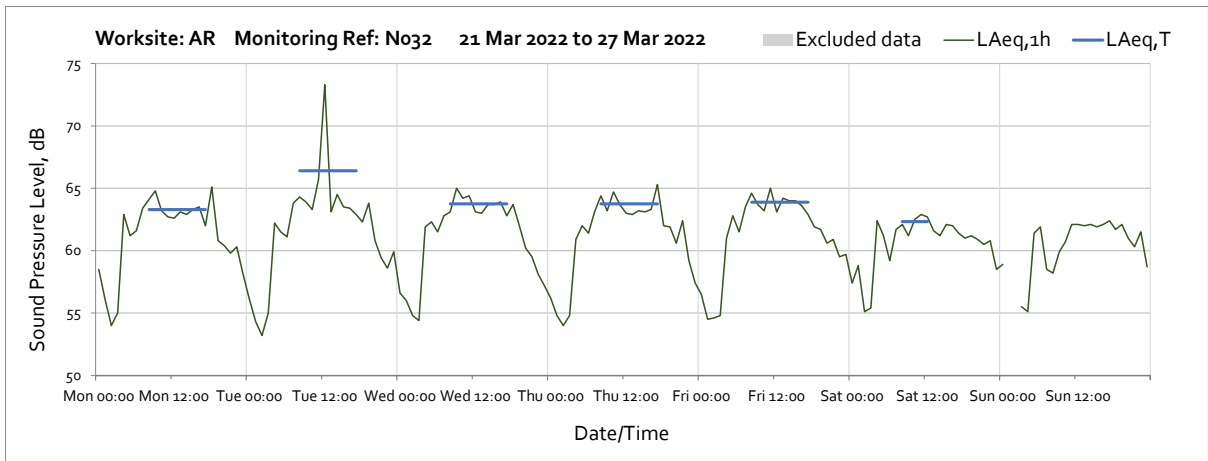
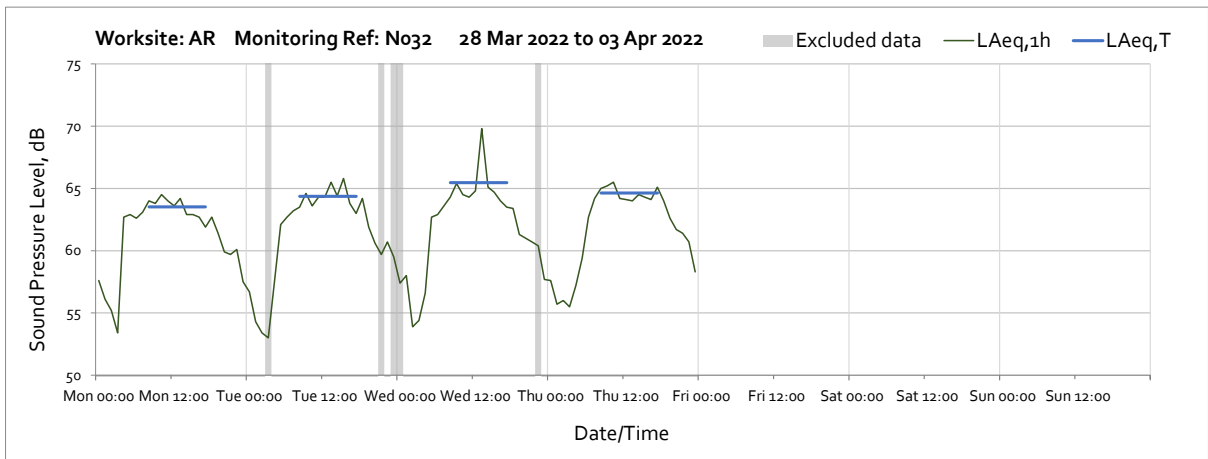
Worksite: Atlas Road worksite (AR) – Monitoring Ref: N032

The following graphs show the hourly measured ambient noise level $L_{Aeq,1h}$ and, where relevant, the averaged noise level $L_{Aeq,T}$ values, where the time period T is as specified in Table 1 of HS2 Information Paper E23. Periods with adversely weather affected noise levels are greyed out and have been excluded from the calculation of the $L_{Aeq,T}$ values in Table 3 of the main report.

Note: Missing data in between 01:00 and 02:00 on Sunday 27th March was due to the clocks going forward at the start of British Summer Time.

2.1.3 Appendix C presents graphs of the noise and vibration monitoring data over the month for each of the measurement locations. Noise data presented consists of the hourly L_{Aeq} values and, where relevant, the $L_{Aeq,T}$ values (where the time period T has been taken to be the averaging period as specified in Table 1 of HS2 Information Paper E23). Vibration data presented consist of hourly PPV values. The full data set for the monitoring equipment can be found at the following location: <https://data.gov.uk/dataset/24542ae7-dd44-444f-b259-871c4cc43b5e/environmental-monitoring-data>.

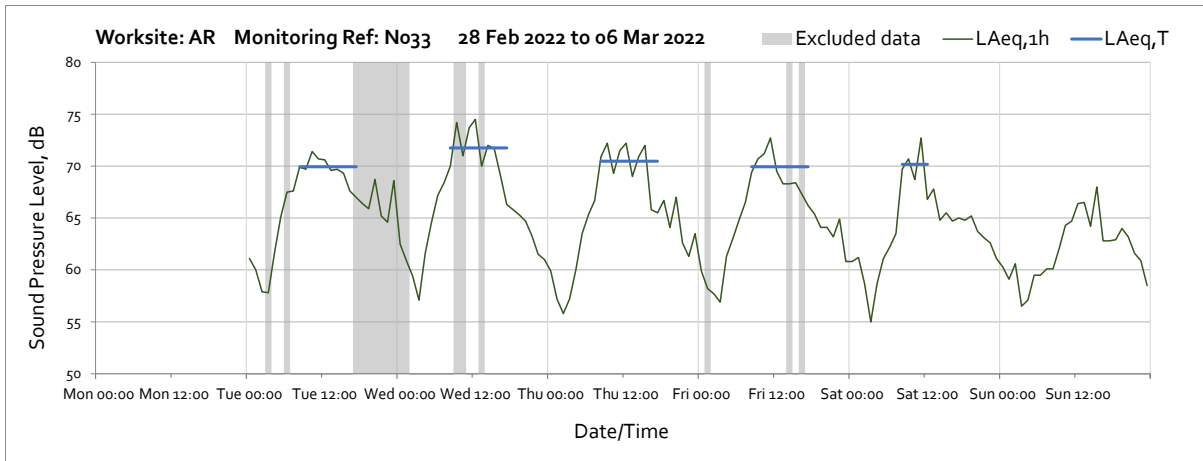
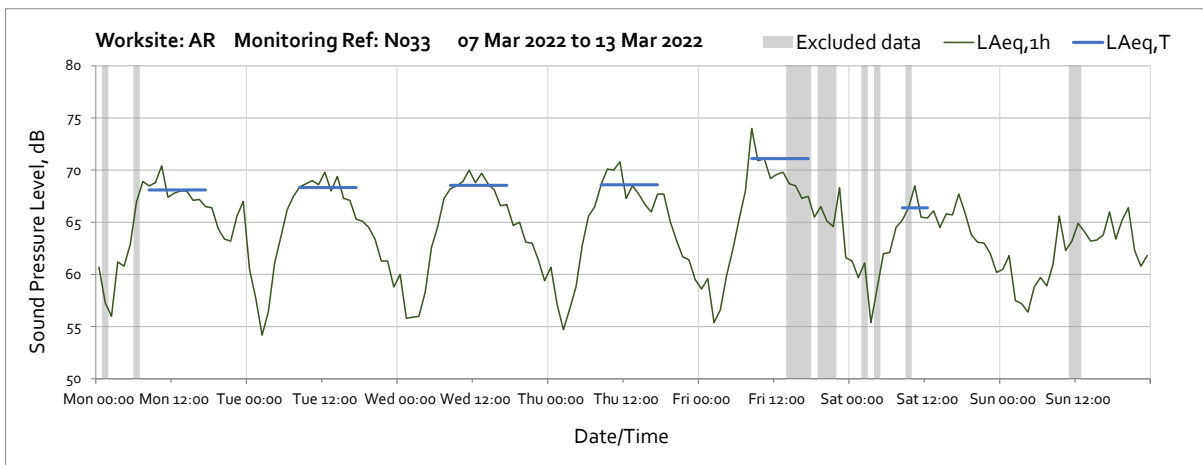
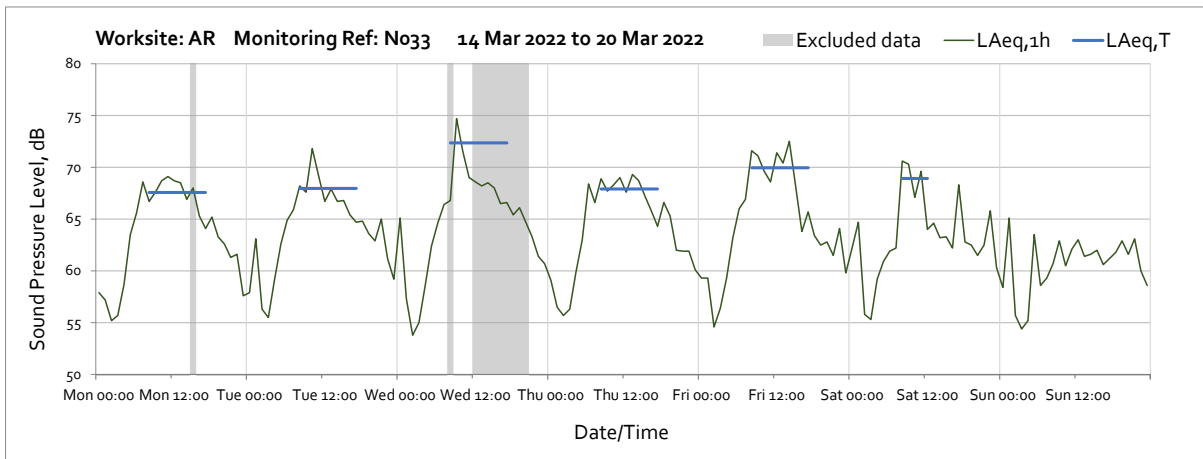
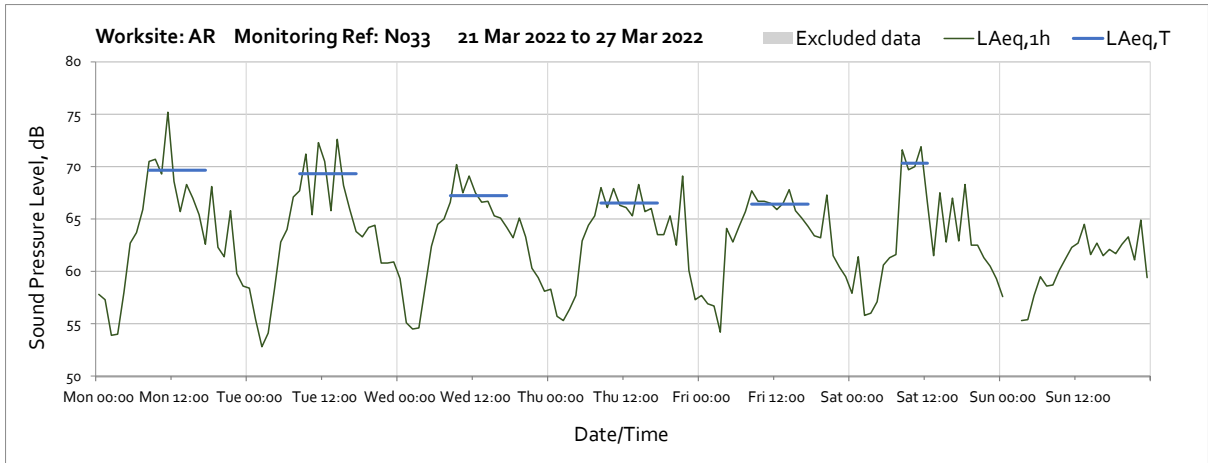
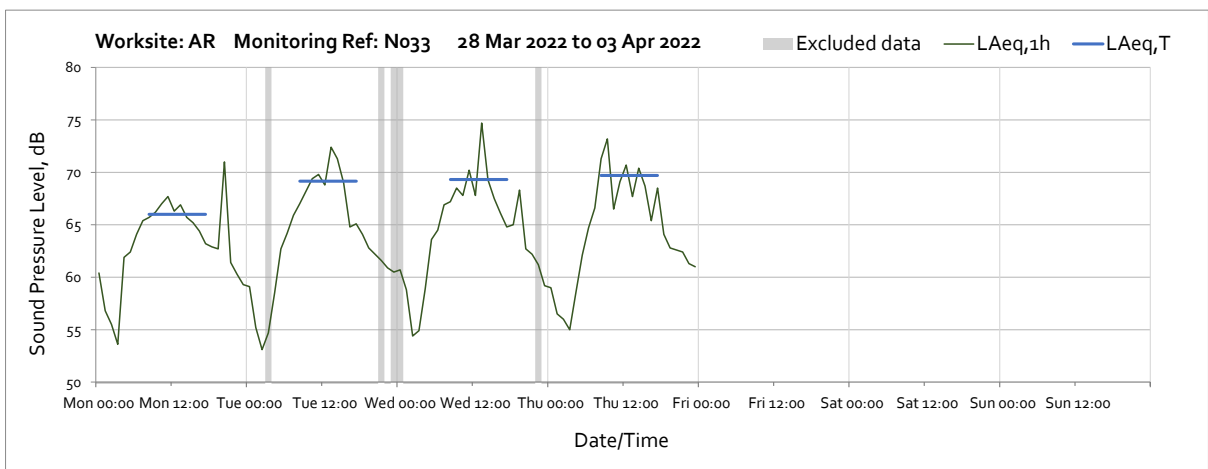
Worksite: Atlas Road worksite (AR) – Monitoring Ref: N033

Note: Missing data in between 01:00 and 02:00 on Sunday 27th March was due to the clocks going forward at the start of British Summer Time.

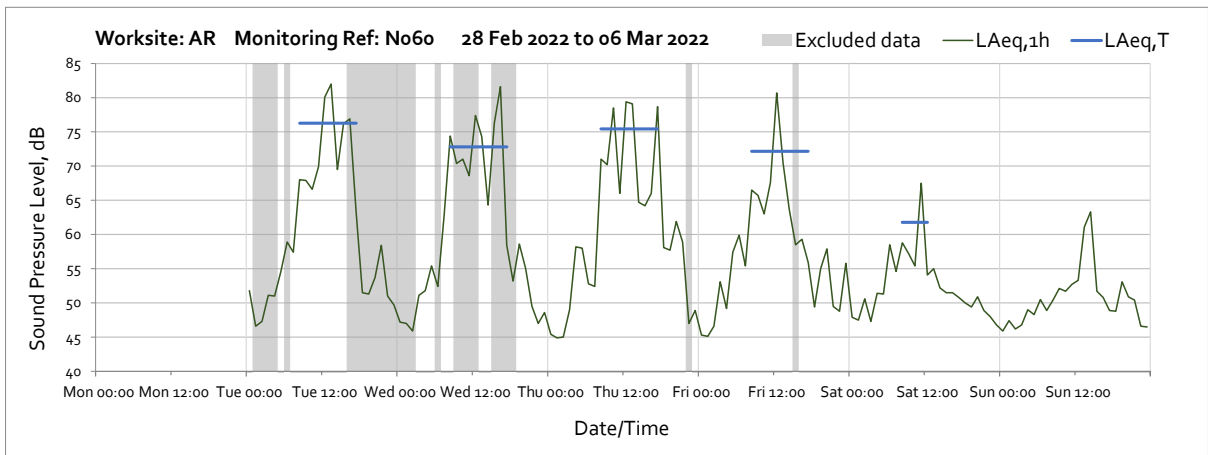
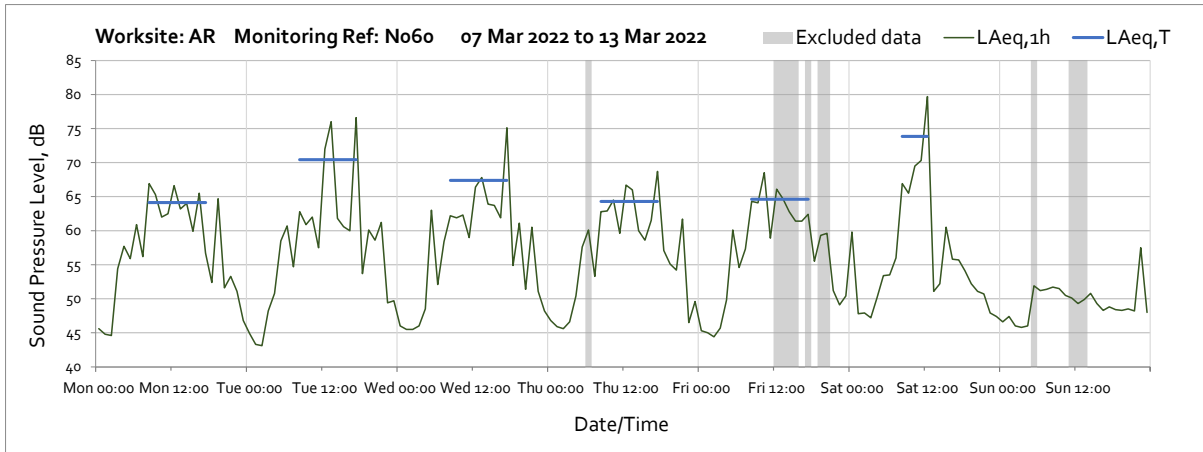
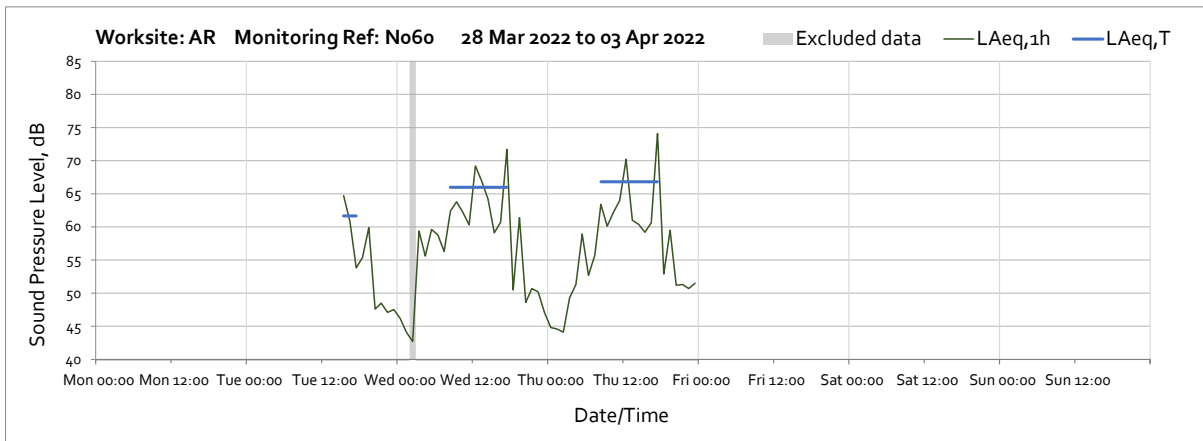
Worksite: Atlas Road worksite (AR) - Monitoring Ref: N060

Note: Missing data in between 00:00 on Monday 14th March 2022 and 14:00 on Tuesday 29th March 2022 was due to loss of power at the monitoring station. The power connection will be restored after access permission is granted.

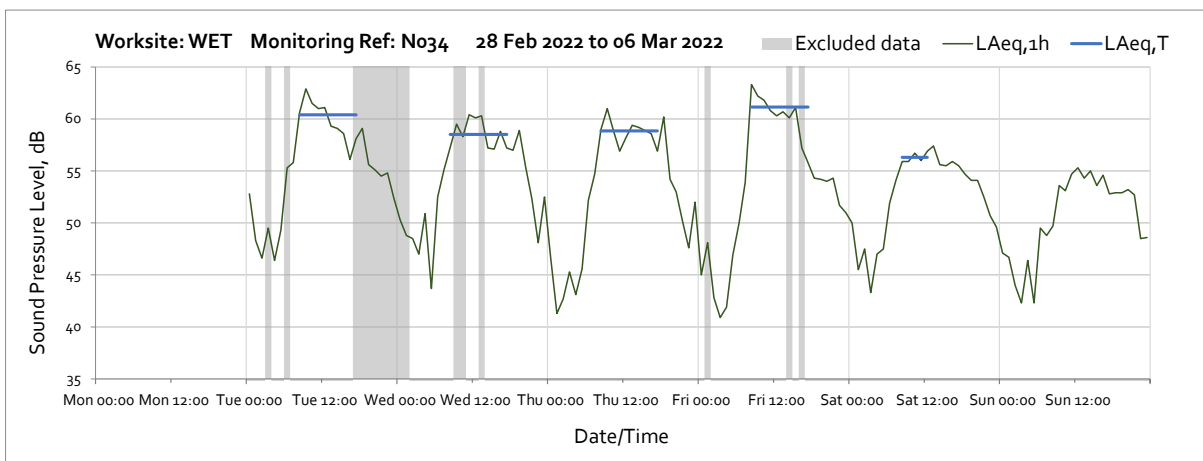
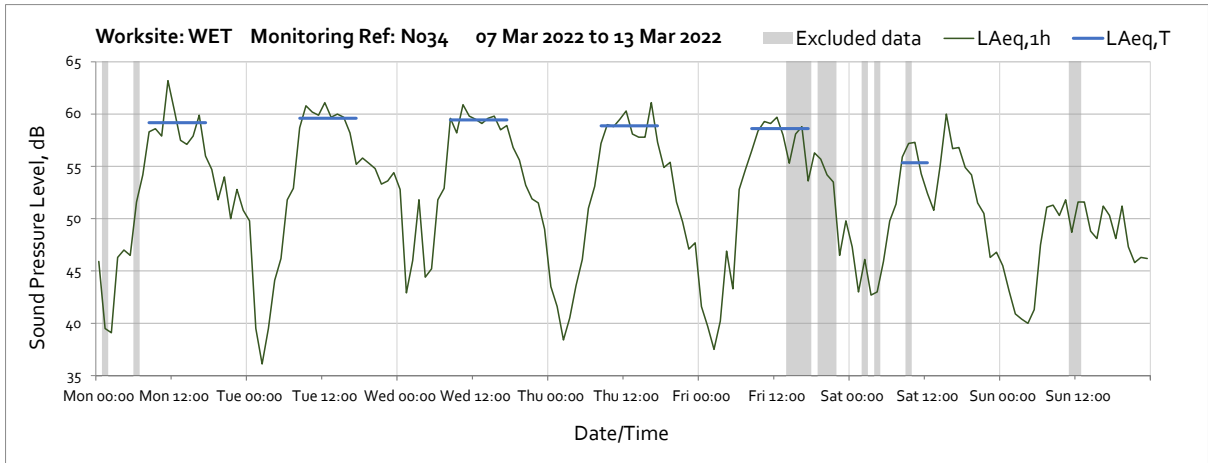
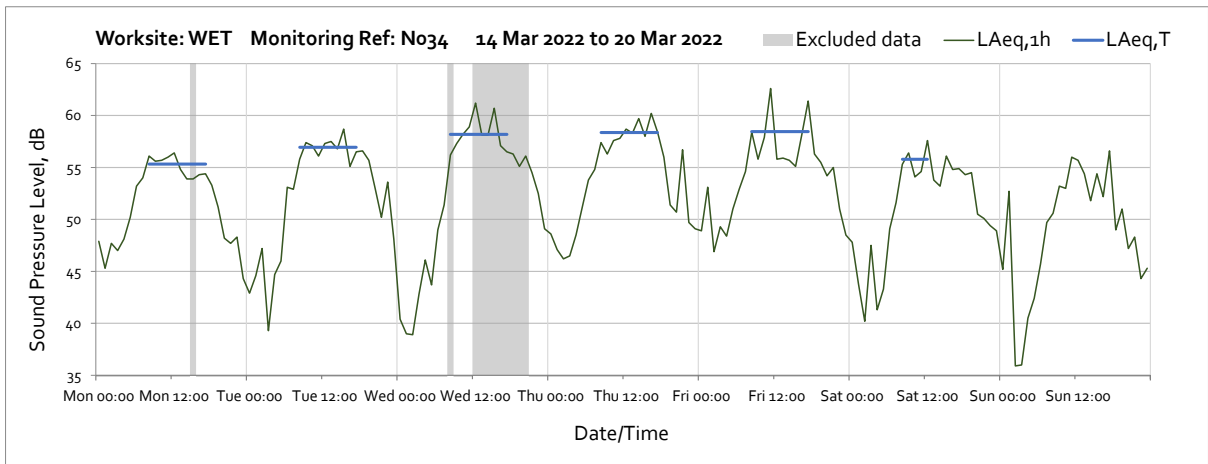
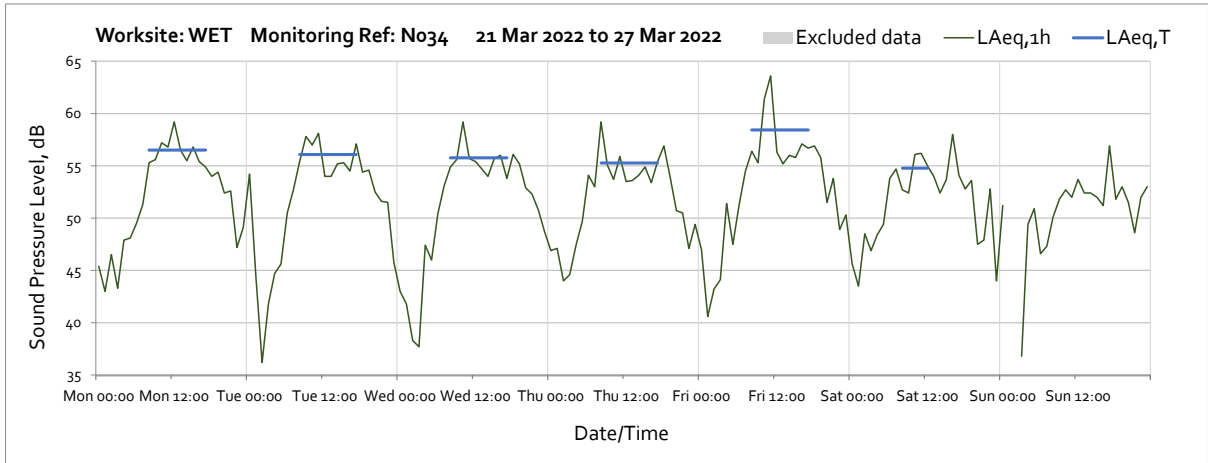
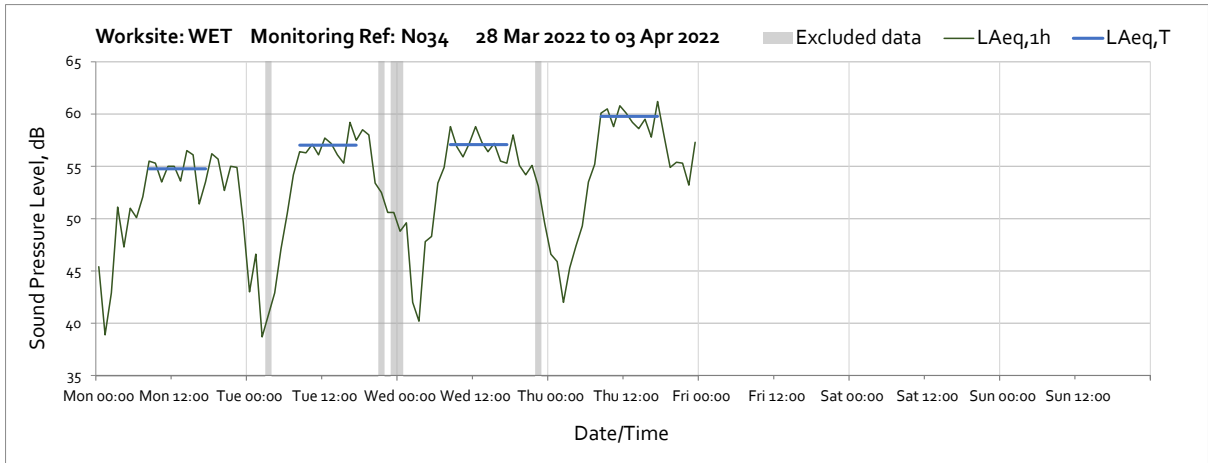
Worksite: Willesden Euro Terminal (WET) - Monitoring Ref: N034

Note: Missing data in between 01:00 and 02:00 on Sunday 27th March was due to the clocks going forward at the start of British Summer Time.

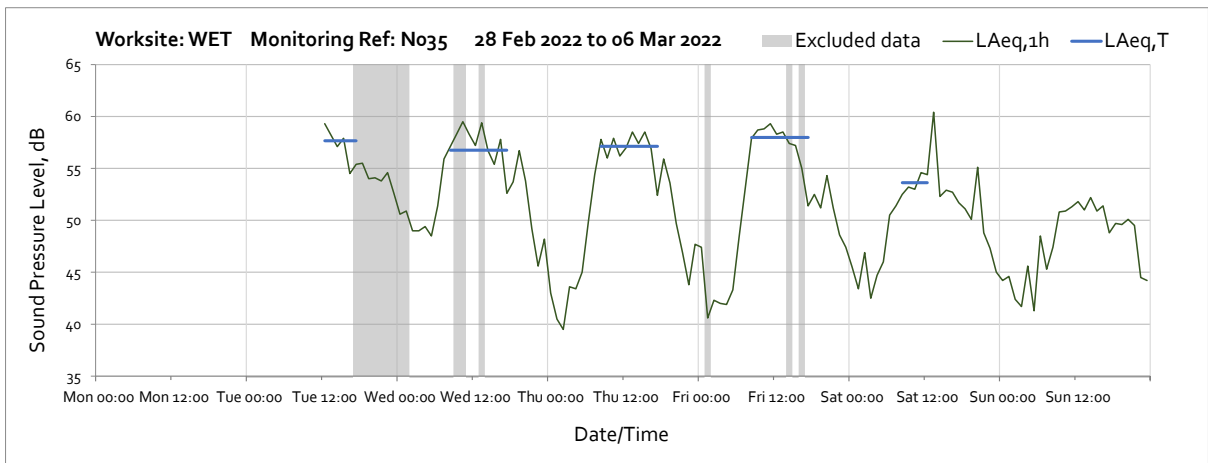
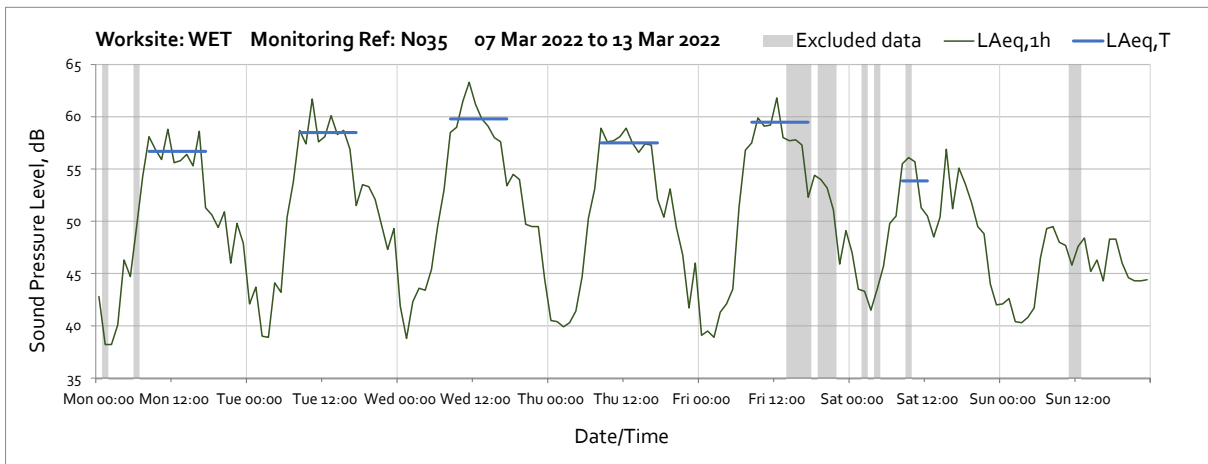
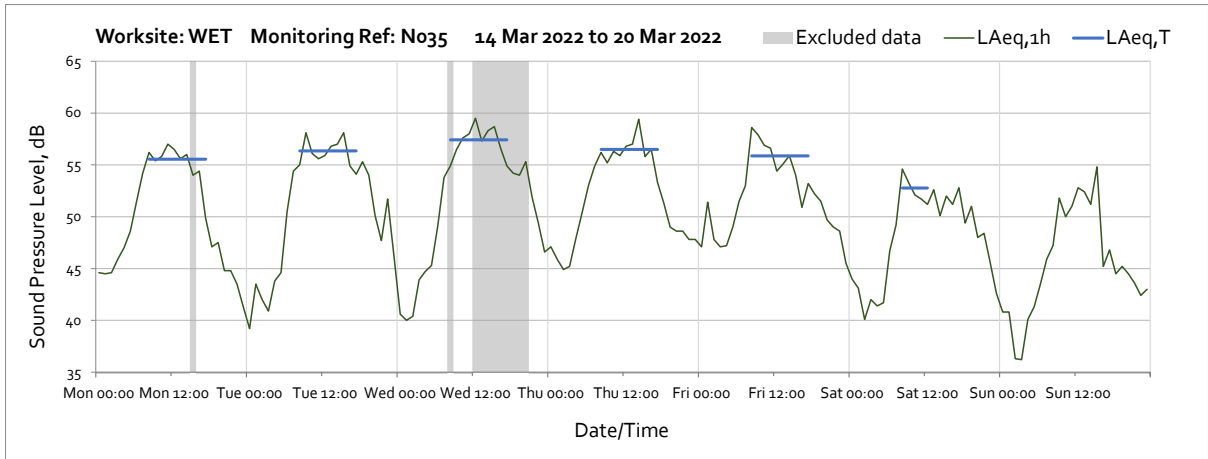
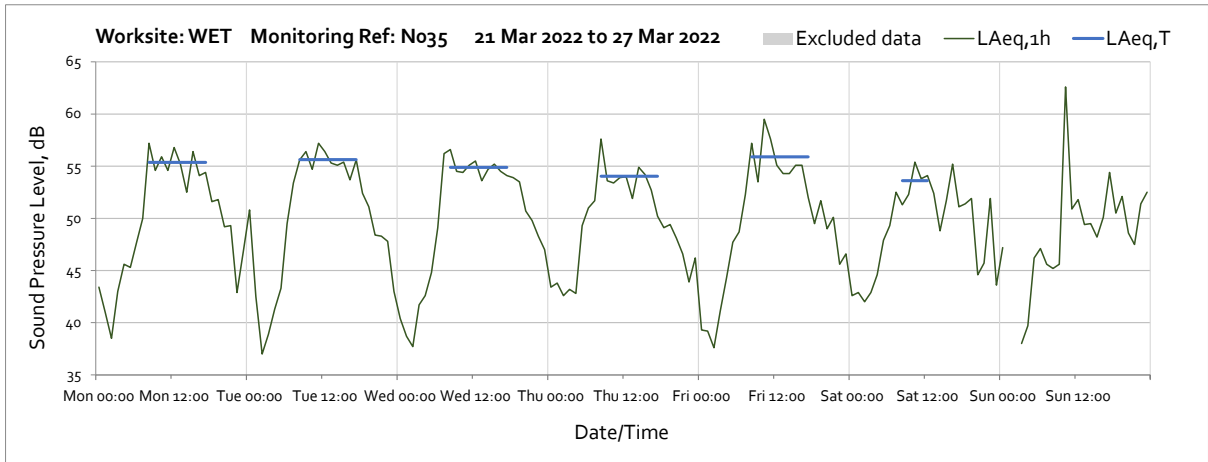
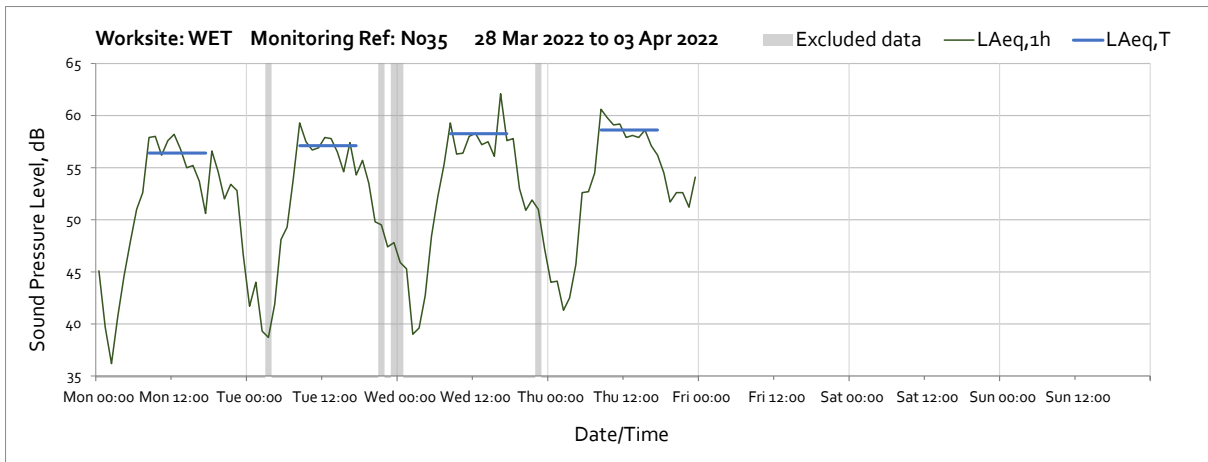
Worksite: Willesden Euro Terminal (WET) – Monitoring Ref: N035

Note: Missing data in between 00:00 and 11:00 on Tuesday 1st March 2022 was due to loss of power at the monitoring station.

Note: Missing data in between 01:00 and 02:00 on Sunday 27th March was due to the clocks going forward at the start of British Summer Time.

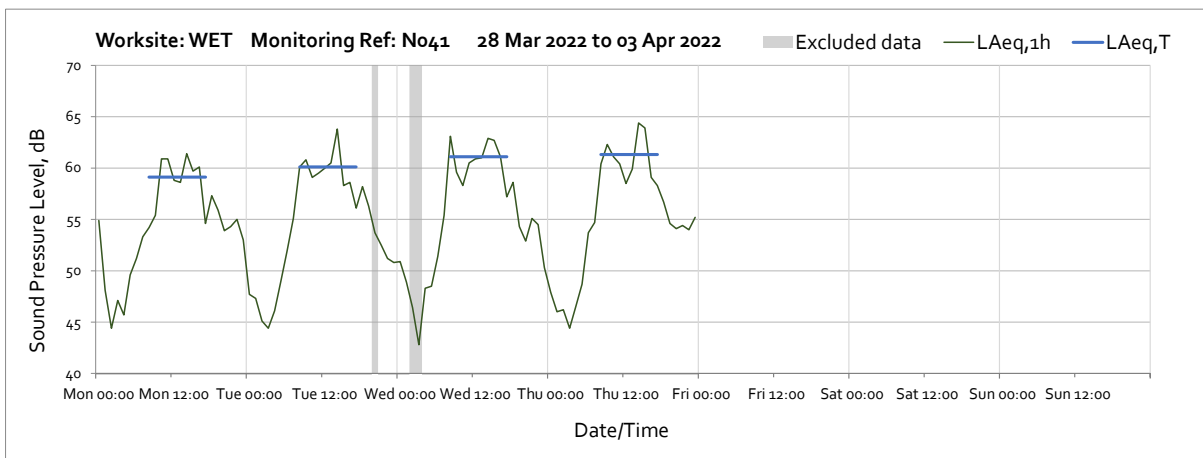
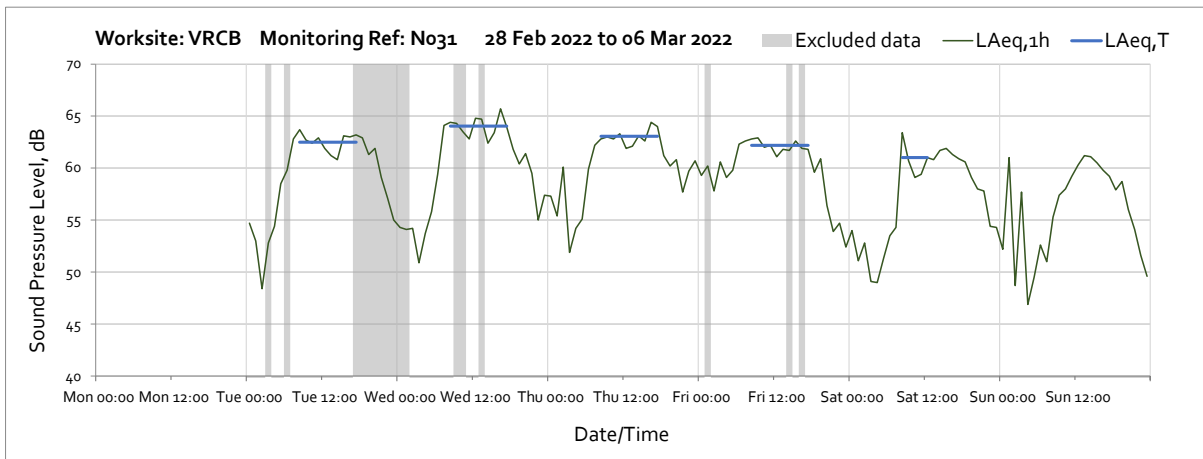
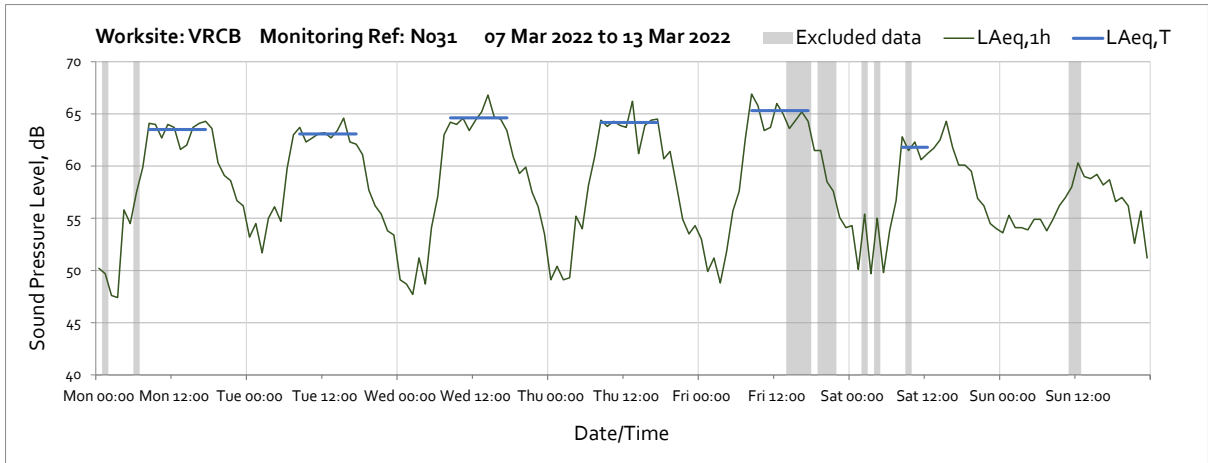
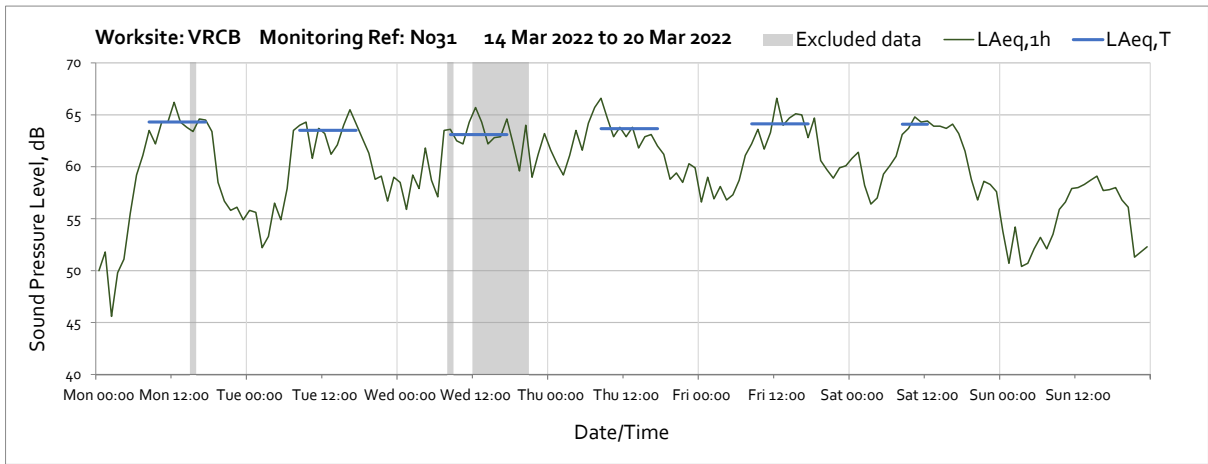
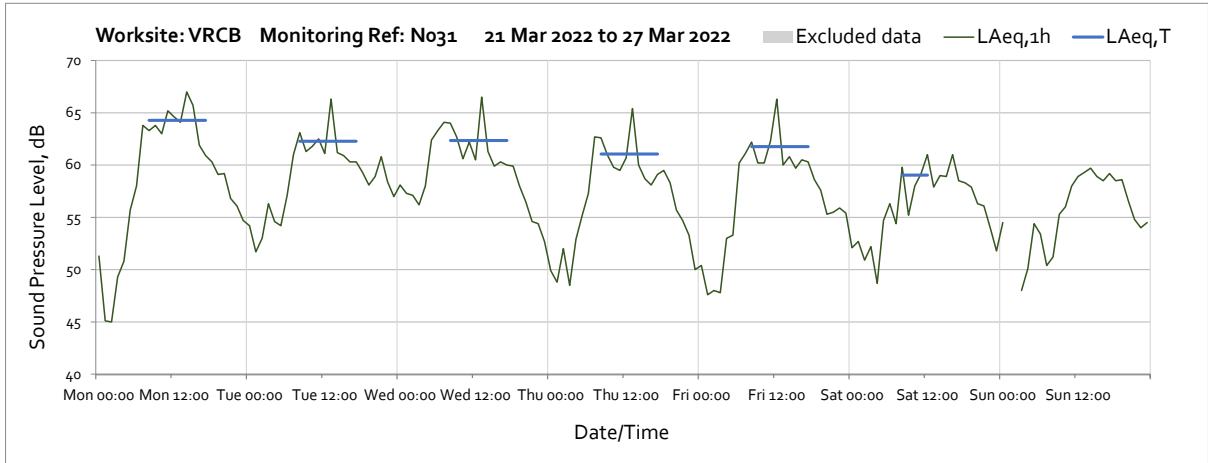
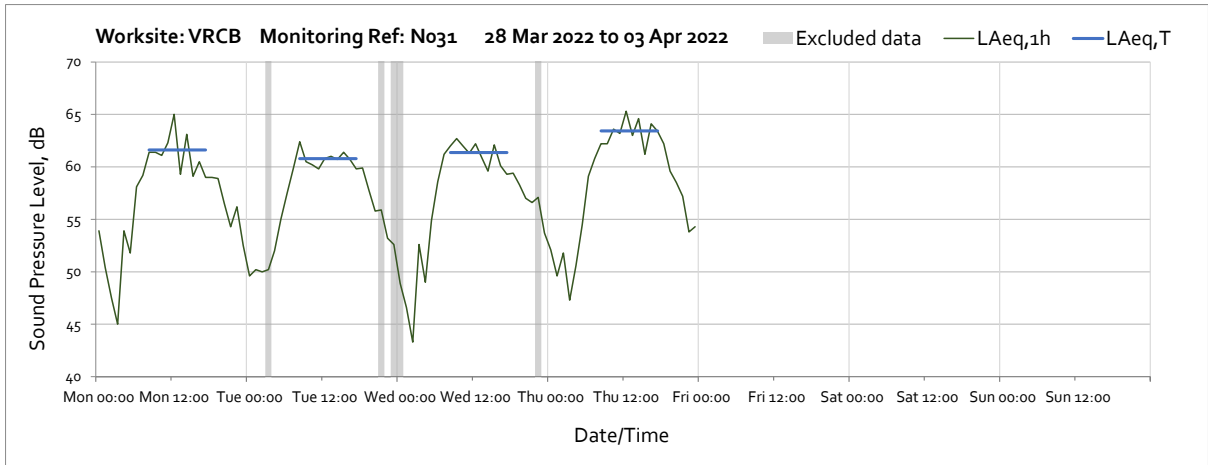
Worksite: Victoria Road Crossover Box (VRCB) – Monitoring Ref: N031

Note: Missing data in between 01:00 and 02:00 on Sunday 27th March was due to the clocks going forward at the start of British Summer Time.

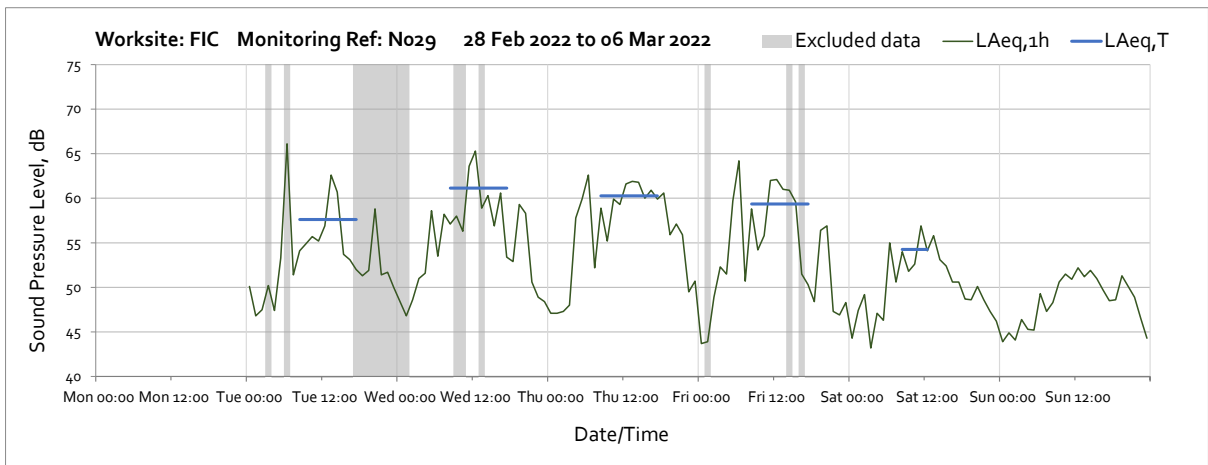
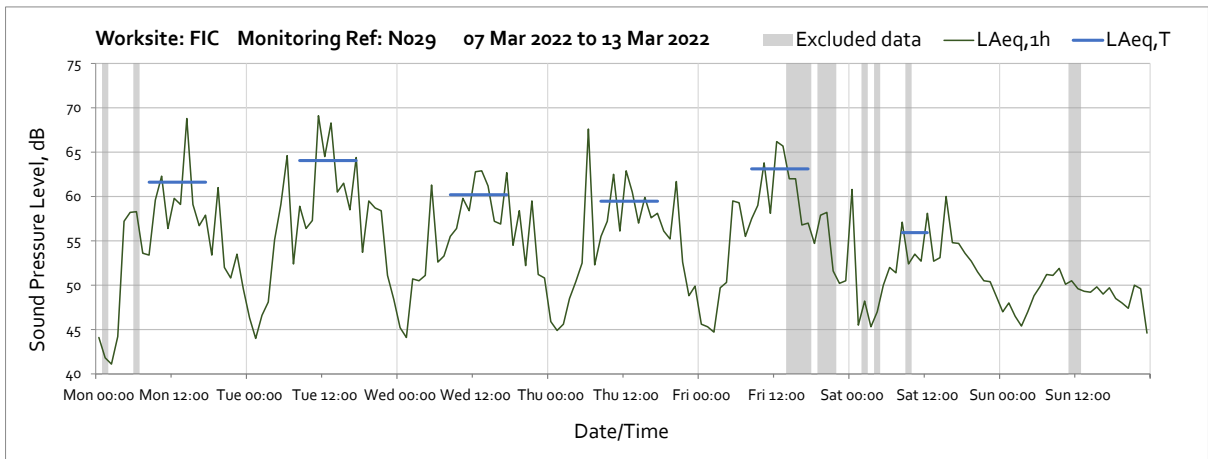
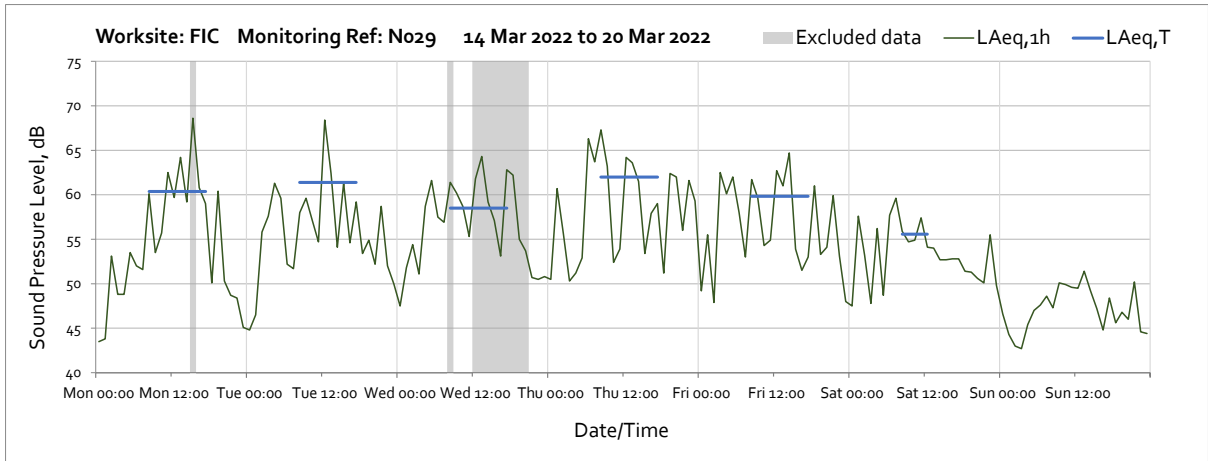
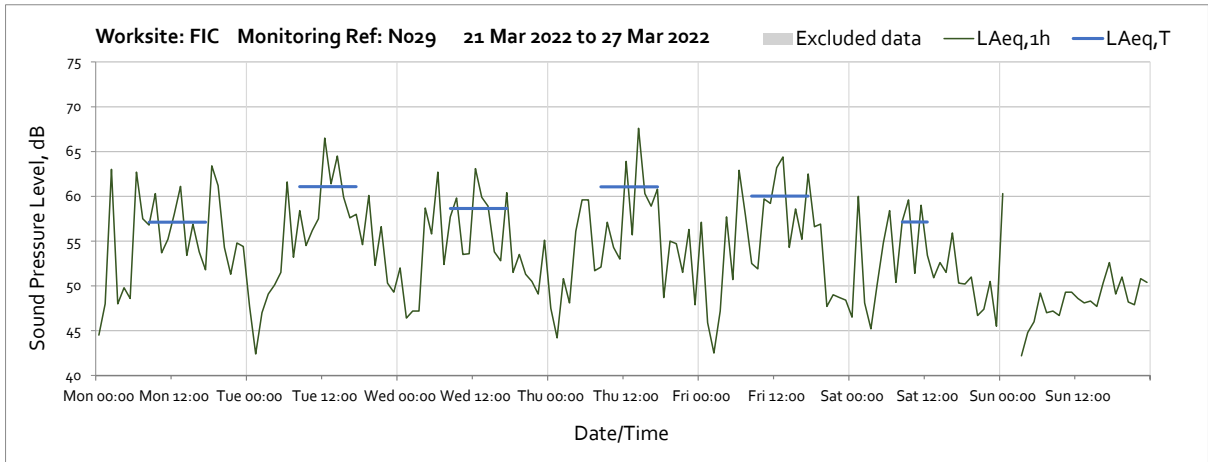
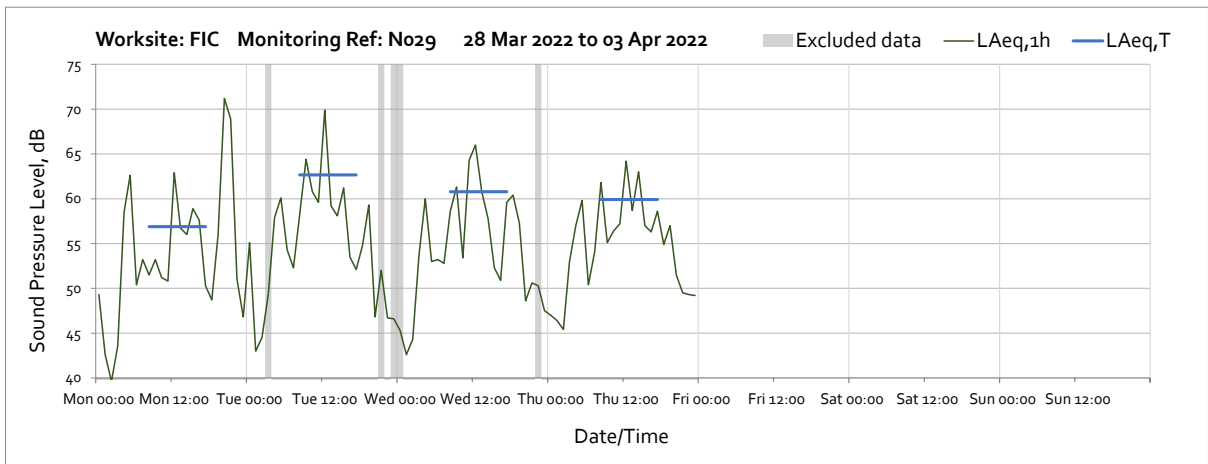
Worksite: Flat Iron Compound (FIC) – Monitoring Ref: N029

Note: Missing data in between 01:00 and 02:00 on Sunday 27th March was due to the clocks going forward at the start of British Summer Time.

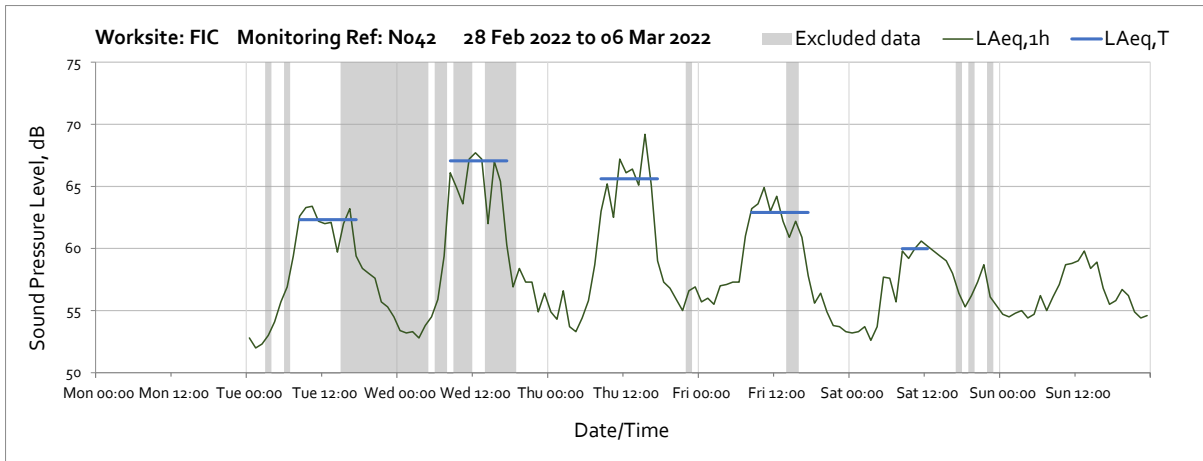
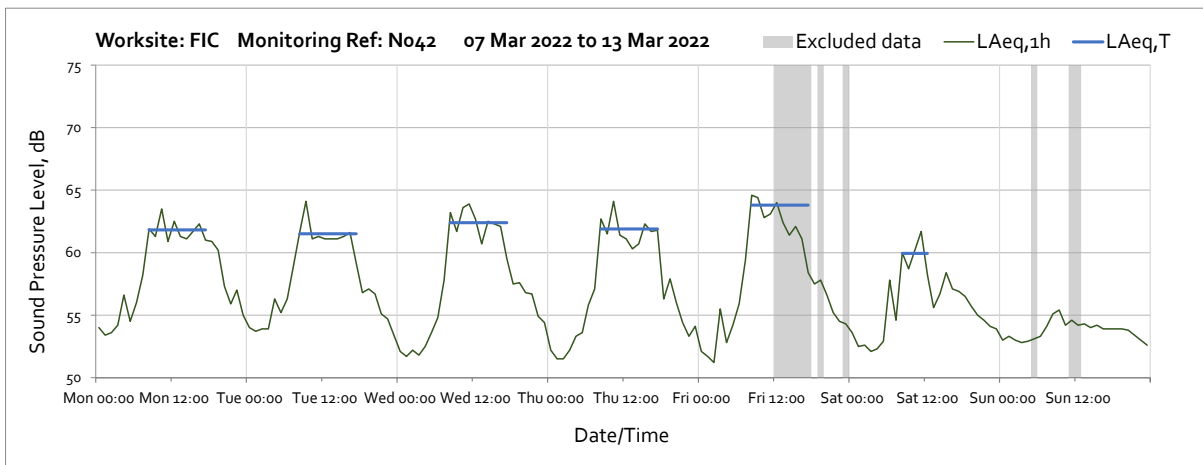
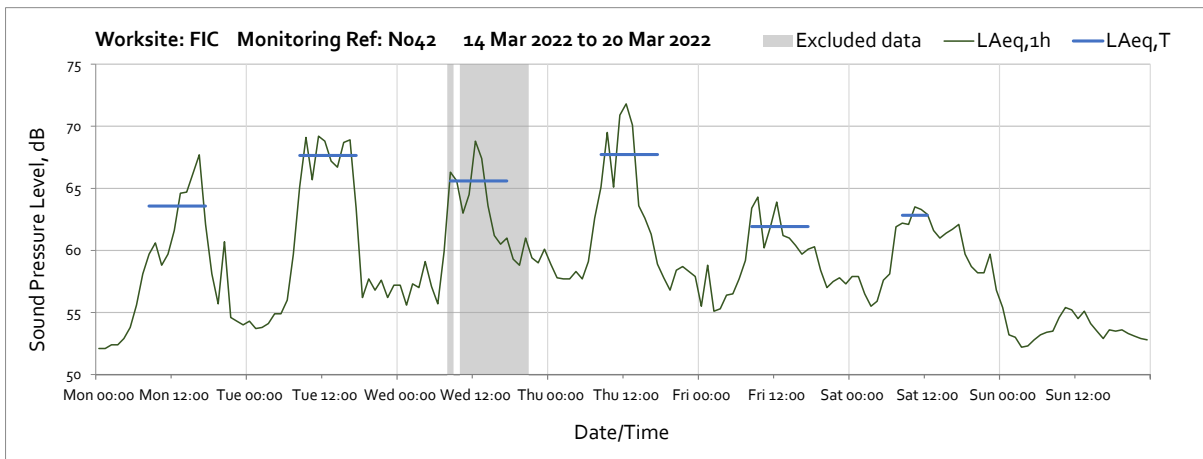
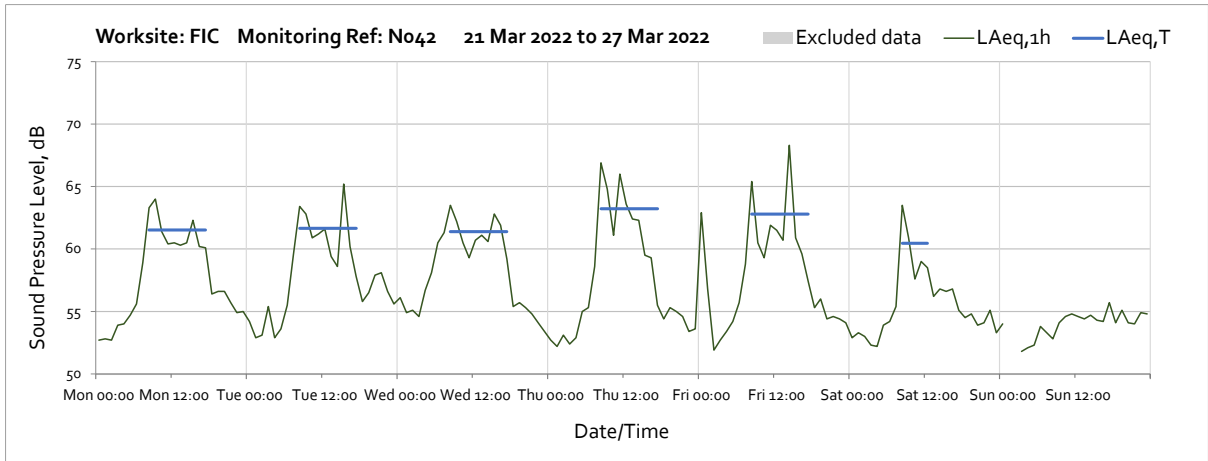
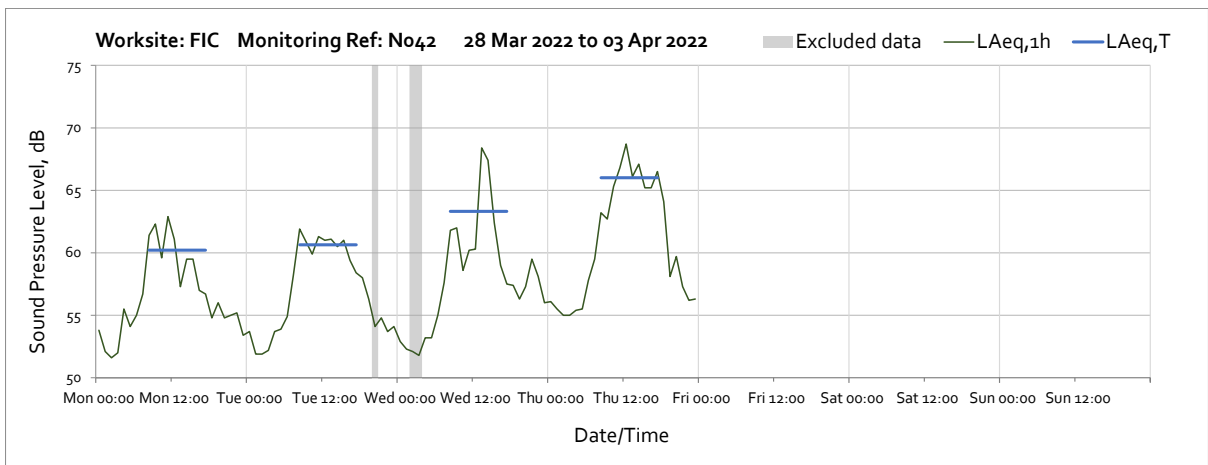
Worksite: Flat Iron Compound (FIC) – Monitoring Ref: N042

Note: Missing data in between 01:00 and 02:00 on Sunday 27th March was due to the clocks going forward at the start of British Summer Time.
