Construction Noise and Vibration Monthly Report – March 2022

London Borough of Ealing

This Noise and Vibration Monitoring Report fulfils HS2 Limited's commitment detailed in the Environmental Minimum Requirements (EMRs), Annex 1, Code of Construction Practice, to present the results of noise and vibration monitoring carried out within the London Borough of Ealing (LBE) (including one monitoring location on the boundary with the London Borough of Hammersmith and Fulham) during the month of March 2022.

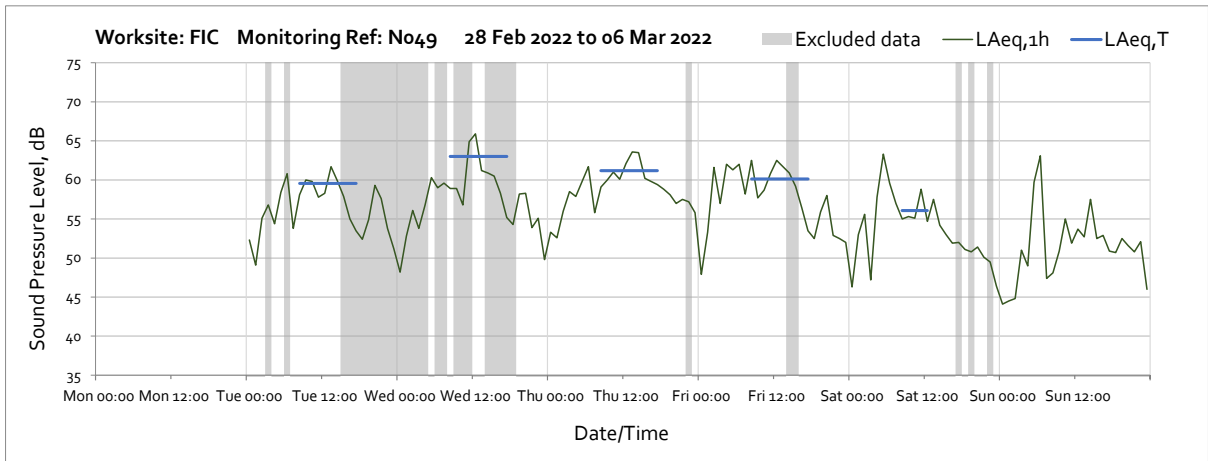
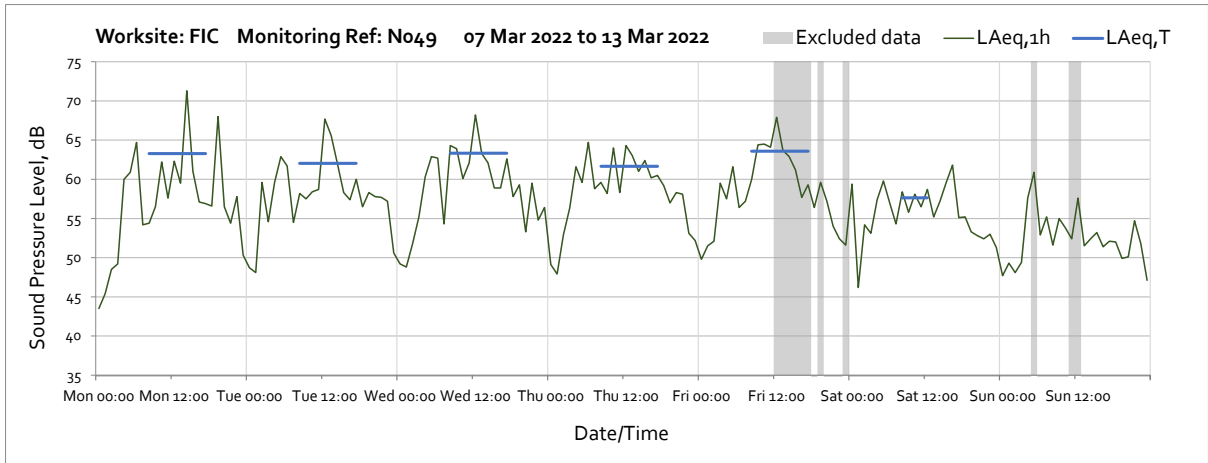
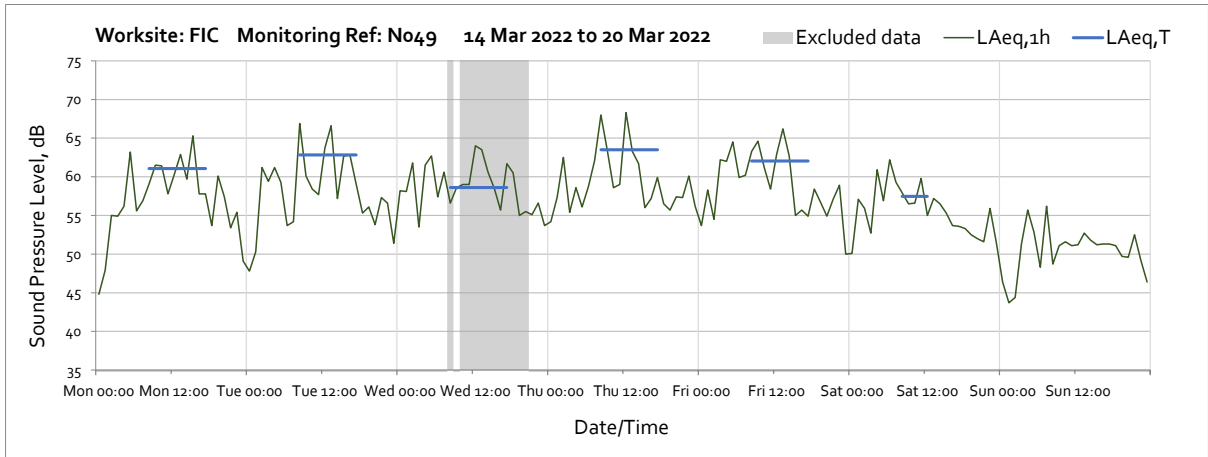
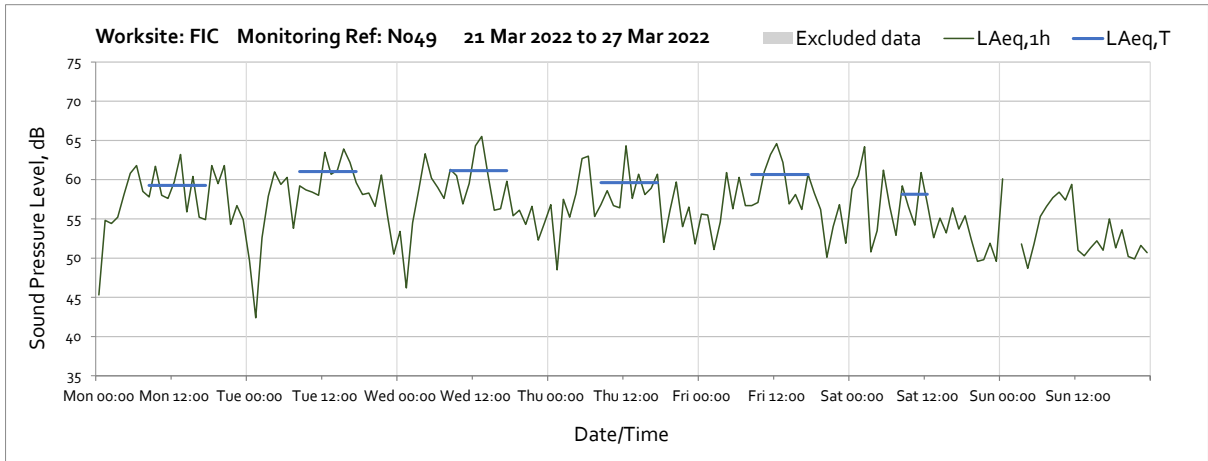
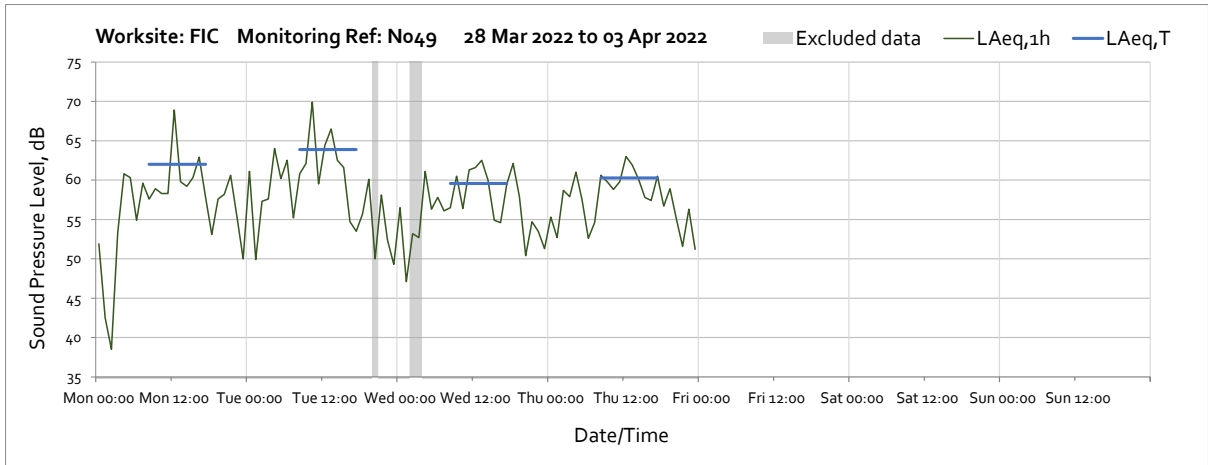
Worksite: Flat Iron Compound (FIC) - Monitoring Ref: N049

Note: Missing data in between 01:00 and 02:00 on Sunday 27th March was due to the clocks going forward at the start of British Summer Time.

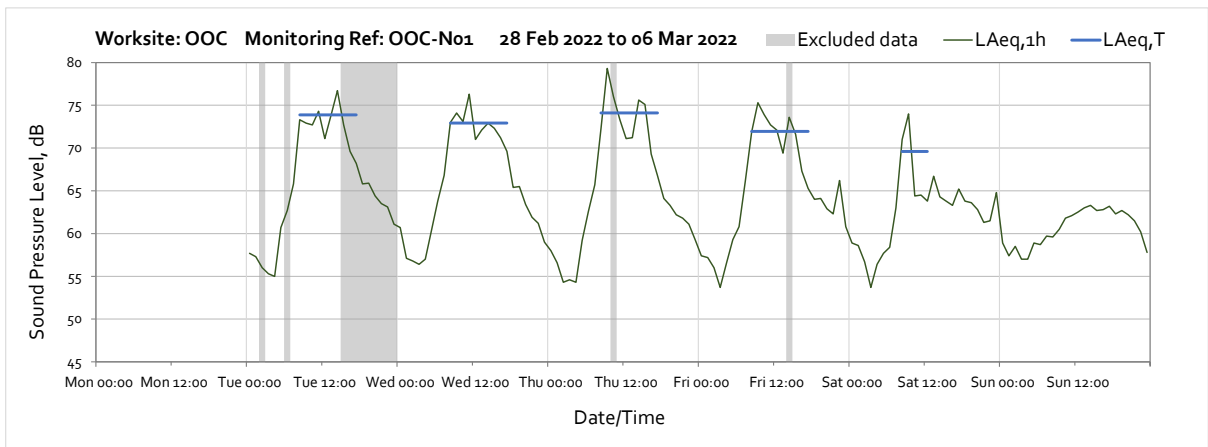
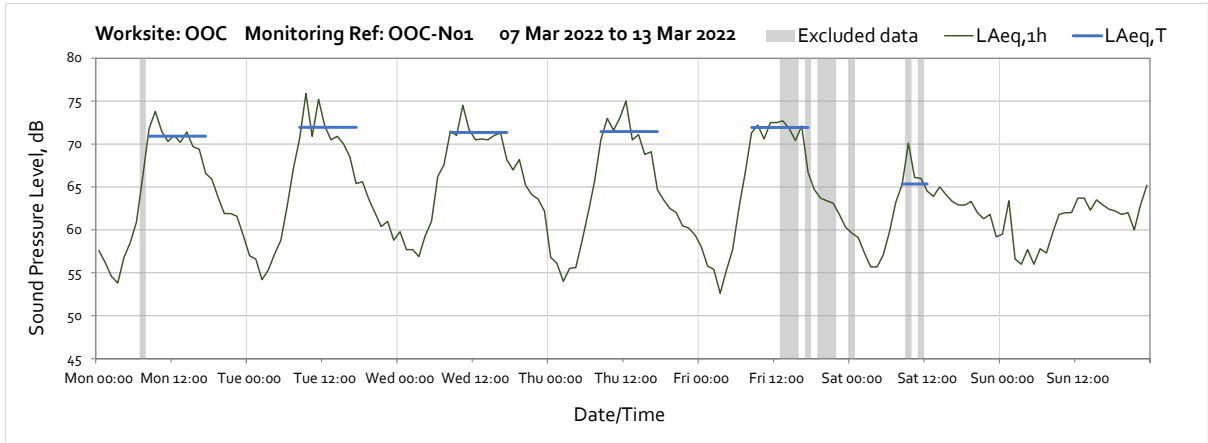
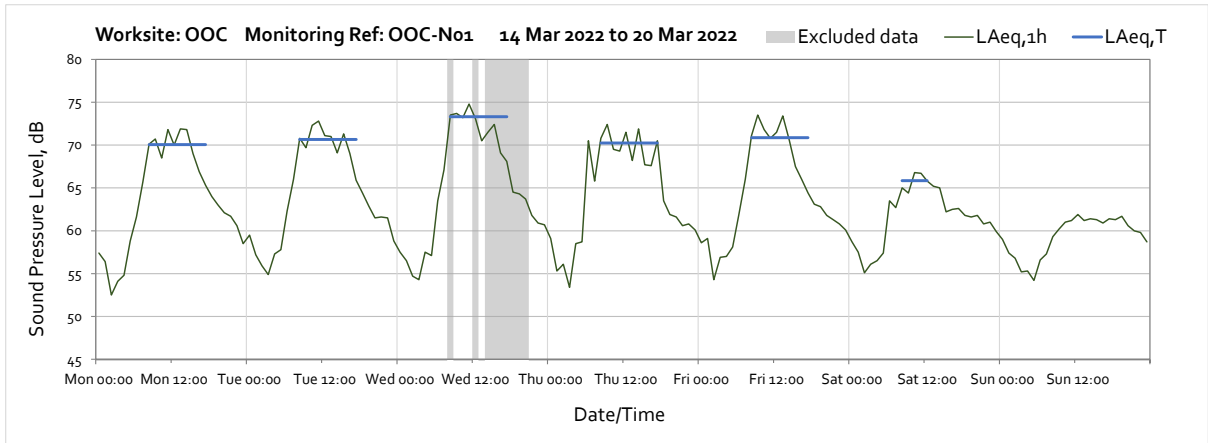
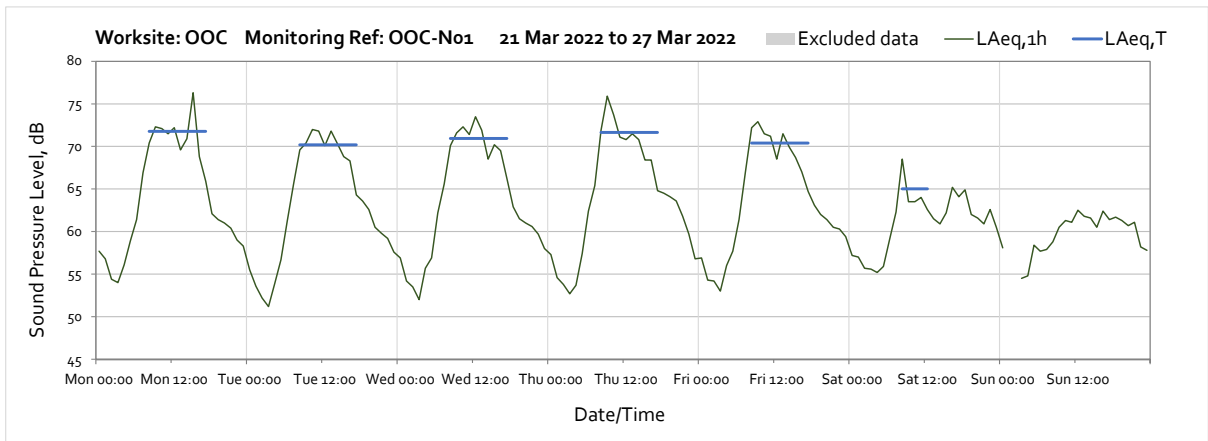
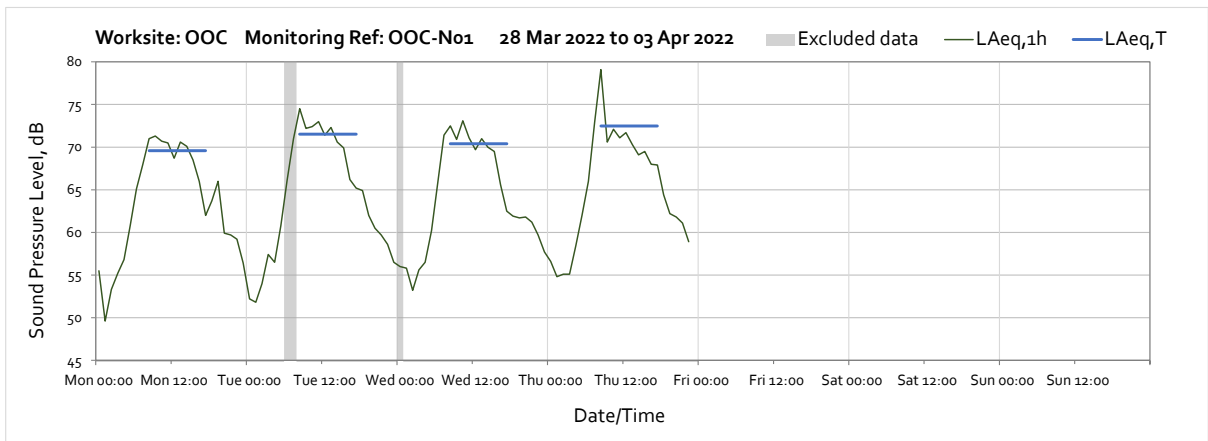
Worksite: Oal Oak Common (OOC) – Monitoring Ref: OOC-N01

Note: Missing data in between 01:00 and 02:00 on Sunday 27th March was due to the clocks going forward at the start of British Summer Time.

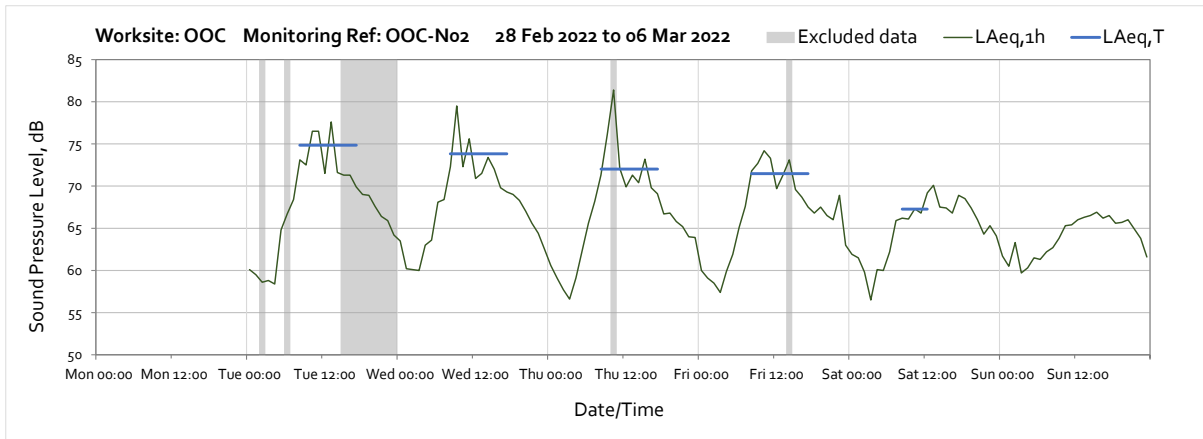
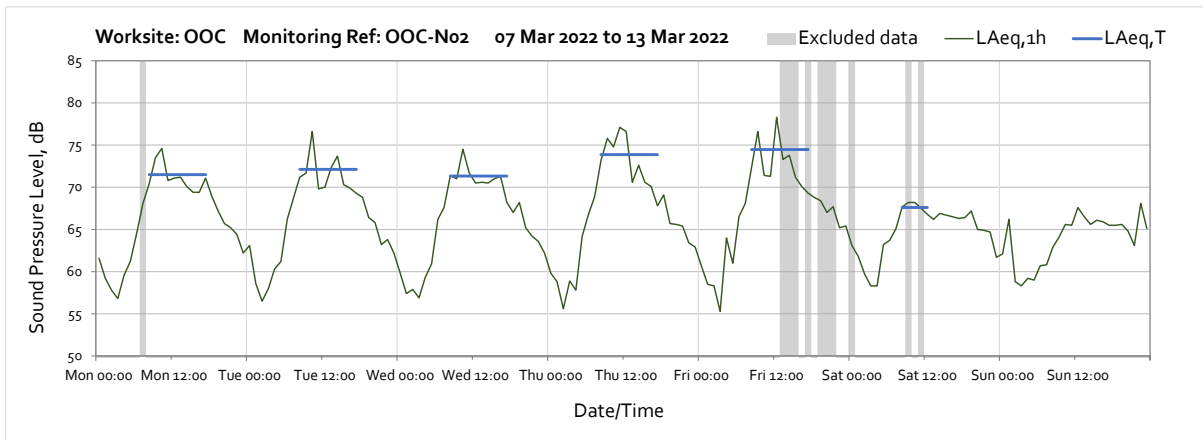
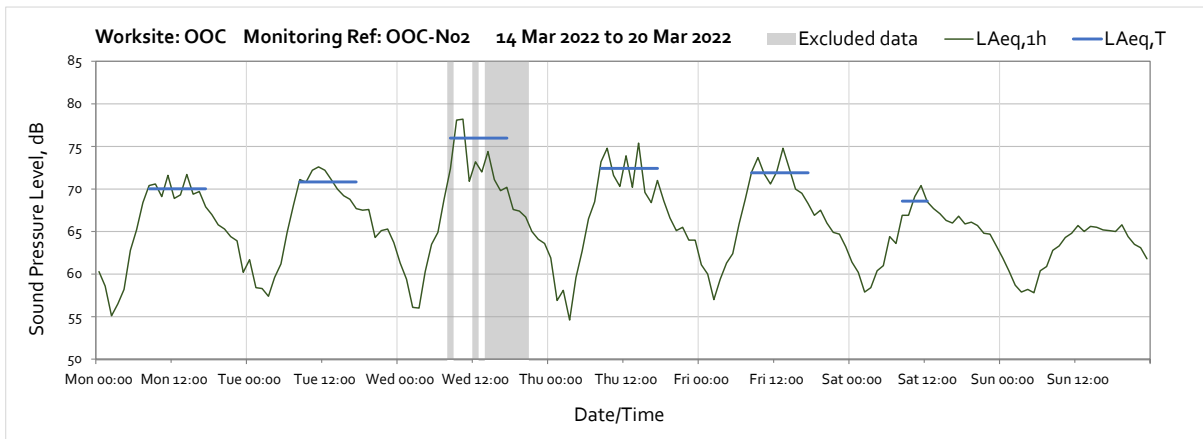
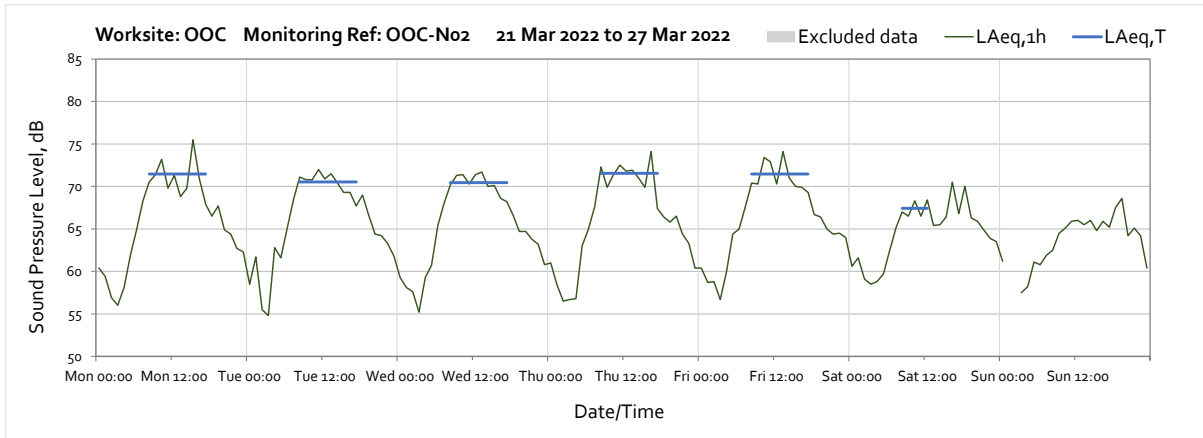
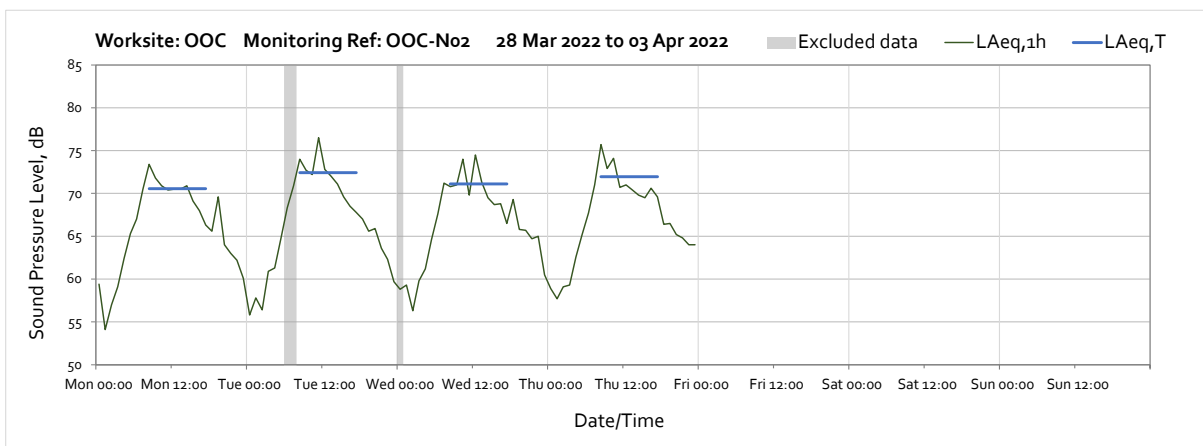
Worksite: Oal Oak Common (OOC) – Monitoring Ref: OOC-N02

Note: Missing data in between 01:00 and 02:00 on Sunday 27th March was due to the clocks going forward at the start of British Summer Time.

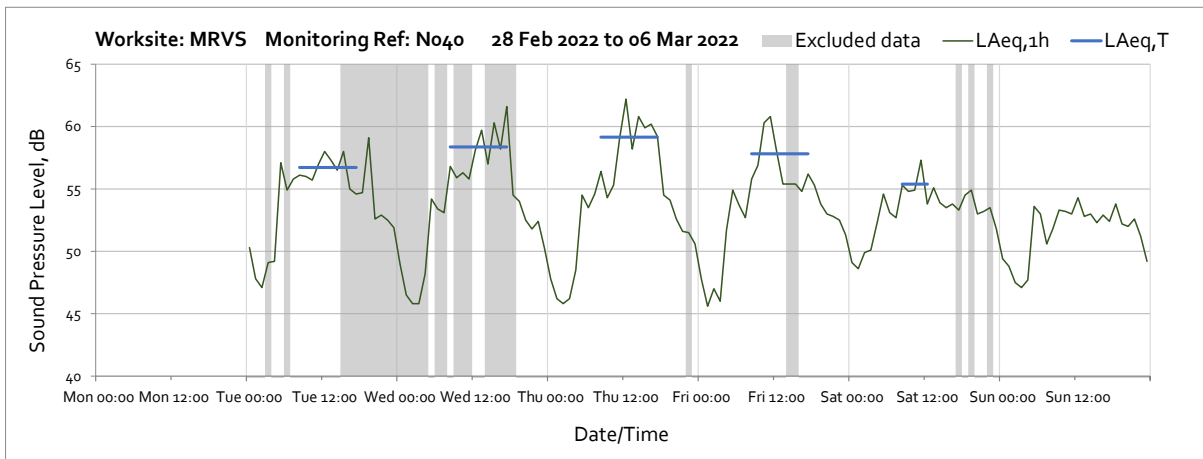
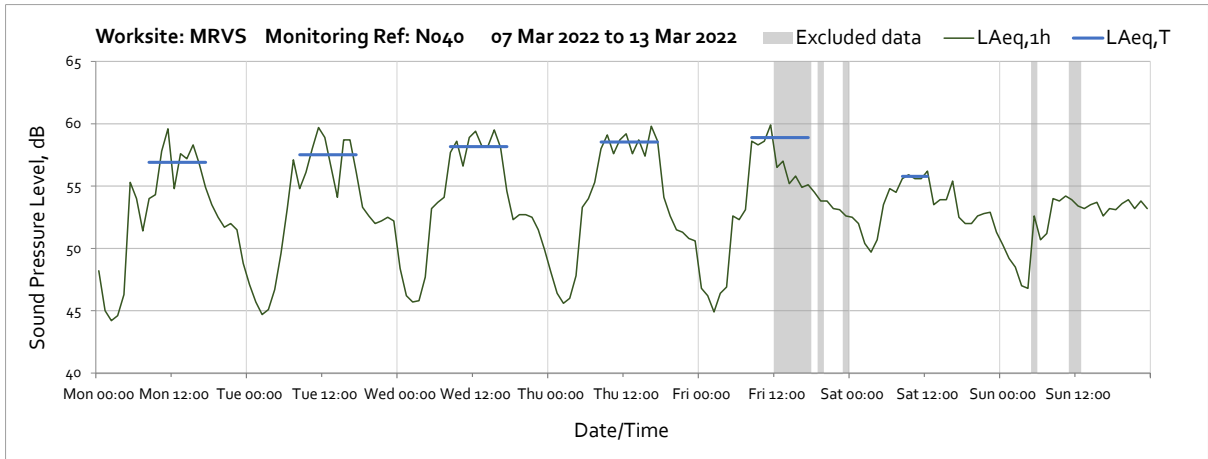
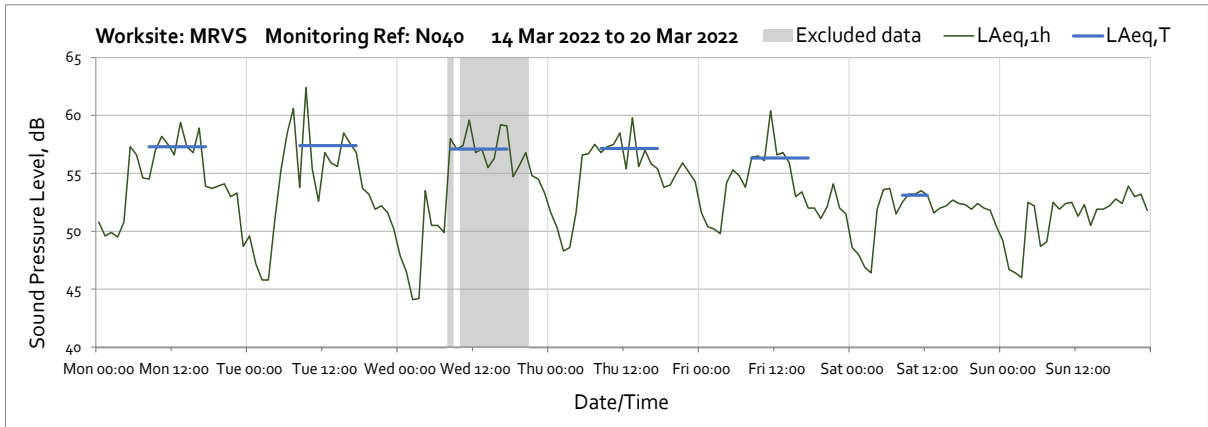
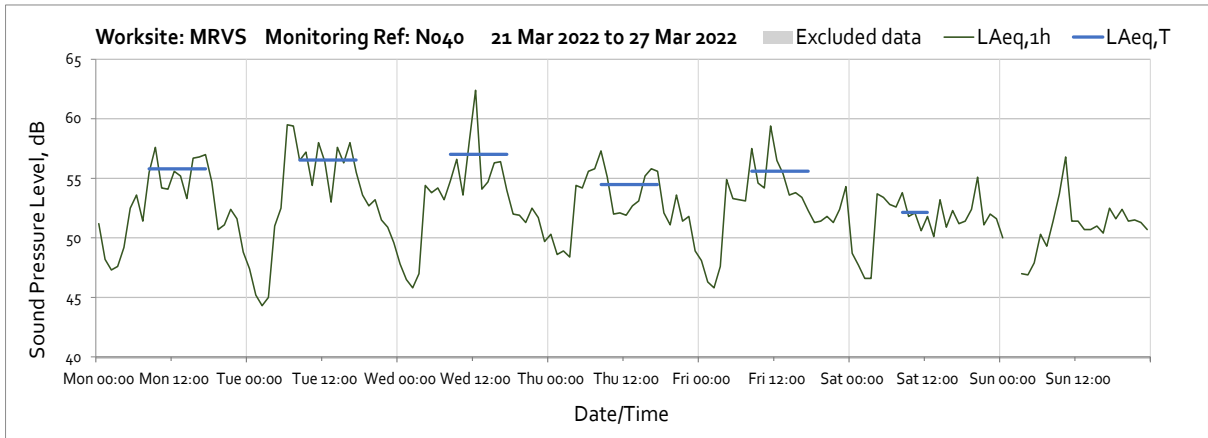
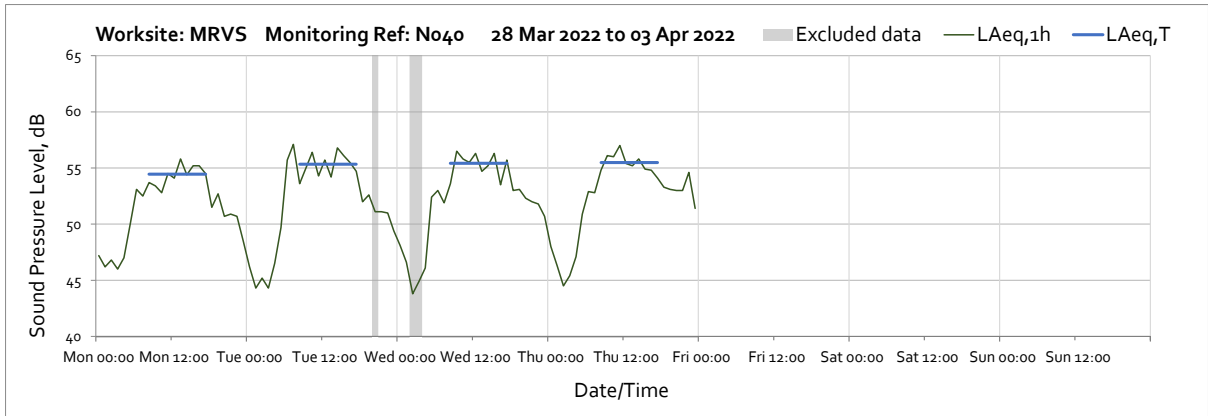
Worksite: Mandeville Road Ventilation Shaft (MRVS) – Monitoring Ref: N040

Note: Missing data in between 01:00 and 02:00 on Sunday 27th March was due to the clocks going forward at the start of British Summer Time.

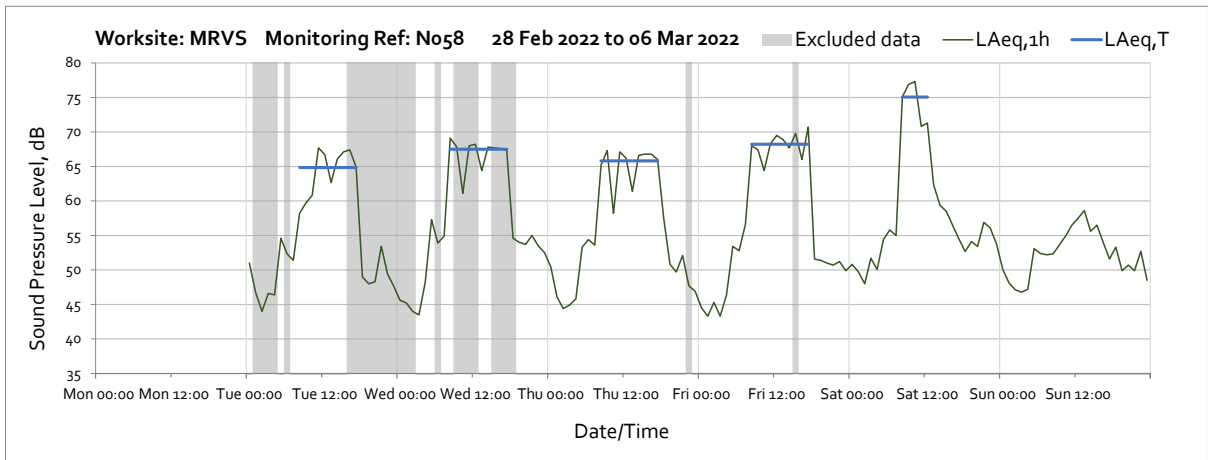
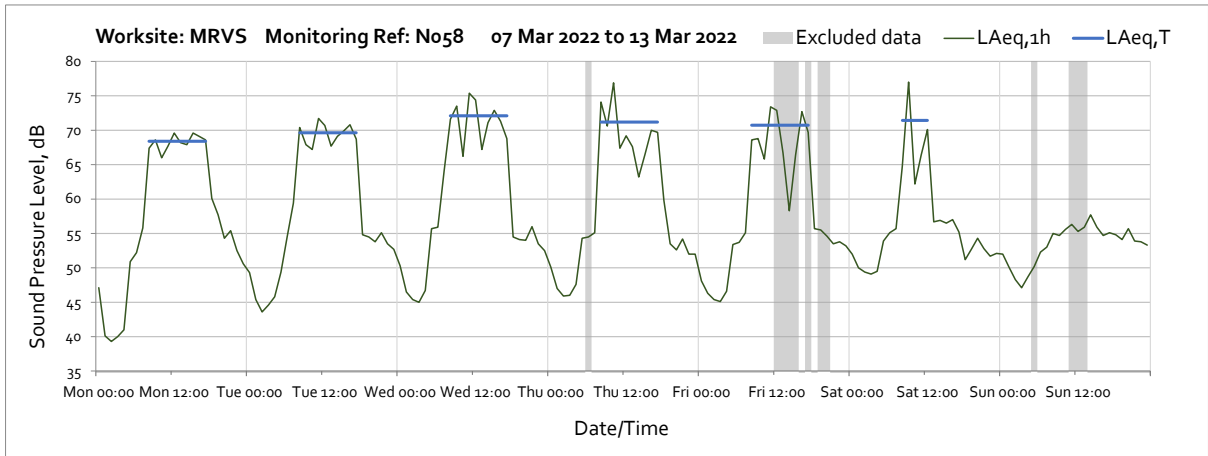
Worksite: Mandeville Road Ventilation Shaft (MRVS) - Monitoring Ref: N058

Note: Missing data in between 01:00 and 02:00 on Sunday 27th March was due to the clocks going forward at the start of British Summer Time.

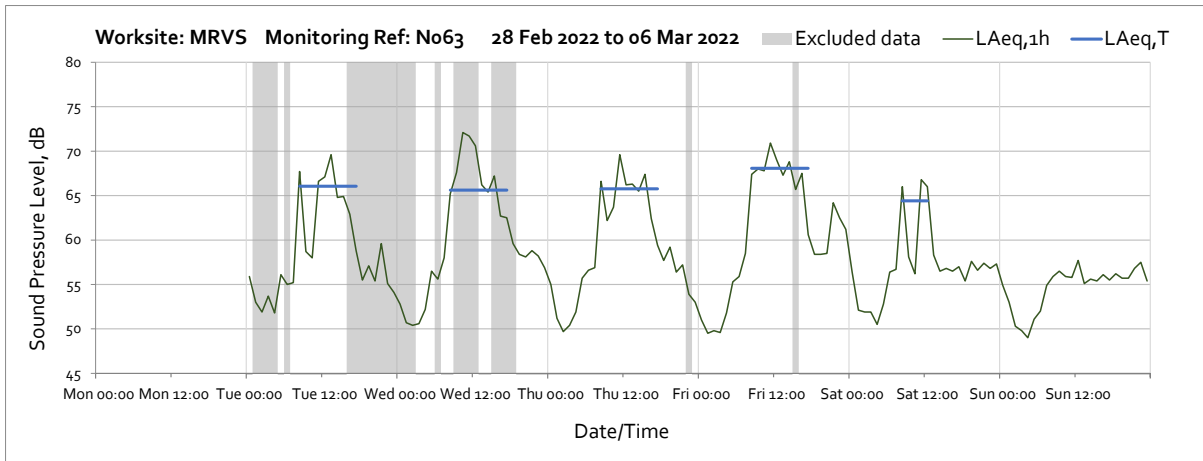
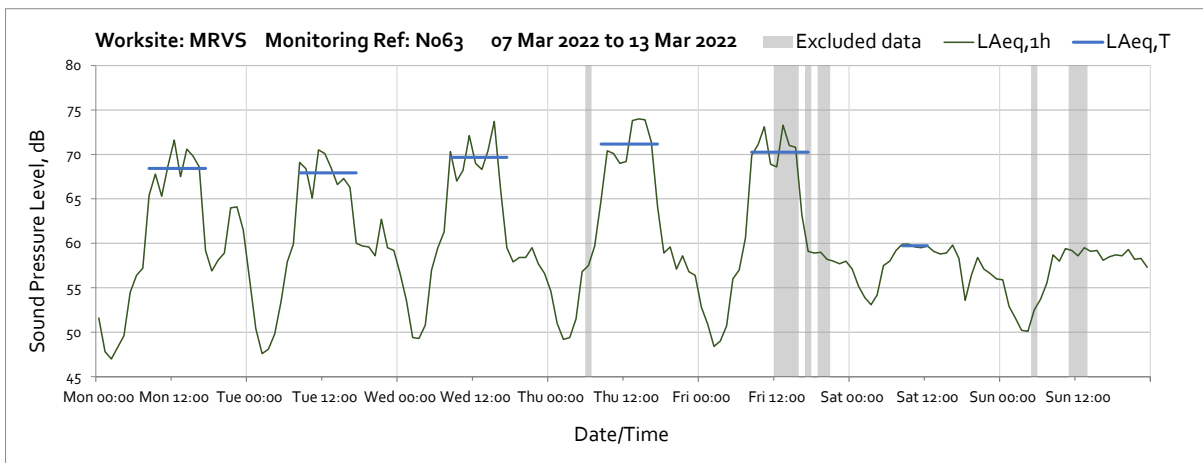
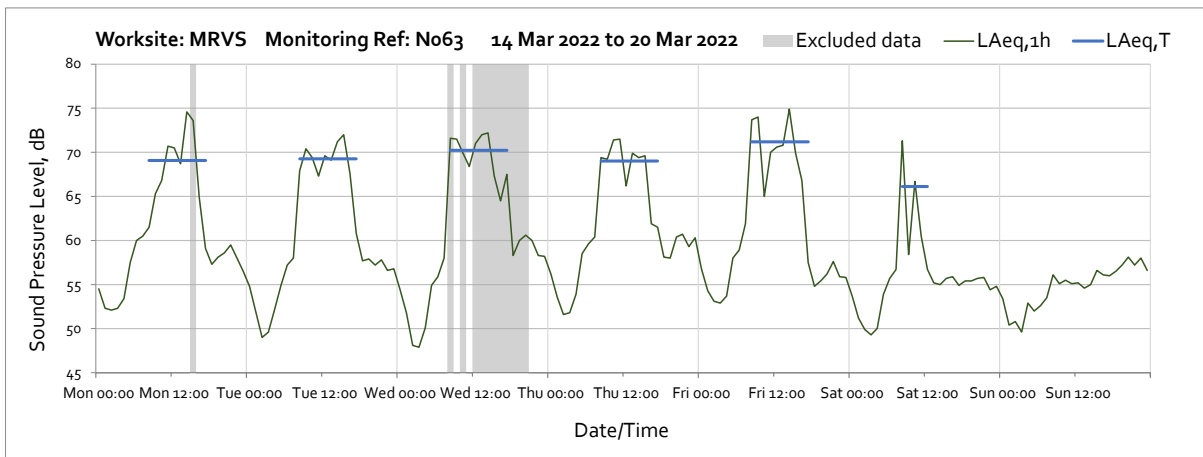
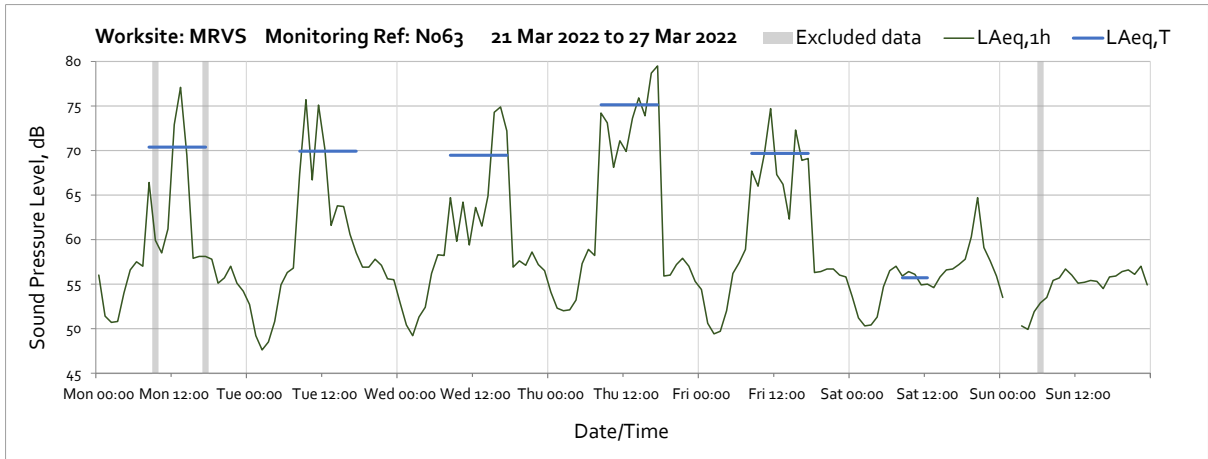
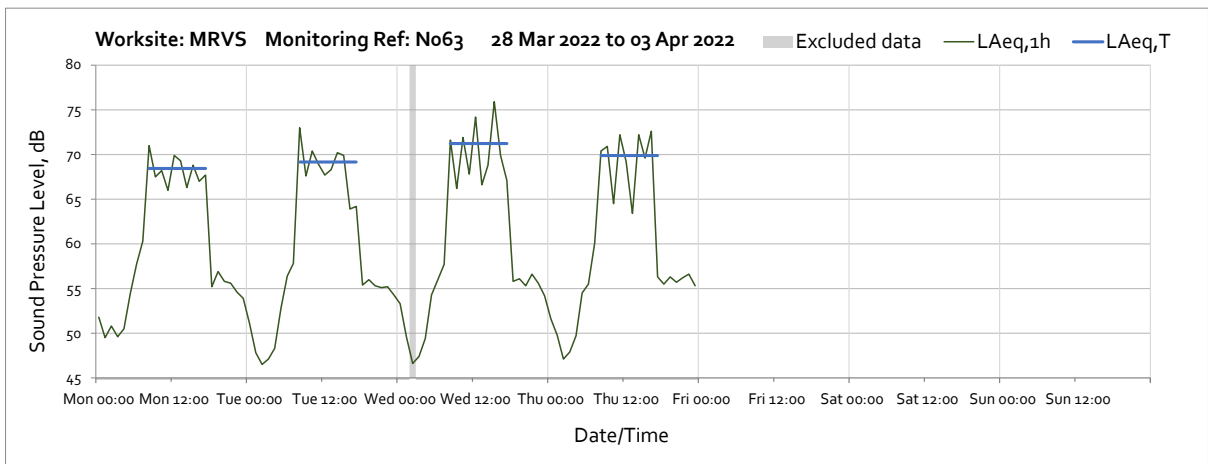
Worksite: Mandeville Road Ventilation Shaft (MRVS) – Monitoring Ref: N063

Note: Missing data in between 01:00 and 02:00 on Sunday 27th March was due to the clocks going forward at the start of British Summer Time.

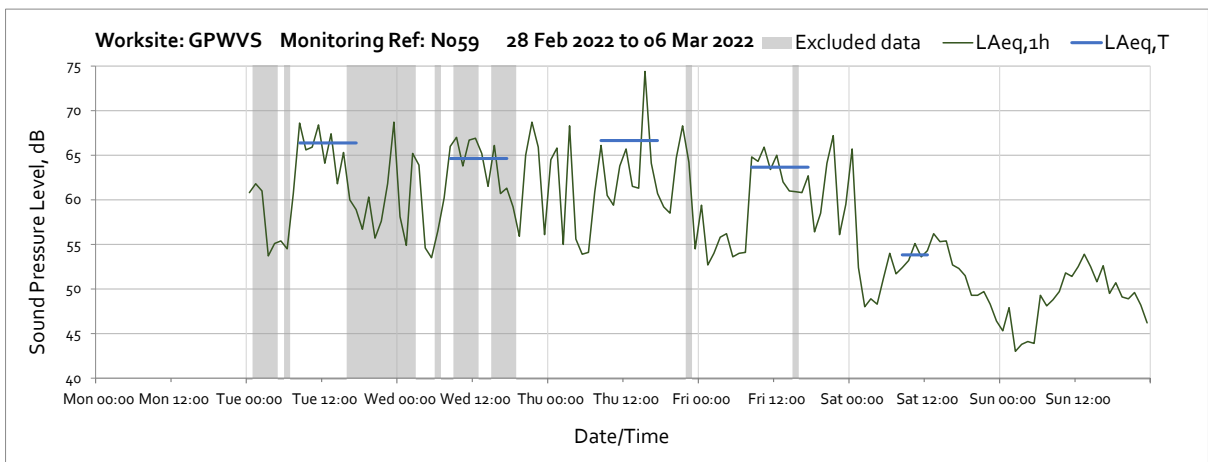
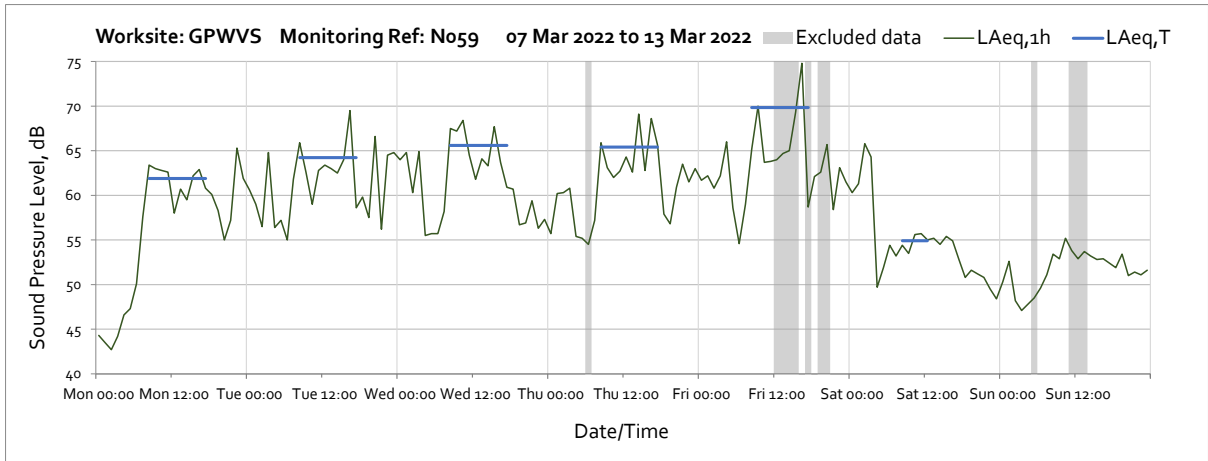
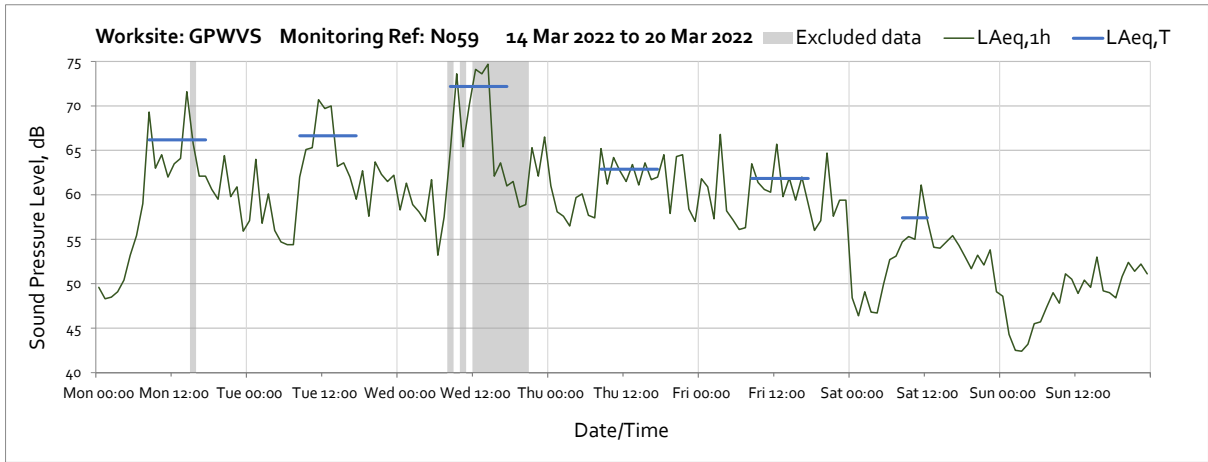
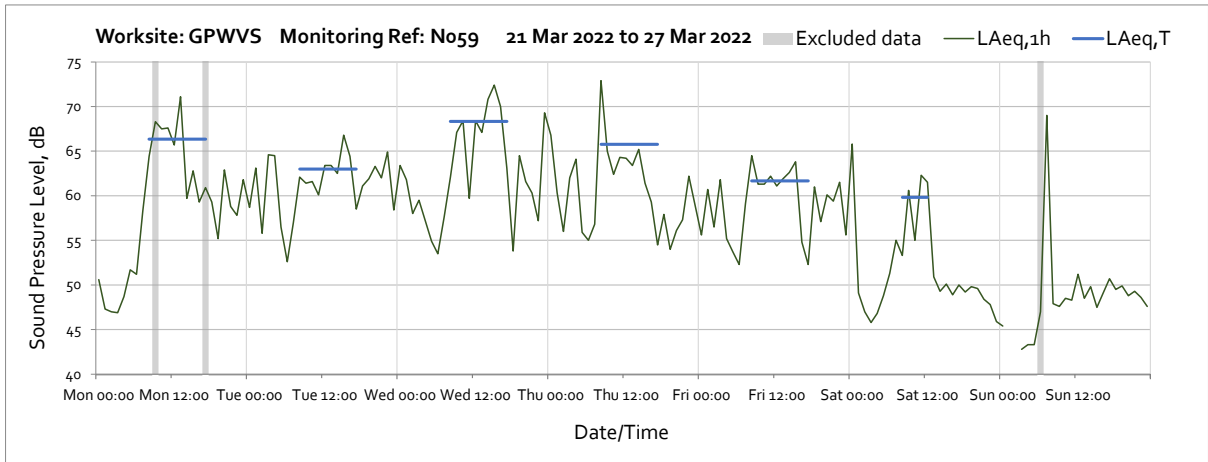
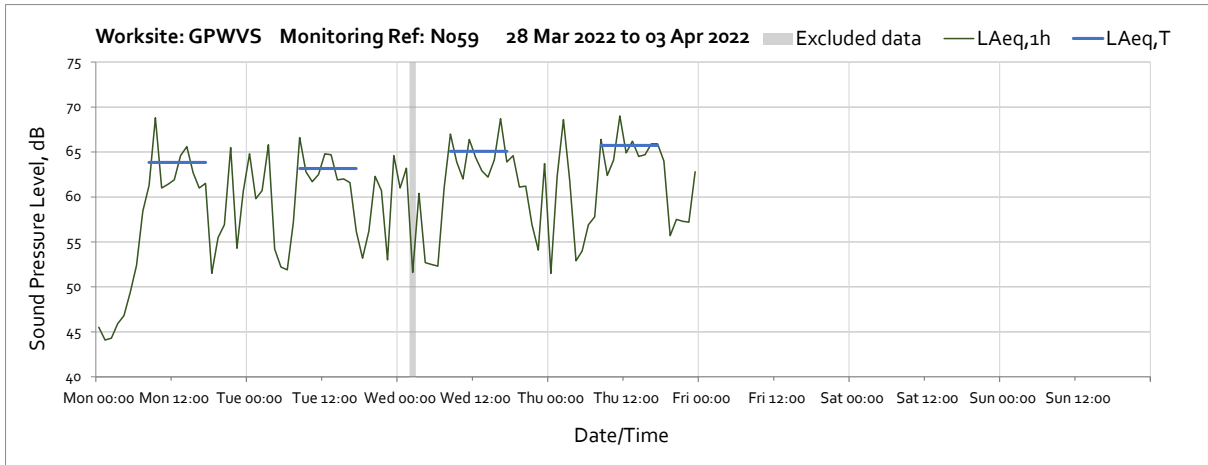
Worksite: Green Park Way Vent Shaft (GPWVS) – Monitoring Ref: N059

Note: Missing data in between 01:00 and 02:00 on Sunday 27th March was due to the clocks going forward at the start of British Summer Time.

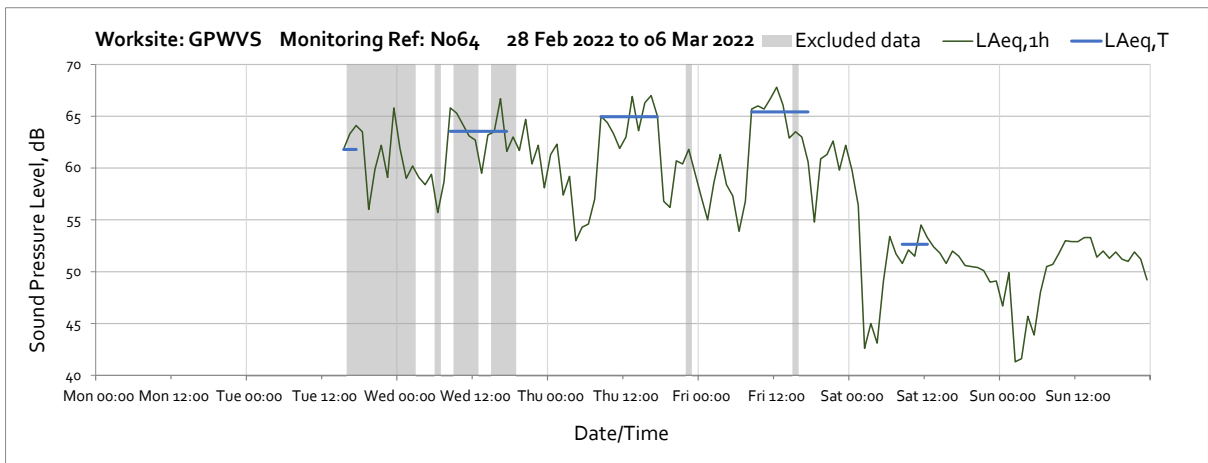
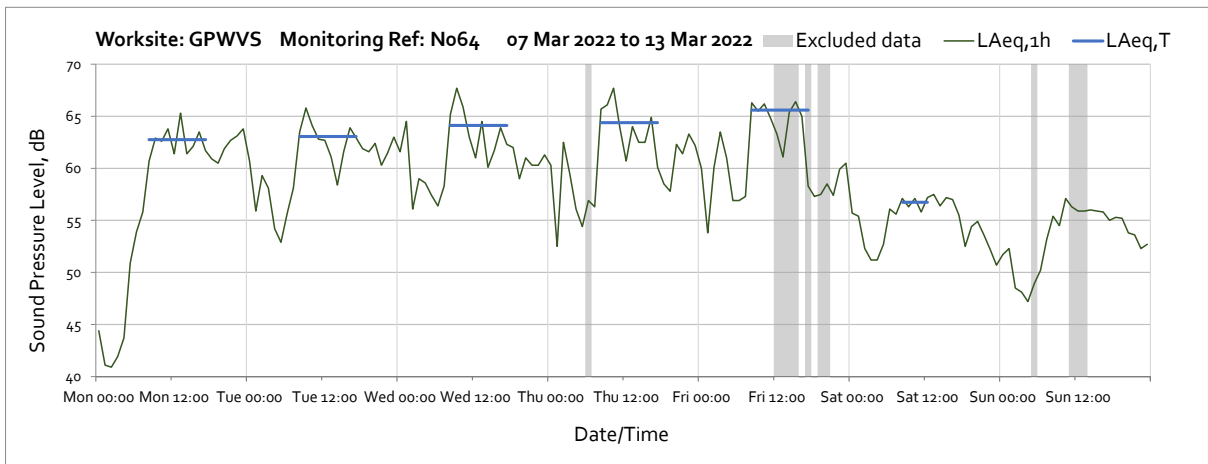
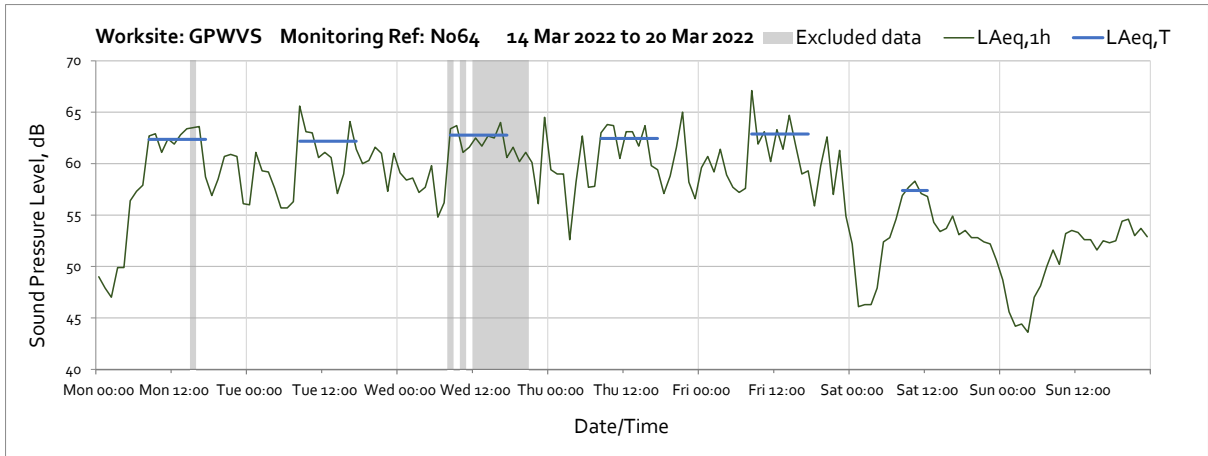
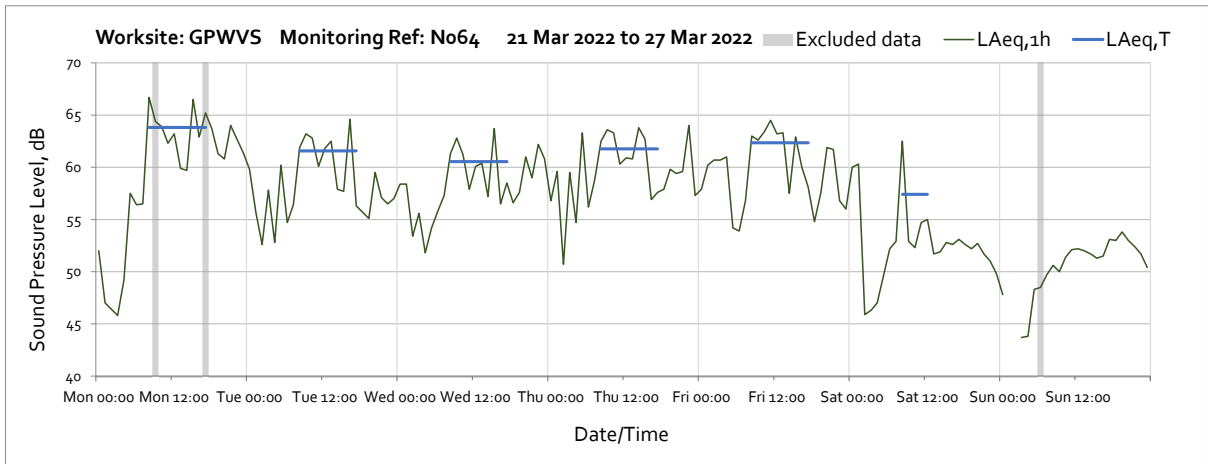
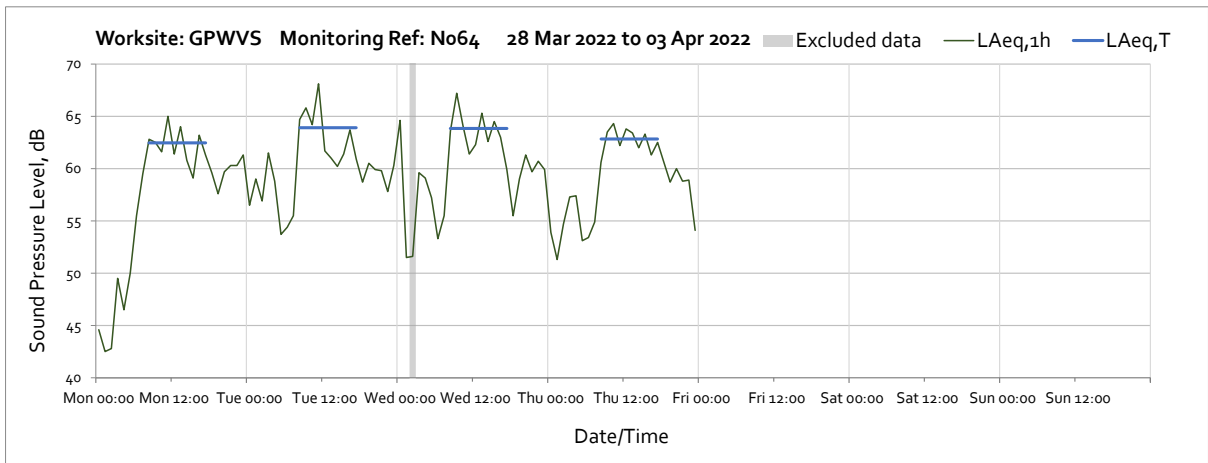
Worksite: Green Park Way Vent Shaft (GPWVS) - Monitoring Ref: N064

Note: Missing data between 00:00 and 14:00 on Tuesday 1st March 2022 was due to loss of power at the monitoring station.

Note: Missing data in between 01:00 and 02:00 on Sunday 27th March was due to the clocks going forward at the start of British Summer Time.
