Construction Noise and Vibration Monthly Report – March 2022

London Borough of Ealing

This Noise and Vibration Monitoring Report fulfils HS2 Limited's commitment detailed in the Environmental Minimum Requirements (EMRs), Annex 1, Code of Construction Practice, to present the results of noise and vibration monitoring carried out within the London Borough of Ealing (LBE) (including one monitoring location on the boundary with the London Borough of Hammersmith and Fulham) during the month of March 2022.

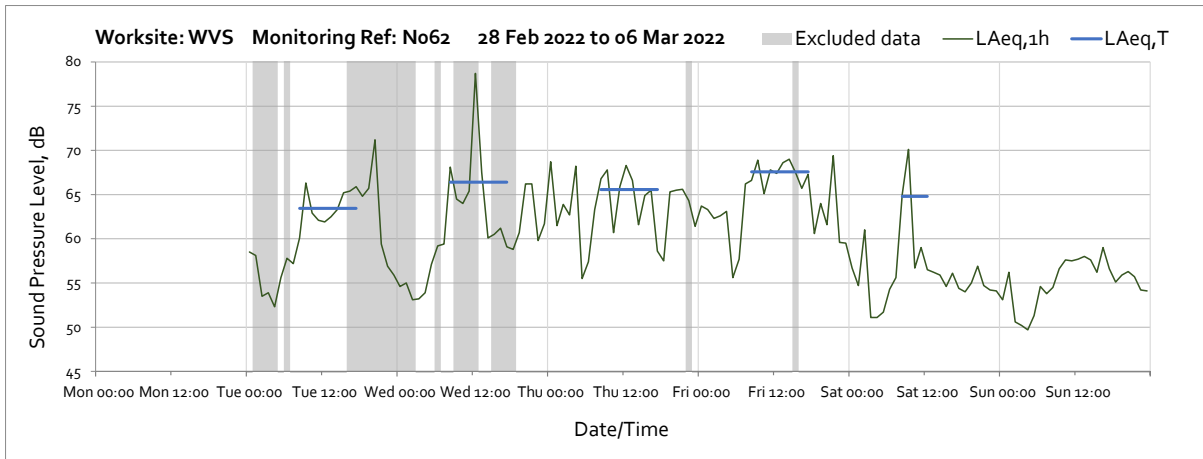
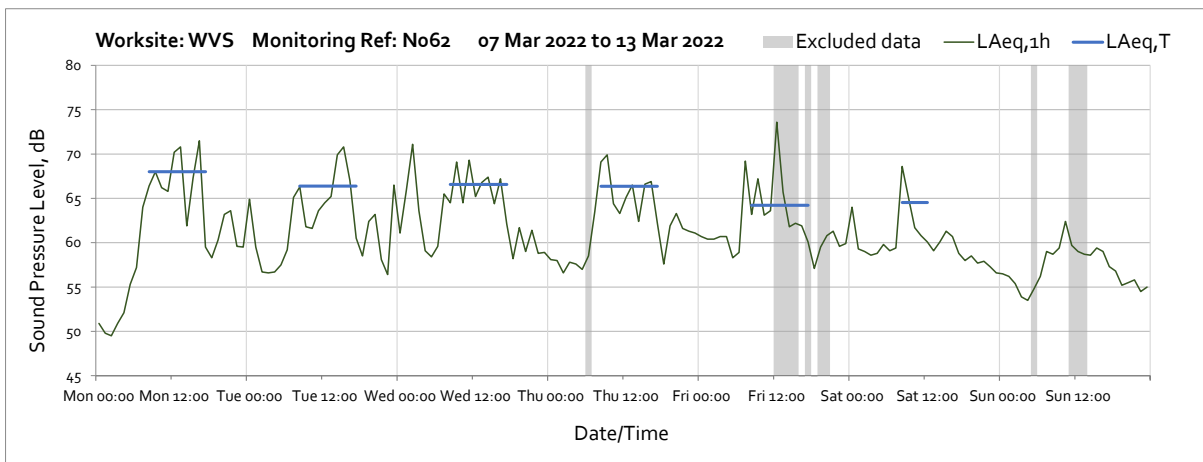
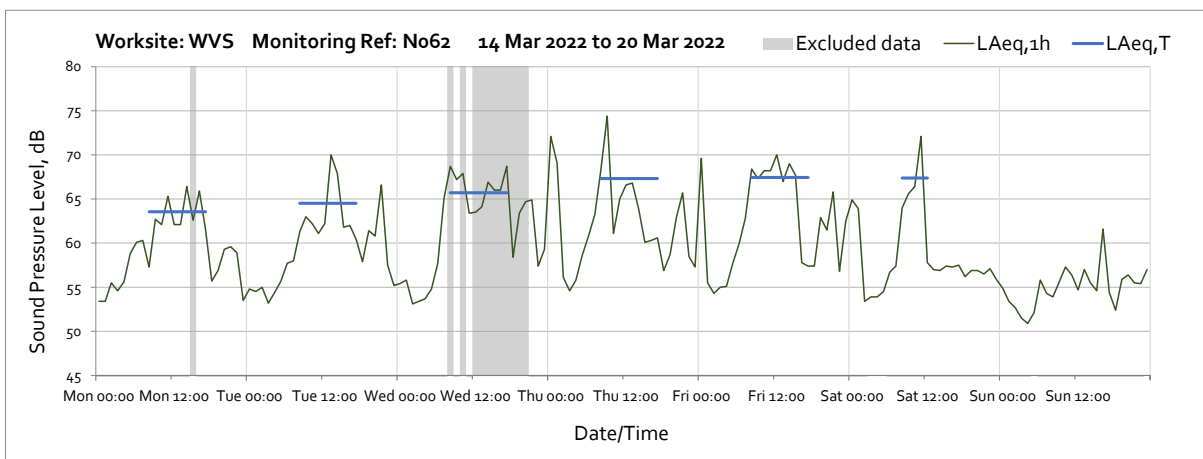
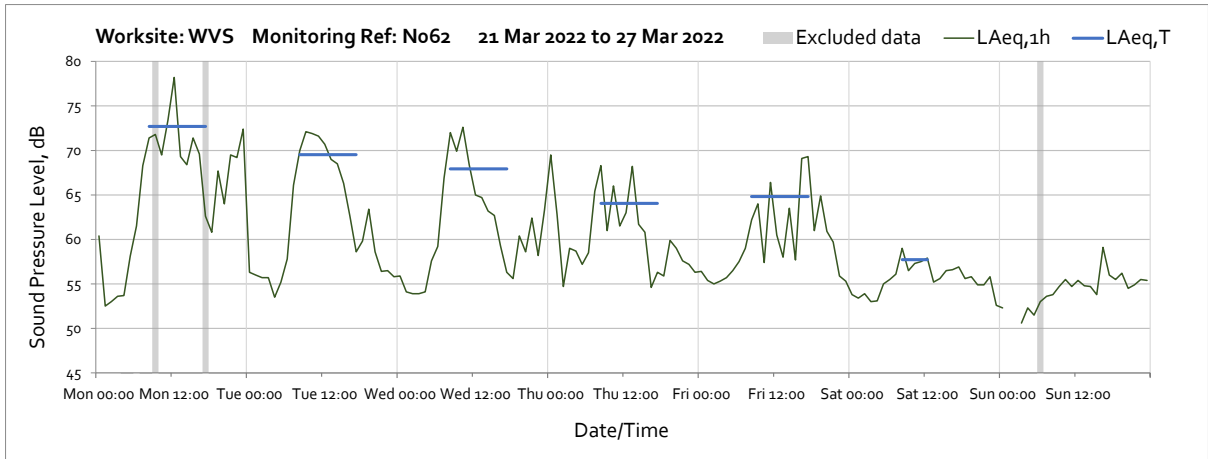
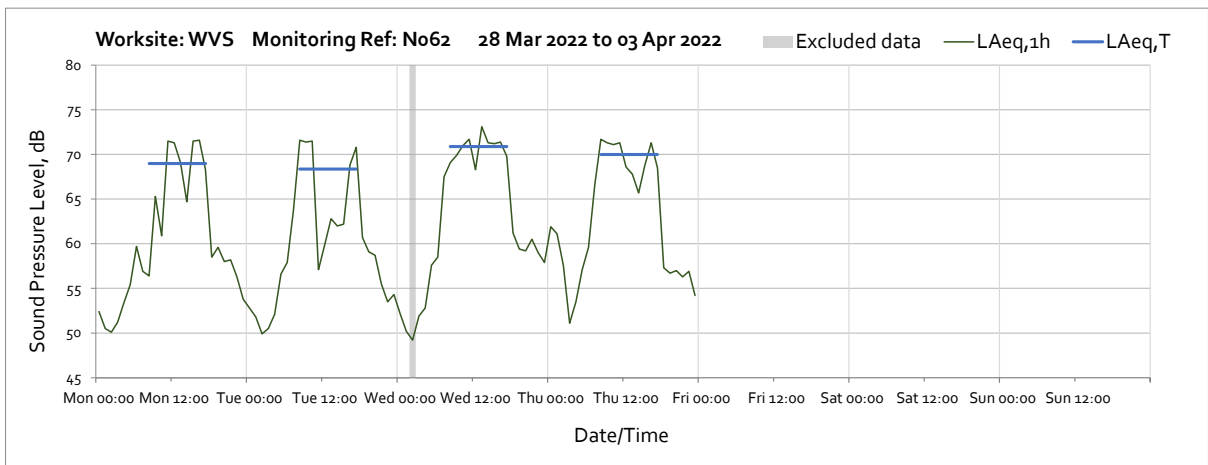
Worksite: Westgate Ventilation Shaft (WVS) – Monitoring Ref: N062

Note: Missing data in between 01:00 and 02:00 on Sunday 27th March was due to the clocks going forward at the start of British Summer Time.

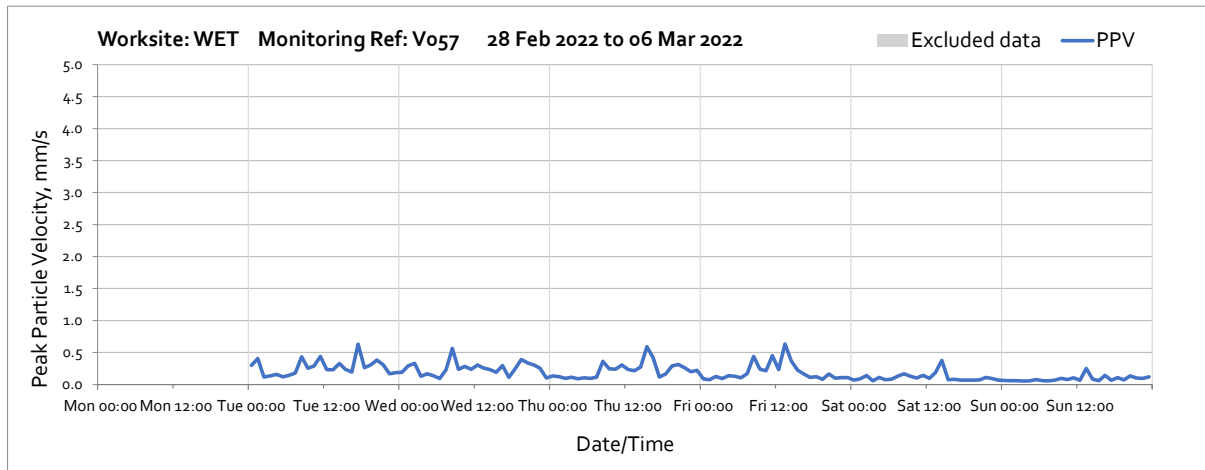
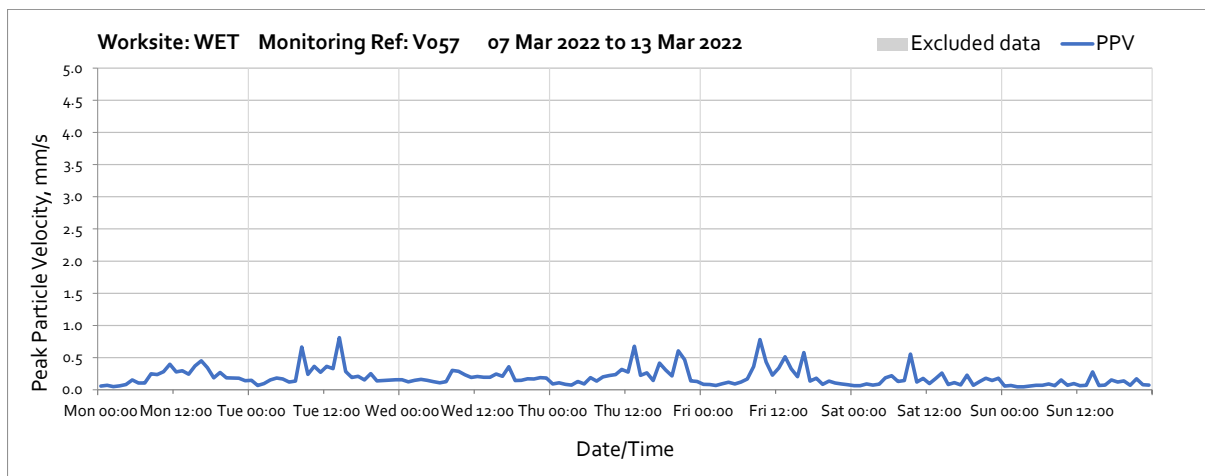
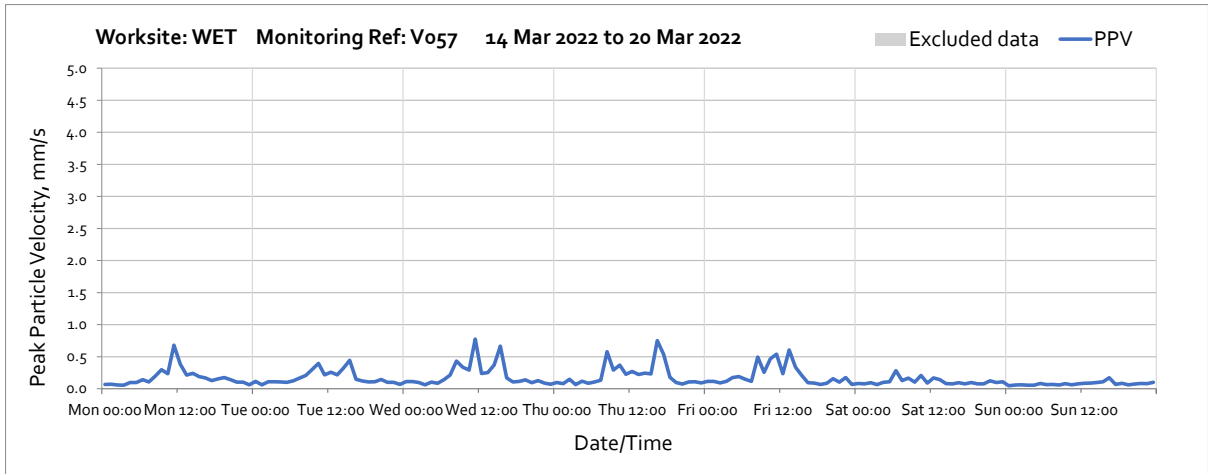
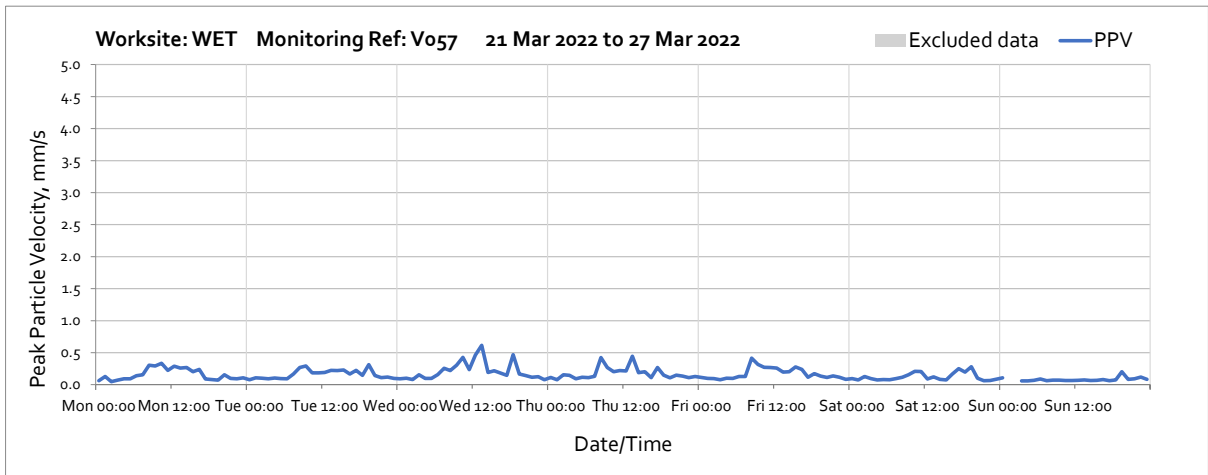
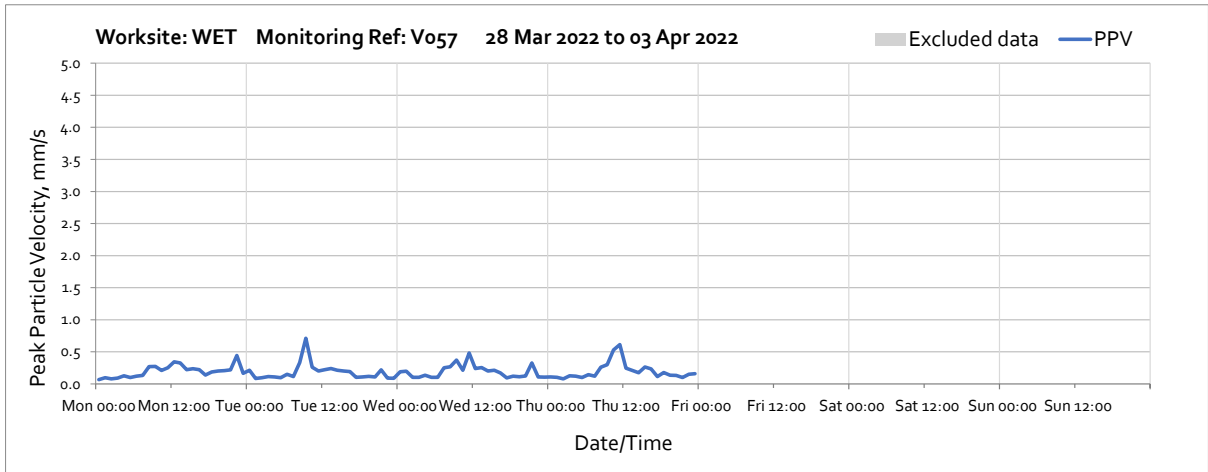
Worksite: Willesden Euro Terminal (WET) – Monitoring Ref: V057

The following graphs show the hourly measured peak particle velocity PPV recorded during the monitoring period. The graphs show the highest PPV of the three orthogonal axis x, y and z. Where high values of PPV were caused by local interference with the vibration monitor, which are not representative of HS2 construction works, these values have been greyed out in the following charts and have been excluded to calculate values in Table 4 of the main report.

Note: Missing data in between 01:00 and 02:00 on Sunday 27th March was due to the clocks going forward at the start of British Summer Time.

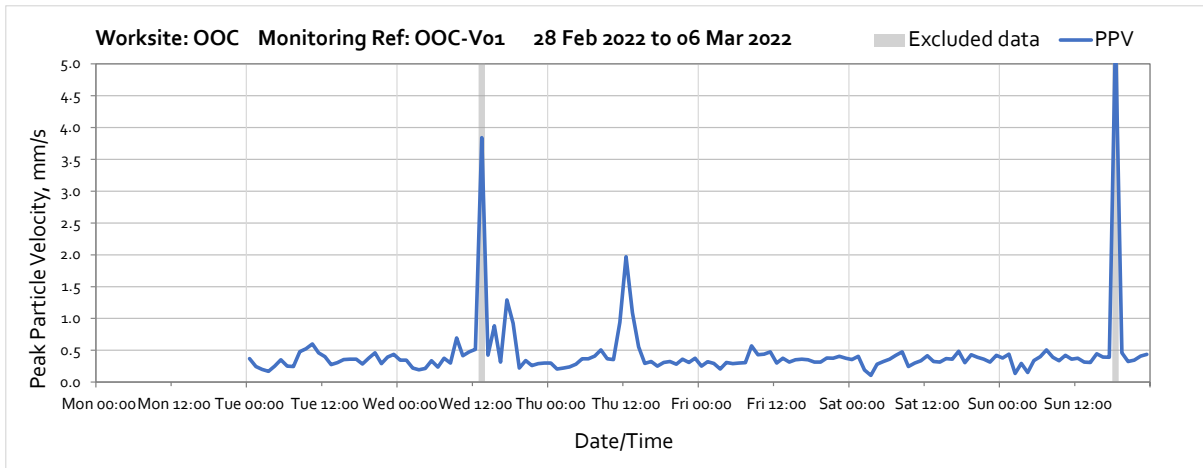
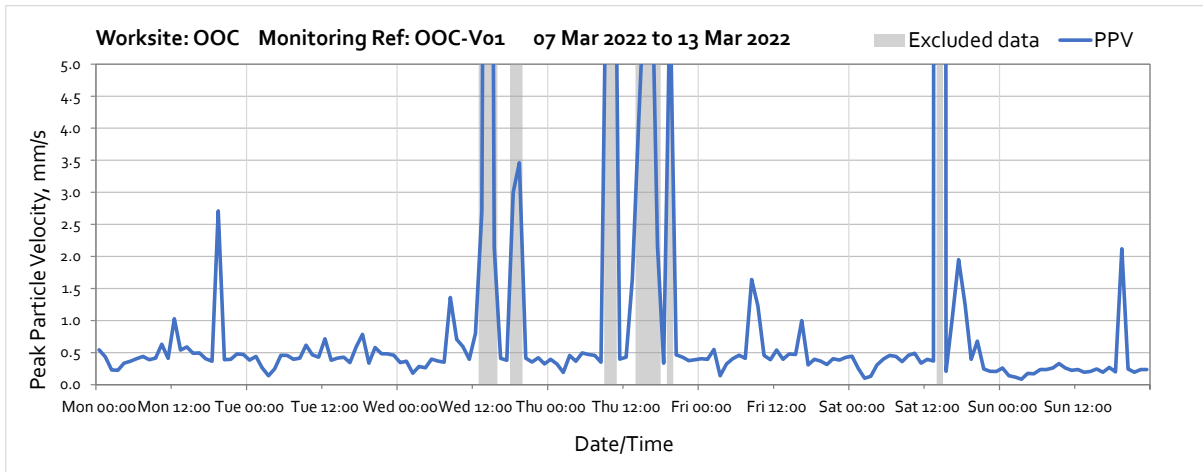
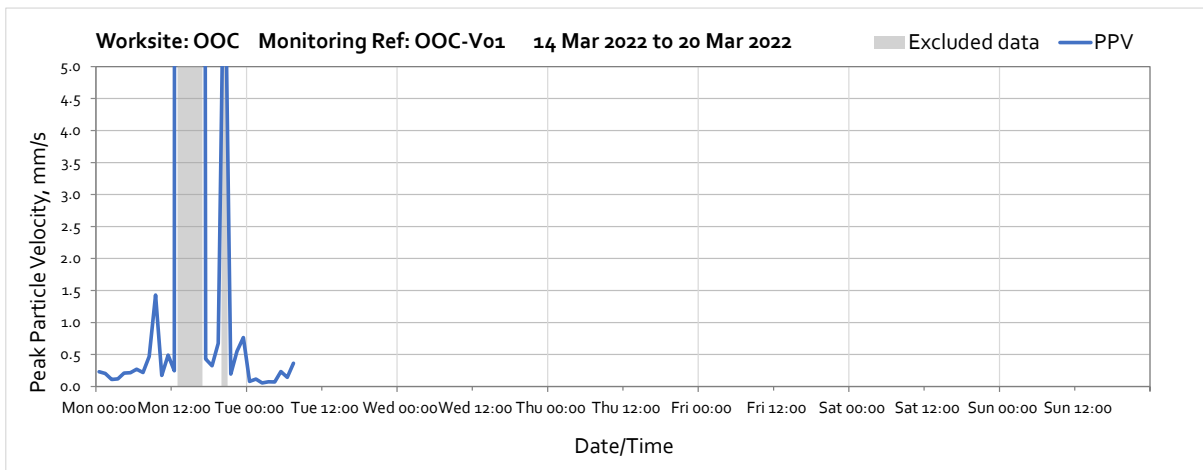
Worksite: Old Oak Common (OOC) – Monitoring Ref: OOC-V01

Note: High vibration levels across the week were due to local disturbance at the monitoring location and not representative of HS2 vibration levels at the receptor.

Note: High vibration levels measured across the week were due to local disturbance at the monitoring location and not representative of HS2 vibration levels at the receptor.

Note: High vibration levels measured across the week were due to local disturbance at the monitoring location and not representative of HS2 vibration levels at the receptor. The monitor has been removed from site on Tuesday 15th March 2022.

1.2.3 On Tuesday 15th March 2022, the vibration monitor ref.: OOC-V01 located at worksite ref.: OOC-V01 has been removed as the number of localised events outweighed any activity caused by construction. A more suitable location representative of properties on Wells House Road is being planned.

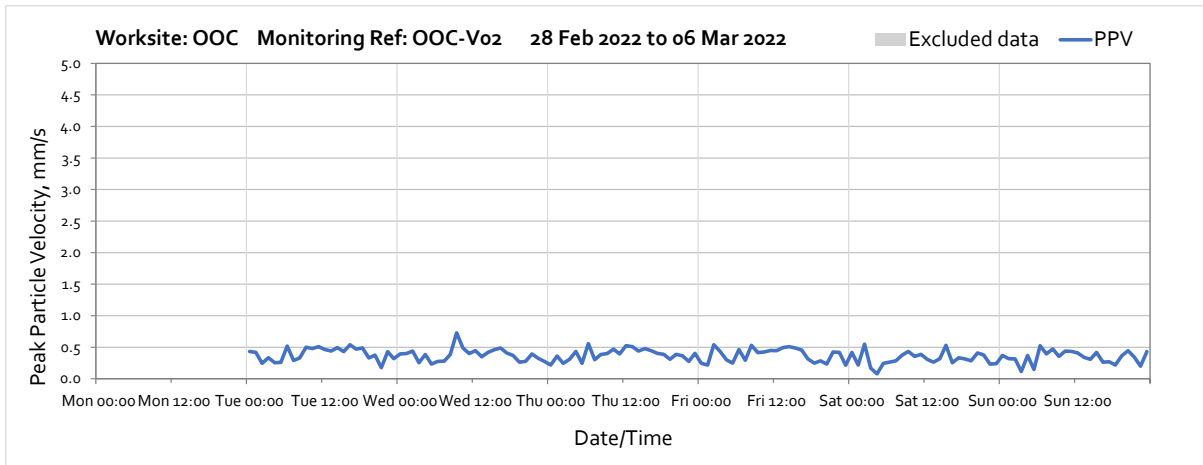
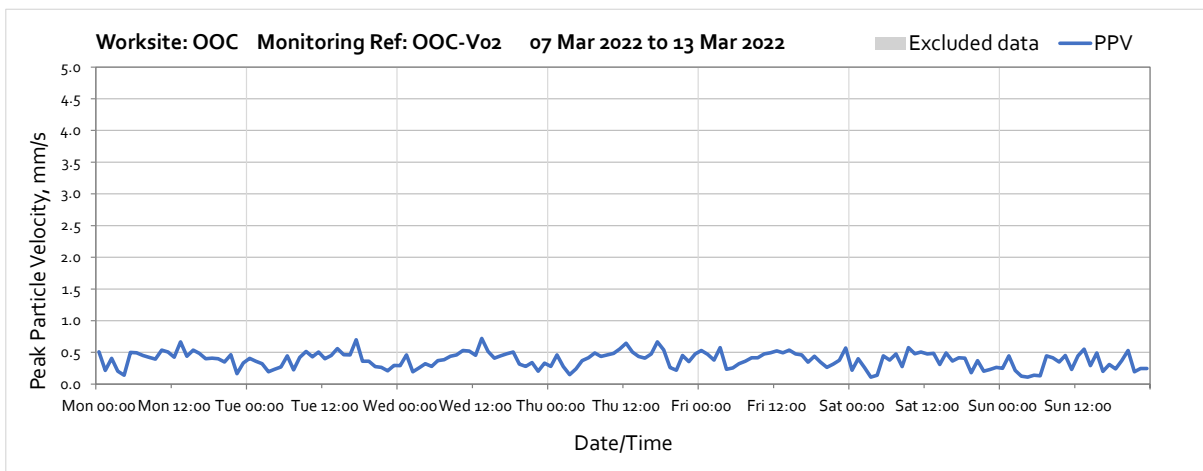
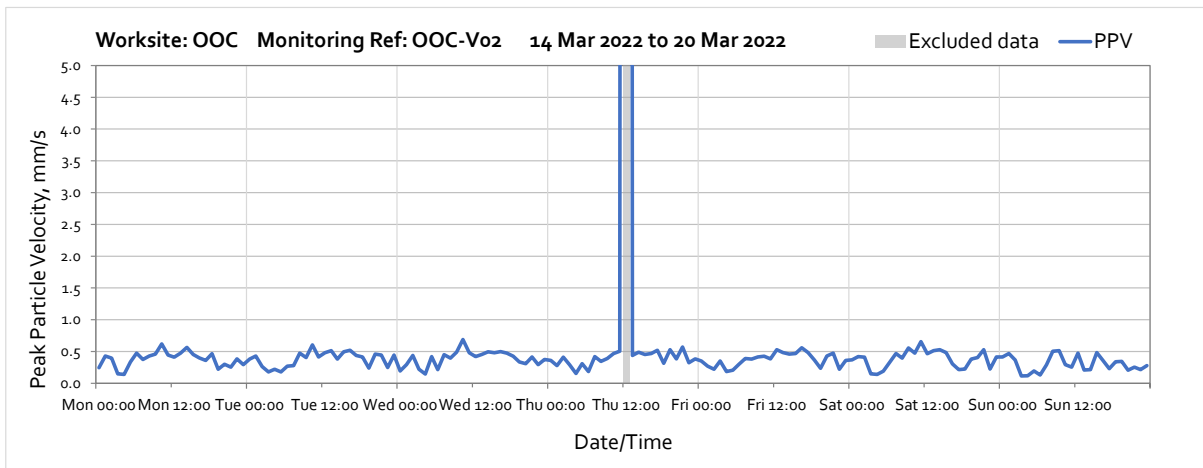
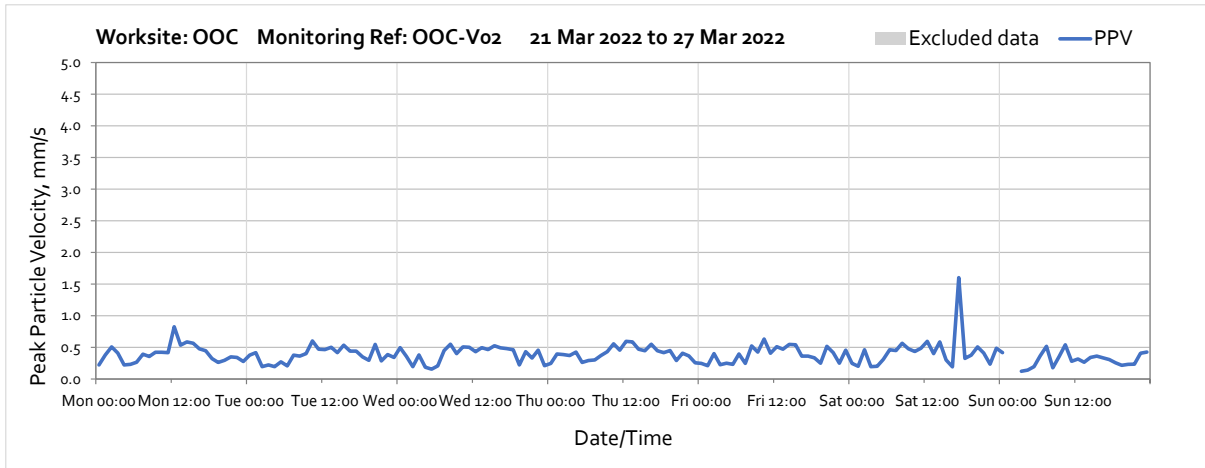
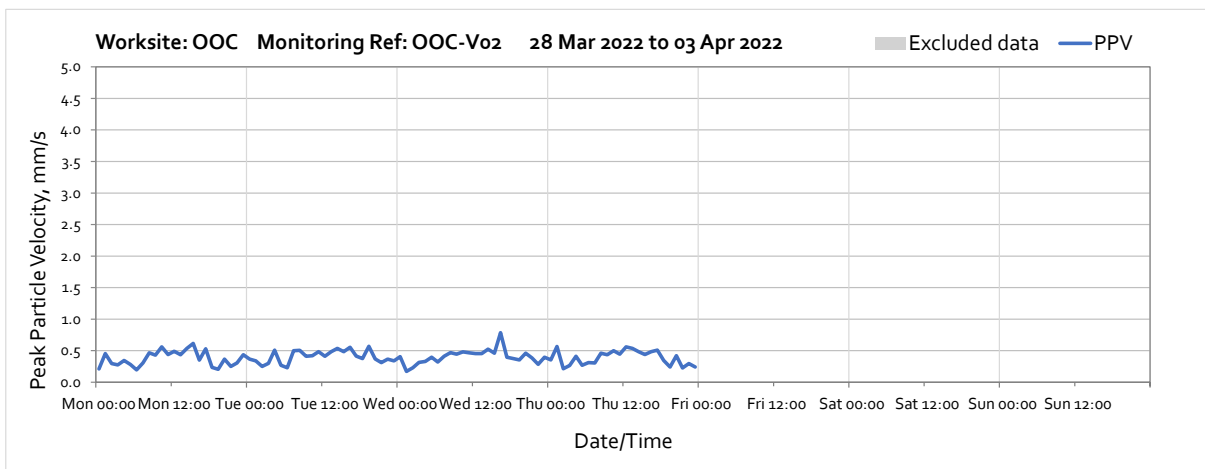
Worksite: Old Oak Common (OOC) – Monitoring Ref: OOC-V02

Note: High vibration levels measured at 12:00 on Thursday 17th March 2022 were due to local disturbance at the monitoring location and not representative of HS2 vibration levels at the receptor.

Note: Missing data in between 01:00 and 02:00 on Sunday 27th March was due to the clocks going forward at the start of British Summer Time.

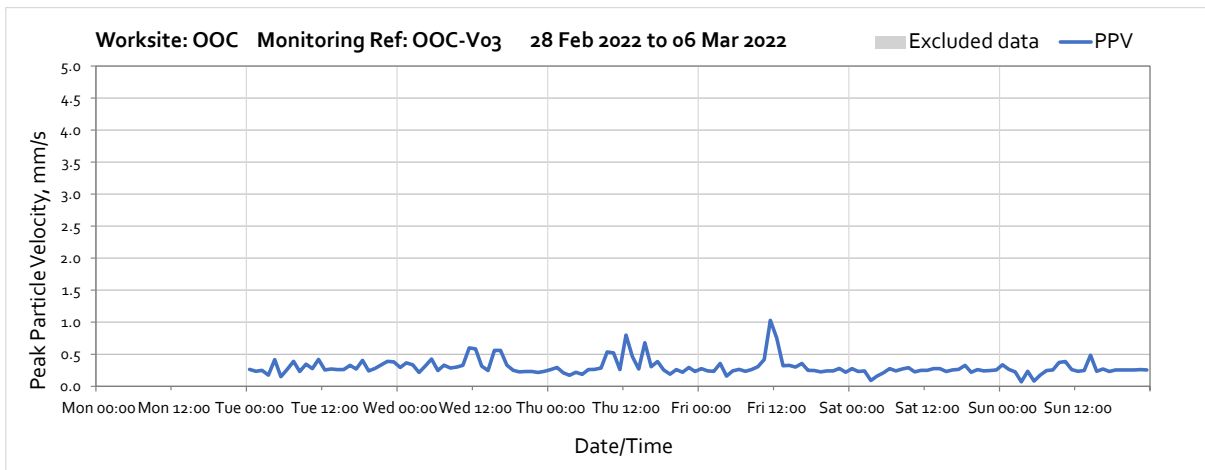
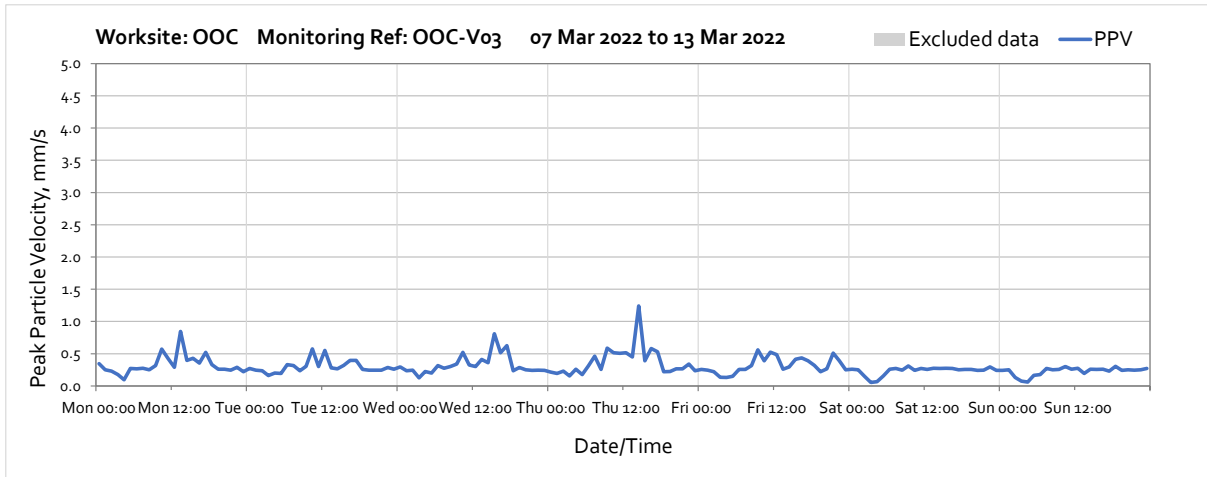
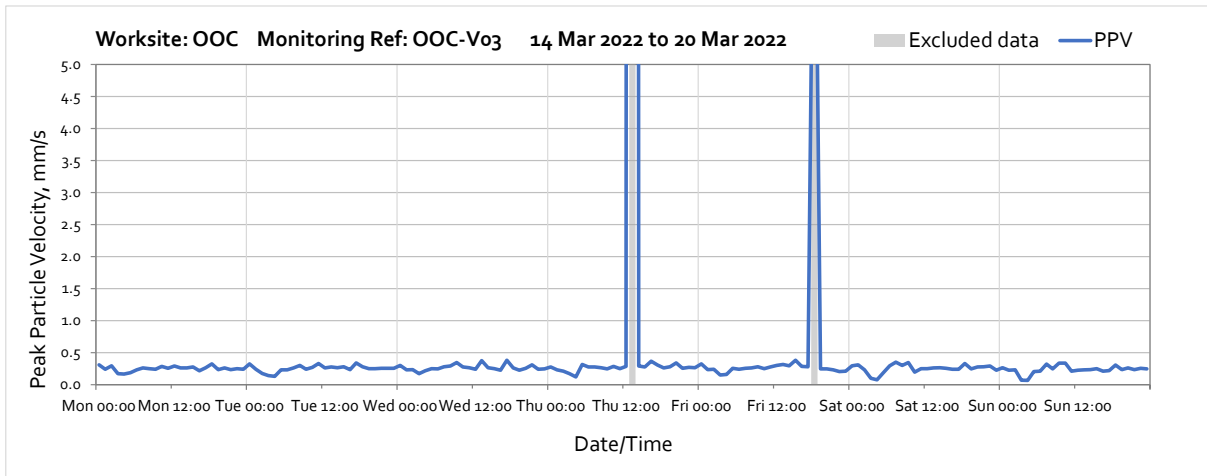
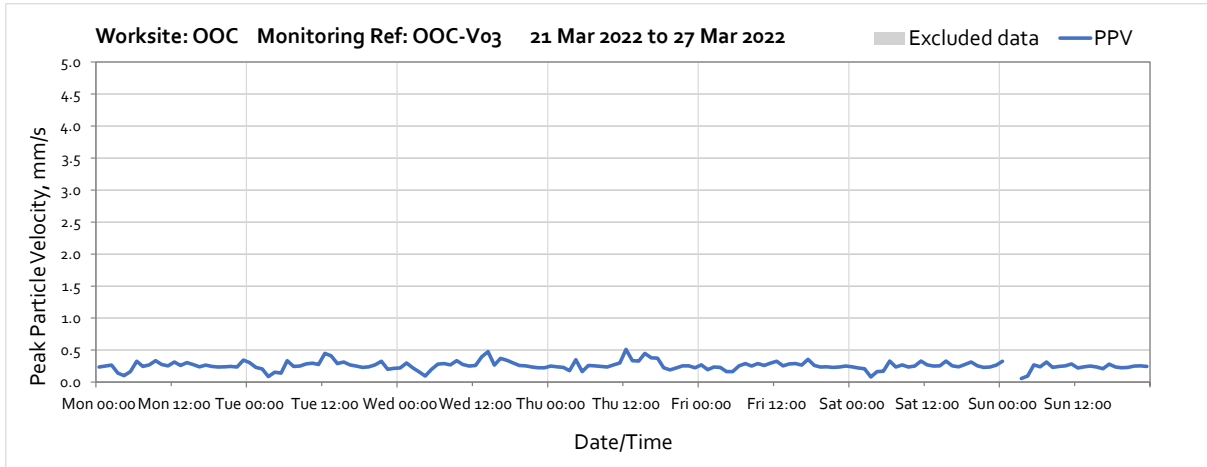
Worksite: Old Oak Common (OOC) – Monitoring Ref: OOC-V03

Note: High vibration levels measured across the week were due to local disturbance at the monitoring location and not representative of HS2 vibration levels at the receptor.

Note: Missing data in between 01:00 and 02:00 on Sunday 27th March was due to the clocks going forward at the start of British Summer Time.

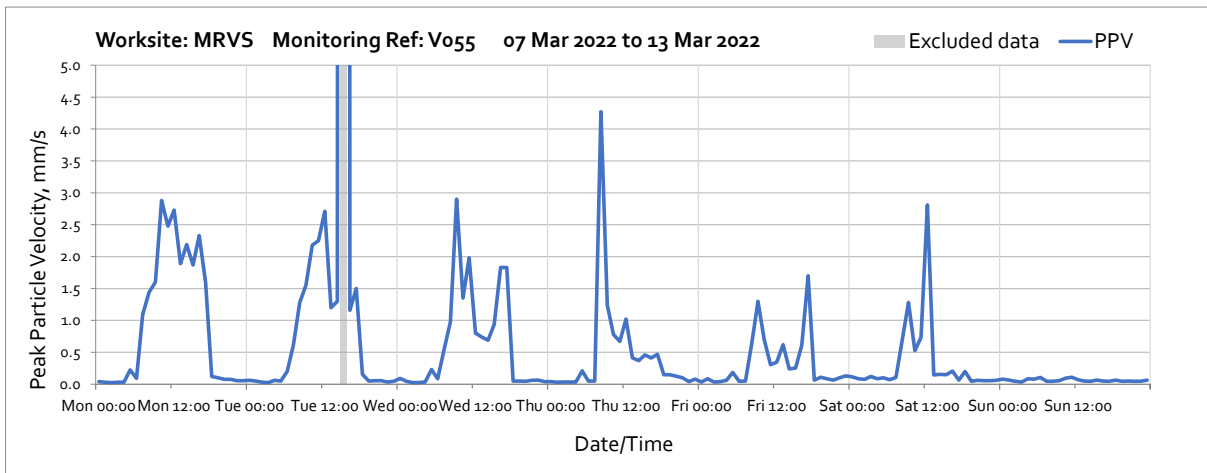
Note: High vibration levels measured at 15:00 on Tuesday 8th March 2022 were due to local disturbance at the monitoring location and not representative of HS2 vibration levels at the receptor.

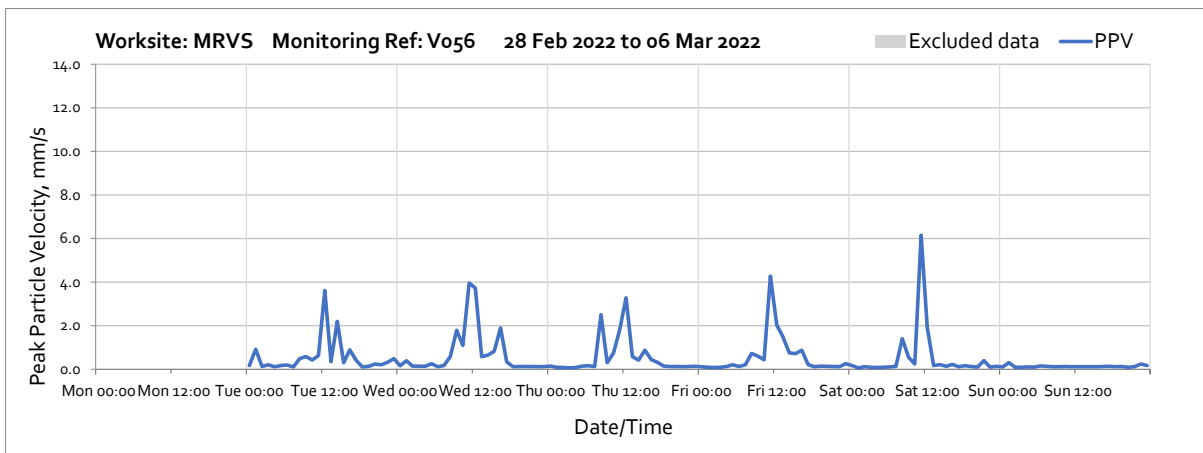
Note: High vibration levels measured at 11:00 on Saturday 5th March 2022 were due to piling works undertaken next to the monitoring station and therefore not representative of HS2 vibration levels at the receptor.

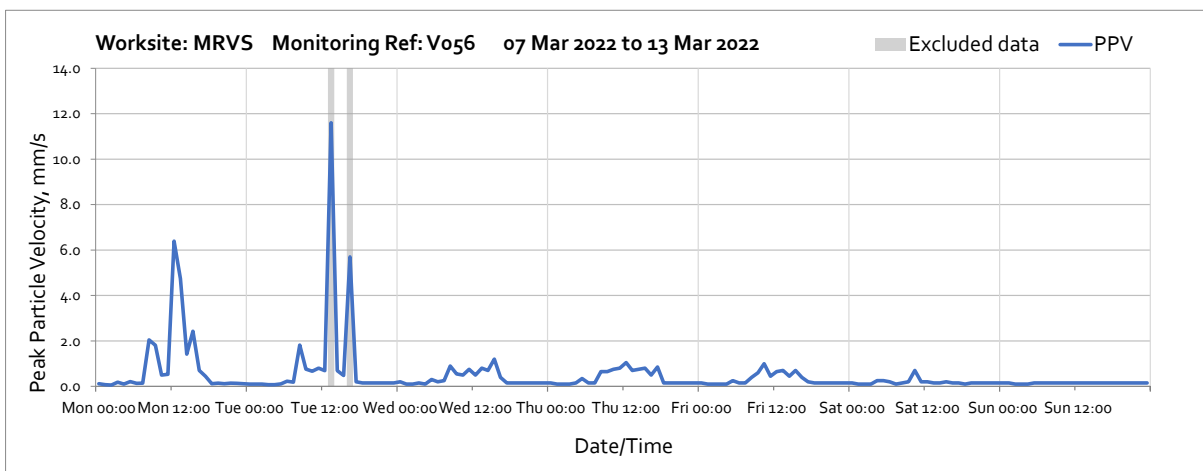
Note: High vibration levels measured at 12:00 on Monday 7th March 2022 were due to piling works undertaken next to the monitoring station and therefore not representative of HS2 vibration levels at the receptor. High vibration levels measured at 13:00 and 16:00 on Tuesday 8th March 2022 were due to local disturbance at the monitoring location and not representative of HS2 vibration levels at the receptor.

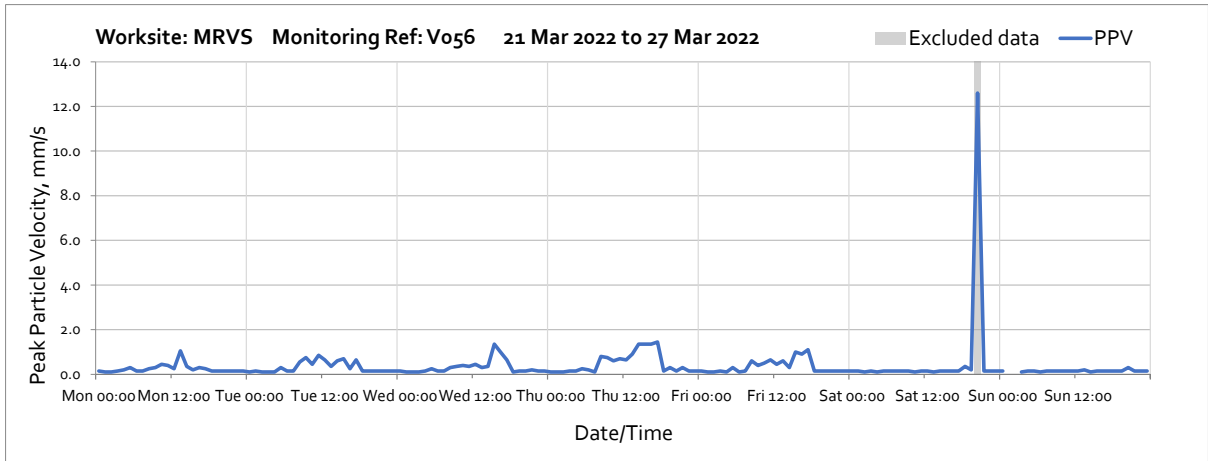
Note: High vibration levels measured at 20:00 on Saturday 26th March 2022 were due to local disturbance at the monitoring location and not representative of HS2 vibration levels at the receptor. Missing data in between 01:00 and 02:00 on Sunday 27th March was due to the clocks going forward at the start of British Summer Time.

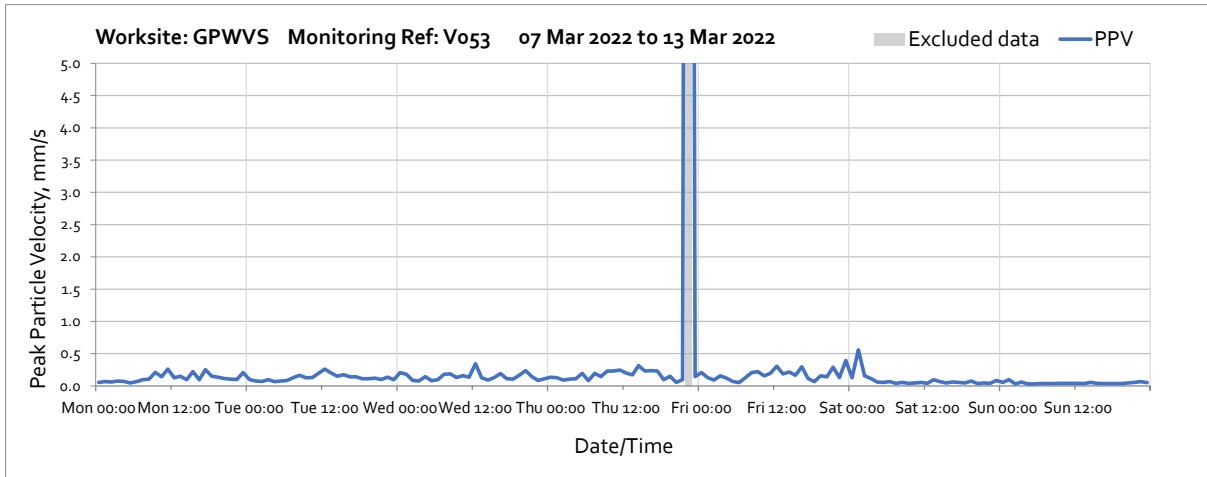
Note: High vibration levels measured at 22:00 on Thursday 10th March 2022 were due to local disturbance at the monitoring location and not representative of HS2 vibration levels at the receptor.

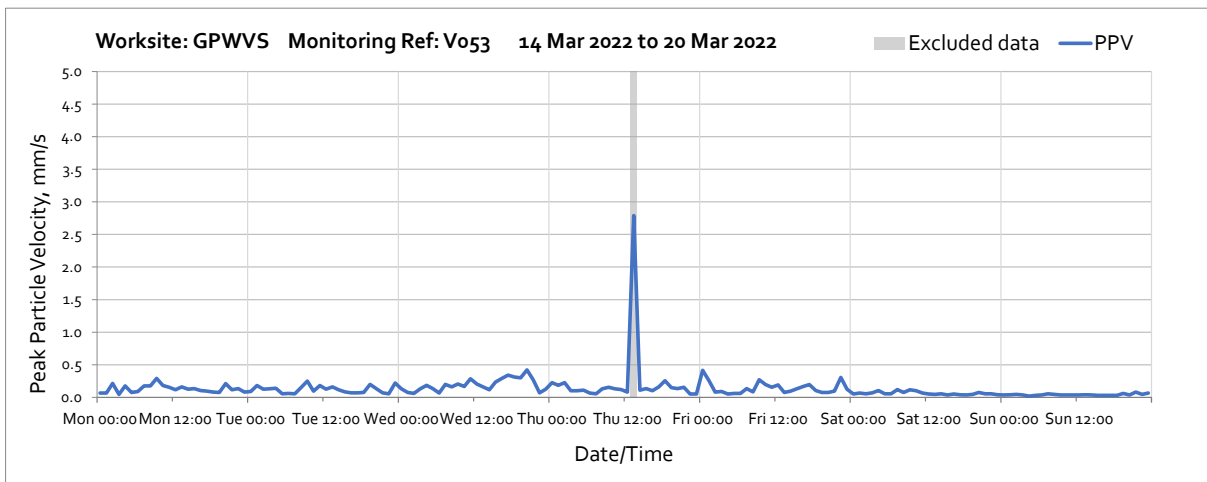
Note: High vibration levels measured at 13:00 on Thursday 17th March 2022 were due to local disturbance at the monitoring location and not representative of HS2 vibration levels at the receptor.

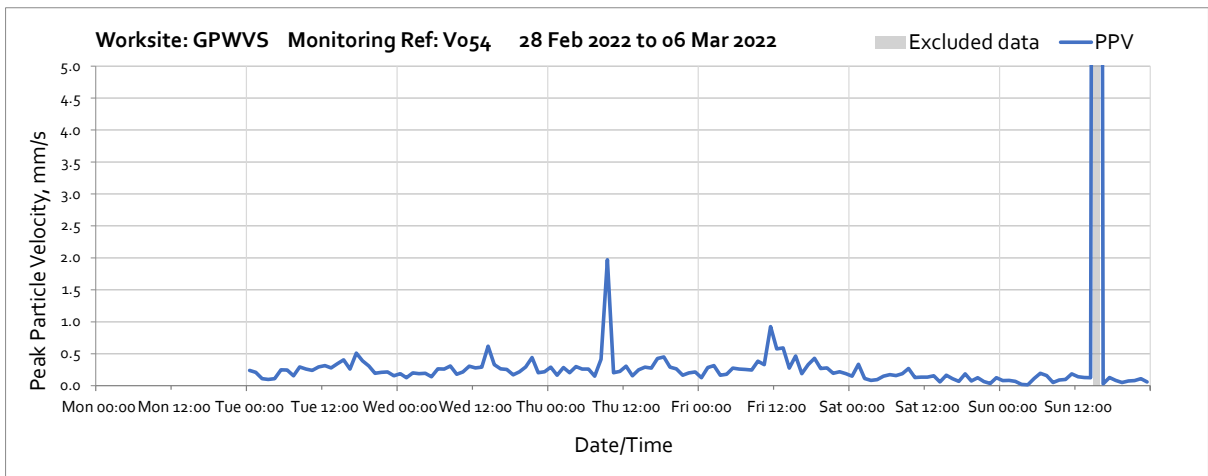
Note: High vibration levels measured at 15:00 on Sunday 6th March 2022 were due to local disturbance at the monitoring location and not representative of HS2 vibration levels at the receptor.

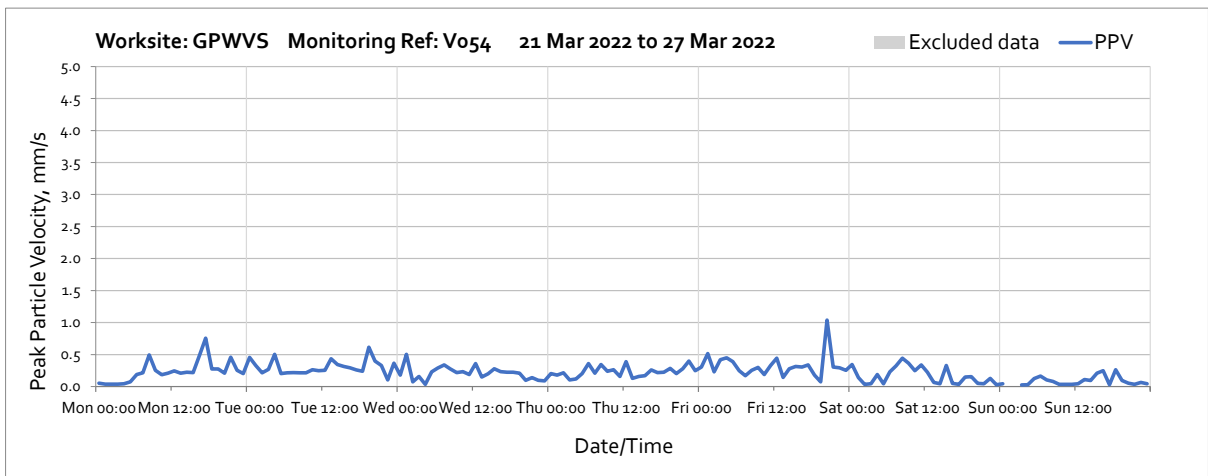
Note: Missing data in between 01:00 and 02:00 on Sunday 27th March was due to the clocks going forward at the start of British Summer Time.
