Construction Noise and Vibration Monthly Report – April 2022

London Borough of Ealing

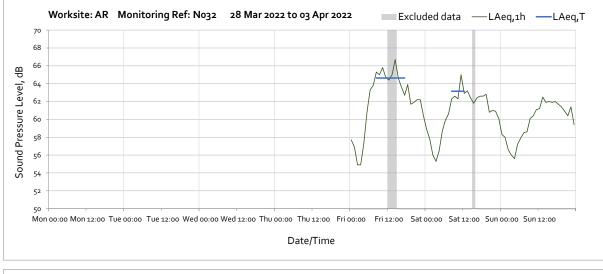
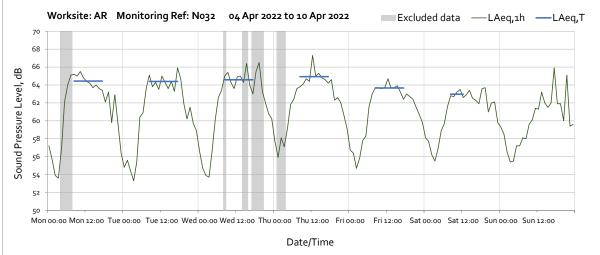
Worksite: Atlas Road worksite (AR) - Monitoring Ref: N032

The following graphs show the hourly measured ambient noise level $L_{Aeq,1h}$ and, where relevant, the averaged noise level $L_{Aeq,T}$ values, where the time period T is as specified in Table 1 of HS2 Information Paper E23. Periods with adversely weather affected noise levels are greyed out and have been excluded from the calculation of the $L_{Aeq,T}$ values in Table 3 of the main report.

2.1.3 Appendix C presents graphs of the noise and vibration monitoring data over the month for each of the measurement locations. Noise data presented consists of the hourly L_{Aeq} values and, where relevant, the L_{Aeq,T} values (where the time period T has been taken to be the averaging period as specified in Table 1 of HS2 Information Paper E23). Vibration data presented consist of hourly PPV values. The full data set for the monitoring equipment can be found at the following location: <u>https://data.gov.uk/dataset/24542ae7-dd44-444f-b259-</u>871c4cc43b5e/environmental-monitoring-data.

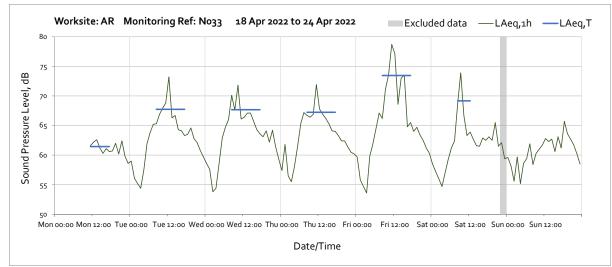
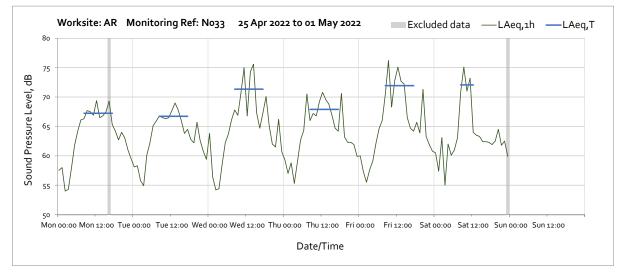
Worksite: Atlas Road worksite (AR) - Monitoring Ref: N033

Note: Missing data between 03:00 on Saturday 16th April and 11:00 on Monday 18th April was due to loss of power at the monitoring station.

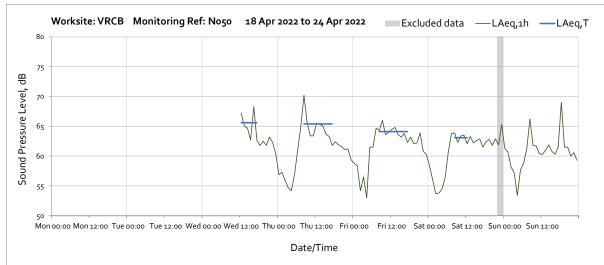
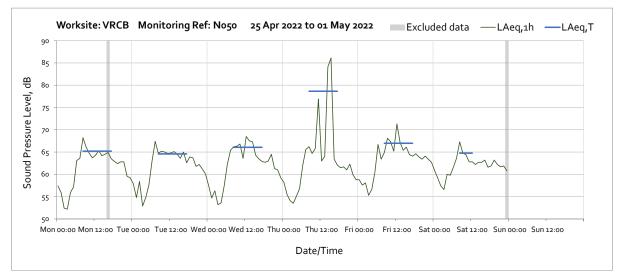
Worksite: Victoria Road Crossover Box (VRCB) – Monitoring Ref: N050

Note: Missing data from beginning of April 2022 was due to loss of power at the monitoring station. The power connection was restored at 12:00 on Wednesday 20th April.

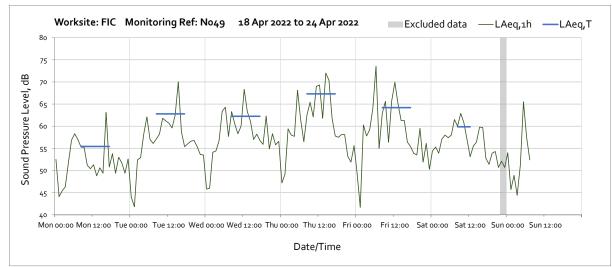
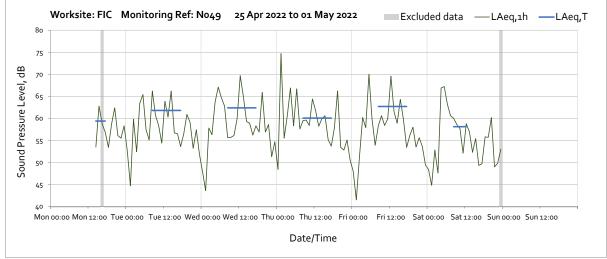
Worksite: Flat Iron Compound (FIC) – Monitoring Ref: N049

Note: Missing data between 08:00 on Sunday 24th April and 13:00 on Monday 25th April was due to loss of power at the monitoring station.

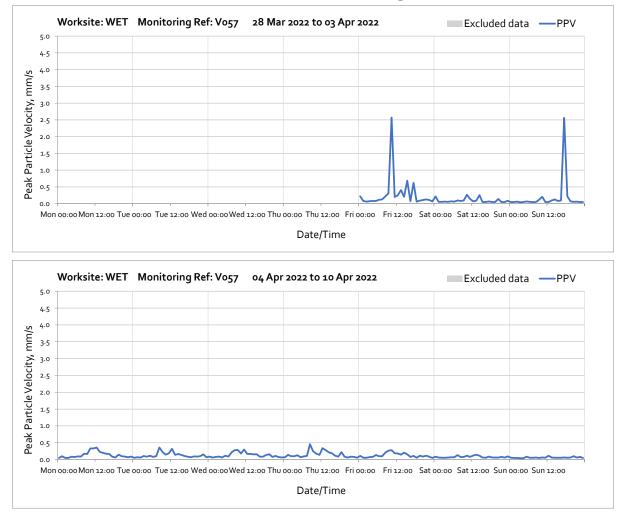
Worksite: Willesden Euro Terminal (WET) - Monitoring Ref: V057

The following graphs show the hourly measured peak particle velocity PPV recorded during the monitoring period. The graphs show the highest PPV of the three orthogonal axis x, y and z. Where high values of PPV were caused by local interference with the vibration monitor, which are not representative of HS2 construction works, these values have been greyed out in the following charts and have been excluded to calculate values in Table 4 of the main report.

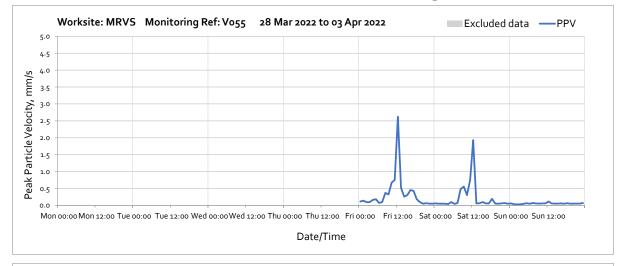
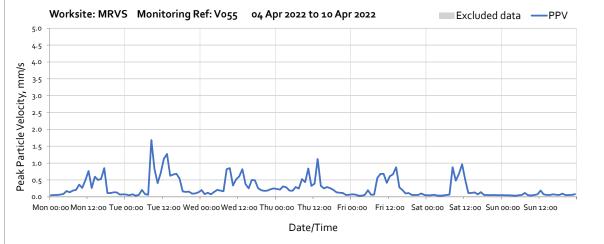
Worksite: Mandeville Road Vent Shaft (MRVS) - Monitoring Ref: V055

Note: High vibration levels measured at 15:00 on Friday 29th April 2022 were due to local disturbance at the monitoring location and not representative of HS2 vibration levels at the receptor.

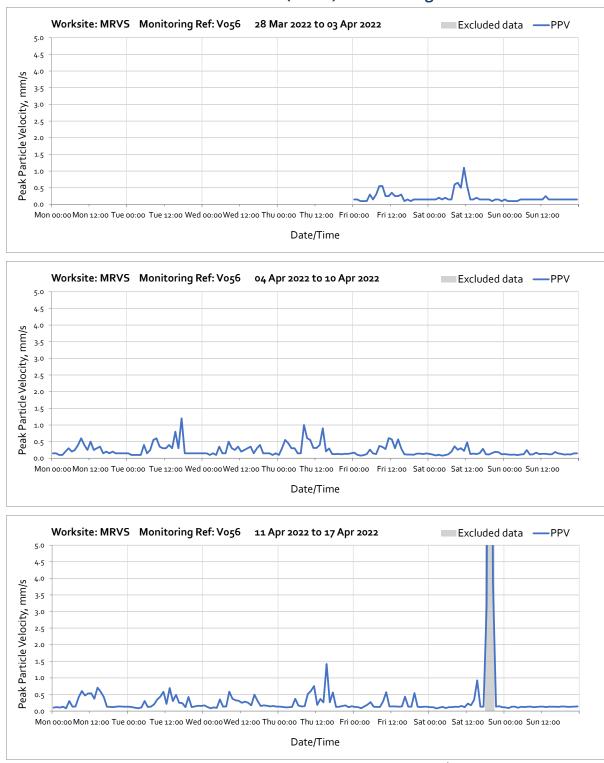
Worksite: Mandeville Road Vent Shaft (MRVS) - Monitoring Ref: V056

Note: High vibration levels measured between 18:00 and 20:00 on Saturday 16th April 2022 were due to local disturbance at the monitoring location and not representative of HS2 vibration levels at the receptor.

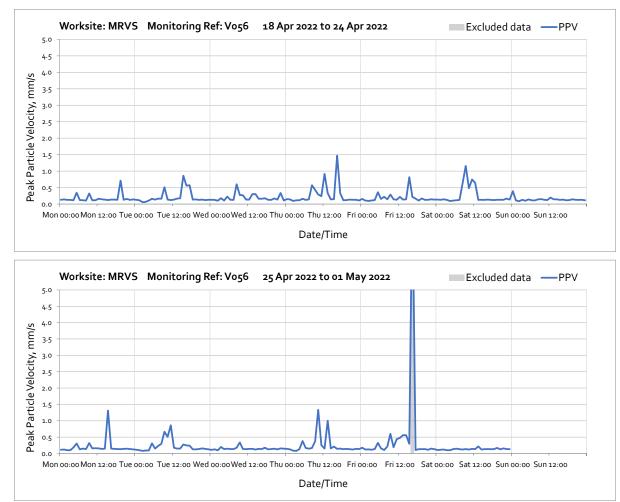
Note: High vibration levels measured at 16:00 on Friday 29th April 2022 were due to local disturbance at the monitoring location and not representative of HS2 vibration levels at the receptor.

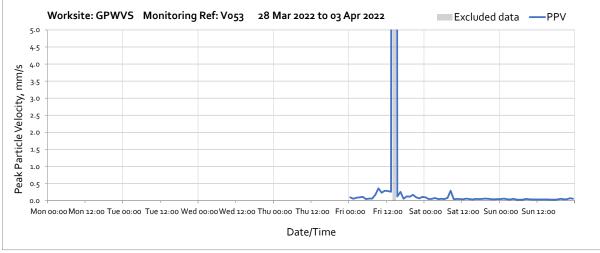
Worksite: Green Park Way Vent Shaft (GPWVS) - Monitoring Ref: V053

Note: High vibration levels measured at 14:00 on Friday 1st April 2022 were due to local disturbance at the monitoring location and not representative of HS2 vibration levels at the receptor.

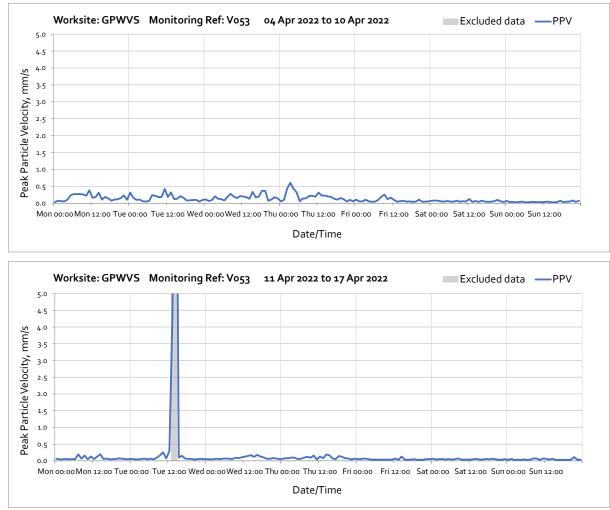
Note: High vibration levels measured between 12:00 and 13:00 on Tuesday 12th April 2022 were due to local disturbance at the monitoring location and not representative of HS2 vibration levels at the receptor.

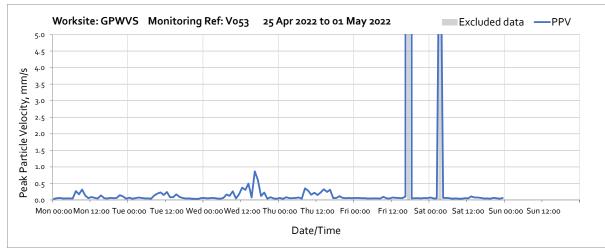
Note: High vibration levels measured at 17:00 on Friday 29th April 2022 and 02:00 on Saturday 30th April were due to local disturbance at the monitoring location and not representative of HS2 vibration levels at the receptor.

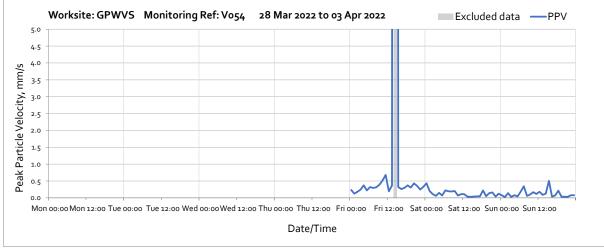
Worksite: Green Park Way Vent Shaft (GPWVS) – Monitoring Ref: V054

Note: High vibration levels measured at 14:00 on Friday 1st April 2022 were due to local disturbance at the monitoring location and not representative of HS2 vibration levels at the receptor.
