Construction Noise and Vibration Monthly Report – May 2022

London Borough of Ealing

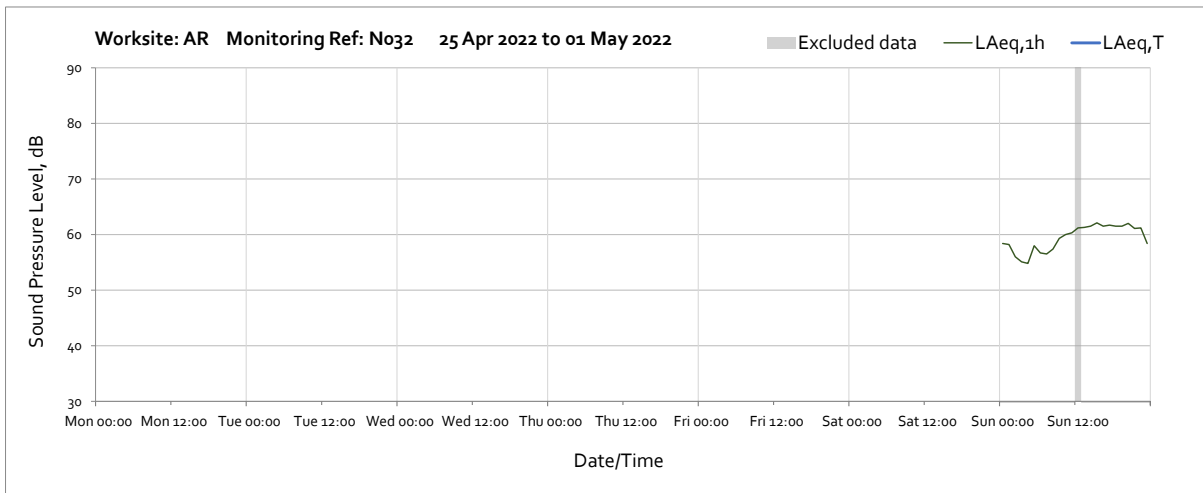
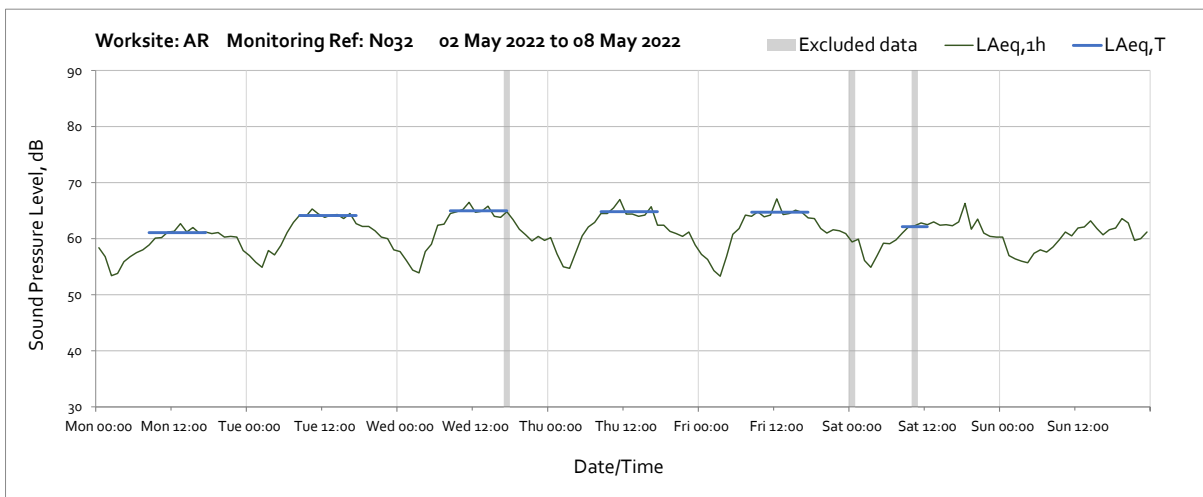
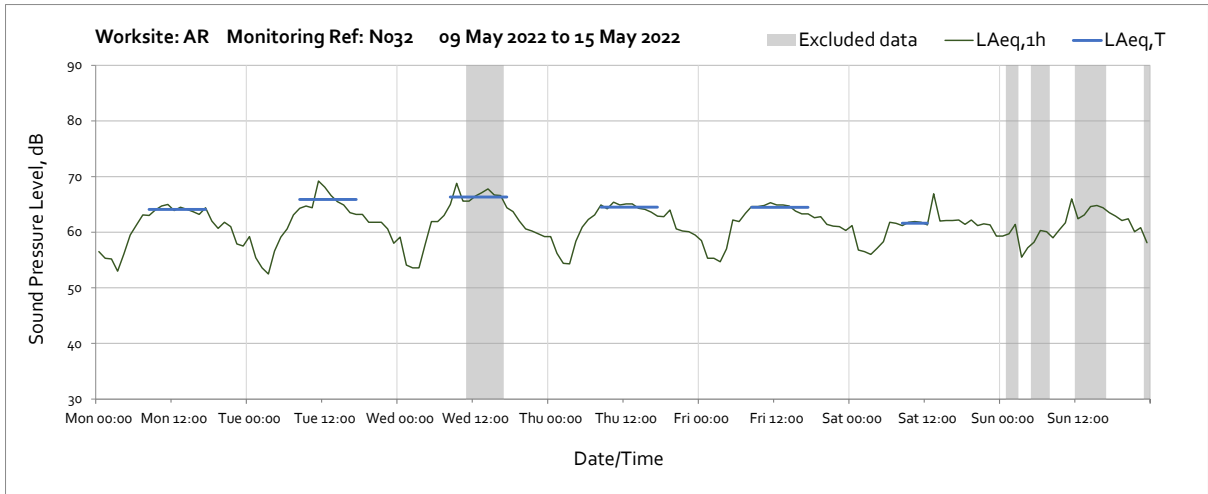
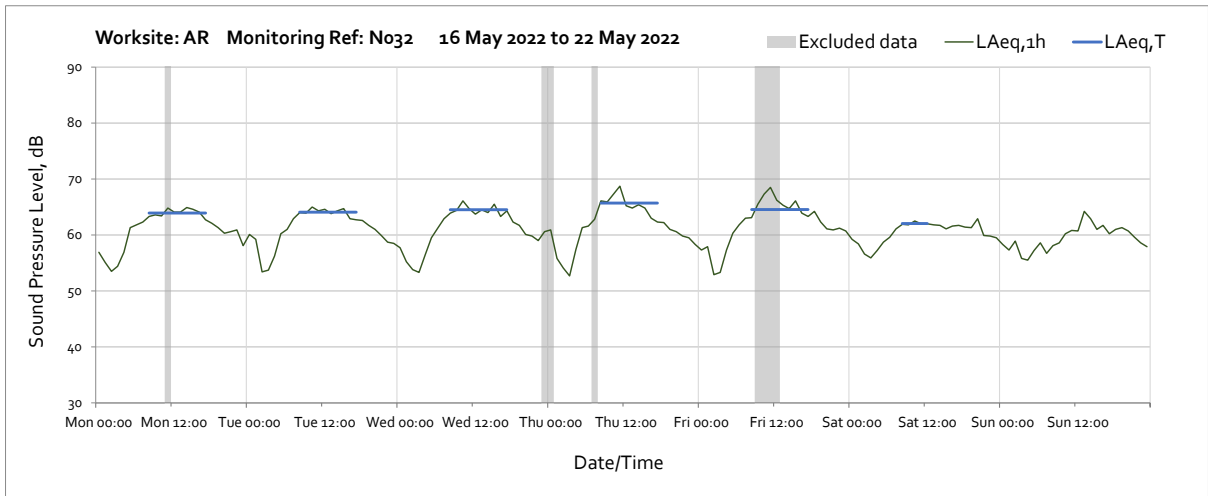
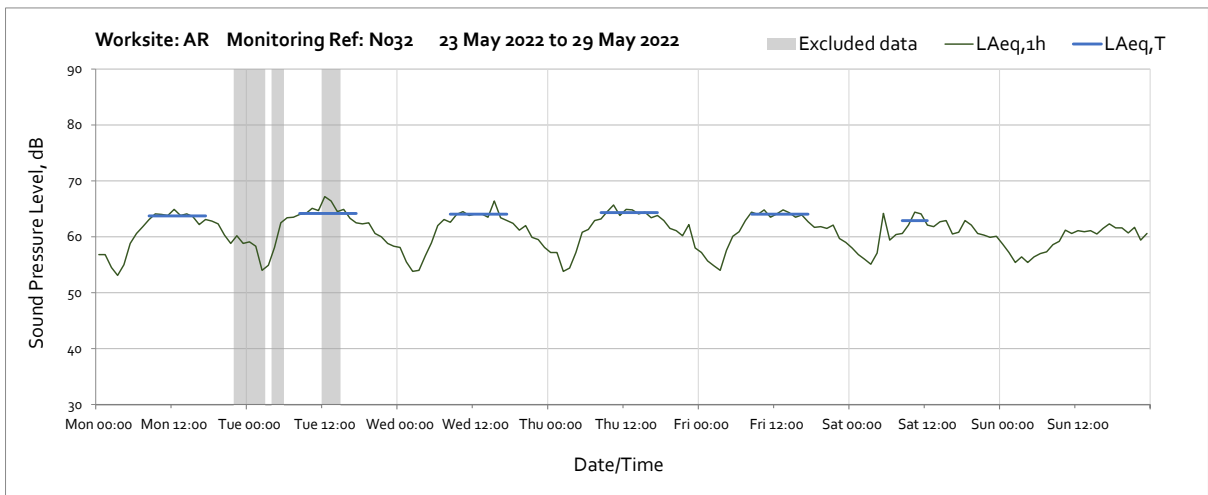
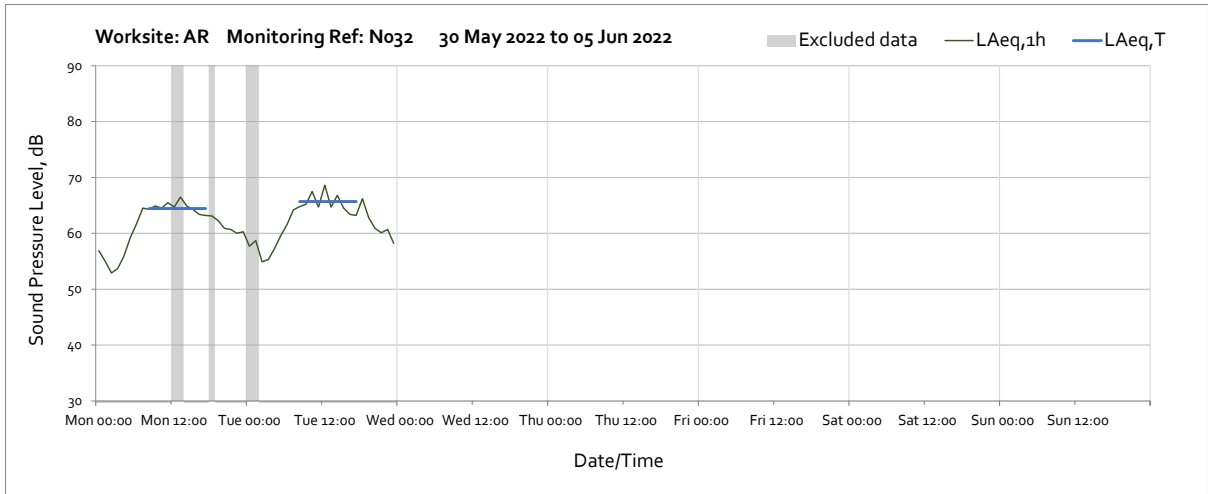
Worksite: Atlas Road worksite (AR) – Monitoring Ref: N032

The following graphs show the hourly measured ambient noise level $L_{Aeq,1h}$ and, where relevant, the averaged noise level $L_{Aeq,T}$ values, where the time period T is as specified in Table 1 of HS2 Information Paper E23. Periods with adversely weather affected noise levels are greyed out and have been excluded from the calculation of the $L_{Aeq,T}$ values in Table 3 of the main report.

2.1.3 Appendix C presents graphs of the noise and vibration monitoring data over the month for each of the measurement locations. Noise data presented consists of the hourly L_{Aeq} values and, where relevant, the $L_{Aeq,T}$ values (where the time period T has been taken to be the averaging period as specified in Table 1 of HS2 Information Paper E23). Vibration data presented consist of hourly PPV values. The full data set for the monitoring equipment can be found at the following location:

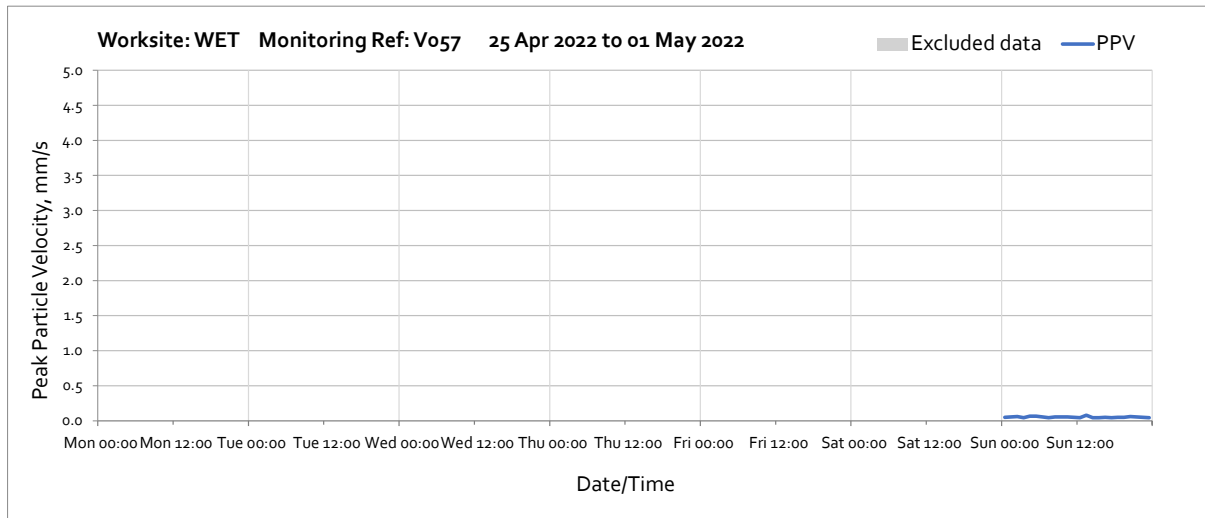
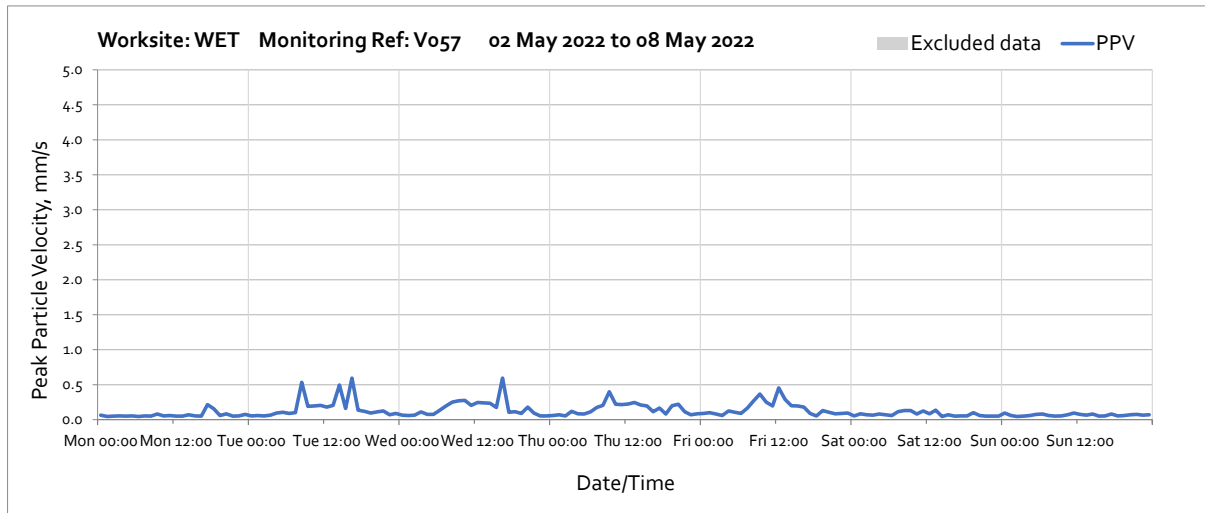
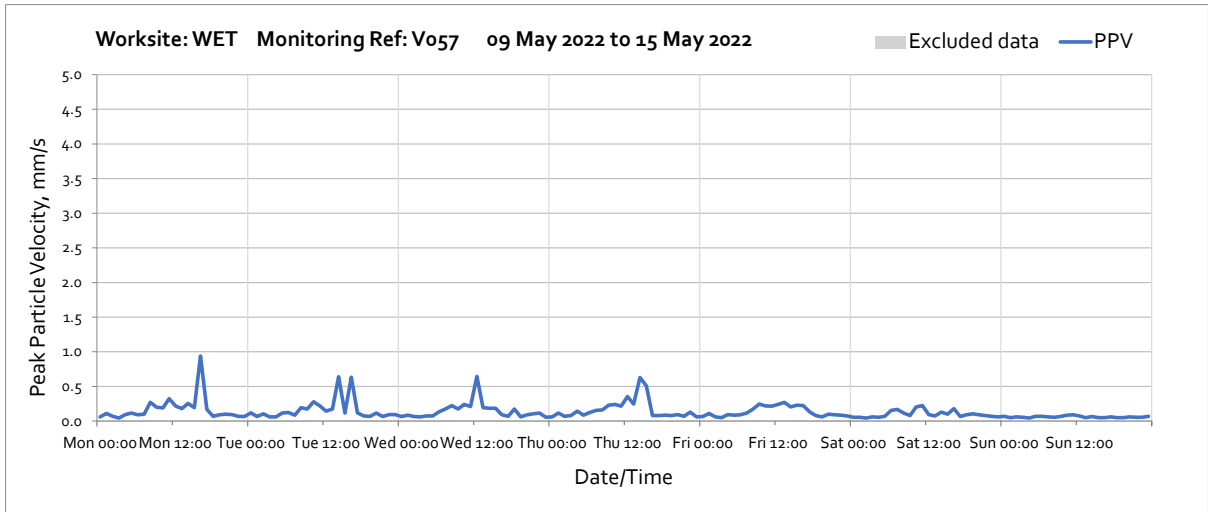
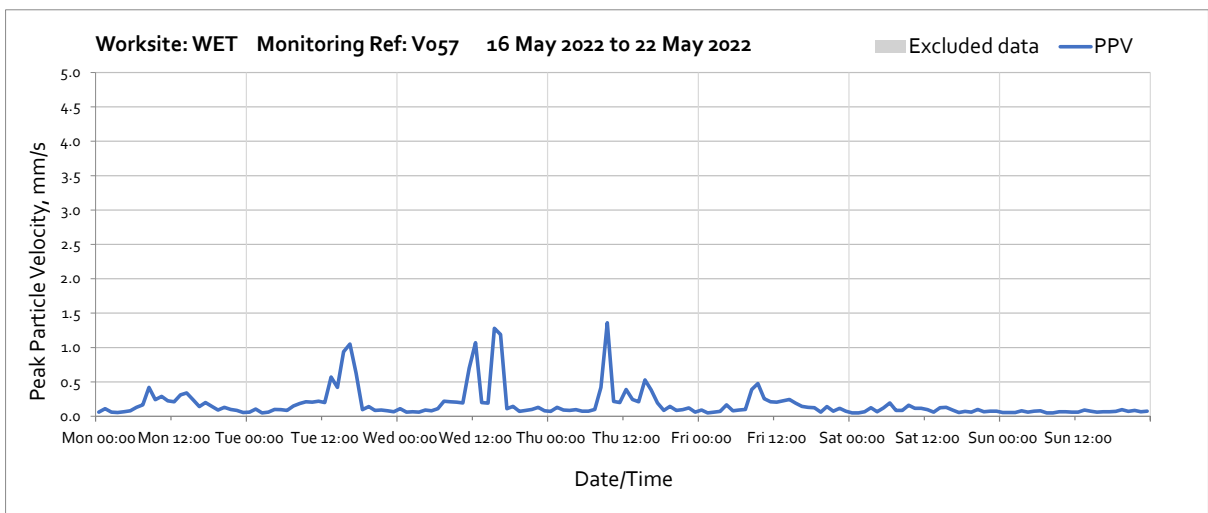
Worksite: Willesden Euro Terminal (WET) – Monitoring Ref: V057

The following graphs show the hourly measured peak particle velocity PPV recorded during the monitoring period. The graphs show the highest PPV of the three orthogonal axis x, y and z. Where high values of PPV were caused by local interference with the vibration monitor, which are not representative of HS2 construction works, these values have been greyed out in the following charts and have been excluded to calculate values in Table 4 of the main report.

Note: High vibration levels measured during Wednesday and Thursday were due to floor sawing/breaking out works undertaken next to the monitoring station. The nearest sensitive receptor is 10m further away compared to the monitor and therefore HS2 vibration levels will be lower at the receptor

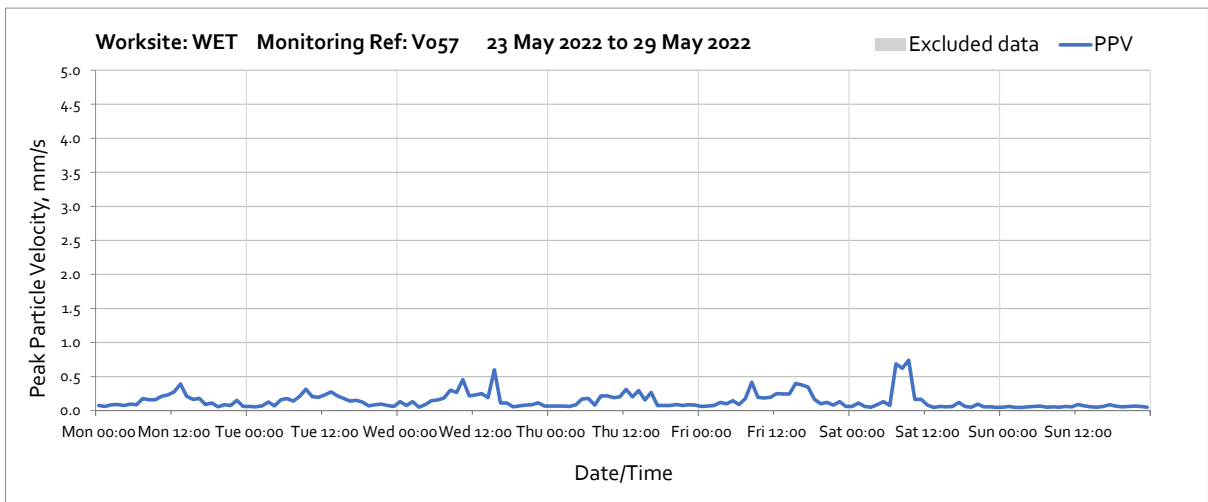
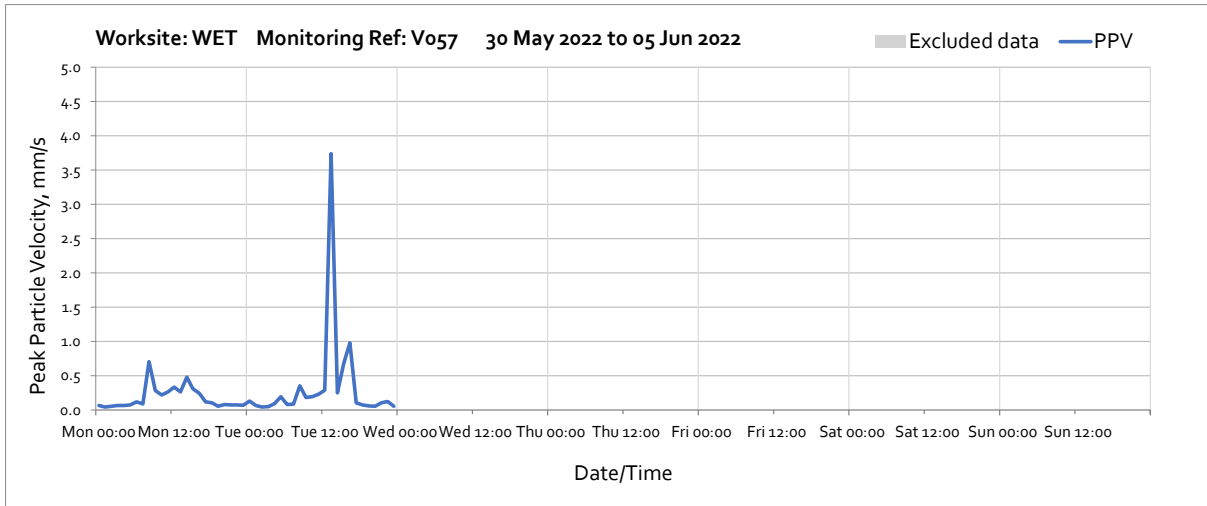
Note: High vibration levels measured at 13:00 and 16:00 on Tuesday 31st May were due to floor sawing/breaking out works undertaken next to the monitoring station. The nearest sensitive receptor is 10m further away compared to the monitor and therefore HS2 vibration levels will be lower at the receptor.

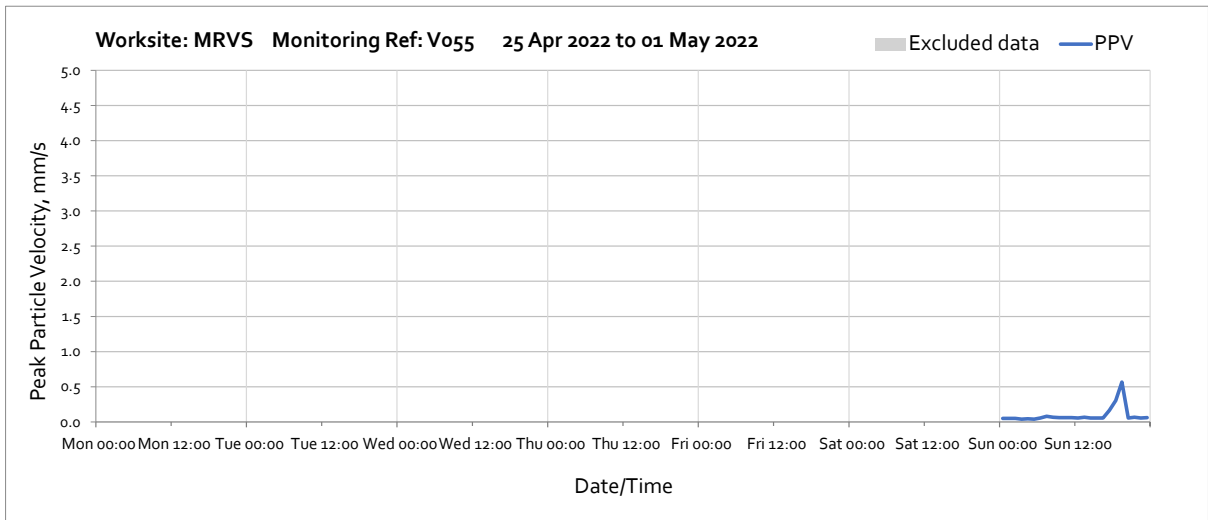
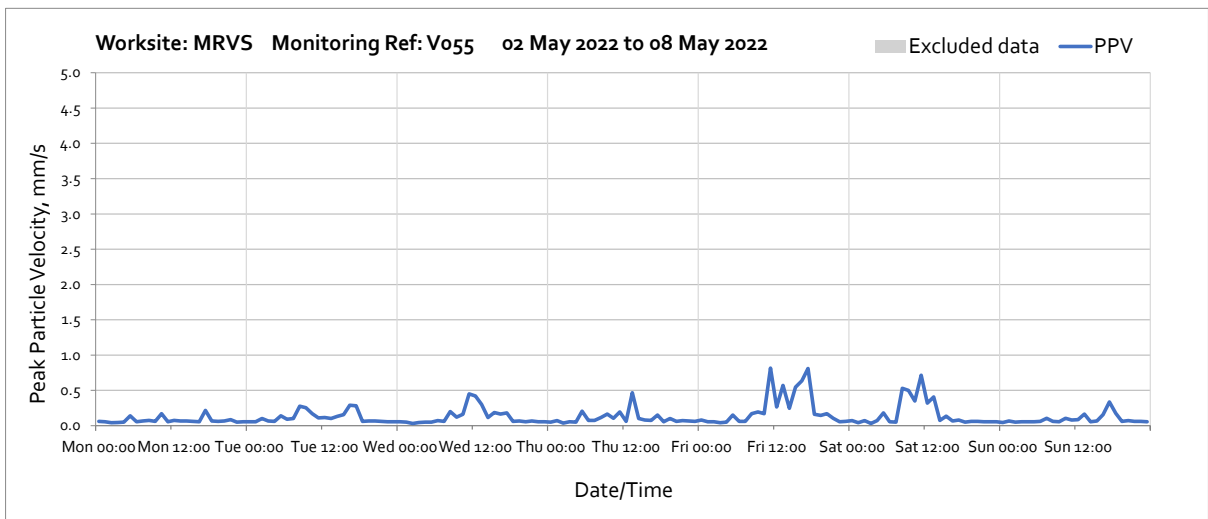
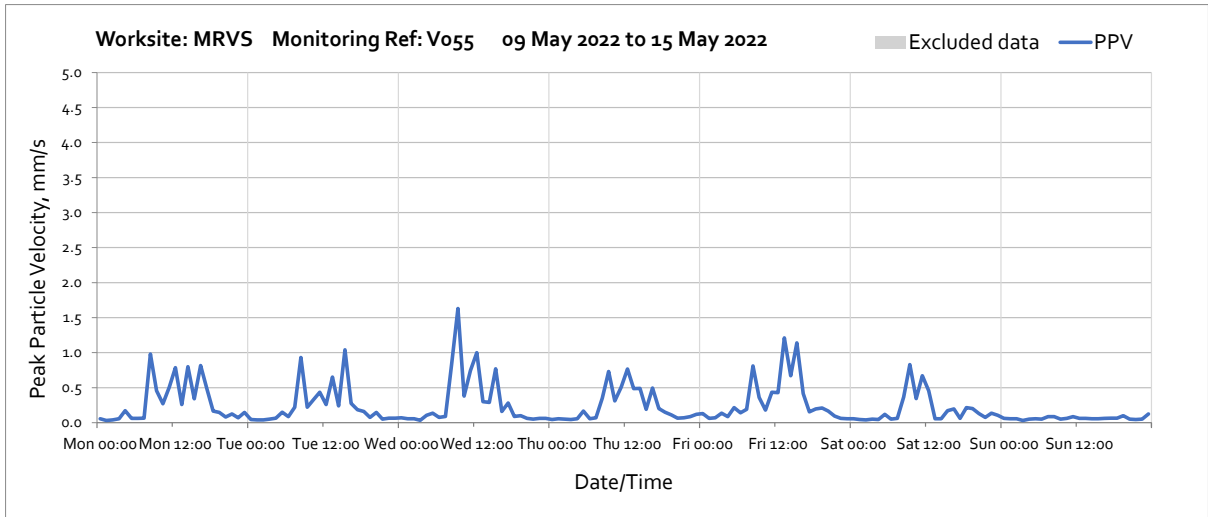
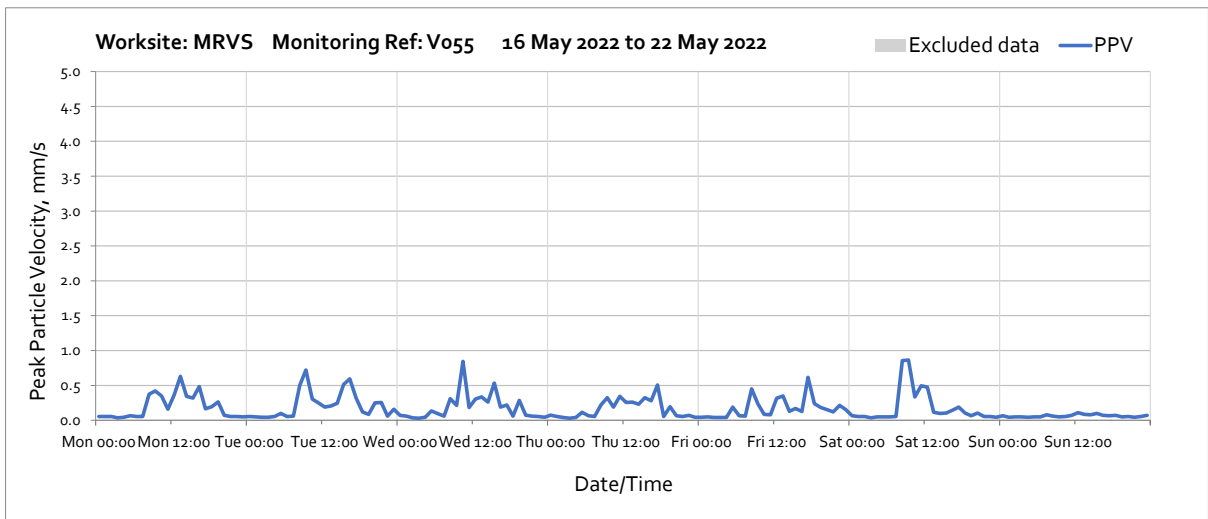
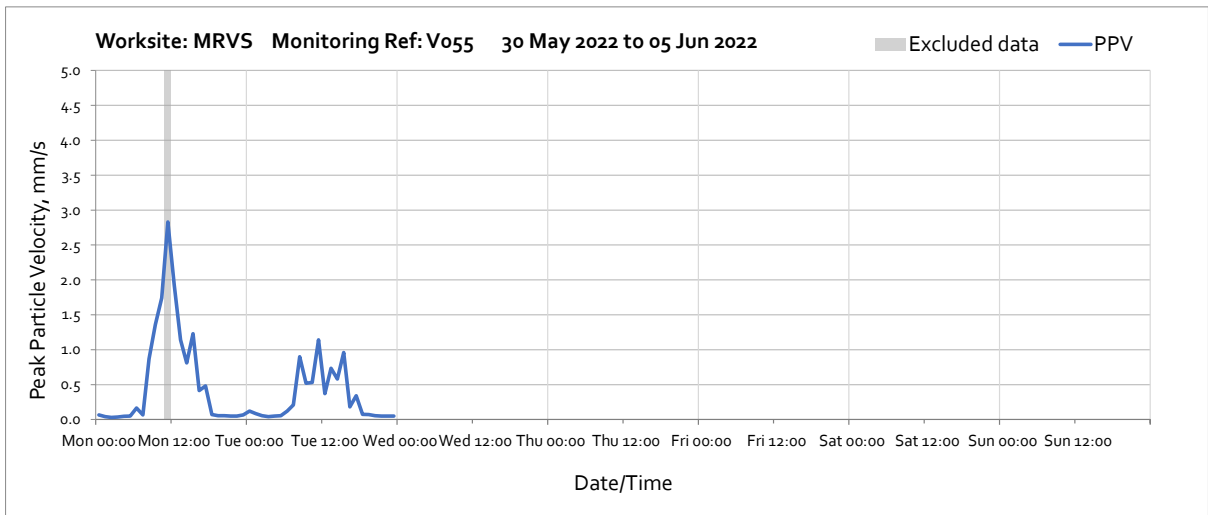
Worksite: Mandeville Road Vent Shaft (MRVS) – Monitoring Ref: V055

Note: High vibration levels measured at 11:00 on Monday 30th May 2022 were due to local disturbance at the monitoring location and not representative of HS2 vibration levels at the receptor.

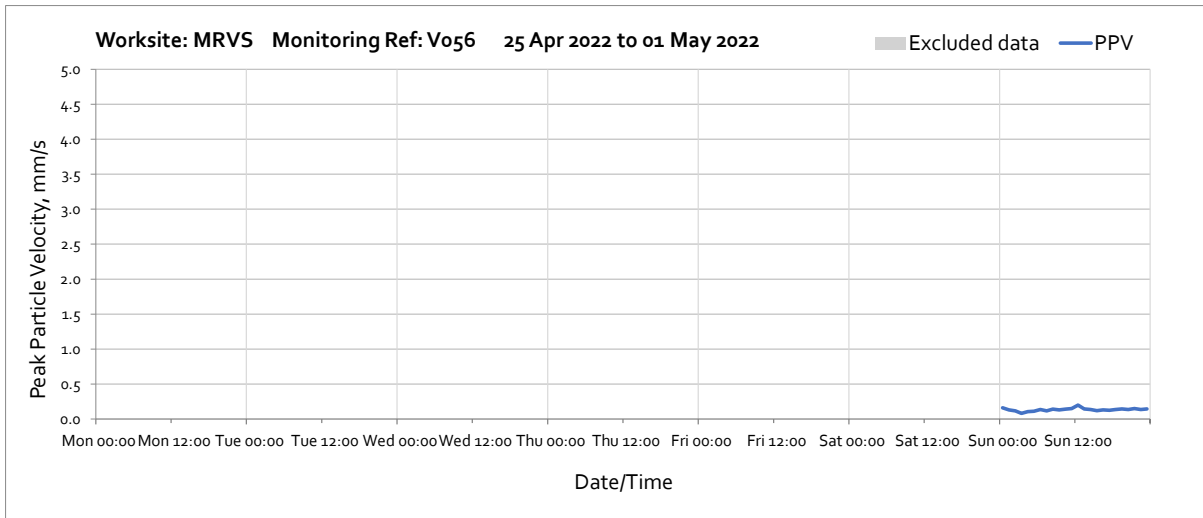
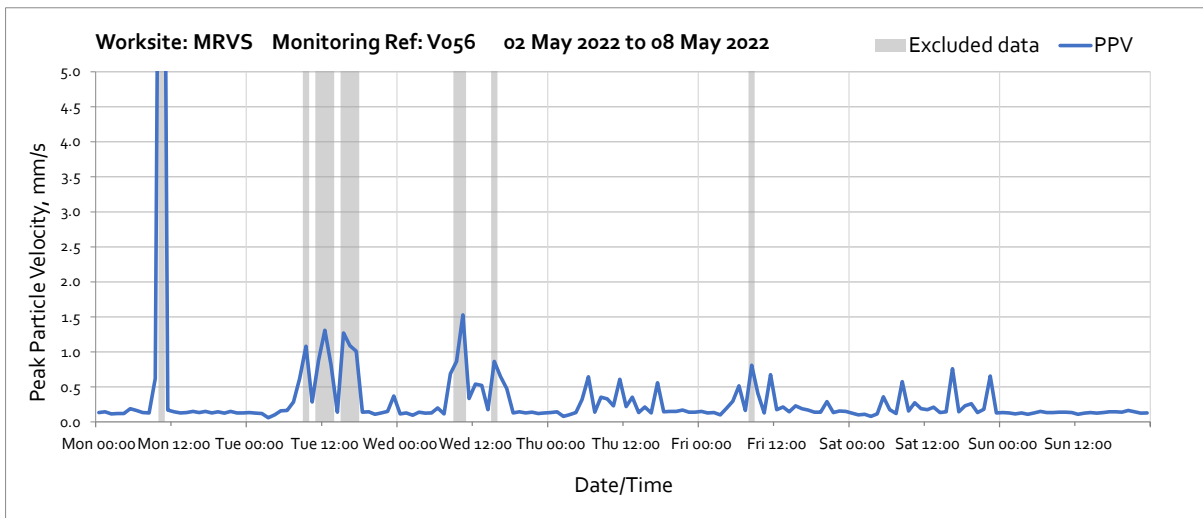
Worksite: Mandeville Road Vent Shaft (MRVS) – Monitoring Ref: V056

Note: High vibration levels measured throughout the week were due to local disturbance at the monitoring location and not representative of HS2 vibration levels at the receptor.

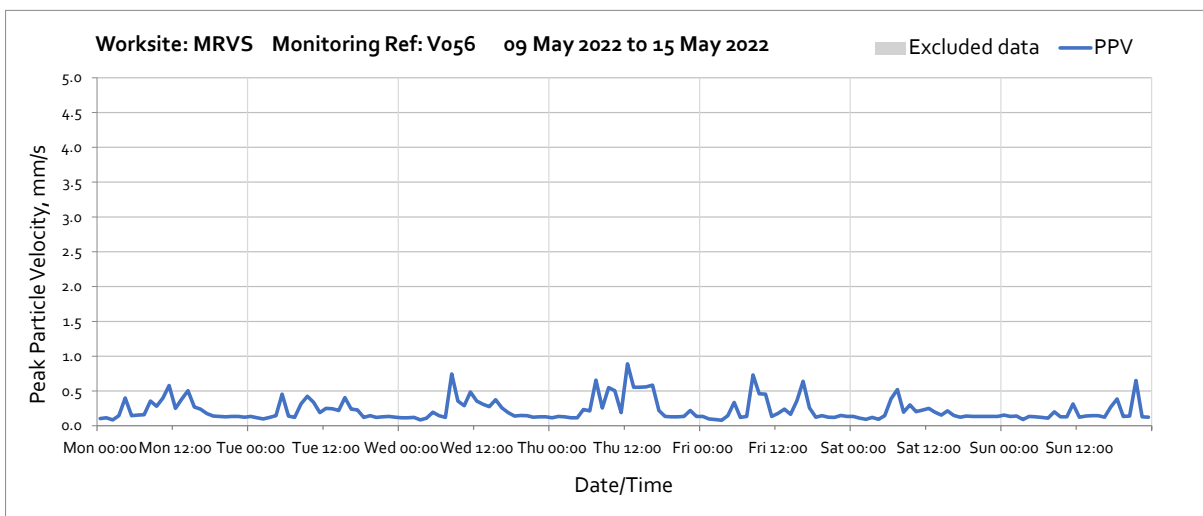
Note: High vibration levels measured throughout the week were due to local disturbance at the monitoring location and not representative of HS2 vibration levels at the receptor.

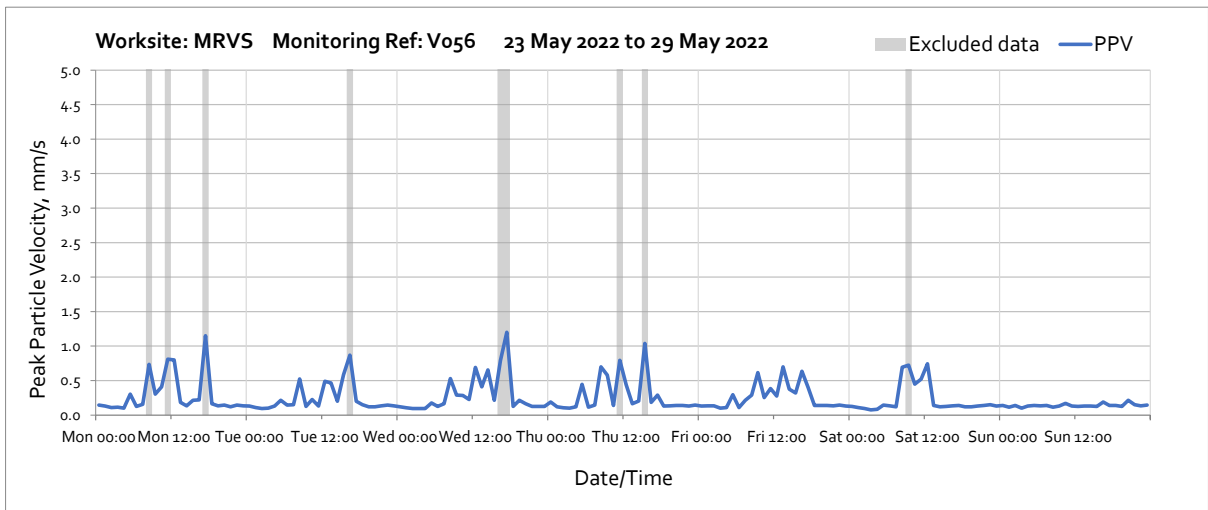
Note: High vibration levels measured throughout the week were due to local disturbance at the monitoring location and not representative of HS2 vibration levels at the receptor.

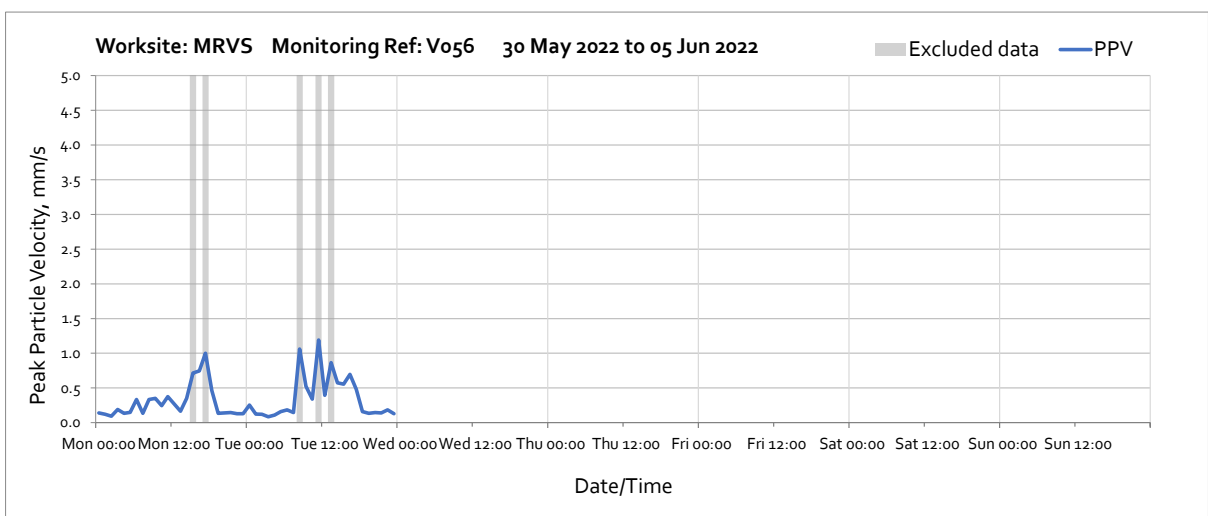
Note: High vibration levels measured throughout the week were due to local disturbance at the monitoring location and not representative of HS2 vibration levels at the receptor.

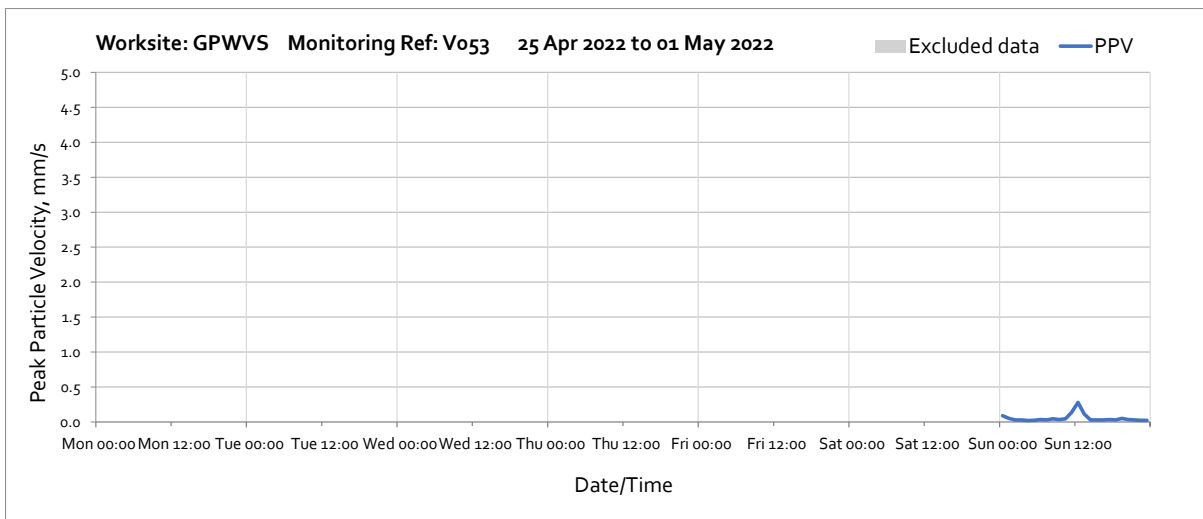
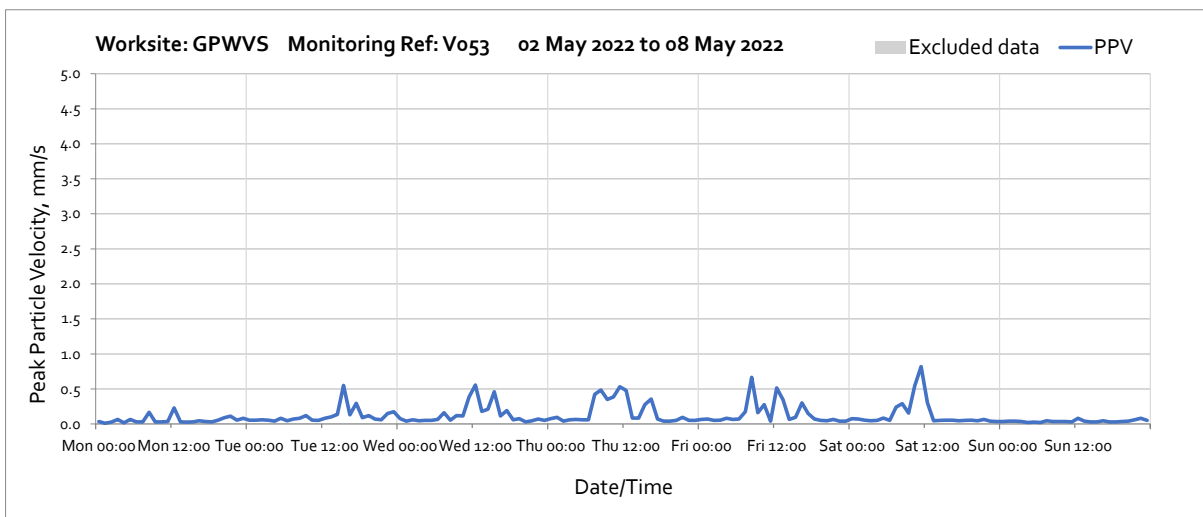
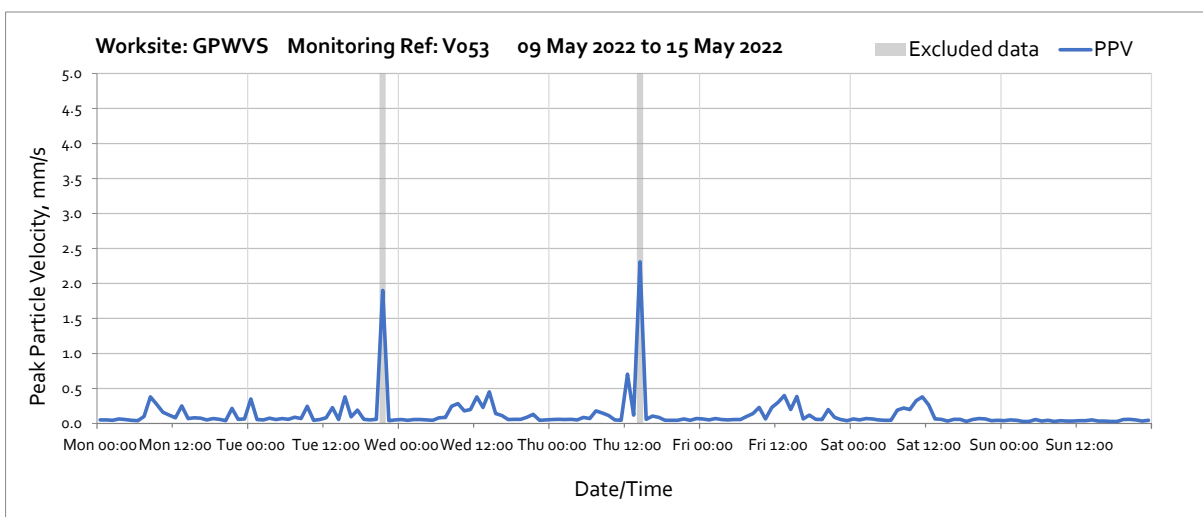
Worksite: Green Park Way Vent Shaft (GPWVS) – Monitoring Ref: V053

Note: High vibration levels measured at 21:00 on Tuesday 10th May and at 14:00 on Thursday 12th May were due to local disturbance at the monitoring location and not representative of HS2 vibration levels at the receptor.

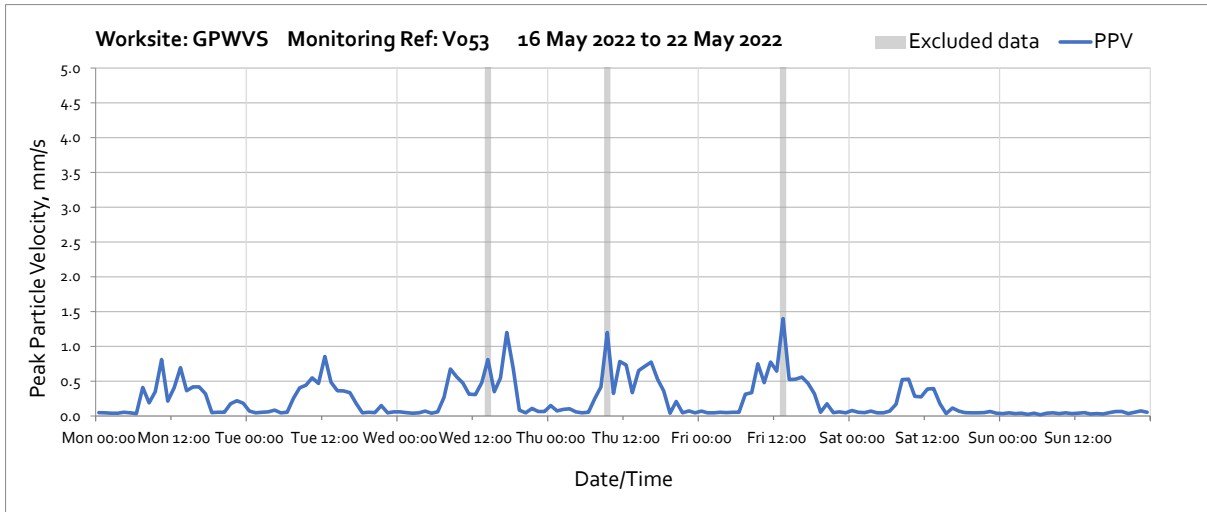
Note: High vibration levels measured throughout the week were due to local disturbance at the monitoring location and not representative of HS2 vibration levels at the receptor.

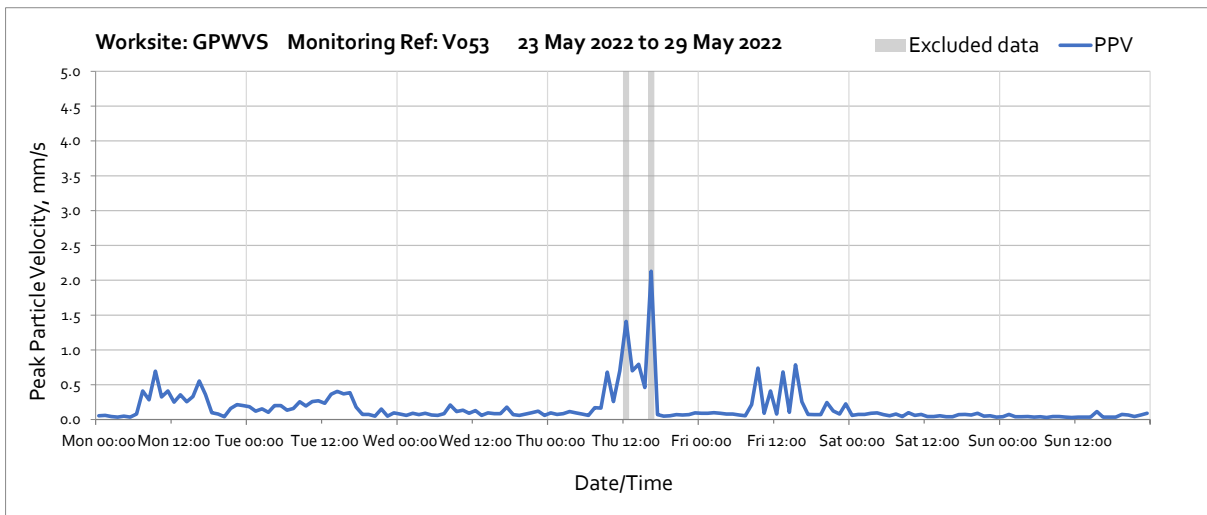
Note: High vibration levels measured at 12:00 and 16:00 on Thursday 26th May were due to local disturbance at the monitoring location and not representative of HS2 vibration levels at the receptor.

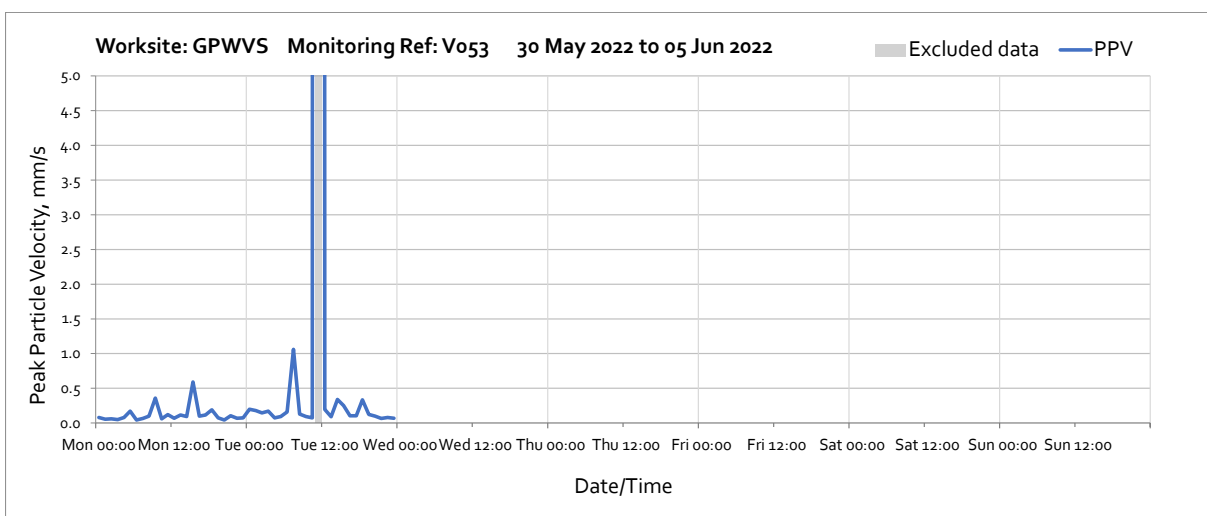
Note: High vibration levels measured at 11:00 on Tuesday 31st May were due to local disturbance at the monitoring location and not representative of HS2 vibration levels at the receptor.

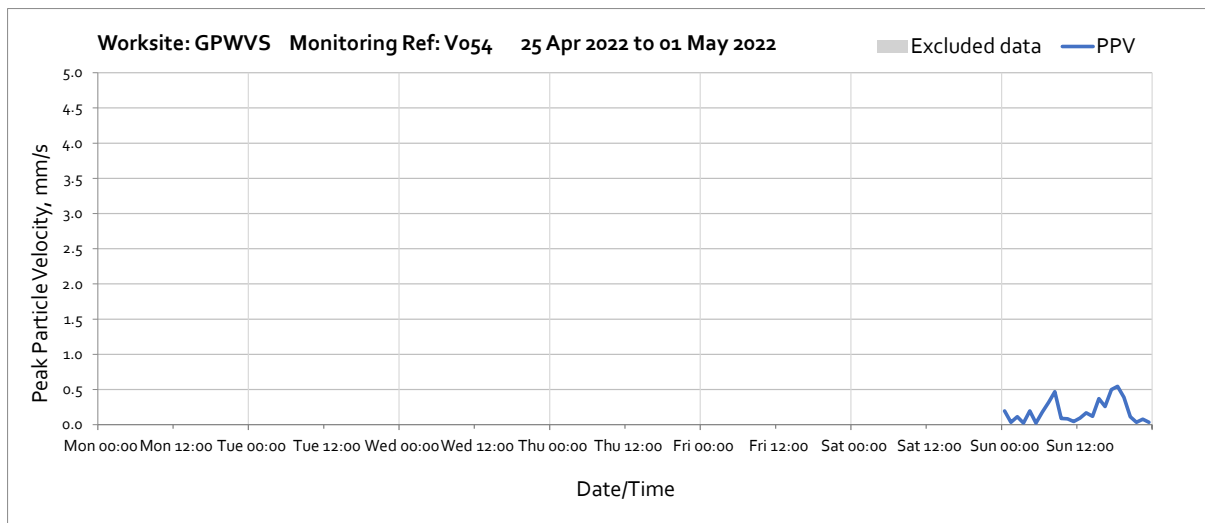
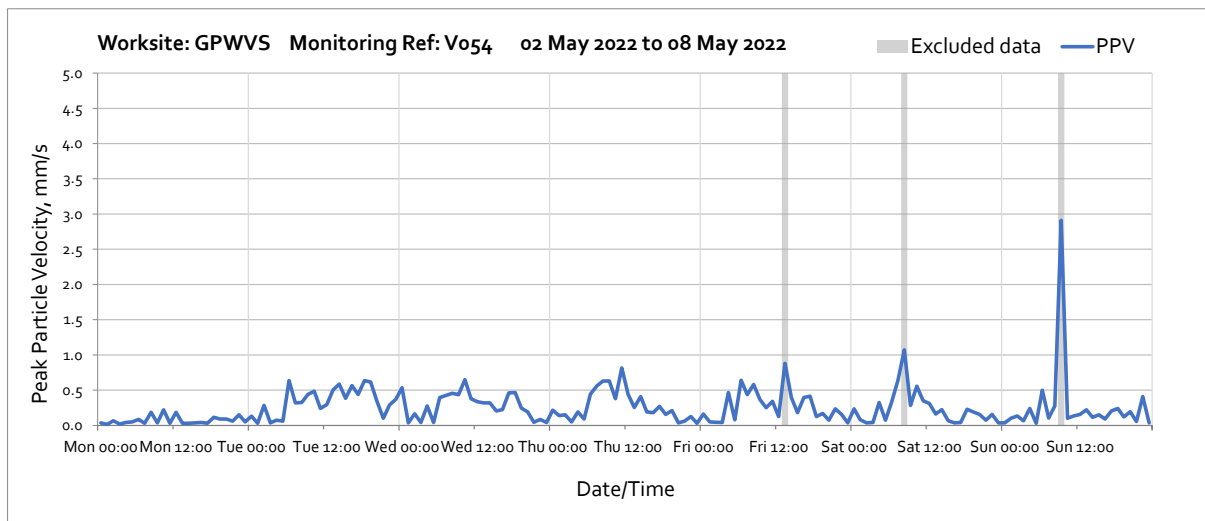
Worksite: Green Park Way Vent Shaft (GPWVS) – Monitoring Ref: V054

Note: High vibration levels measured throughout the week were due to local disturbance at the monitoring location and not representative of HS2 vibration levels at the receptor.

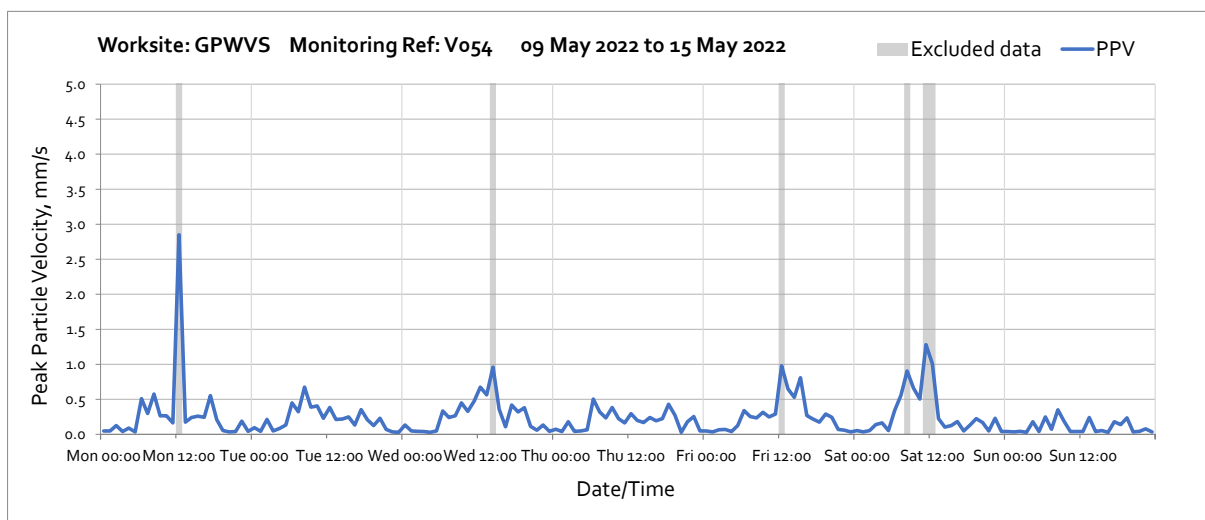
Note: High vibration levels measured throughout the week were due to local disturbance at the monitoring location and not representative of HS2 vibration levels at the receptor.

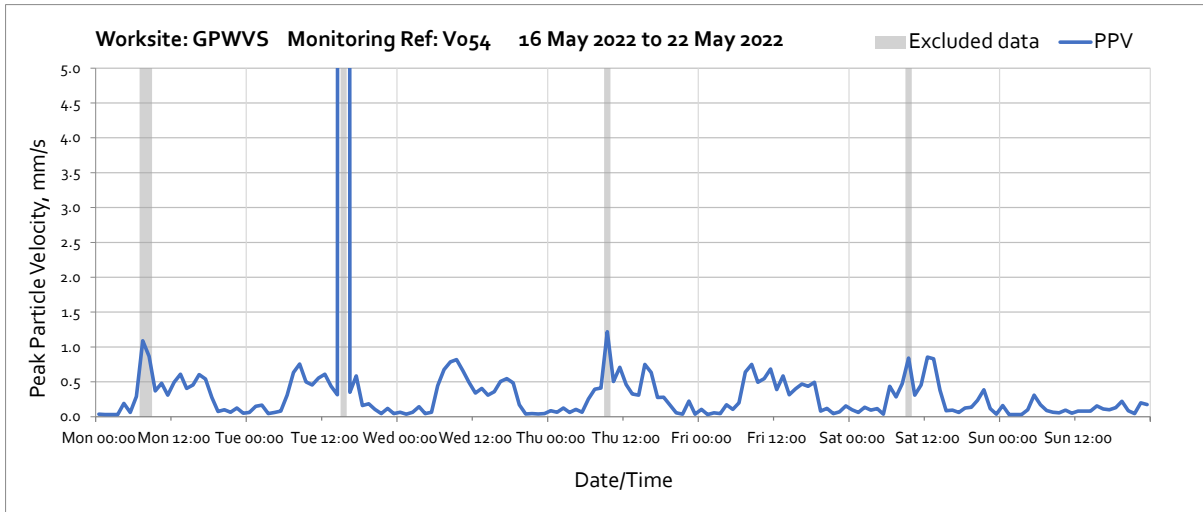
Note: High vibration levels measured throughout the week were due to local disturbance at the monitoring location and not representative of HS2 vibration levels at the receptor.

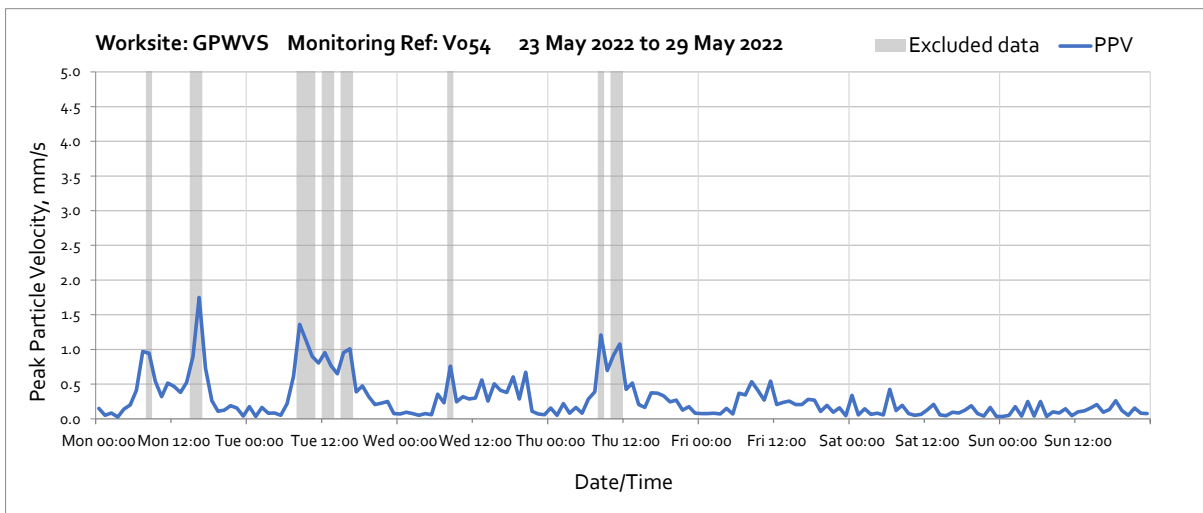
Note: High vibration levels measured throughout the week were due to local disturbance at the monitoring location and not representative of HS2 vibration levels at the receptor.

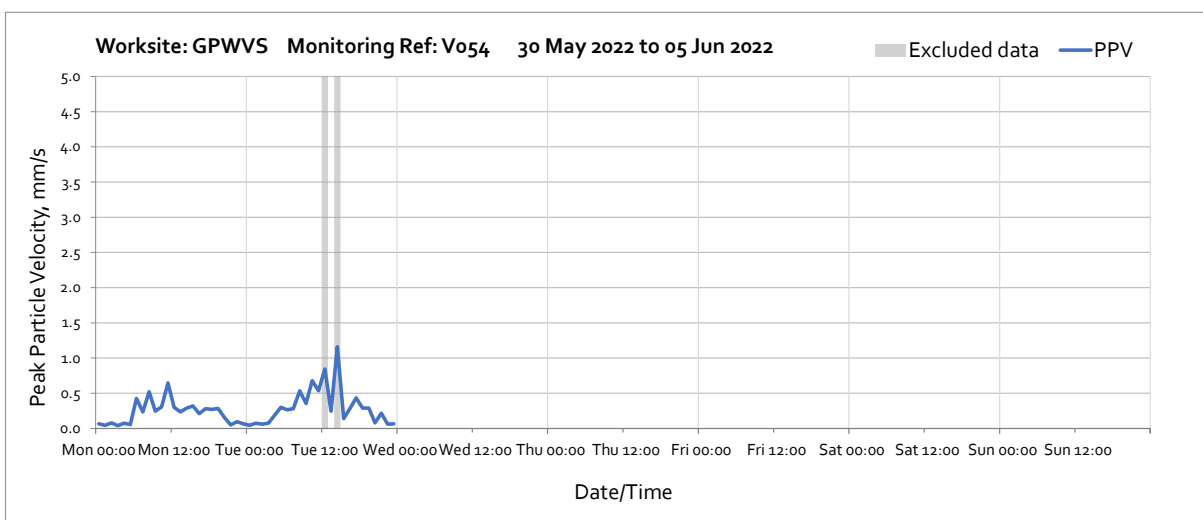
Note: High vibration levels measured at 12:00 and 14:00 on Tuesday 31st May were due to local disturbance at the monitoring location and not representative of HS2 vibration levels at the receptor.
