February 2023

# HS2

## Construction Noise and Vibration Monthly Report – December 2022

North Warwickshire Borough Council

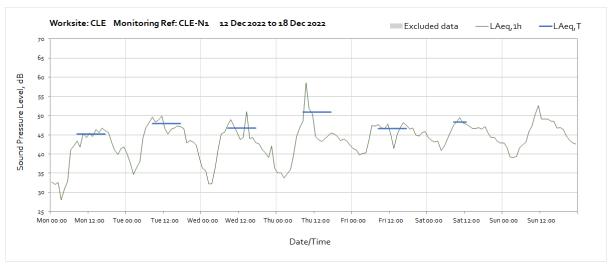
#### **Worksite: CLE - Monitoring Ref: CLE-N1**

The following graphs show the hourly measured ambient noise level  $L_{Aeq,1h}$  and, where relevant, the averaged noise level  $L_{Aeq,T}$  values, where the time period T is as specified in Table 1 of HS2 Information Paper E23. Periods with adversely weather affected noise levels are greyed out and have been excluded from the calculation of the  $L_{Aeq,T}$  values in Table 3 of the main report.:

2.1.3 Appendix C presents graphs of the noise and vibration monitoring data over the month for each of the measurement locations. Noise data presented consists of the hourly L<sub>Aeq</sub> values and, where relevant, the L<sub>Aeq,T</sub> values (where the time period T has been taken to be the averaging period as specified in Table 1 of HS2 Information Paper E23). Vibration data presented consist of hourly PPV values. The full data set for the monitoring equipment can be found at the following location: <a href="https://data.gov.uk/dataset/24542ae7-dd44-444f-b259-871c4cc43b5e/environmental-monitoring-data">https://data.gov.uk/dataset/24542ae7-dd44-444f-b259-871c4cc43b5e/environmental-monitoring-data</a>.
