## Air Quality and Dust Monitoring Monthly Report – January 2023

London Borough of Ealing

## Department for Transport

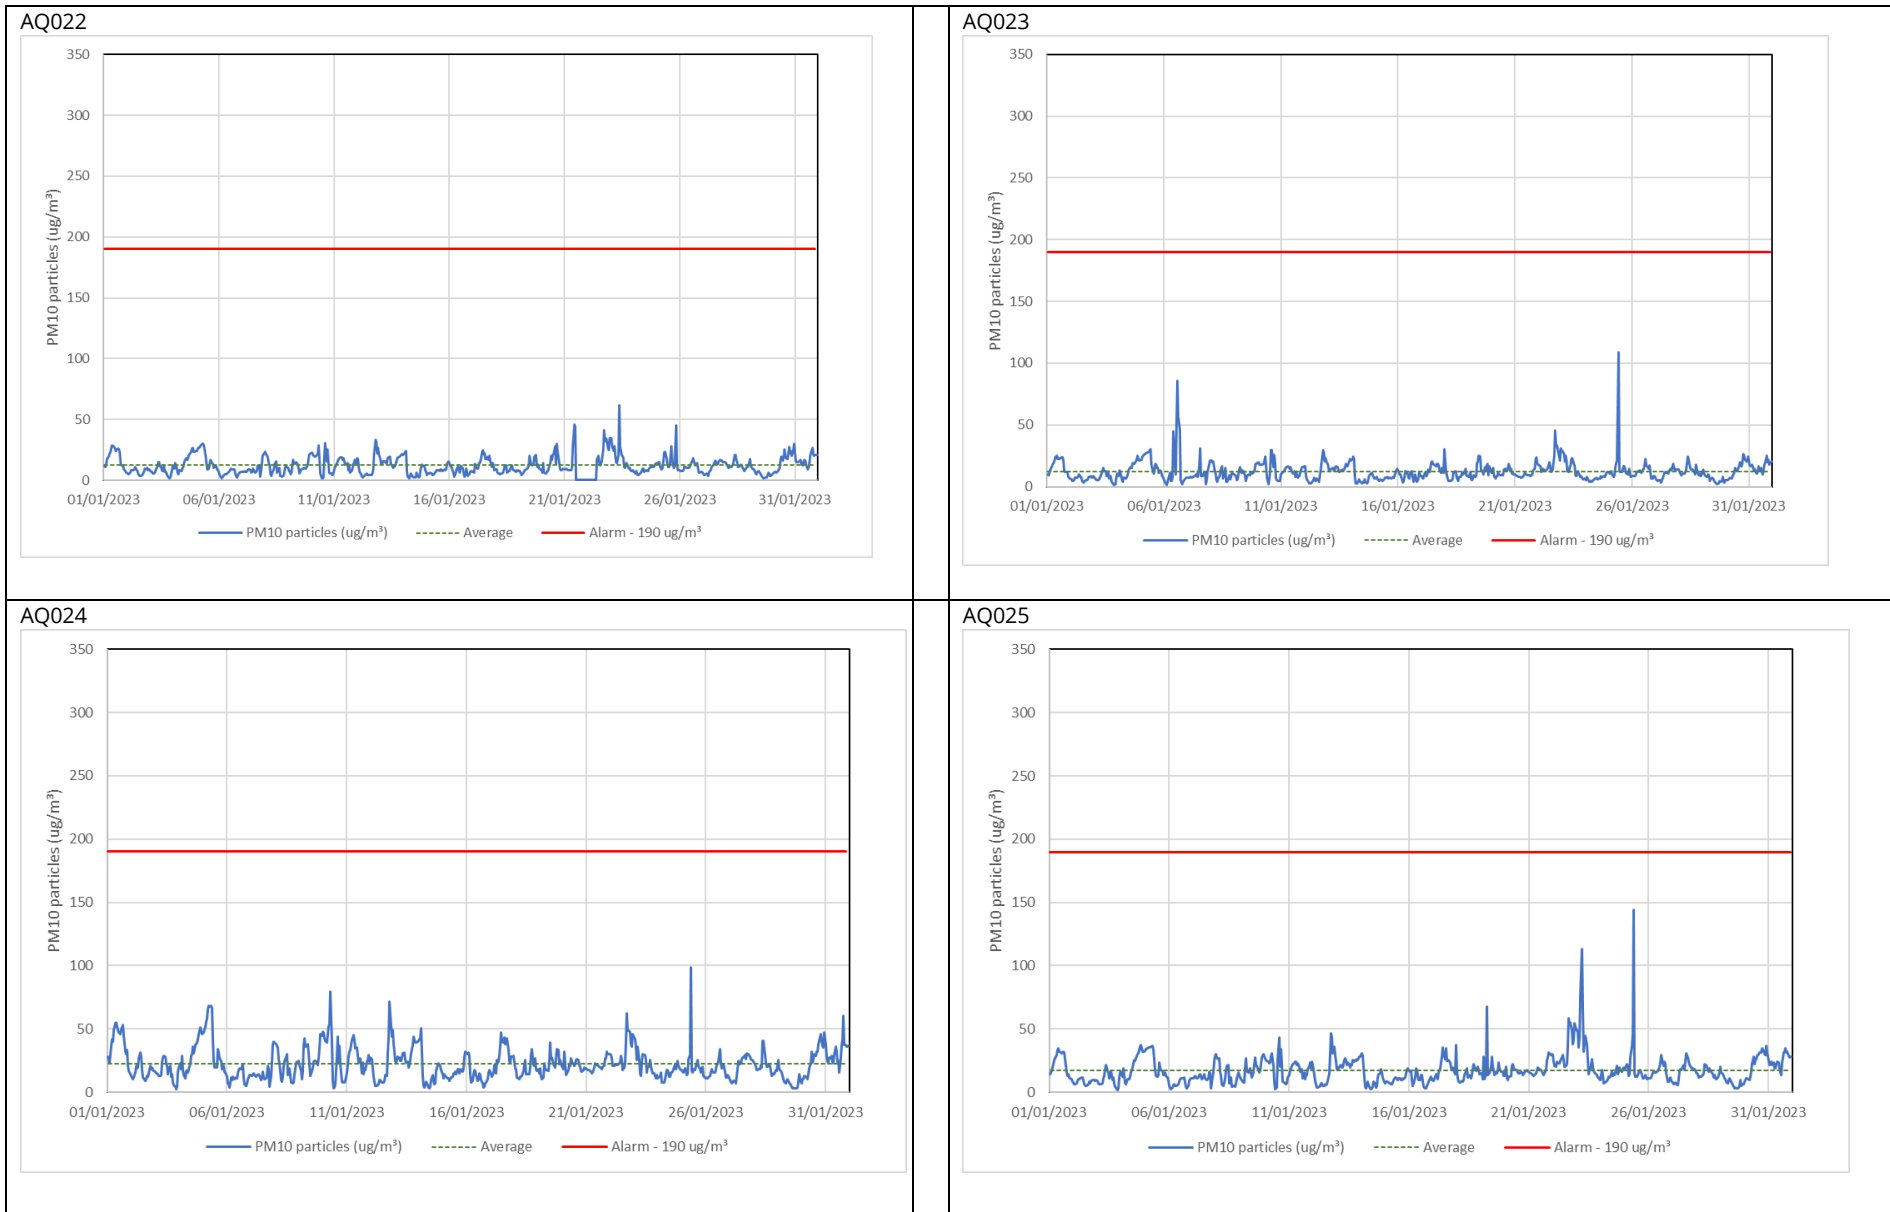
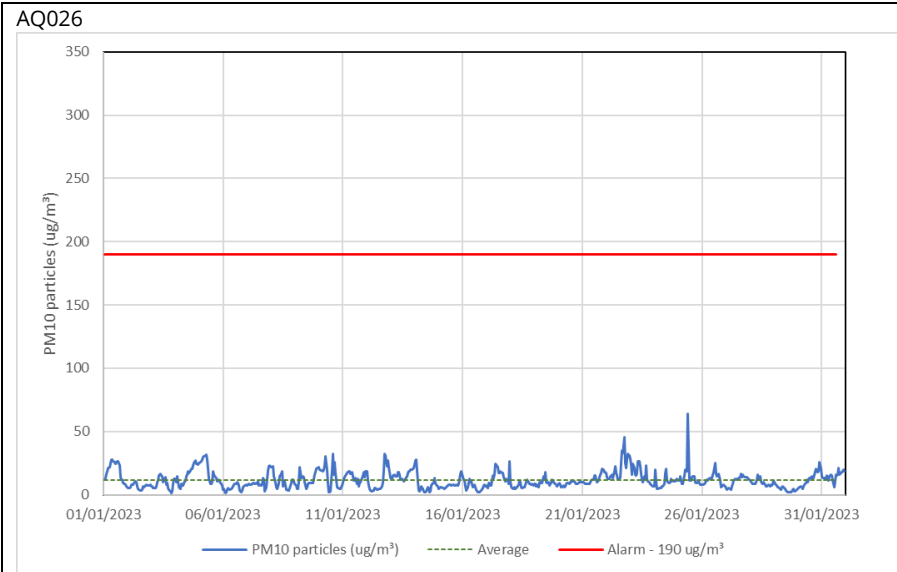
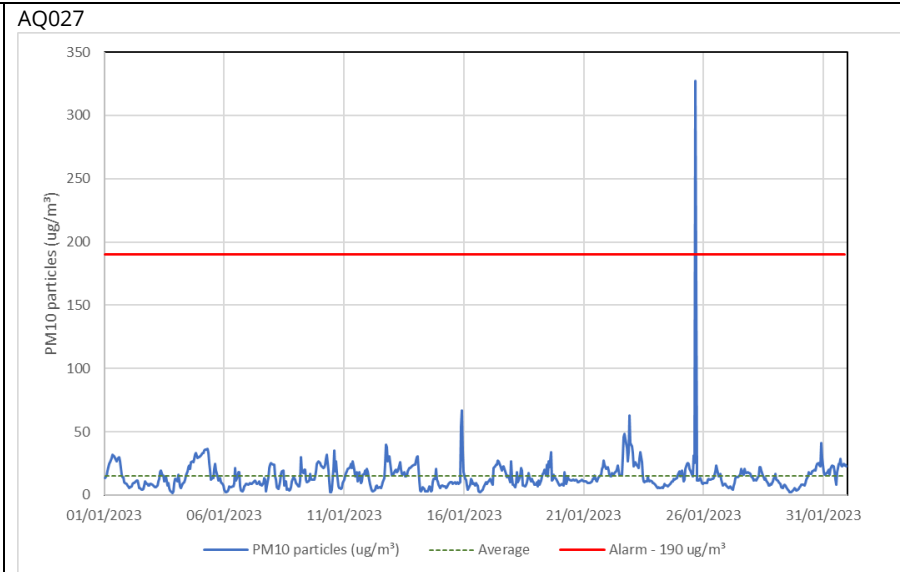
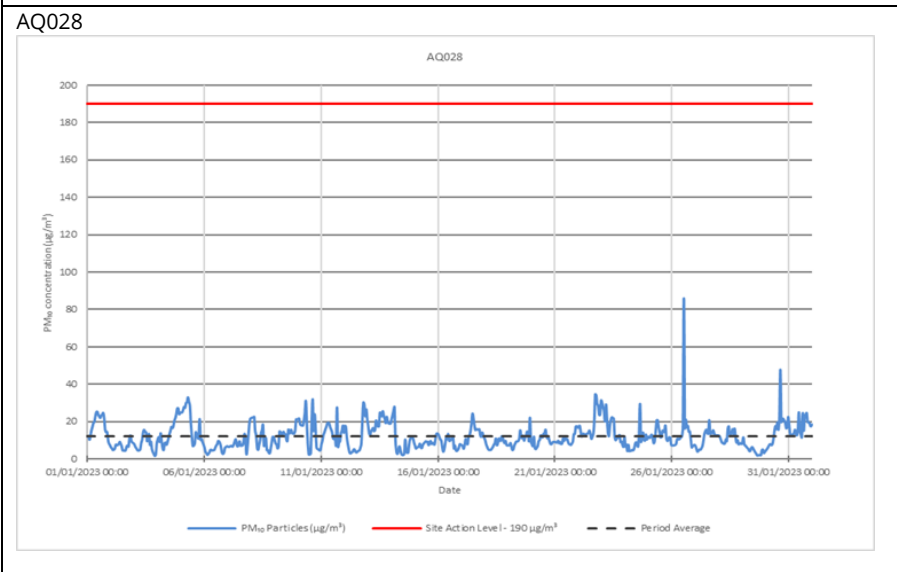
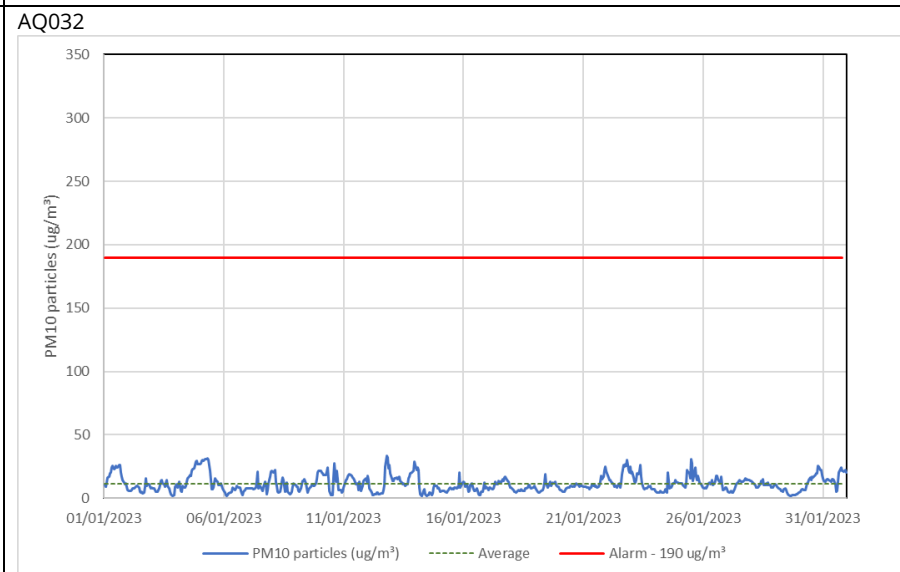
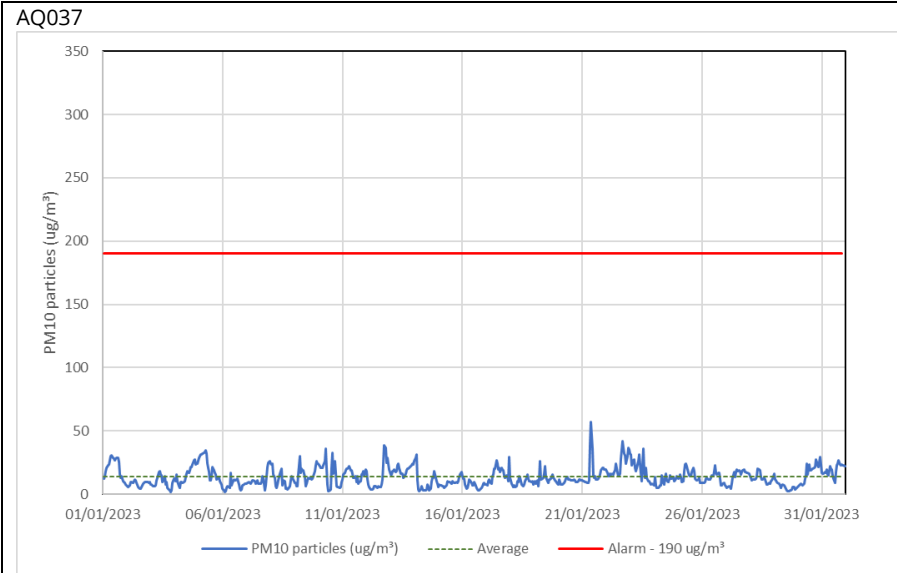
Figure 5: Construction dust 1-hour mean indicative PM<sub>10</sub> concentration for dust monitors

- 1.1.5 Fifteen (15) dust monitors were installed around worksites, where works are underway. These sites returned a medium dust risk rating.
- 1.1.6 Dust monitoring locations and results are presented in Appendix B, Table 2, together with line charts of monthly data from each dust monitor, Figure 5. All continuous dust monitoring is undertaken using indicative monitors. Despite being Environment Agency (MCERTS) certified, indicative monitors carry a higher level of uncertainty than reference monitors, and therefore cannot be strictly compared with Air Quality Standards for human health and the environment. The purpose of the monitoring undertaken is to ensure the effectiveness of the on-site mitigation.
