OFFICIAL-SENSITIVE
Sea King HC Mk 4 Release to Service

Fig B3.4 – SM/SK/0030 Carson Main Rotor Blades and 5 Bladed Tail Rotor - Normal Visual Flight Envelope 103% RRPM

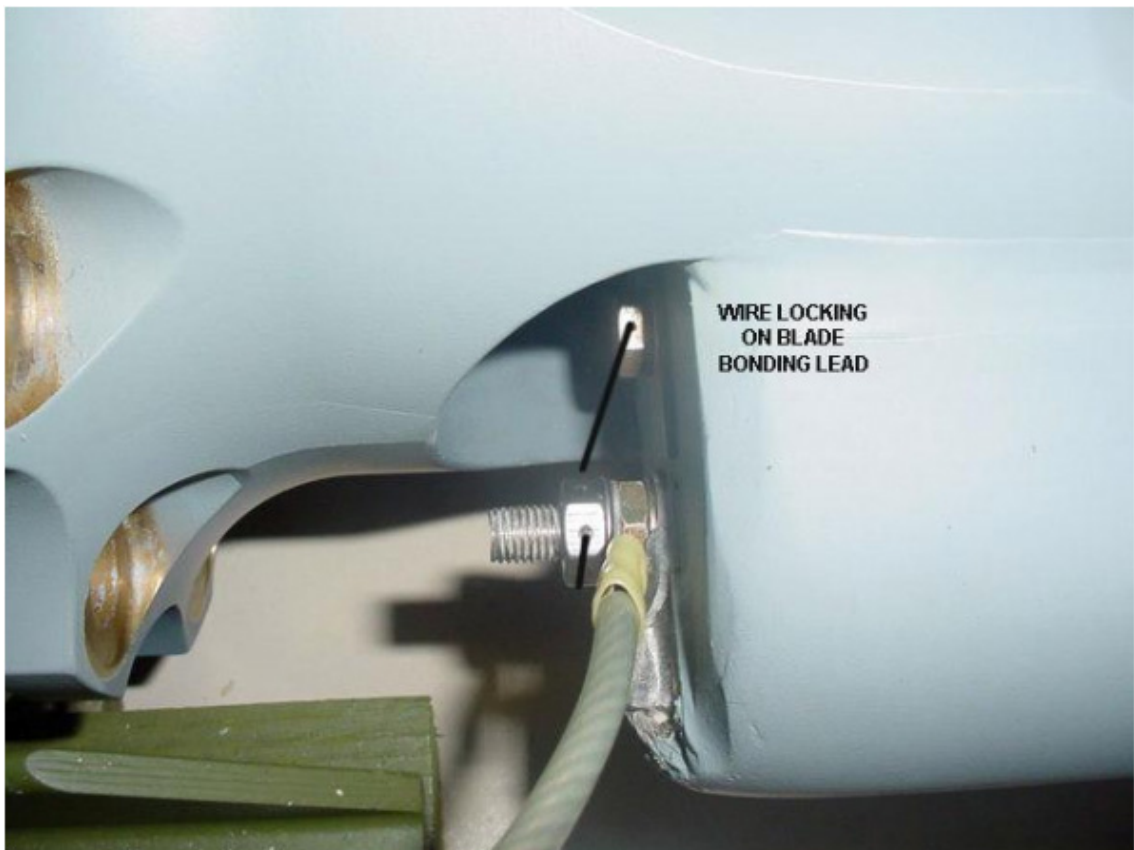
SWM00224A-01

Figure 4 Wire Locking on Blade Bonding Lead

- (35) Attach bonding lead Pt No MRE0-005 to stub at blade root, use nut Pt No NAS 509-5C and washer Pt No AN960C516L. Tighten the nut and wirelock (C126) the nut to bolt inboard of stud (See Fig. 4).
- (36) Attach the bonding lead to the bracket, use screw Pt No AN525 -10R6 and washer AN960 -10L (See Fig. 2).
- (37) Torque tighten the ten bolts (1-3) to between 70 and 80 lbf ft (9.66 and 11.04 kg/m). Lock the ten bolts with wire (C126).
- (38) Use the assist pole to release and carefully remove the blade handler (1-5) and the blade handler clamps (1-6).

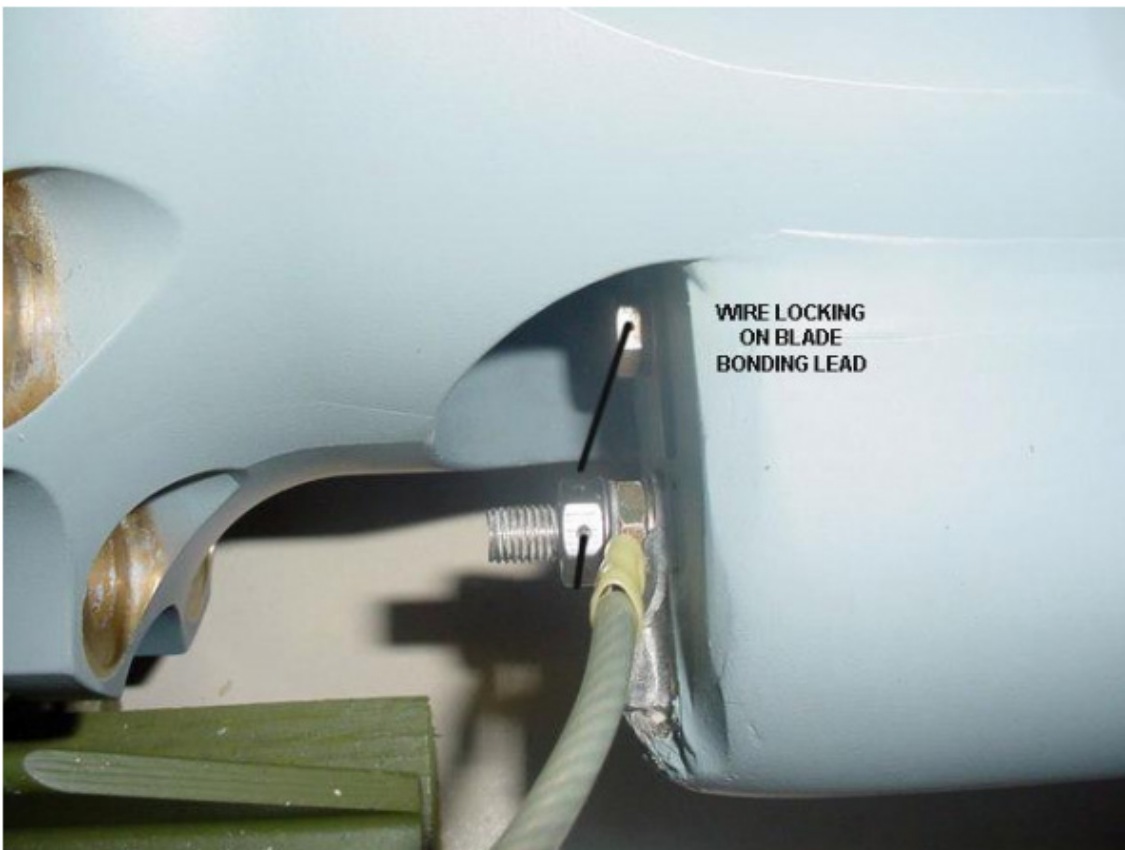
SWM00224A-01

Fig 4 Wire Locking on Blade Bonding Lead
