SERIOUS INCIDENT

Aircraft Type and Registration:	Tekever AR5 Evolution Mk 2, G-TEKV	
No & Type of Engines:	2 3W 2-stroke piston engines	
Year of Manufacture:	2019 (Serial no: E505)	
Date & Time (UTC):	17 January 2023 at 1346 hrs	
Location:	Temporary Danger Area EG D098, over English Channel	
Type of Flight:	Commercial operations (UAS)	
Persons on Board:	Crew - None	Passengers - None
Injuries:	Crew - N/A	Passengers - N/A
Nature of Damage:	None	
Commander's Licence:	Other	
Commander's Age:	31 years	
Commander's Flying Experience:	254 hours (of which 125 were on type) Last 90 days - 38 hours Last 28 days - 5 hours	
Information Source:	Aircraft Accident Report Form submitted by the pilot and further enquiries by the AAIB

Synopsis

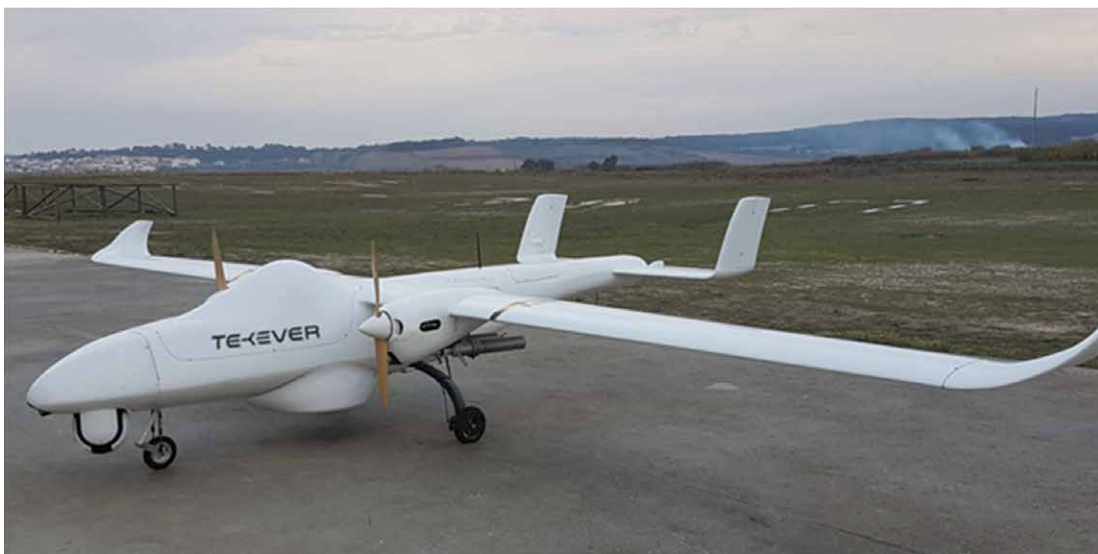
Figure 1
Tekever AR5 Evolution

The Tekever AR5 Evolution UAS (AR5) consists of a manned GCS and an unmanned aircraft (Figure 1). The aircraft has a maximum takeoff mass of 180 kg¹, a wingspan of 7.29 m, a length of 4.03 m and is powered by two 170 cc two-stroke boxer engines. It has an endurance of up to 12 hours.
