November 2023

HS2

Air Quality and Dust Monitoring Monthly Report - November 2023 Buckinghamshire Council

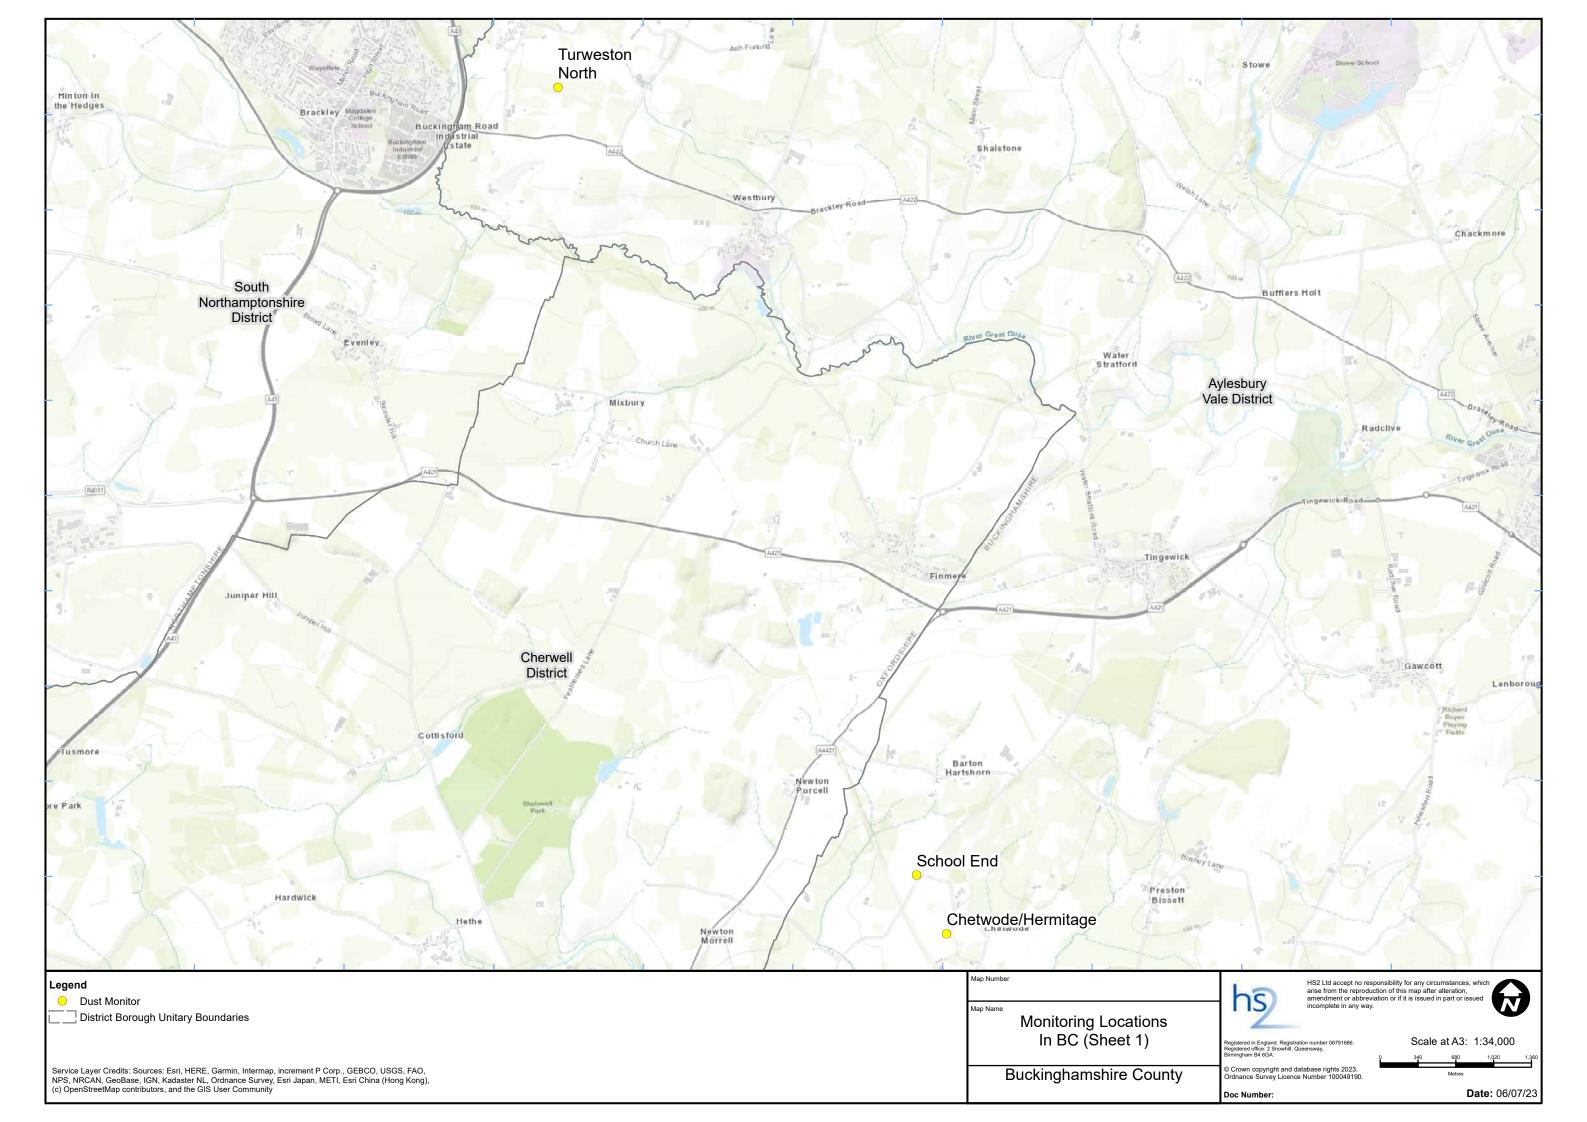
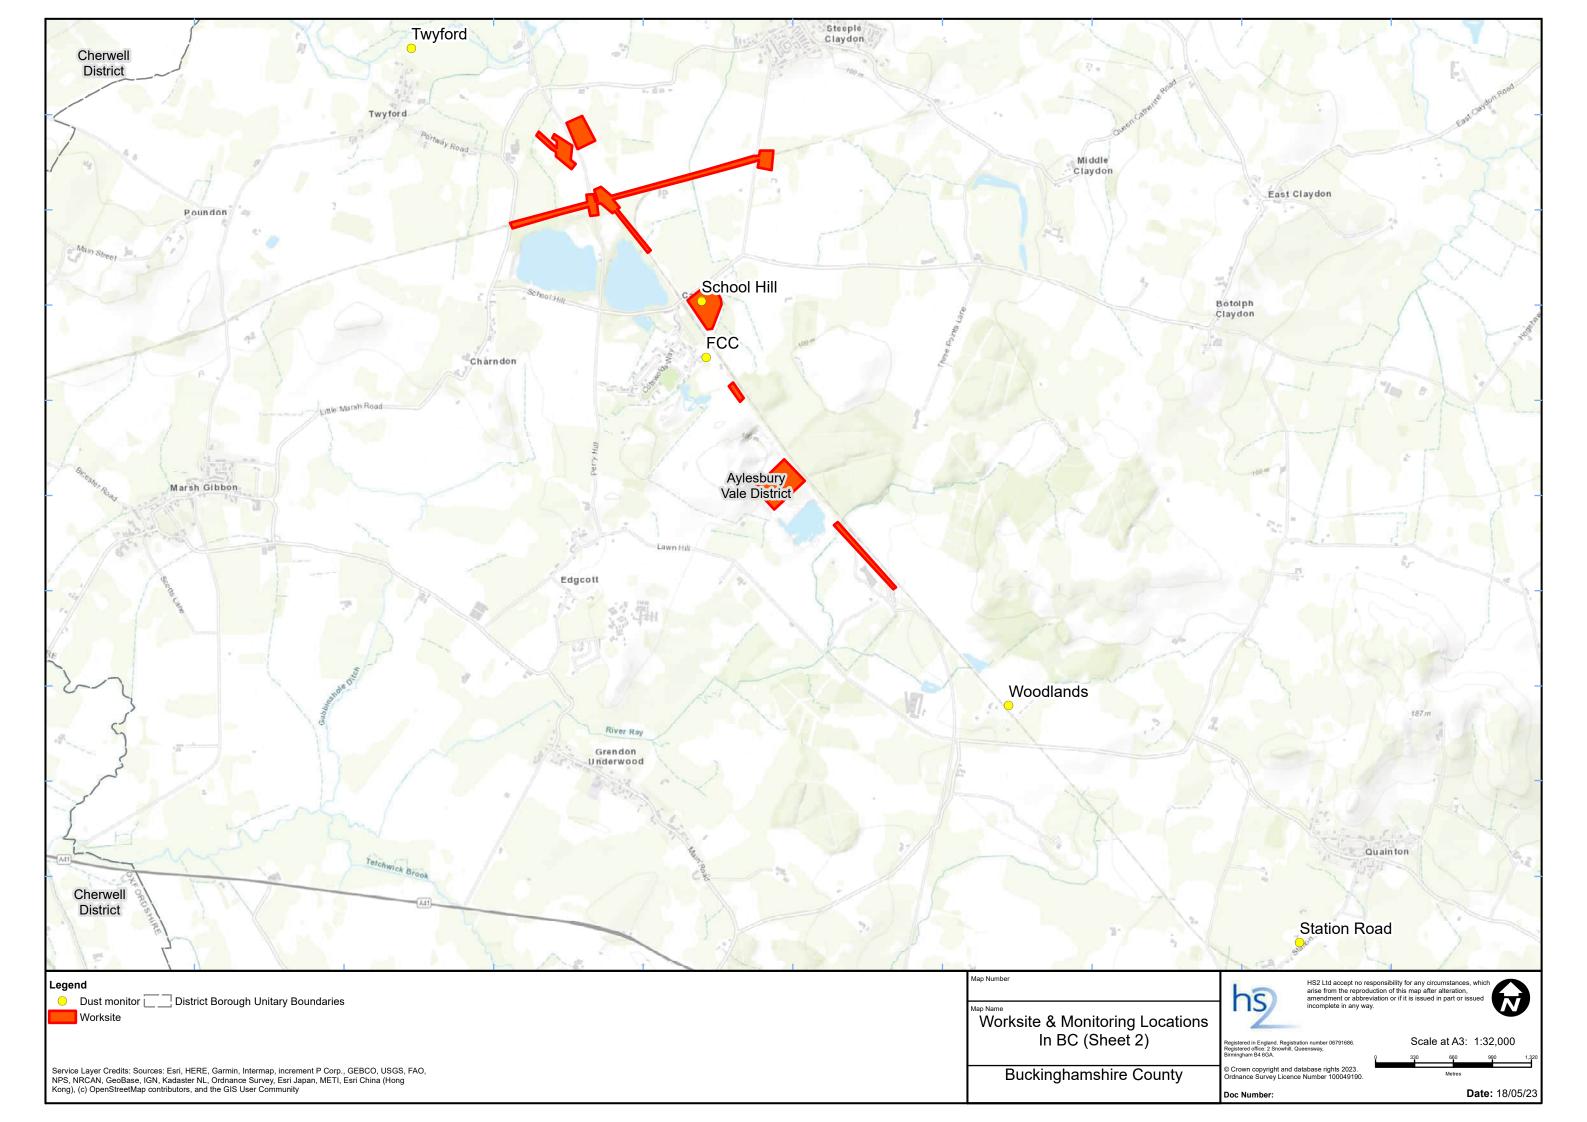
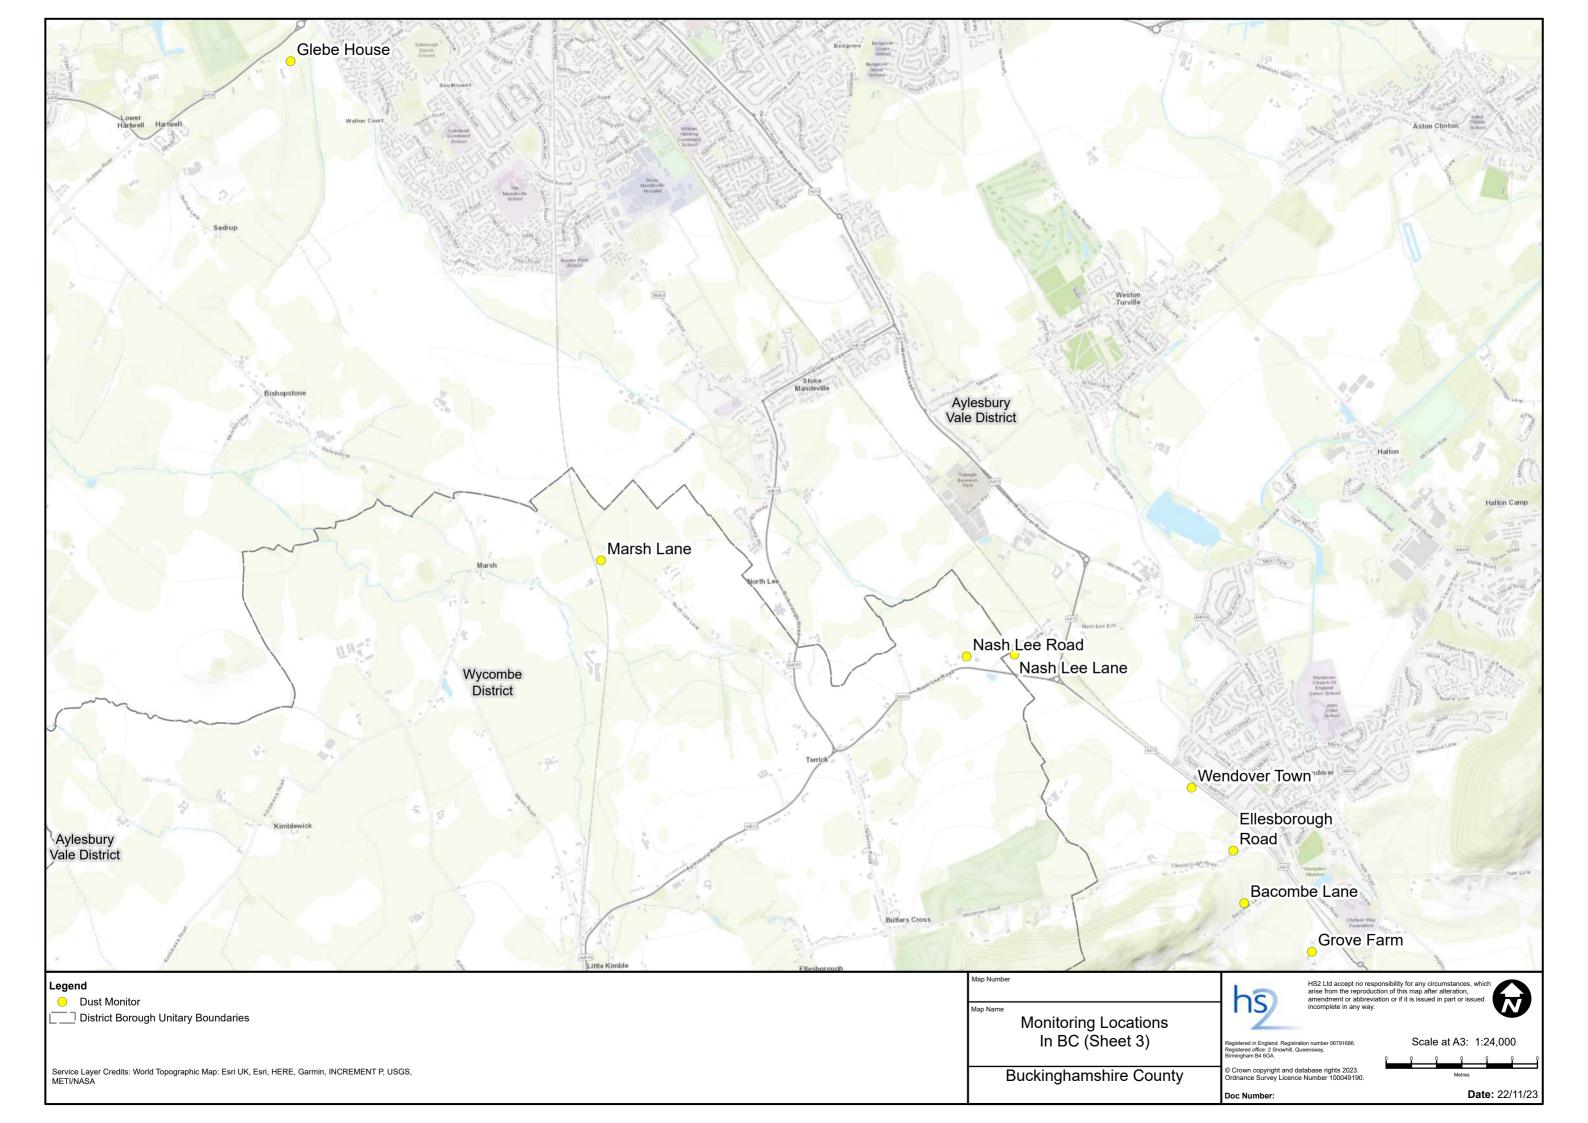
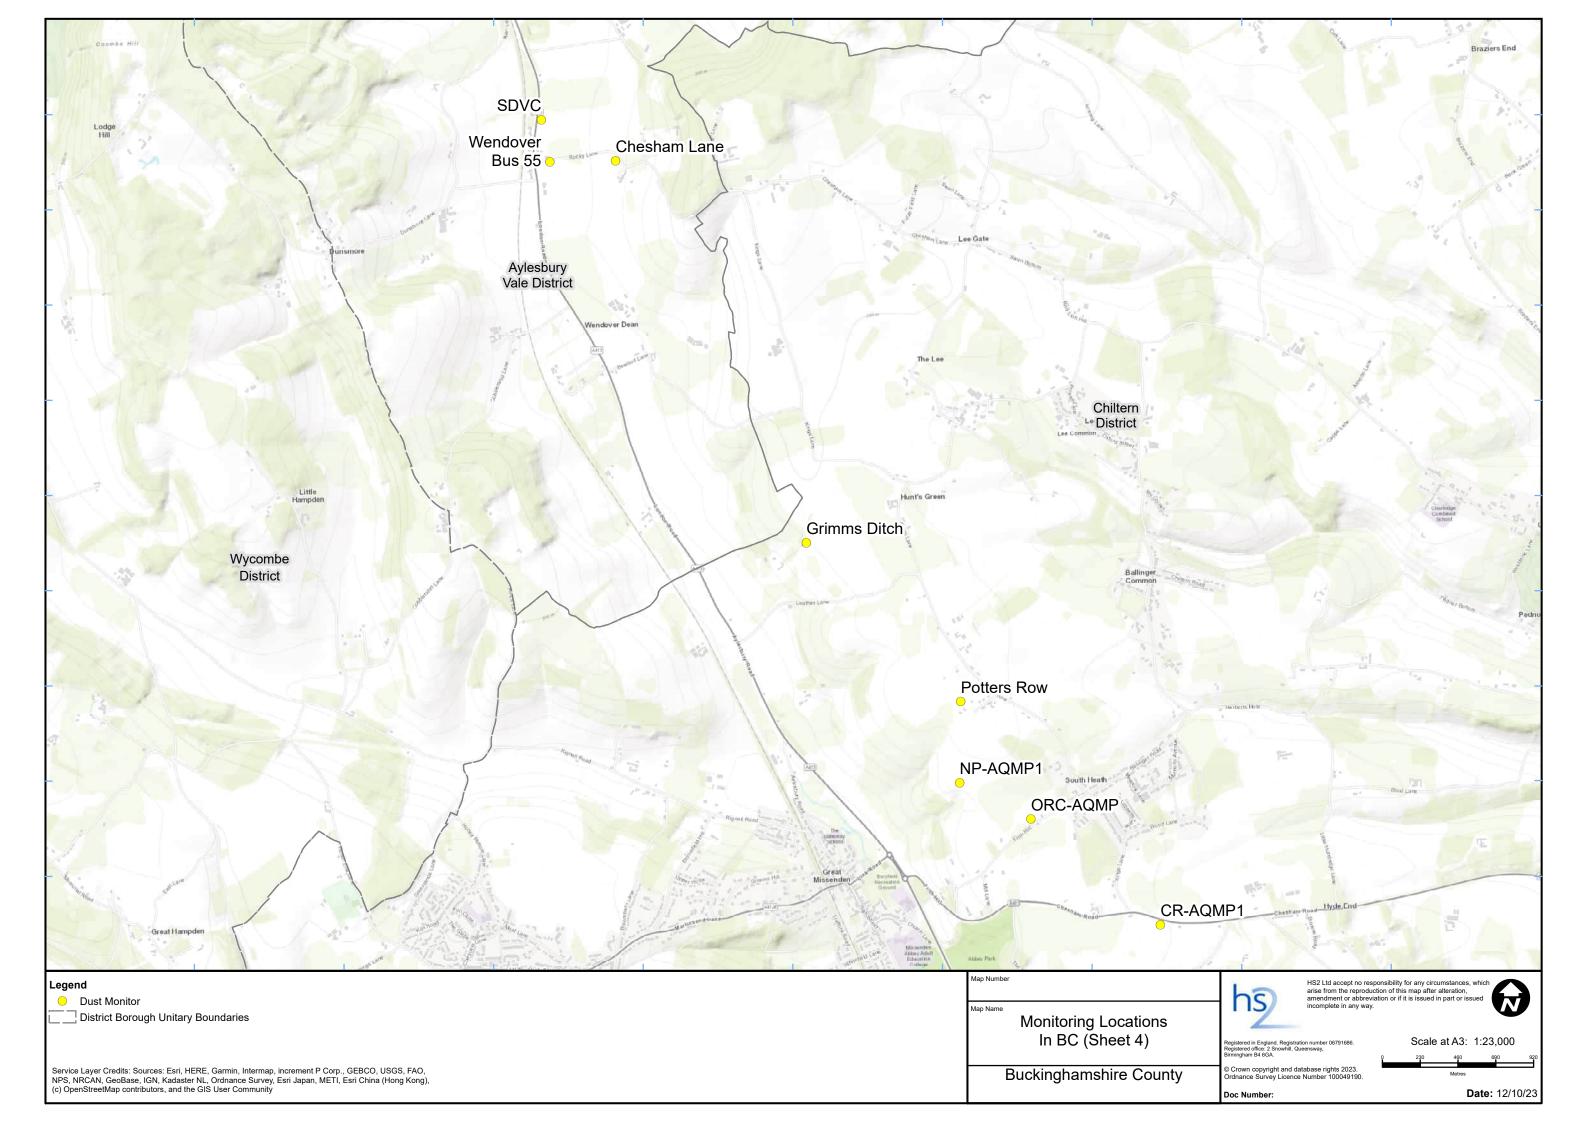
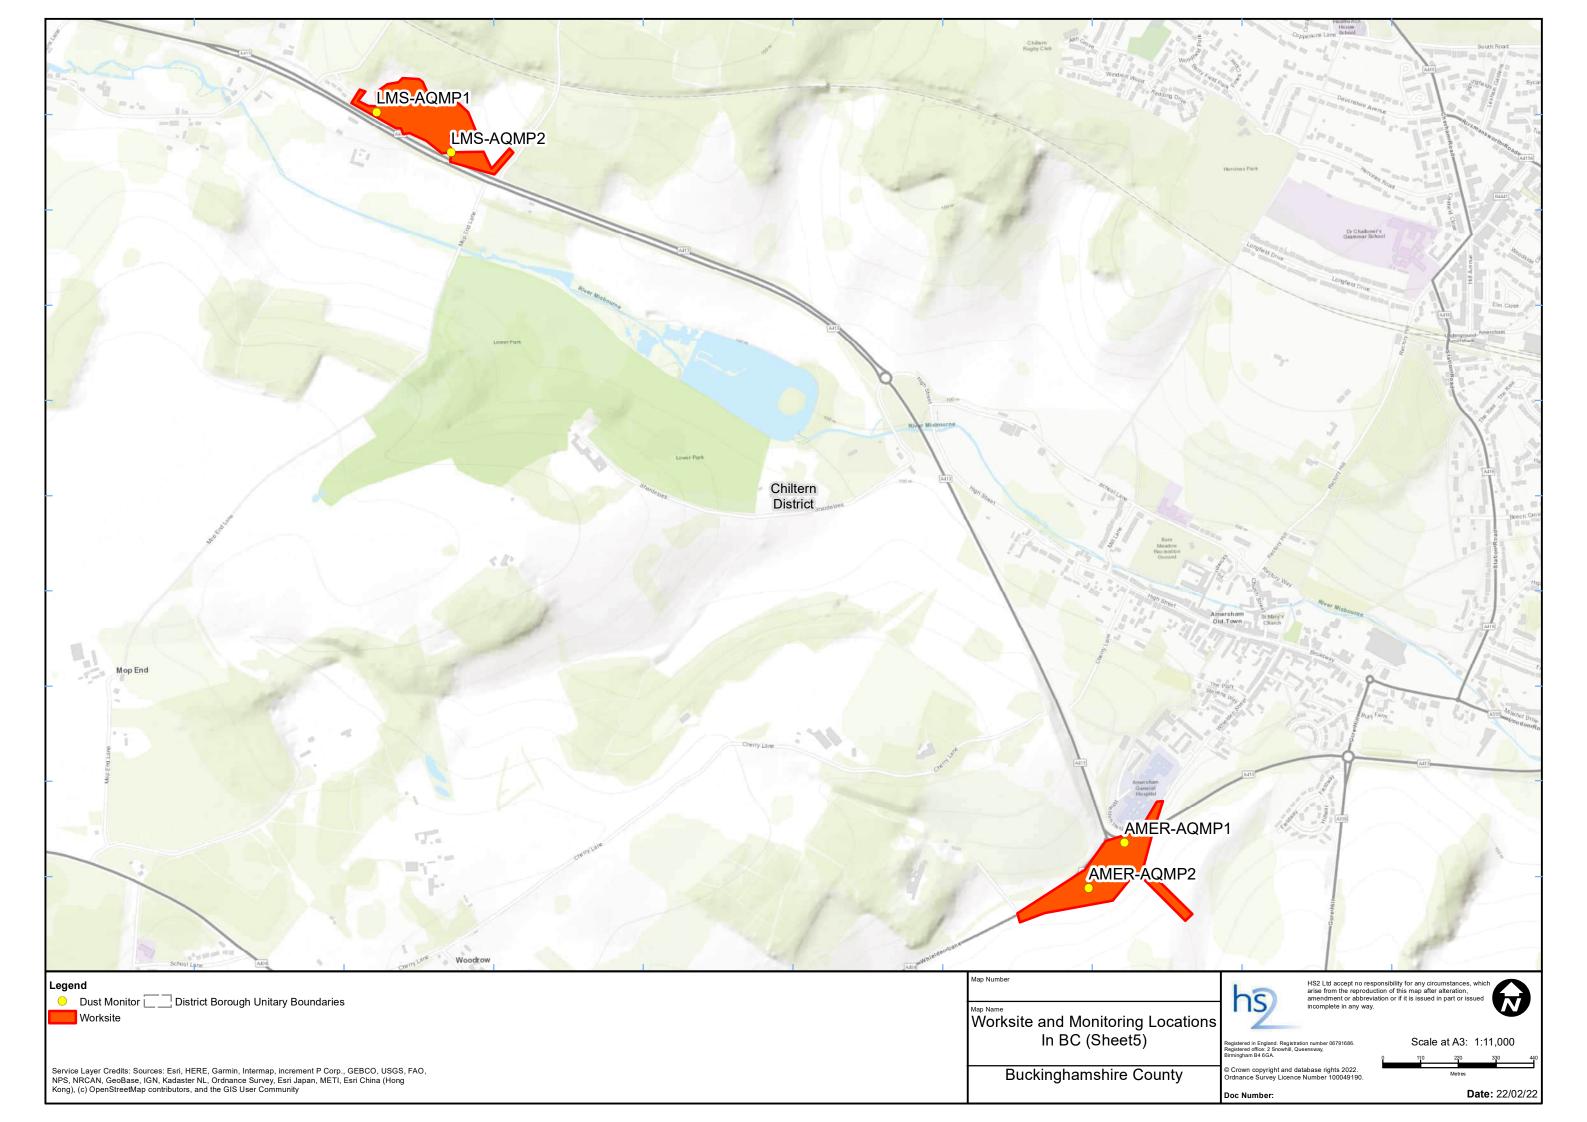
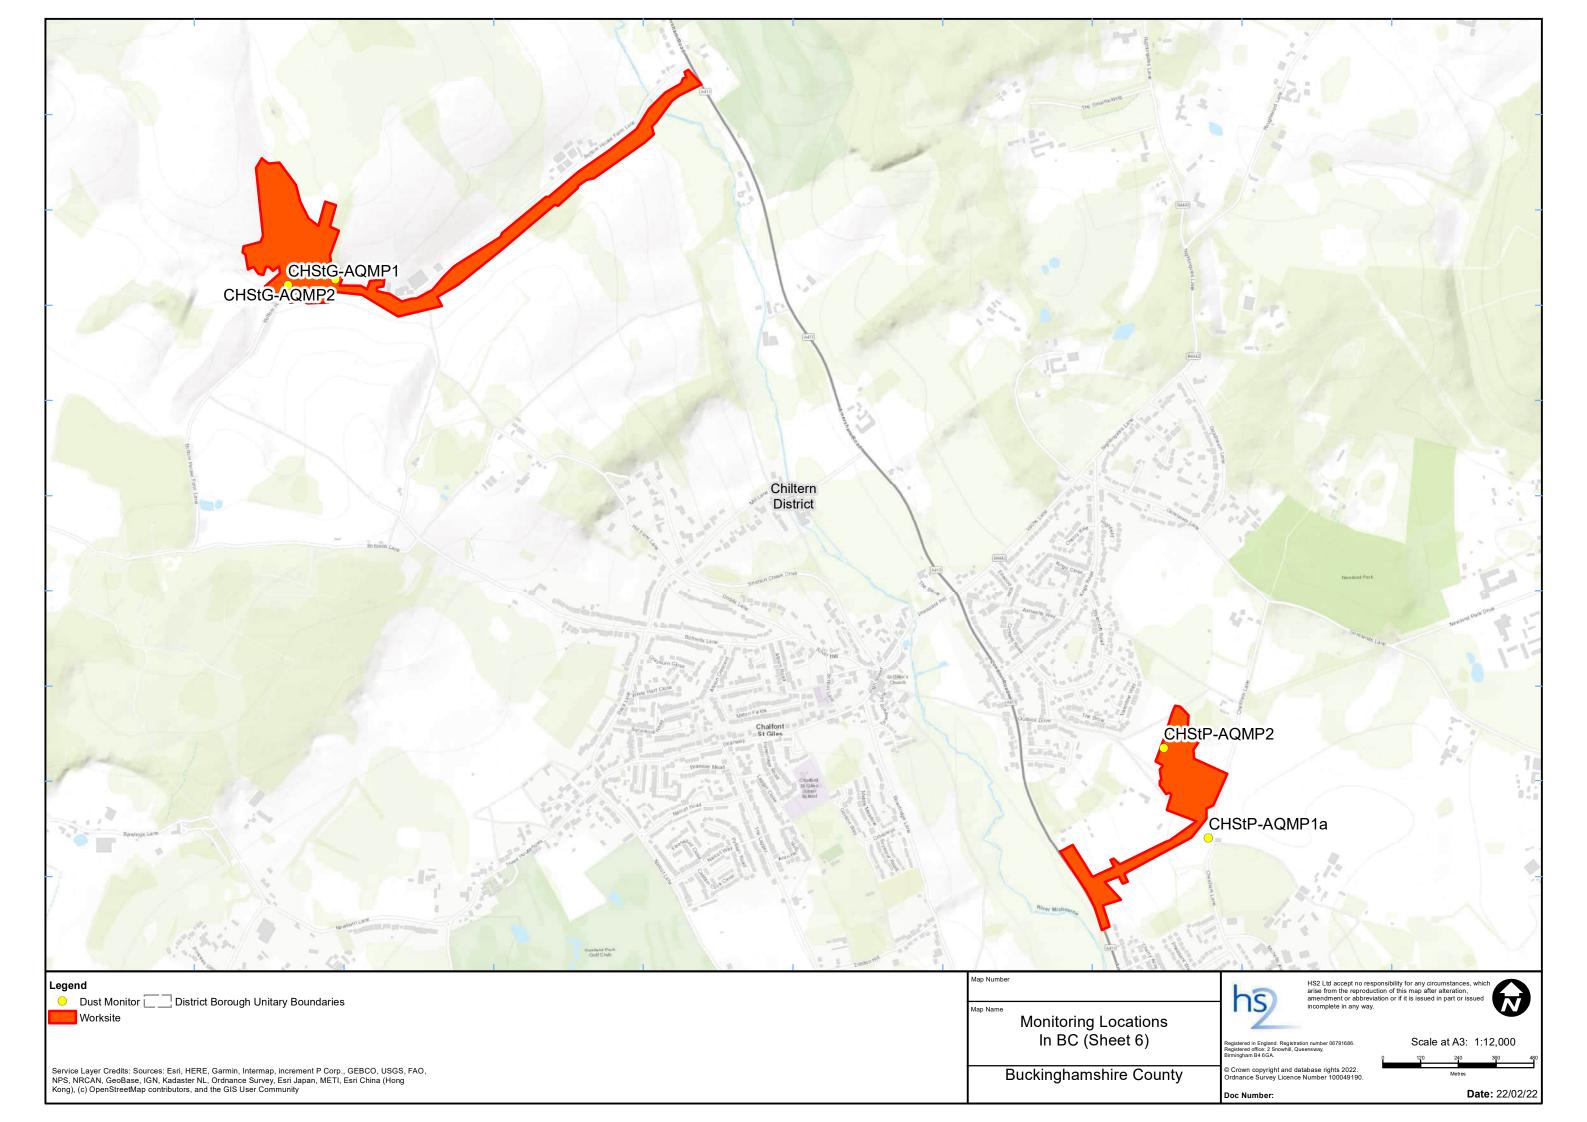
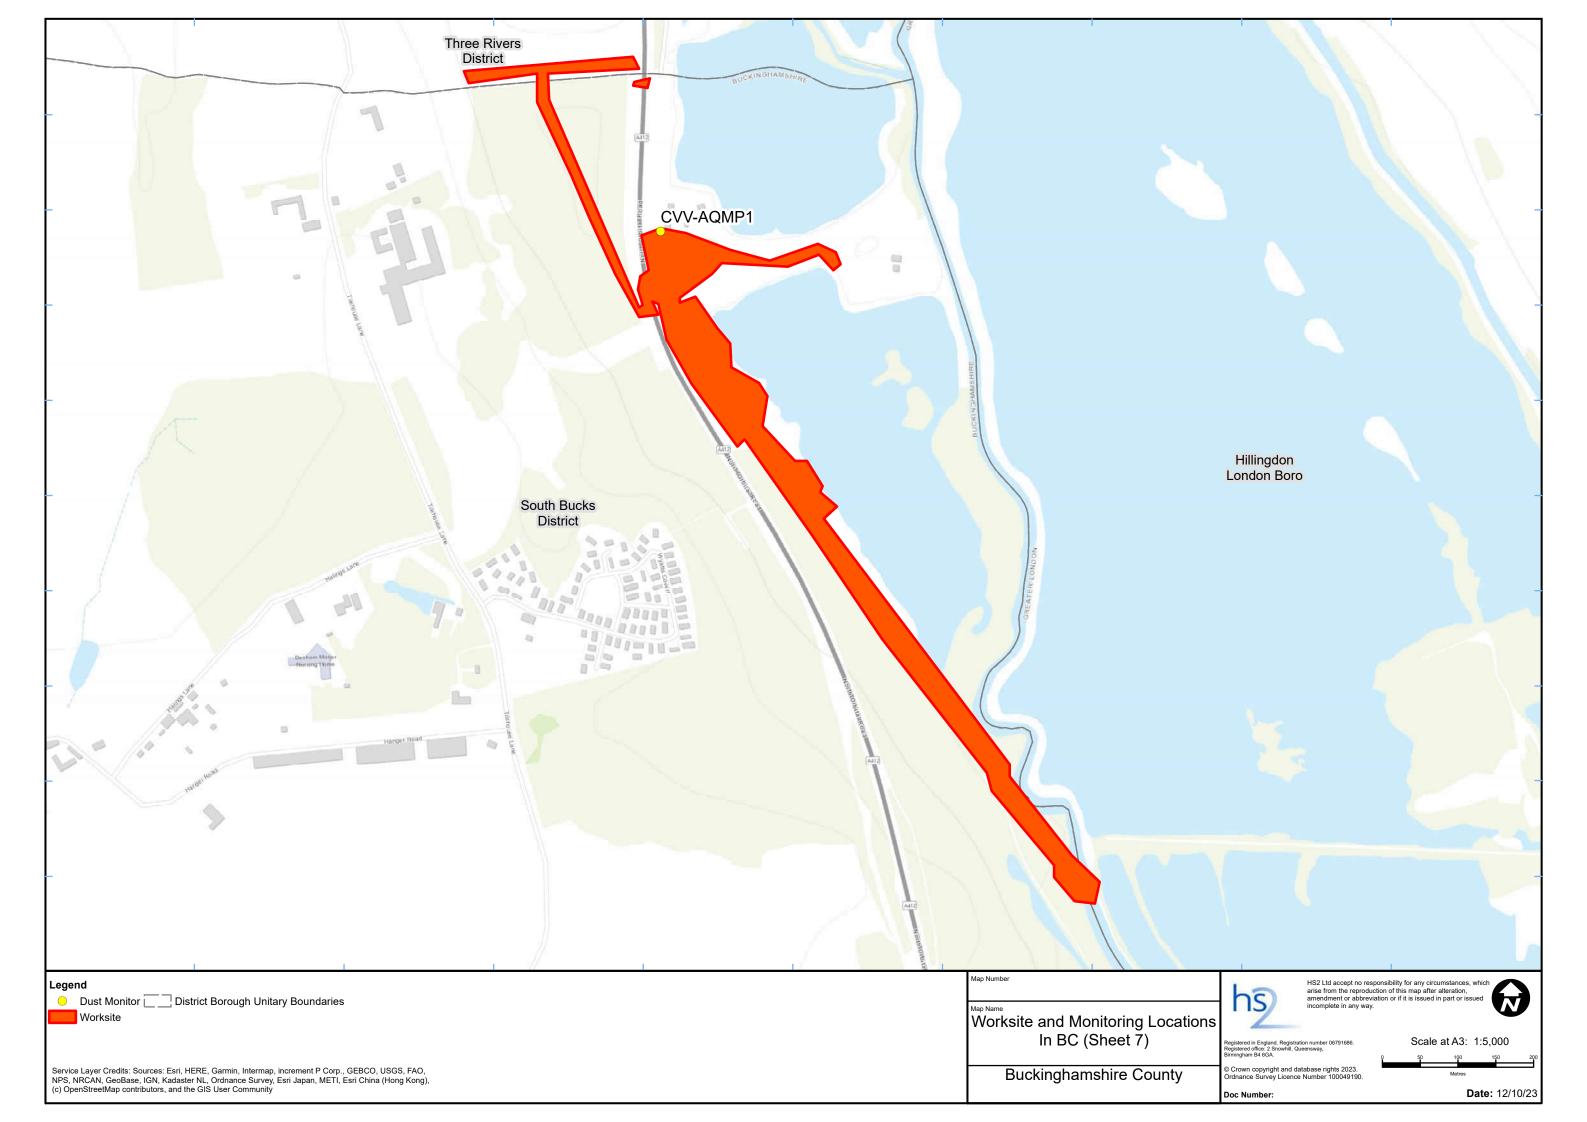
Figures 1-7: Worksite and Monitoring locations within BC

Appendix A - Worksite and Dust Monitoring Locations

- 1.1.1 This Summary Report is published in fulfilment of commitments detailed in the High-Speed Rail (London-West Midlands) Environmental Minimum Requirements, Annex 1: Code of Construction Practice, for the nominated undertaker to present the results of dust monitoring undertaken in the Buckinghamshire Council (BC) during November 2023.
- 1.1.2 Figures 1-7 in Appendix A present the current worksites together with the dust monitoring locations.
- 1.1.3 This summary should be read in conjunction with the overview monitoring report available from www.gov.uk/government/collections/monitoring-the-environmental-effects-of-hs2, which highlights the applicable standards and guidance, as well as the air quality and dust monitoring methodologies to be implemented by nominated undertakers throughout construction.
- 1.1.4 The current worksites, as presented in Appendix A, Figures 1-7, include:
