CAMP No 116 HATFIELD HEATH
 RESTORATION of MOWP
 STANDARD HUTS
 1:20/1:5 @ A2 10/27/11-D
 CC 296/116-1

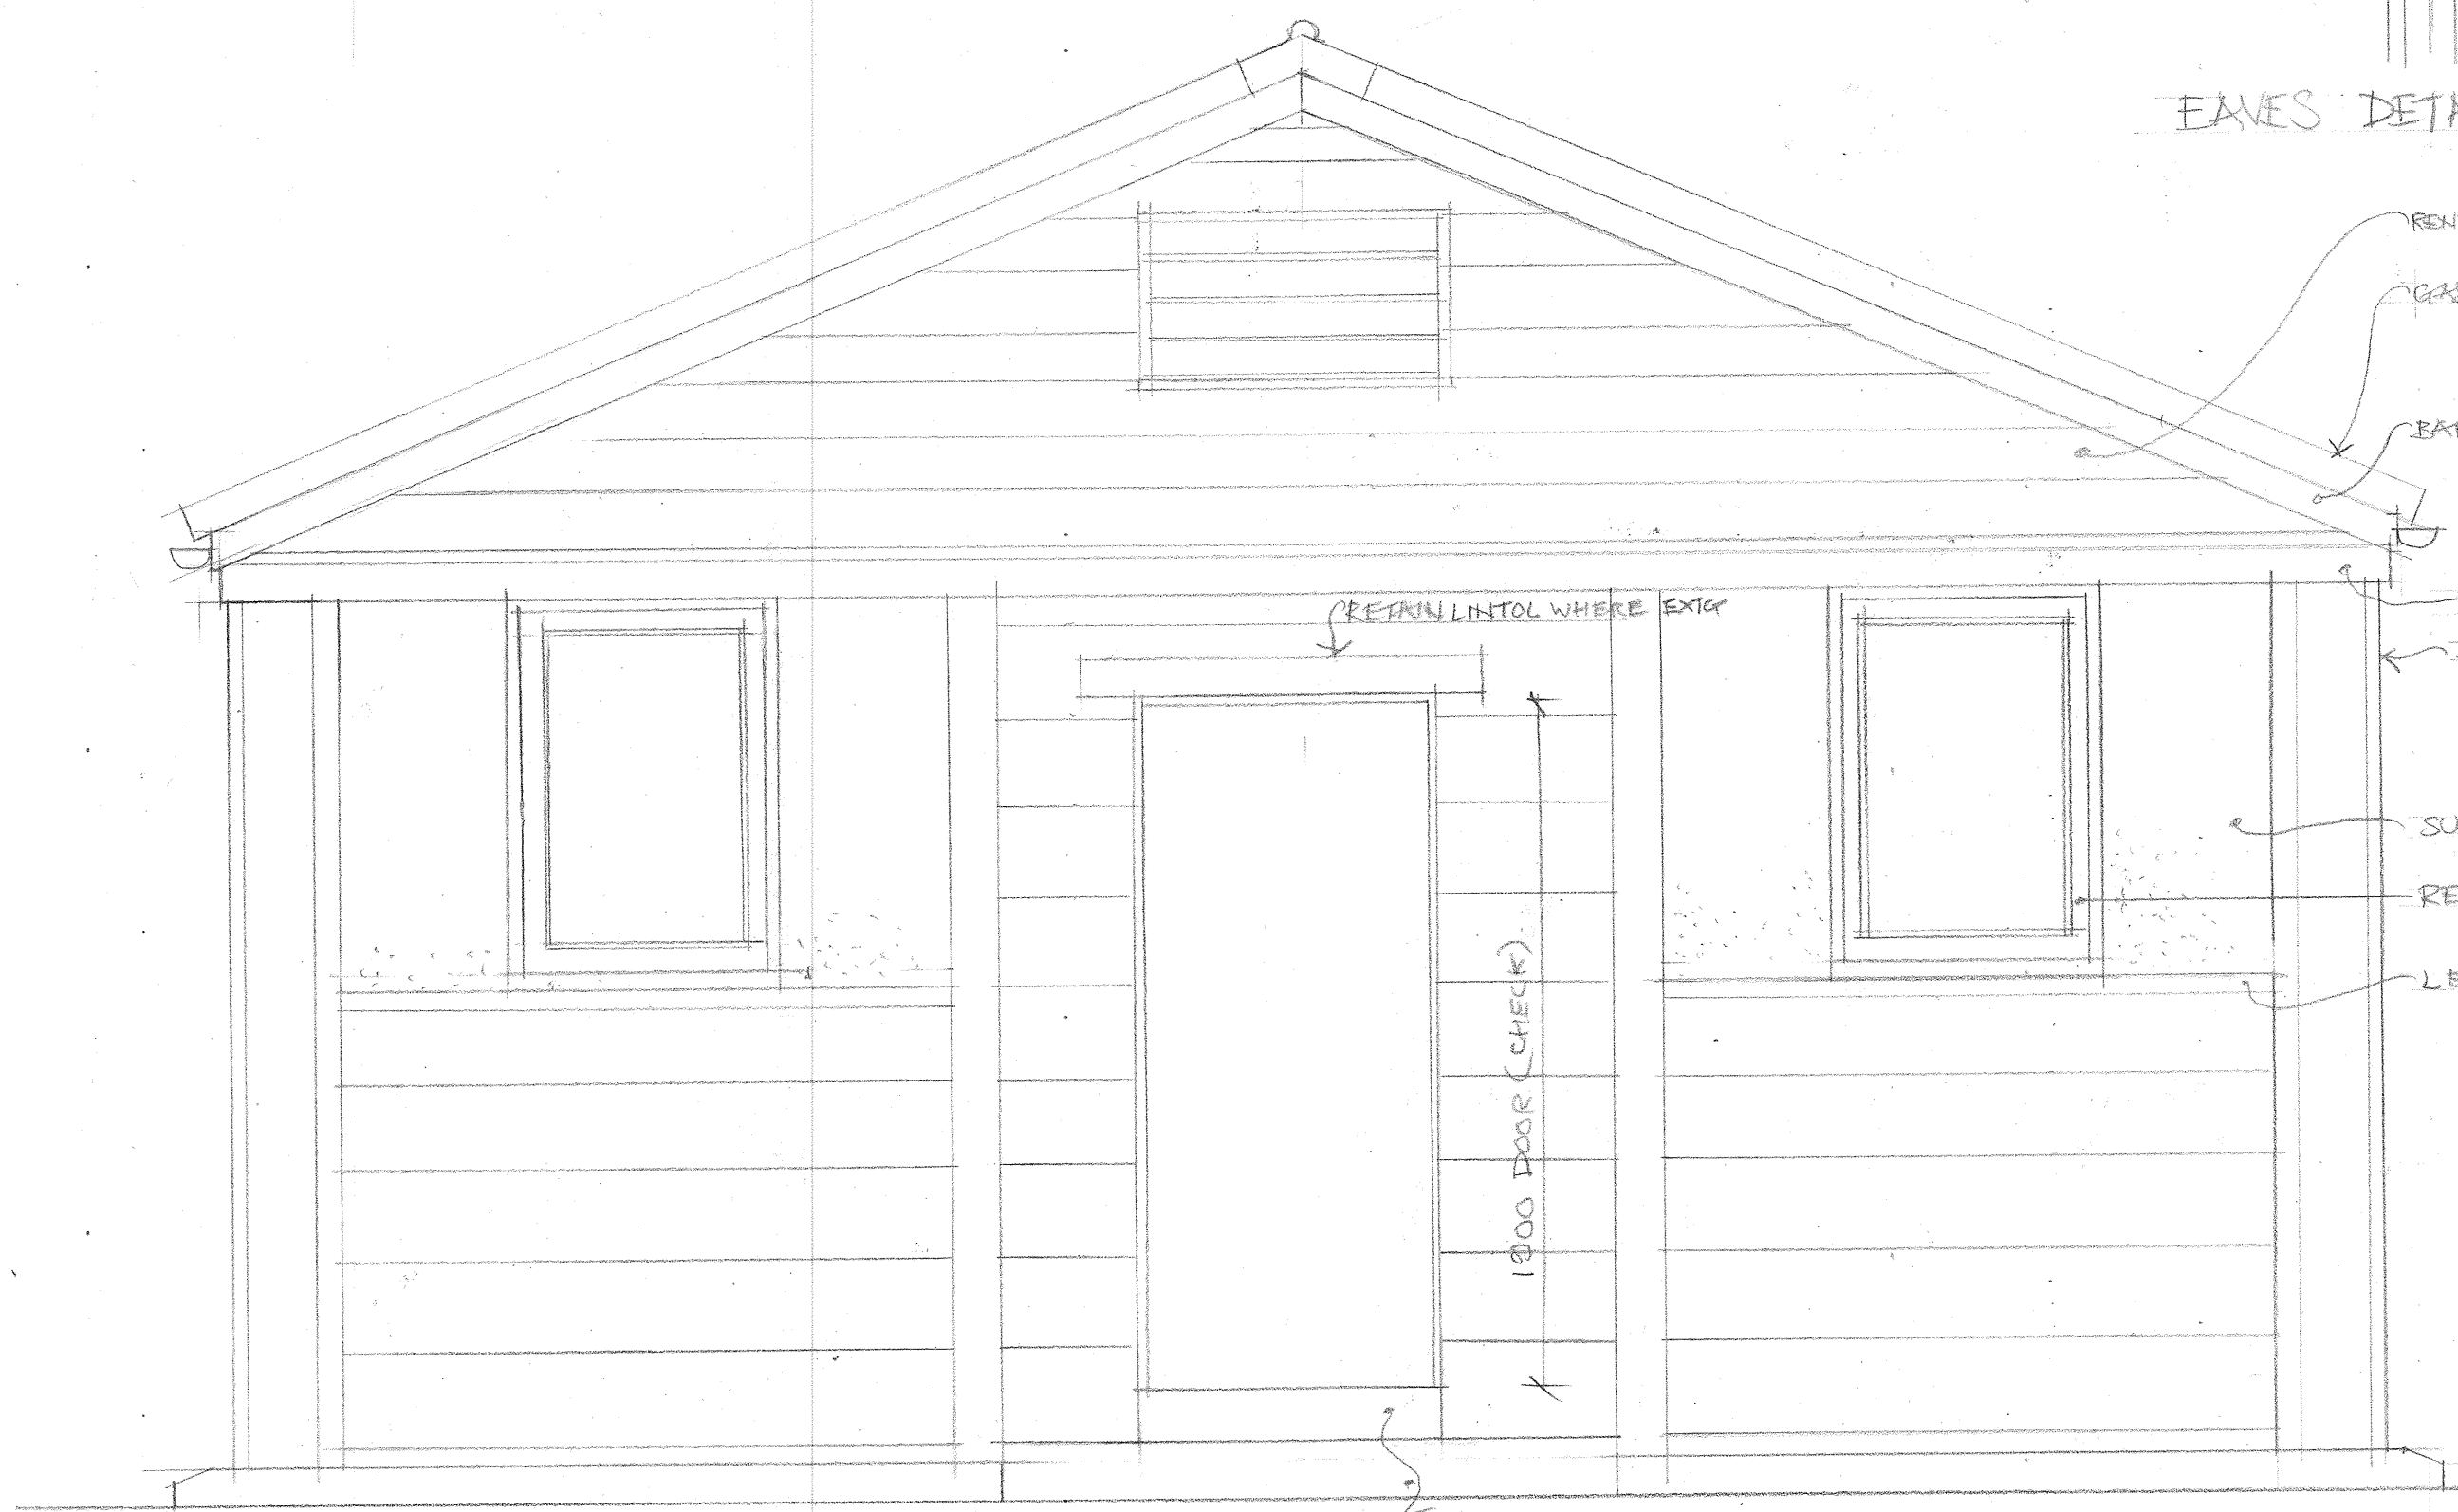
TYPICAL ELEVATION of END of HVT 1:20

- INS. CORR STEEL IN LIEU OF ASBESTOS
- PURLIN
- FASCIA ON GUSSETS
- CONCRETE EAVES BEAM
- TIMBER WINDOW
- INTERMEDIATE CONC POST
- RENEW TIMBER / BRICK AS APPROPRIATE
- GABLE FLASHING
- BARGE BOARD
- EXTG GABLE LINTOL
- EXTG CORNER POST
- SUPRUX SHEET IN LIEU OF ASBESTOS
- RENEW WINDOWS
- LEAD CILL
