Air Quality and Dust Monitoring Monthly Report – December 2023

London Borough of Camden

A report prepared by EWCs and MWCCs on behalf of HS2 Ltd.

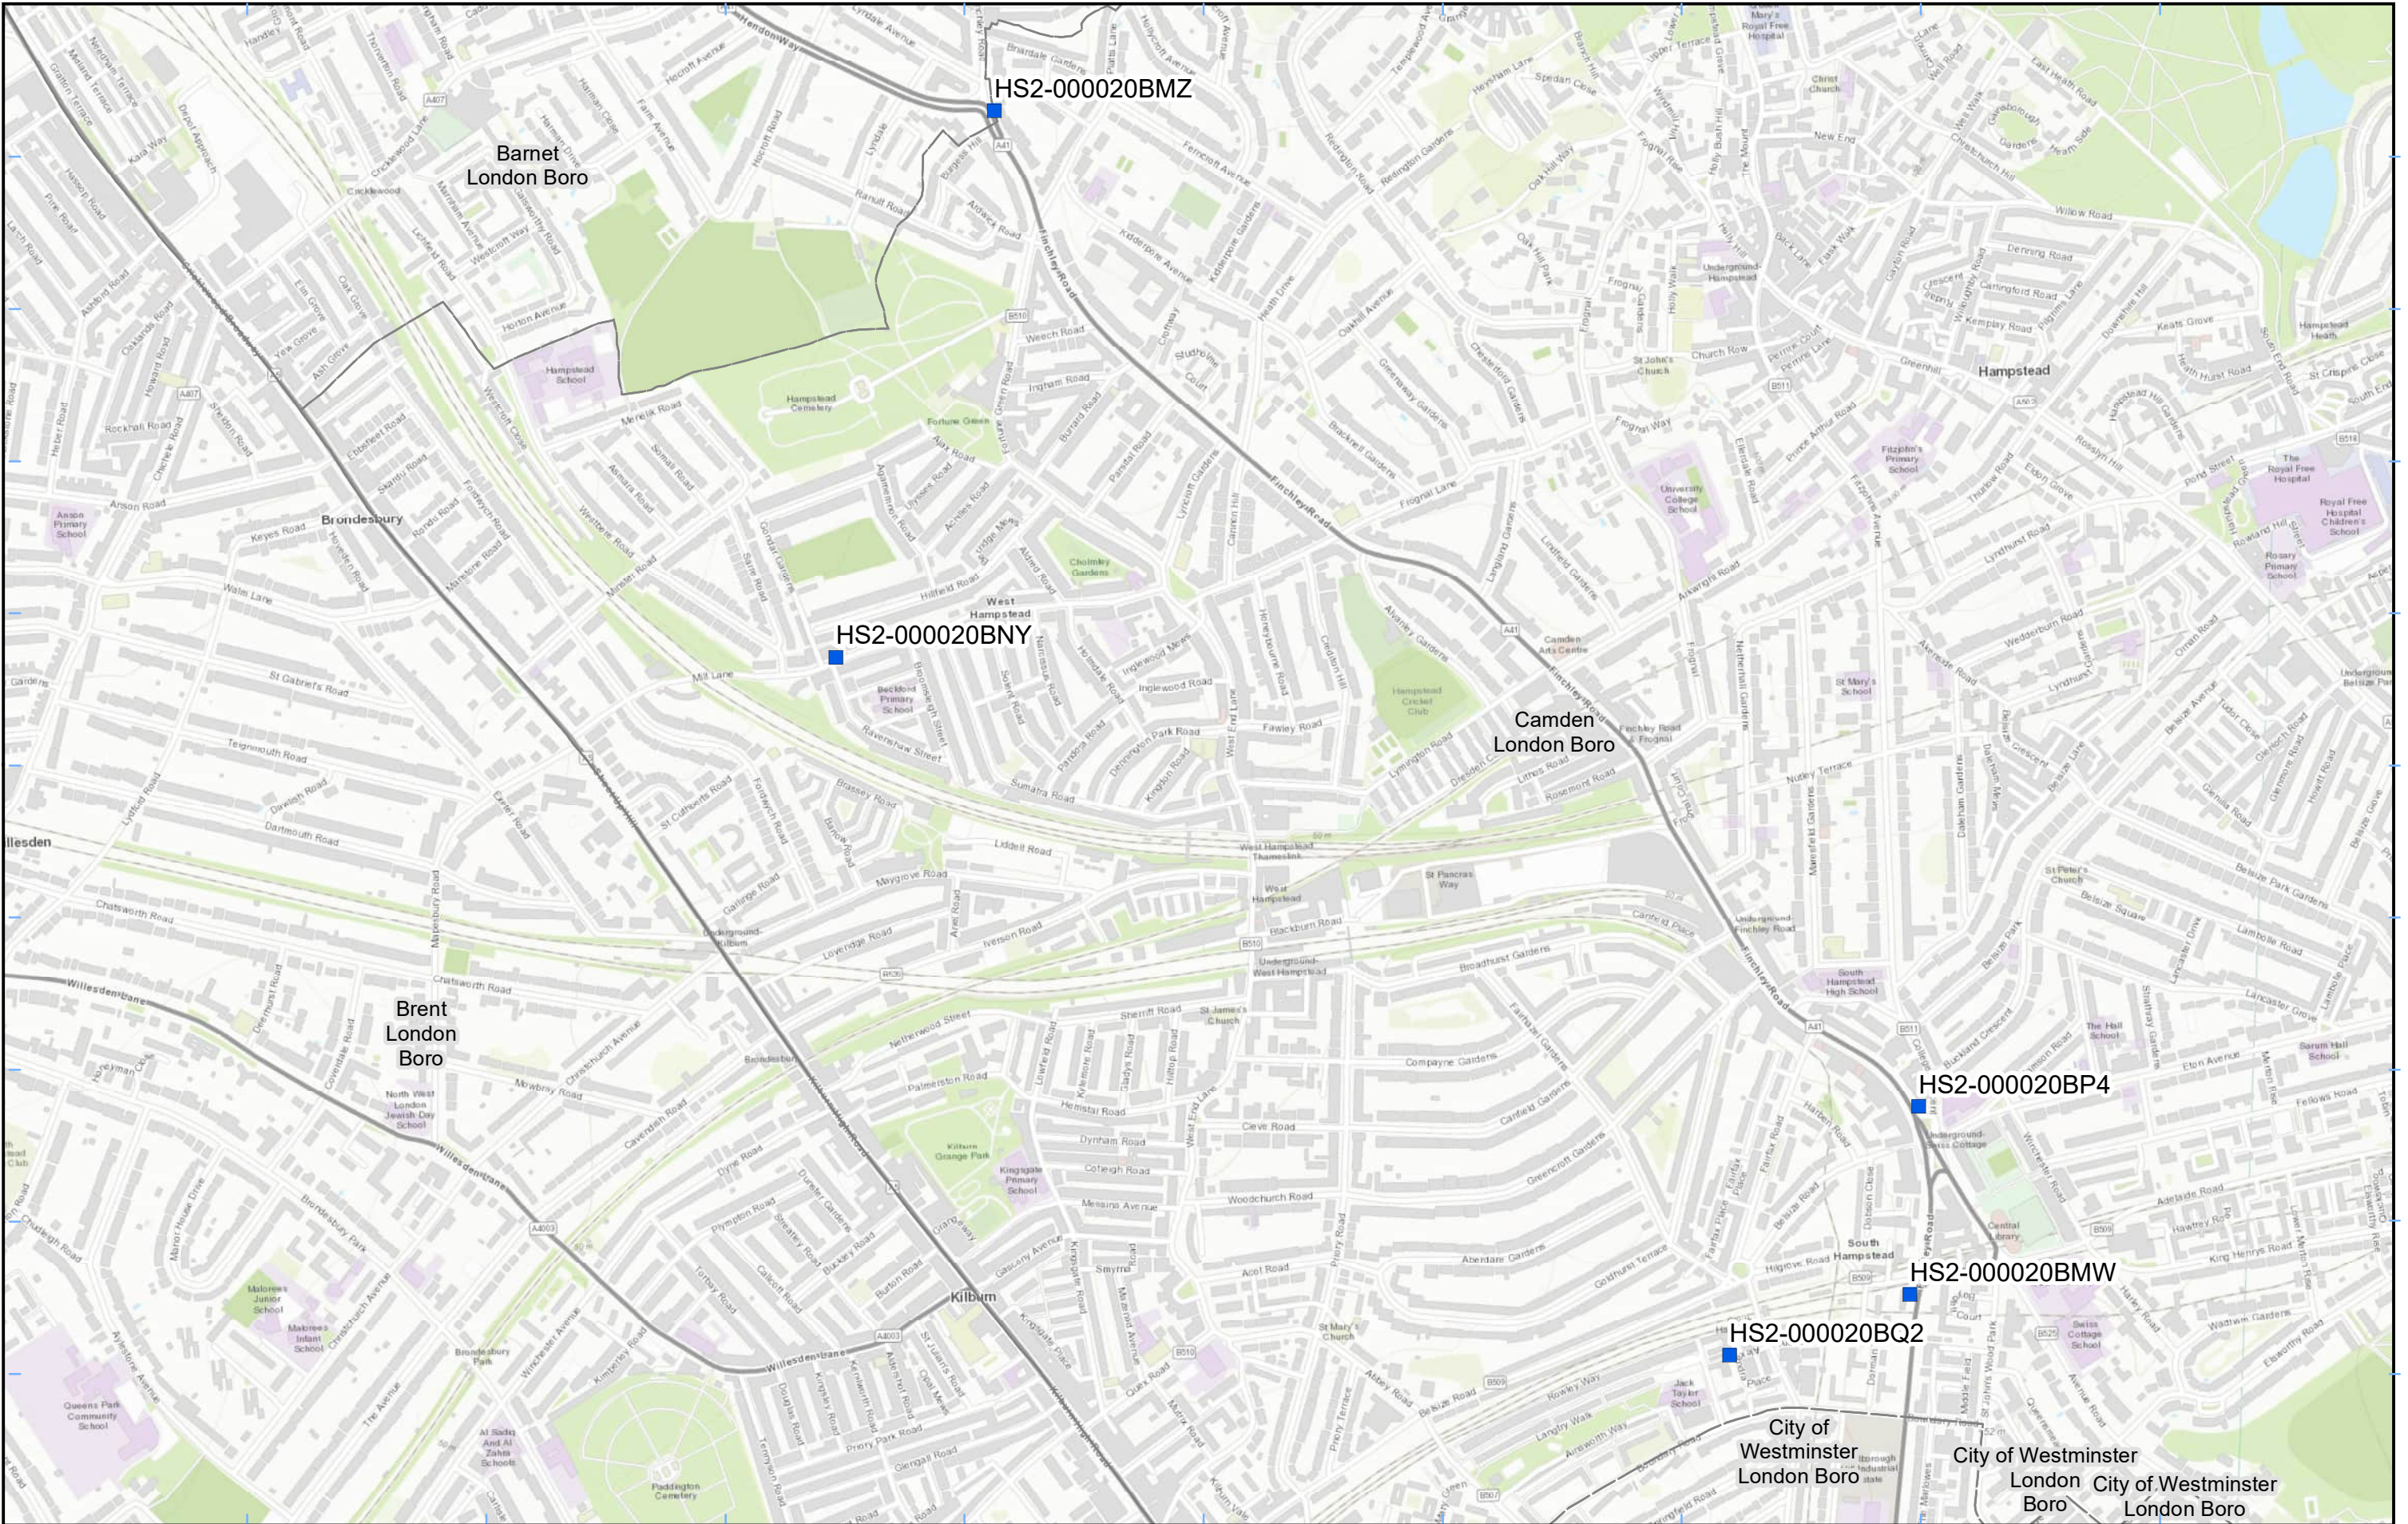
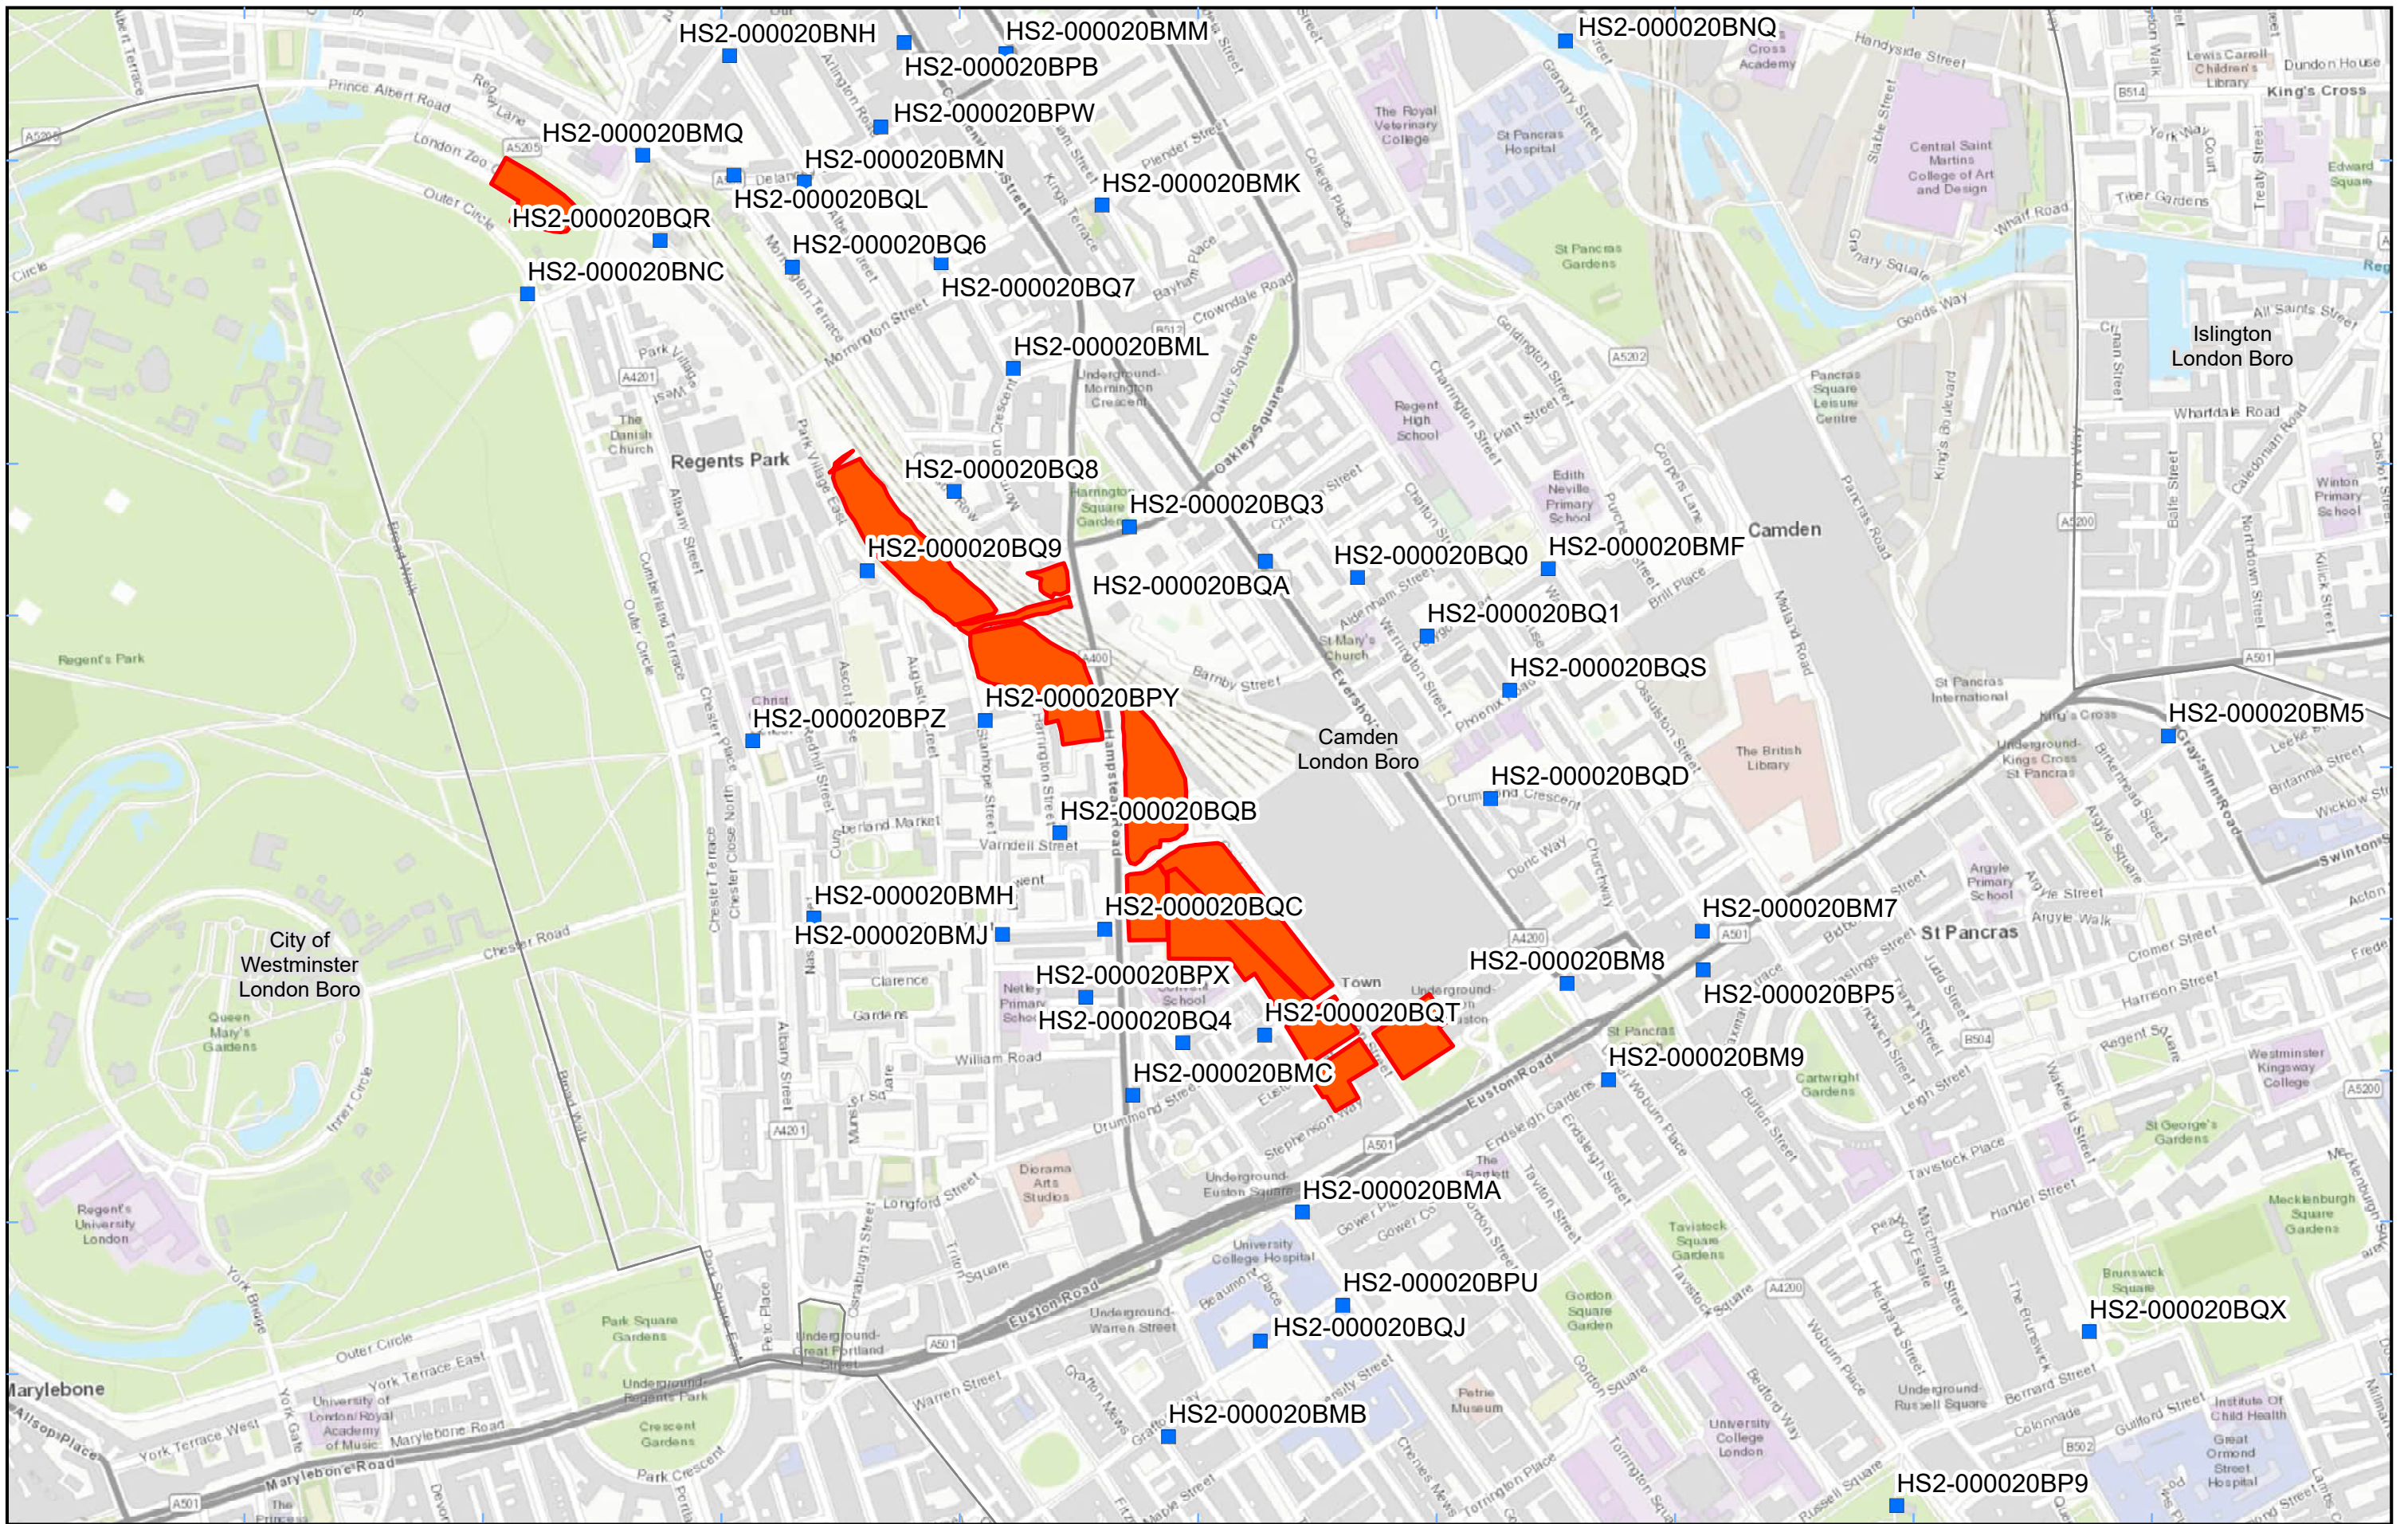
Figure 1 to Figure 5: Worksites and monitoring locations within the LBC

- 1.1.2 Figure 1 to Figure 5 in Appendix A present the current worksites together with air quality and dust monitoring locations.
- 1.1.3 This summary should be read in conjunction with the overview monitoring report available from www.gov.uk/government/collections/monitoring-the-environmental-effects-of-hs2, which highlights: the applicable standards and guidance, as well as the air quality and dust monitoring methodologies to be implemented by nominated undertakers throughout construction.

- 1.1.4 The current worksites, as presented in Appendix A, Figure 1 to Figure 5, include:
