Managing Older Buildings:

A guide for estates maintenance staff

April 2024

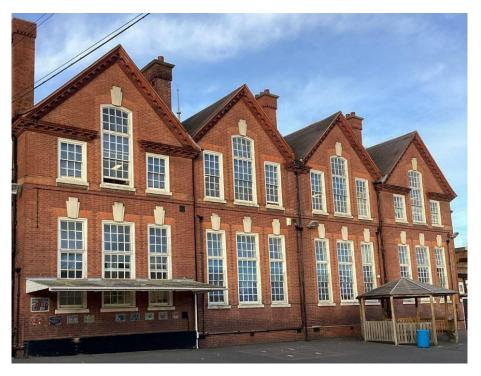
Figure 1: Example of pre-war traditional school construction

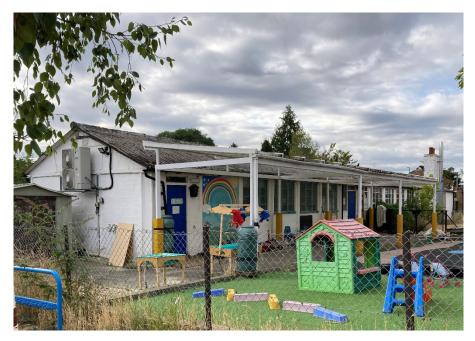
HORSA huts are beyond their expected lifespan and require careful maintenance.

Figure 2: Example of a HORSA hut

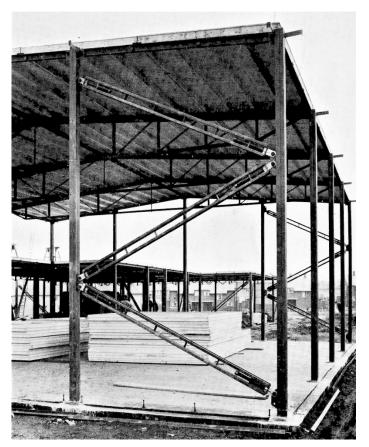
In some cases, the consortia developed a single system, for example CLASP (with its distinctive bracing design). In other cases, they developed a range of solutions using different materials, for example SEAC (steel, concrete and masonry systems). Private suppliers included Orlit and Derwent (also known as Vic Hallam). Further details of these systems are provided in Appendix A.

Figure 3: Example of a post-war system build (CLASP)

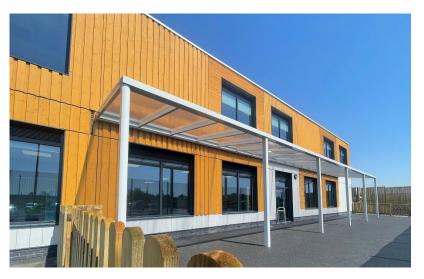
Figure 6: Example of a completed school using MMC/DfMA

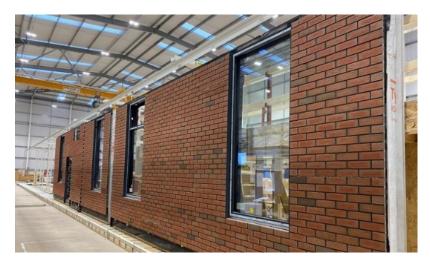
Figure 7: Example of MMC/DfMA off-site manufacture

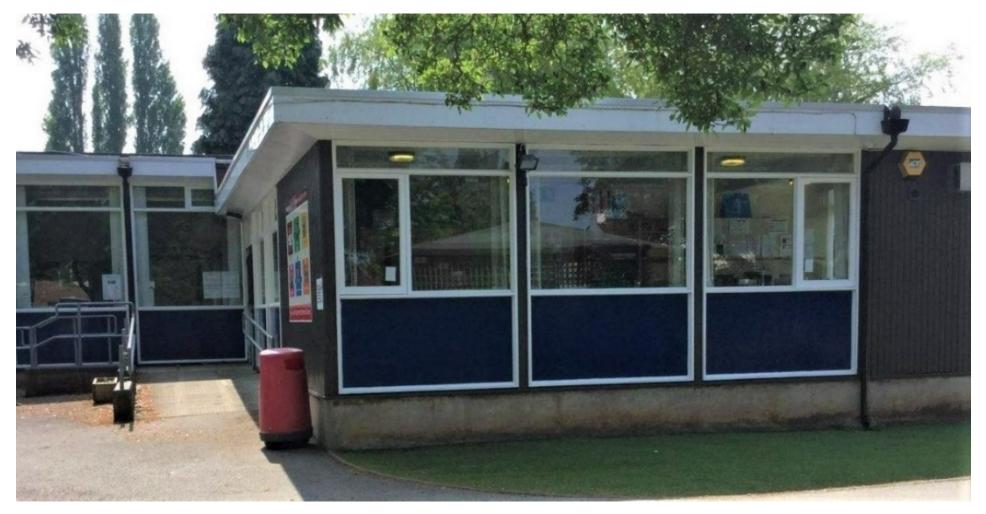
Figure 8: Example of Derwent school accommodation

Foundations	Vary to suit ground type/conditions
Ground floor	Concrete
Upper floors	Timber plywood on battens
Roof	Timber plywood on battens with 12° pitch
Vertical structure	Timber columns with some load bearing timber panels
Horizontal stability	Infill timber panels
Planning grid	6' 4" (1,930mm)
Structural grid	6' 4" (1,930mm)
Planning height	1' 4" (406mm)
Typical column size	4" (102mm)
Typical beam size	Varies

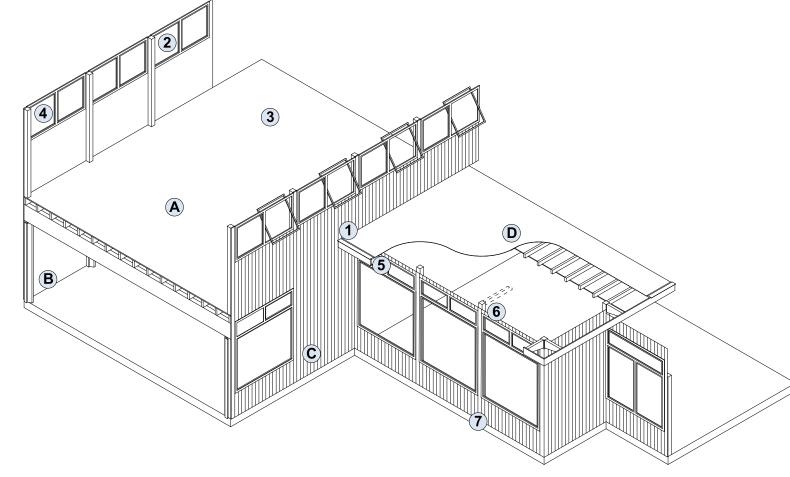
The sketch below outlines the defining characteristics of a Derwent building and indicates where inspection should be carried out to identify common maintenance items with this construction type. The items shown should be cross referenced against Part 2 and Appendix B of this document.

Identifying features:

- 1 Cladding materials: vertical timber boarding, brick, stonework and sheet materials (e.g., plywood)
- 2 Panel module: 6' (1.8m) panel width and 4" (100mm) column
- 3 Plywood sheeting
- 4 Column details see overleaf
- 5 500mm overhanging eaves
- 6 Column roof purlin connection
- 7 Indicative location of column base

- A Decay of columns leads to movement of beams and uneven floors
- B Wet rot at base of column due to water ingress
- C Decay of timber columns can lead to column failure, distortion of external elevations and bulges in the exterior timber cladding
- D Wet rot to roof structure due to water ingress

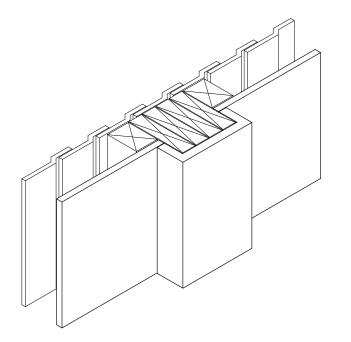
Column profile:

Columns on the ground floor of a single storey building and first floor of a two-storey building are formed from small timber sections, typically four no. 4" x 1" timbers and are susceptible to decay.

Figure 10: Column profile

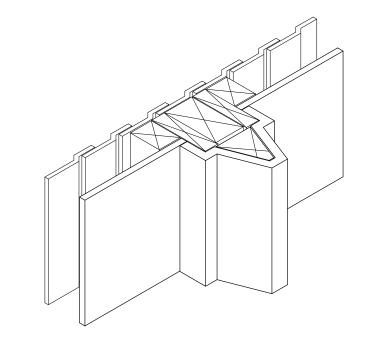
Column profile with tapered fin:

Columns on the ground floor of a two-storey building are likewise formed from small timber sections and have an additional tapered fin attached to the main column to support the first-floor beam.

Figure 11: Column profile: tapered fin

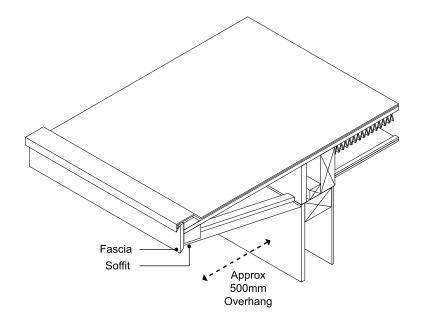
Eaves detail identifying feature:

Typical 500mm overhanging eaves with timber fascia, external rainwater pipes and $^{3}/_{16}$ " plywood soffit.

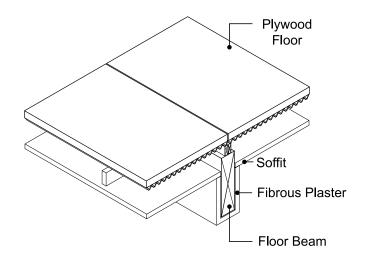
Floor beam: typical identifying feature:

Solid laminated timber floor beam with cross battens supporting plywood floor. Cellular plasterboard soffit secured to underside of battens and beams encased with fibrous plaster to provide 30-minute fire protection.

Figure 14: Floor beam

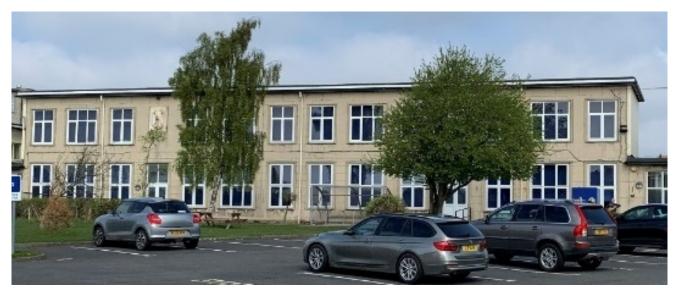
Figure 15: Example of Orlit school accommodation

Orlit was the design concept of Czech architect, Erwin Katona. It was originally designed as a precast concrete framed structure for housing, and externally clad with 2-inch reinforced concrete hollow blocks. Orlit houses are classified as 'defective'⁴ in England and Wales and have typically been subject to extensive repairs or demolished.

Foundations	Concrete
Ground floor	Concrete
Upper floors	Timber plywood on battens, on secondary concrete beams
Roof	Precast concrete slabs on precast concrete secondary beams, with screed to falls and asphalt or bituminous felt covering. Pitched roof option: timber or steel structure, tiled finish
Vertical structure	Precast concrete columns
Horizontal stability	Precast concrete secondary beams or (where there is a concrete floor) precast inverted channel floor slabs
Planning grid	Variable
Structural grid	Columns at 10' (3.050m) or 12' (3.660m) centres
Planning height	Variable
Typical column size	5½" square (140mm)
Typical beam size	Primary: 8" depth (200mm) Secondary: 7" x 4" (178 x 102mm) at 4' (1220mm) centres

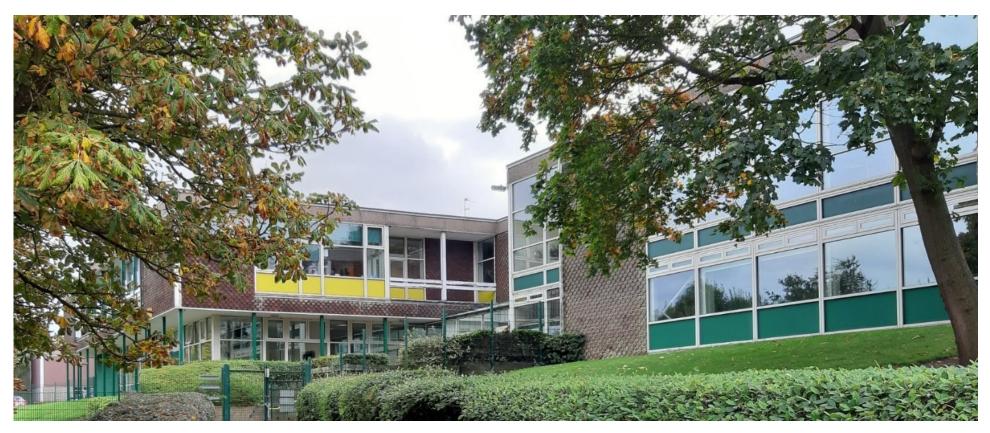
Figure 17: School constructed with CLASP

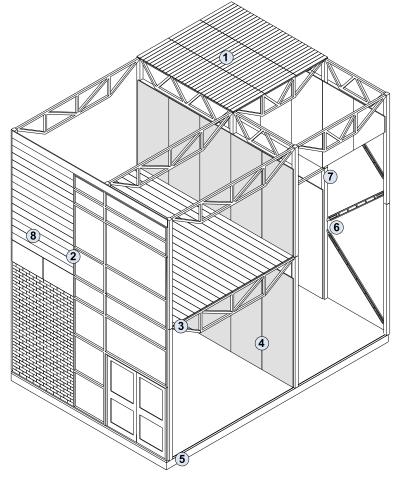
The sketch below outlines the defining characteristics of a CLASP building and indicates where inspection should be carried out to identify common maintenance items of this construction type. The items shown should be cross referenced against Part 2 and Appendix B of this document.

Identifying features:

- 1 Roof: prefabricated timber panels formed of ³⁄₄" boards nailed to joists with 3 layers bituminous felt & ¹⁄₂" gravel chippings
- 2 Window cills set at 2', 2' 8" or 3' 4" above finish floor level (FFL). Transoms and door heads at 6' 8" above FFL
- 3 Floor finish: 1¹/₂" x 4" t&g boarding spanning 3' 4" between steel secondary beams

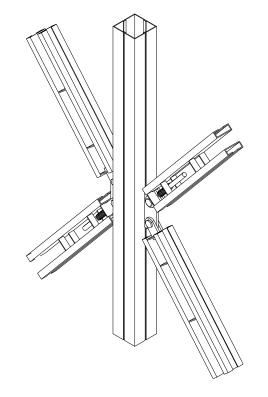
Wind bracing identifying feature:

Spring loaded steel bracing incorporating a pair of heavy coil compression springs was unique to CLASP. This is generally concealed within external walls and partitions but is occasionally exposed.

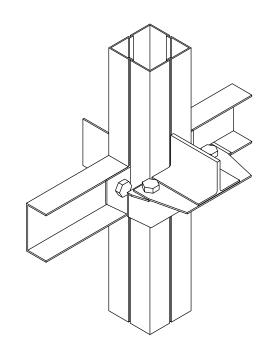
Figure 20: Column/beam connection
