Chase New Homes Limited

**Friends School, Saffron
Walden**
Desk Study Report – Revision 1

June, 2024

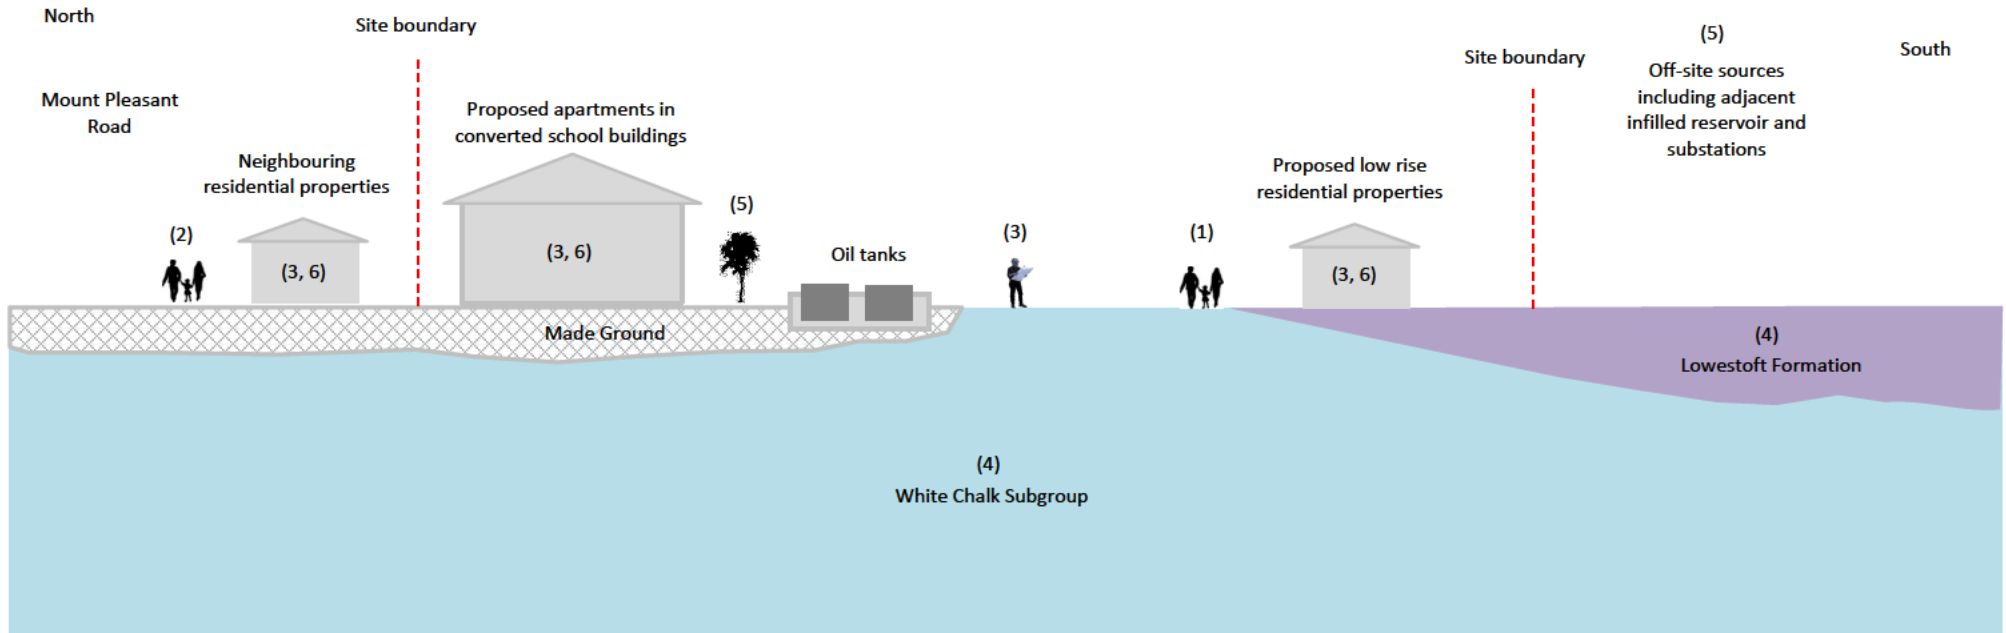
| | <p>Title</p> <p>Preliminary Conceptual Site Model</p> | <p>Figure No.</p> <p>Figure 3</p> |

5. Migration on to site of contamination from nearby off-site sources → **Low to medium risk**
6. Ingress and accumulation of ground gases and vapours, from on-site or off-site sources, in internal spaces → **Low to medium risk**

7. Root uptake of phytotoxic contaminants by plants and vegetation → **Low risk**

A preliminary conceptual site model (CSM) has been compiled based on the findings of the desk study and walkover to identify the potential sources of contamination and associated potential pollutant linkages which have been considered for the site. A pictorial representation of the preliminary CSM is included as Figure 3.
