Accident

Aircraft Type and Registration:	AW189, G-FSAR	
No & Type of Engines:	2 General Electric Co CT7-2E1 turboshaft engines	
Year of Manufacture:	2015 (Serial no: 89004)	
Date & Time (UTC):	22 July 2024 at 2050 hrs	
Location:	Approx 190 nm East of Stanley Airfield, Falkland Islands	
Type of Flight:	Search and Rescue	
Persons on Board:	Crew - 4	Passengers - 1
Injuries:	Crew - 1 minor	Passengers - 1 missing
Nature of Damage:	None reported	
Commander's Licence:	Airline Transport Pilot's Licence	
Commander's Age:	45 years	
Commander's Flying Experience:	4,257 hours (of which 1,260 were on type) Last 90 days - 28 hours Last 28 days - 2 hours	
Information Source:	Aircraft Accident Report Form submitted by the pilot

Synopsis

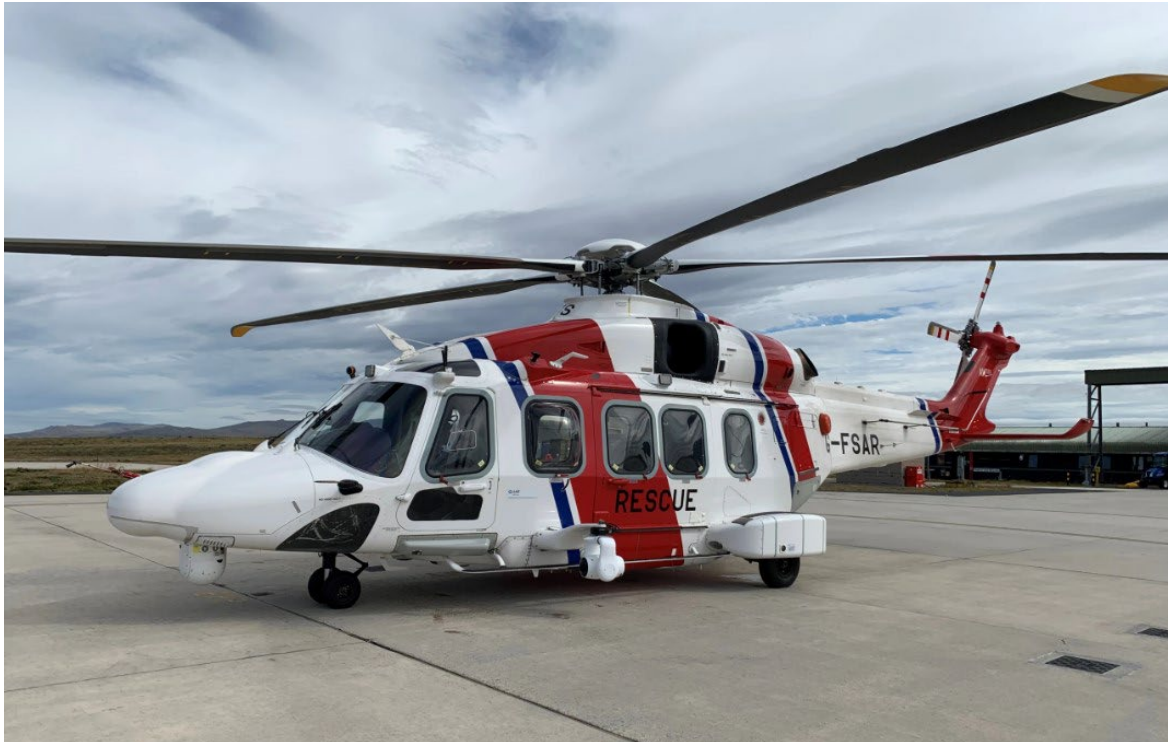
Figure 1

AW 189 SAR Aircraft

The AW 189 Search and Rescue (SAR) aircraft in the Falkland Islands (Figure 1) are contracted to the Ministry of Defence (MOD) and their operations are directed by the military Joint Operations Centre (JOC) at Mount Pleasant Airport (MPA). At the SAR shift handover briefing on 22 July, the commander was informed that a fishing vessel was in distress 213 nm east of MPA. With the option of a refuel at Stanley Airfield the commander considered that it may be possible to operate to that range with sufficient time on scene to recover at least some of the crew. Non-essential equipment was offloaded from the aircraft to allow it to pick up eight casualties without exceeding its maximum permitted mass. The vessel was 187 nm from Stanley. The commander calculated that with a forecast wind of 270° at 40 to 50 kt the aircraft could achieve 190 nm max range with 20 minutes on task. The commander asked the off going duty pilot to confirm his calculations before offering the capability to the JOC. Shortly after receiving the information the JOC tasked the crew to respond and informed them that the engine room of the vessel was taking on water and that the ship's crew were preparing to abandon the vessel.
